# WASHINGTON STATE'S BRIDGE SEISMIC RETROFIT PROGRAM

## Abstract

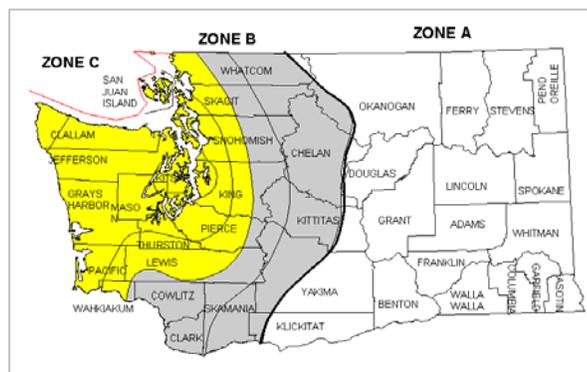
WSDOT uses a map to identify different seismic zones with peak ground accelerations (PGA) in Washington based on USGS information. "Zone C" is considered "High Risk" and covers the area with PGA greater than 0.20 times the force of gravity. "Zone B" is considered "Moderate Risk" and contains an area of PGA between 0.10 and 0.20 times the force of gravity. "Zone A" is considered "Low Risk" and contains an area of PGA less than 0.10 times the force of gravity.

**WSDOT SEISMIC ZONE MAP**

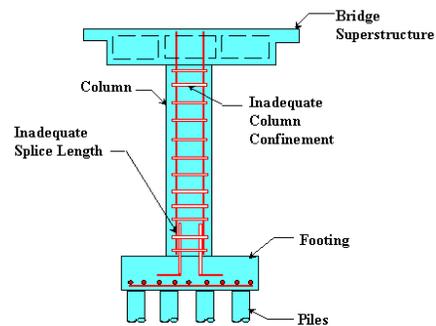
1. Inadequate confinement reinforcement for main longitudinal reinforcing steel in concrete columns.
2. Inadequate splice length of main longitudinal column reinforcing to footing dowels.
3. Inadequate development length of footing dowels (footing embedment).
4. Absence of reinforcement in the tops of footings.
5. Inadequate footing support capacity.

**TYPICAL COLUMN DEFICIENCIES**

The first three items were easily identified by a review of the bridge plans. Splice and confinement reinforcing, design, and detailing practices have changed so significantly that vulnerability is more of a yes or no determination rather than a degree of deficiency. The same is true of reinforcing in the tops of footings. Footing support adequacy is a function of the column retrofit scheme selected and existing footing's capacity to withstand the forces from a design earthquake. Footing retrofit techniques are expensive relative to the cost of retrofitting superstructures and columns.

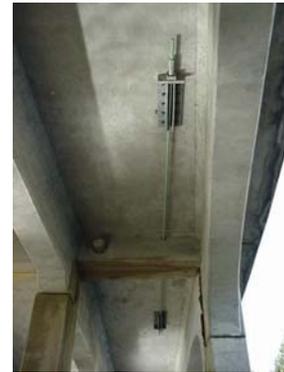
Techniques for restraining longitudinal and transverse movement of bridge superstructures typically include various combinations of restraining bars, hold downs, and reinforced concrete stops and thrust blocks. Replacement or modification of vulnerable bearing types have also been done. Bridges requiring this work are essentially done.

**LONGITUDINAL  
RESTRAINER**

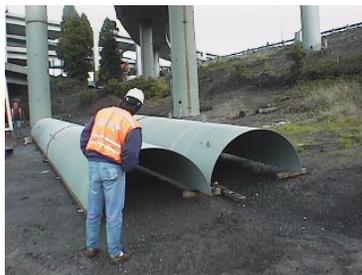
Past earthquakes and experimental tests have shown that concrete columns on pre-1983 bridges are vulnerable to brittle failure if exposed to a significant seismic event. Column jacketing permits ductile behavior of the bridge during an earthquake by providing additional shear capacity and confinement thus allowing the formation of plastic hinges at one or both ends of the column.

**COLUMN RETROFIT STEEL**

The primary material used by WSDOT to retrofit concrete columns is welded steel jackets. The process includes using two steel sections that are attached around a column and then welded together. Thickness of the steel jacket is determined by the size of the existing columns. Composite materials such as carbon fiber and fiber reinforced polymers (FRP) were installed on 9 bridges but was discontinued since the cost was 2 to 3 times more than steel.

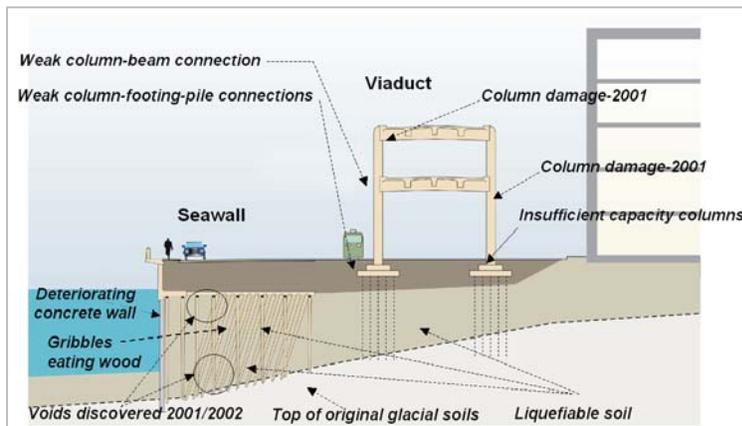
Post-earthquake inspections of the viaduct revealed both good and bad news concerning its condition. The good news was that the viaduct survived the 6.8 magnitude earthquake. The bad news was the earthquake caused damage to the viaduct's joints and columns, further weakening the structure and revealing its severe vulnerability. The team of experts concluded that it was not cost-effective to fully retrofit the majority of the viaduct; rather, the viaduct would need to be rebuilt or replaced.

**ALASKAN WAY VIADUCT – VUNERABILITY AREAS**

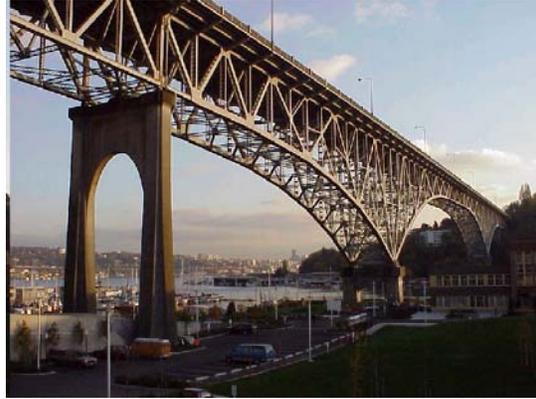
The George Washington Bridge is a long-span cantilever truss structure spanning the Lake Washington ship canal at the entrance to Lake Union in Seattle. The structure was designed and built between 1929 and 1931. The 800 ft. long main span is one of Seattle's longest and tallest spans and is currently registered as one of four Historic Bridges in King County. The bridge carries 6 lanes of arterial traffic averaging 73,836 vehicles a day. The Aurora Bridge has been designated as a critical emergency route and is considered an essential bridge by the Seattle Engineering Department Traffic Section.

**GEORGE WASHINGTON BRIDGE**

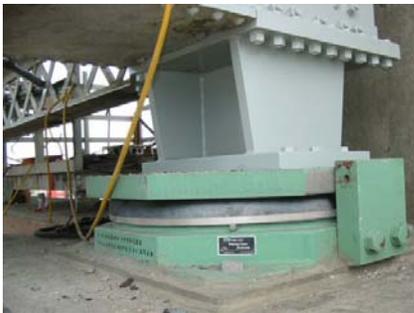
WSDOT decided to address the seismic deficiencies in three separate projects due to the total retrofit cost. The first stage project added restrainers to the bridge and was completed in 2000 at a cost of \$2.1 million. The second stage retrofit work included replacing 24 existing rocker bearings with friction pendulum base isolation bearings. These bearings are designed to mitigate the deficiencies of columns at piers S-3 to N-3 (inclusive) and deficient members in the main truss spans. The expansion joints were replaced to allow greater movement in a seismic event. A couple of the lower cord truss members were also replaced. The second stage project was completed in 2004 at a cost of \$7.3 million.

**FRICTION PENDULUM BEARING**

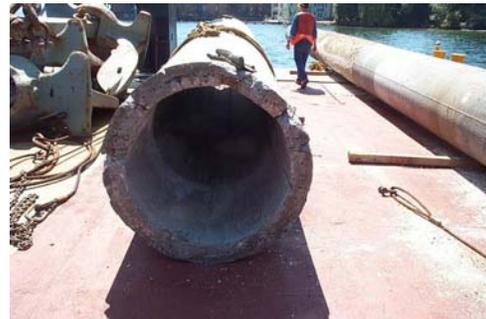
A second, and possibly more severe deficiency could result from spalling of the interior surface of the piles at fairly low lateral displacements and modest pile curvature (flexural rotation induced by lateral seismic loads). The concrete inner surface is unconfined and under compressive strains as low as 0.004, the concrete spalls. These thin walled piles (typically five inches thick on these circa 1960s bridges) rapidly loose vertical load capacity with any amount of spalling, unlike conventional solid columns which are indifferent to spalls so long as the concrete core and reinforcing that confines the main longitudinal steel are intact.

**TYPICAL PRESTRESSED CONCRETE HOLLOW COLUMN**

One of the primary problems (non-ductile performance) occurs in the top several feet of the piles (a length equivalent to the pile diameter) where plastic hinging develops in the pile-to-pile cap connection. Tests performed to verify effectiveness of retrofits in this area have shown that while providing addition confinement and longitudinal reinforcing in this area improves shear capacity, it actually reduces pile ductility by driving the plastic hinging region to the mid height of the pile.

The results of a series of tests at the University Of California at San Diego tests on retrofitted and unretrofitted hollow core piles shows that displacements equal to that required to initiate yielding of the main pile reinforcing steel initiate cracking, and at 2.5-4 times that displacement a non-ductile failure, best described as instantaneous implosion, occurred. By comparison, WSDOT typically uses column retrofit methods that ensure ductile performance up to eight times yield displacement. There is no established method for effectively retrofitting hollow-core piles to improve ductile performance for high seismic loading.

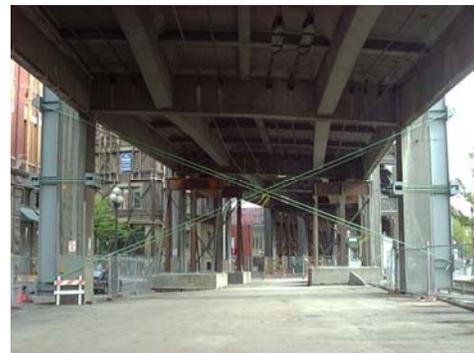
The numbers of bridges damaged based on their design type were: Reinforced concrete bridges (36); Prestressed concrete bridges (20); Steel bridges (16); Movable bridges (6). No damage was reported to timber or masonry bridges. The most common type of reported damage (48 bridges) consisted of concrete cracking and spalling. The Alaskan Way Viaduct sustained significant damage, which required temporary shoring. The total cost to repair the damage to state bridges was approximately \$5 million.

**ALASKAN WAY VIADUCT SHORING**
