# Deception Pass Log Rail

Submitted for presentation at the 84<sup>th</sup> Annual Meeting of the Transportation Research Board, Washington D.C.  
2005.

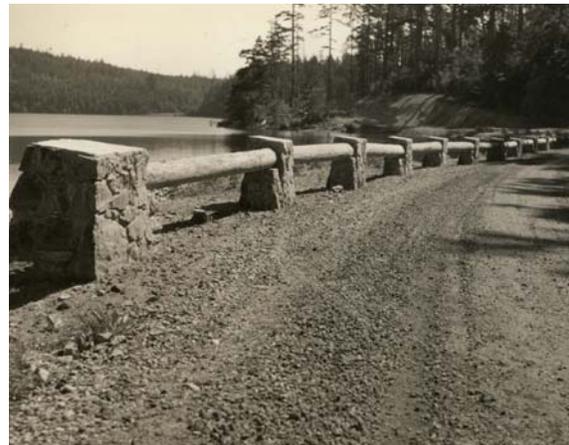
**FIGURE 2 CCC bollard and log rail system.**

The portion of SR 20 within the park was constructed by the Civilian Conservation Corps (CCC) in the mid 1930's. As part of this work, the CCC constructed a stone masonry bollard and log rail system to delineate the edge of the road and prevent early model vehicles from leaving the roadway (see Figure 2). Due to their age, quality of workmanship, and importance to the surroundings, the bridges and log rails are eligible for the National Register of Historic Places.

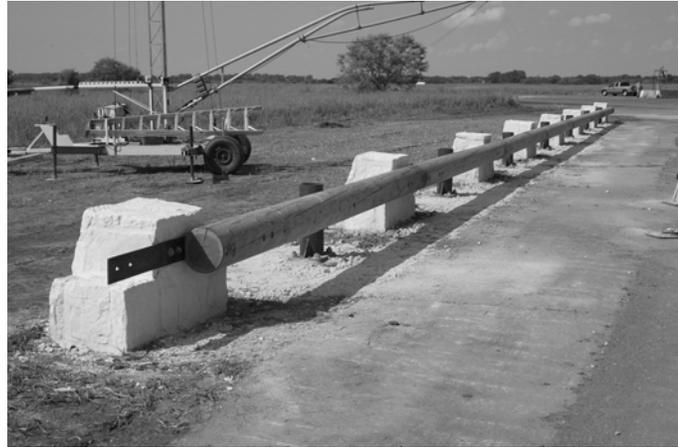
**FIGURE 3 Prototype Barrier**

The barrier that was developed consisted of a steel backed log that is supported by stone fascia bollards (see Figure 3). The steel backed timber log rail consisted of 12-inch diameter “turned” Douglas Fir logs. The logs were sawn with a 6-inch flat back to accommodate a 6-inch wide by 3/8 inch thick steel plate. The plates were attached to the back of the log using wood lag screws. The height to the top of the log is 27 inches from the ground.

The bollards were designed with a natural stone facade over a reinforced concrete core, footing, and an 18” diameter reinforced concrete shaft. It is expected that this foundation may be modified depending on site conditions (depth of rock, etc.). The stone supports were designed for an 18 foot maximum spacing and may be installed at lesser spacing to give the barrier a non-uniform appearance. To achieve the 18 foot spacing, it was determined, based on the analyses and computer modeling, that an intermediate support was necessary. The intermediate support consists of a steel pipe support with a reinforced concrete shaft foundation. The initial design used an 8” diameter pipe. However, in the final design, this was changed to a 6” pipe to make it less noticeable.

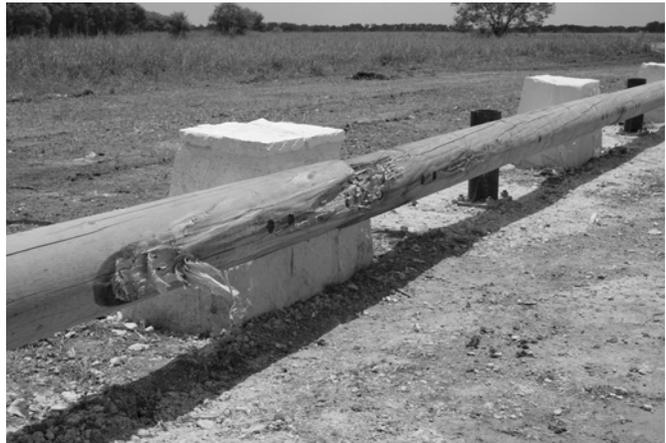
**FIGURE 4 Barrier damage from test 400561-1.**

Damage to the log rail was primarily to the timber log element, as shown in Figure 4. The log element was gouged to a maximum depth of 0.8" near bollard 5. Tire marks extended 3.5" under the log element just downstream of the splice at bollard 5. Bollard 5 was pushed toward the field side 0.4". The vehicle was in contact with the log element for 11.5'. Maximum dynamic deflection was not measurable.

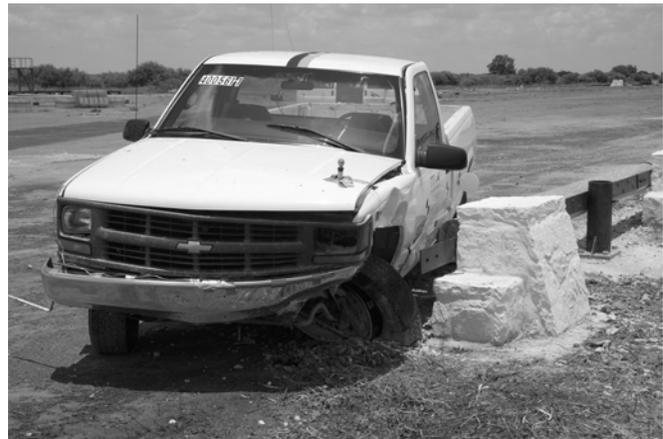
**FIGURE 5 Vehicle damage from test 400561-1.**

The left front quarter of the pickup truck sustained most of the damage, as shown in Figure 5. Structural damage was imparted to the left upper and lower A-arm, left outer tie rod, and left frame rail. Also damaged were the front bumper, grill, left front quarter panel, left front tire and wheel rim, left door, and left rear wheel rim. Maximum exterior crush to the vehicle was 25.0" in the frontal plane at the left front corner near bumper height. Maximum occupant compartment deformation was 2.3" in the center front floorpan over the transmission tunnel

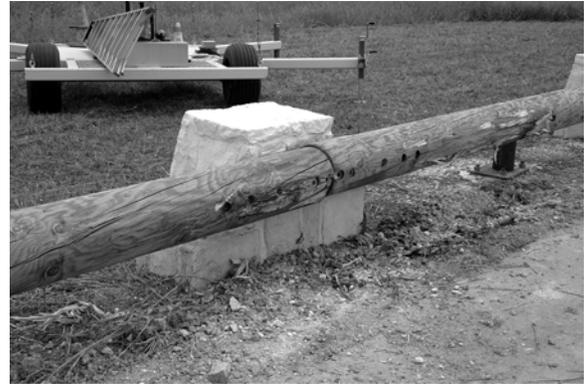
**FIGURE 6 Barrier damage from test 400561-**

Damage to the log rail was primarily to the timber log element, as shown in Figure 6. The log element was gouged and tire marks extended along the face of the log. Bollard 6 was disturbed only. The vehicle was in contact with the log element 12.5 ft. Maximum dynamic deflection was not measurable.

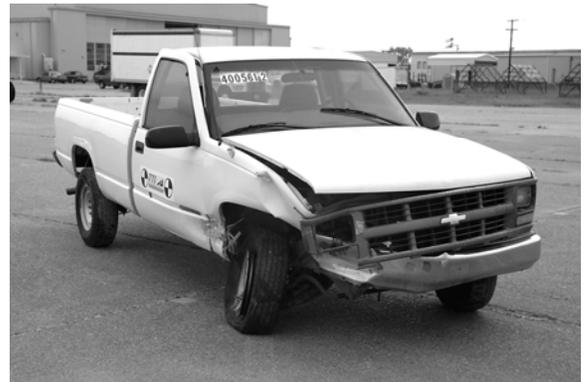
**FIGURE 7 Vehicle damage from test 400561-**

The right front quarter of the pickup truck sustained most of the damage, as shown in Figure 7. Structural damage was imparted to the right upper A-arm, right side floor pan, and right frame rail. Also damaged were the front bumper, grill, right front quarter panel, right front tire and wheel rim, and right door. Maximum exterior crush to the vehicle was 23.6" in the frontal plane at the left front corner near bumper height. Maximum occupant compartment deformation was 2.5" in the center front floor pan over the transmission tunnel.

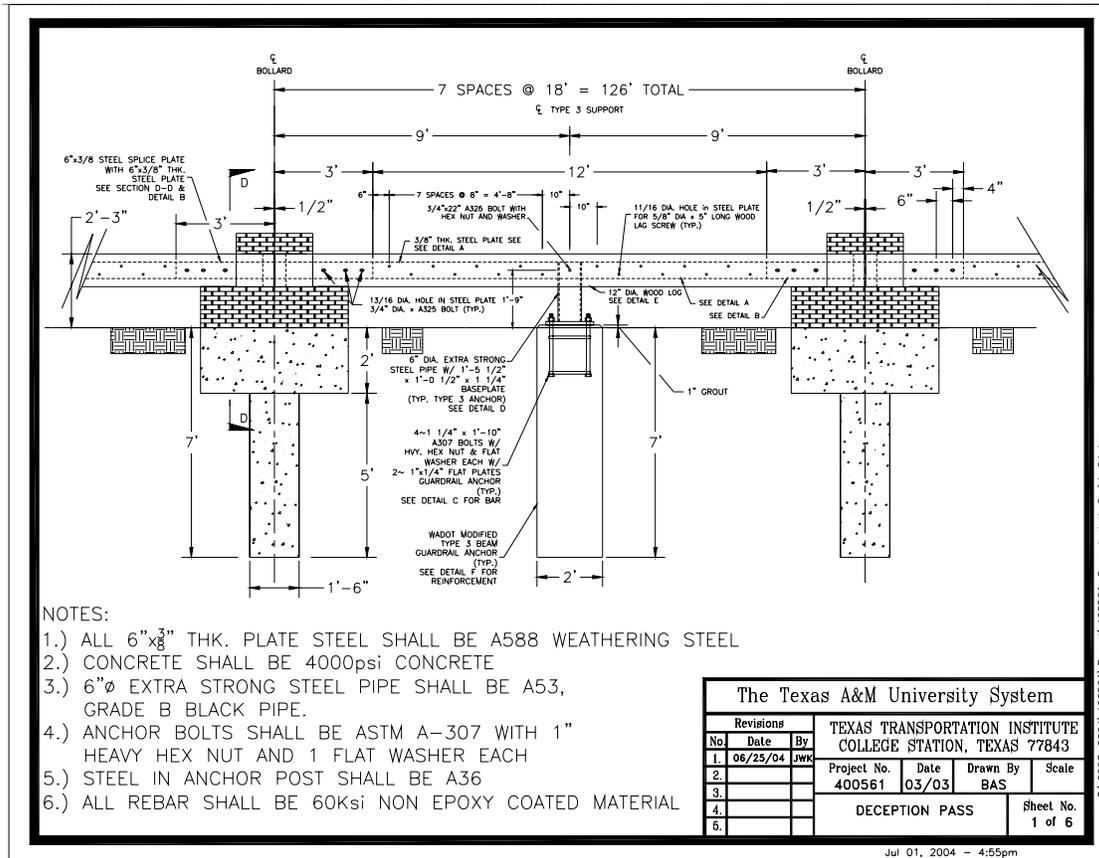
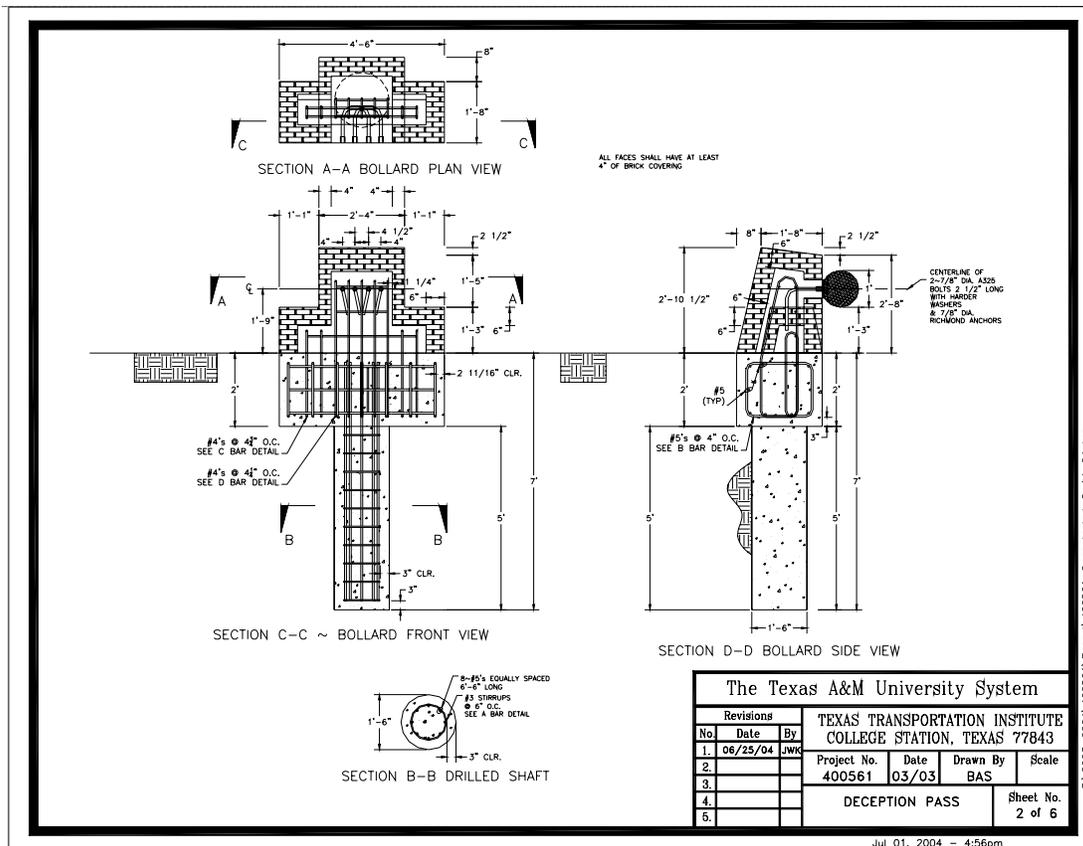
FIGURE 8 Deception Pass Log Rail details.

This design incorporated 6 of the 10 character defining features that were previously identified. Details of the final design are shown on Figure 8.

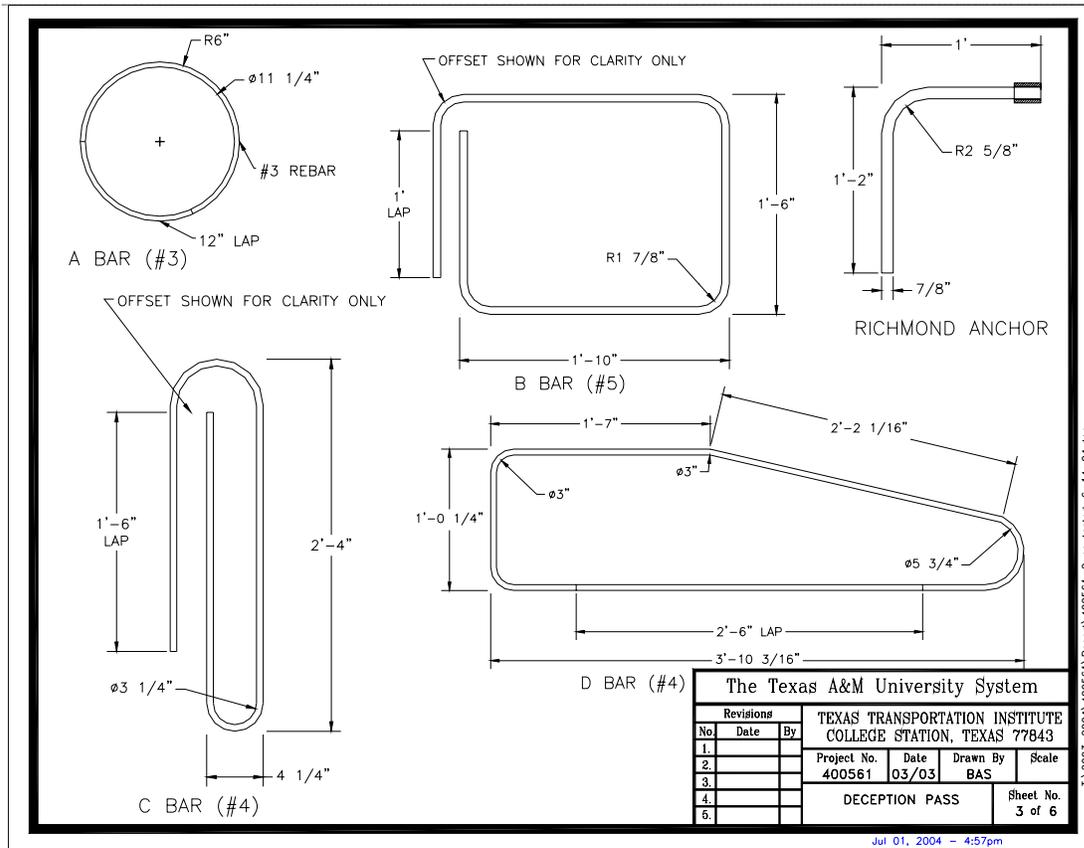
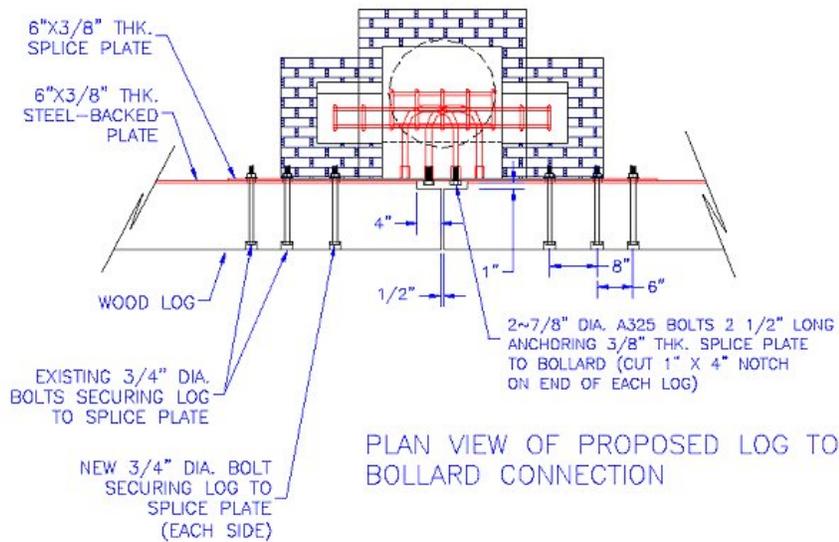
FIGURE 8 (continued) Deception Pass Log Rail details.

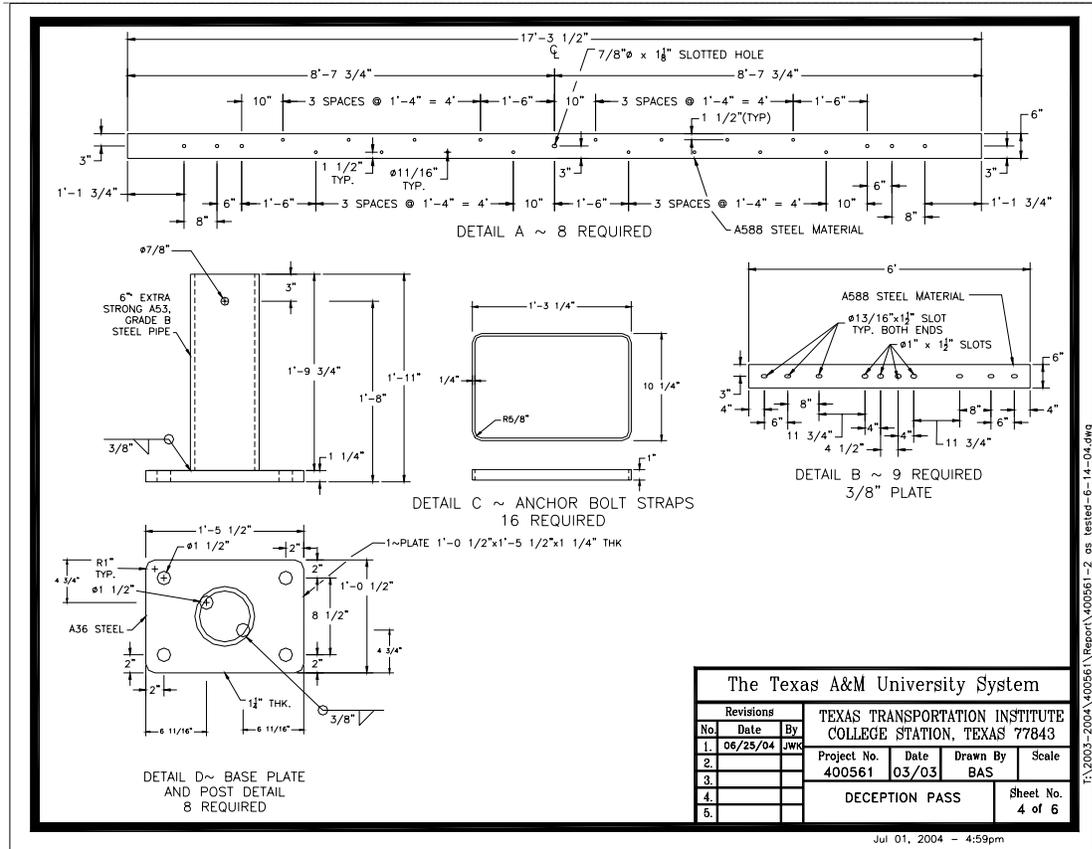
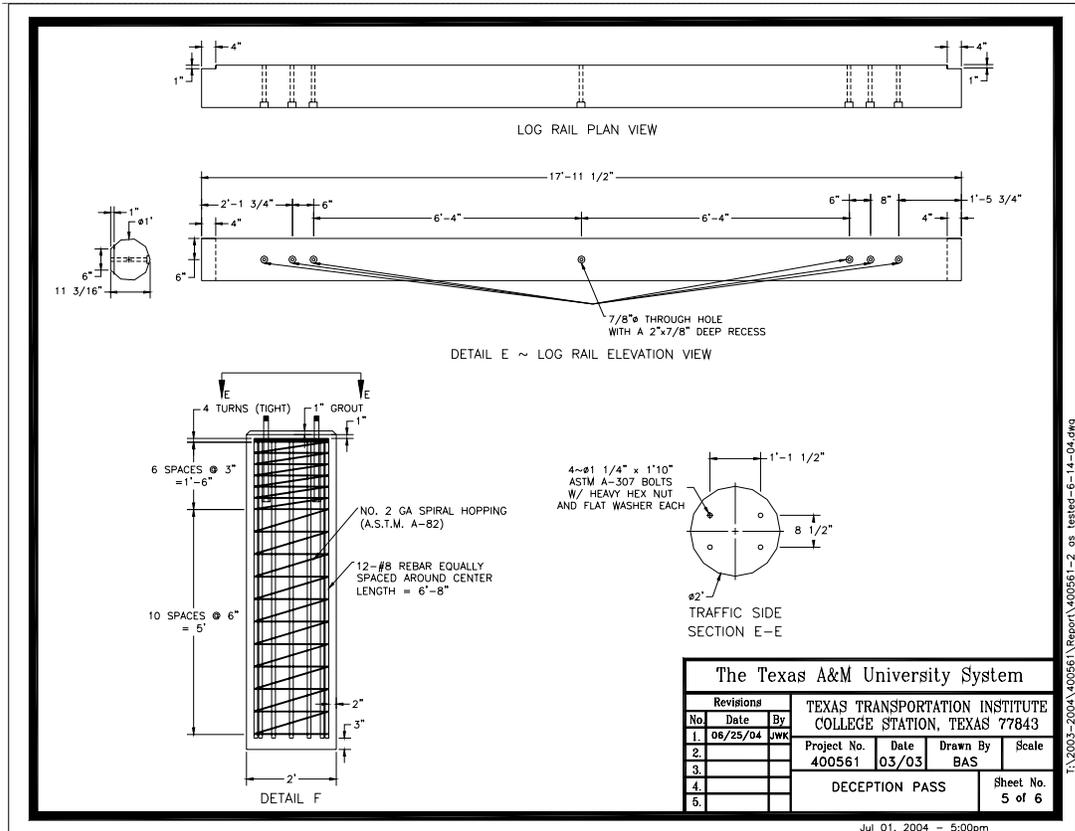
FIGURE 8 (continued) Deception Pass Log Rail details.

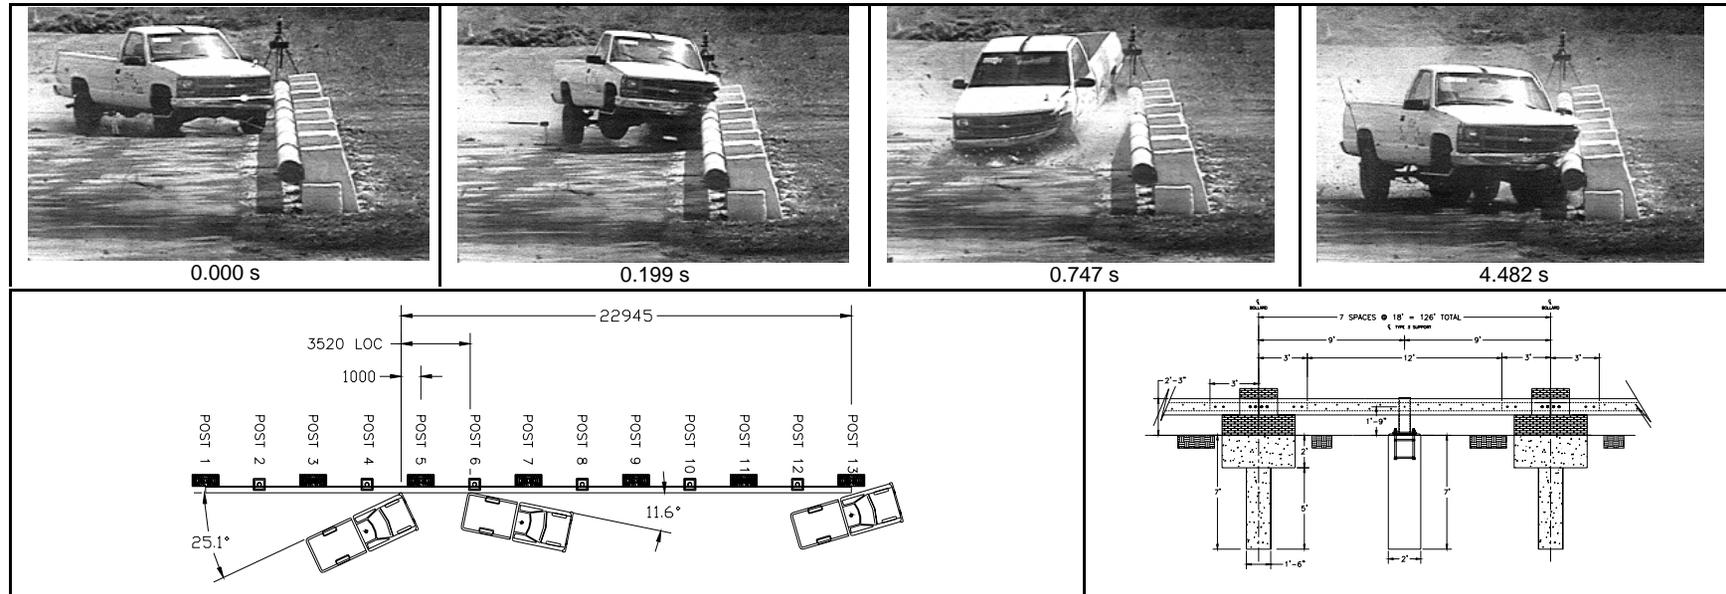
(during 1.0 s after impact)  
 Max. Yaw Angle (deg) ..... 36.4  
 Max. Pitch Angle (deg) ..... -9.9  
 Max. Roll Angle (deg) ..... -17.1

**FIGURE 9 Summary of test results – Test 400561-1.**

This test met all of the evaluation criteria in NCHRP Report 350. A summary of the test information is shown on Figure 9.

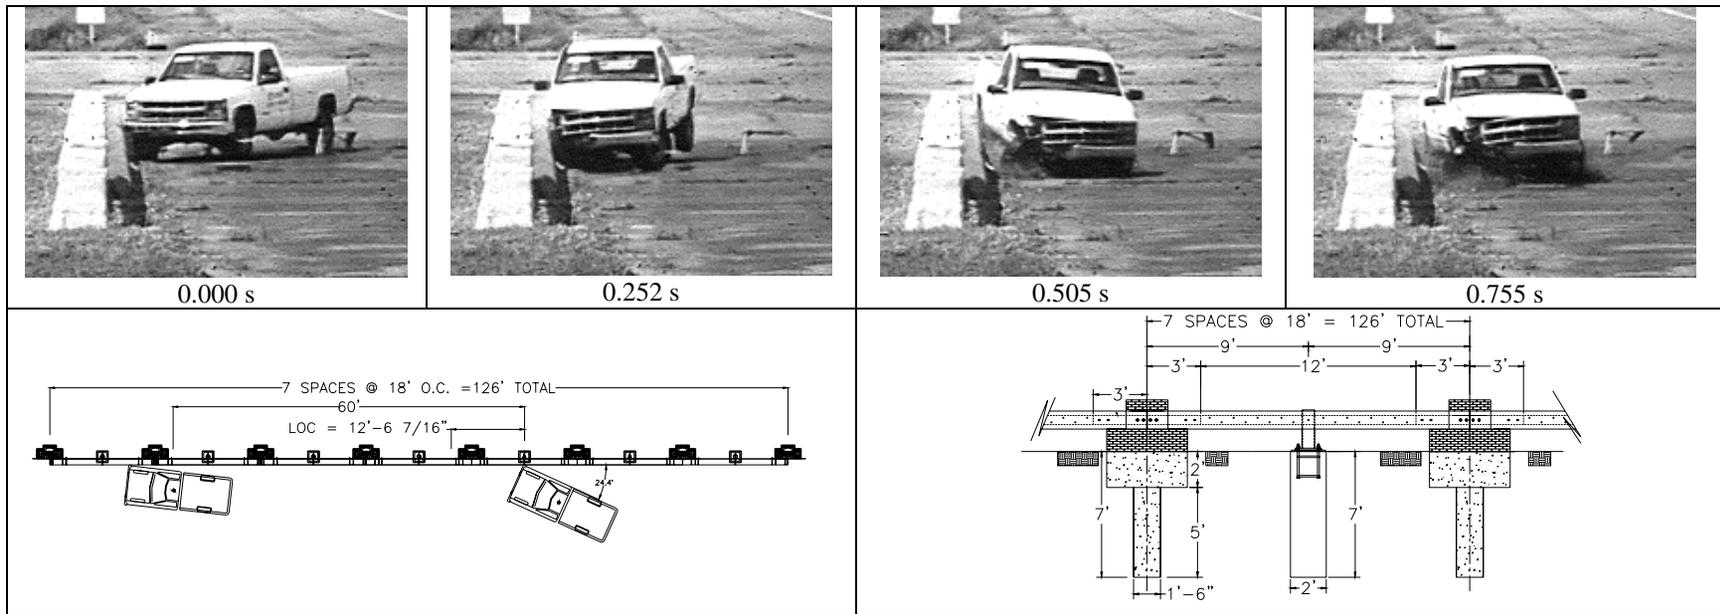
<b>General Information</b>		<b>Impact Conditions</b>		<b>Test Article Deflections (ft)</b>	
Test Agency.....	Texas Transportation Institute	Speed (mph).....	44.7 (71.9 km/h)	Dynamic.....	N/A
Test No. ....	400561-2	Angle (deg).....	25.0	Permanent.....	Disturbed
Date .....	06/14/2004	<b>Exit Conditions</b>		Working Width.....	1.6 (0.5 m)
<b>Test Article</b>		Speed (mph).....	22.0 (35.4 km/h)	<b>Vehicle Damage</b>	
Type.....	Guardrail	Angle (deg).....	6.5	<b>Exterior</b>	
Name .....	Deception Pass State Park Log Rail	<b>Occupant Risk Values</b>		VDS.....	01RF2
Installation Length (ft)	126.0 (38.4 m)	Impact Velocity (ft/s)		CDC.....	01RFEW2
Material or Key Elements .....	Steel-Backed Log Rail Supported by Stone Bollards and Steel Pipe Posts	Longitudinal.....	23.0 (7.0 m/s)	Maximum Exterior	
<b>Soil Type and Condition .....</b>		Lateral .....	16.7 (5.1 m/s)	Vehicle Crush (inches).....	23.6
Standard Soil, Dry		THIV (km/h).....	29.7	<b>Interior</b>	(600 mm)
