***WSF BAINBRIDGE ISLAND FERRY TERMINAL PRESERVATION  
PROJECT***

**UNDERWATER SOUND LEVELS  
ASSOCIATED WITH PILE DRIVING AT  
THE BAINBRIDGE ISLAND FERRY  
TERMINAL PRESERVATION PROJECT**

*Prepared by:  
Jim Laughlin  
Washington State Department of  
Transportation  
Office of Air Quality and Noise  
15700 Dayton Avenue North, P.O. Box  
330310  
Seattle, WA 98133-9710*

**November 2005**

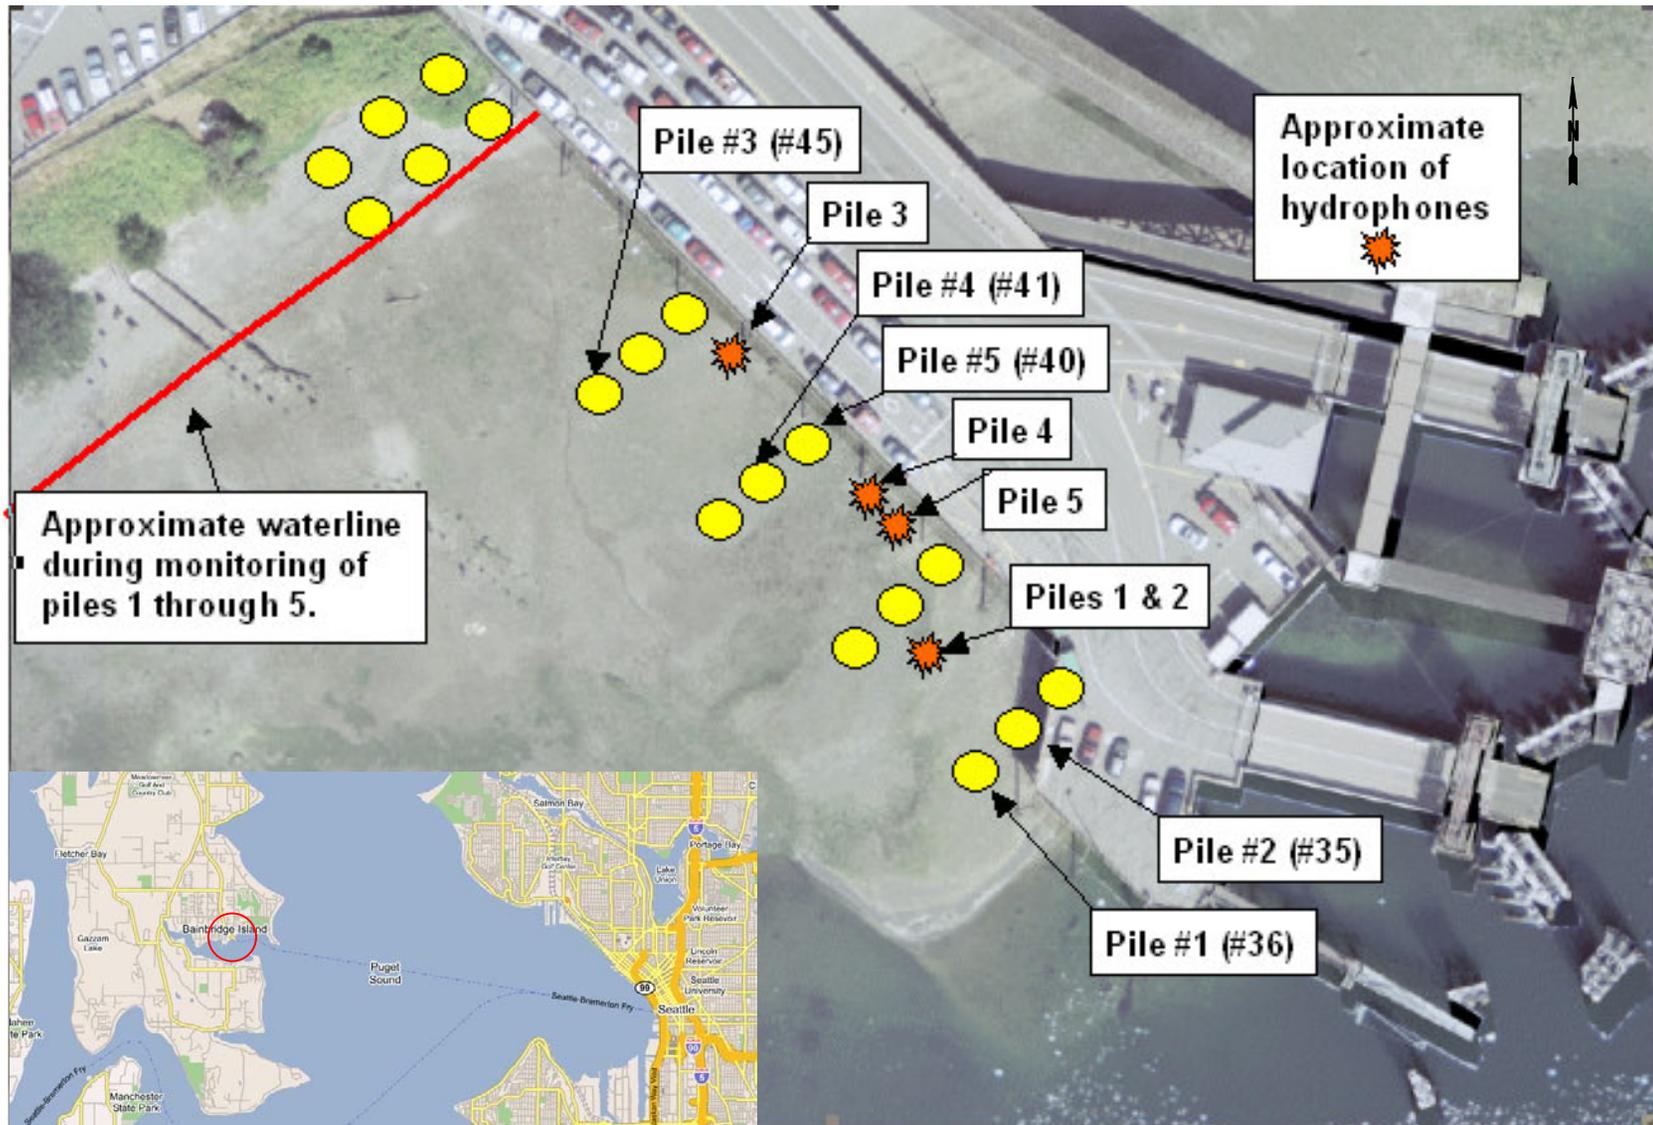
**Figure 1: Location of underwater noise monitoring sites at the Bainbridge Island Ferry Terminal project. Note: The current configuration of the loading dock is different from that shown in the aerial, however, orientation of the piles is still valid. Piles are not to scale.**

This technical report presents results of underwater sound levels measured during the driving of five 24-inch steel piles at the Bainbridge Island Ferry Terminal Preservation Project in October 2005 (Contract Number: 006995). The piles were driven to support the terminal trestle. Five 24-inch piles were monitored at different water depths in the harbor. The bubble curtain was tested with on/off cycles during each pile driving event. Figure 1 shows the locations of monitored piles.

The project location is on Bainbridge Island on the north side of Eagle Harbor (Figure 1). Figure 2 shows the approximate pile locations and approximate bottom topography of the harbor. Water depths at the monitoring locations varied from eight feet to ten feet deep. There was no substantial tidal flux or currents in the area monitored.

Also known as pile # 36 according to the contractors numbering system is located approximately 30 feet southwest of the southeastern end of the dock (see Figure 1). The pile is located in 11 feet of water.

Pile 2 is also designated as pile # 35 in the contractors numbering system. It is located approximately 20 feet southwest of the southeastern end of the dock (see Figure 1). The pile is located in 11 feet of water.

Also known as pile # 45 in the contractors numbering system. It is located approximately 80 feet offshore and 30 feet from the southwest edge of the dock (see Figure 1). This pile is located in 7 feet of water.

Pile 4 is also designated as pile # 41 in the contractors numbering system. It is located approximately 20 feet southwest of the southeastern edge of the dock and 160 feet offshore (see Figure 1). The pile is located in 9 feet of water.

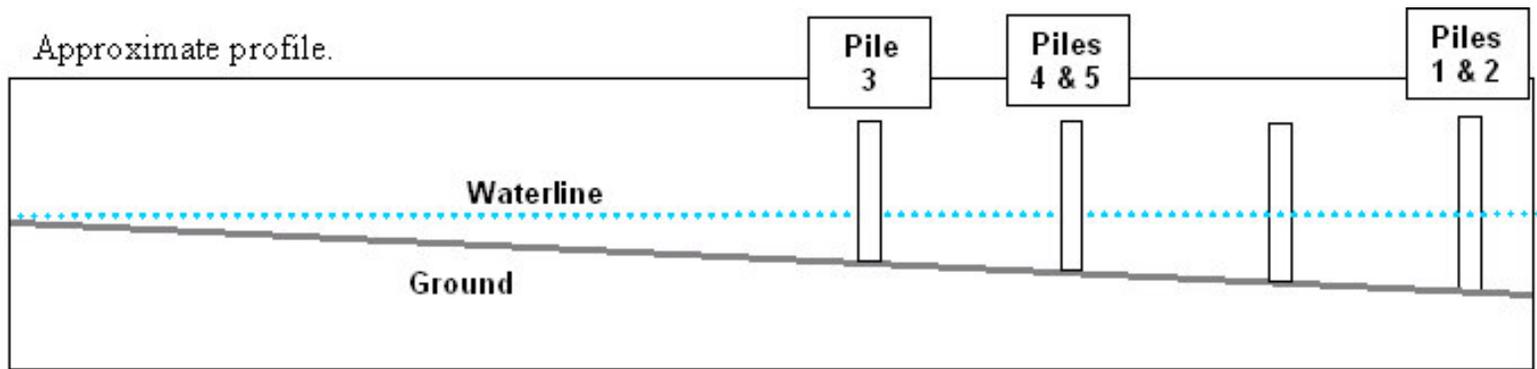
**Figure 2: Location of piles relative to the bottom topography in the monitoring area. The sediment is a mixture of sand and fist-sized rocks with an occasional 1-foot diameter rock.**

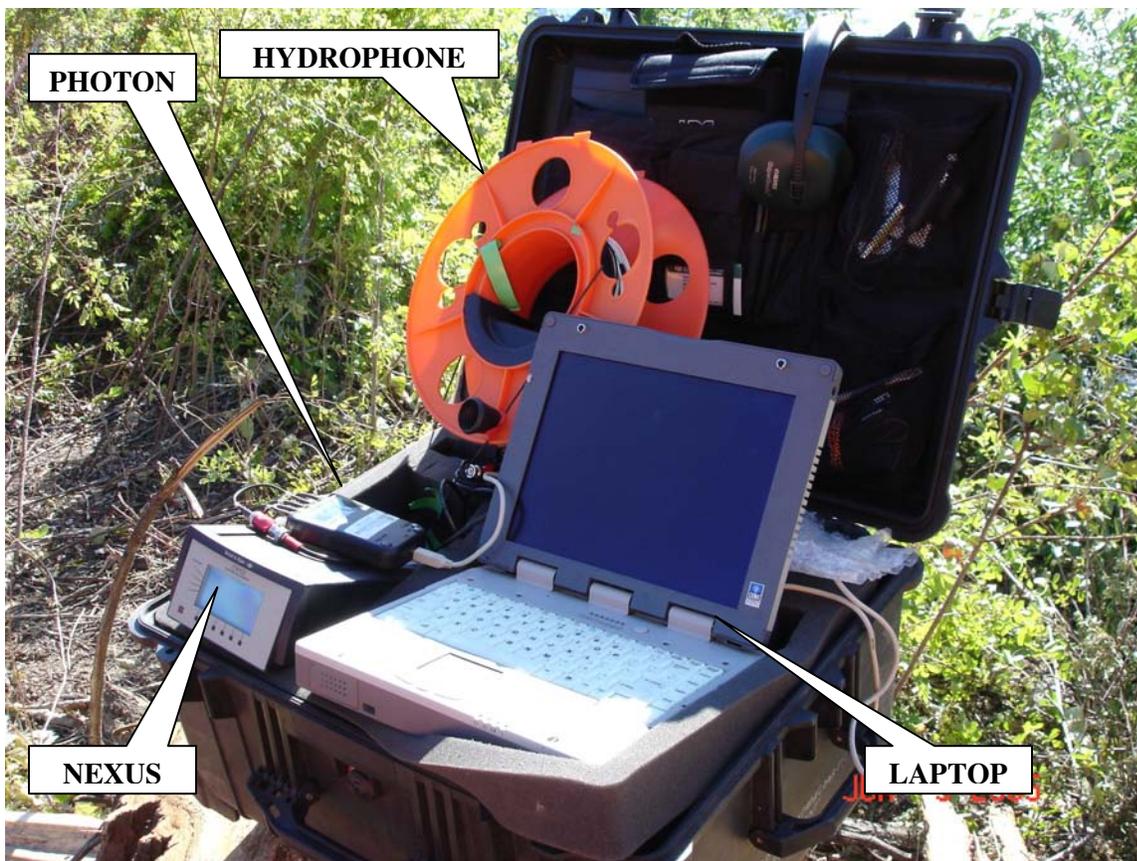
**Figure 3: Underwater Sound Level Measurement Equipment**

Underwater sound levels were measured using two Reson TC 4013 hydrophones. One hydrophone was positioned approximately at mid-water level. The second hydrophone was positioned approximately one foot from the bottom. The hydrophones were located at a distance of 33 feet from the pile being monitored. The measurement system includes a Brüel and Kjær Nexus type 2692 4-channel signal conditioner, which kept the high underwater sound levels within the dynamic range of the signal analyzer (Figure 3). The output of the Nexus signal conditioner is received by a Dactron Photon 4-channel signal spectrum analyzer that is attached to an Itronix GoBook II laptop computer. The waveform of the pile strikes along with the number of strikes, overpressure minimum and maximum, absolute peak values, and RMS sound levels, integrated over 90% of the duration of the pulse, were captured and stored on the laptop hard drive for subsequent signal analysis. The system and software calibration is checked annually against a NIST traceable standard. The operation of the hydrophone was checked in the field using a GRAS type 42AC high-level pistonphone with a hydrophone adaptor. The pistonphone signal was 146 dB re: 1  $\mu$ Pa. The pistonphone signal levels produced by the pistonphone and measured by the measurement system were within 1 dB and the operation of the system was judged acceptable over the study period. A photograph of the system and its components are shown in Figure 4.

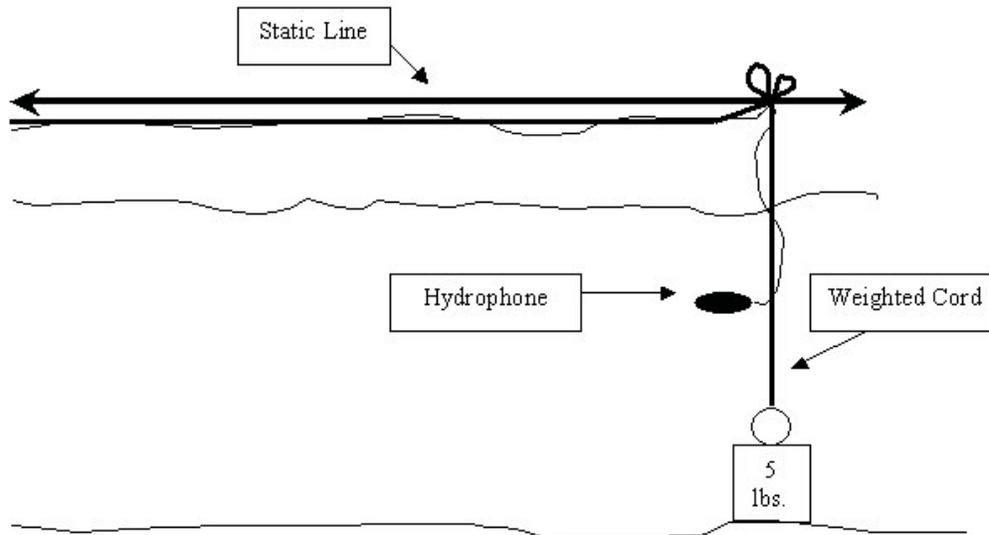
**Figure 4: Diagram of hydrophone deployment at the monitoring location for piles 1 and 2.**

The location of the hydrophones is determined by allowing a clear line of sight between the pile and the hydrophone, with no other structures nearby. The distance from the pile to the hydrophone location was measured using a Bushnell Yardage Pro rangefinder. The hydrophone was attached to a weighted nylon cord anchored with a five-pound weight. The cord and hydrophone cables were tied to a static line at the surface 33 feet (10 meters) from the pile

(Figure 4) for monitoring piles 1 and 2 but simply lowered from the edge of the dock for the remainder of the piles.

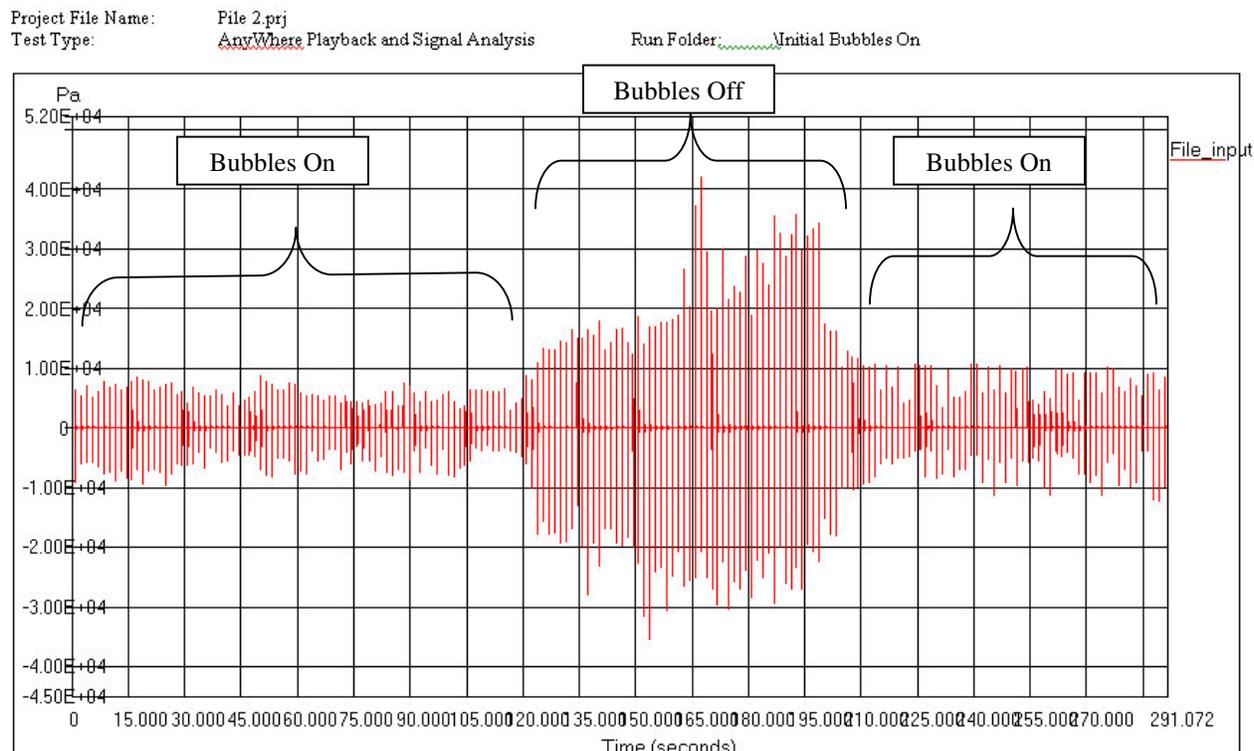
Figure 5: Waveform recording indicating the effects on amplitude with bubble curtain on versus bubble curtain off for pile 2.

Pile 2 was driven in water depth of 11 feet. The contractor started the pile driving with the bubbles turned on then after two minutes, the air was turned off. The air remained off for 1.5 minutes and then turned back on for 1.75 minutes. Figure 5 indicates the visible changes in signal amplitude with bubbles off versus bubbles on.

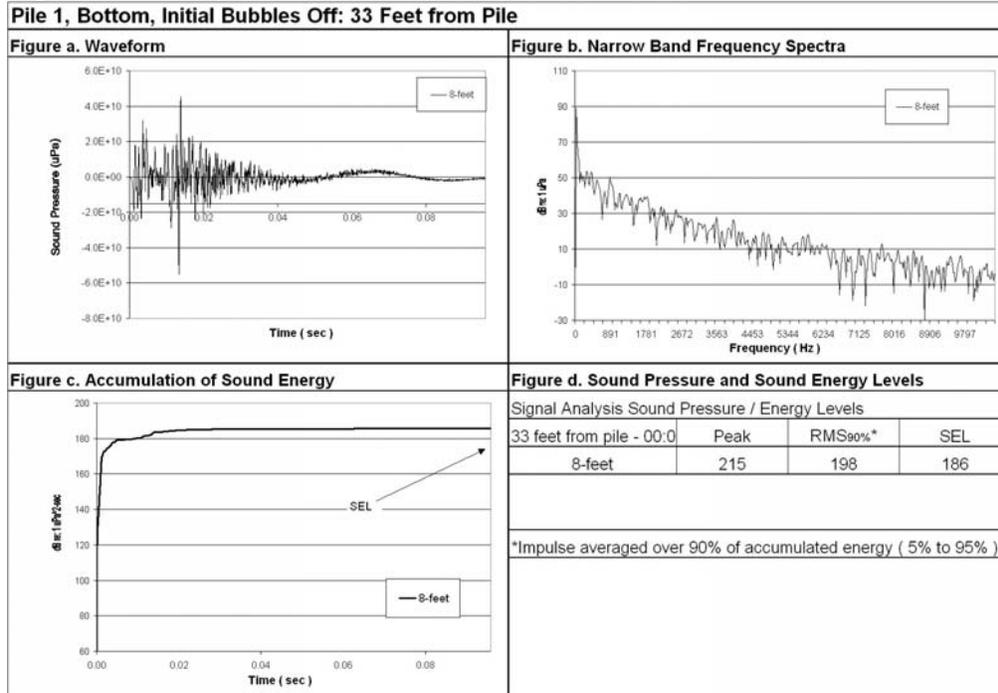
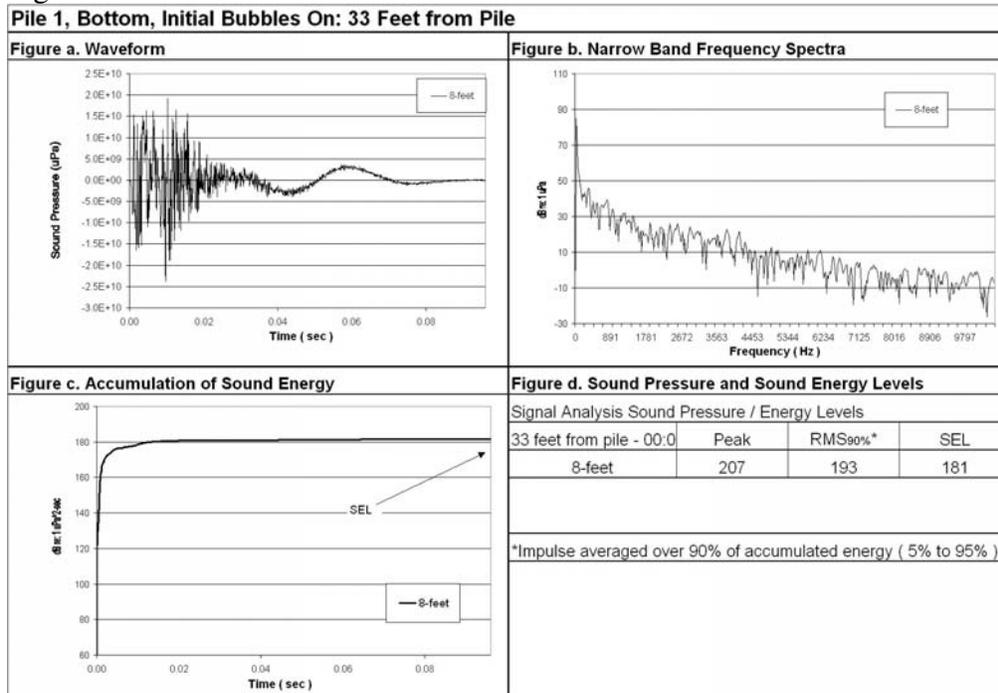
Figure 6: Waveform Analysis of Pile 1 Sound Pressure Levels with Bubble Curtain Initial Off, Midwater and Bottom.

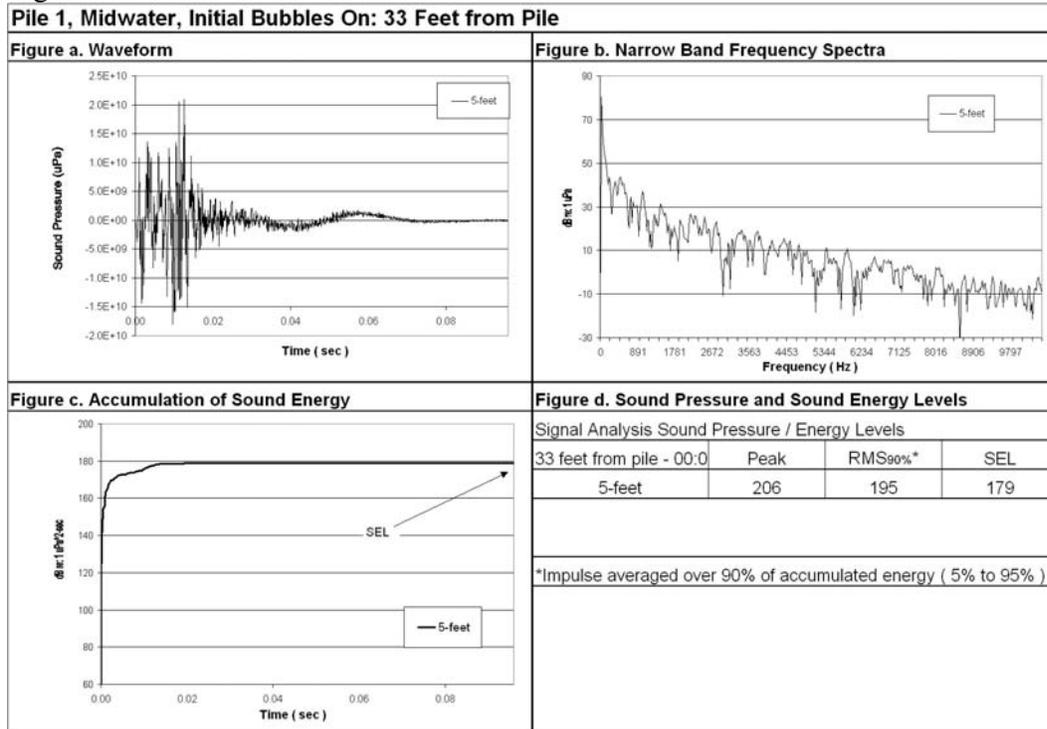
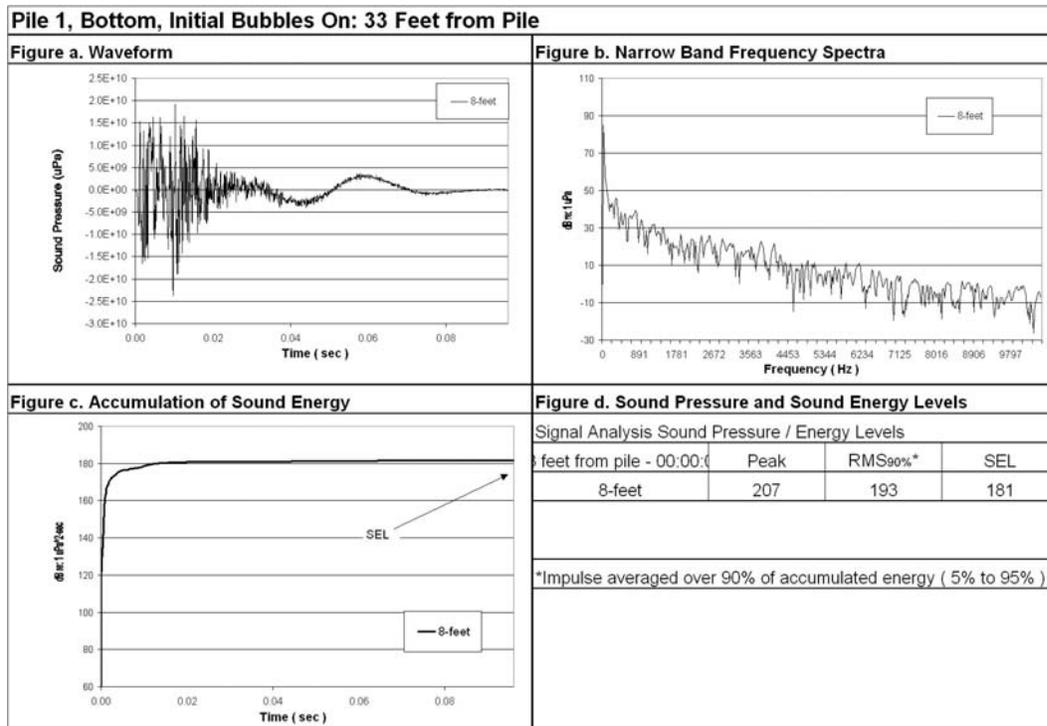
**Figure 7: Waveform Analysis of Pile 1 Sound Pressure Levels with Bubble Curtain Initial On, Midwater and Bottom.**

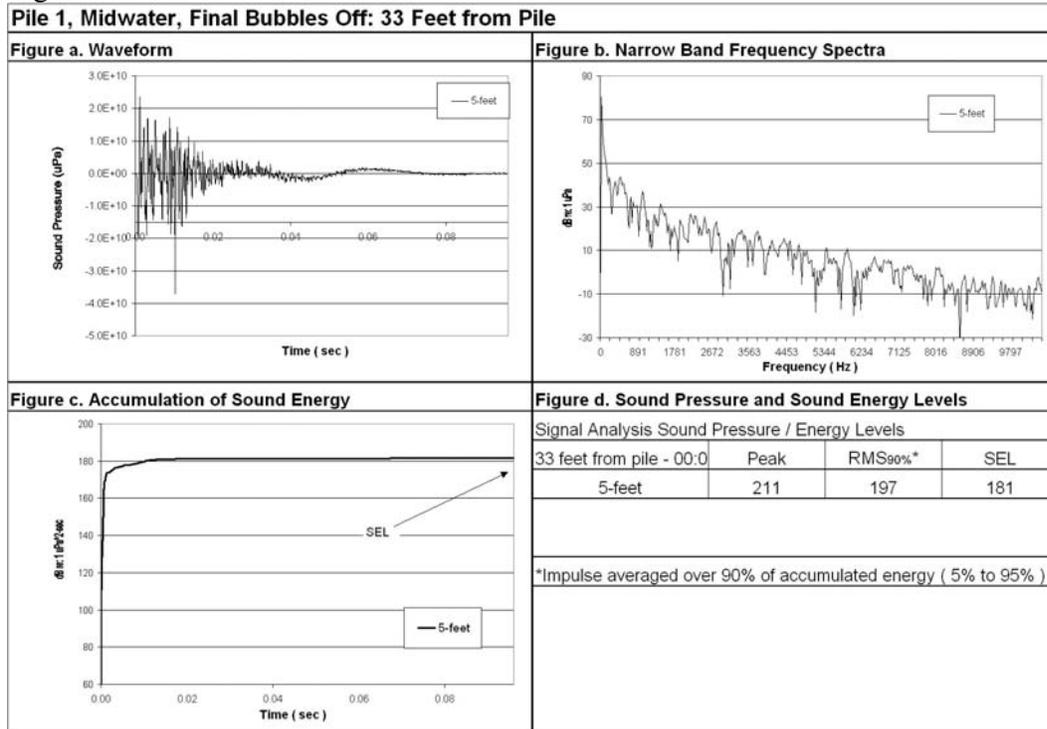
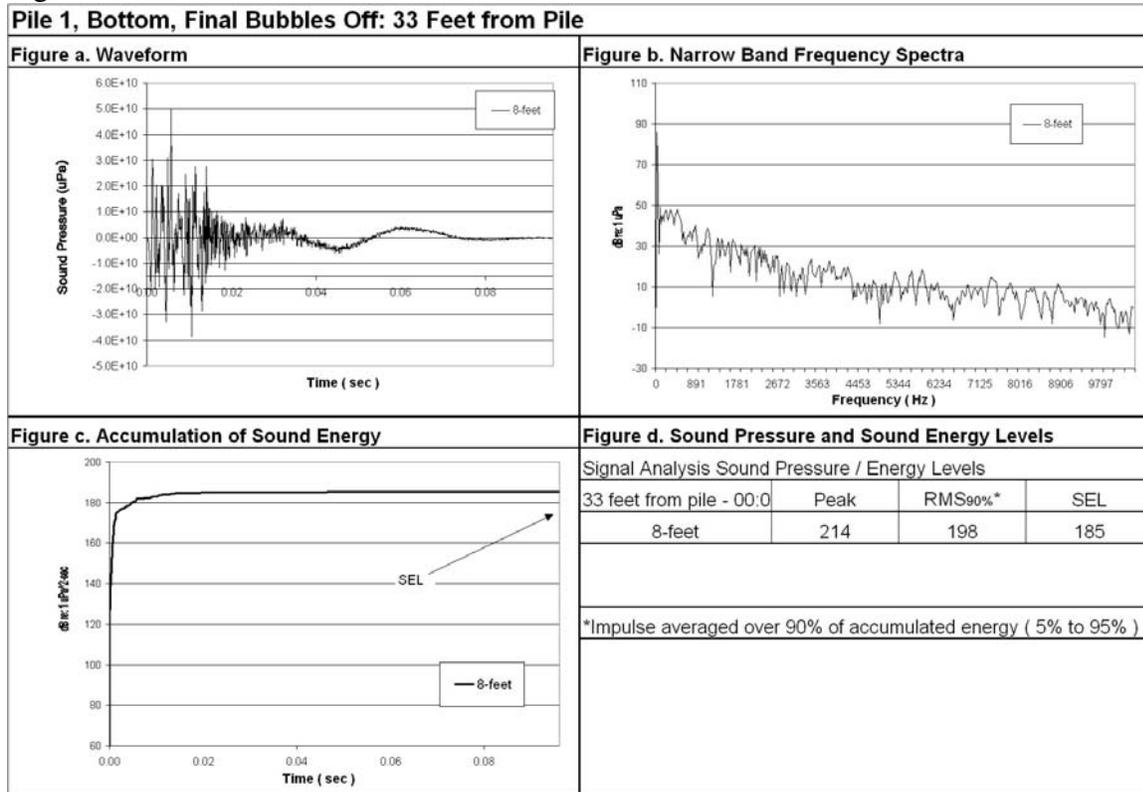
Figure 8: Waveform Analysis of Pile 1 Sound Pressure Levels with Bubble Curtain Final Off, Midwater and Bottom.

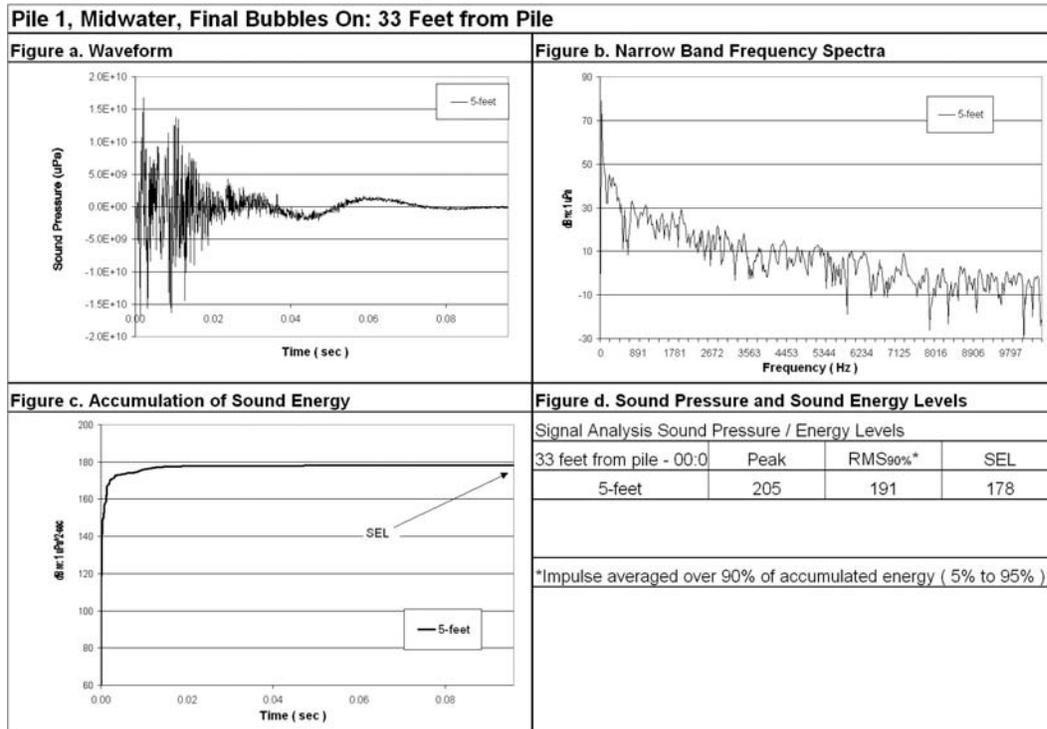
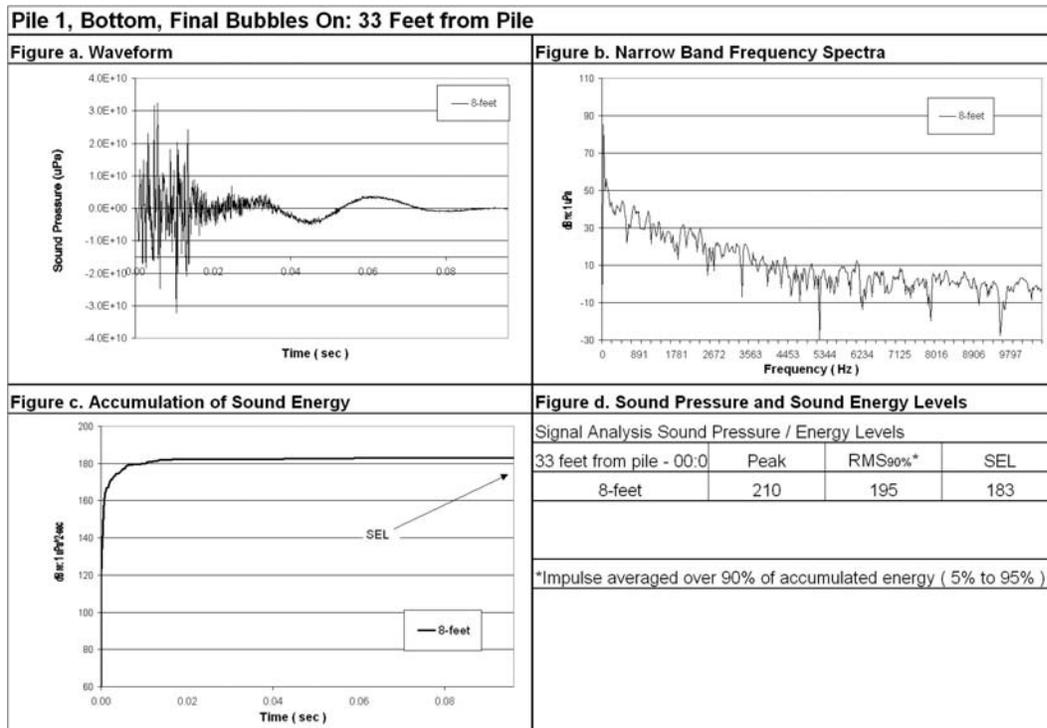
**Figure 9: Waveform Analysis of Pile 1 Sound Pressure Levels with Bubble Curtain Final On, Midwater and Bottom.**

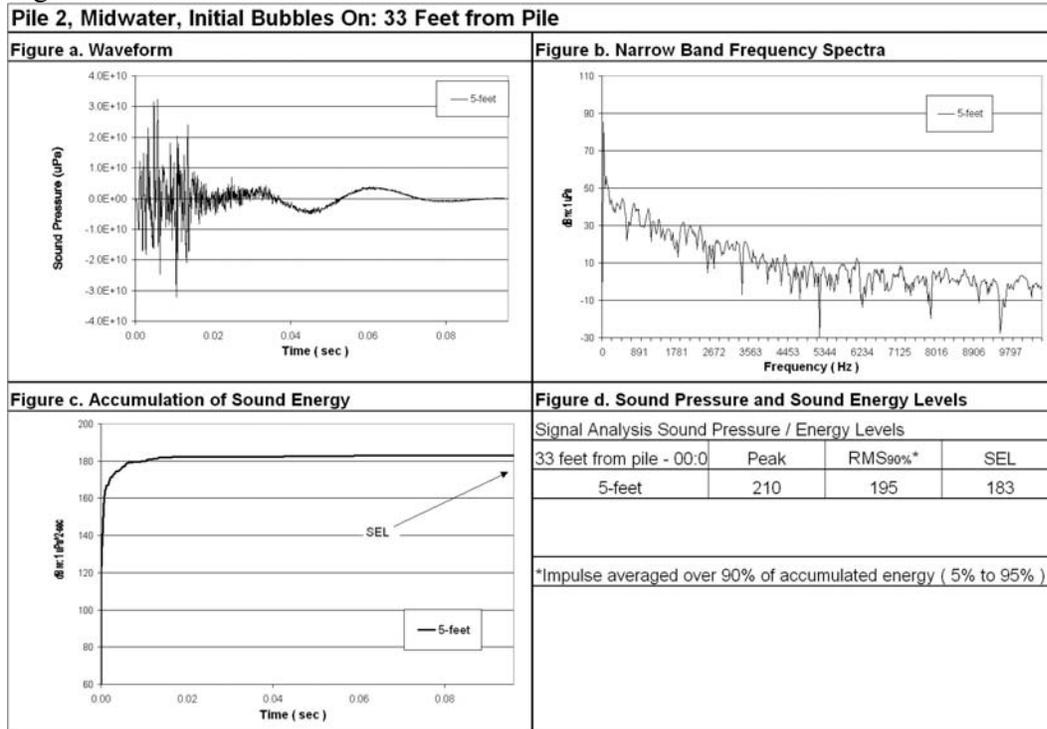
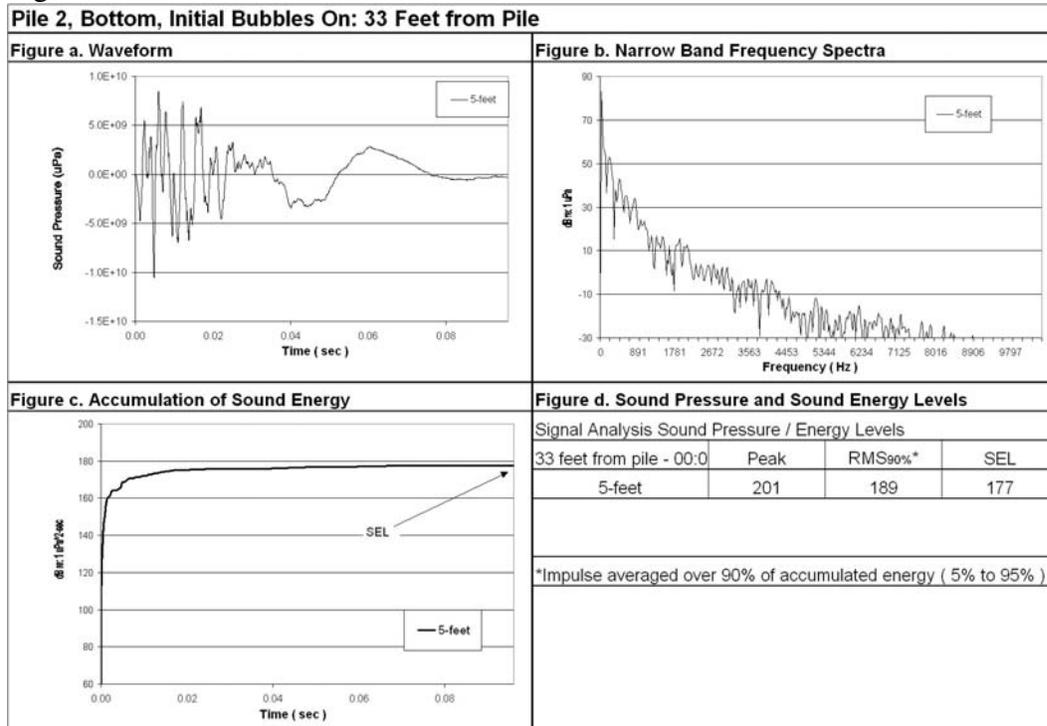
Figure 10: Waveform Analysis of Pile 2 Sound Pressure Levels with Bubble Curtain Initial On, Midwater and Bottom.

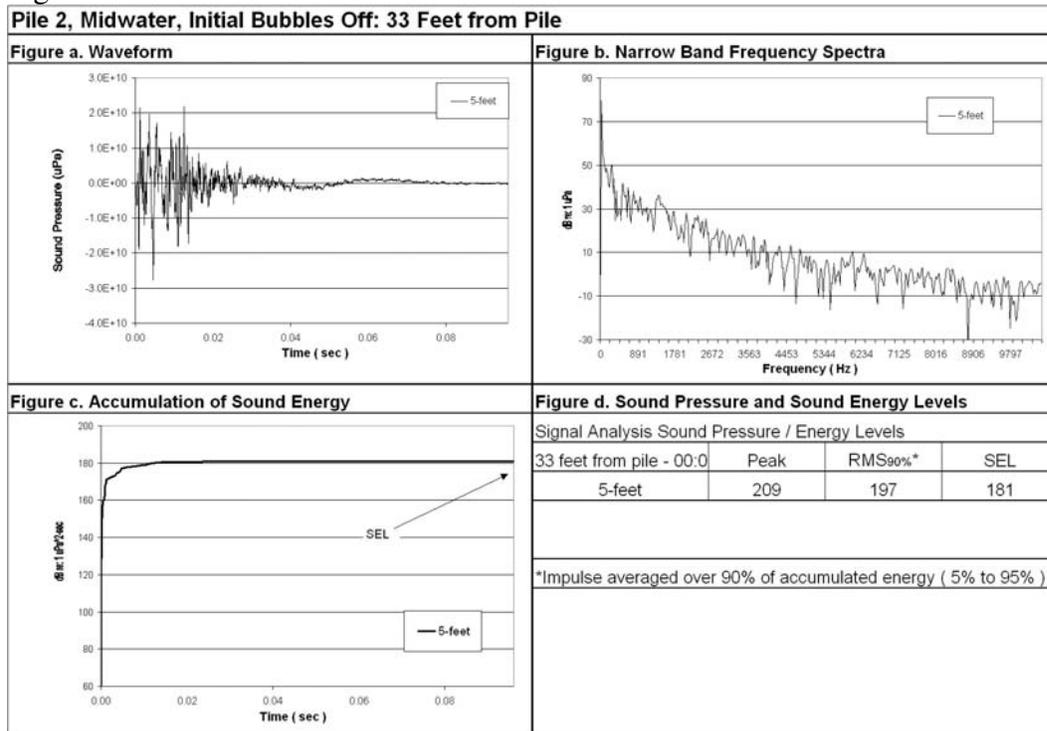
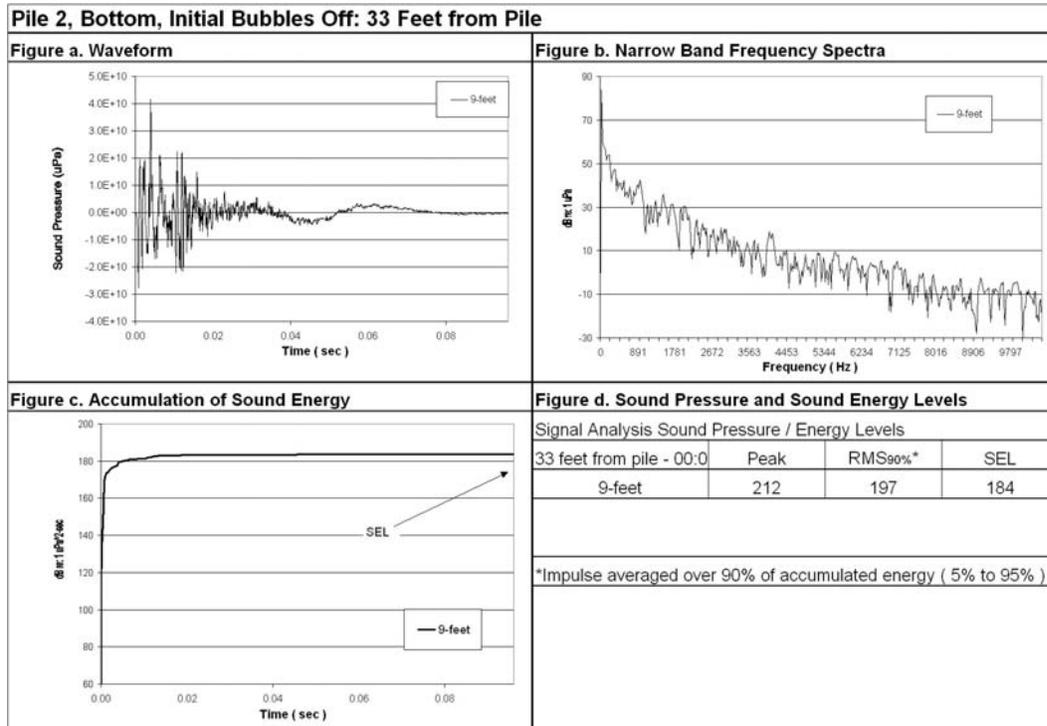
**Figure 11: Waveform Analysis of Pile 2 Sound Pressure Levels with Bubble Curtain Initial Off, Midwater and Bottom.**

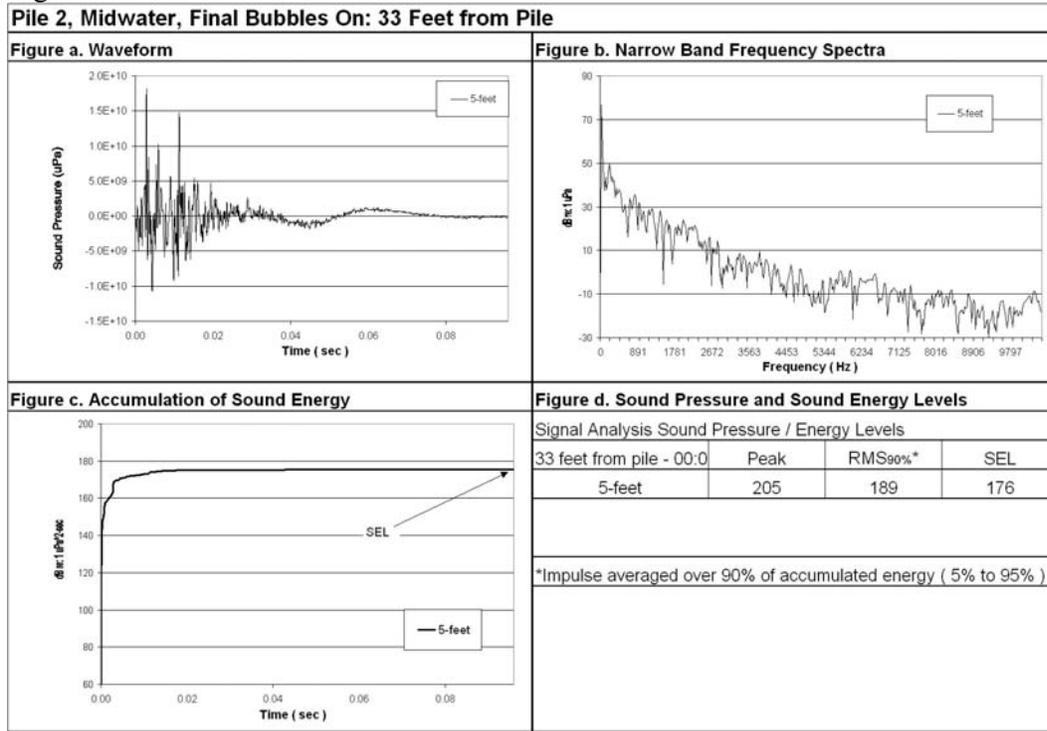
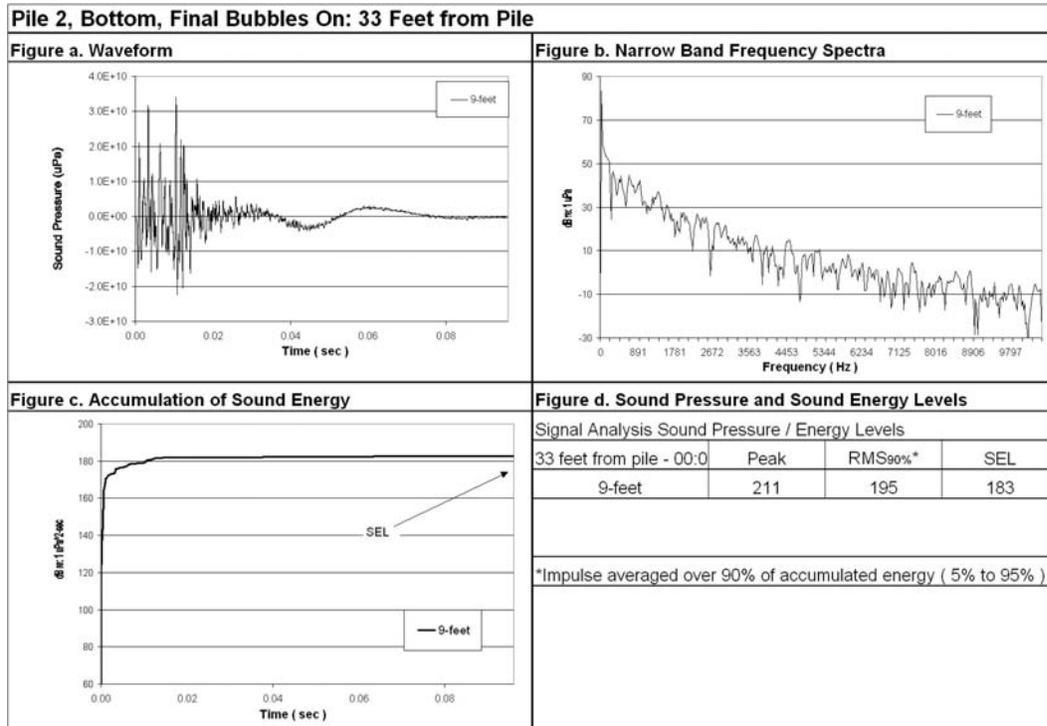
**Figure 12: Waveform Analysis of Pile 2 Sound Pressure Levels with Bubble Curtain Final On, Midwater and Bottom.**

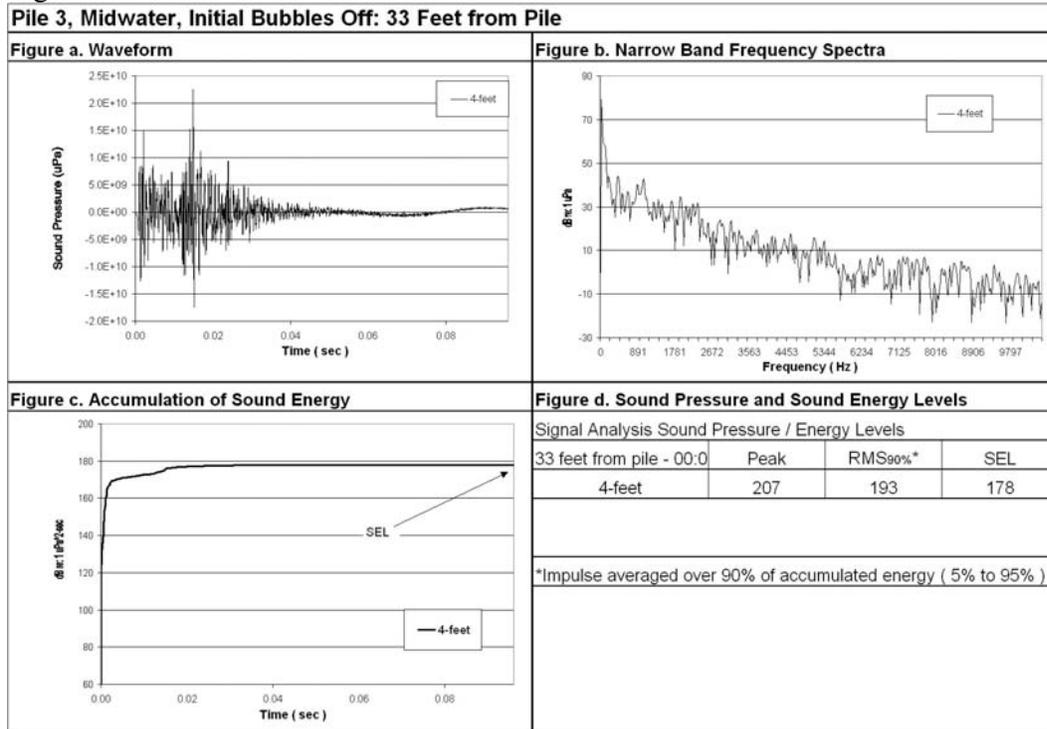
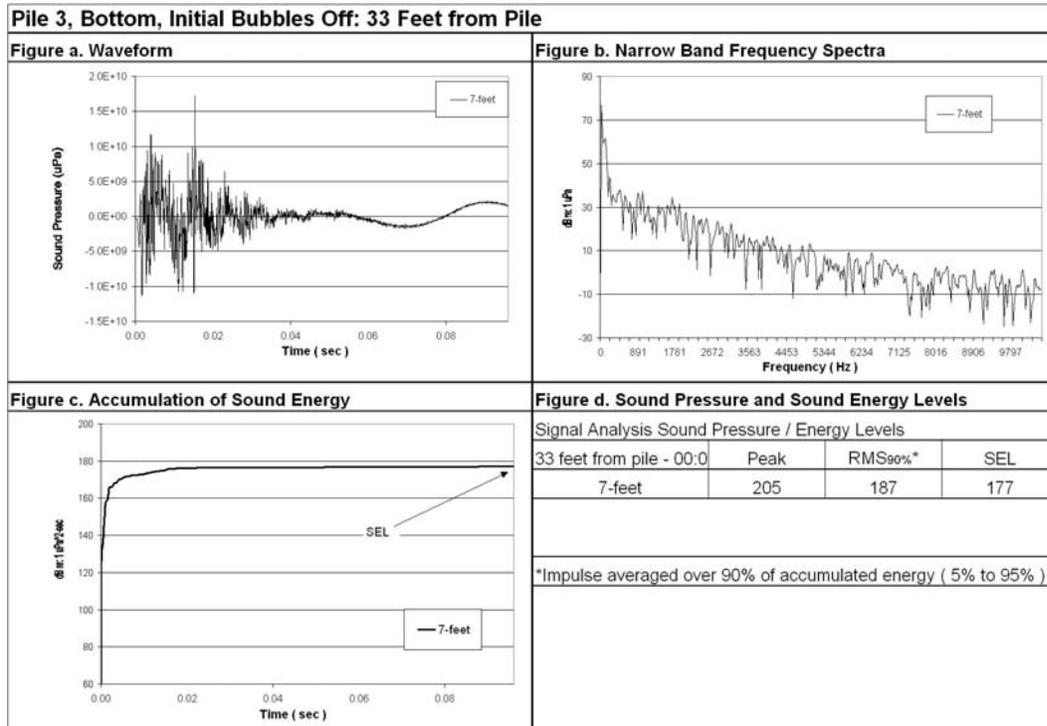
**Figure 13: Waveform Analysis of Pile Number 3 Sound Pressure Levels with Bubble Curtain Initial Off, Midwater and Bottom.**

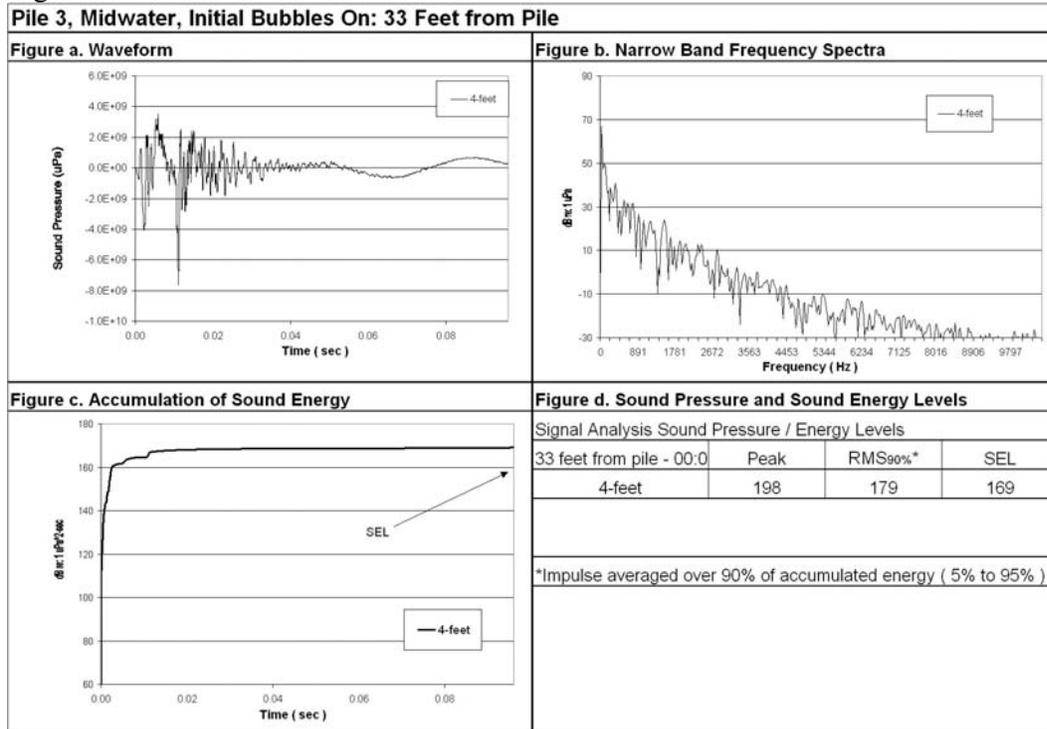
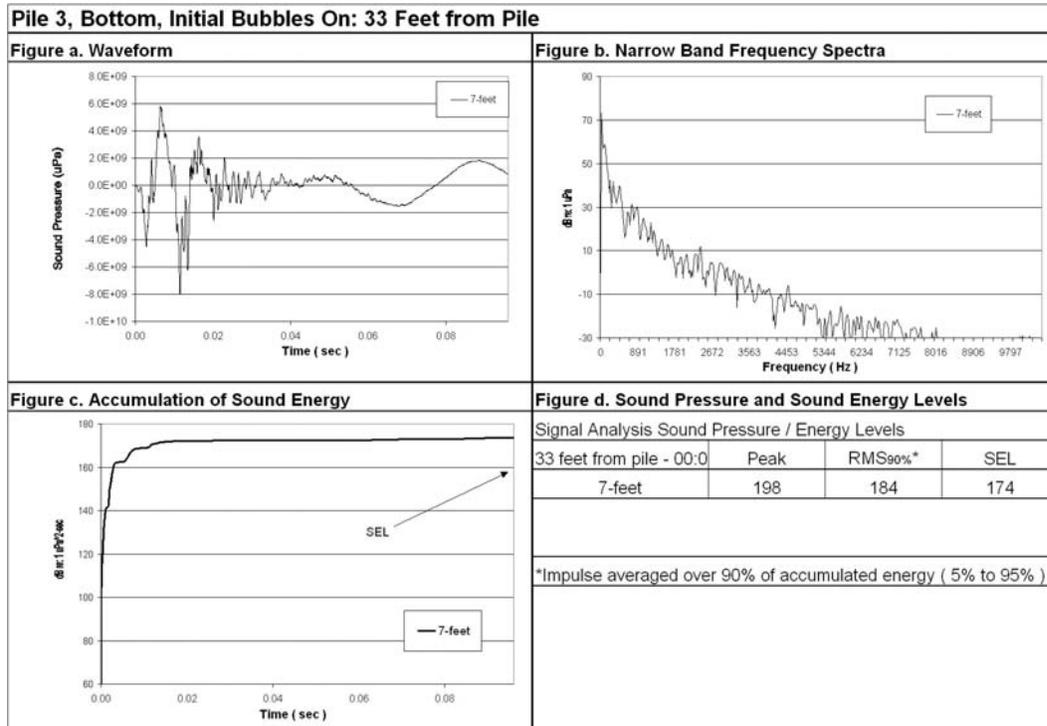
**Figure 14: Waveform Analysis of Pile Number 3 Sound Pressure Levels with Bubble Curtain Initial On, Midwater and Bottom.**

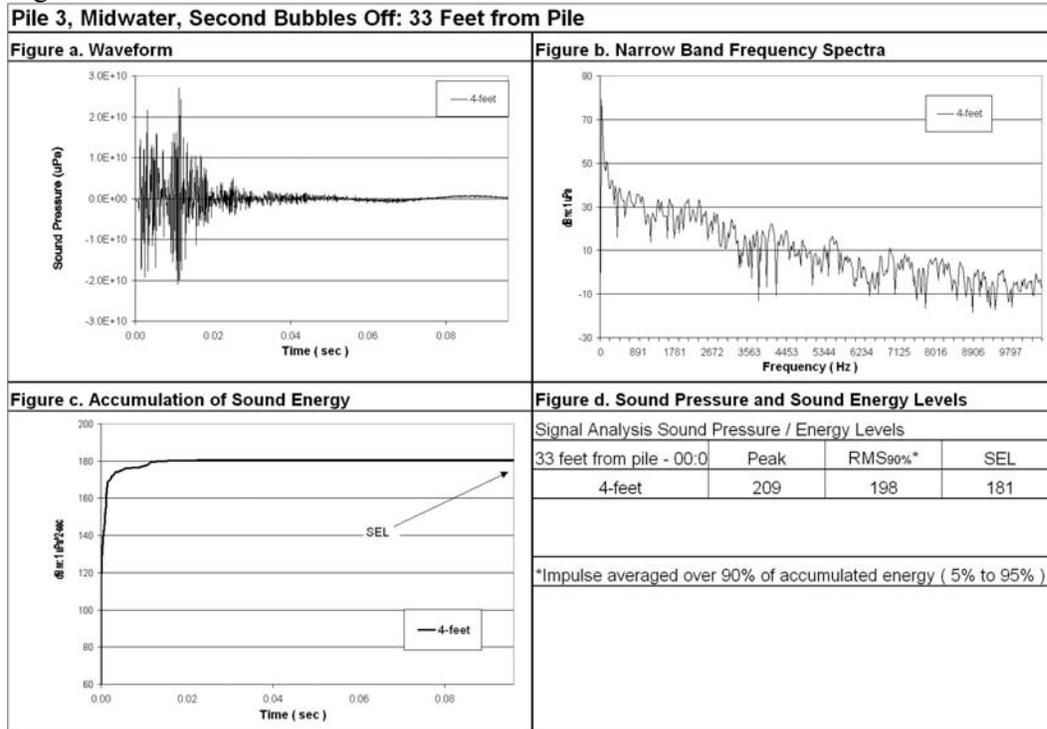
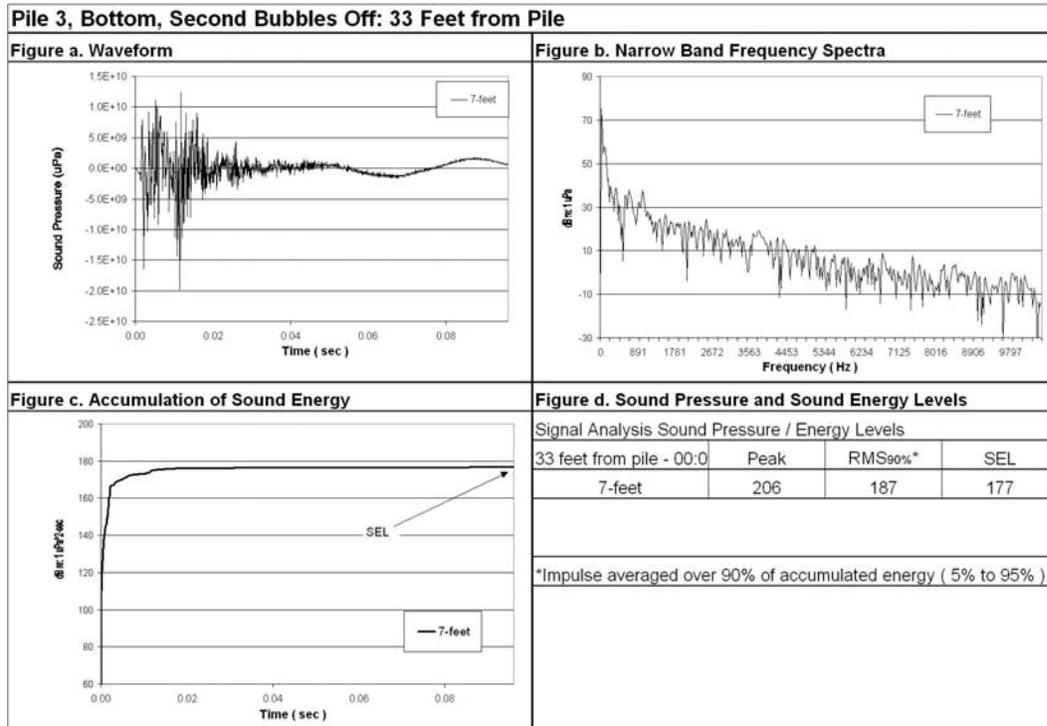
**Figure 15: Waveform Analysis of Pile Number 3 Sound Pressure Levels with Bubble Curtain Second Off, Midwater and Bottom.**
