***WSF BAINBRIDGE ISLAND FERRY TERMINAL PRESERVATION  
PROJECT***

**UNDERWATER SOUND LEVELS  
ASSOCIATED WITH PILE DRIVING AT  
THE BAINBRIDGE ISLAND FERRY  
TERMINAL PRESERVATION PROJECT**

*Prepared by:  
Jim Laughlin  
Washington State Department of  
Transportation  
Office of Air Quality and Noise  
15700 Dayton Avenue North, P.O. Box  
330310  
Seattle, WA 98133-9710*

**November 2005**

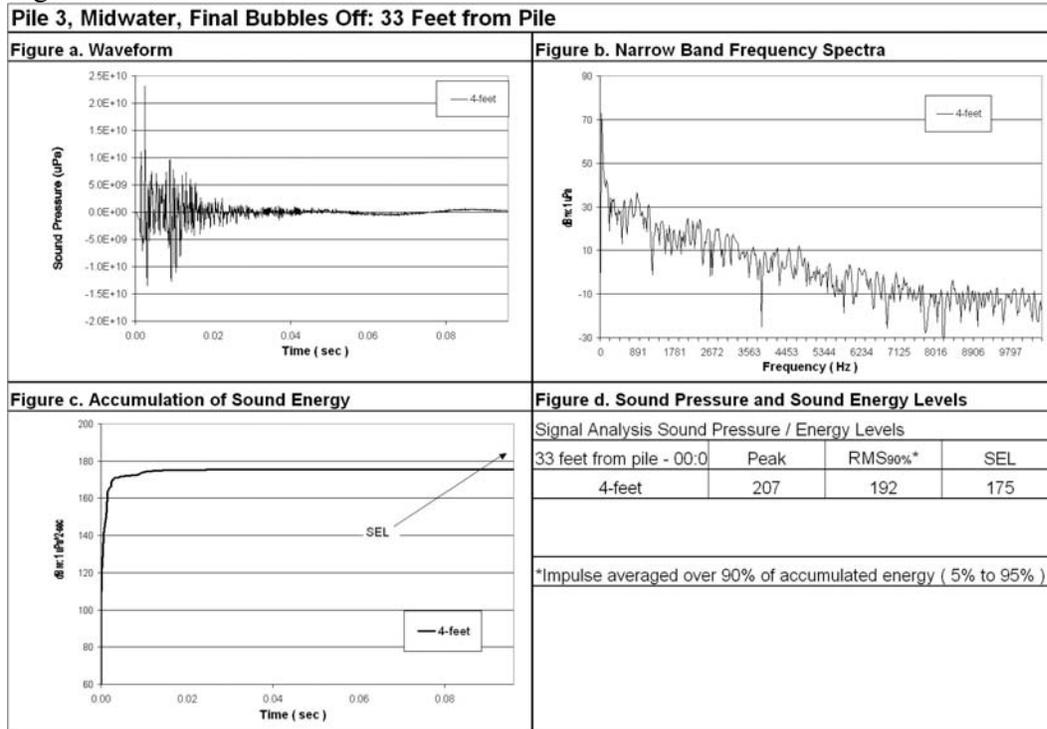
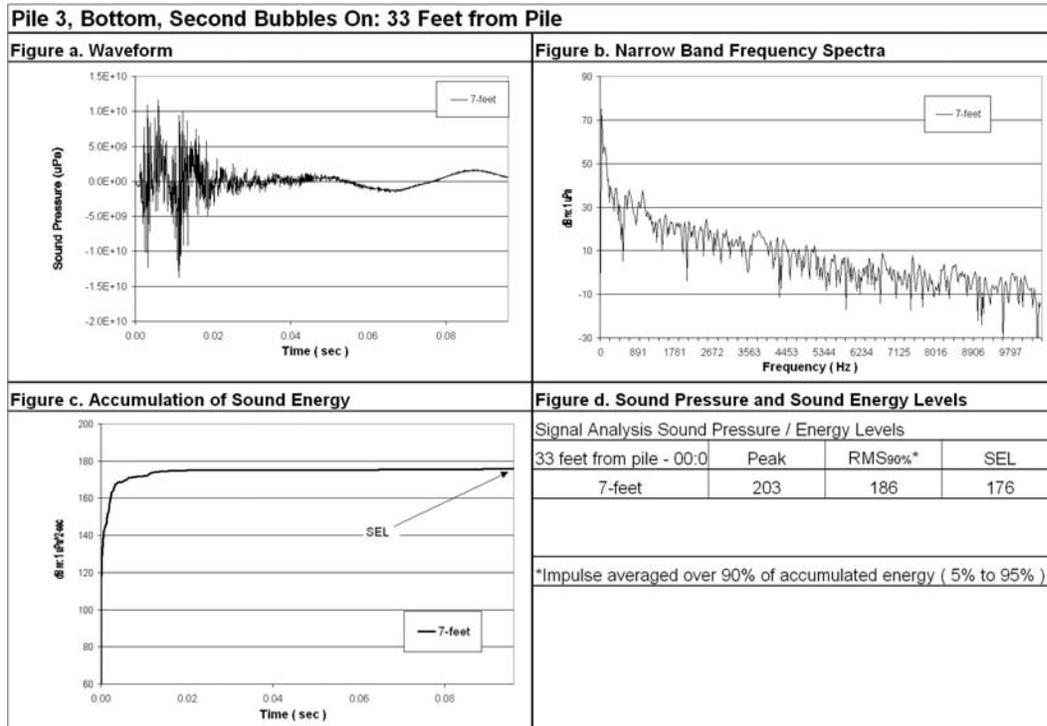
**Figure 16: Waveform Analysis of Pile Number 3 Sound Pressure Levels with Bubble Curtain Second On, Midwater and Bottom.**

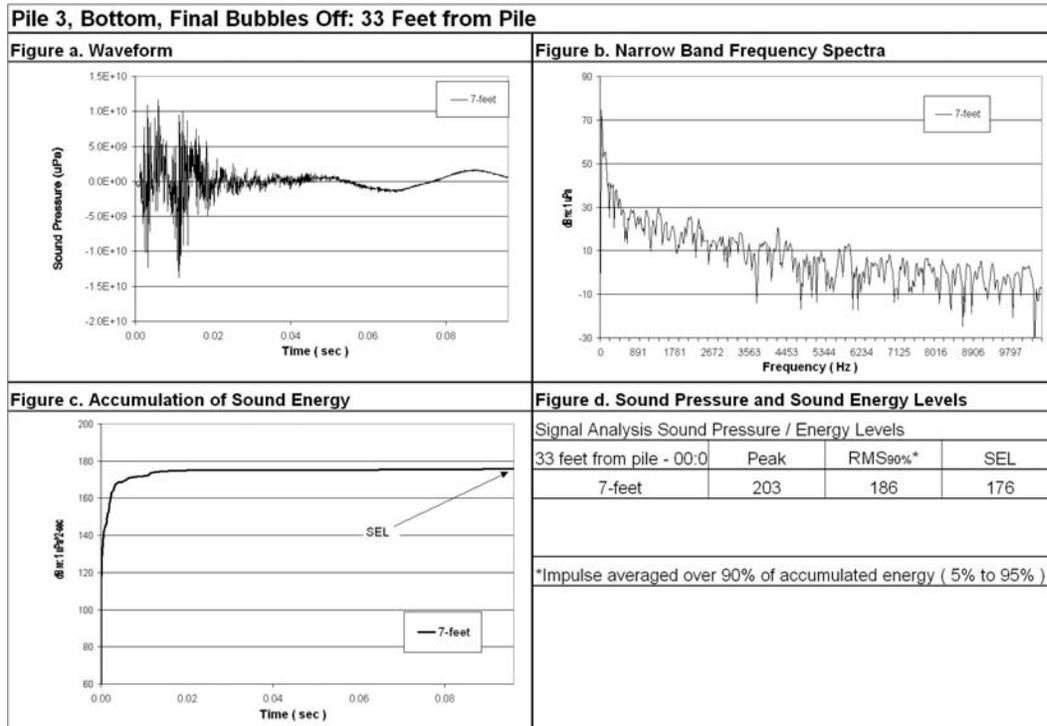
Figure 17b

**Figure 17: Waveform Analysis of Pile Number 3 Sound Pressure Levels with Bubble Curtain Final Off, Midwater and Bottom.**

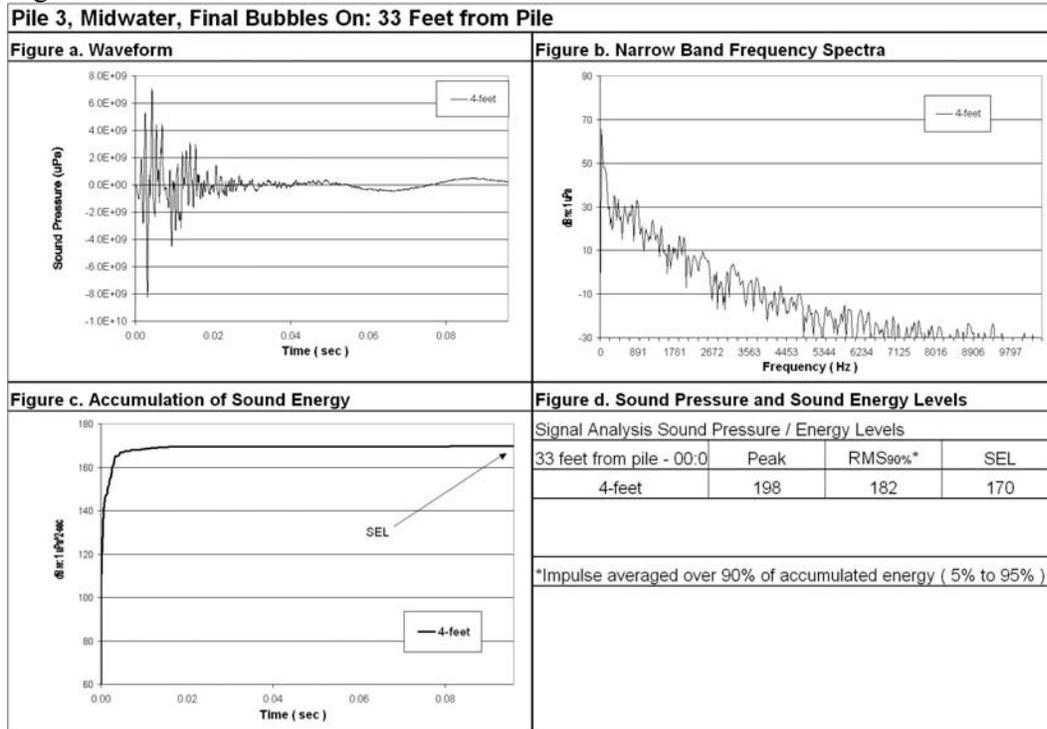
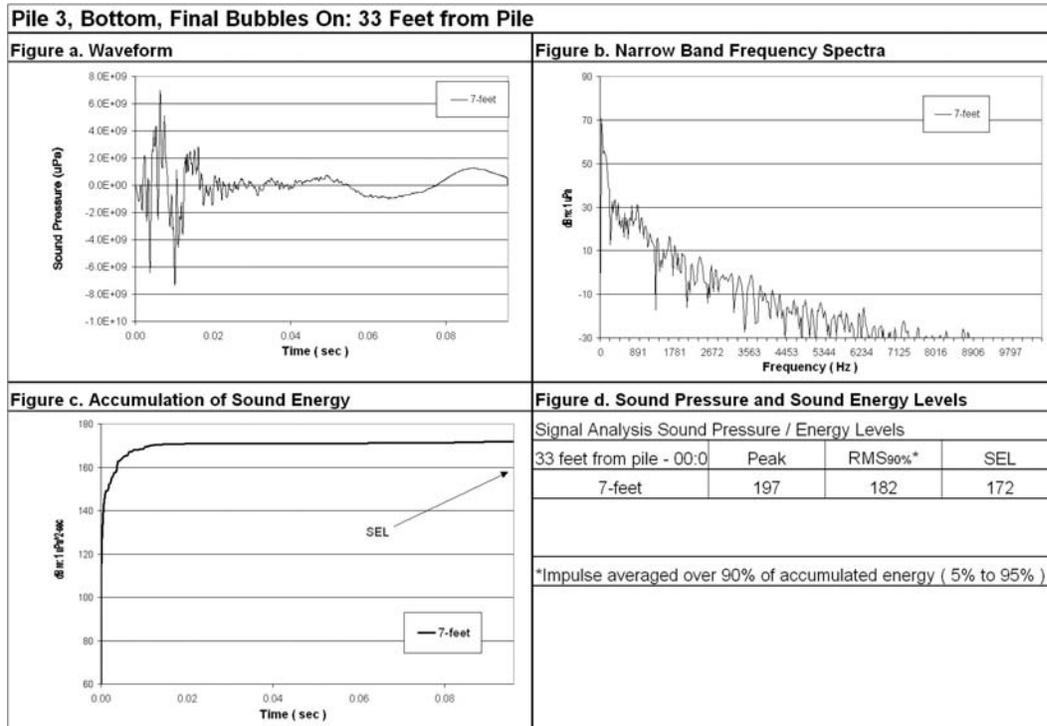
**Figure 18: Waveform Analysis of Pile Number 3 Sound Pressure Levels with Bubbles Curtain Final On, Midwater and Bottom.**

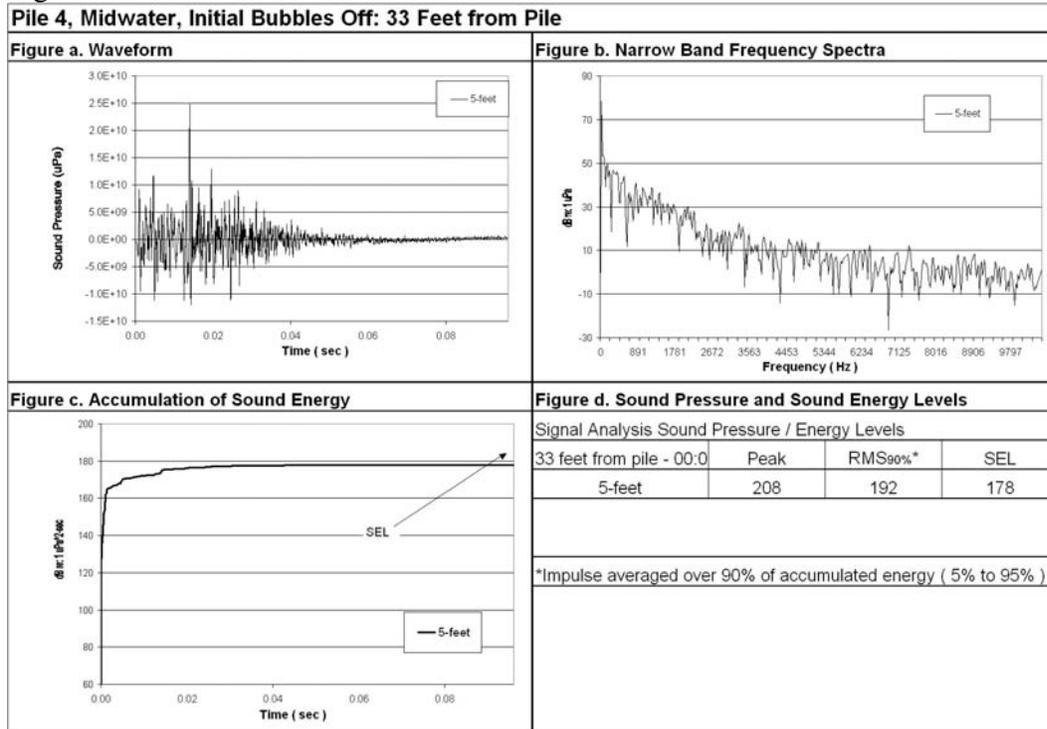
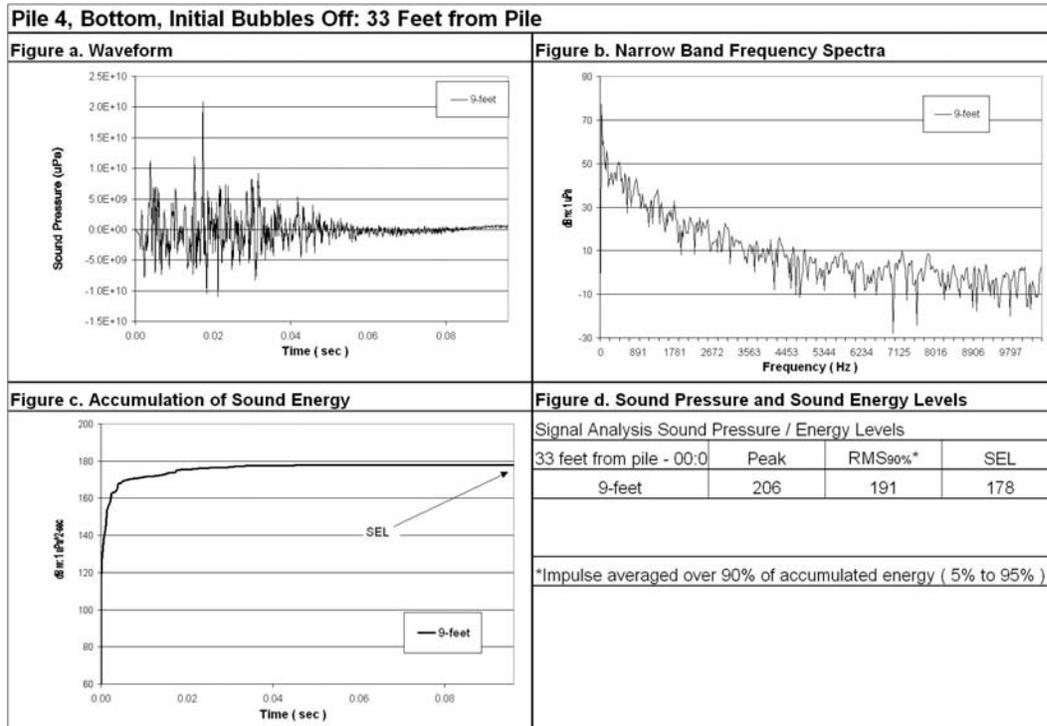
**Figure 19: Waveform Analysis of Pile Number 4 Sound Pressure Levels with Bubbles Curtain Initial Off, Midwater and Bottom.**

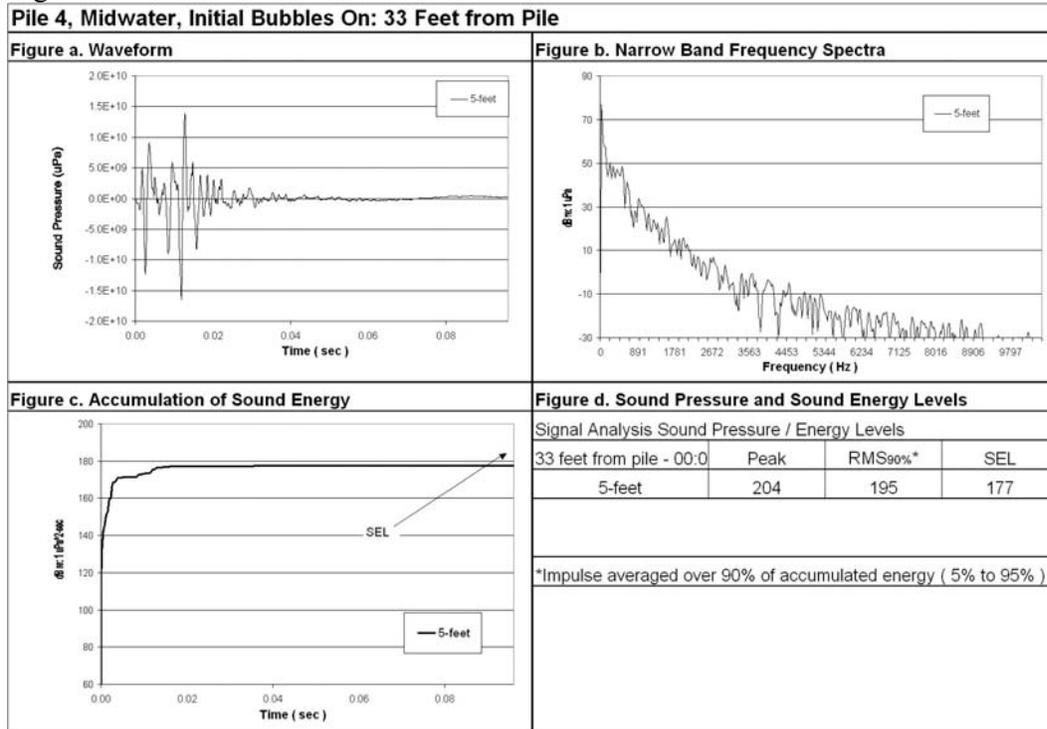
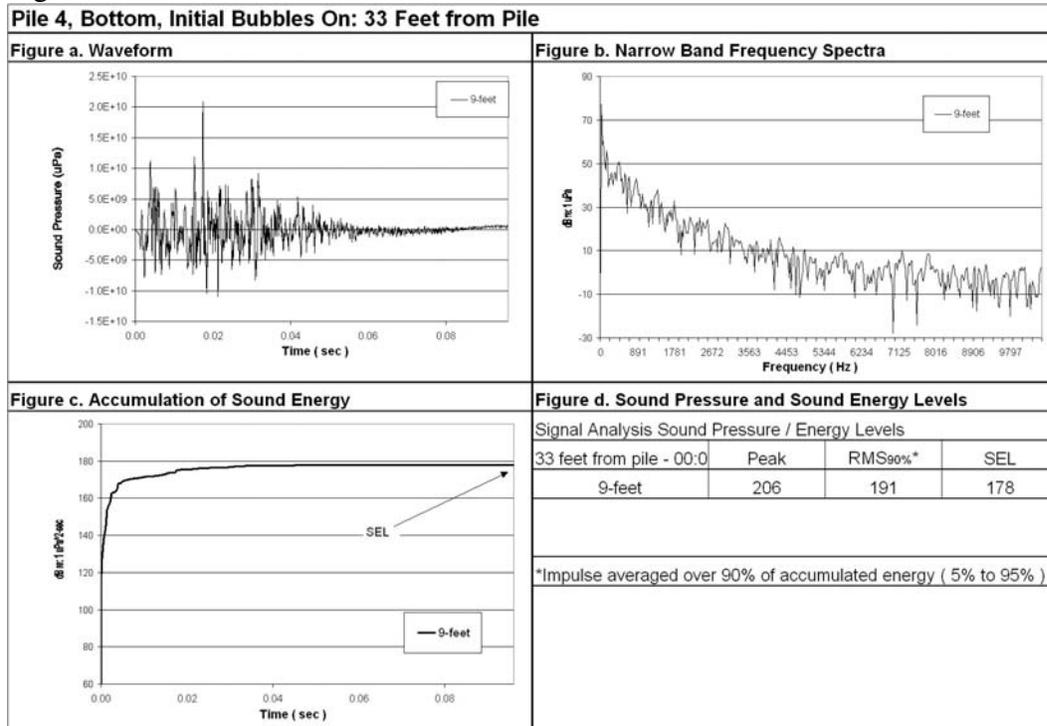
Figure 20: Waveform Analysis of Pile Number 4 Sound Pressure Levels with Bubbles Curtain Initial On, Midwater and Bottom.

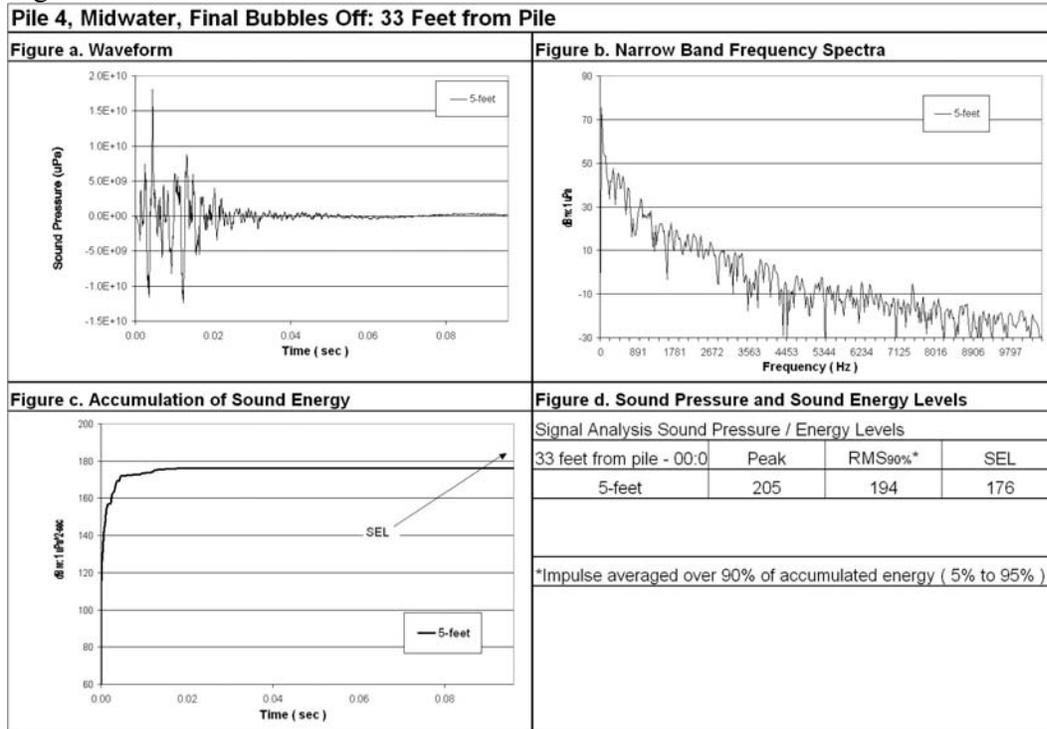
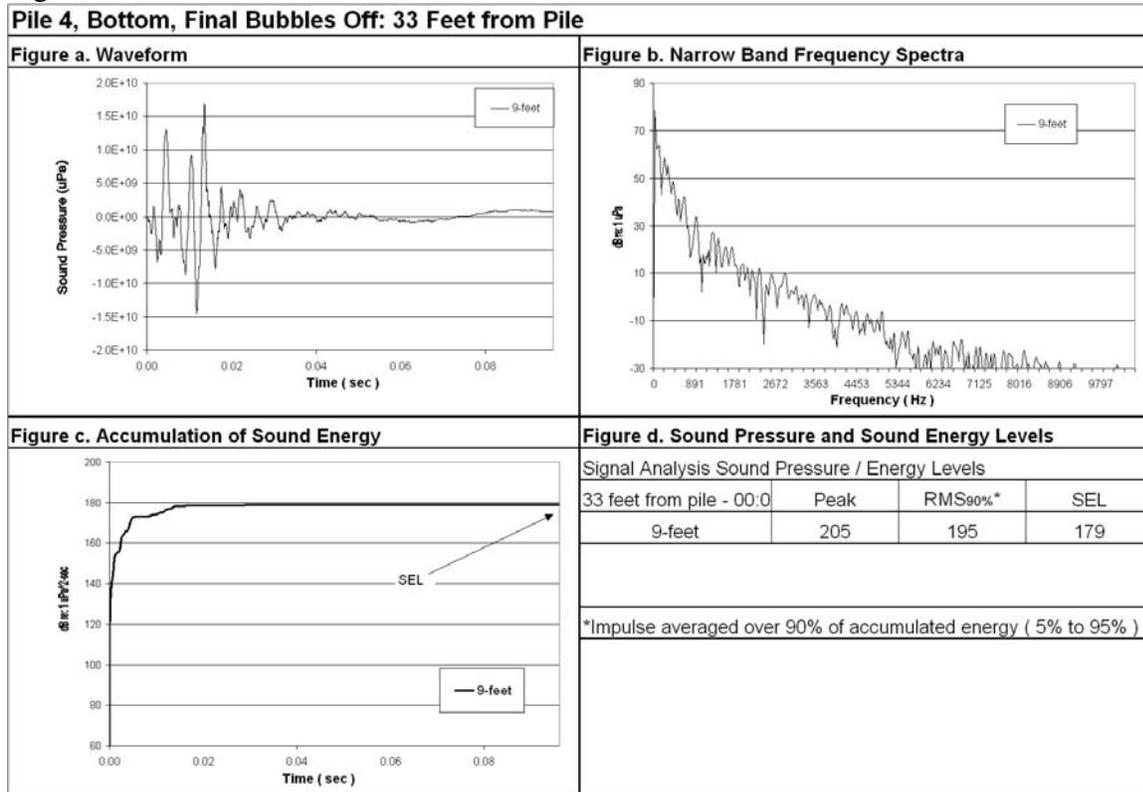
Figure 21: Waveform Analysis of Pile Number 4 Sound Pressure Levels with Bubbles Curtain Final Off, Midwater and Bottom.

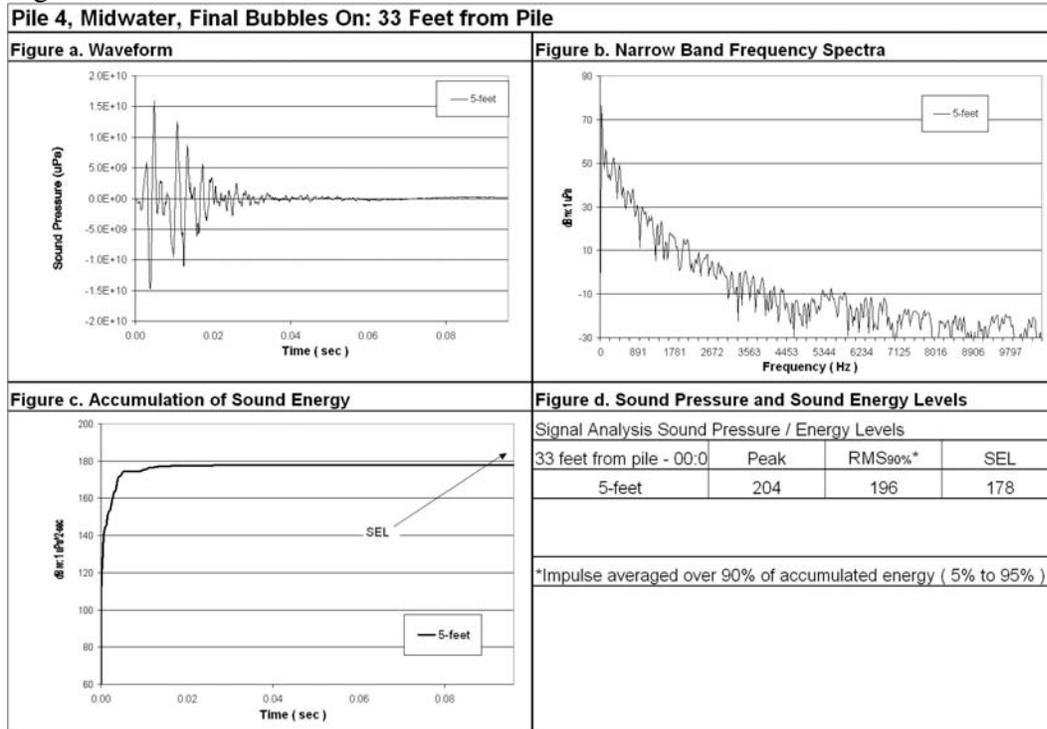
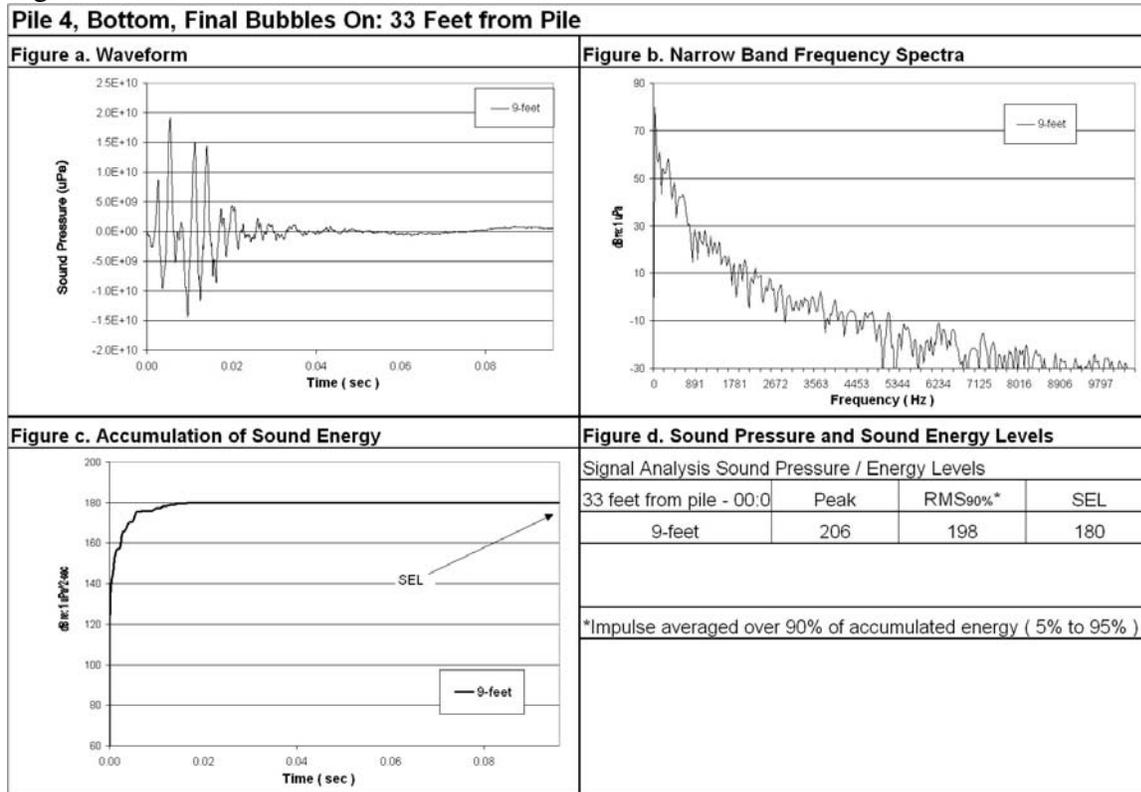
Figure 22: Waveform Analysis of Pile Number 4 Sound Pressure Levels with Bubbles Curtain Final On, Midwater and Bottom.

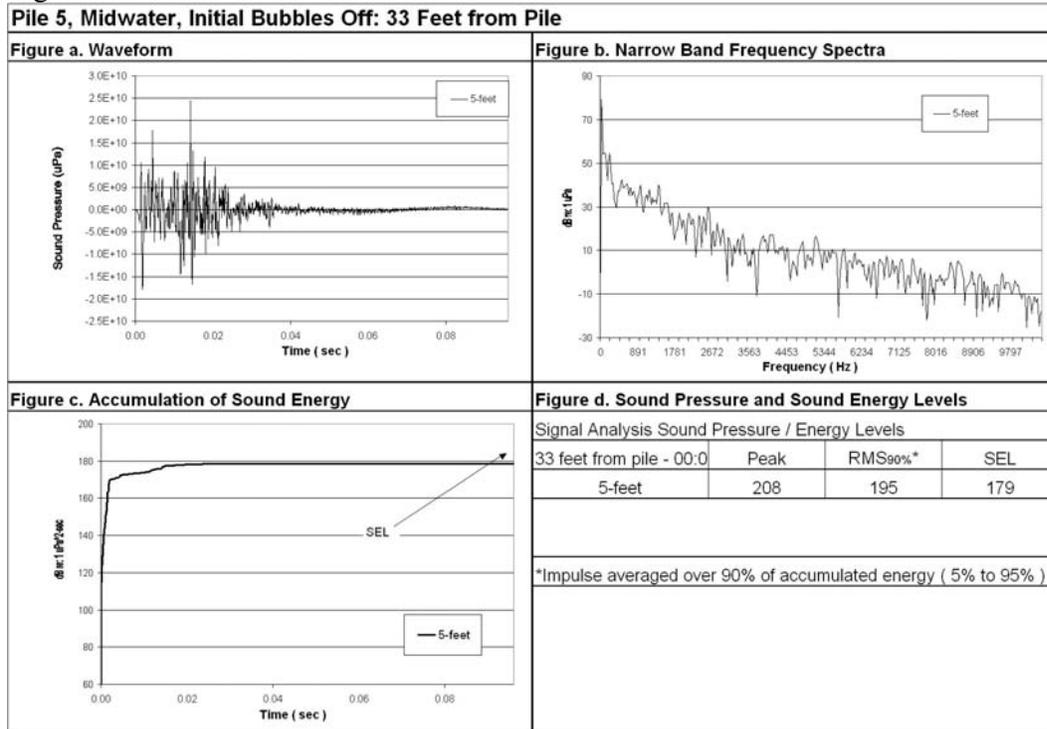
Figure 23a

Figure 23: Waveform Analysis of Pile Number 5 Sound Pressure Levels with Bubbles Curtain Initial Off, Midwater and Bottom.

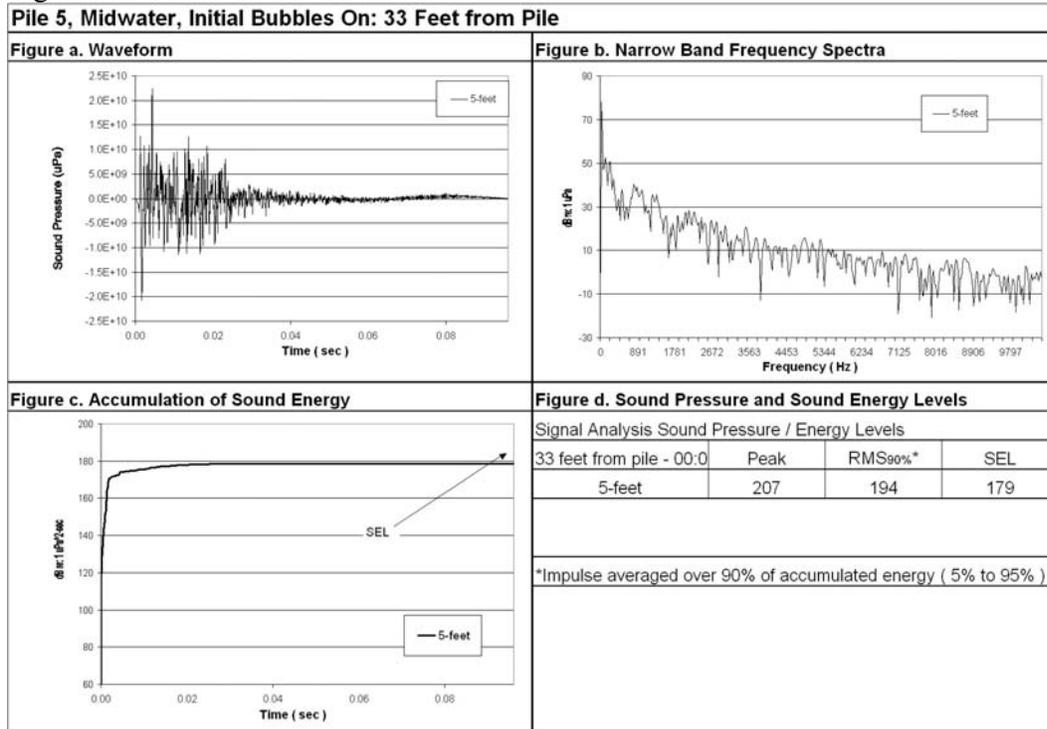
Figure 24a

**Figure 24: Waveform Analysis of Pile Number 5 Sound Pressure Levels with Bubbles Curtain Initial On, Midwater and Bottom.**

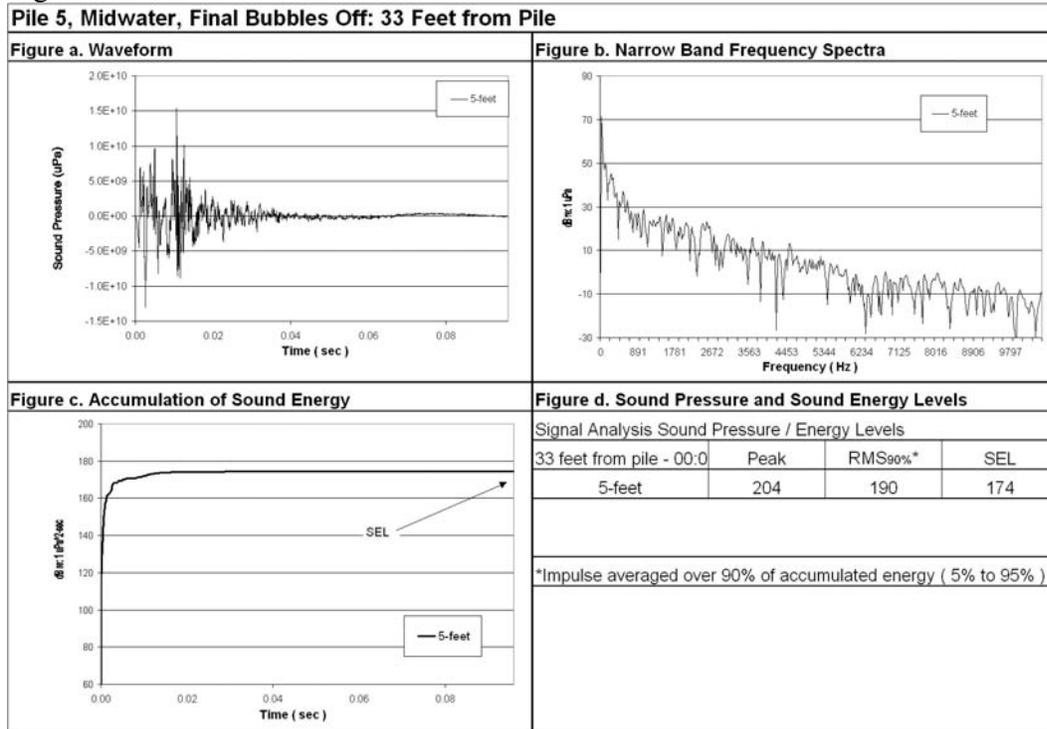
Figure 25a

**Figure 25: Waveform Analysis of Pile Number 5 Sound Pressure Levels with Bubbles Curtain Final Off, Midwater and Bottom.**

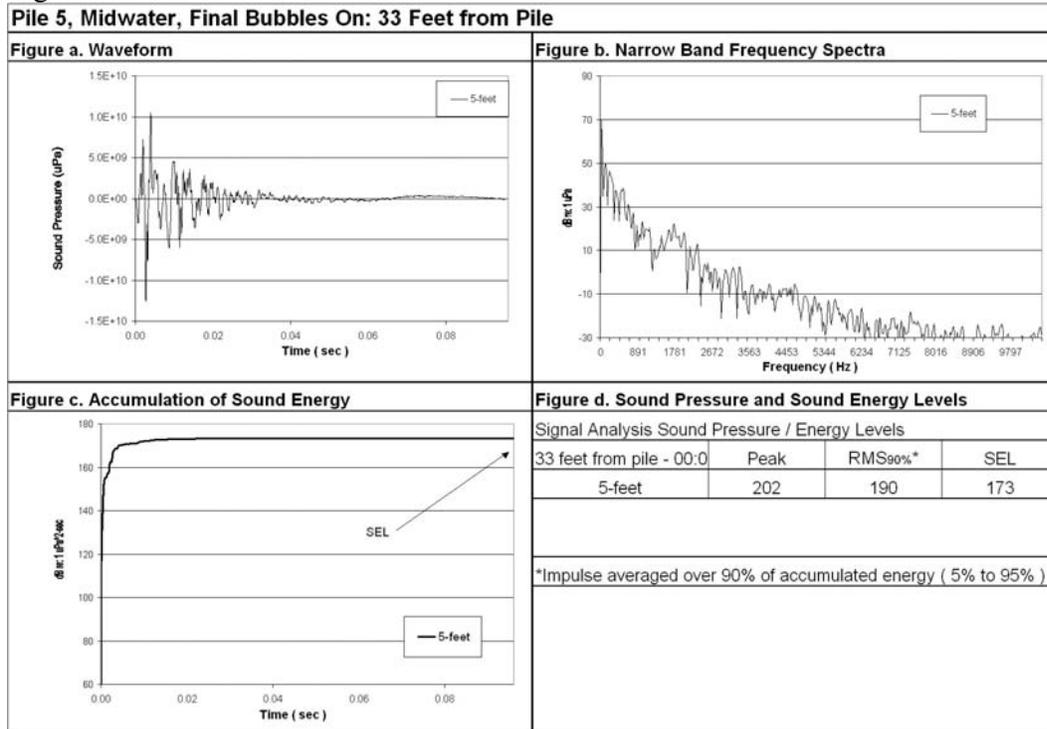
Figure 26a

**Figure 26: Waveform Analysis of Pile Number 5 Sound Pressure Levels with Bubbles Curtain Final On, Midwater and Bottom.**
