SR 99: ALASKAN WAY VIADUCT &  
SEAWALL REPLACEMENT PROJECT

# Draft Environmental Impact Statement Appendix U Hazardous Materials Discipline Report

MARCH 2004

## Draft EIS Hazardous Materials Discipline Report

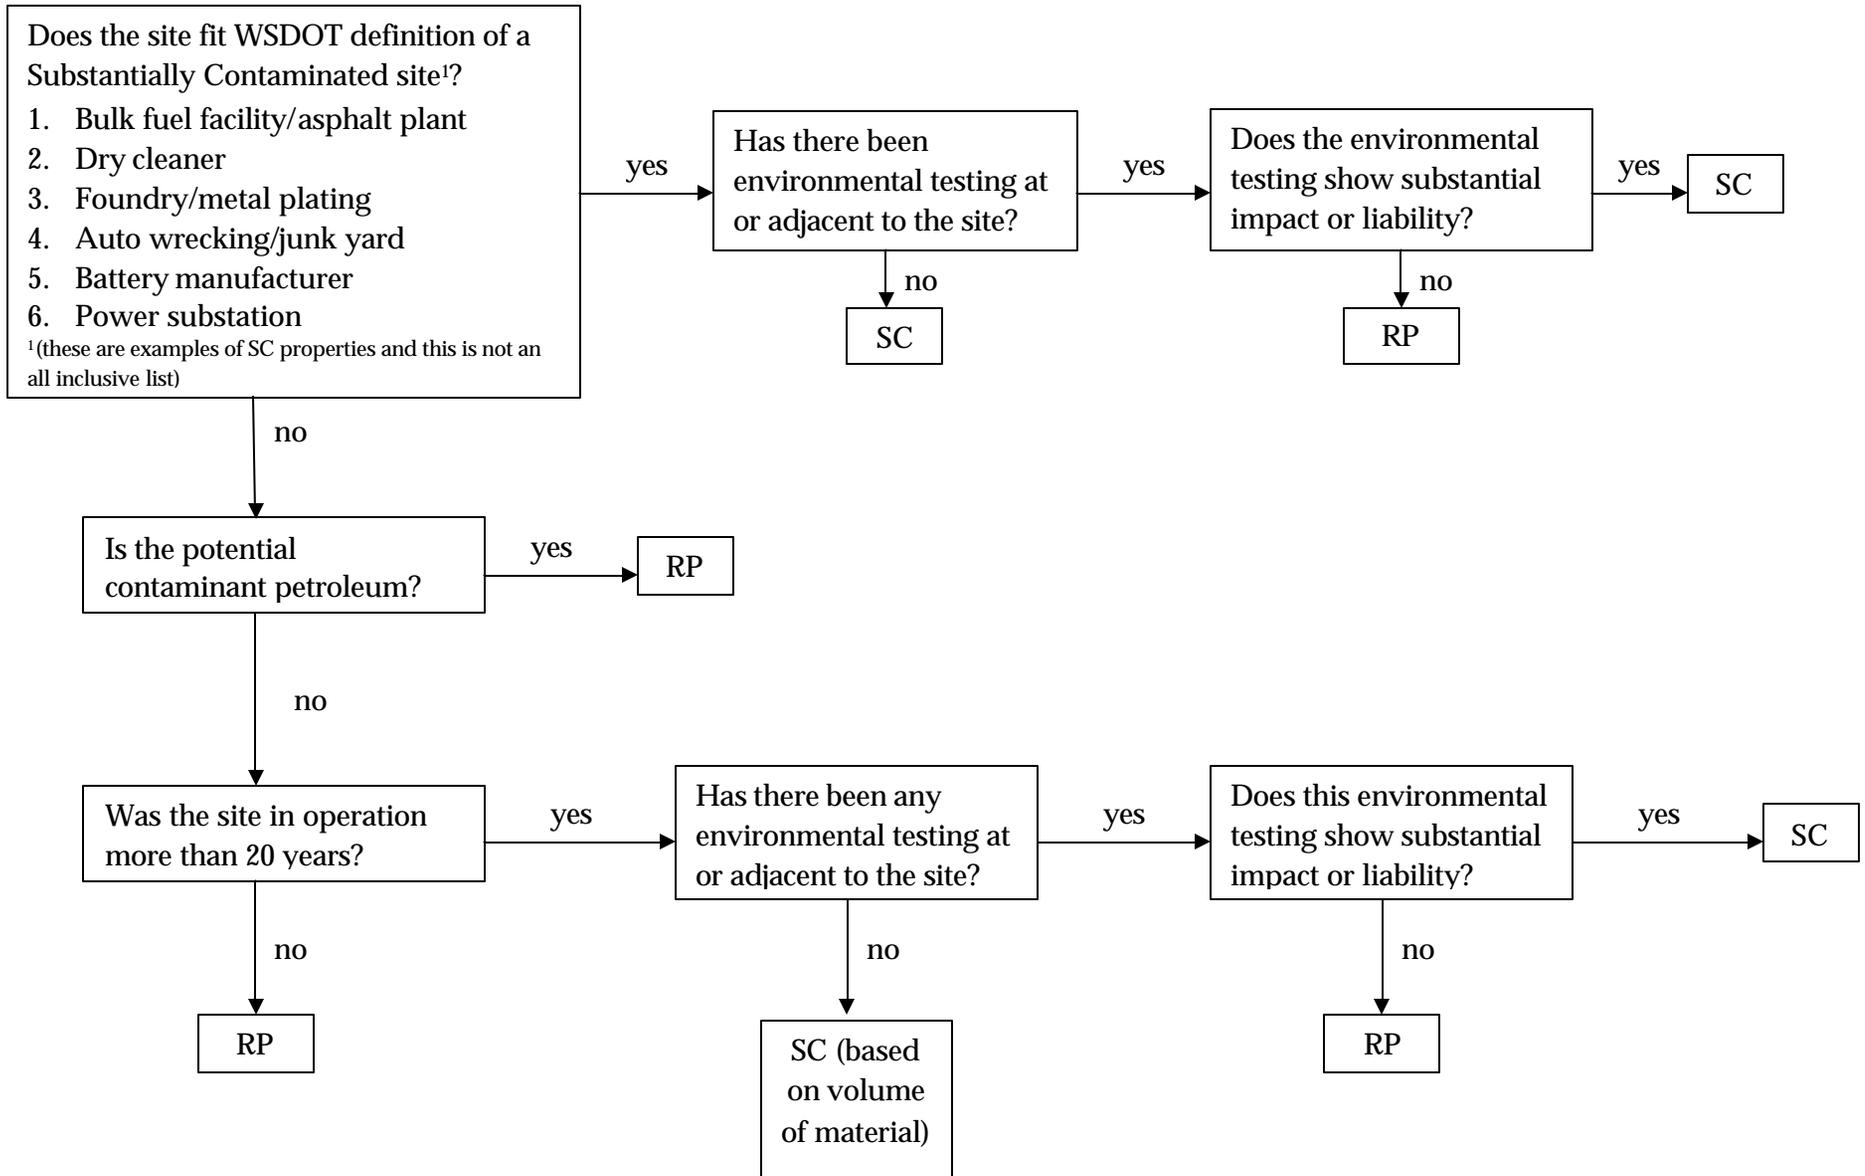
Exhibit 3-6. Substantially Contaminated (SC) and Reasonably Predictable (RP) Flow Chart

Substantially contaminated sites may pose a potential for major liability for WSDOT either in construction liability or by virtue of acquiring all or a part of the site. If the site has undergone a detailed investigation and a feasibility study, the impacts and remediation costs may have been predicted. Nonetheless, the site is identified as substantially contaminated because of its potential impact to the project. Other sites are considered substantially contaminated sites because their impacts are not reasonably predictable. In general, substantially contaminated sites possess a potential for substantial soil, water, and/or sediment contamination, and/or the information necessary to predict remedial costs is lacking, and/or the contaminants are persistent and/or expensive to manage. The site may be contaminated over a large area with a single contaminant or over a smaller area with multiple contaminants. Substantially contaminated sites are typically large and/or have large volumes of contaminated material, and/or have a long history of industrial or commercial use. Examples of sites that would be classified as substantially contaminated include wood treating operations, metal plating facilities, large bulk petroleum facilities, refineries, hazardous material treatment facilities, or other sites that use or have used large amounts of contaminating materials (WSDOT 2003).
