# SR 99: ALASKAN WAY VIADUCT & SEAWALL REPLACEMENT PROJECT

Hazardous Materials Discipline Report

## Supplemental Draft EIS Hazardous Materials Discipline Report

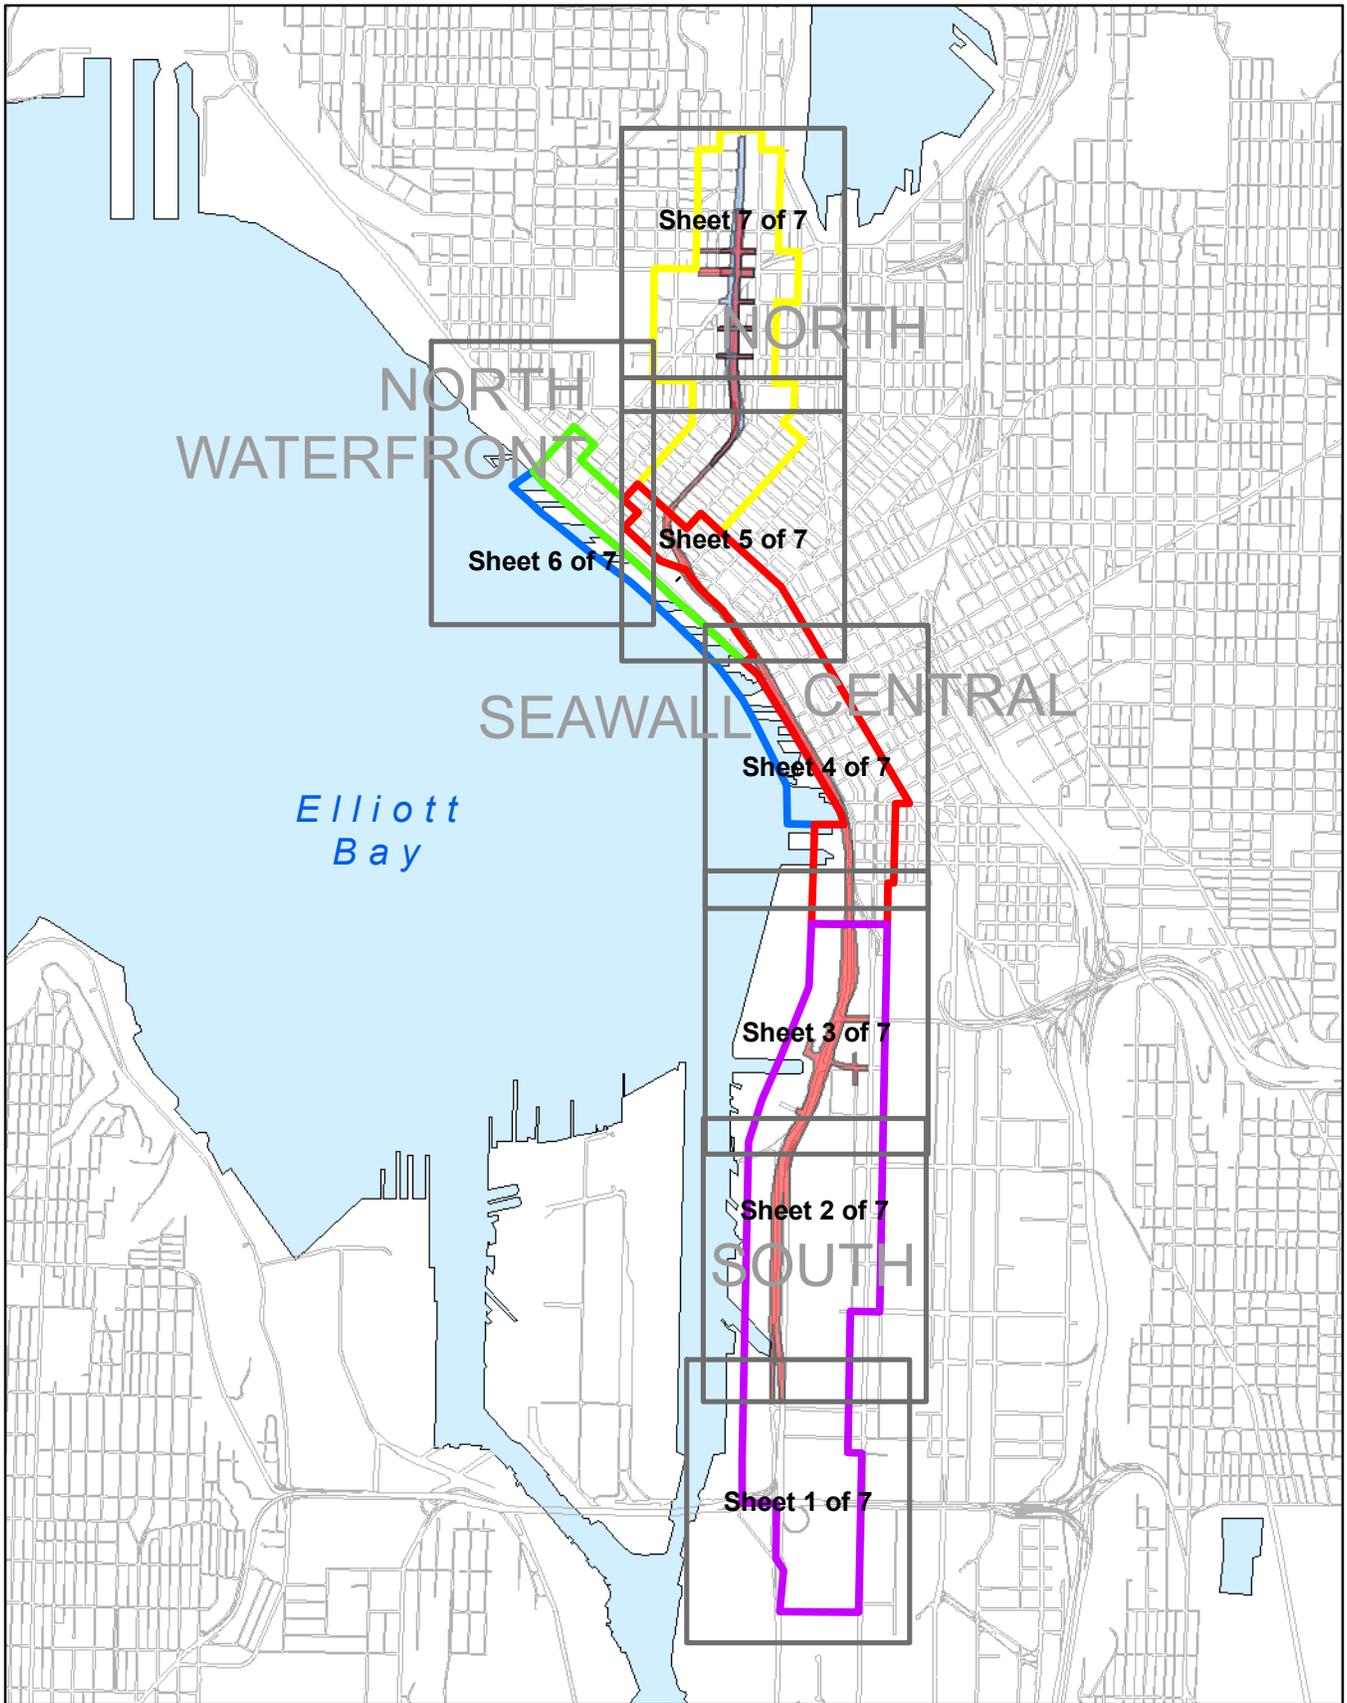
In addition to the environmental sampling conducted in 2002 for preliminary design and the EIS, additional borings were drilled in the central and south areas and in the area north of the Battery Street Tunnel in 2004 and 2005. These borings were drilled to support continuing design of the Alaskan Way Viaduct. Selected soil and groundwater samples were analyzed to identify contaminants that may affect disposal or treatment of the respective media. The results are discussed in Chapter 4. Summaries of soil and groundwater analytical testing results, along with complete analytical laboratory reports, are provided in the *Geotechnical and Environmental Data Report* (Shannon & Wilson, Inc. 2005a) and the *Geotechnical and Environmental Data Report - North of the Battery Street Tunnel* (Shannon & Wilson, Inc. 2005b). Exhibit 3-2 includes the explorations drilled in 2004 and 2005.
