SR 529 EBHEY SLOUGH BRIDGE REPLACEMENT PROJECT

**UNDERWATER SOUND LEVELS
ASSOCIATED WITH DRIVING 72-inch
STEEL PILES AT THE SR 529 EBHEY
SLOUGH BRIDGE REPLACEMENT
PROJECT**

March 2011

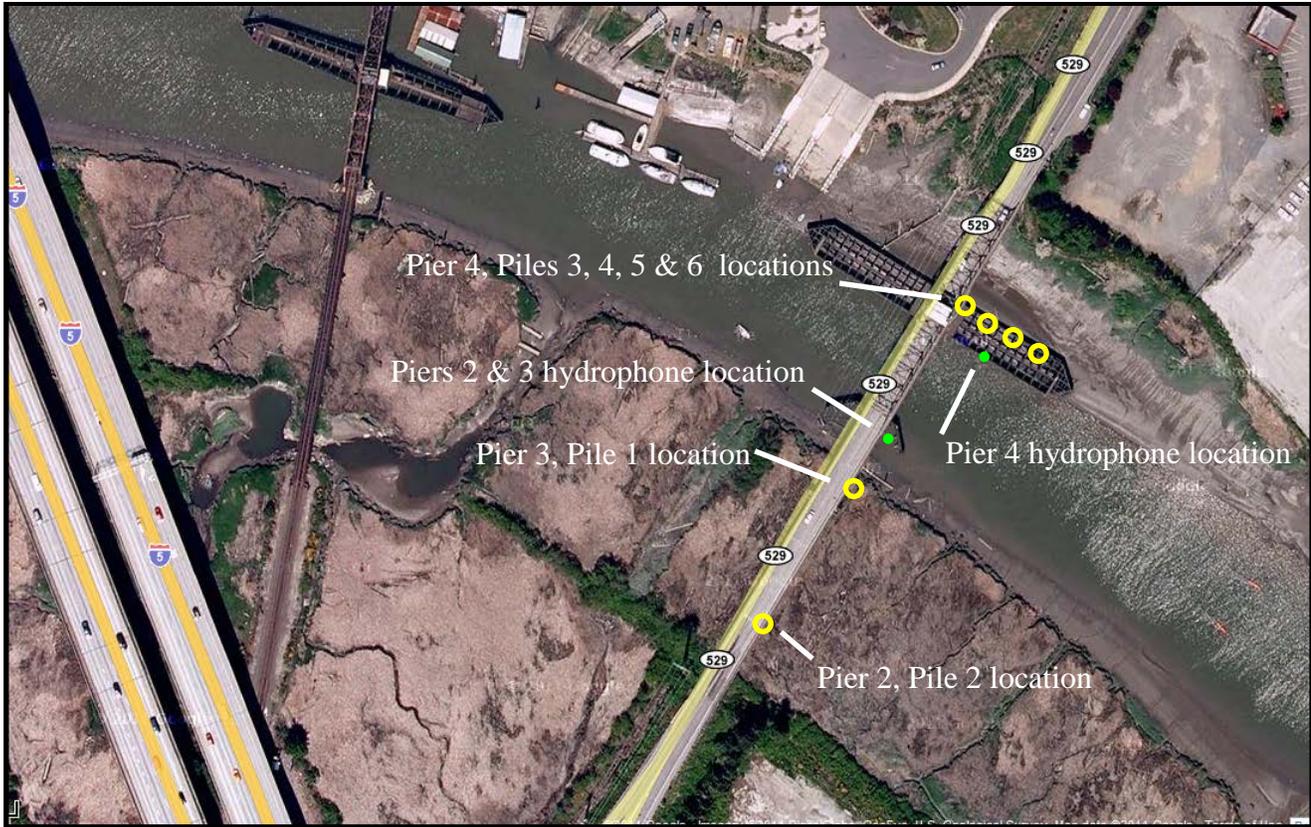
Figure 2: Approximate location of 72-inch piles and hydrophones at the SR 529 Ebey Slough Bridge Replacement Project.

○ = 72-inch Steel Pile; ● = Hydrophone

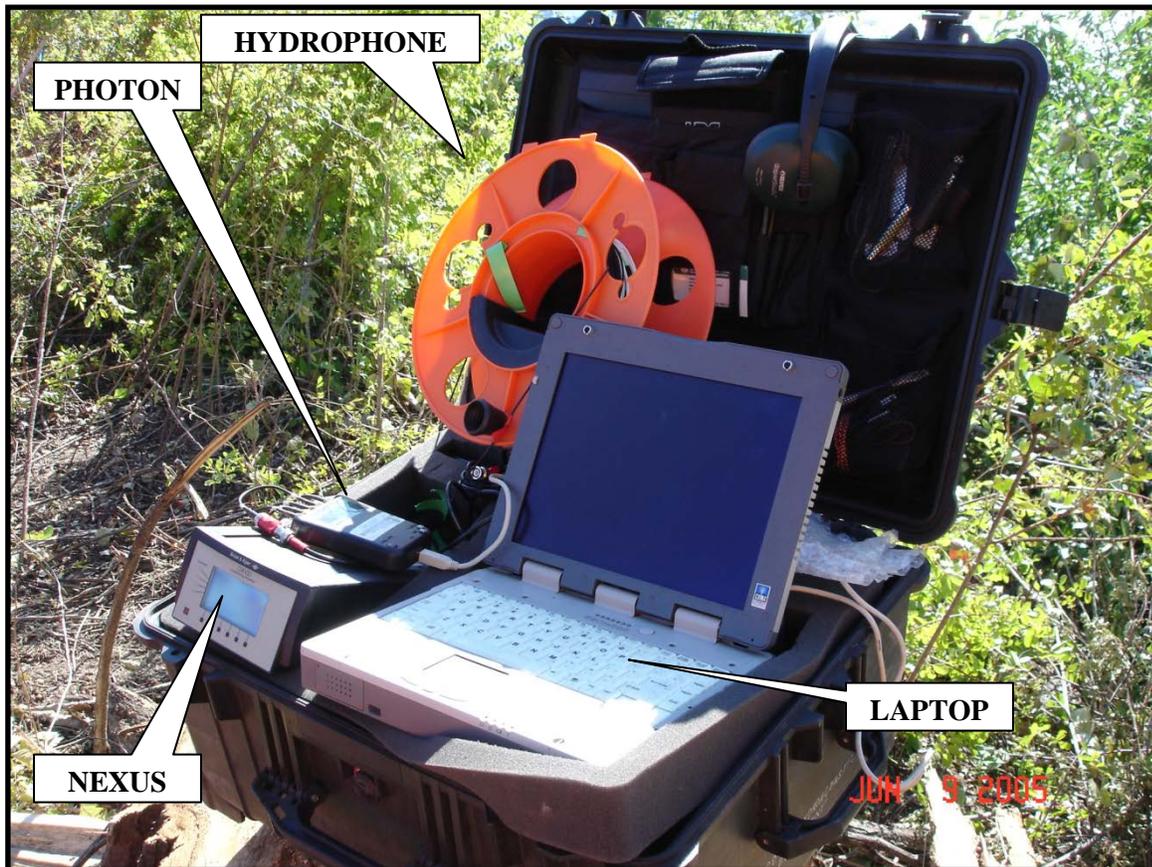
Figure 3: Near field acoustical monitoring equipment

Underwater sound levels were measured near the pile (near field) using one Reson TC 4013 hydrophone deployed on a nylon cord off the side of the Ebey Slough bridge. The hydrophone was positioned at a distance of between 10 and 74 meters from the individual pile being monitored and at either mid-water level or one foot from the bottom depending on the stage of tidal flux. The measurement system includes a Brüel and Kjær Nexus type 2692 4-channel signal conditioner, which kept the high underwater sound levels within the dynamic range of the signal analyzer (Figure 3). The output of the Nexus signal conditioner is received by a Dactron Photon 4-channel signal spectrum analyzer that is attached to an Itronix GoBook II laptop computer (Figure 3).

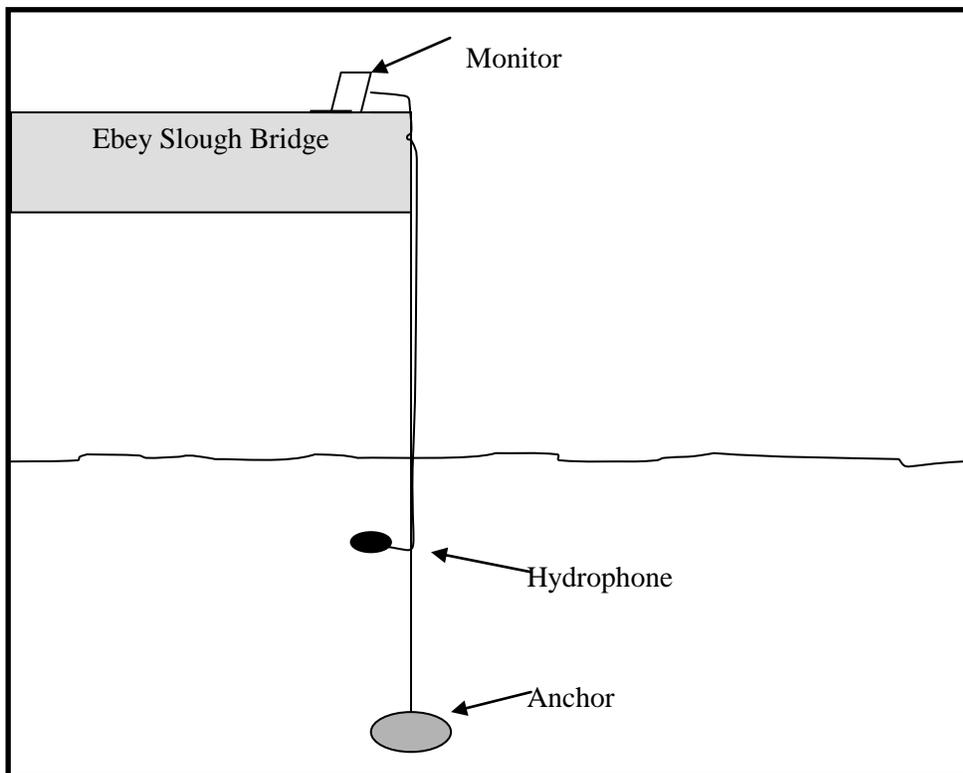
Figure 4: Diagram of hydrophone deployment configuration.

The location of the hydrophones is determined by allowing a clear line of sight between the pile and the hydrophone, with no other structures nearby. The distance from the pile to the hydrophone location was measured using a Bushnell Yardage Pro rangefinder. The hydrophone was attached to a weighted nylon cord anchored with a five-pound weight. The cord and hydrophone cables were lowered off the side of the bridge (Figure 4). For those piles driven above the OHWM the hydrophone was located in the water and as close as possible to the pile.

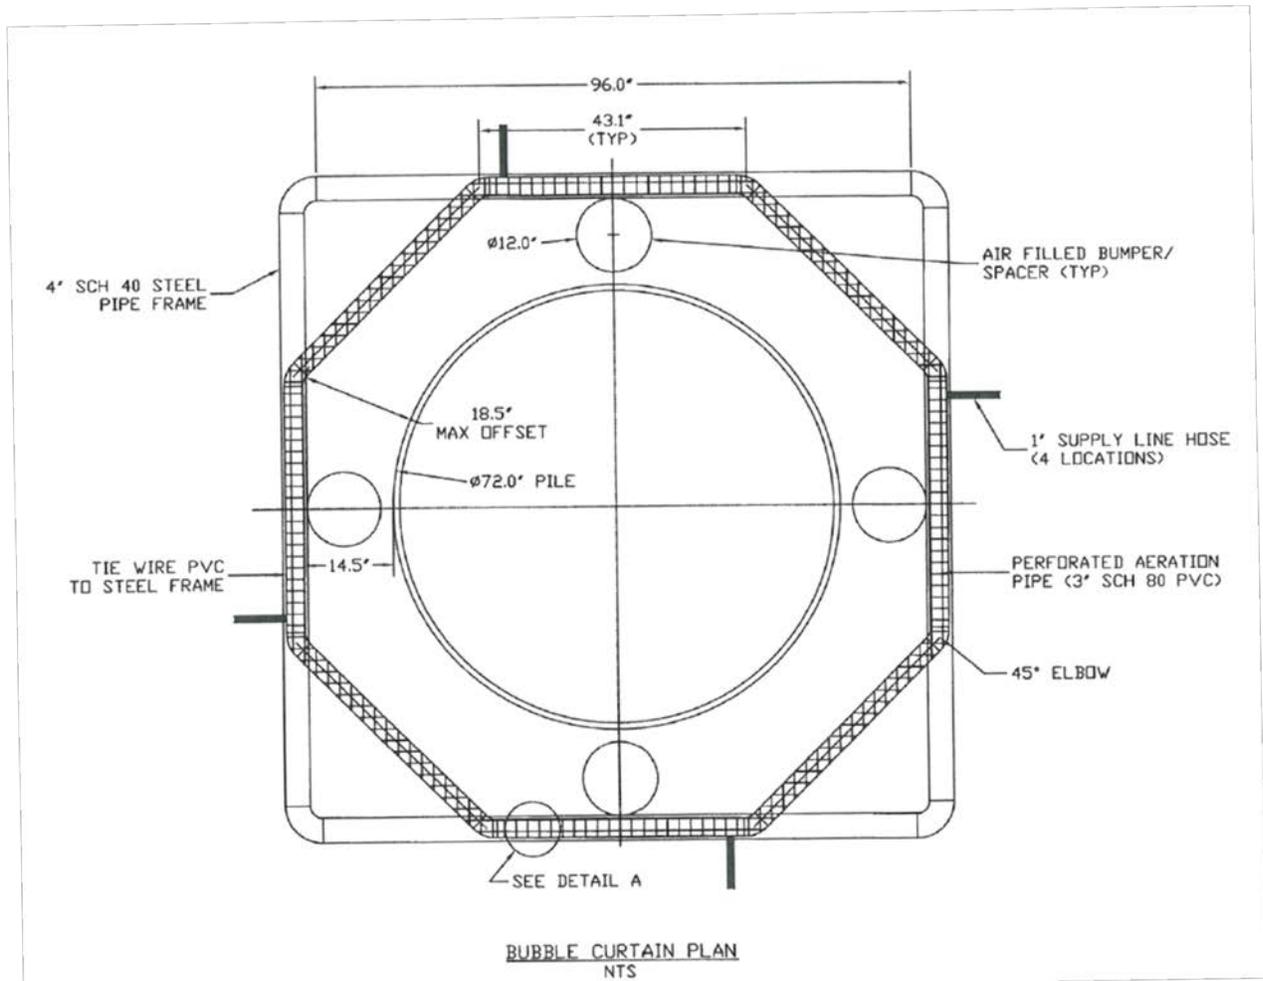
Figure 5: Diagram of unconfined bubble curtain.

A confined bubble curtain with a single ring at the bottom was tested as a part of this project (Figure 5). The bubble curtain is placed around the pile being driven with the ring on the

substrate. The compressor was attached with a separate hose on each half of the ring and maintained a flow of 32.91 cubic feet per minute per linear foot of pipe. The bubble curtain was constructed using 3-inch diameter Schedule 80 PVC pipe and 1/16-inch diameter air holes at 3/4-inch on center in four rows. The manifold was attached to a square steel frame which weighted it to the substrate. The original drawing (Figure 5) indicates that there were four air filled bumpers/spacers on the inside of the ring to act as resilient pile guides. However, in the field these were not used because the ring was able to maintain adequate distance from the pile during operation.

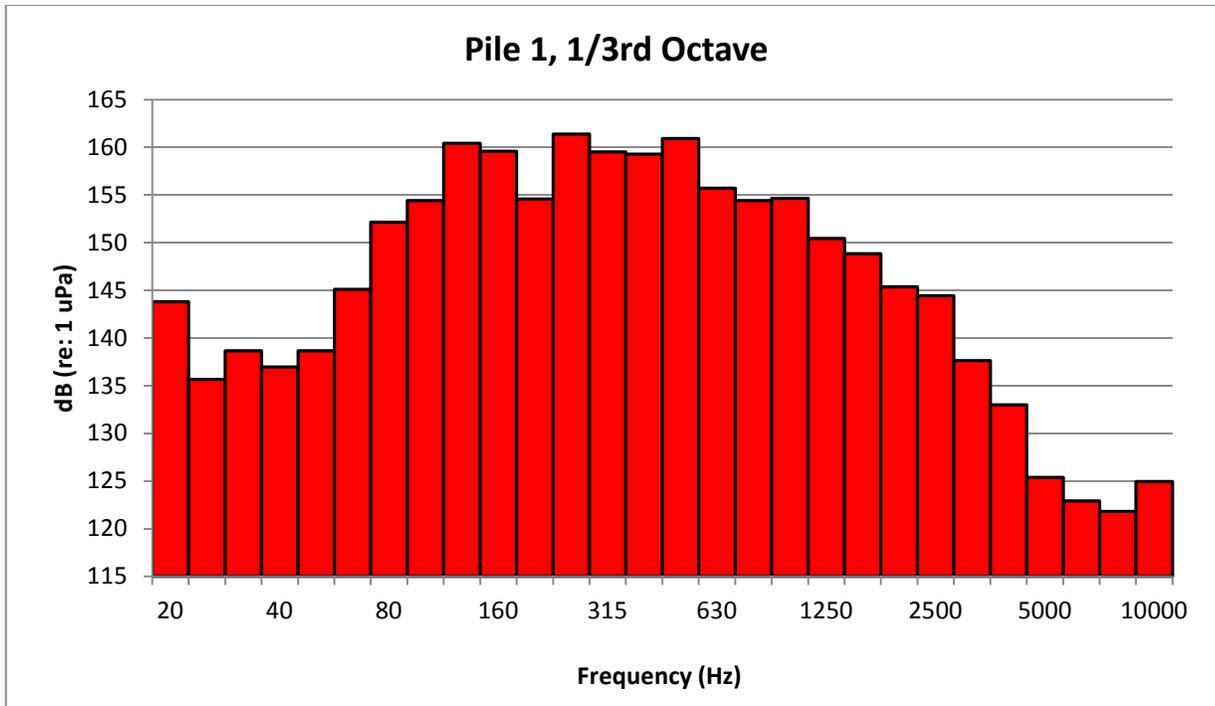
Figure 6: 1/3rd Octave frequency distribution for impact pile driving of Pile 1.

The 1/3rd Octave frequency distribution for Pile 1 (Figure 6) range between 125 Hz and 500 Hz and there are potentially three dominant frequencies at 125 Hz, 250 Hz and 500 Hz.

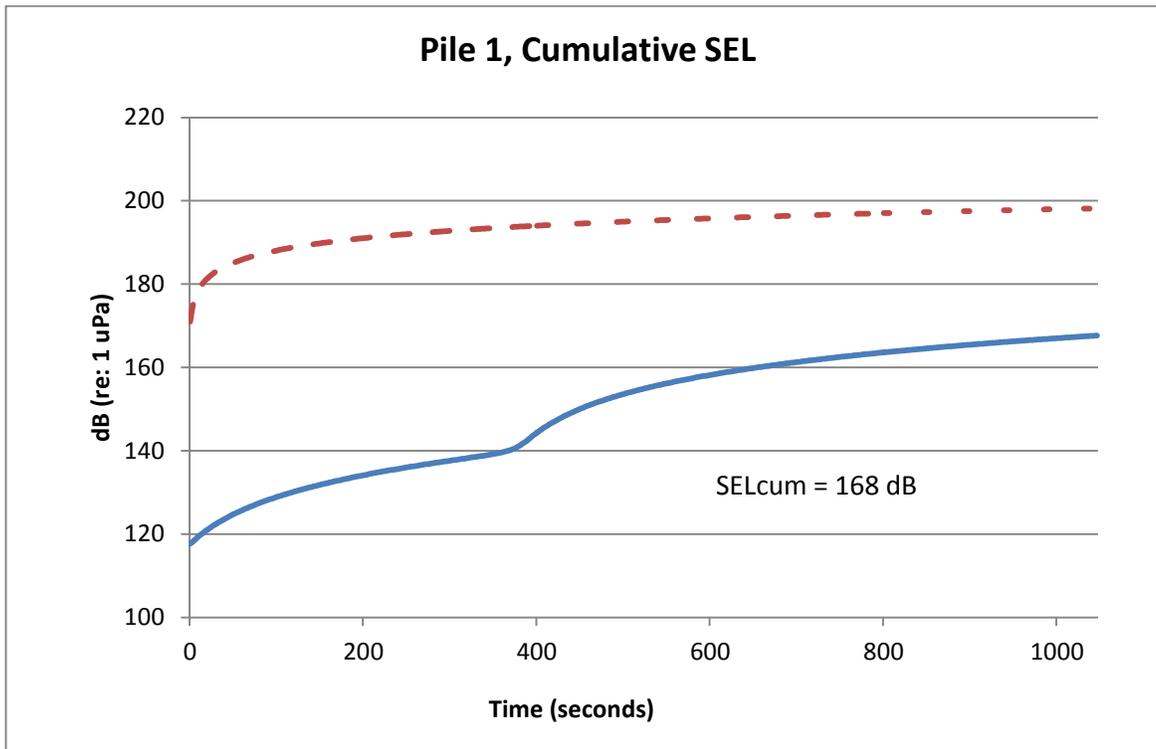
Figure 7: Cumulative SEL plot for Pile 1 showing the cumulative plot for SEL values calculated for each pile strike (blue) versus the more conservative SEL plot based on the total number of strikes (red-dashed).

The cumulative SEL values calculated for each individual pile strike (Figure 7, blue line) were compared against the more conservative cumulative SEL calculation based on the total number of pile strikes (red dashed line). The two methods differ on average by about 44 decibels with the individual strike method being substantially lower.

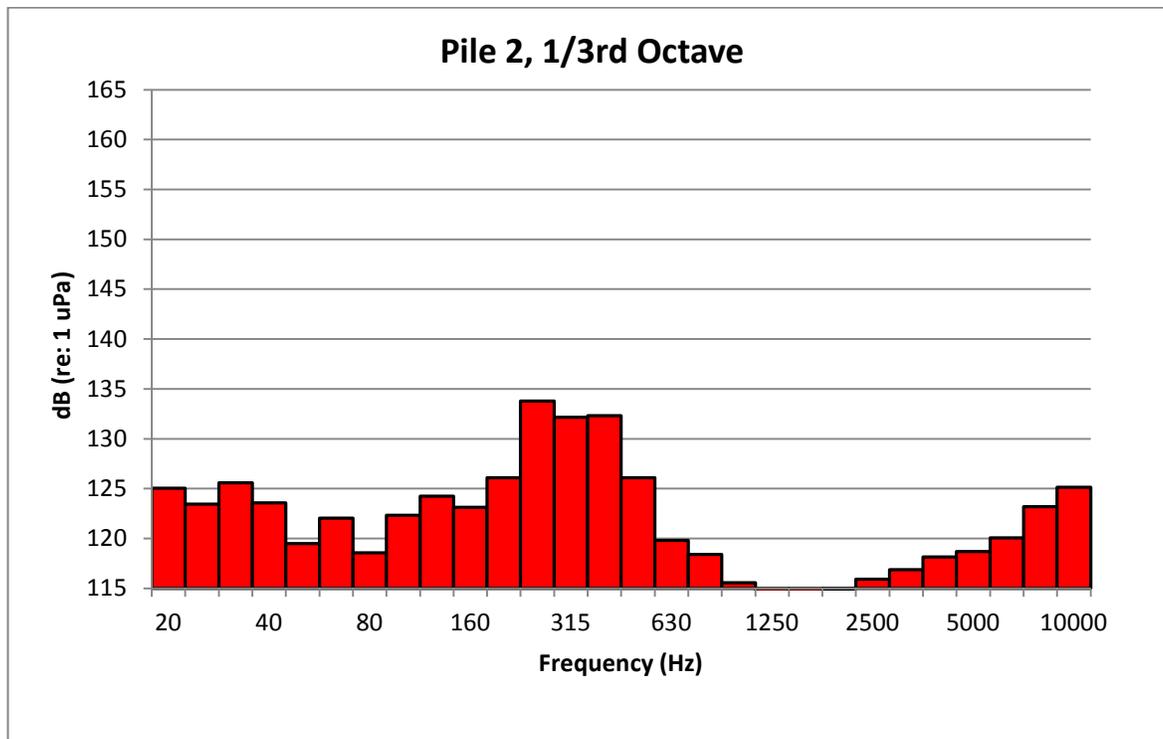
Figure 8: 1/3rd Octave frequency distribution for impact pile driving of Pile 2.

The dominant 1/3rd Octave frequency distribution for Pile 2 range between 250 Hz and 400 Hz with a peak at 250 Hz (Figure 8). There is a clear dominant lower frequency with relatively little energy at the lowest and highest frequencies. This is likely due to Pile 2 being driven 230 feet above the OHWM, which means that virtually all of the sound entering the water at the hydrophone is being transmitted through the substrate. The substrate will quickly attenuate the higher frequencies and some of the lower frequencies due to the compression of the substrate around the pile and over this distance.

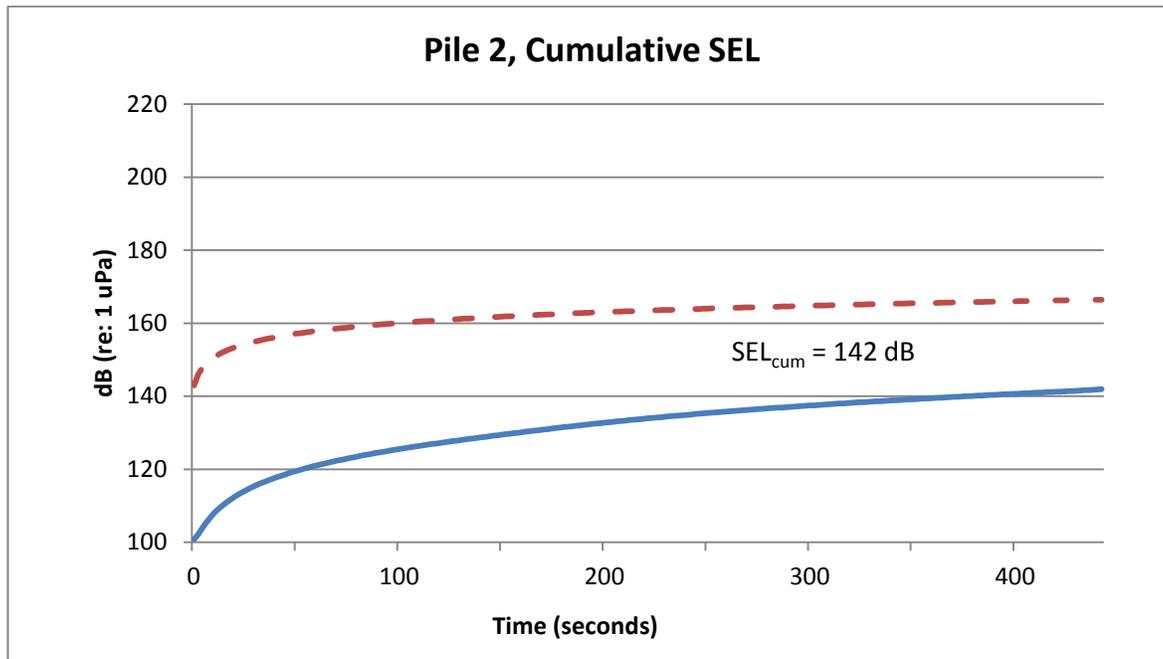
Figure 9: Cumulative SEL plot for Pile 2 showing the cumulative plot for SEL values calculated for each pile strike (blue) versus the more conservative SEL plot based on the number of strikes (red-dashed).

The attenuated cumulative SEL did not exceed the 204 dBSEL_{cum} threshold after 276 strikes and would not have exceeded until the pile was struck for 1,258,925 strikes (Table 2). The SEL was estimated for each individual pile strike by calculating a 1-second SEL for each pile strike. Plots of the cumulative SEL values for each pile strike (Figure 9, blue line) compares the calculated cumulative SEL based on the number of strikes (Figure 9, red dashed line). The two methods differ on average by about 31 decibels with the individual strike method being substantially lower. Neither method of calculating the cumulative SEL exceeded the 204 dBSEL_{cum} threshold.

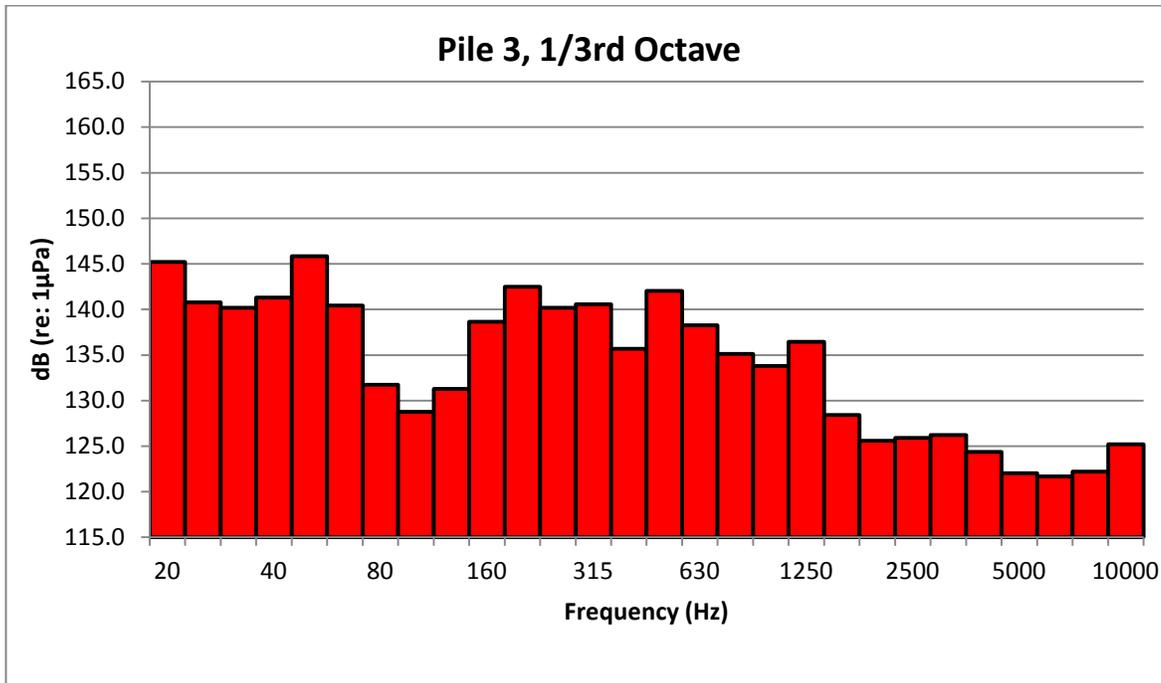
Figure 10: 1/3rd Octave frequency distribution for impact pile driving of Pile 3.

The 1/3rd Octave frequency distribution for Pile 3 shows that the dominant frequency was 50 Hz and a secondary lesser peak at 200 Hz (Figure 10). Most of the energy is below 500 Hz.

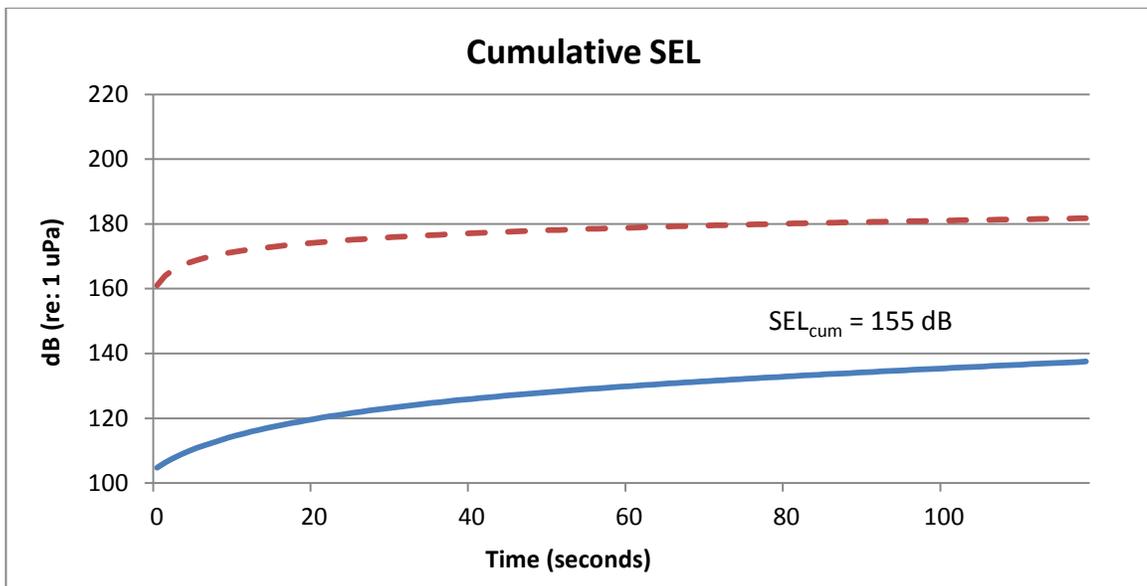
Figure 11: Cumulative SEL plot for Pile 3 showing the cumulative plot for SEL values calculated for each pile strike (blue) versus the more conservative SEL plot based on the number of strikes (red-dashed).

The attenuated cumulative SEL of 155 dBSEL_{cum} did not exceed the 204 dBSEL_{cum} threshold after 121 strikes (Table 2). The SEL was estimated for each individual pile strike while the bubble curtain was active by calculating a 1-second SEL for each pile strike. Plots of the cumulative SEL values for each pile strike (Figure 11, blue line) compares this against the calculated cumulative SEL based on the number of strikes (Figure 11, red dashed line). The two methods differ on average by about 32 decibels with the individual strike method being substantially lower. Neither cumulative SEL exceeded the 204 dBSEL_{cum} threshold.

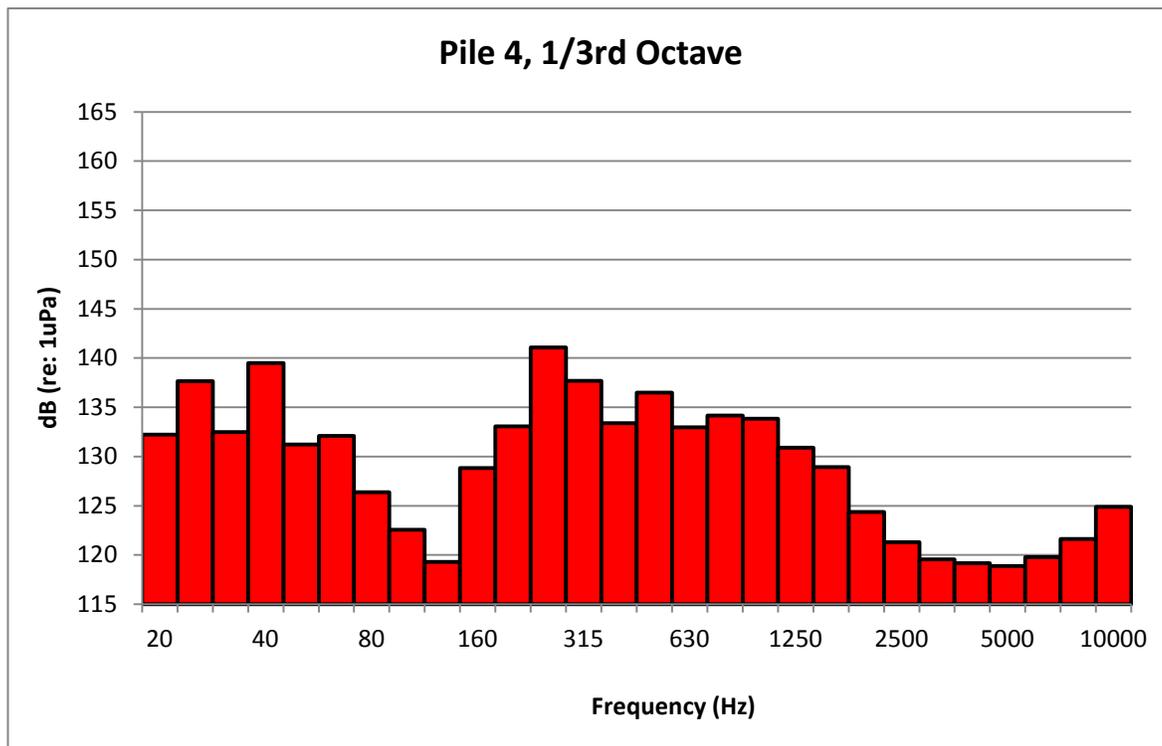
Figure 12: 1/3rd Octave frequency distribution for impact pile driving of Pile 4.

The 1/3rd Octave frequency distribution for Pile 4 shows that the dominant frequency was 250 Hz and a lesser secondary peak at 40 Hz (Figure 12). Most of the energy was below 400 Hz.

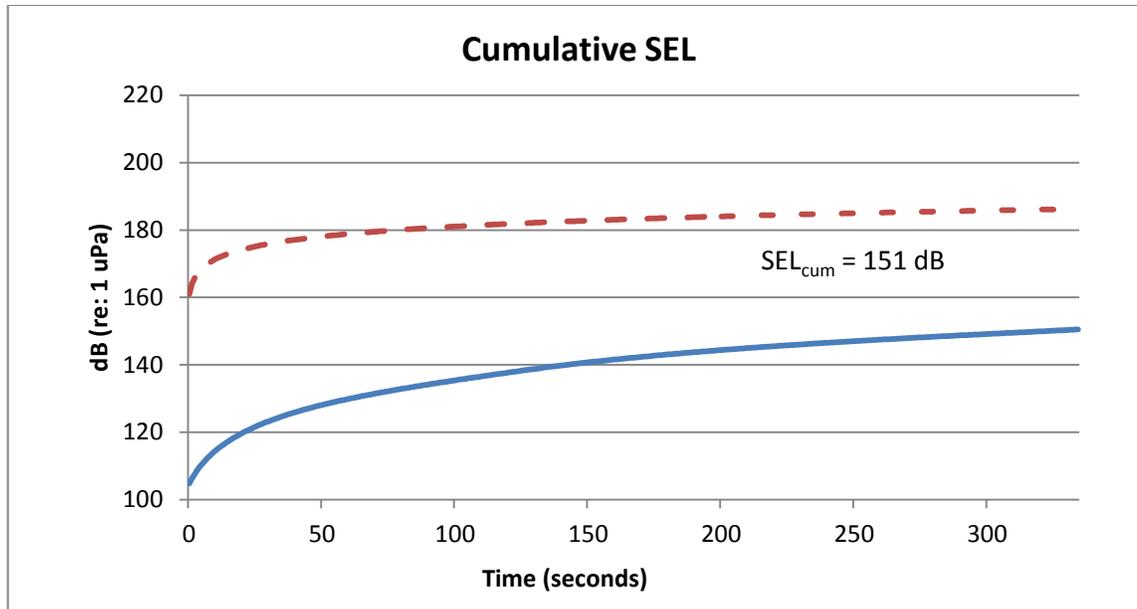
Figure 13: Cumulative SEL plot for Pile 4 showing the cumulative plot for SEL values calculated for each pile strike (blue) versus the more conservative SEL plot based on the number of strikes (red-dashed).

The cumulative SEL of 151 $\text{dBSEL}_{\text{cum}}$ did not exceed the 204 $\text{dBSEL}_{\text{cum}}$ threshold after 331 strikes (Table 2). The attenuated SEL was estimated for each individual pile strike while the bubble curtain was active by calculating a 1-second SEL for each pile strike. The cumulative SEL value for each pile strike differs on average by about 43 decibels with the individual strike method (Figure 13). Neither cumulative SEL exceeded the 204 $\text{dBSEL}_{\text{cum}}$ threshold.

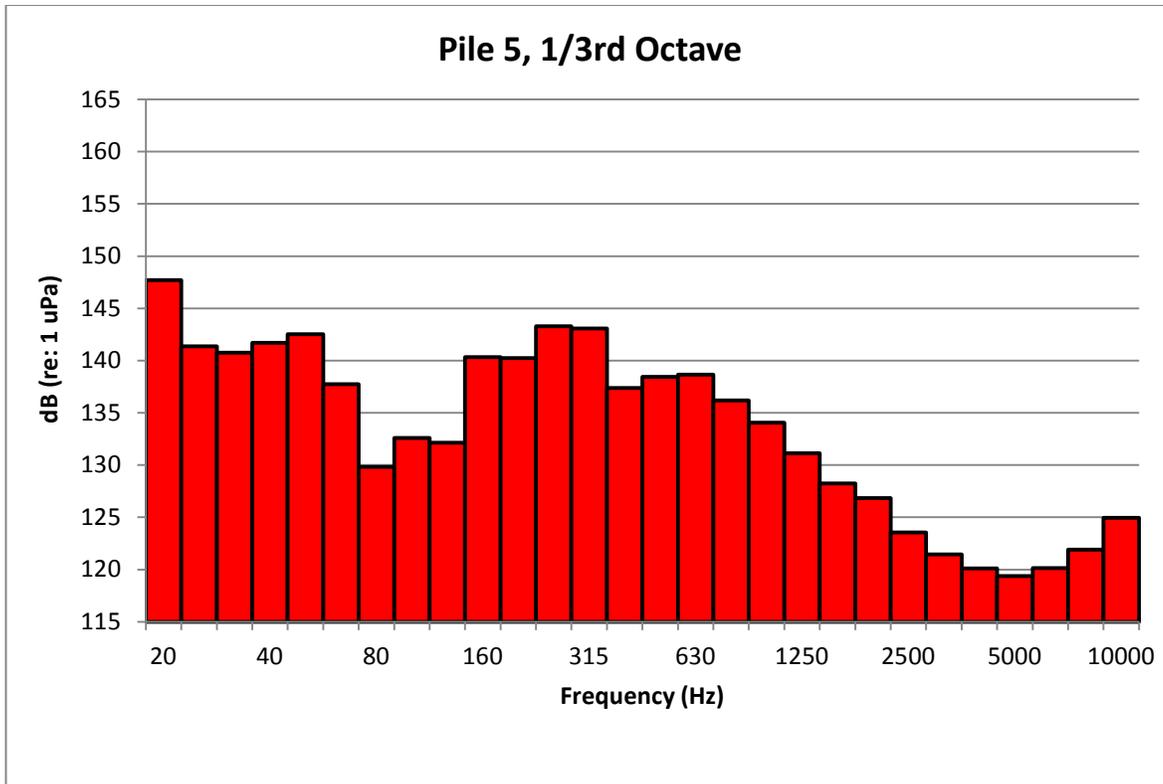
Figure 14: 1/3rd Octave frequency distribution for impact pile driving of Pile 5.

The 1/3rd Octave frequency distribution for Pile 5 indicates that the dominant frequency was 20 Hz and a lesser secondary peak at 200 Hz (Figure 14). Most of the energy is below 315 Hz.

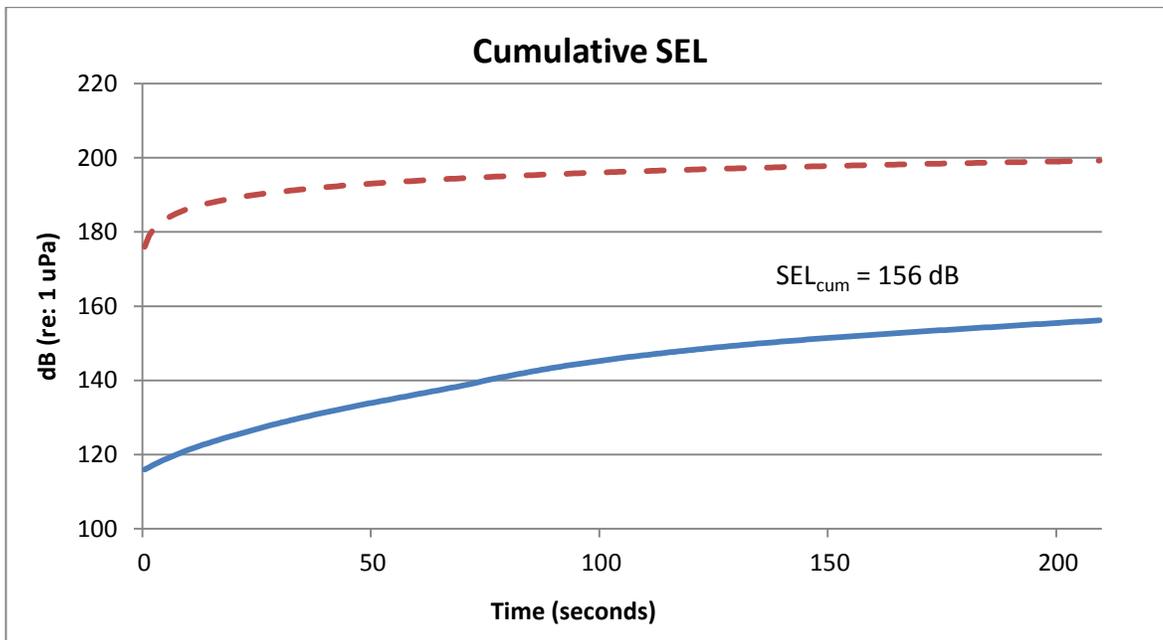
Figure 15: Cumulative SEL plot for Pile 5 showing the cumulative plot for SEL values calculated for each pile strike (blue) versus the more conservative SEL plot based on the number of strikes (red-dashed).

The cumulative SEL of 156 $\text{dBSEL}_{\text{cum}}$ did not exceed the 204 $\text{dBSEL}_{\text{cum}}$ threshold after 209 strikes (Table 2). The SEL was estimated for each individual pile strike while the bubble curtain was active by calculating a 1-second SEL for each pile strike. The cumulative SEL values for each pile strike (Figure 15, blue line) differ by about 52 decibels with the individual strike method (red dashed line). Neither cumulative SEL exceeded the 204 $\text{dBSEL}_{\text{cum}}$ threshold.

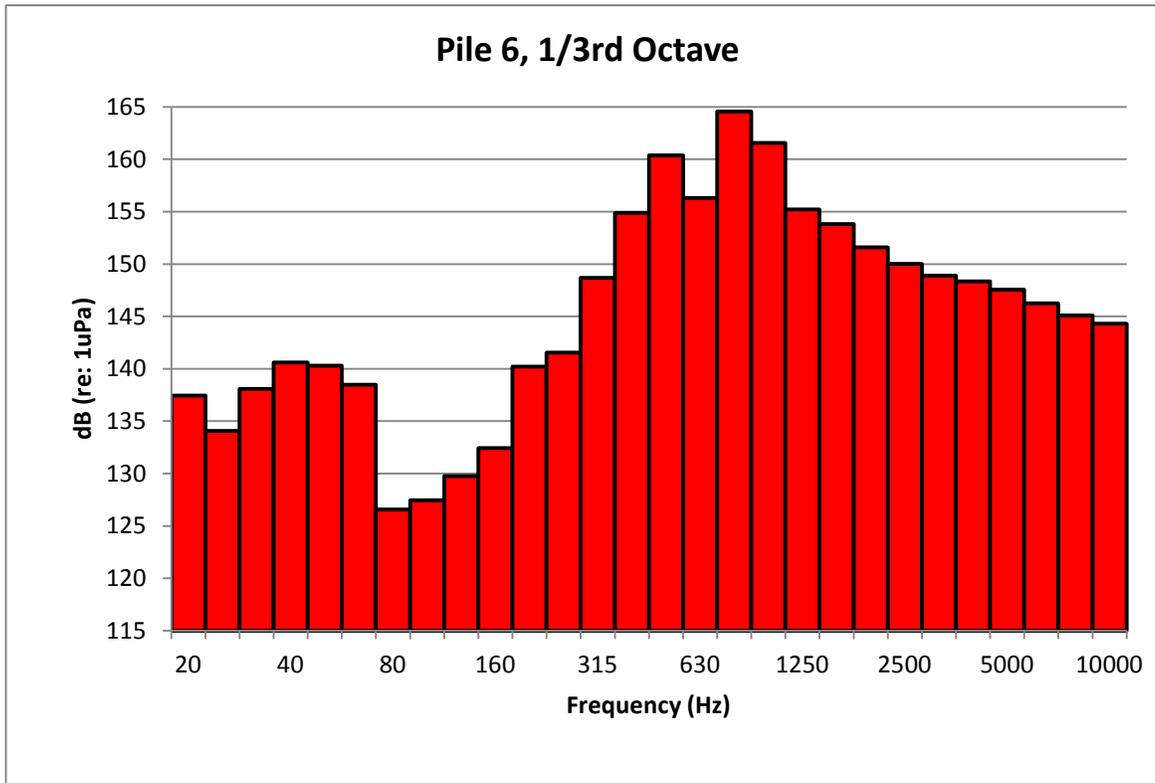
Figure 16: 1/3rd Octave frequency distribution for impact pile driving of Pile 6.

The 1/3rd Octave frequency distribution for Pile 6 indicates that the dominant frequency was 800 Hz (Figure 16). Most of the energy is below 1000 Hz.

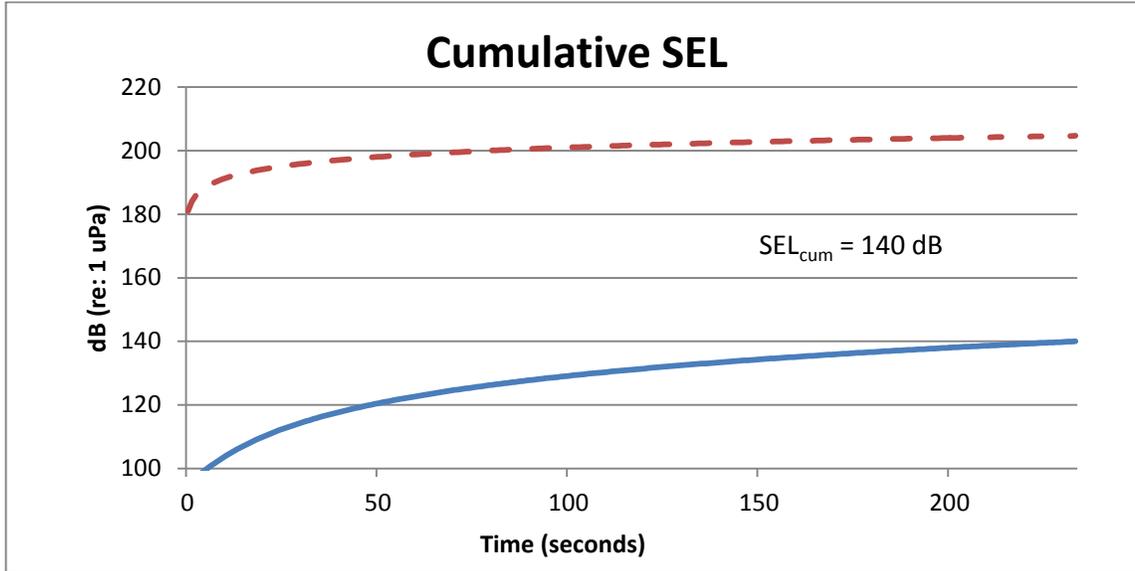
Figure 17: Cumulative SEL plot for Pile 6 showing the cumulative plot for SEL values calculated for each pile strike (blue) versus the more conservative SEL plot based on the number of strikes (red-dashed).

The cumulative SEL of 140 dBSEL_{cum} did not exceed the 204 dBSEL_{cum} threshold after 233 strikes. The SEL was estimated for each individual pile strike while the bubble curtain was active by calculating a 1-second SEL for each pile strike. The cumulative SEL values for each pile strike (Figure 17, blue line) differ by about 72 decibels with the individual strike method (red dashed line). Neither cumulative SEL exceeded the 204 dBSEL_{cum} threshold.

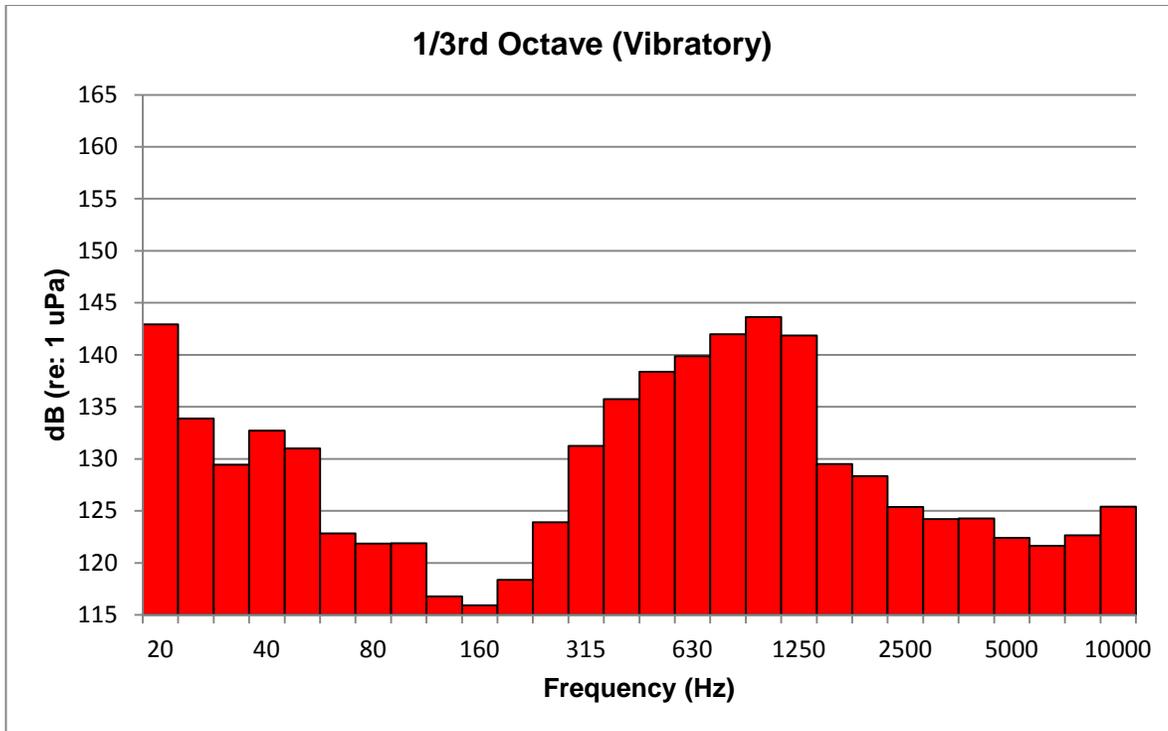
Figure 18: 1/3rd Octave frequency distribution for impact pile driving of Pile 2.

The 1/3rd Octave frequency distribution for the pile driven using a vibratory hammer indicates that the dominant frequencies occur at about 20 Hz and a second peak at 1000 Hz (Figure 18). The secondary peak at 1000 Hz could have been due to turbulence from water movement past the piles upstream from the hydrophone. The substrate will quickly attenuate the higher frequencies and some of the lower frequencies due to the compression of the substrate around the pile.

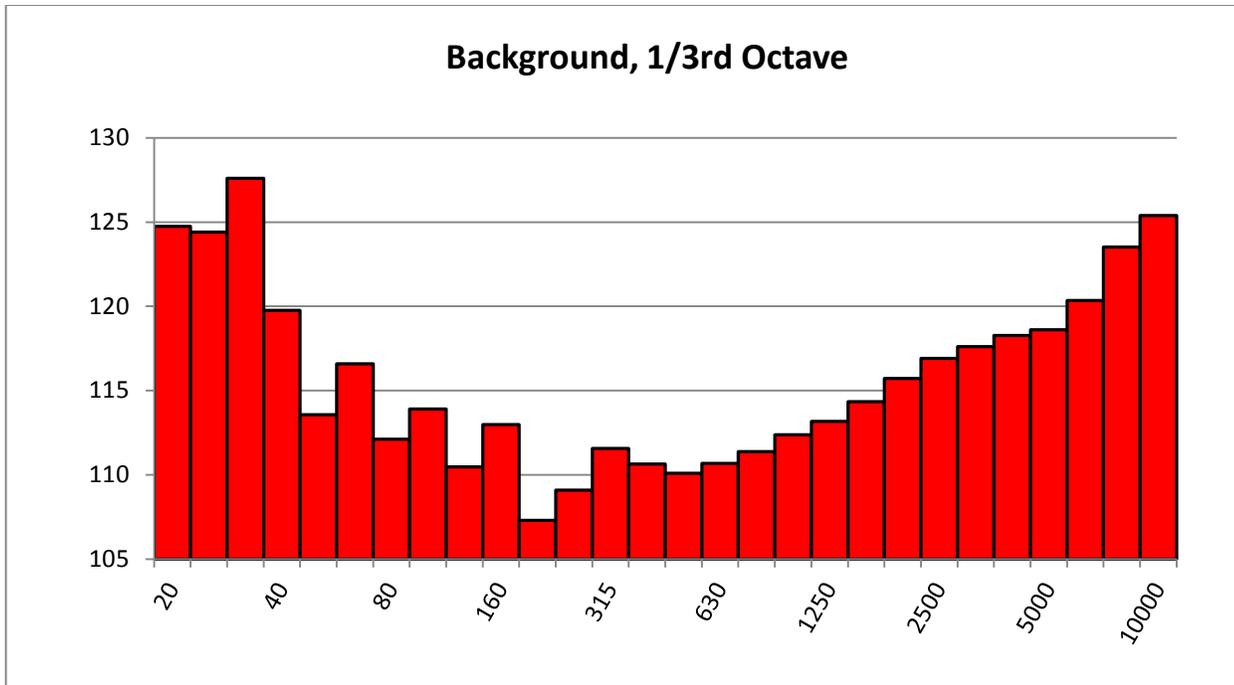
Figure 19: 1/3rd Octave frequency distribution for broadband background noise levels.

Broadband Root Mean Square (RMS) (background) noise levels are reported in terms of the 30-second average continuous sound level and have been computed from the Fourier transform of pressure waveforms in 30-second time intervals. Although the methodology did not strictly follow the NOAA guidance on measuring background sound levels underwater, background RMS values were measured for eight minutes prior to pile driving activities on October 22, 2010. Average broadband (20 Hz to 10000 Hz) RMS background levels were 142 dB_{RMS}. The 1/3rd Octave band frequency distribution for the background noise measurements indicates a curious high frequency component between about 1,000 and 10,000 Hz (Figure 19). When a high pass filter was applied to remove all frequencies below 1,000 Hz, as the NOAA guidance recommends, background levels were lowered to 131 dB RMS.

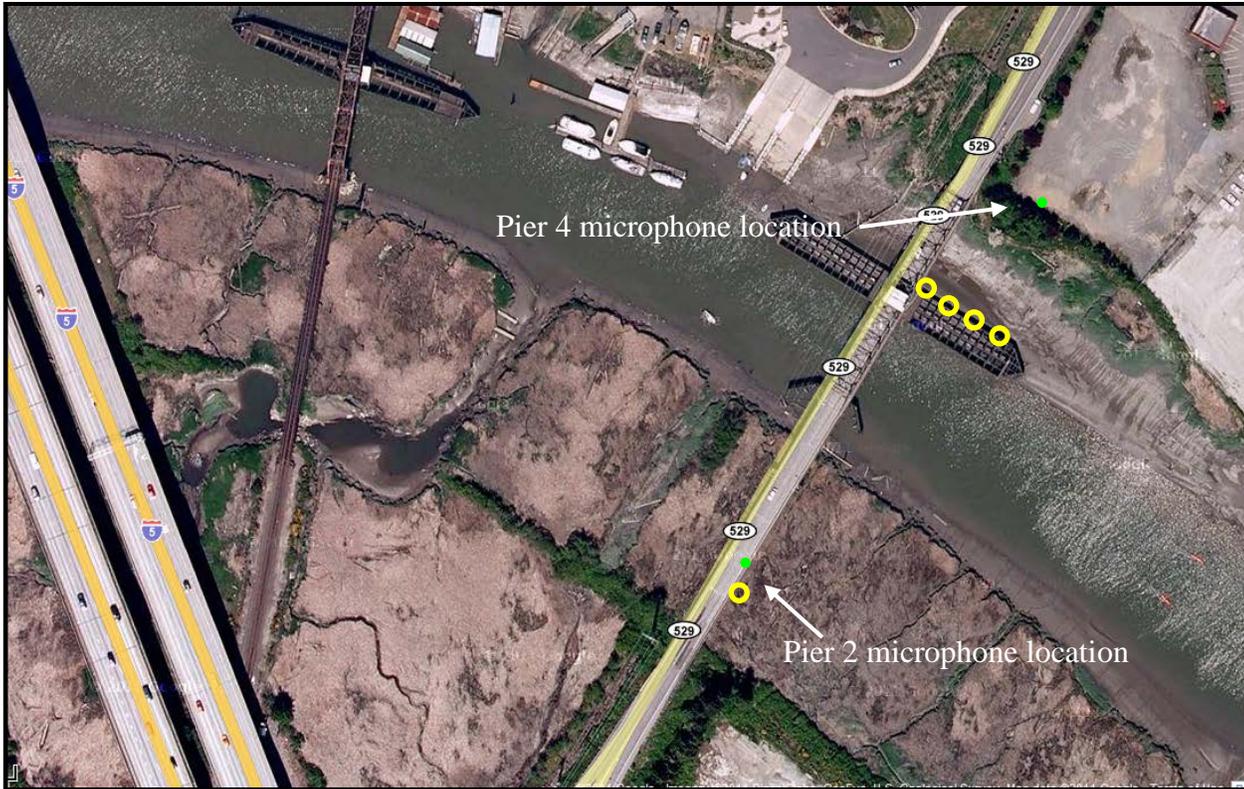
Figure 20: Location of airborne noise measurements at the SR 529 Ebey Slough Bridge Project.
 ○ = 72-inch Steel Pile; ● = Airborne Microphone

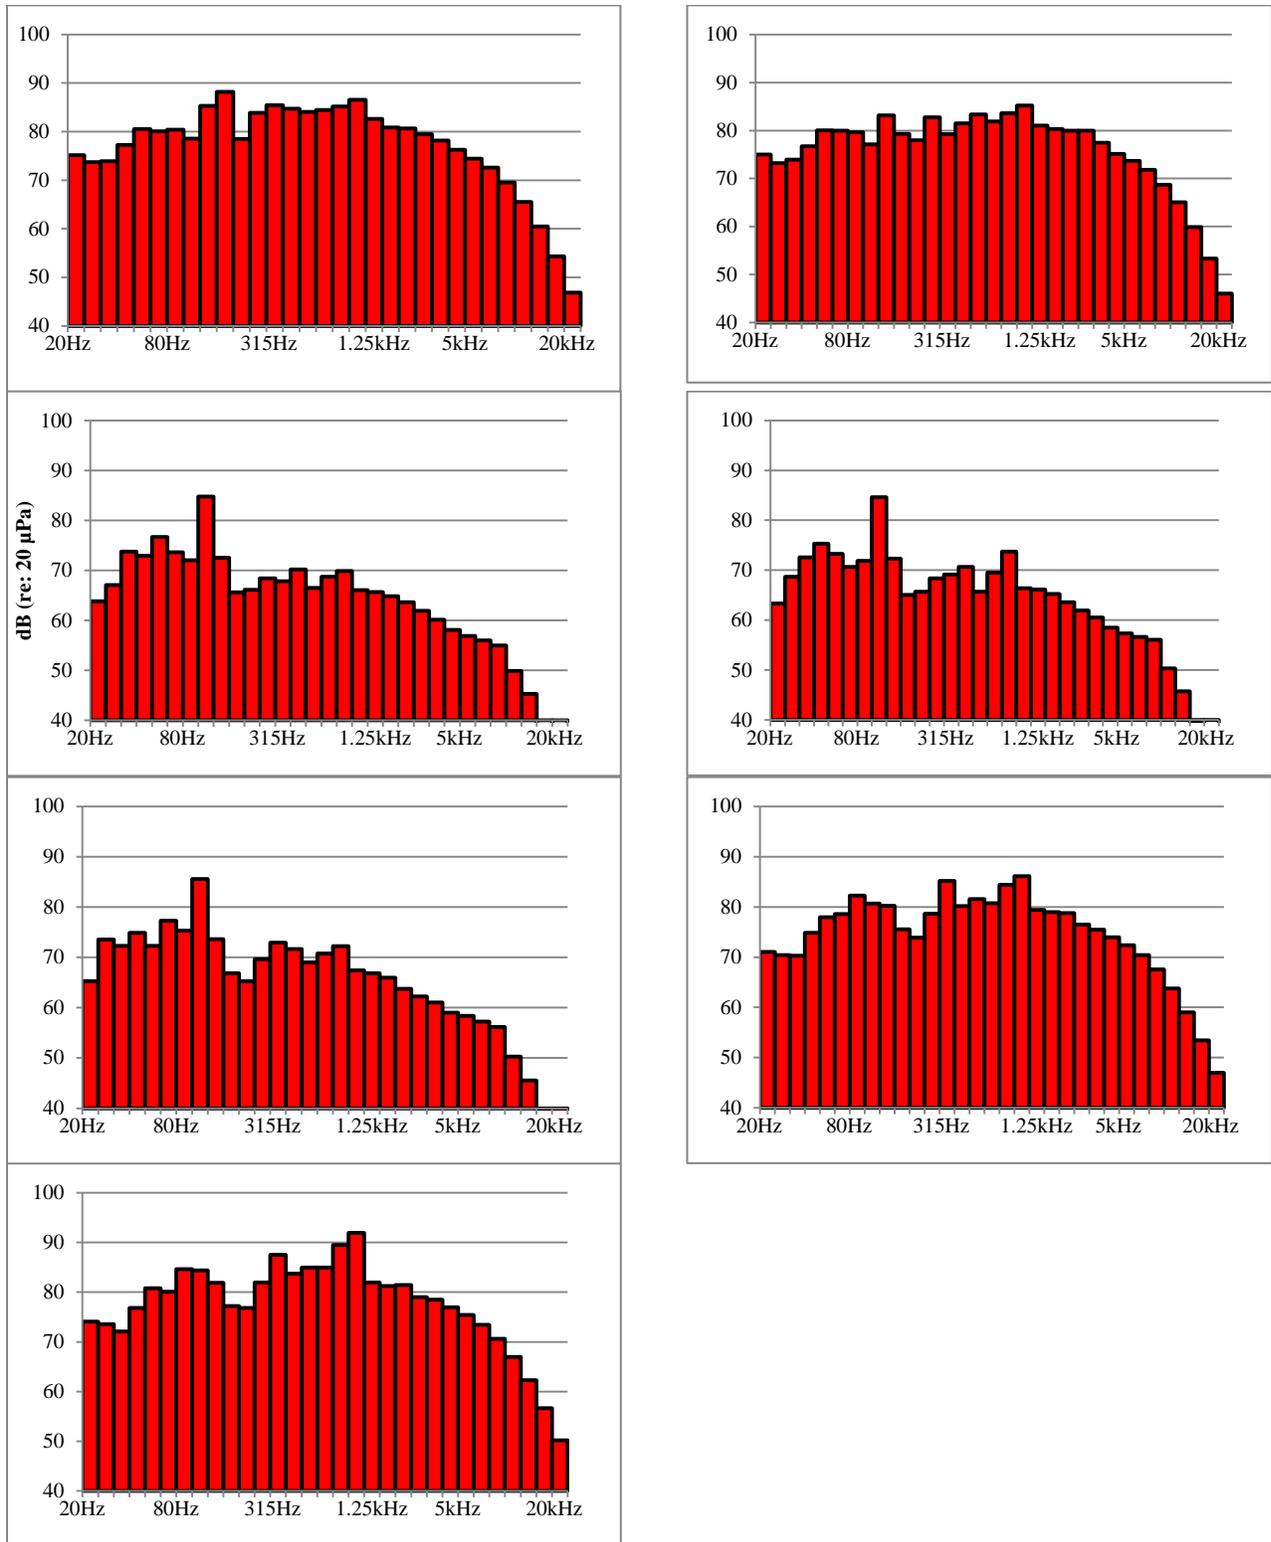
Figure 21: Comparison of 1/3rd Octave un-weighted airborne frequency distributions for the L_{eq}/RMS metric with an impact hammer on 72-inch steel piles.

The 1/3rd octave frequency distribution for the un-weighted airborne noise measurements indicate that the frequency distributions between measurements and between piles are relatively similar (Figure 21). In most cases the dominant energy occurs at approximately at 100 Hz with most of the sound energy occurring below 100 Hz. In a few instances there was a dominant frequency measured at around 1,000 Hz. This could have been produced by the occasional ringing of the pile during impact driving. In all cases the sound energy drops off sharply above 1,000 Hz.

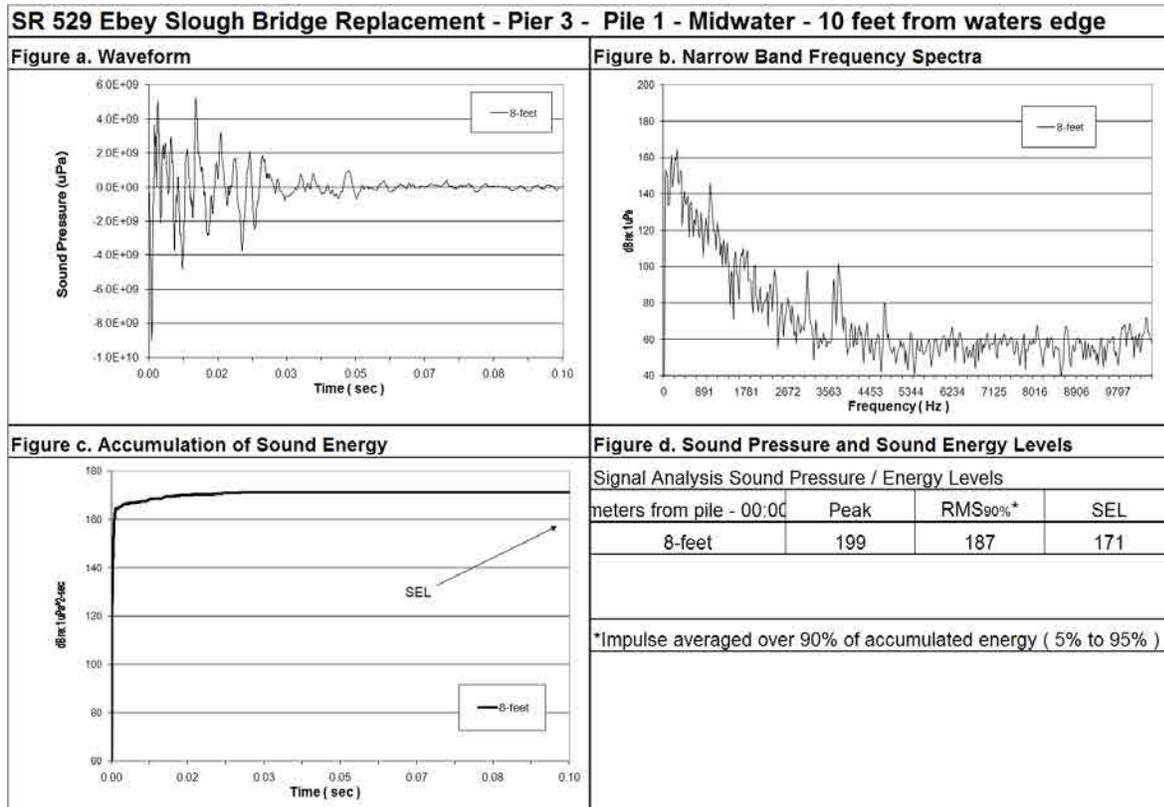
Pier 3, Pile 1 – No Mitigation, 10-feet Above OHWM

Figure 22: Waveform analysis of Pile 1 sound pressure levels with no mitigation, 10 feet above OHWM.

The waveform analysis for Pile 1 indicates that there was a relatively short delay between the initial onset of the impulse and the unattenuated absolute peak (rise time of 0.7 milliseconds) (Appendix A, Figure 9).
