SR 529 EBHEY SLOUGH BRIDGE REPLACEMENT PROJECT

**UNDERWATER SOUND LEVELS
ASSOCIATED WITH DRIVING 72-inch
STEEL PILES AT THE SR 529 EBHEY
SLOUGH BRIDGE REPLACEMENT
PROJECT**

March 2011

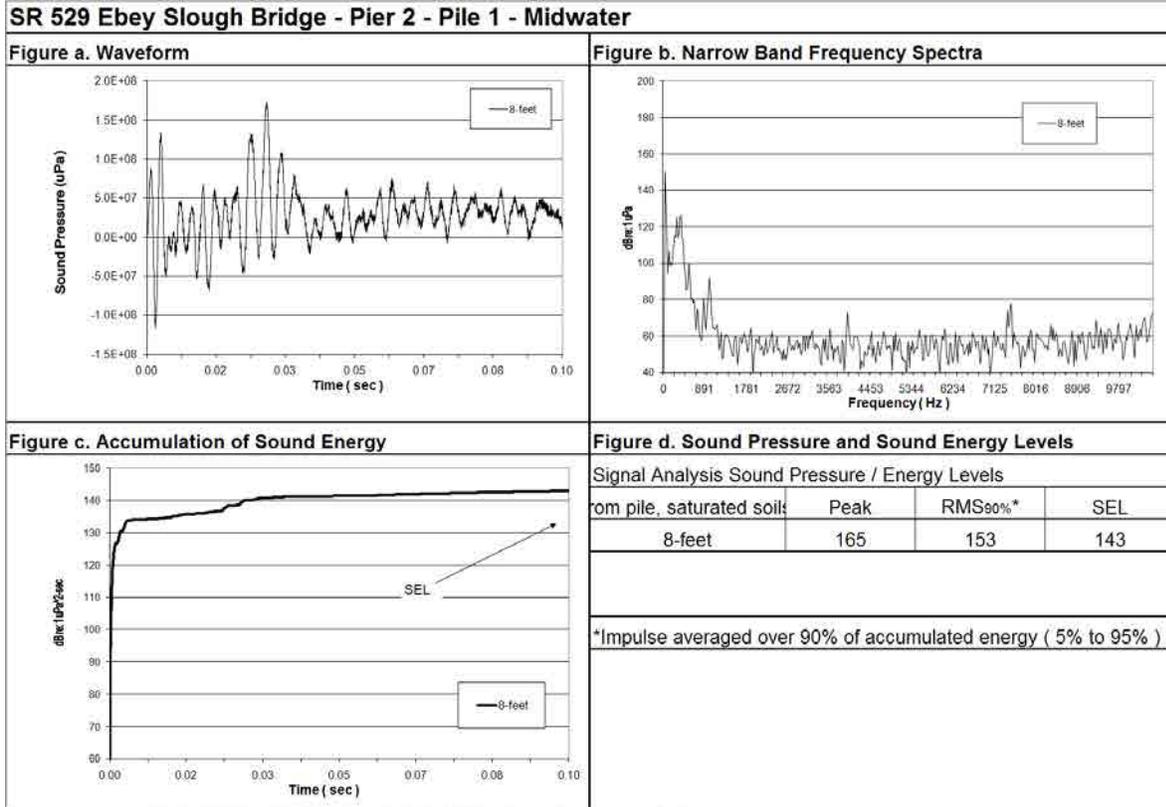
Pier 2, Pile 2 – No Mitigation, 230-feet Above OHWM

Figure 23: Waveform analysis of Pile 2 sound pressure levels 230 feet above the OHWM, midwater.

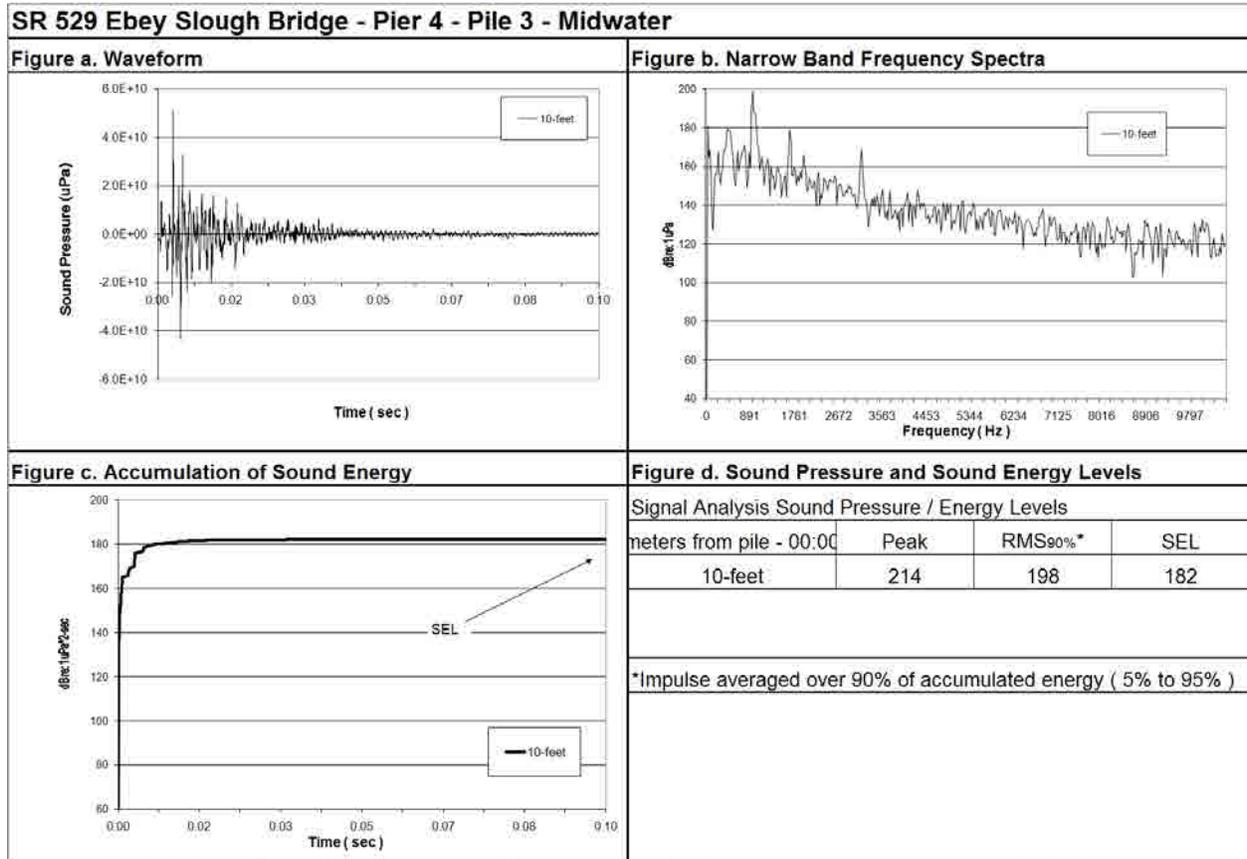
Pier 4, Pile 3 – without Bubbles On Start of Drive

Figure 24: Waveform analysis of Pier 4, Pile 3 sound pressure levels with bubbles off first part of drive, midwater.

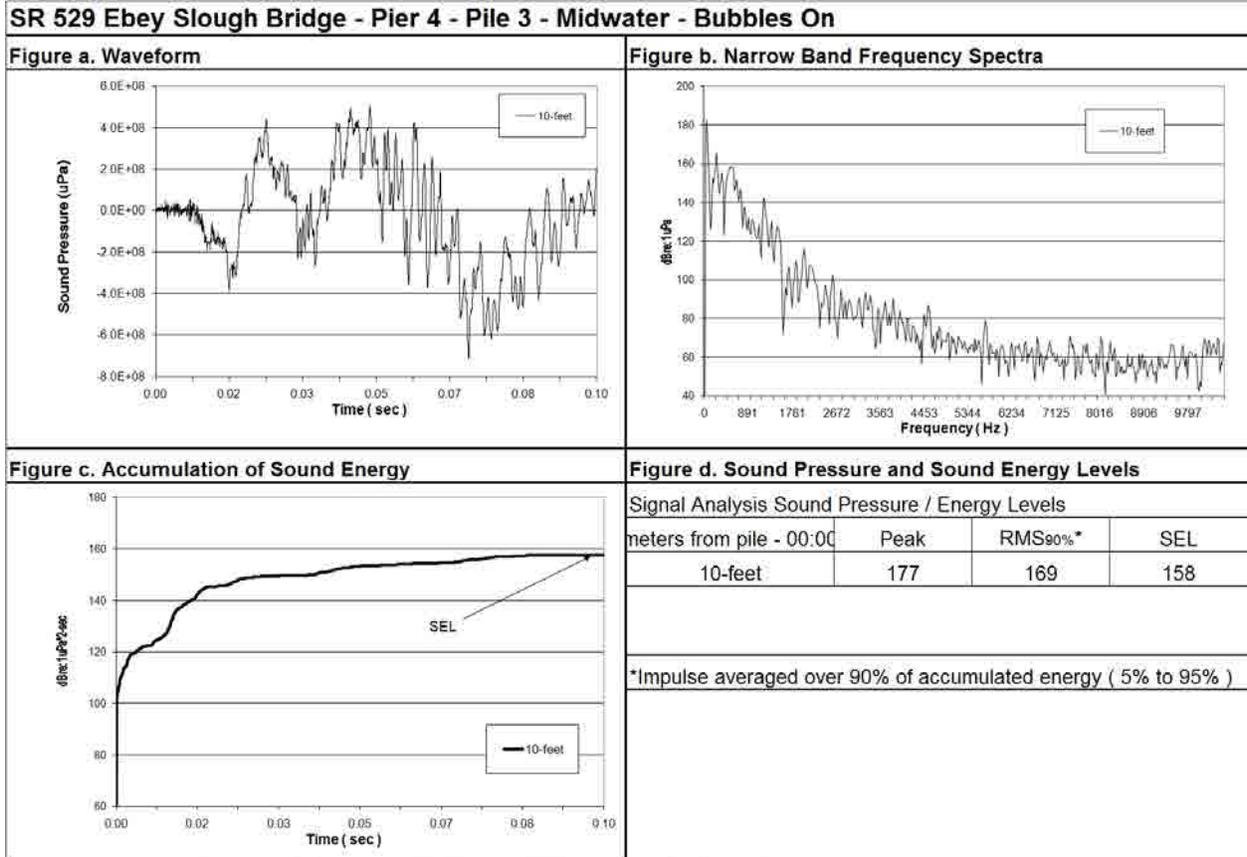
Pier 4, Pile 3 – with Bubbles On Middle of Drive

Figure 25: Waveform analysis of Pier 4, Pile 3 sound pressure levels with bubbles off first part of drive, midwater.

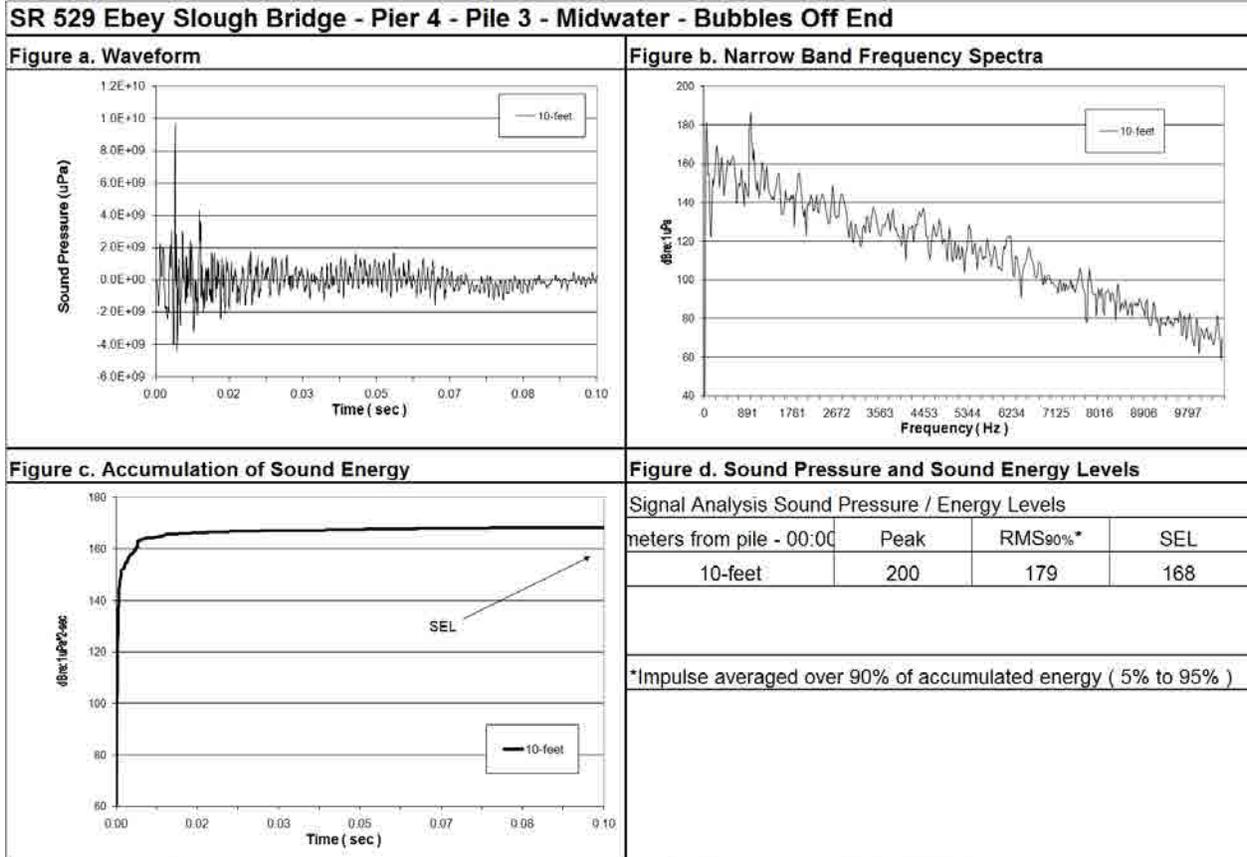
Pier 4, Pile 3 – with Bubbles Off End of Drive

Figure 26: Waveform analysis of Pier 4, Pile 3 sound pressure levels with bubbles off first part of drive, midwater.

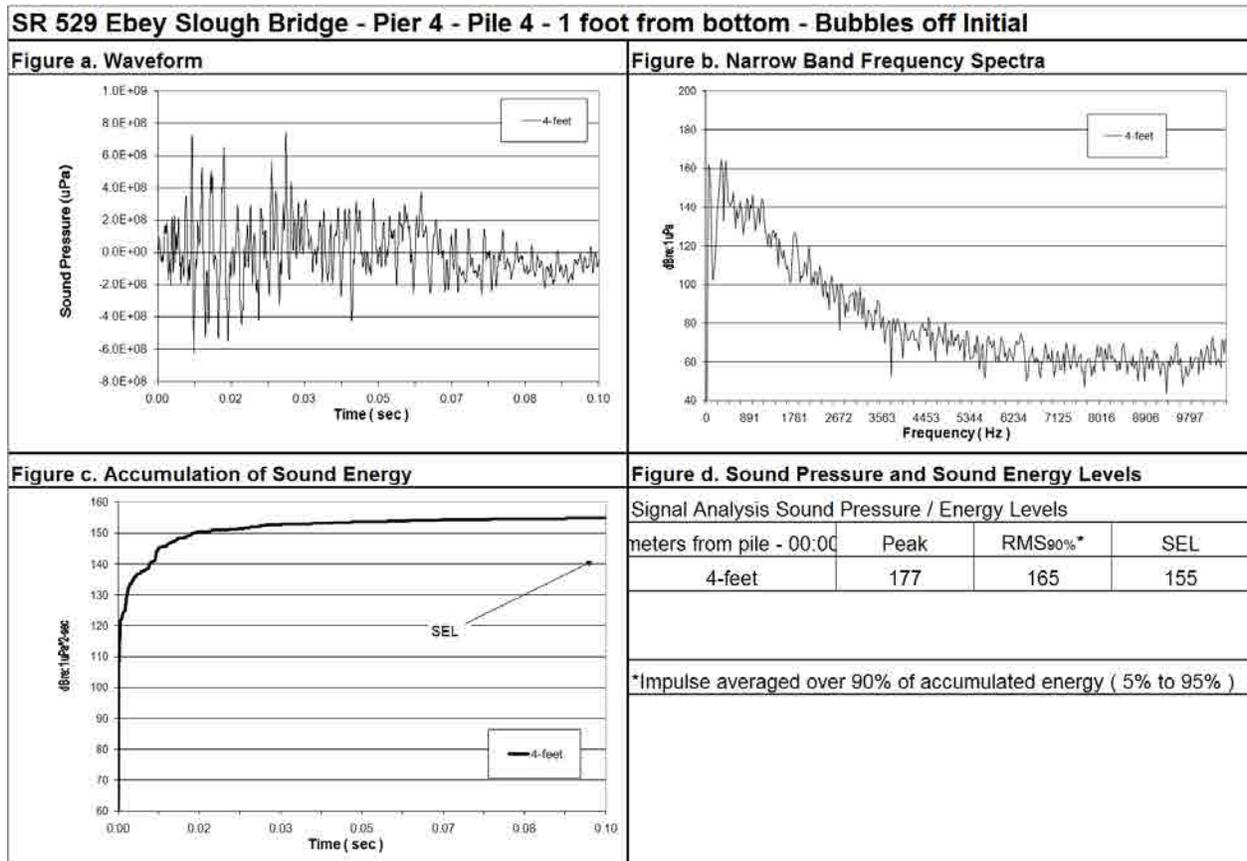
Pier 4, Pile 4 – with Bubbles OFF Start of Drive

Figure 27: Waveform analysis of Pier 4, Pile 3 sound pressure levels with bubbles off first part of drive, midwater.

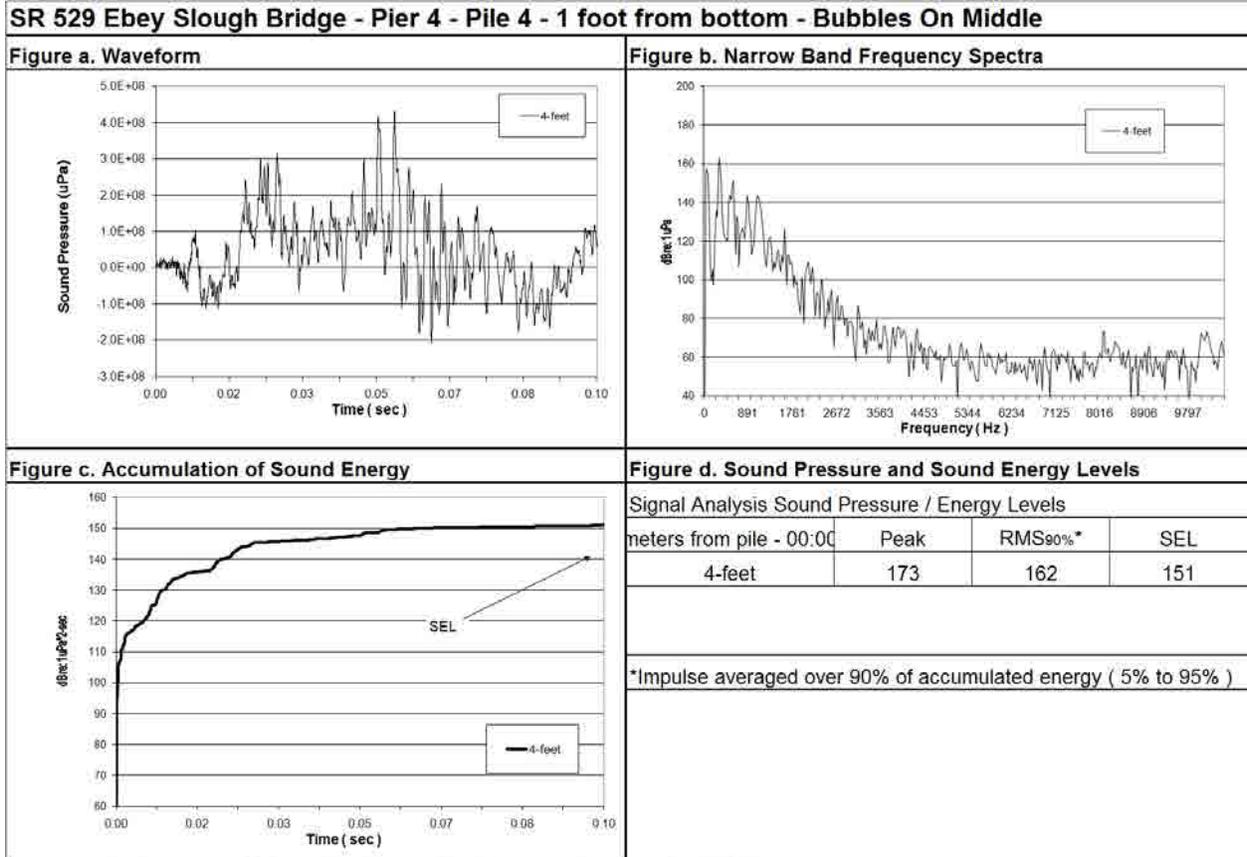
Pier 4, Pile 4 – with Bubbles On Middle of Drive

Figure 28: Waveform analysis of Pier 4, Pile 3 sound pressure levels with bubbles off first part of drive, midwater.

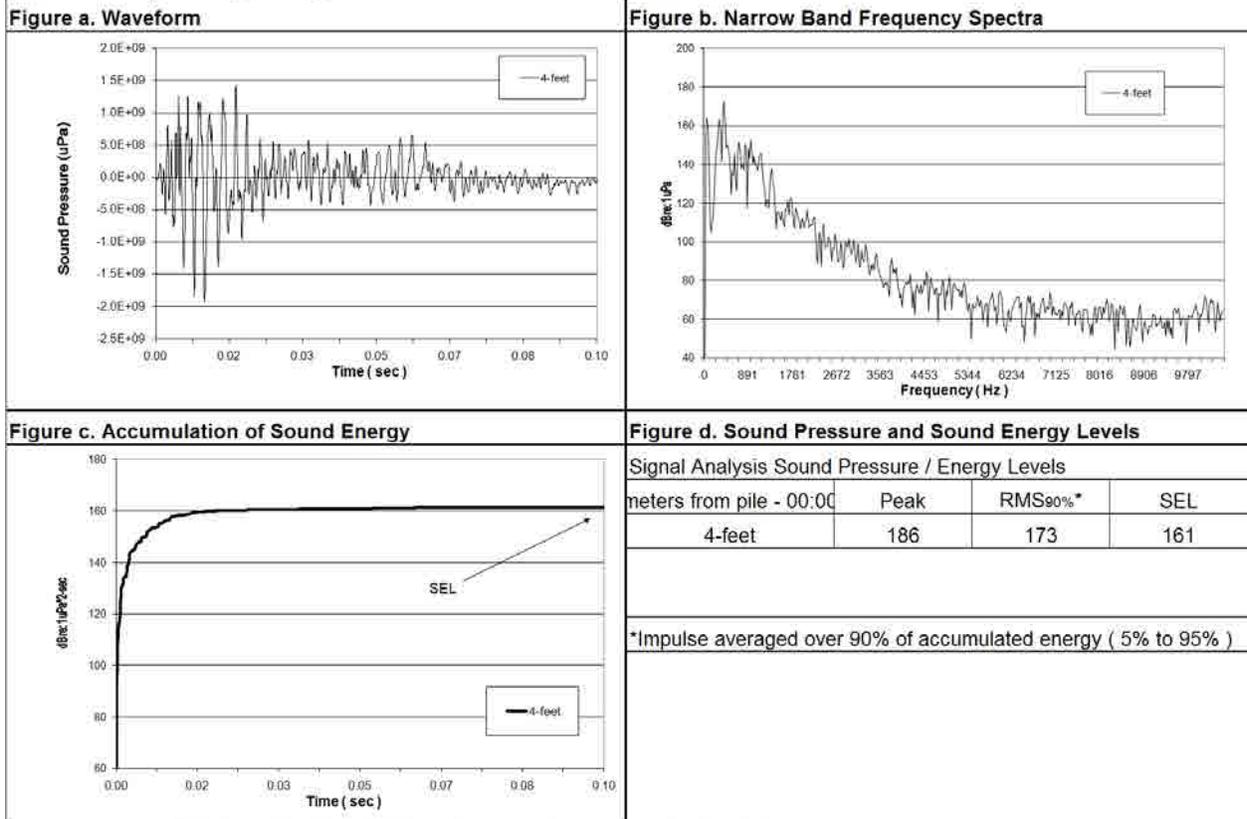
PiER 4 Pile 4 – Bubbles Off End of Drive

Figure 29: Waveform analysis of Pile 1 sound pressure levels with 1st, 2nd and 3rd rings air on, Midwater.

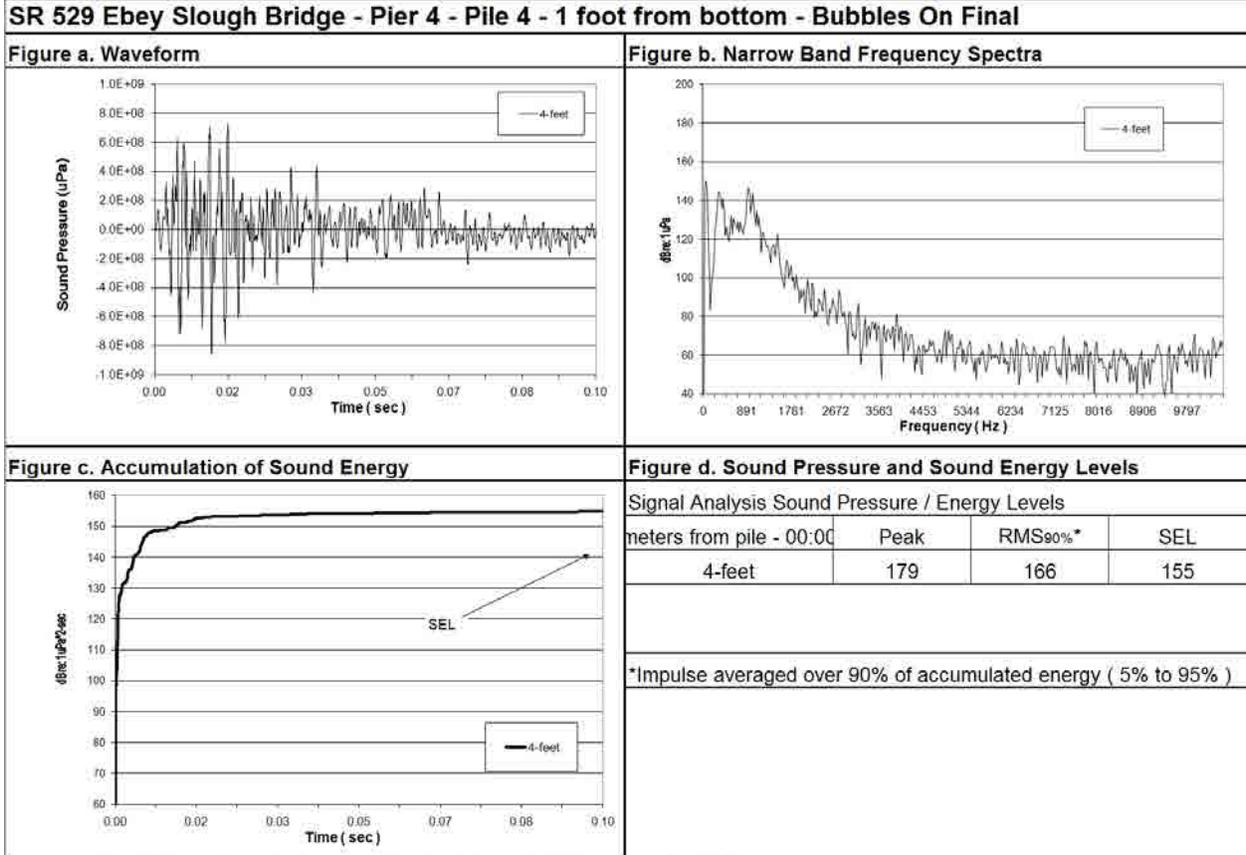
PiER 4 Pile 4 – Bubbles ON End of Drive

Figure 30: Waveform analysis of Pile 1 sound pressure levels with 1st, 2nd and 3rd rings air on, Midwater.

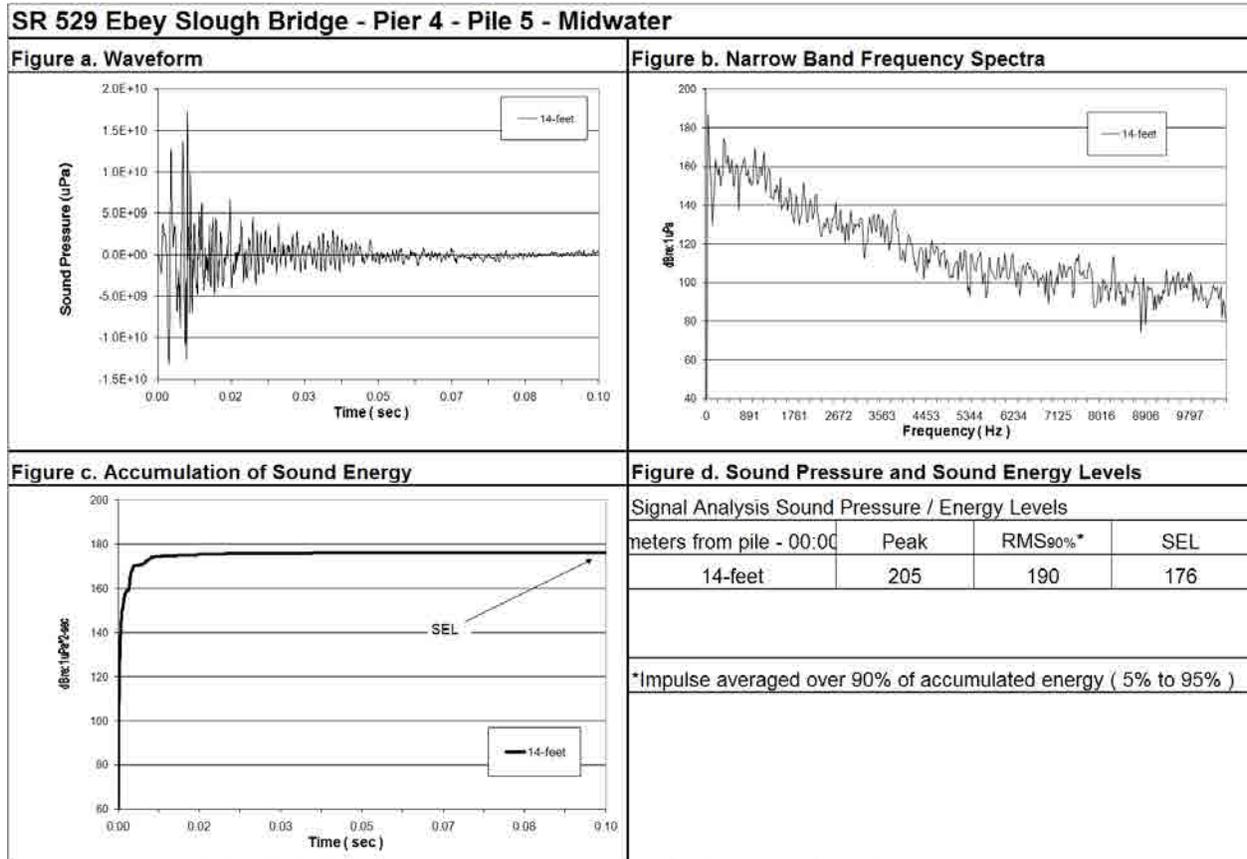
Pier 4, Pile 5 – with Bubbles OFF Start of Drive

Figure 31: Waveform analysis of Pile 1 sound pressure levels with first and second ring air on, midwater.

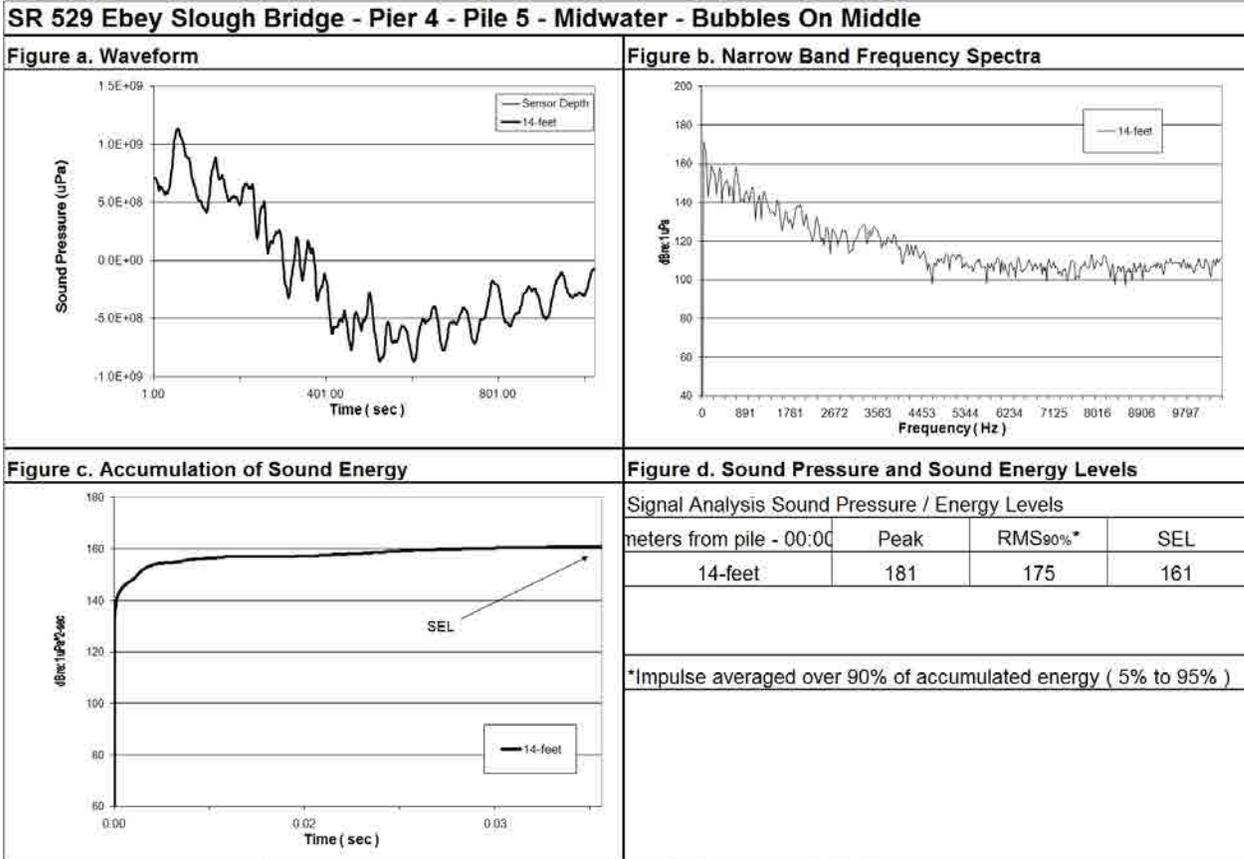
Pier 4, Pile 5 – with Bubbles On Middle of Drive

Figure 32: Waveform analysis of Pile 1 sound pressure levels with first and second ring air on, midwater.

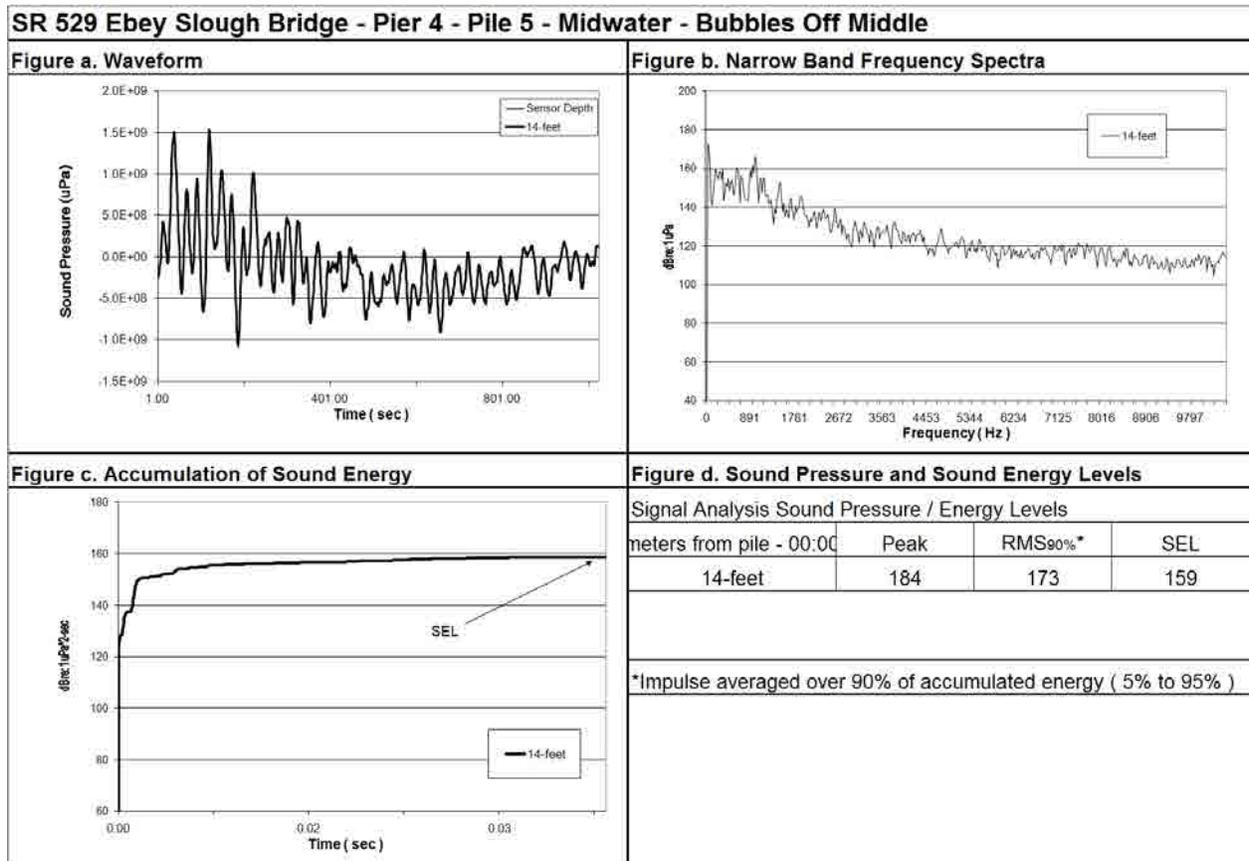
Pier 4, Pile 5 – with Bubbles OFF Middle of Drive

Figure 33: Waveform analysis of Pile 1 sound pressure levels with first and second ring air on, midwater.

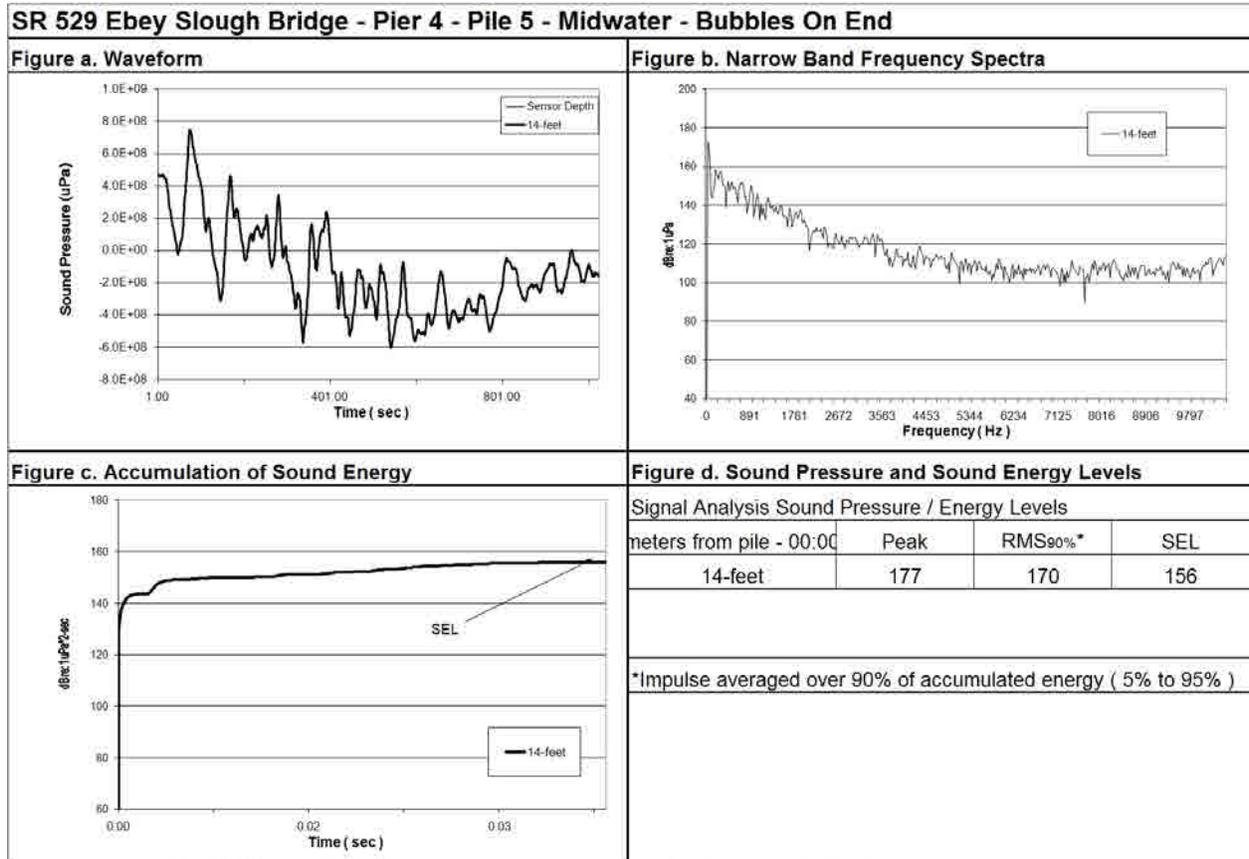
Pier 4, Pile 5 – with Bubbles ON End of Drive

Figure 34: Waveform analysis of Pile 1 sound pressure levels with first and second ring air on, midwater.

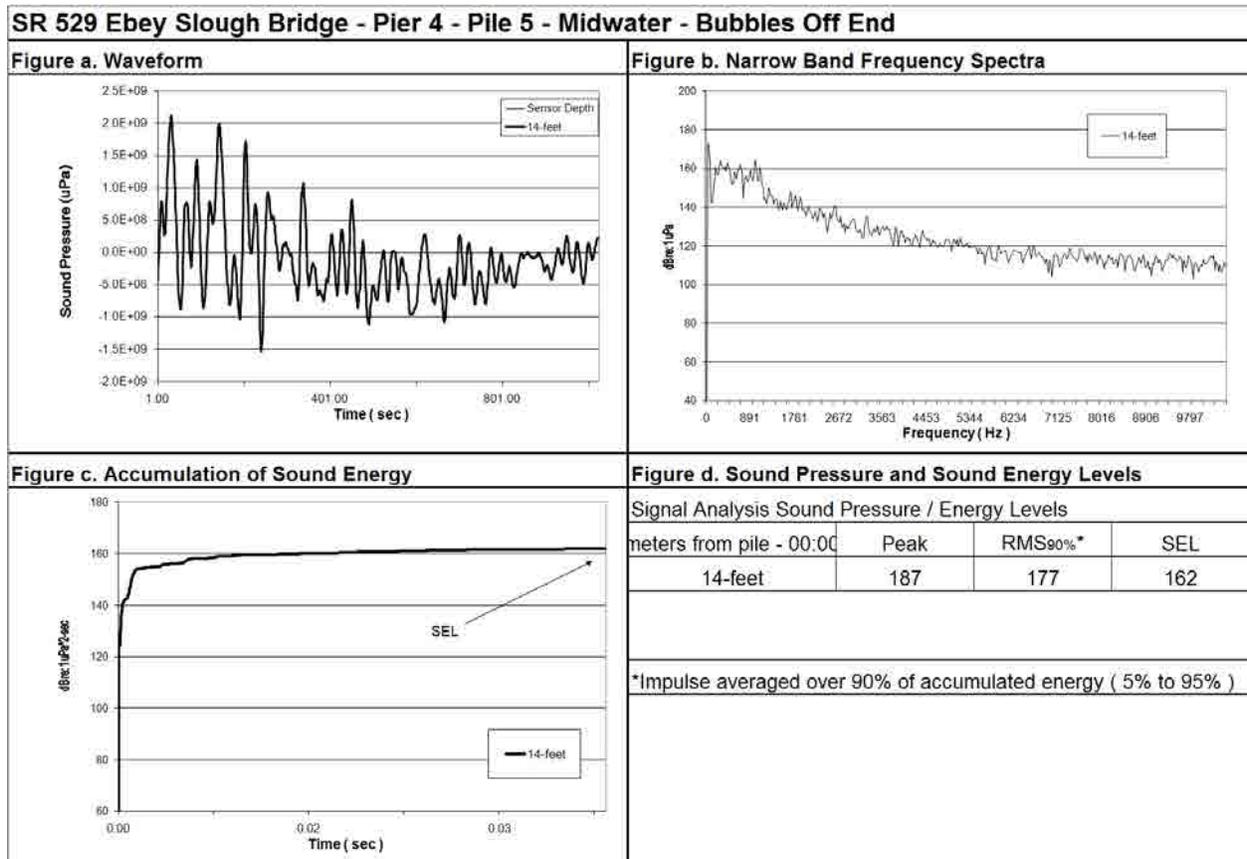
Pier 4, Pile 5 – with Bubbles OFF End of Drive

Figure 35: Waveform analysis of Pile 1 sound pressure levels with first and second ring air on, midwater.

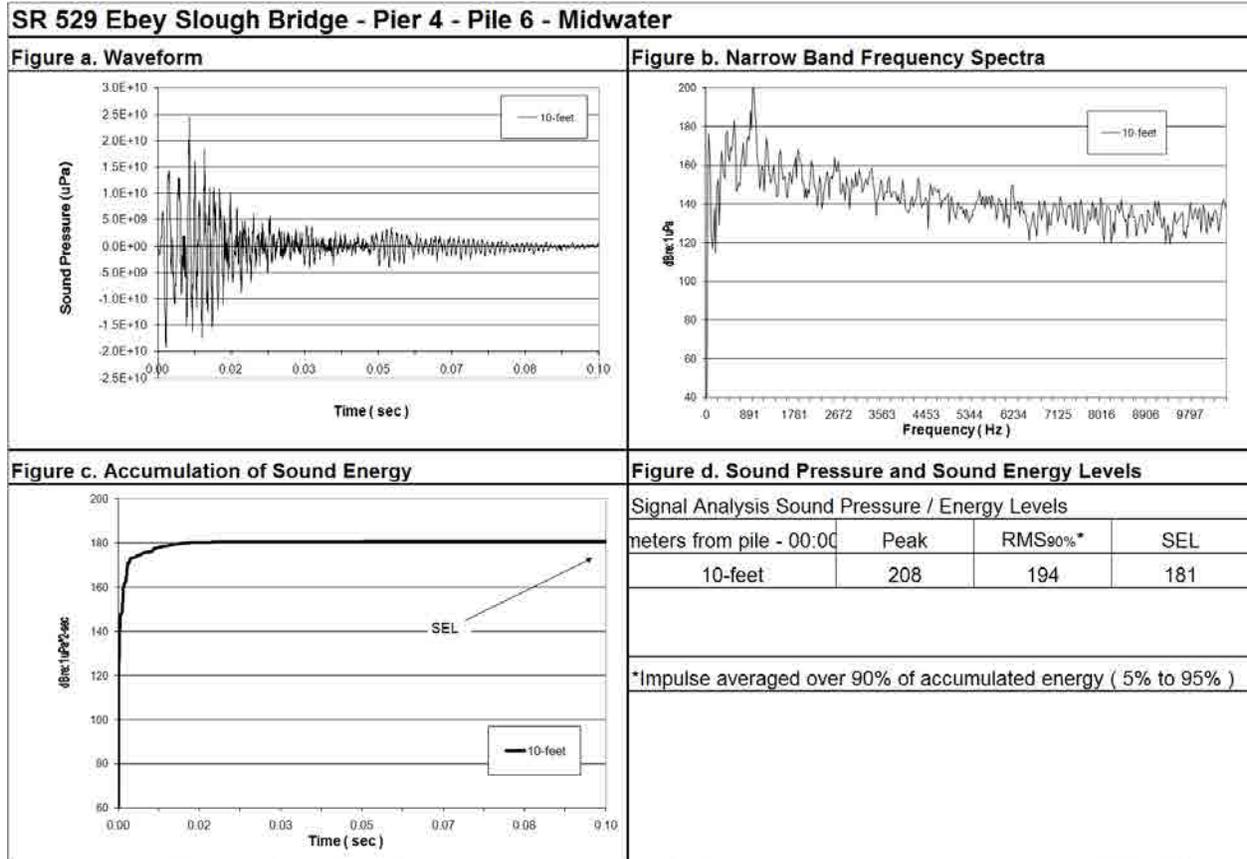
Pier 4, Pile 6 – with Bubbles OFF Start of Drive

Figure 36: Waveform analysis of Pier 4, Pile 6 sound pressure levels with bubbles off, midwater.

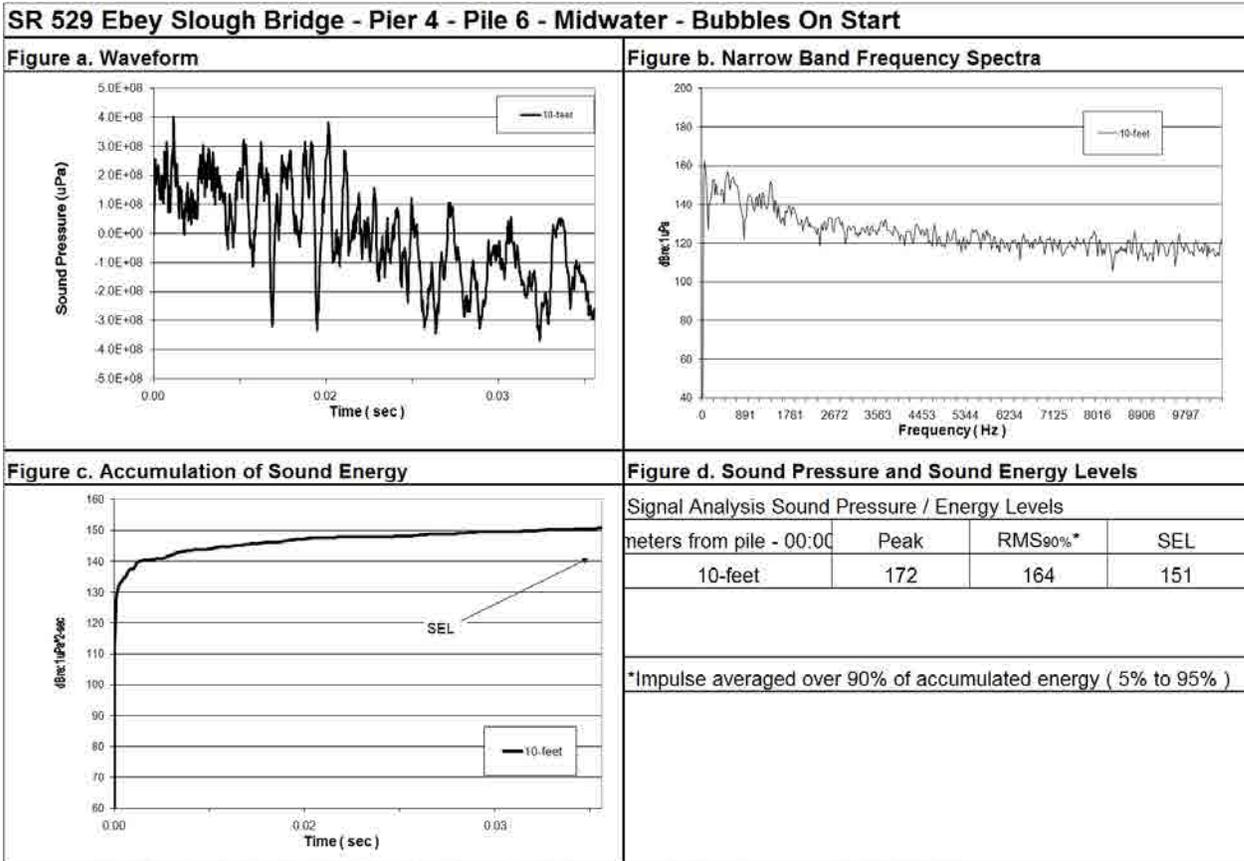
Pier 4, Pile 6 – with Bubbles On Start of Drive

Figure 37: Waveform analysis of Pile 1 sound pressure levels with all rings on full for the second time near the end of the drive, midwater.

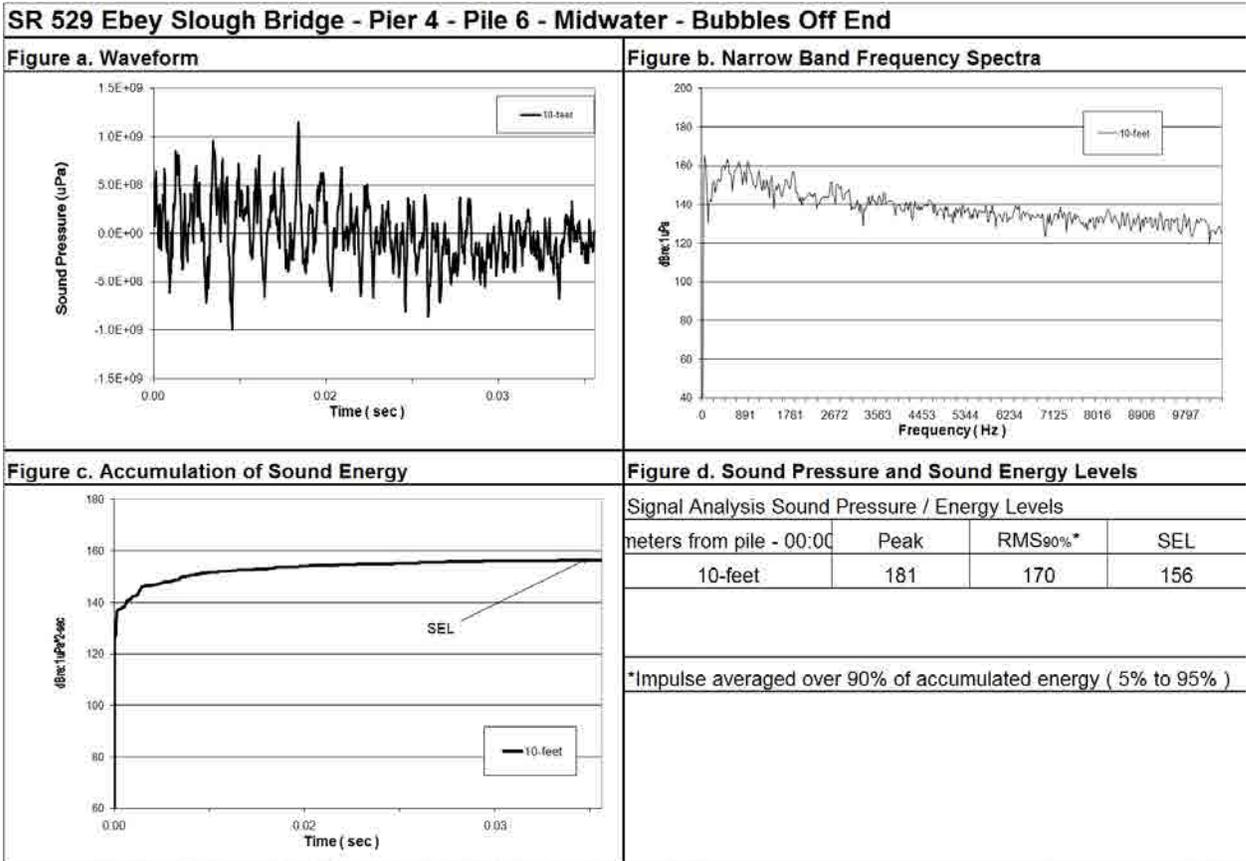
Pier 4, Pile 6 – with Bubbles OFF End of Drive

Figure 38: Waveform analysis of Pile 1 sound pressure levels with all rings off at the end of the drive, midwater.

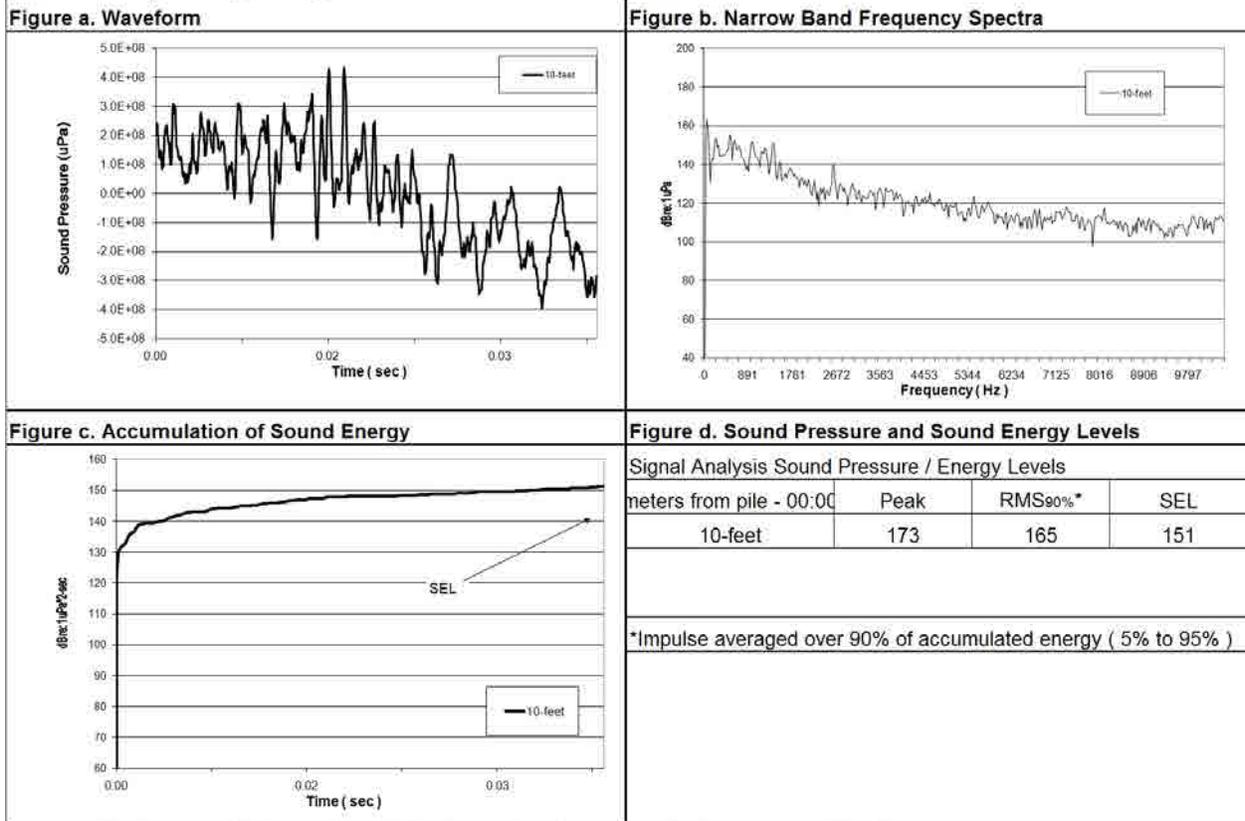
Pier 4, Pile 6 – with Bubbles On End of Drive

Figure 39: Waveform analysis of Pile 2 sound pressure levels with all bubbles off initial, midwater.
