**Exhibit 4-2: Stream Basin Characteristics**

I-405, NE 8TH STREET TO SR 520 IMPROVEMENT PROJECT  
 WATER RESOURCES DISCIPLINE REPORT

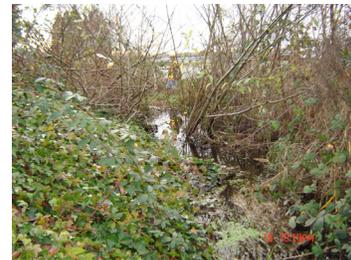
**Sturtevant Creek**

The main branch of Sturtevant Creek originates in Lake Bellevue, which is located approximately 1,500 feet northeast of the I-405/NE 8th Street interchange (see Exhibit 4-3 and 4-4). The stream begins as an open channel discharge from the southwestern end of the lake and continues south alongside the BNSF Railway right-of-way. Near the intersection of NE 8th Street and 118th Avenue NE, the stream flows into a closed pipe system. From there, Sturtevant Creek flows generally west/southwest along I-405 in alternating segments of closed pipes and narrow open channels. Upstream of the I-405 crossing, the stream flows into a closed conveyance system. At I-405 milepost 13.28, south of the southern project limit, the stream crosses under I-405 via two 48-inch concrete culverts from east to west.
