RE: SR 103 – Pedestrian Path Project (Hines Marsh) Wetland Mitigation Site
USACE Nationwide Permit (23) Number 200601351

The Washington State Department of Transportation recently completed aerial photo analysis of the Hines Marsh Wetland Mitigation Site in order to address Year-3 performance measures. Aerial photo/GIS analysis involved determining the amount of created open water habitat. This Year-3 report is being issued for compliance with the USACE Permit Number 200601351 reporting requirements. This mitigation site also provides mitigation for the US 101/Sandridge Road-Safety Improvement Project. A separate letter has been submitted concerning compliance with the permit related to that project (USACE Permit Number 2006-1163).

General Site Information	
USACE IP (23) Number	200601351
Restoration Location	North end of the Long Beach Peninsula, Leadbetter Point State Park, Pacific County
Restoration Date	2007
Monitoring Period	2008-2012
Year of Monitoring	3 of 5
Type of Project Impact	Wetland
Area of Project Impact	0.05 acre
Type of Mitigation	Wetland Habitat Enhancement ¹
Area of Mitigation	1.0 acre

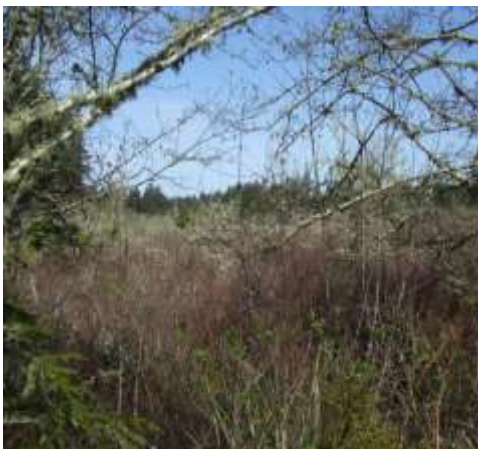
Photo 1 was taken prior to implementation of the plan from the dike on the north end of the project near the parking location.

Photo 1 Pre implementation of the enhancement

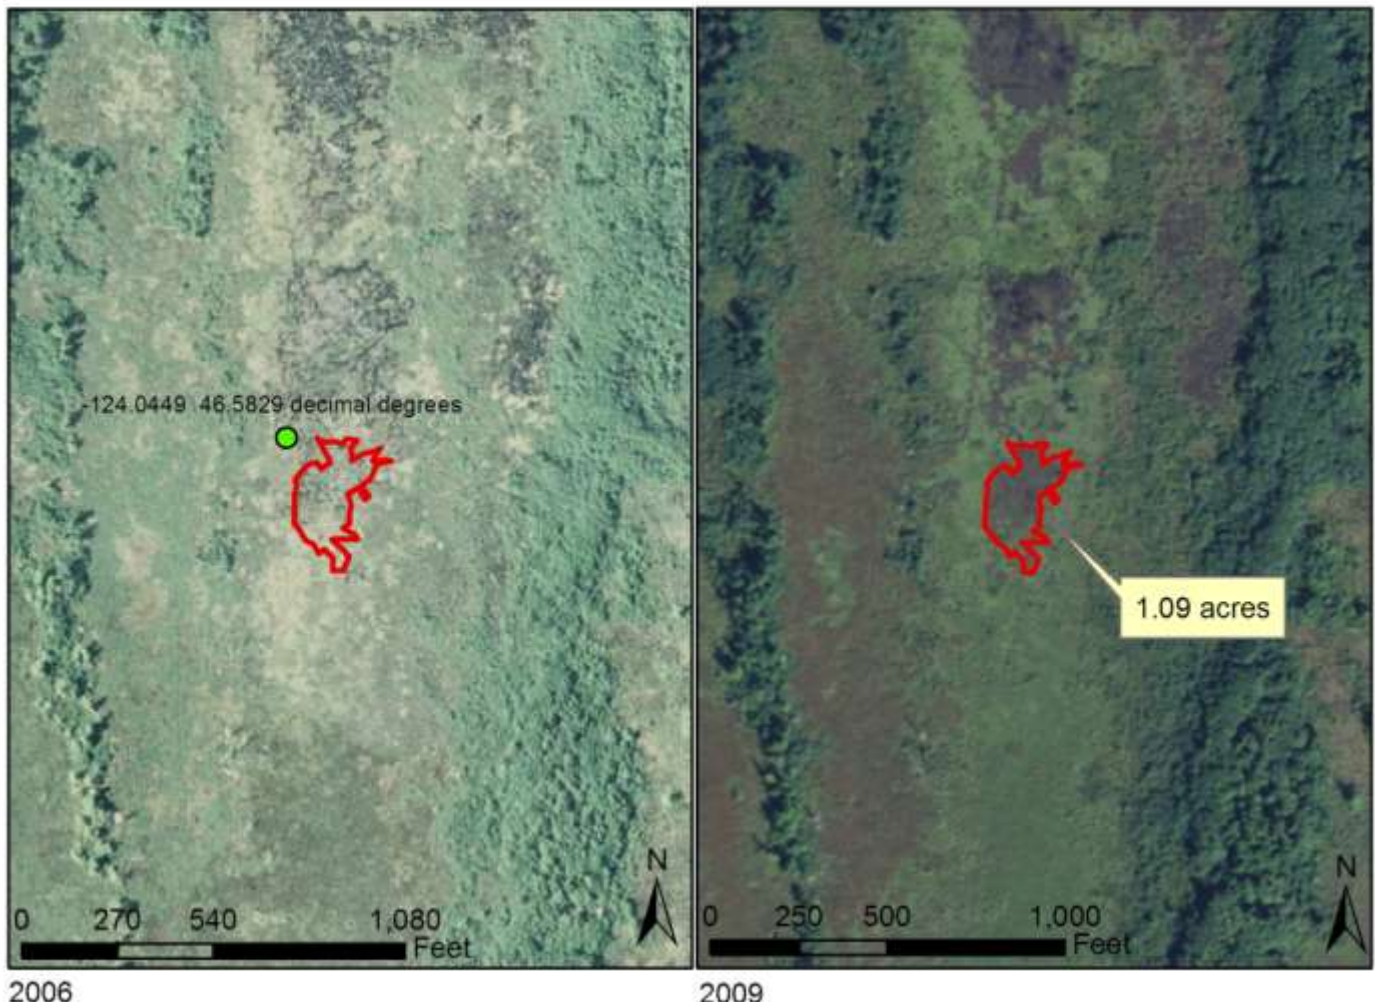
According to the aerial photo analysis, a total of 1.09 acres of open water and dead woody vegetation were present within the mitigation site in 2009. No open water was present in this area in 2006 (Figure 1).

Figure 1: Comparison of amount of open water and PEM. 2006 to 2009.

According to Figure 1, mitigation activities have created additional Cowardin classes including open-water and emergent vegetation communities.

2009 observations of trumpeter swans and the increased amount of open water visible in the 2009 aerial photo suggest that the wildlife habitat in this areas has been improved by WSDOT mitigation efforts.
