ALASKAN WAY VIADUCT

EVALUATION OF GRAY'S RETROFIT PROPOSAL

Prepared for the
Washington State Department of Transportation

By
T.Y. Lin International

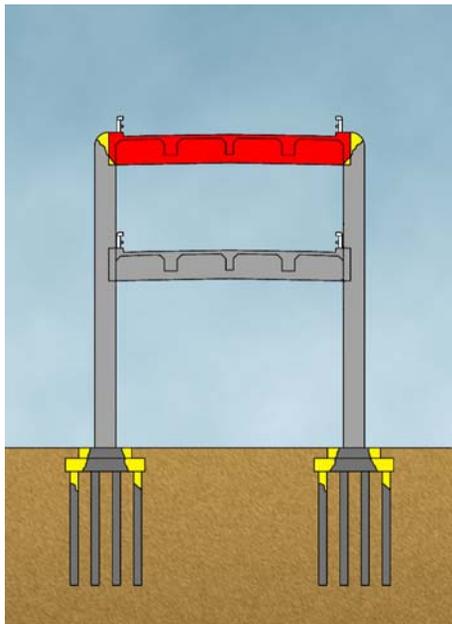
Expected Damage for Design (500 yr) EQ

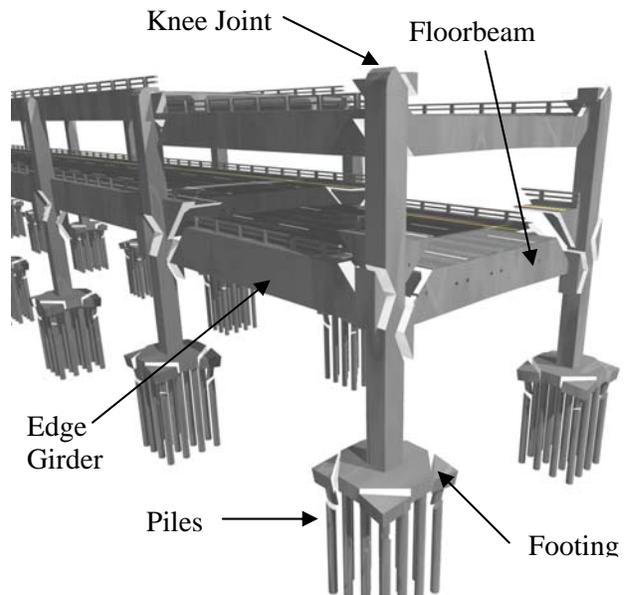
General Failure Modes – Design and Rare EQ

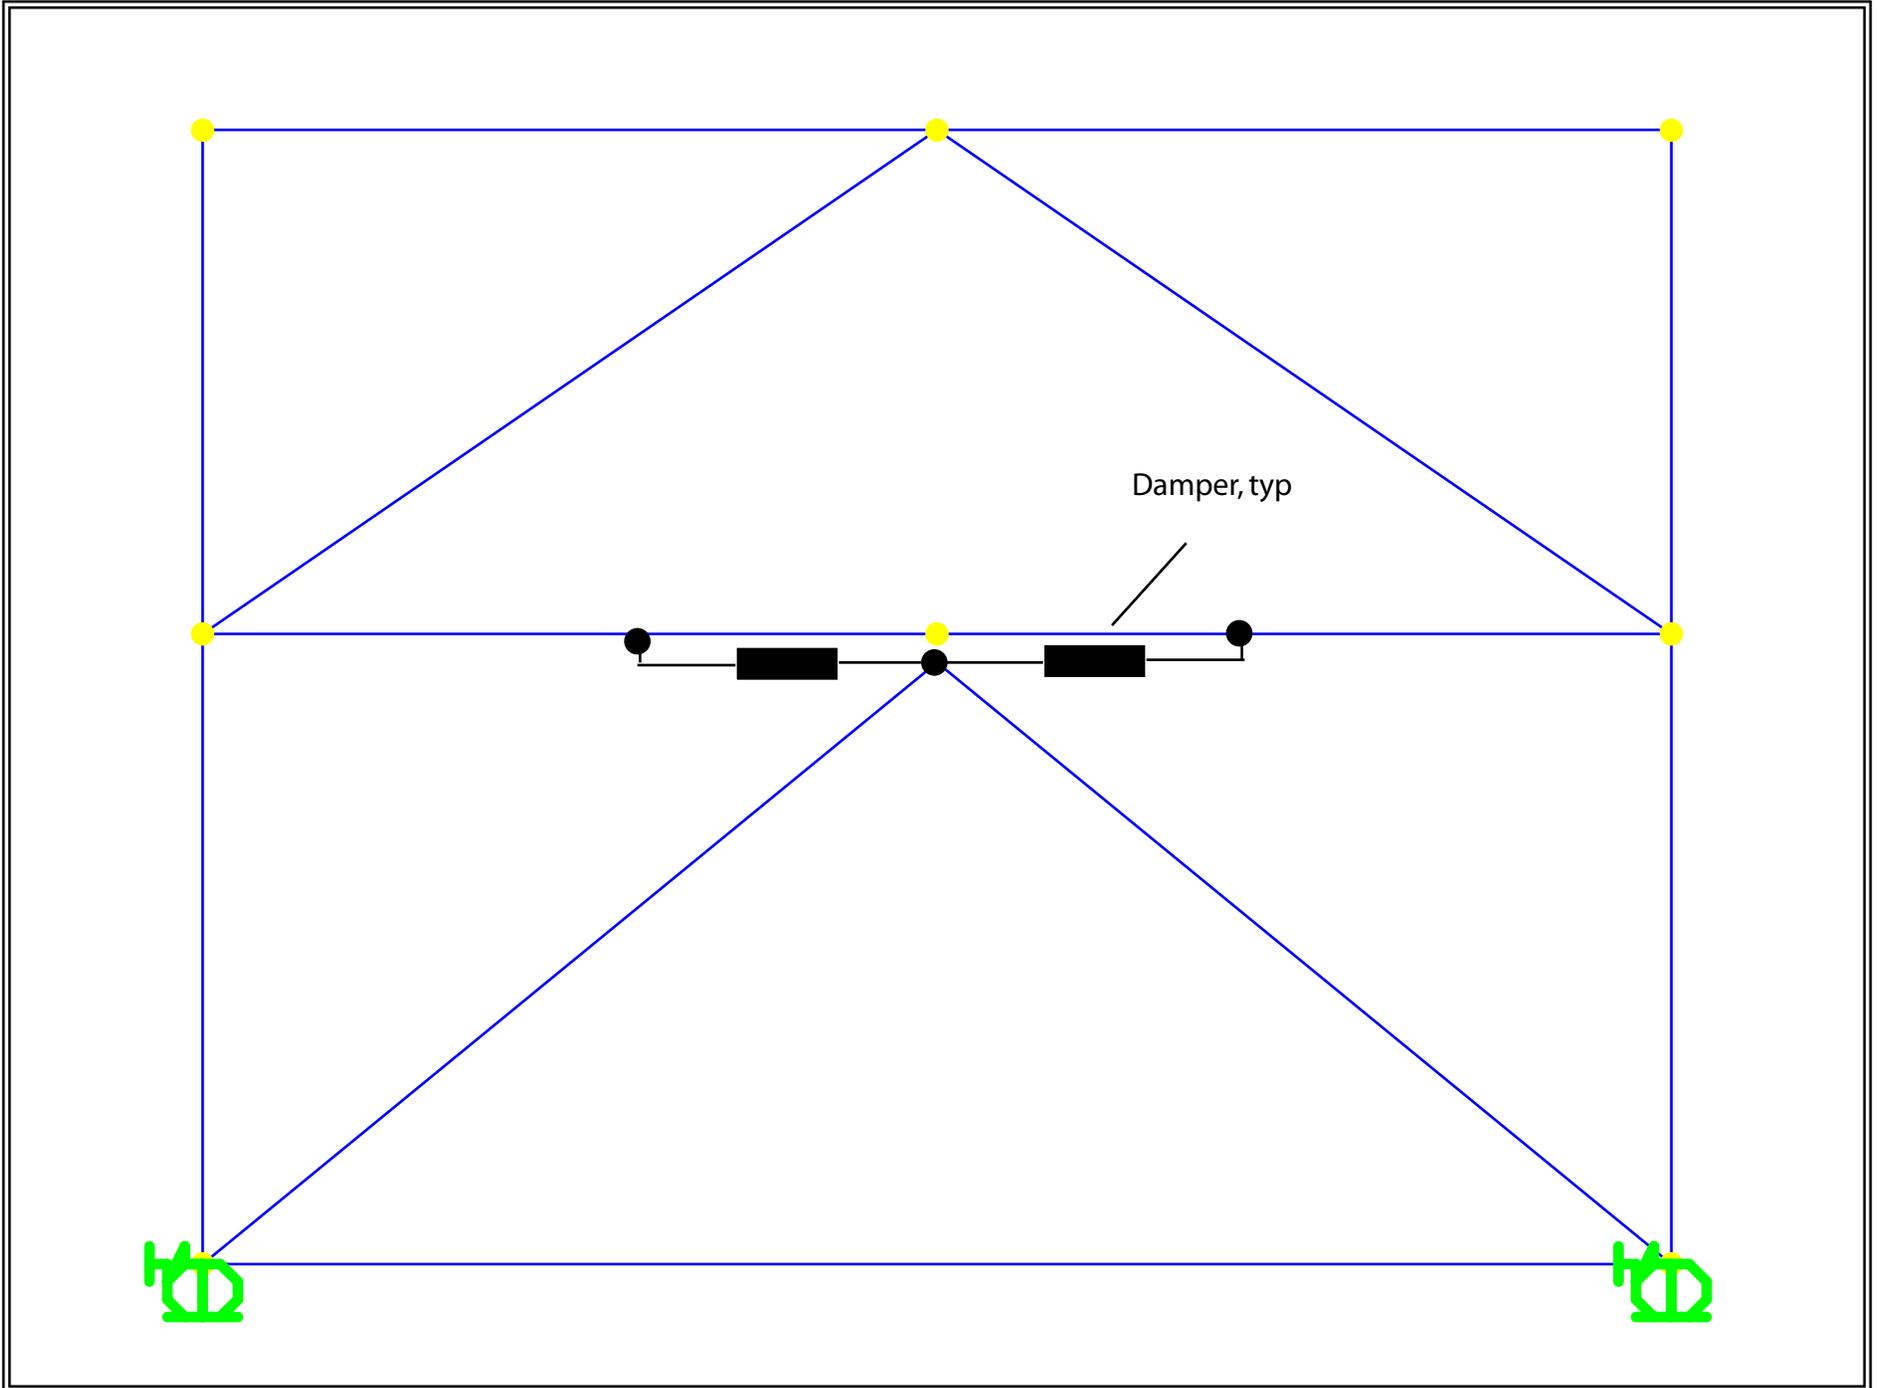
Figure 2a, Longitudinal auxiliary frame per Gray's proposal

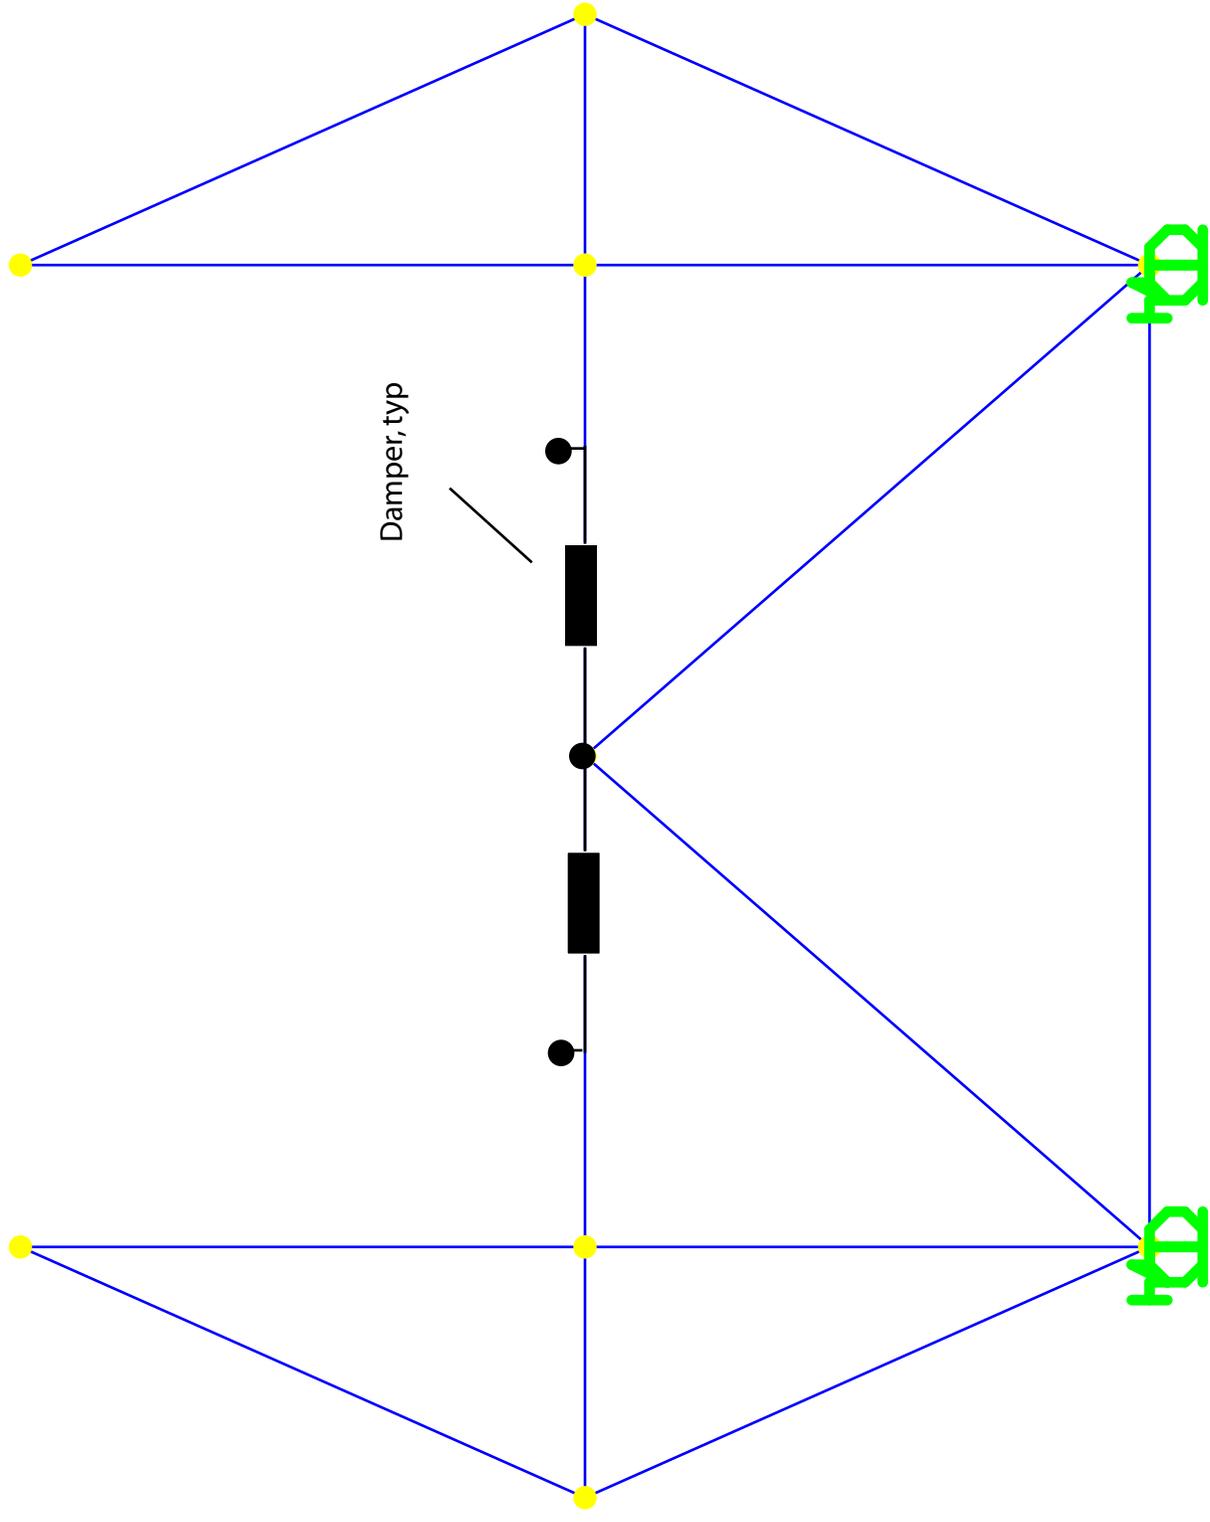
Figure 2b, Transverse auxiliary frame per Gray's proposal

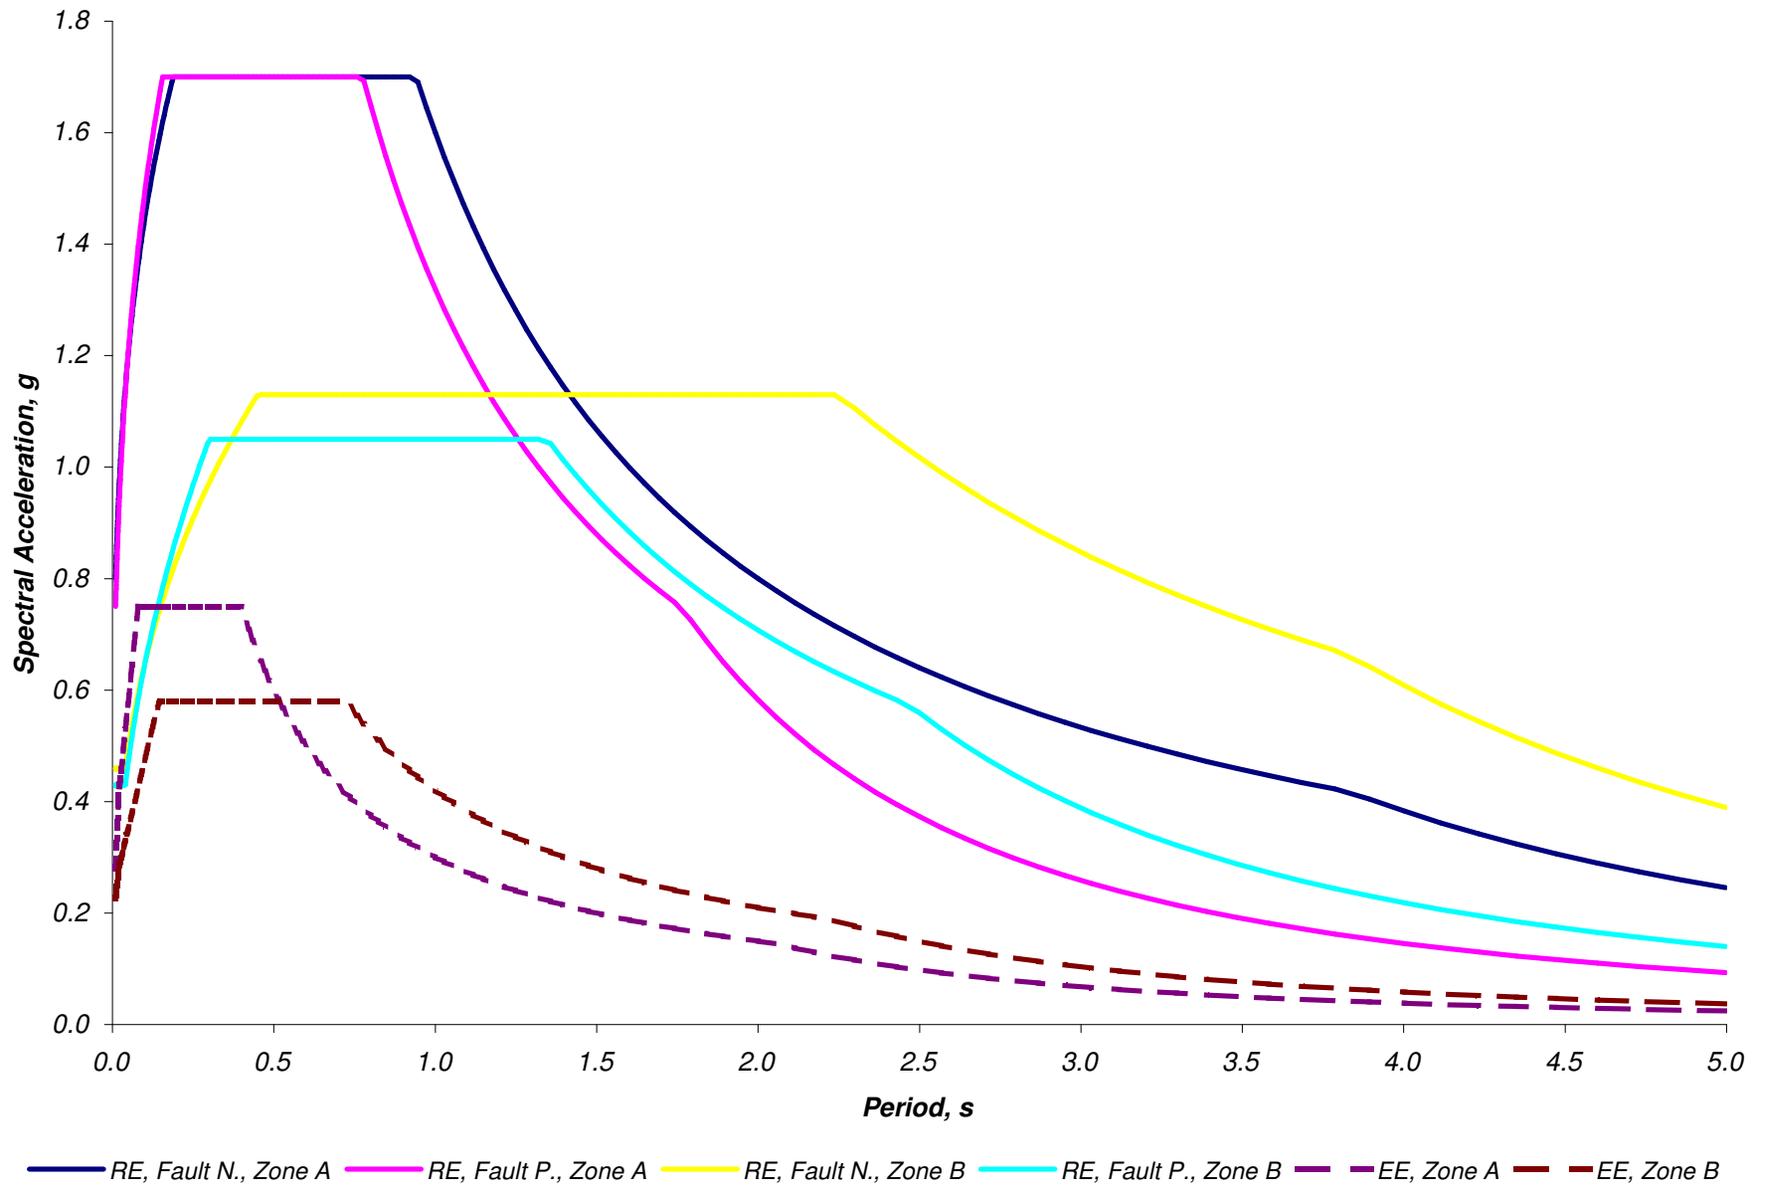
Figure 3a, Acceleration spectra for horizontal motions, rare and expected earthquakes

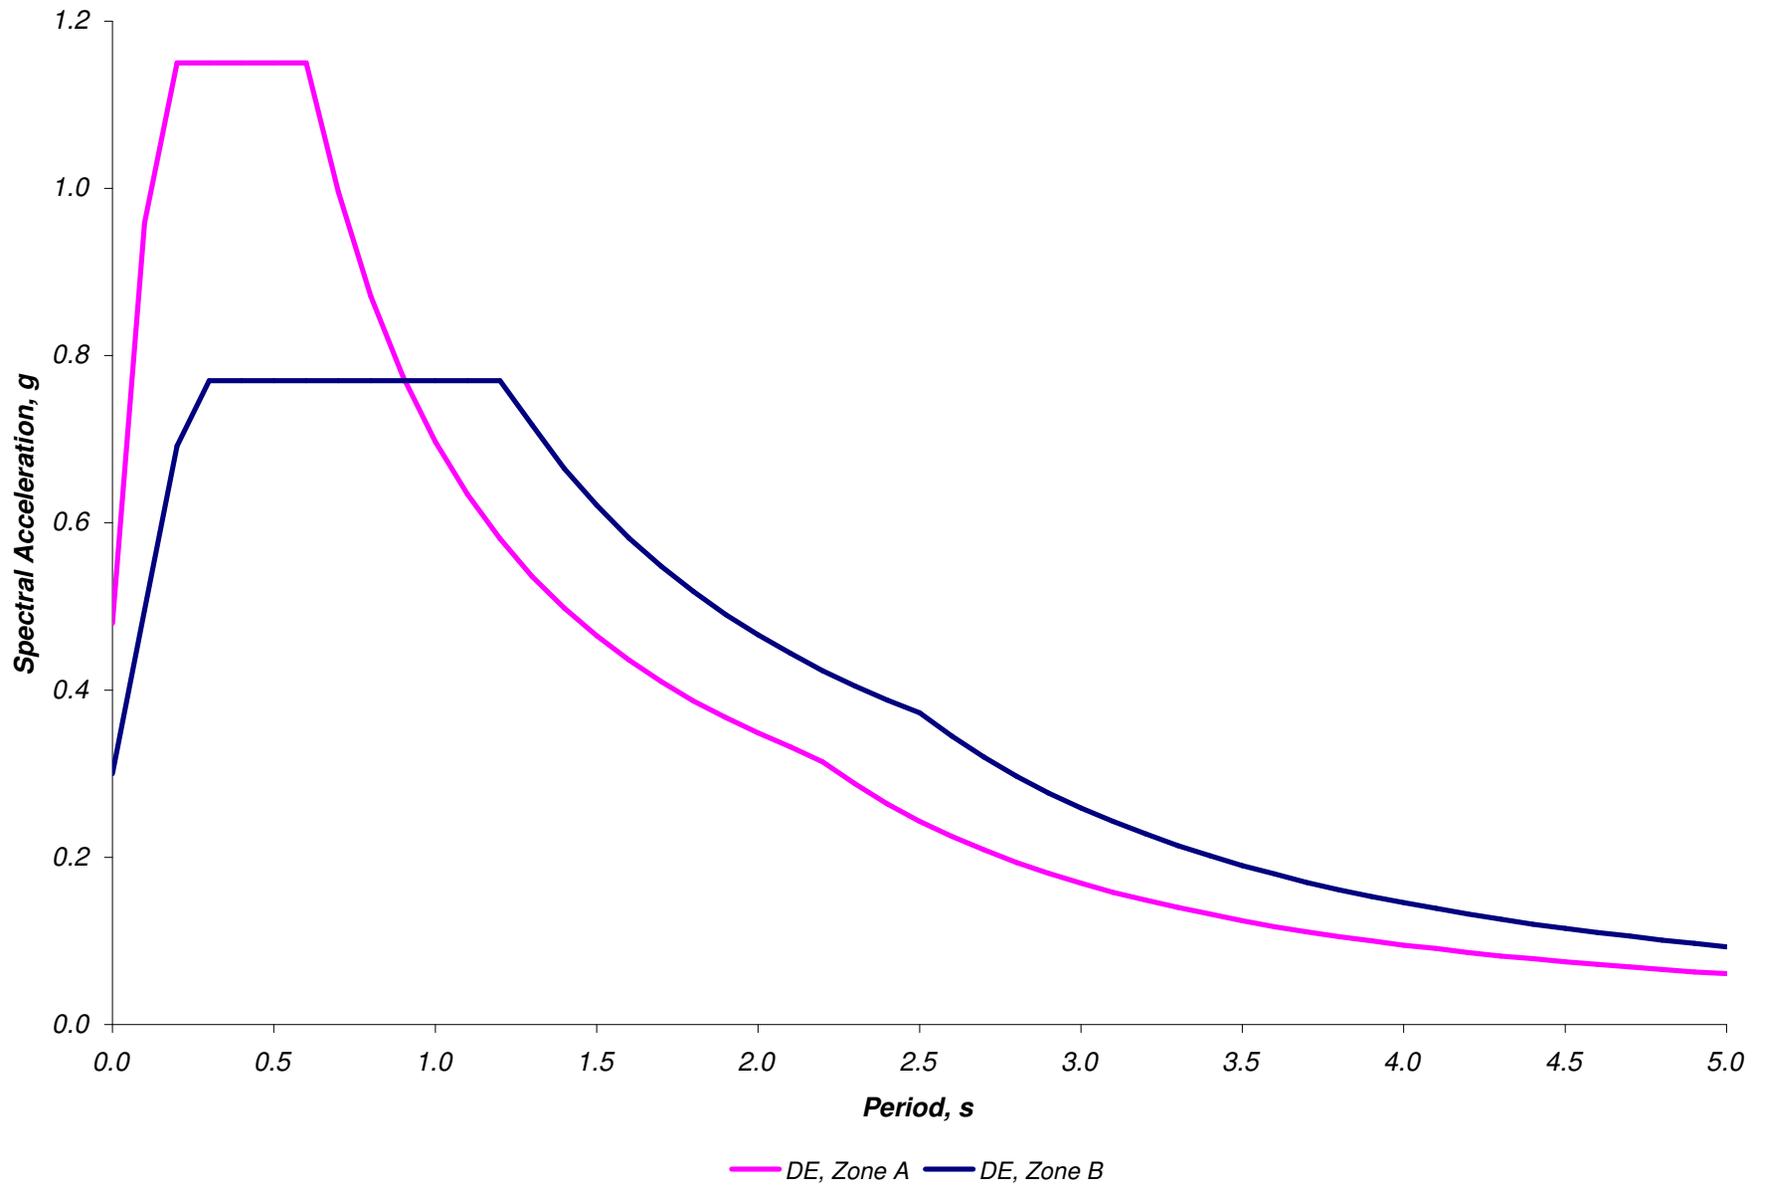
Figure 3b, Acceleration spectra for horizontal motions, design earthquake

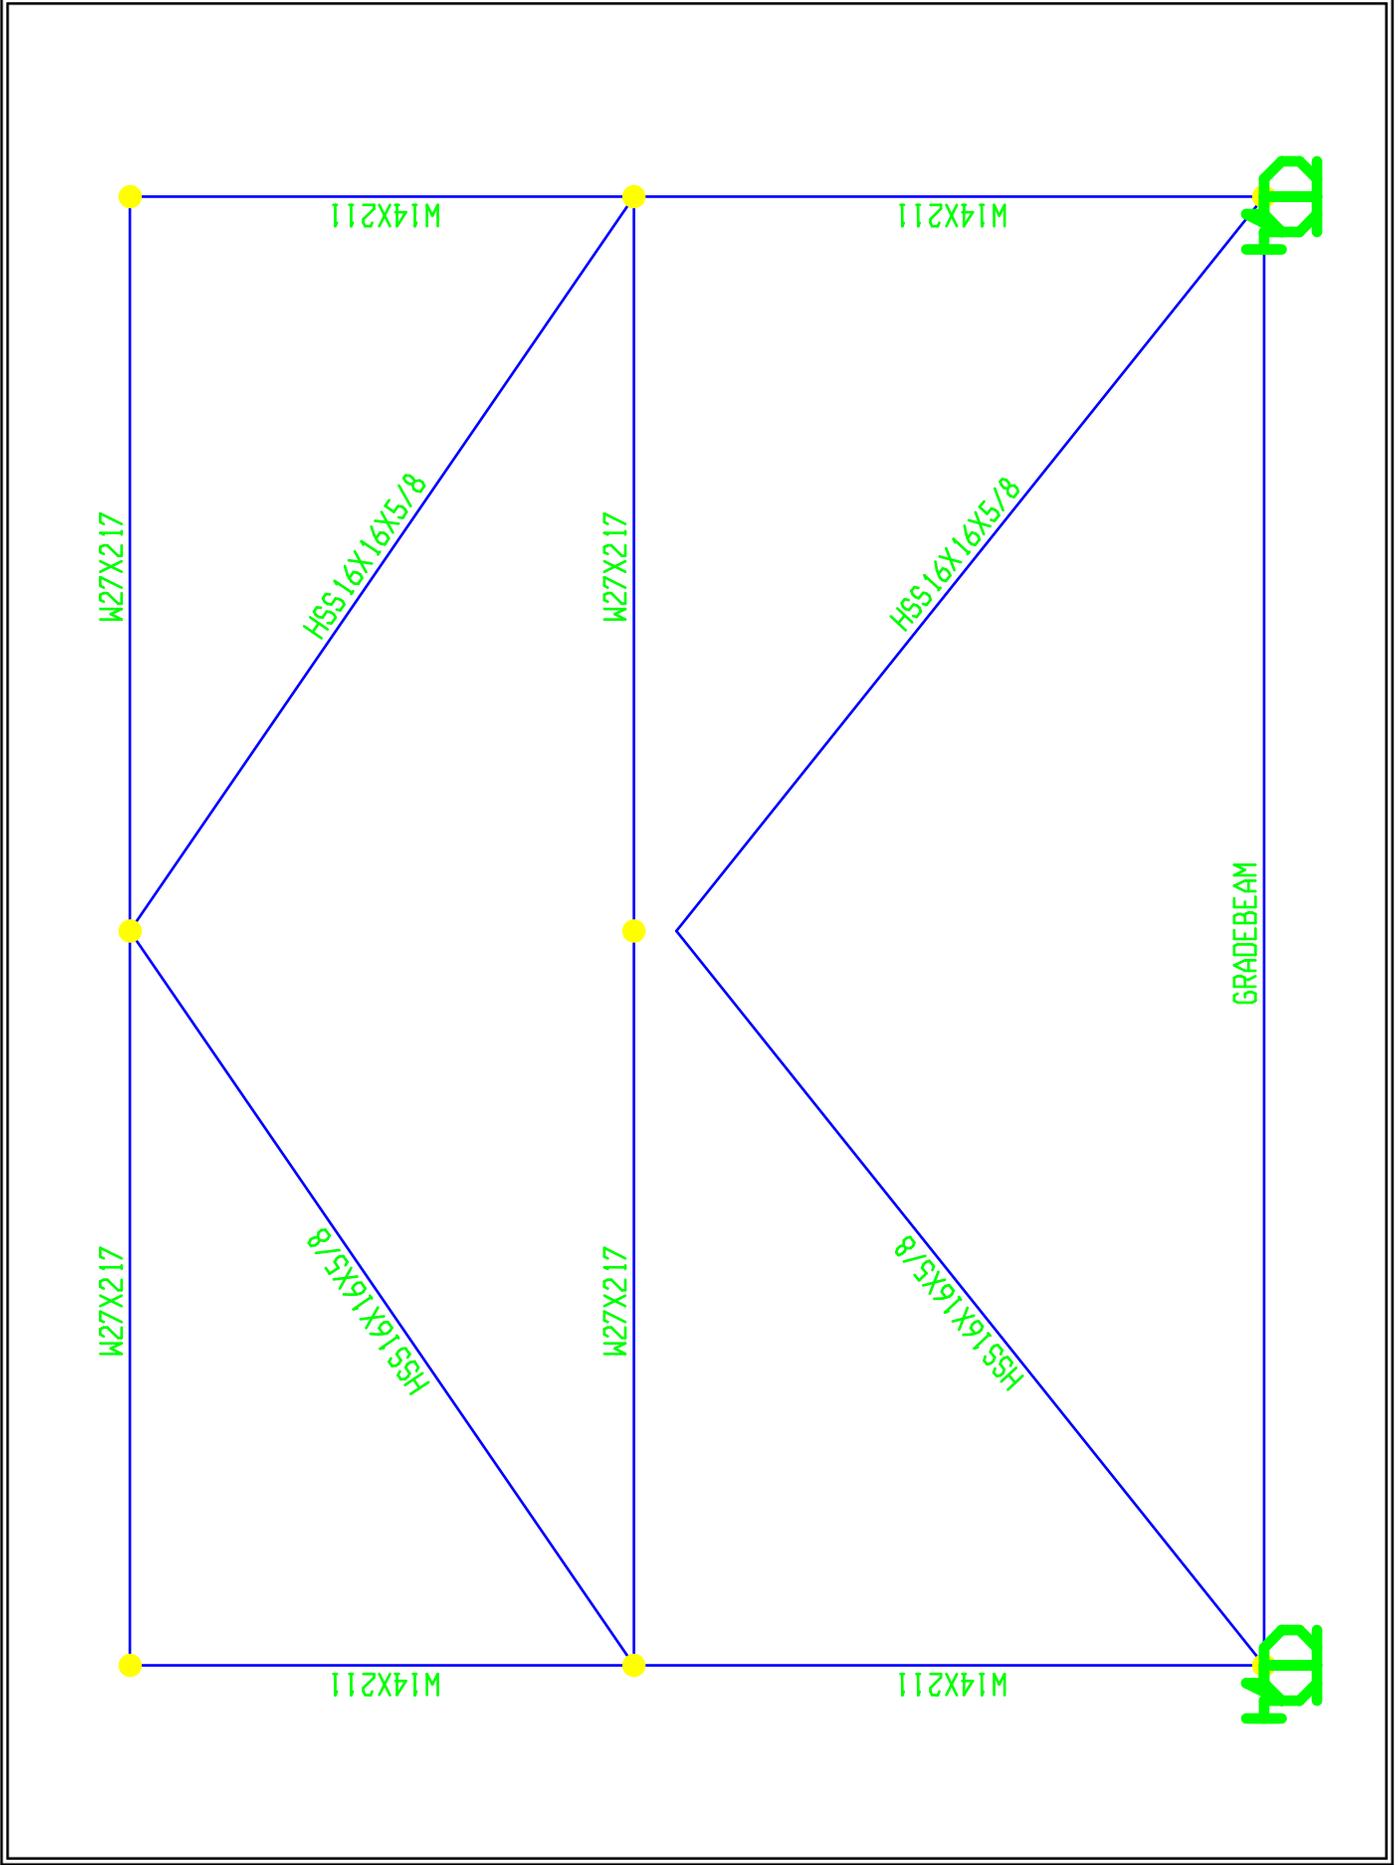
Figure 5a, Auxiliary frame member sizes, longitudinal frames

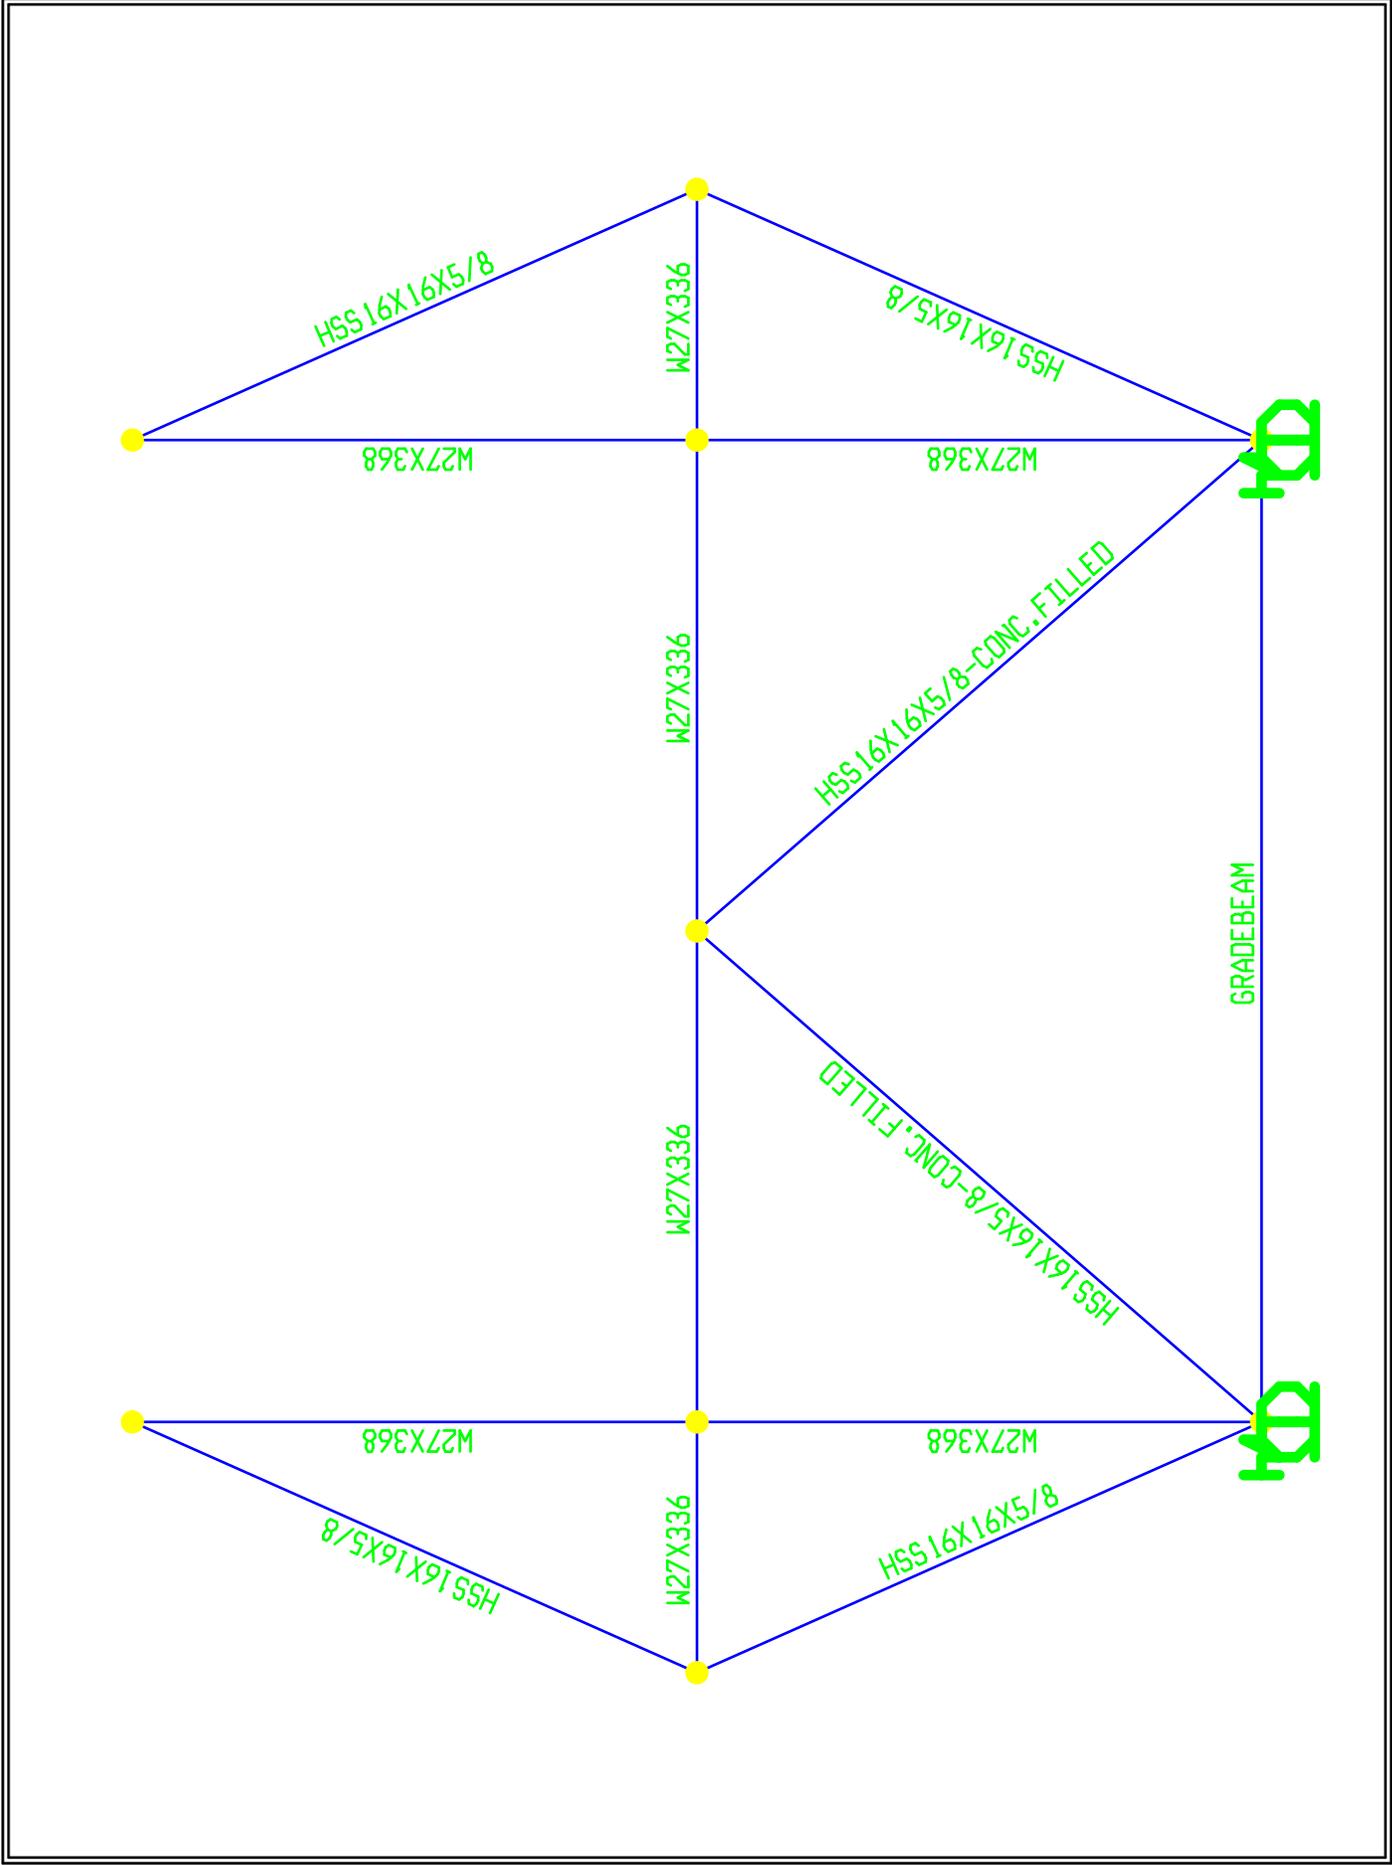
Figure 5b, Auxiliary frame member sizes, transverse frames

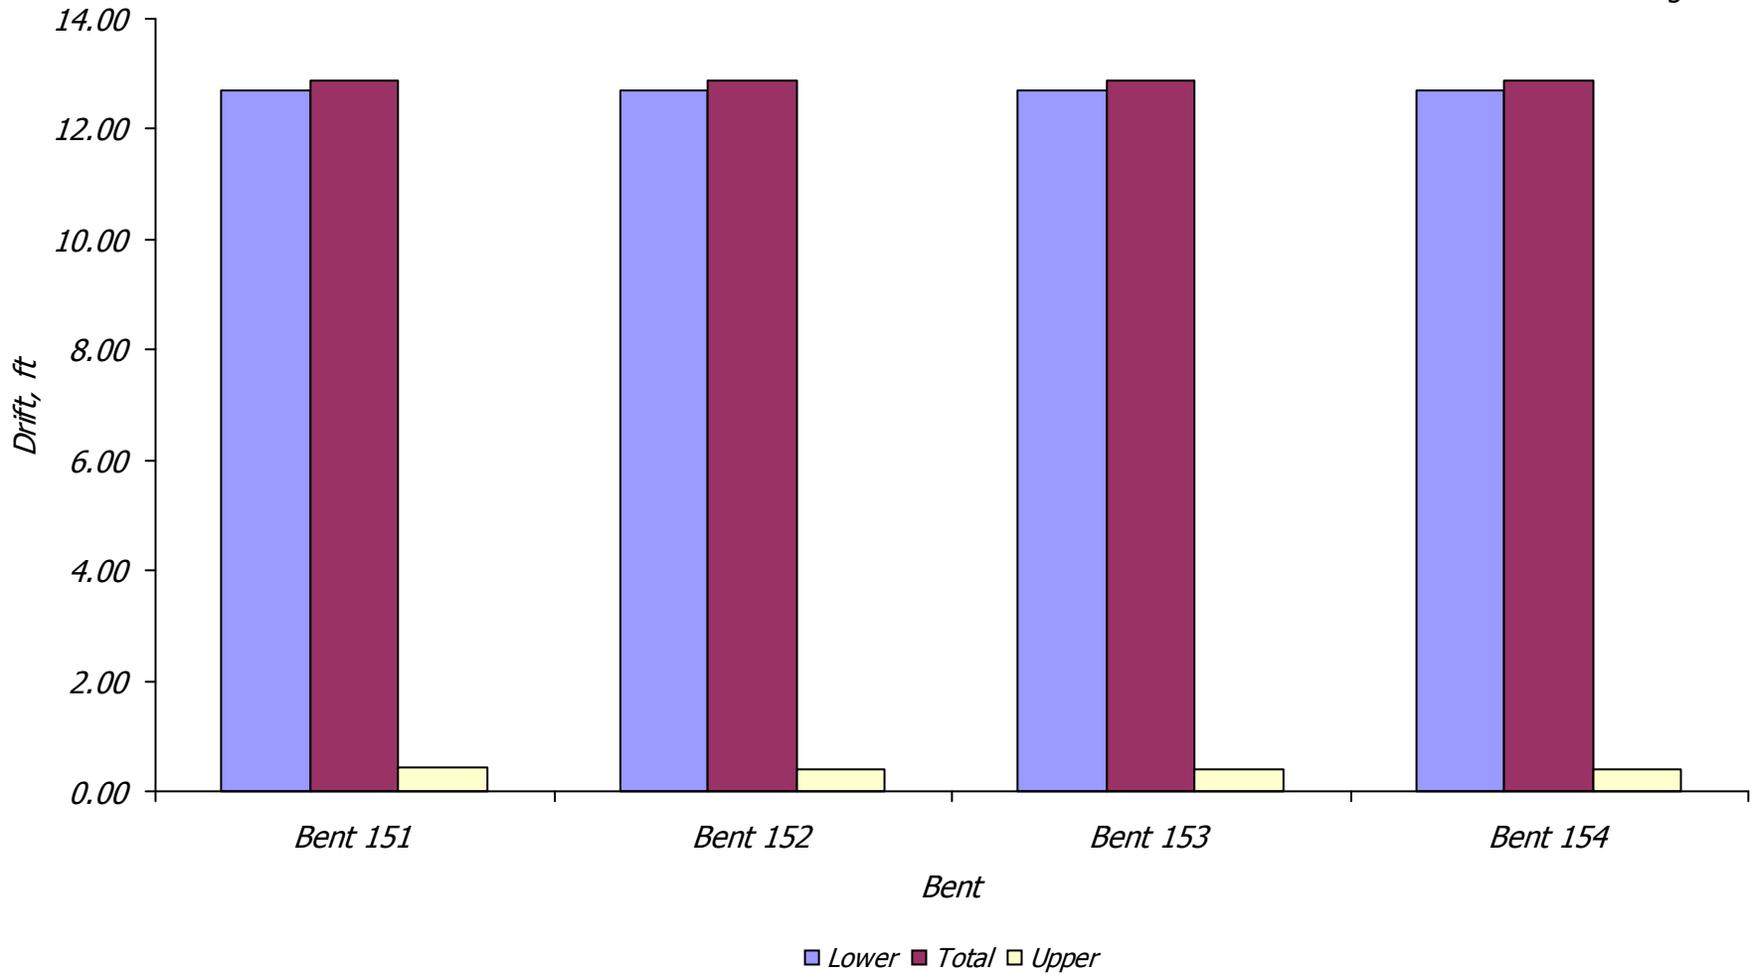
Figure 6a Drift of existing structure, rare earthquake, longitudinal direction

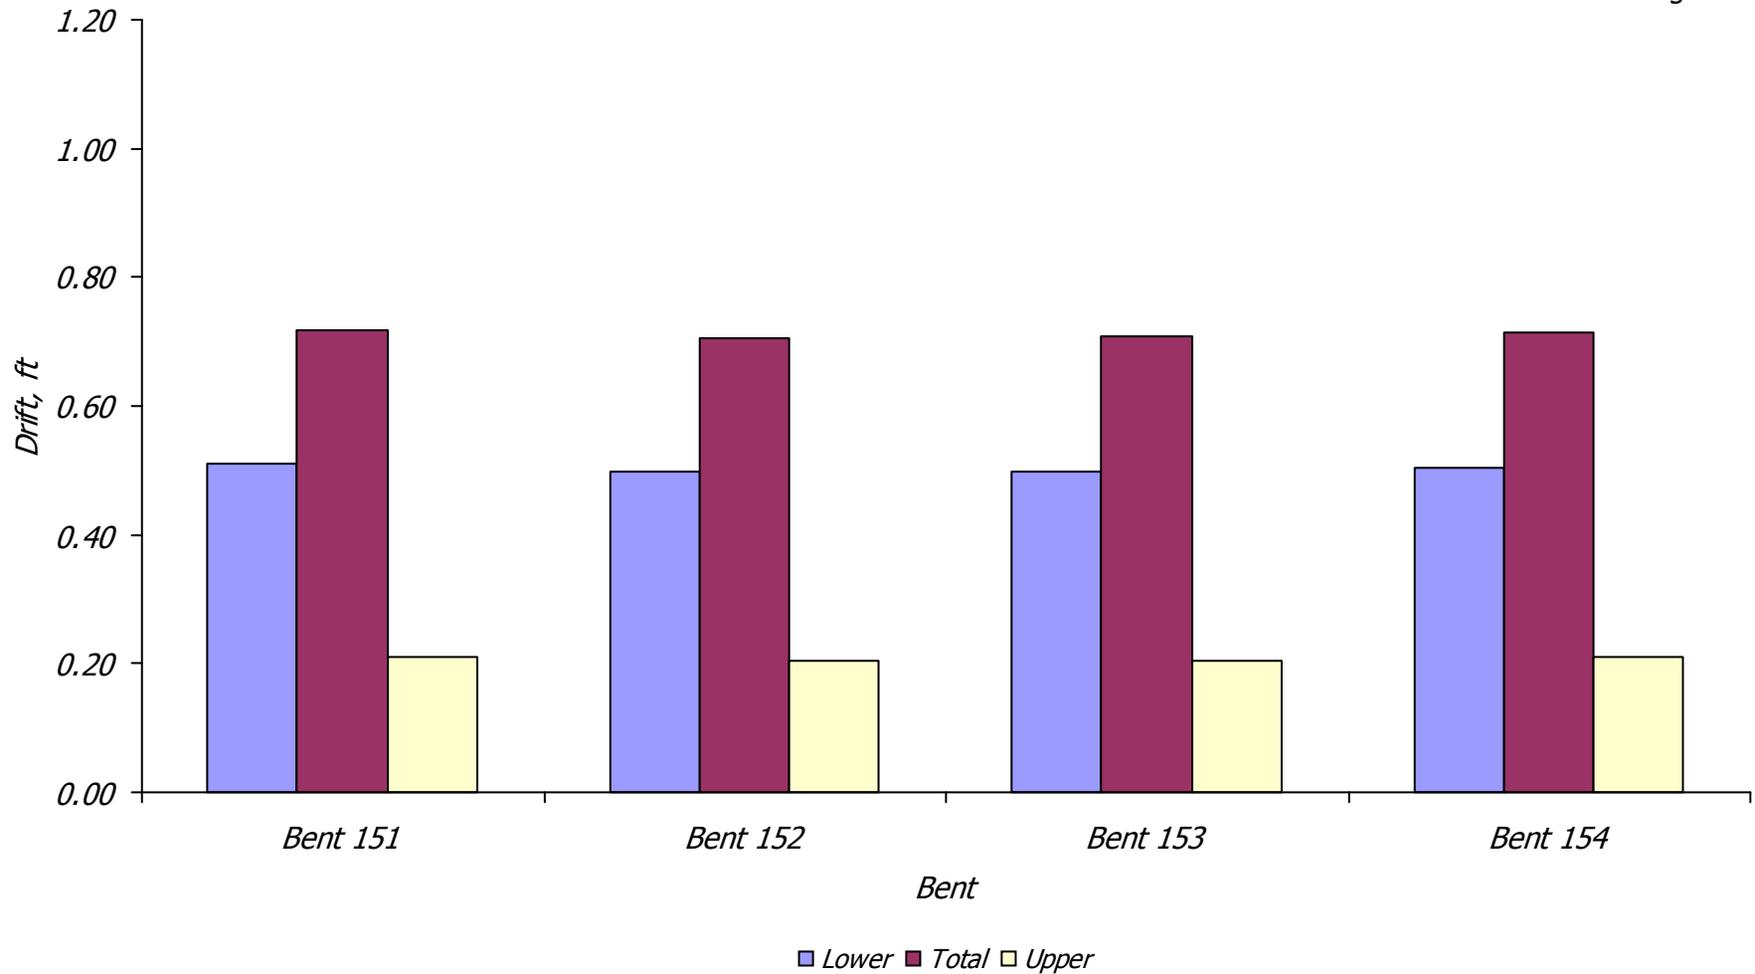
Figure 7a Drift of existing structure, expected earthquake, longitudinal direction

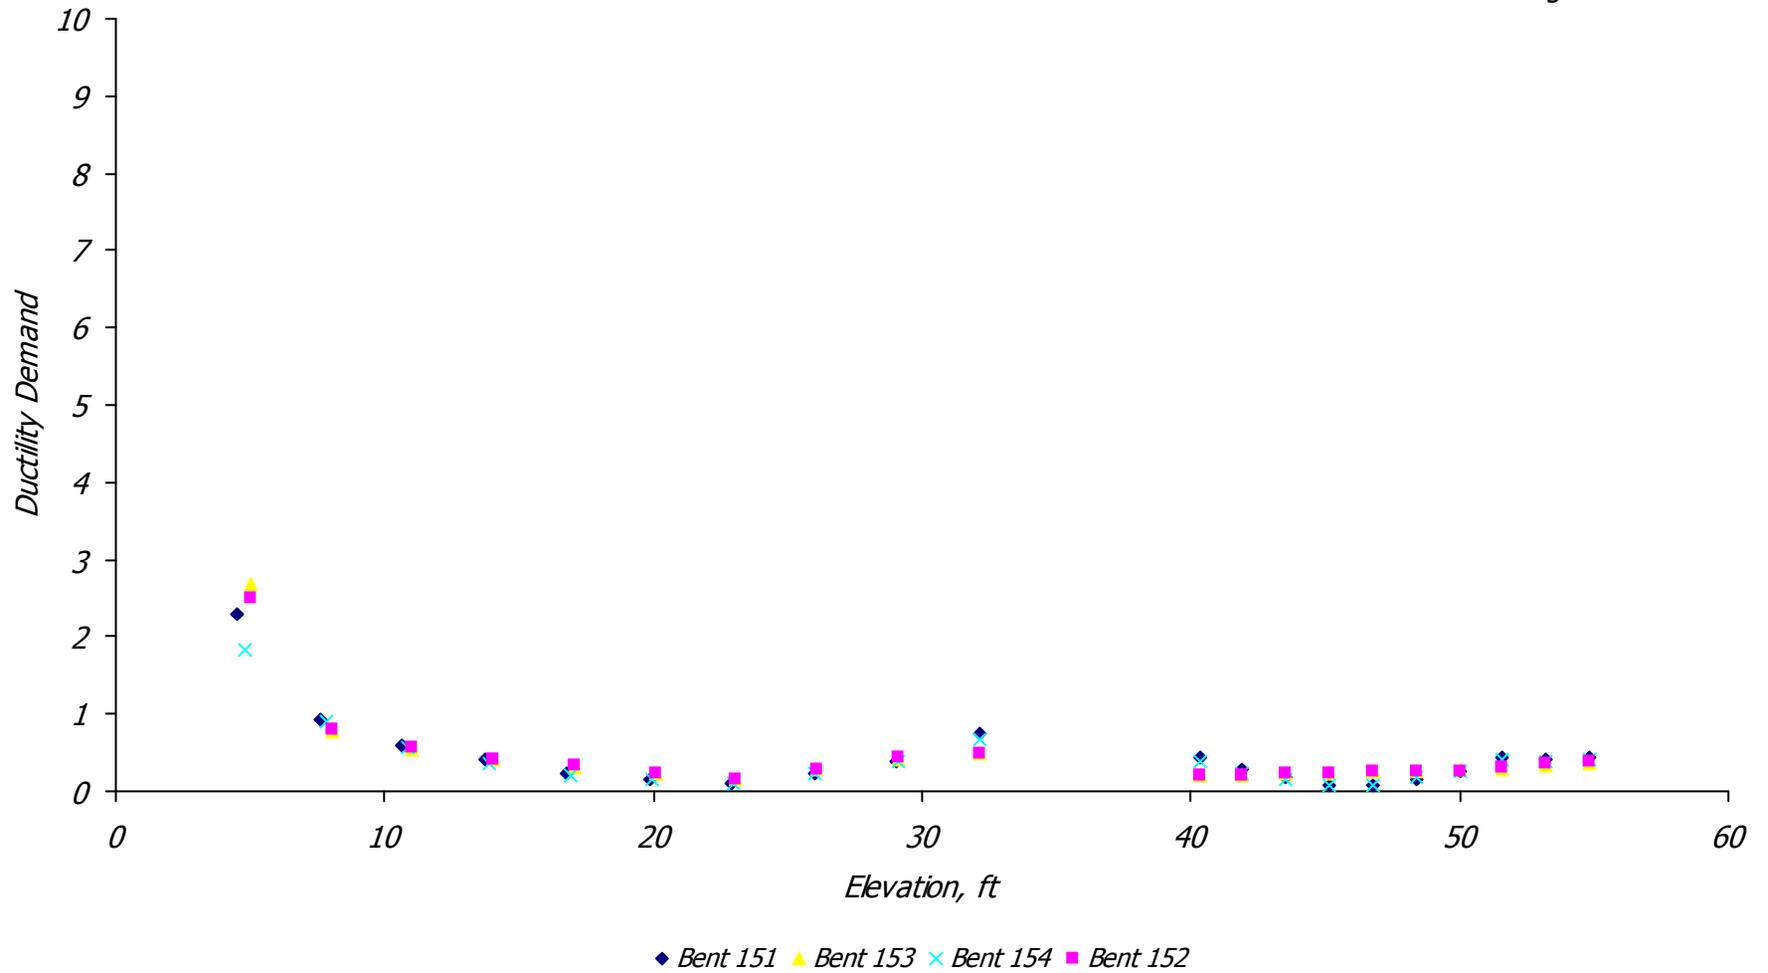
Figure 8a

Column curvature ductility demand, existing structure, expected earthquake, longitudinal direction

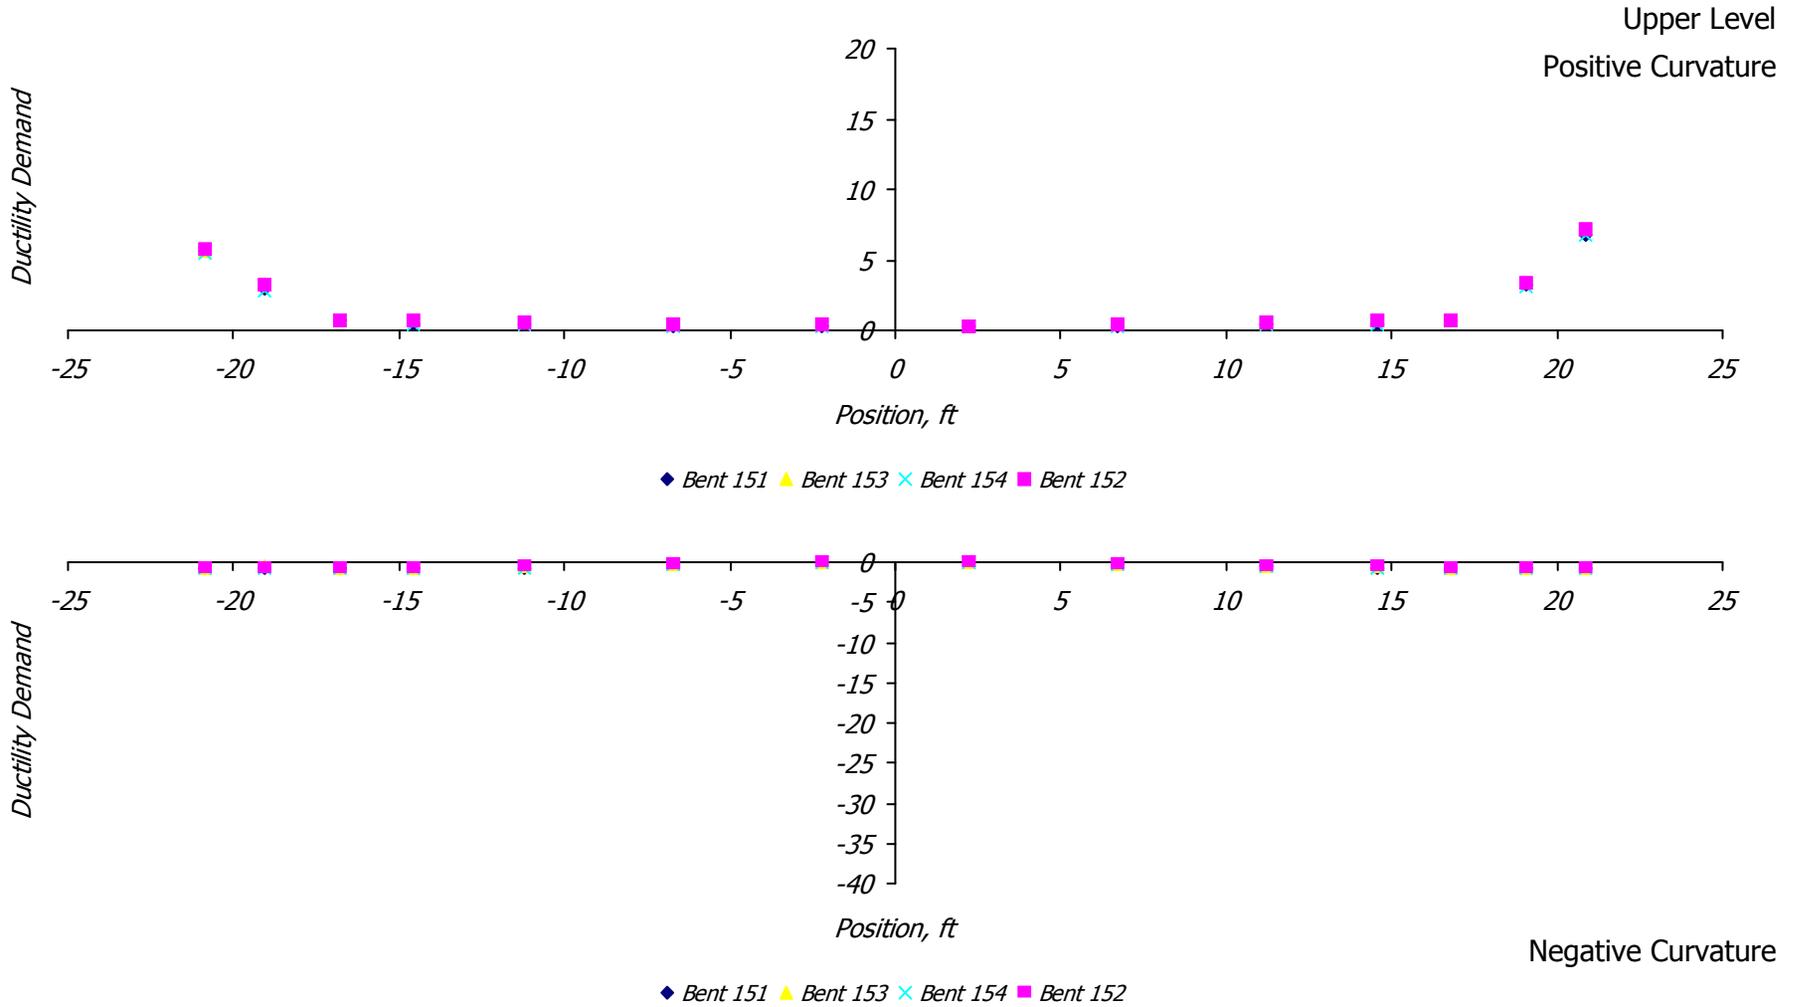
Figure 9a Floorbeam curvature ductility demand, existing structure, expected earthquake, upper level
