ALASKAN WAY VIADUCT

EVALUATION OF GRAY'S RETROFIT PROPOSAL

Prepared for the
Washington State Department of Transportation

By
T.Y. Lin International

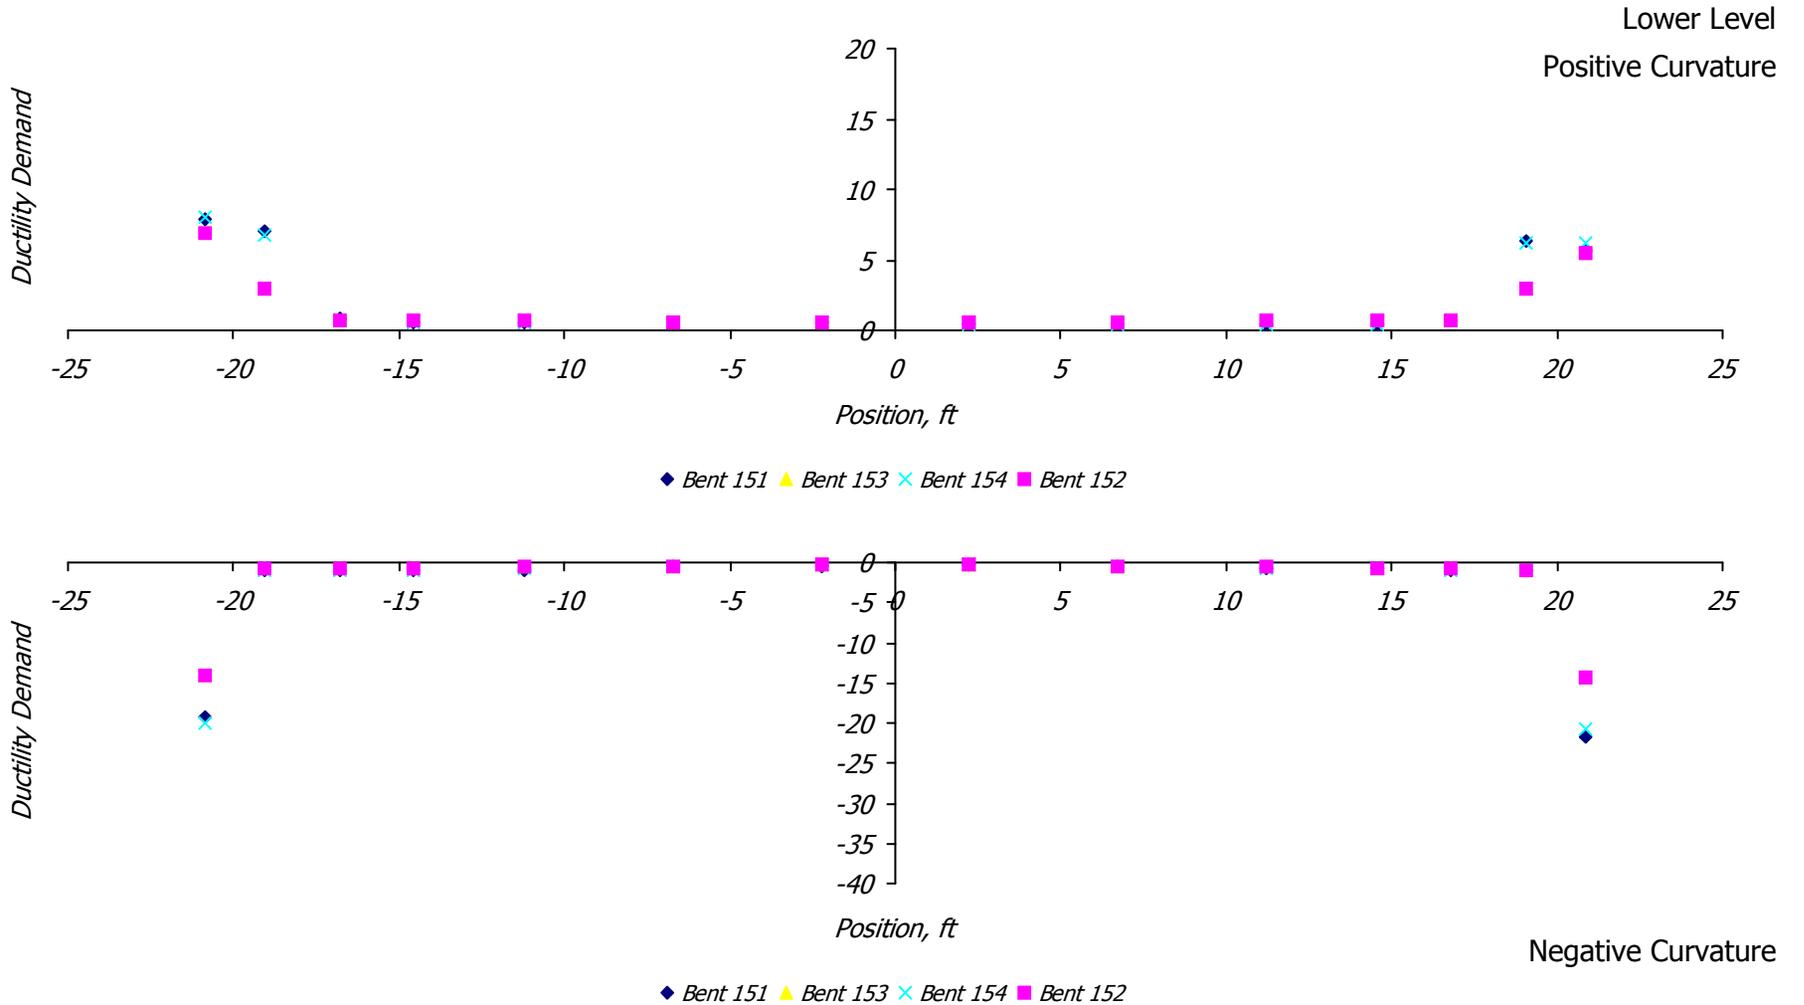
Figure 9b

Floorbeam curvature ductility demand, existing structure, expected earthquake, lower level

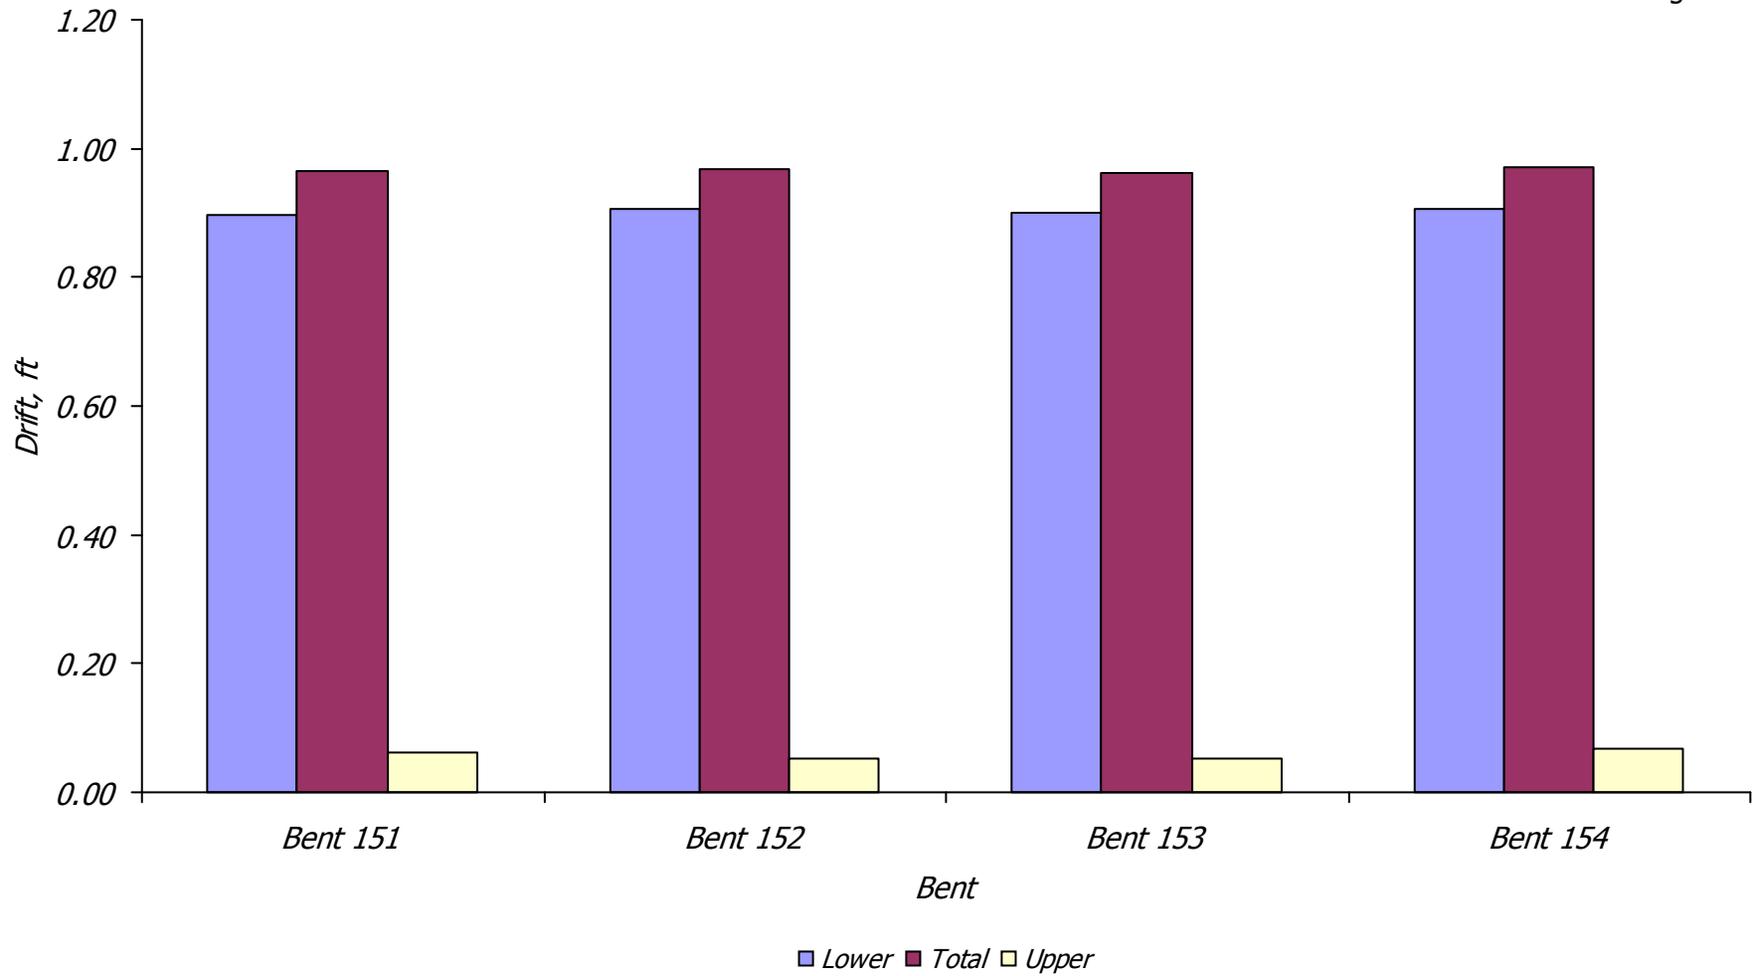
Figure 10a Drift of retrofitted structure, rare earthquake, longitudinal direction

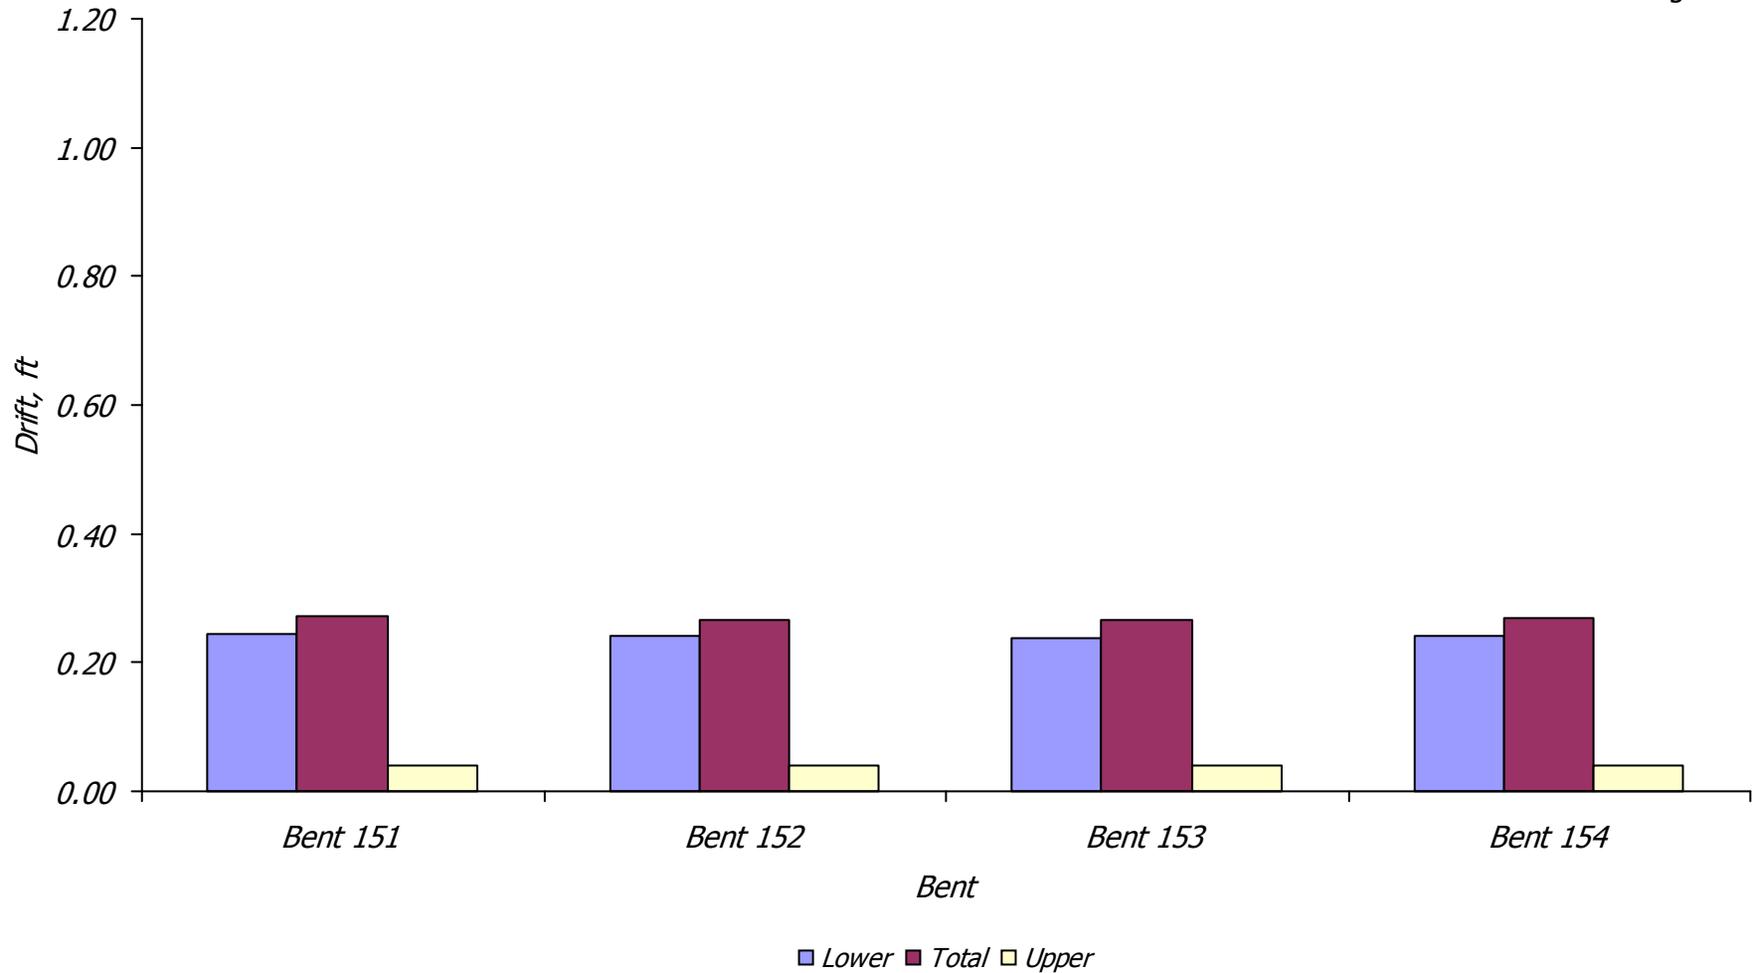
Figure 12a Drift of retrofitted structure, design earthquake, longitudinal direction

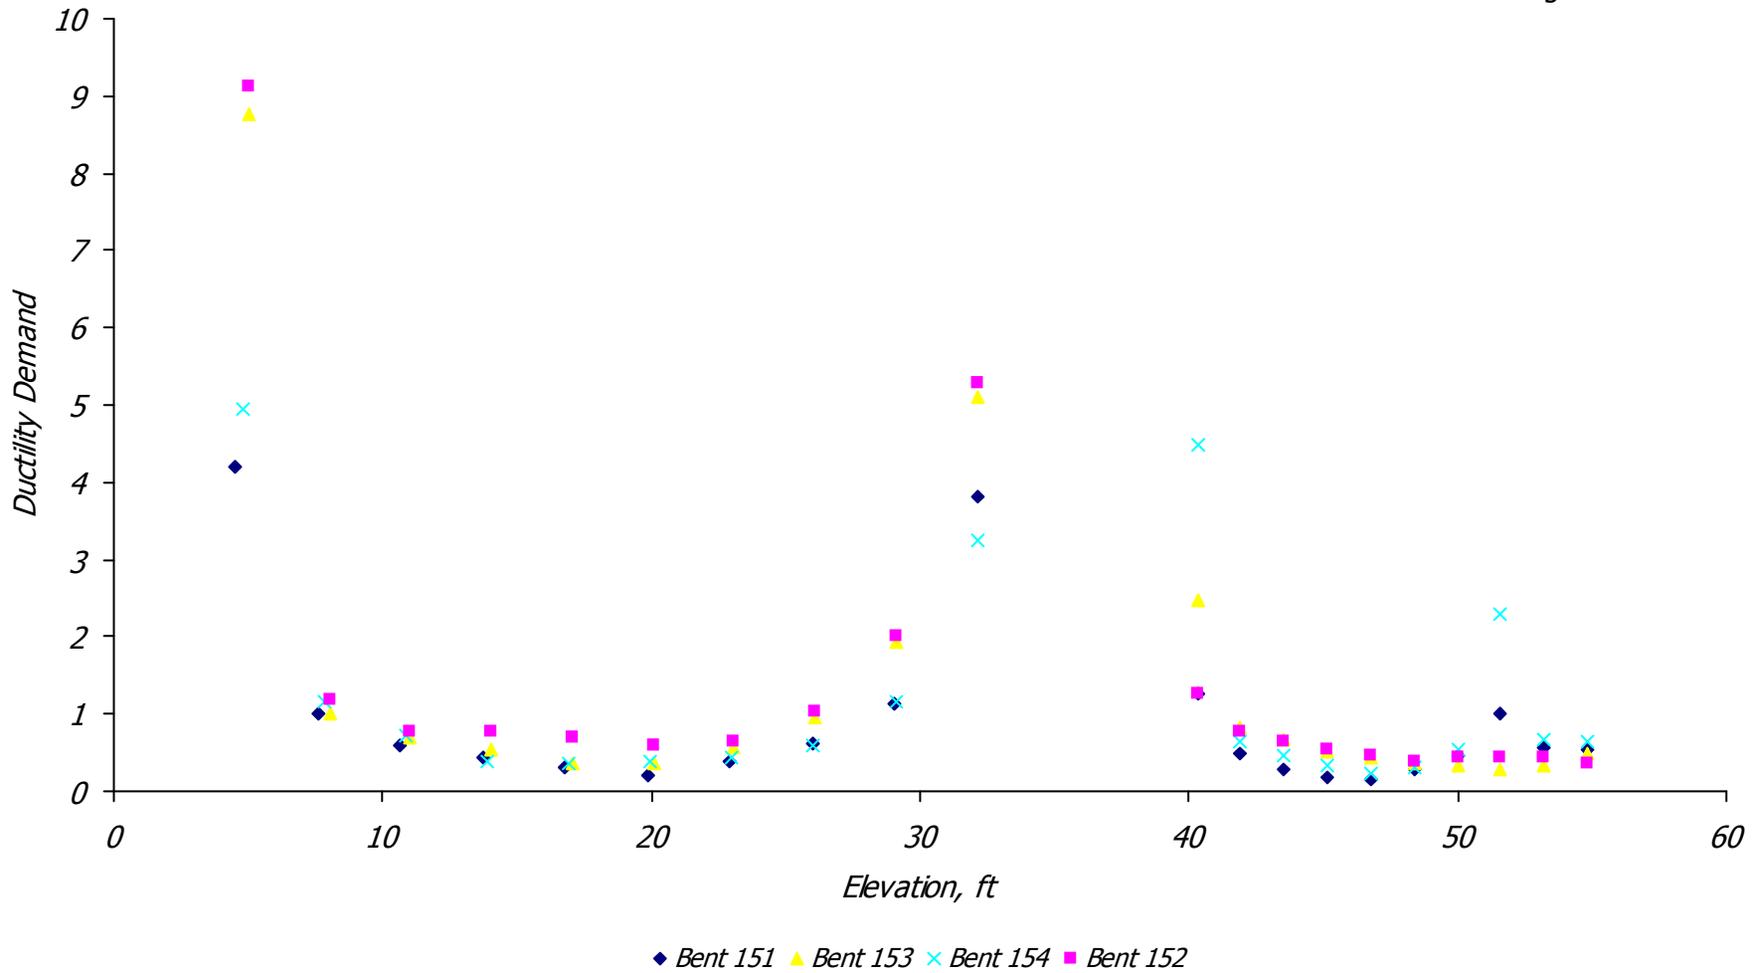
Figure 14a Column curvature ductility demand, retrofitted structure, rare earthquake, longitudinal direction

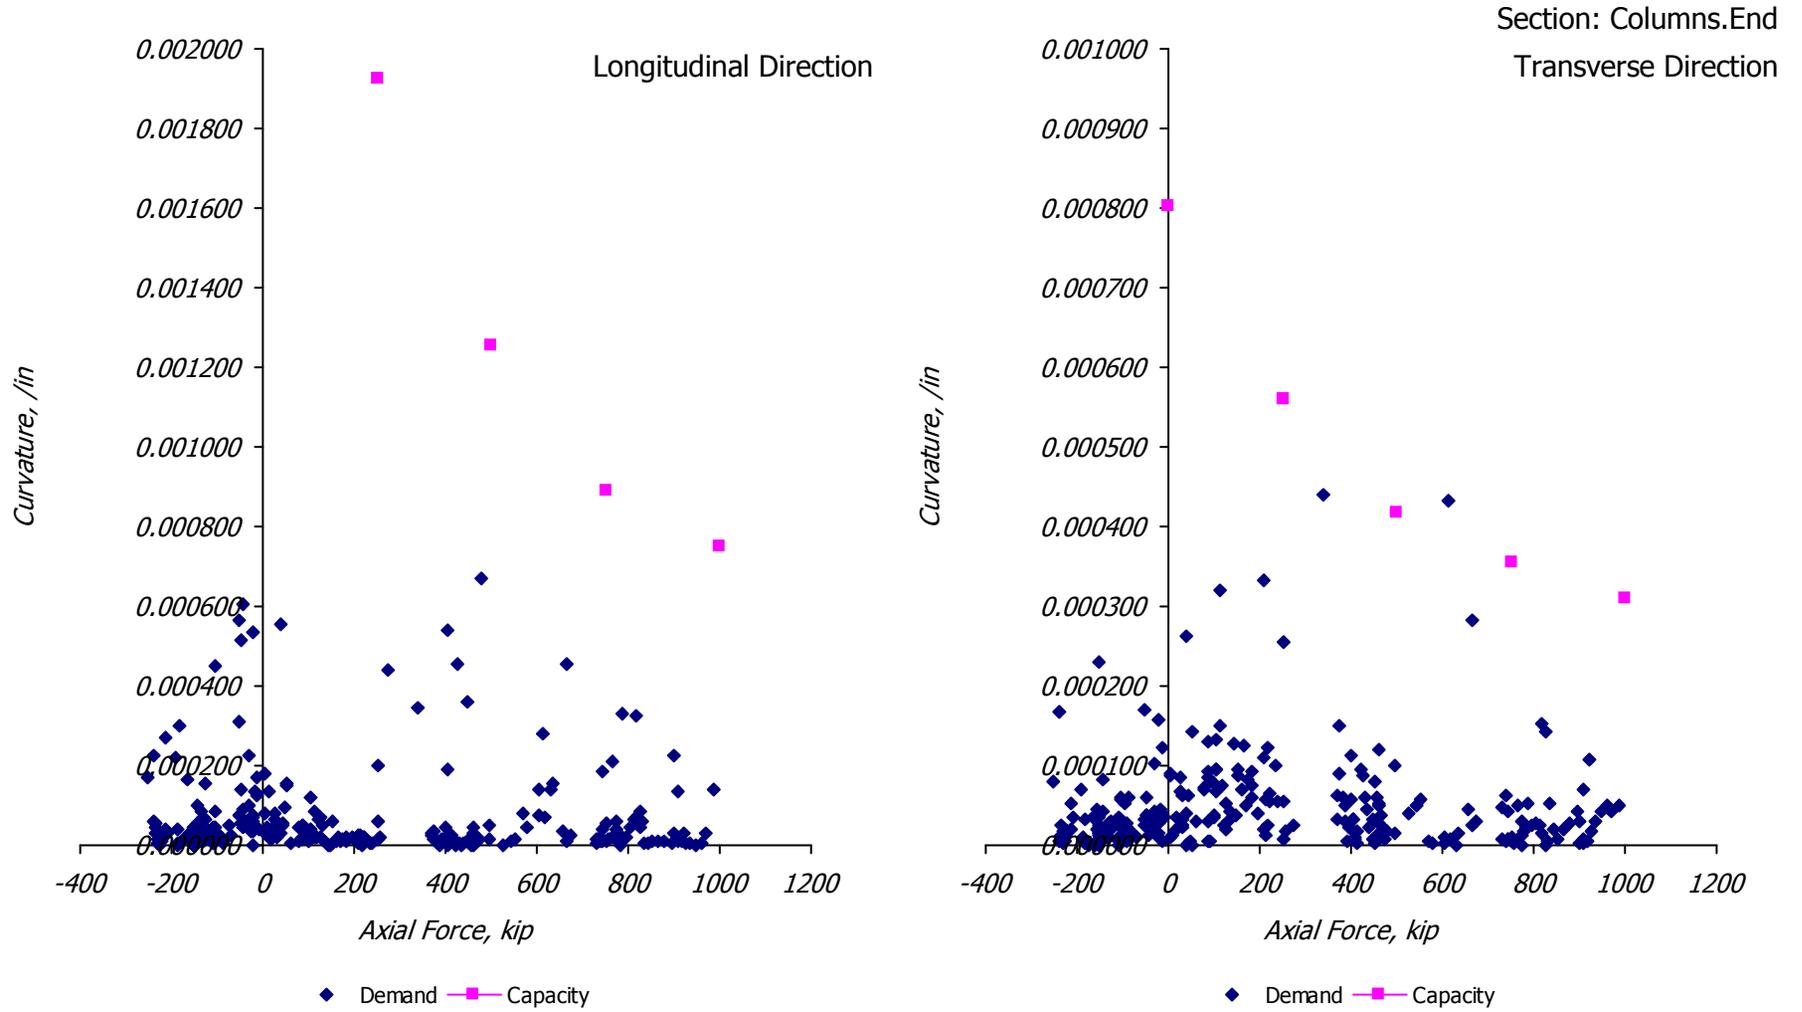
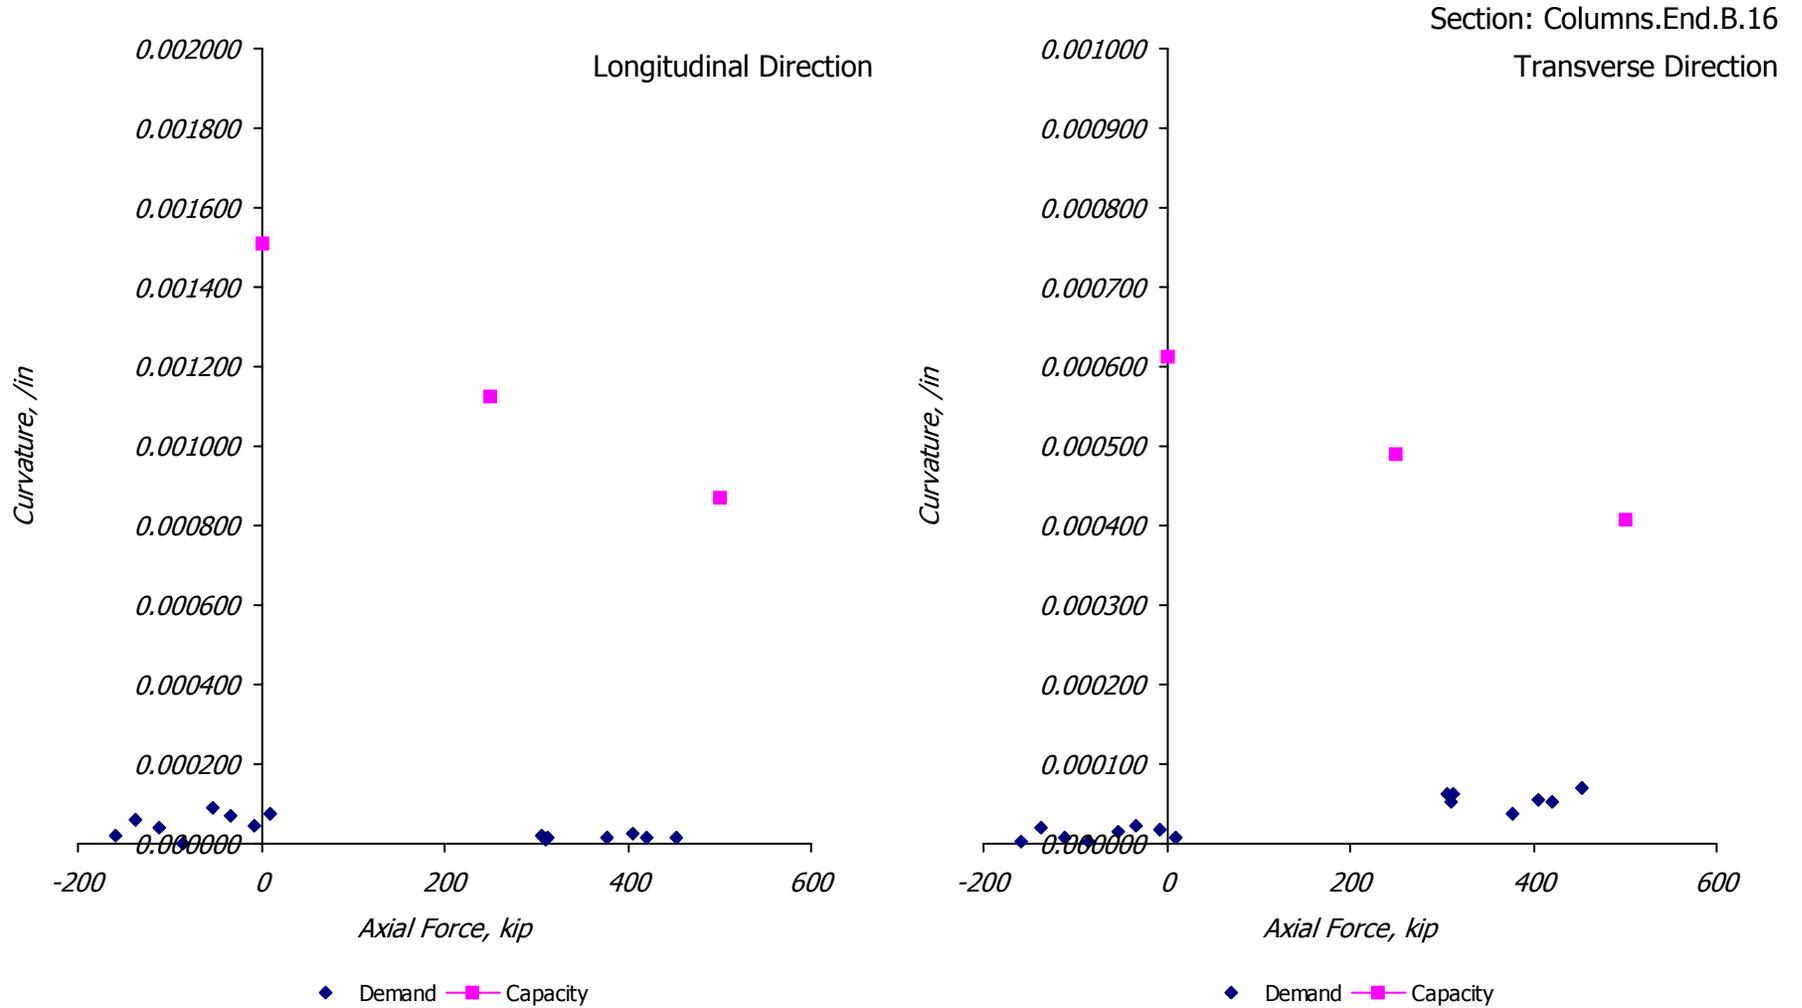
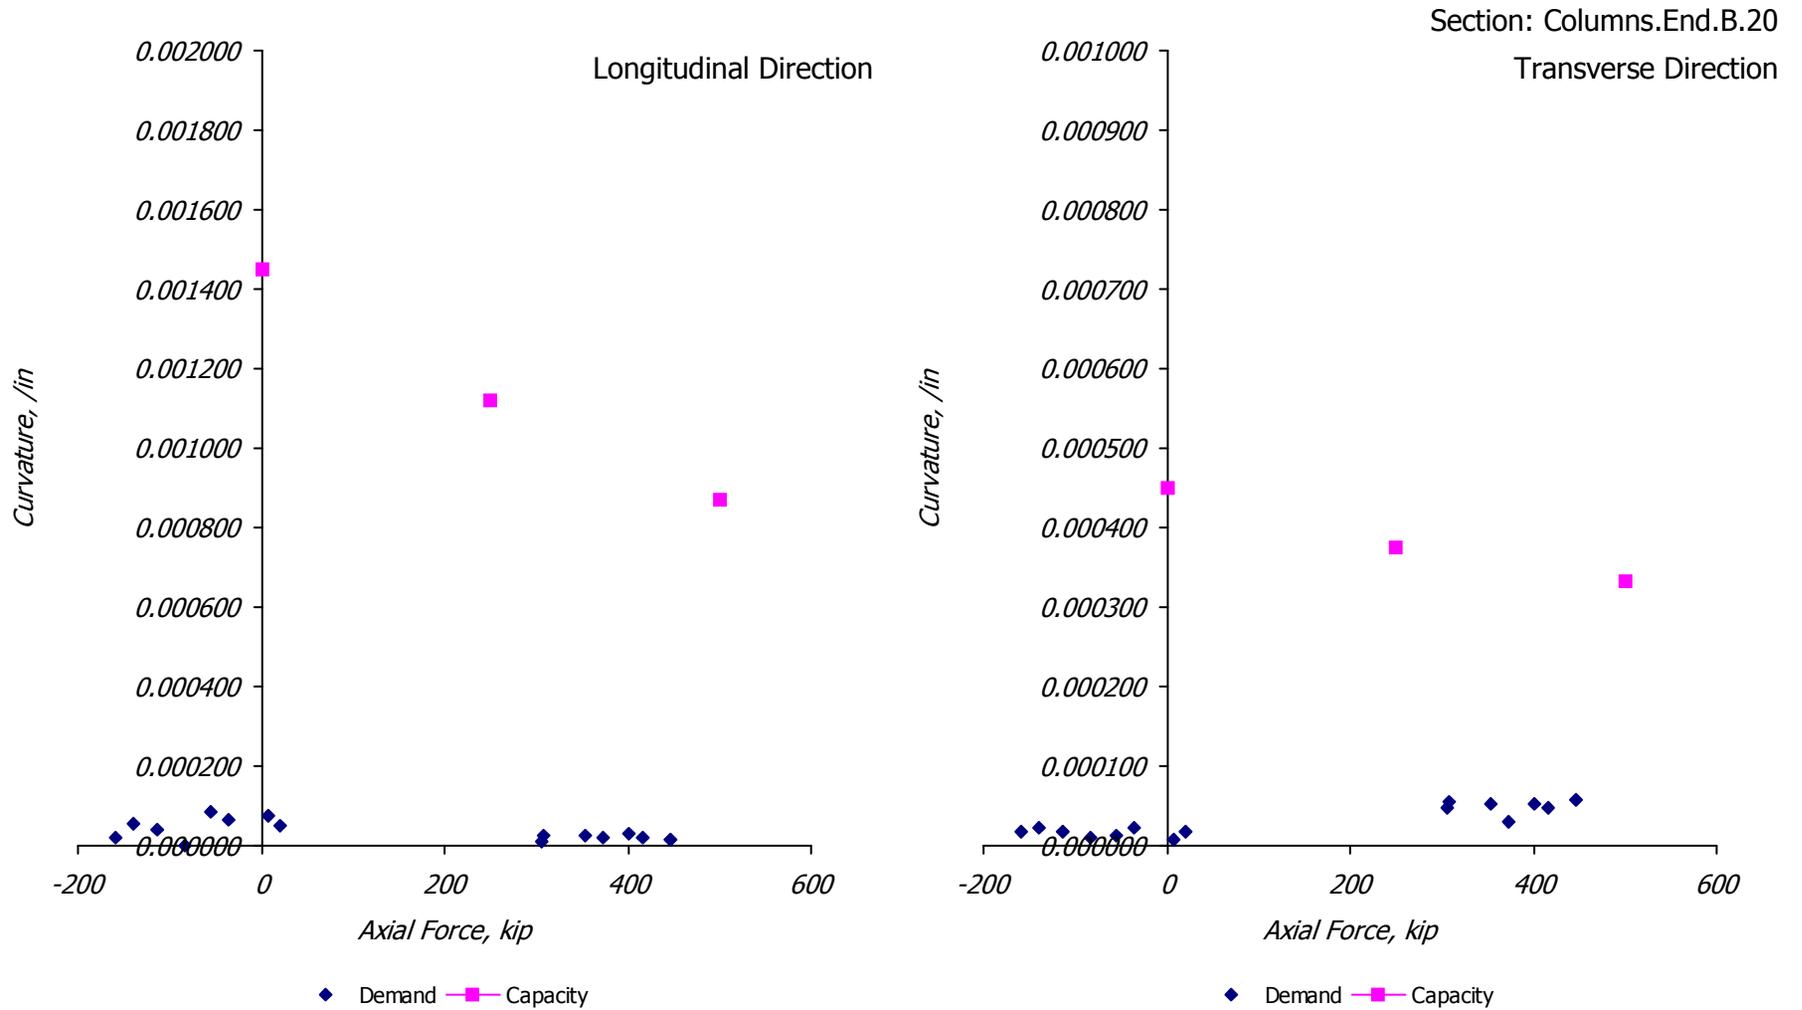
Figure 15 Column curvature versus axial force, retrofitted structure, rare earthquake, end bents

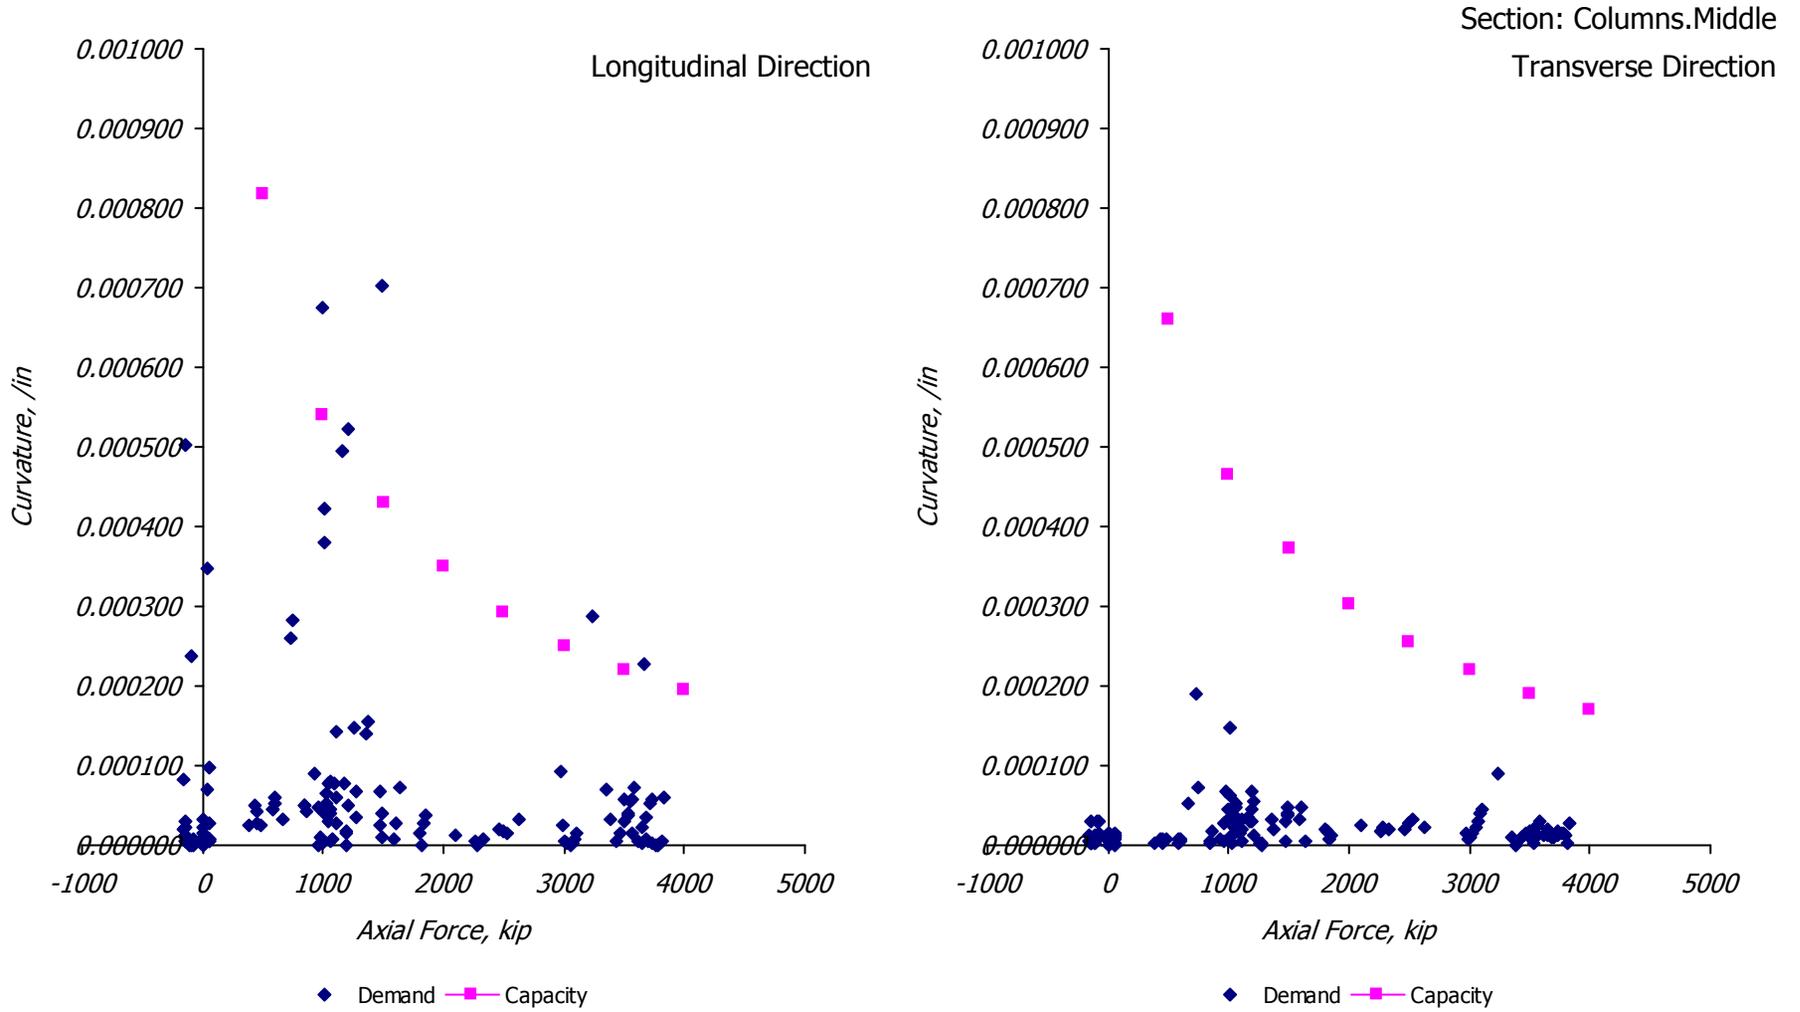
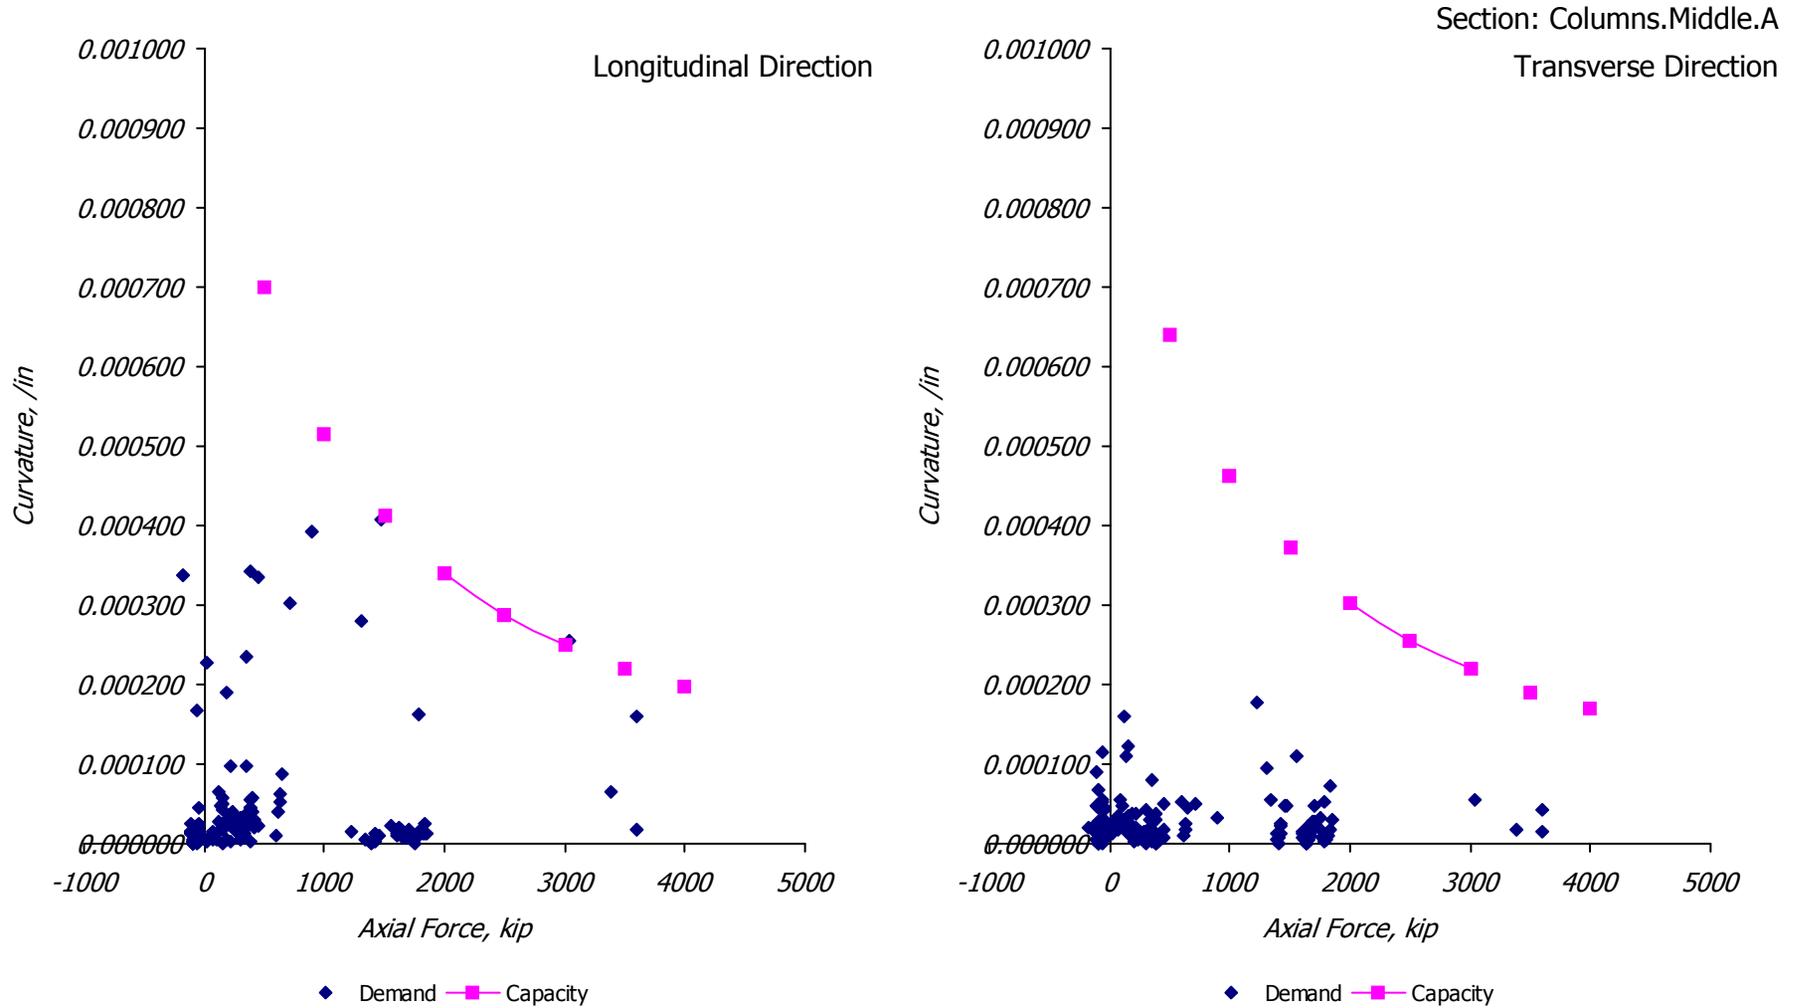
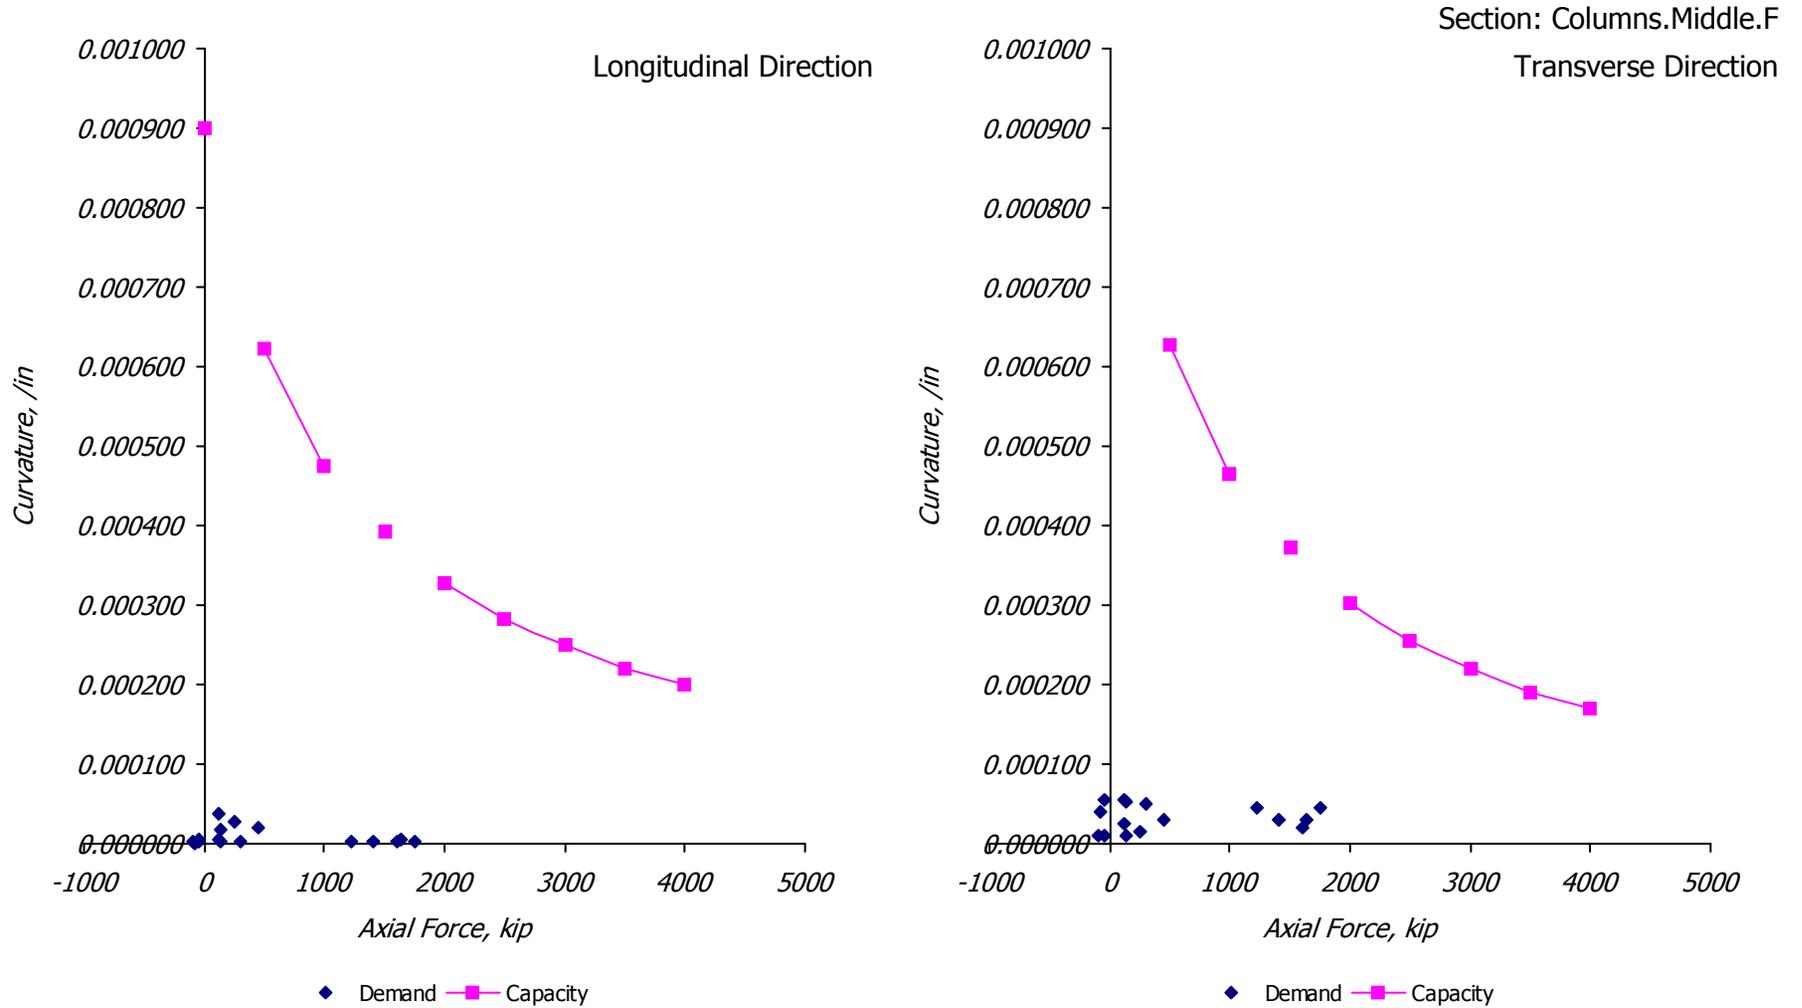
Figure 16 Column curvature versus axial force, retrofitted structure, rare earthquake, middle bents

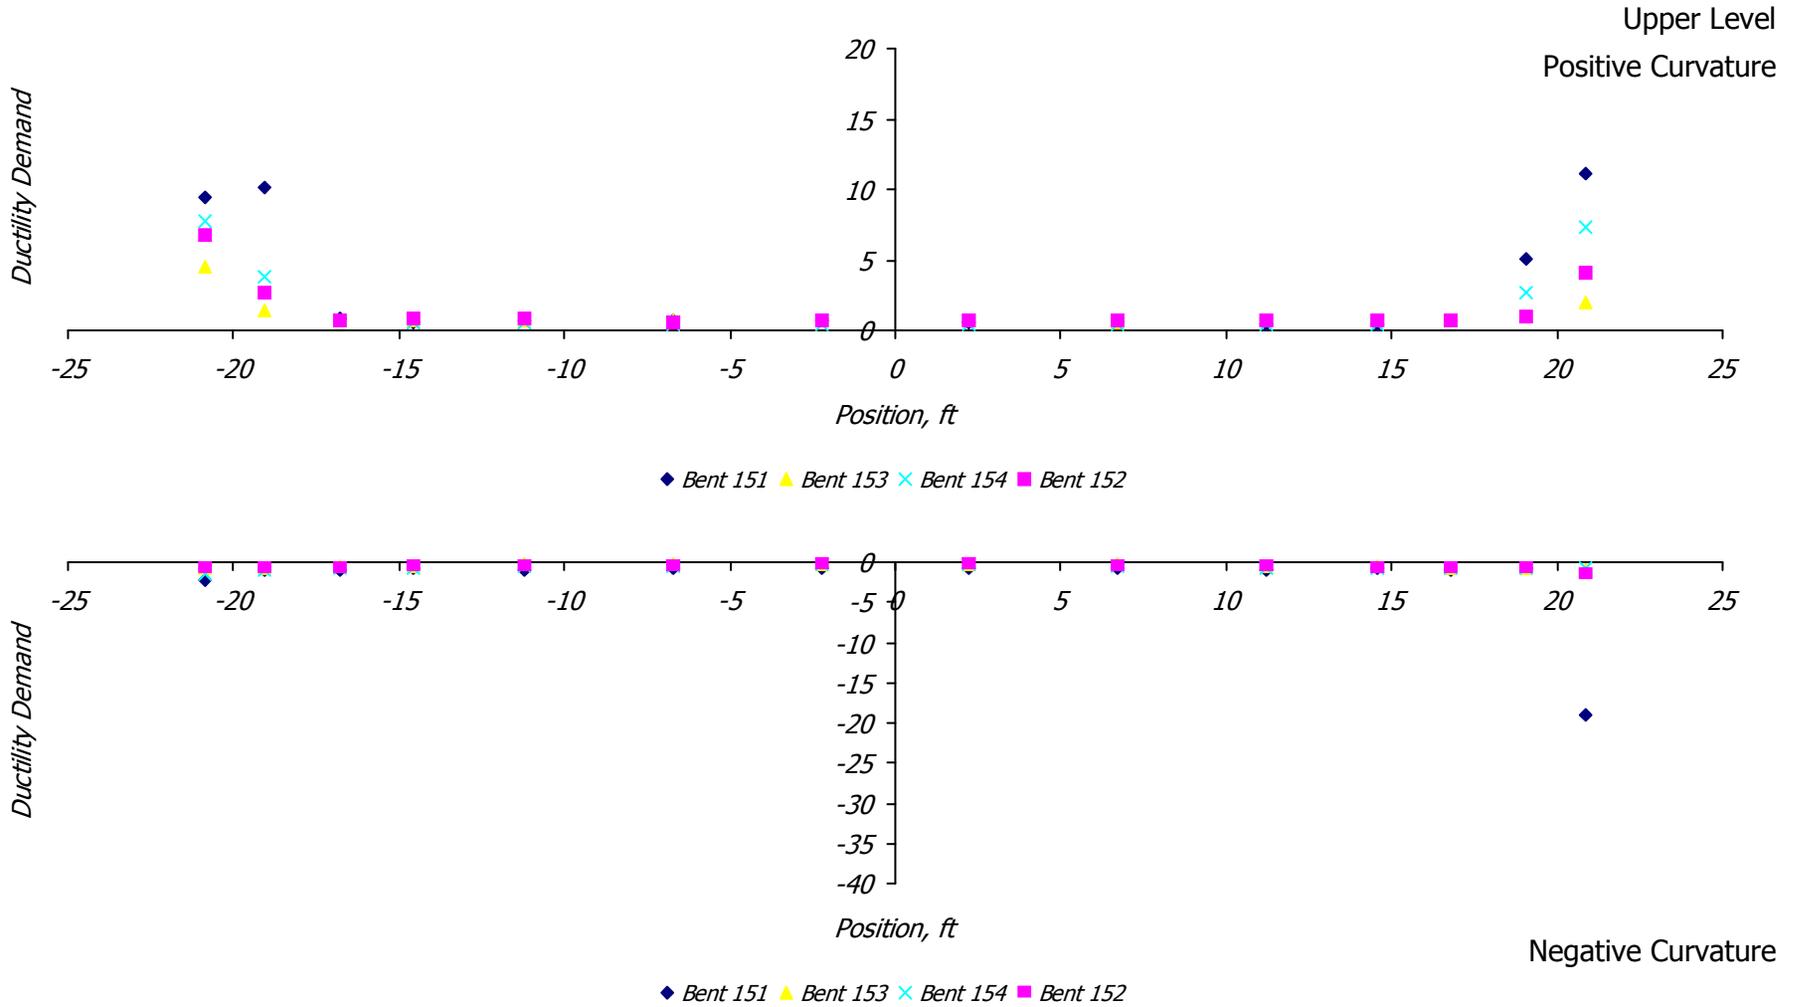
Figure 19a Floorbeam curvature ductility demand, retrofitted structure, rare earthquake, upper level

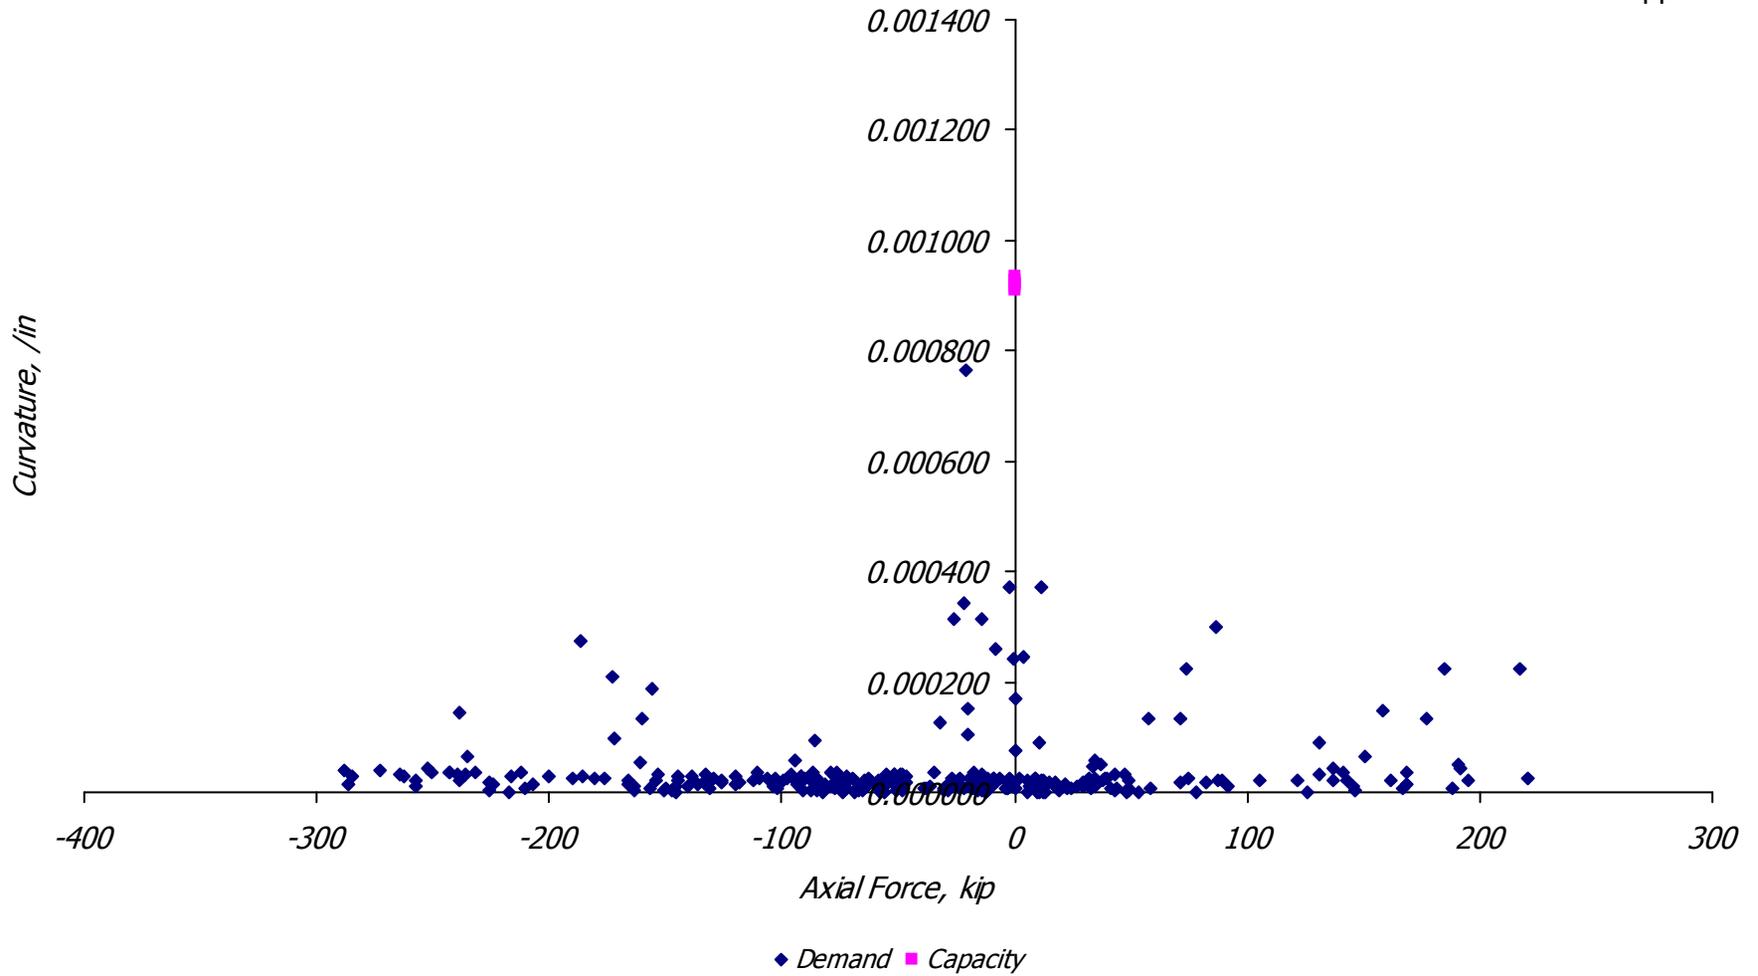
Figure 20a Floorbeam curvature versus axial force, retrofitted structure, rare earthquake, upper level
