ALASKAN WAY VIADUCT

EVALUATION OF GRAY'S RETROFIT PROPOSAL

Prepared for the
Washington State Department of Transportation

By
T.Y. Lin International

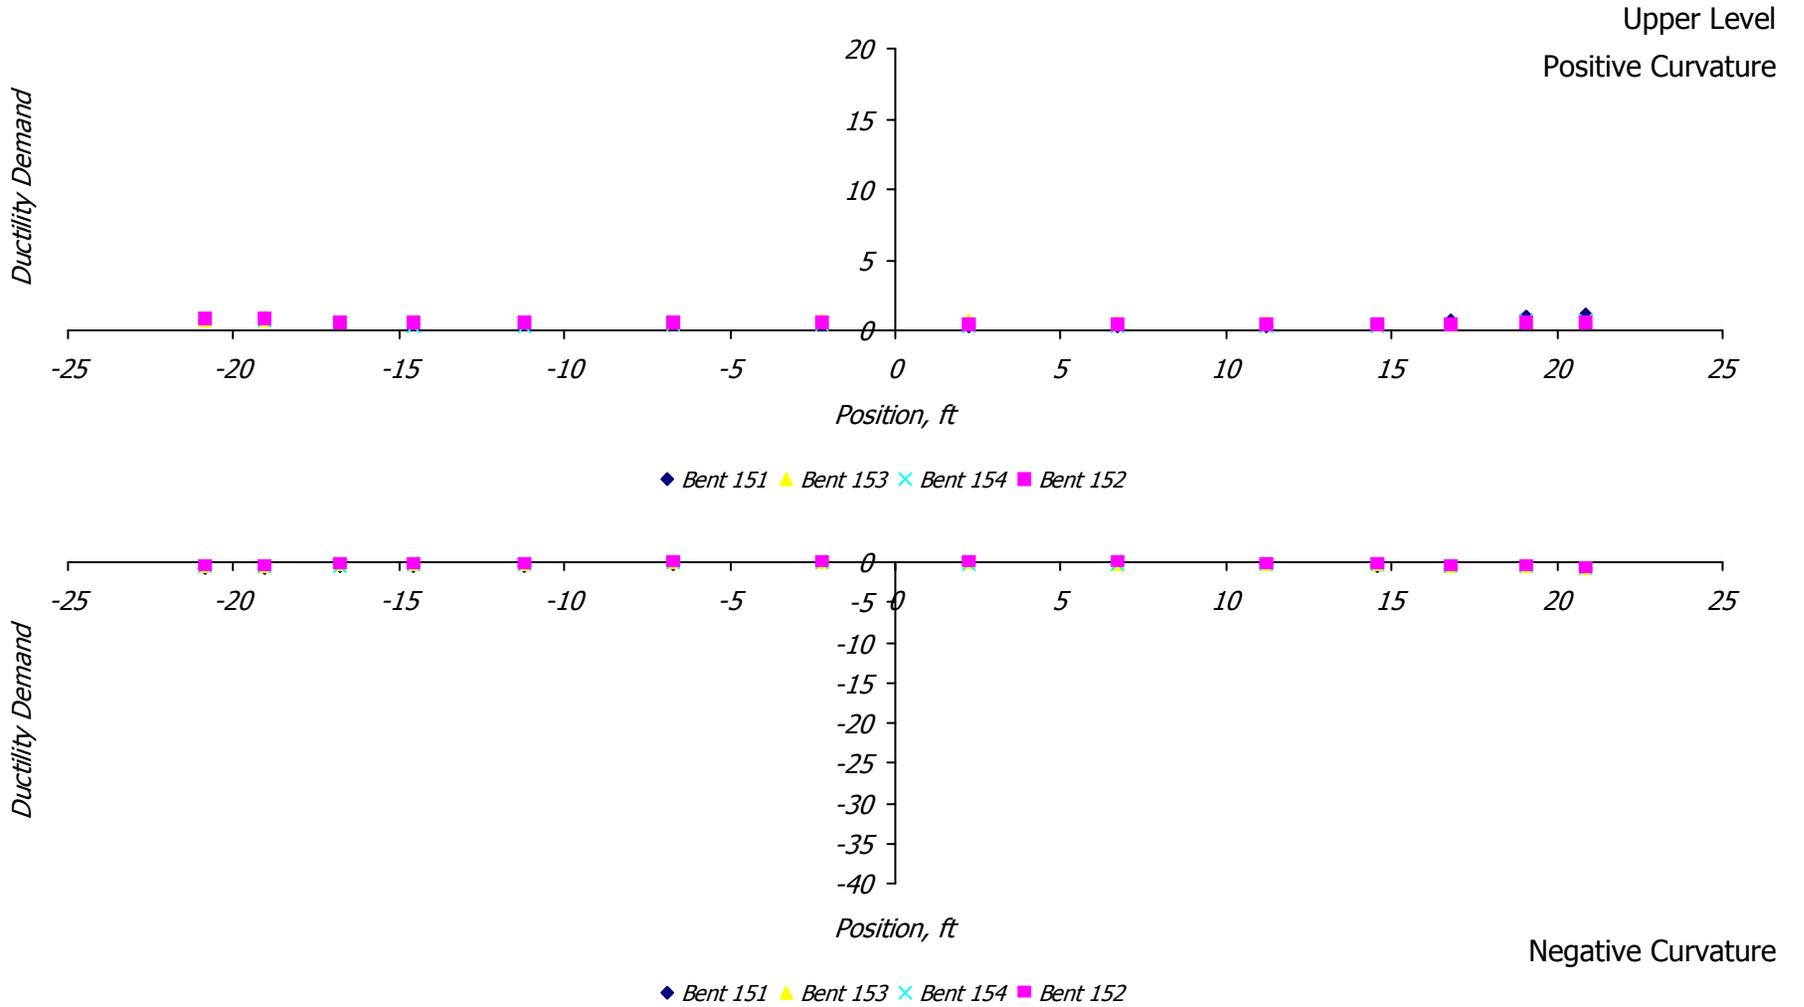
Figure 21a Floorbeam curvature ductility demand, retrofitted structure, design earthquake, upper level

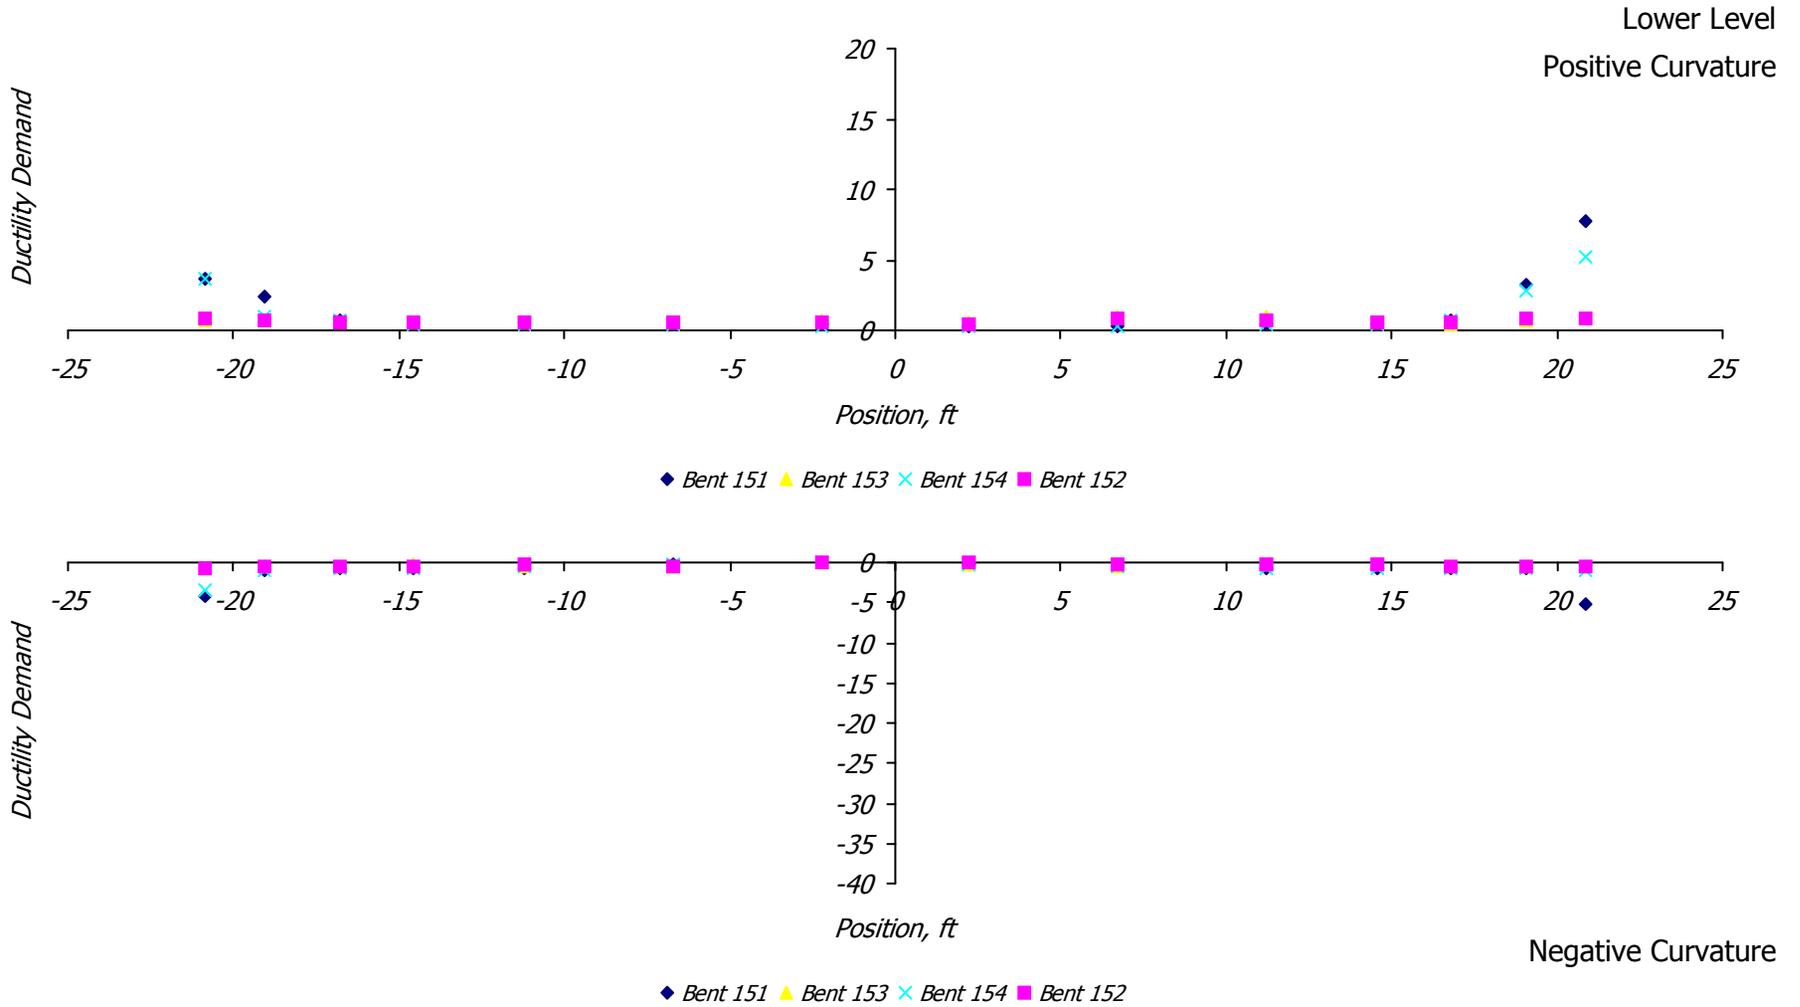
Figure 21b Floorbeam curvature ductility demand, retrofitted structure, design earthquake, lower level

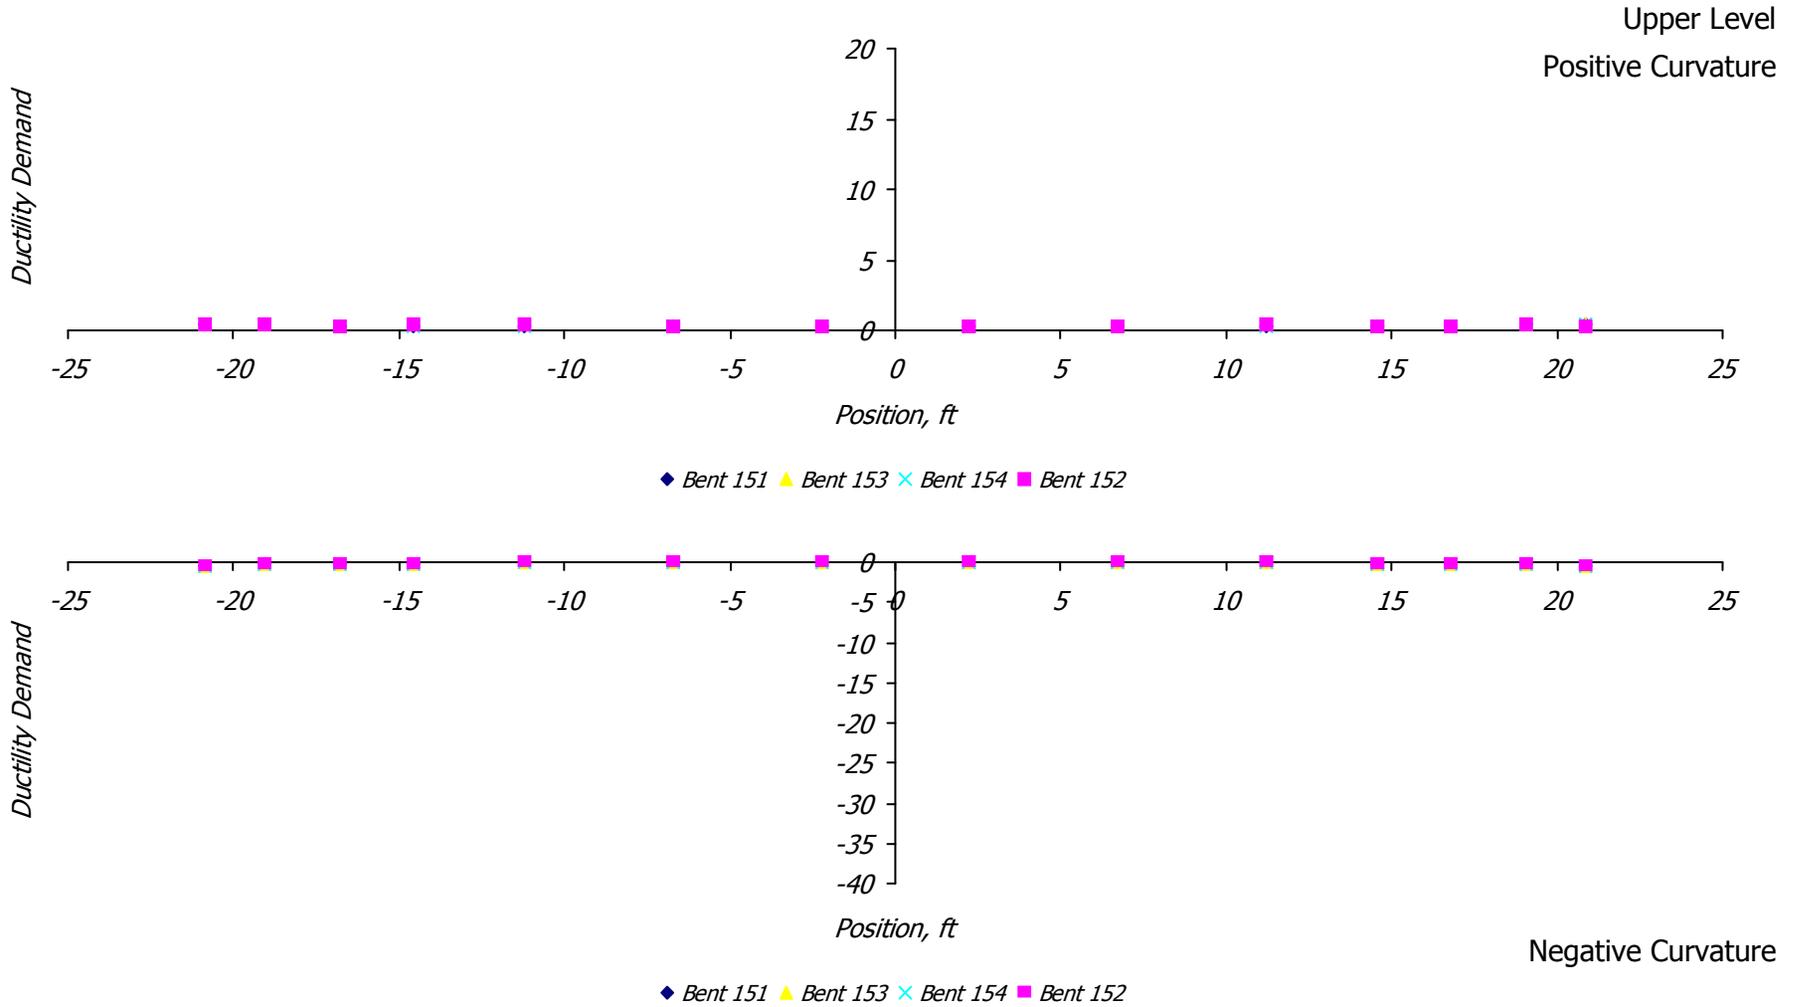
Figure 22a Floorbeam curvature ductility demand, retrofitted structure, expected earthquake, upper level

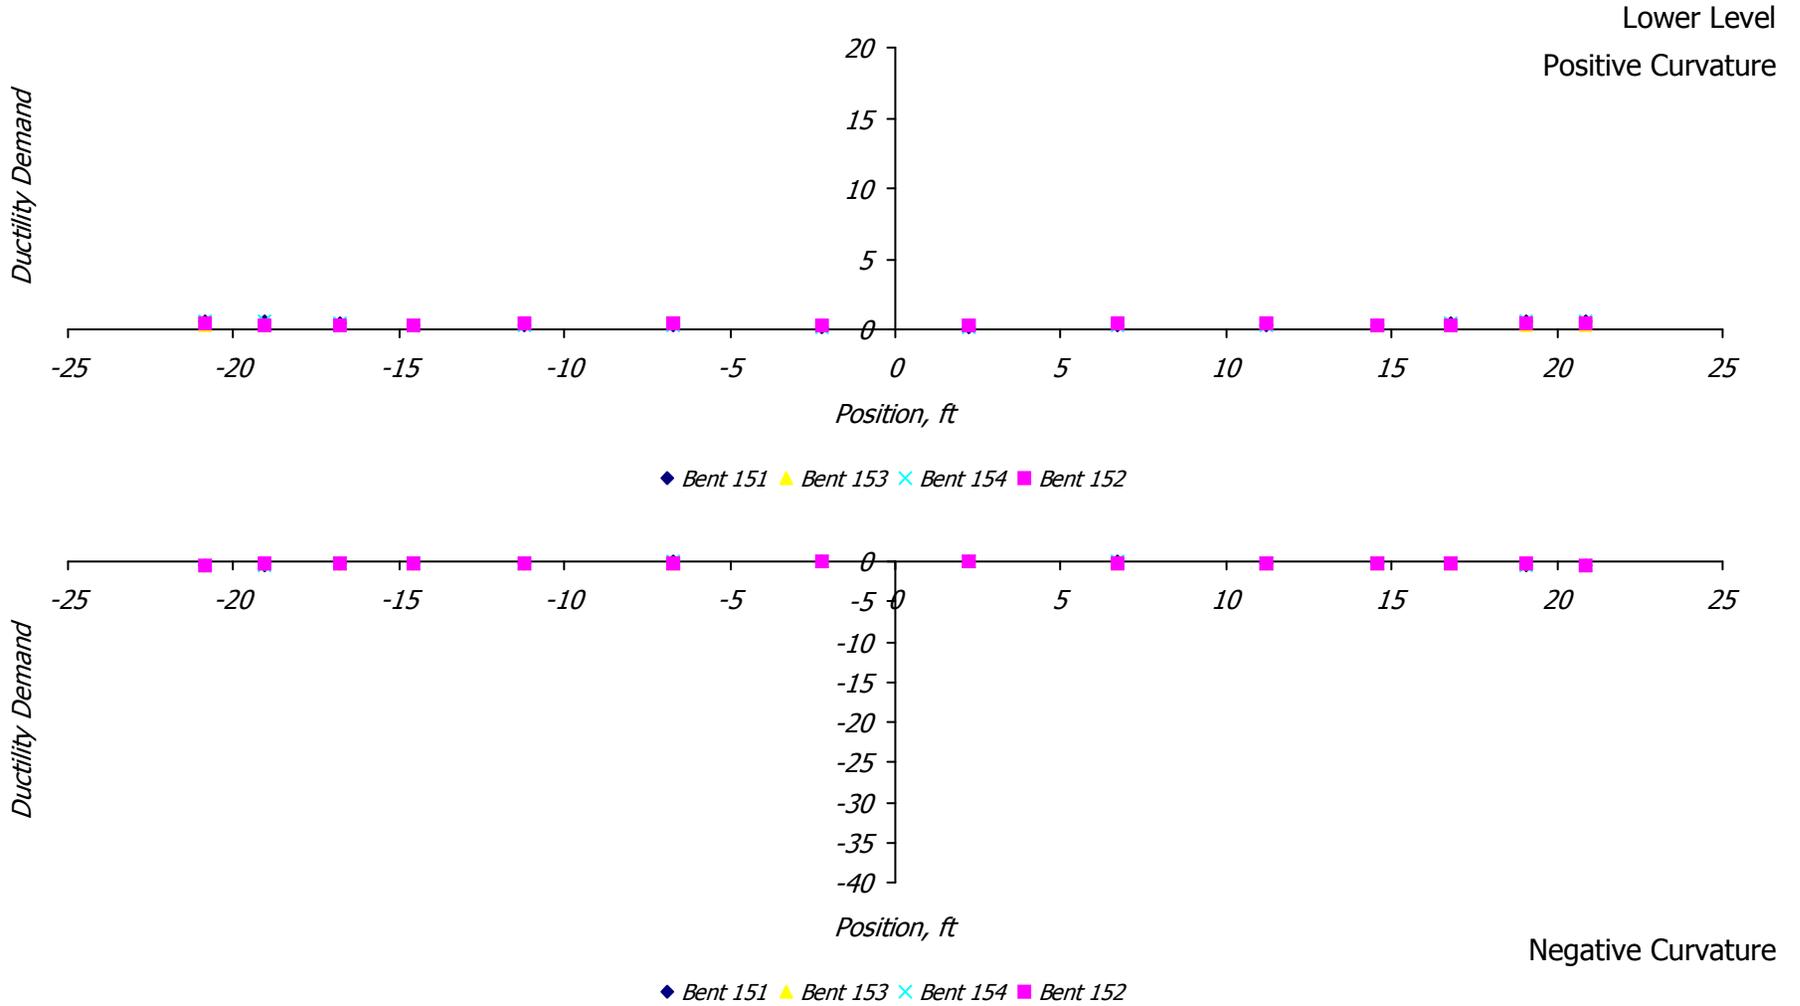
Figure 22b Floorbeam curvature ductility demand, retrofitted structure, expected earthquake, lower level

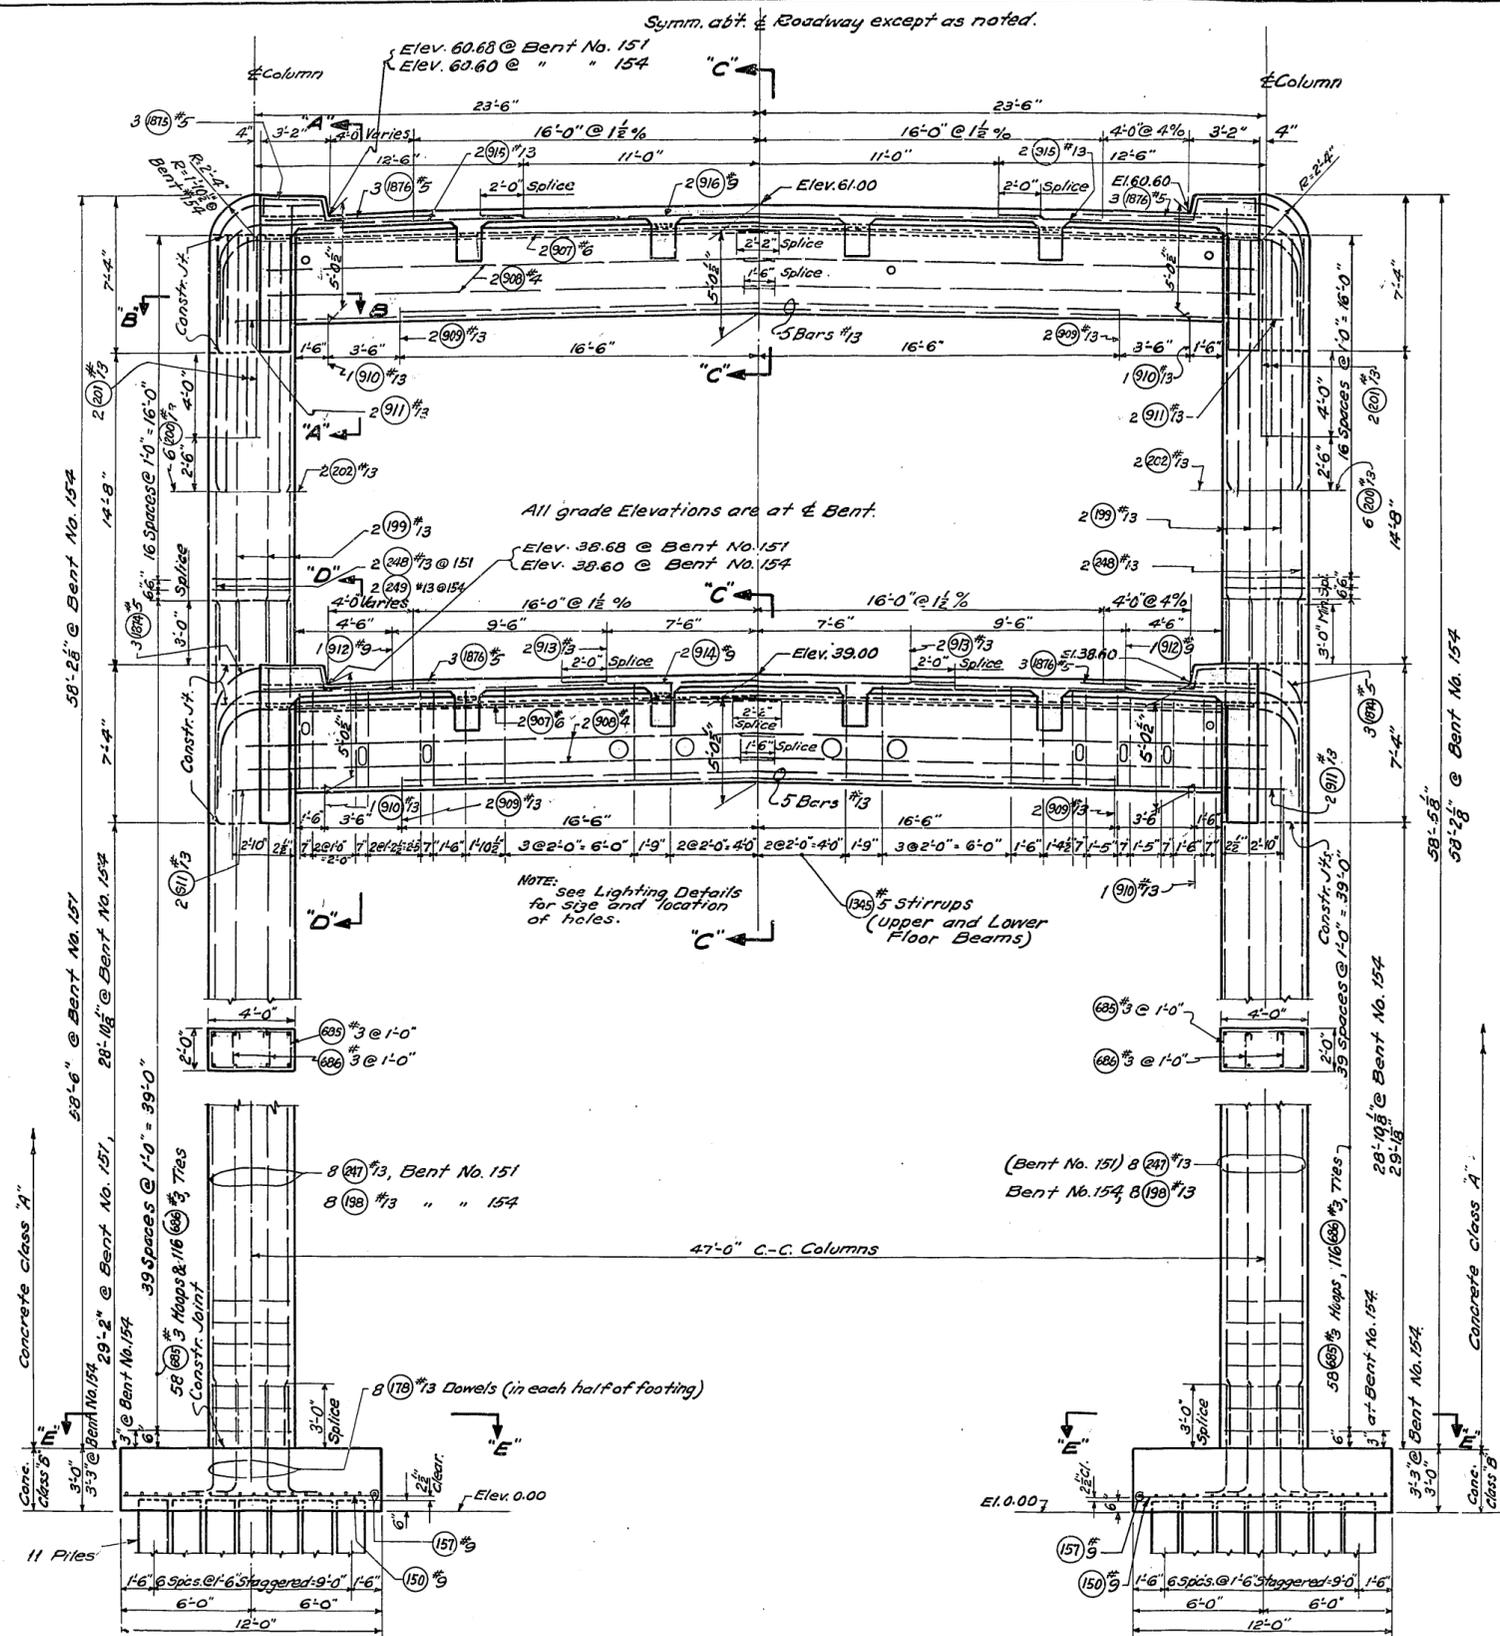
ELEVATION-END BENT NO. 151
(Typical End Bent - 184' Unit)
North 1/2 Bent No. 151 shown, south 1/2 similar.
North 1/2 Bent No. 154 similar except as noted.
See "Elevation of South-half of Bent No. 154" for footing details @ Bent No. 154.

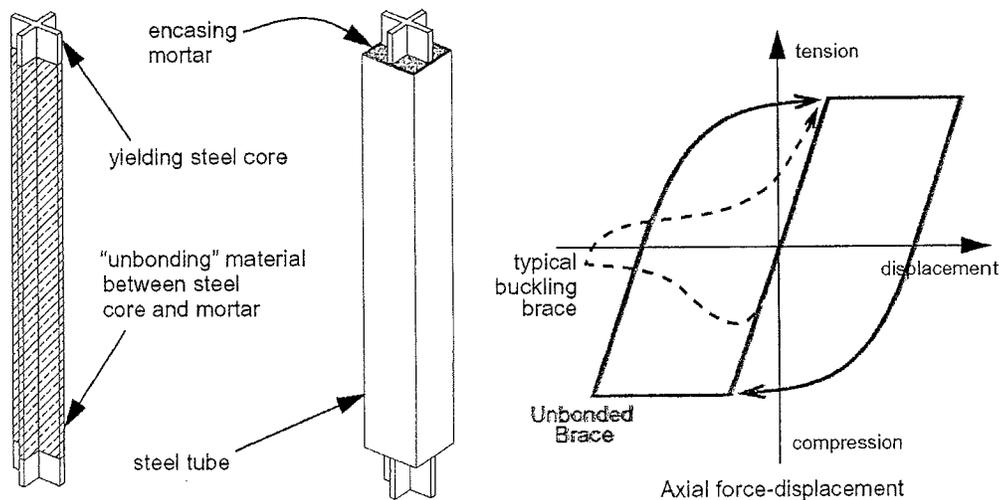
The Unbonded Brace is one type of buckling-restrained brace, and is a simple but yet remarkably effective configuration of steel and concrete producing a tension-compression load-carrying brace element capable of stable yielding behavior without buckling. The basic concept of the Unbonded Brace is the prevention of compression buckling of a central steel core by encasing it over its length in a steel tube filled with concrete or mortar. A slip interface, or "unbonding" layer, between the steel core and the surrounding concrete is provided to ensure that compression and tension loads are carried only by the steel core. The materials and geometry of the slip layer must be carefully designed and constructed to allow relative movement between the steel core and the concrete due to shearing and Poisson's effect, while simultaneously inhibiting local buckling of the core as it yields in compression.

Unbonded Brace concept and typical hysteretic behavior

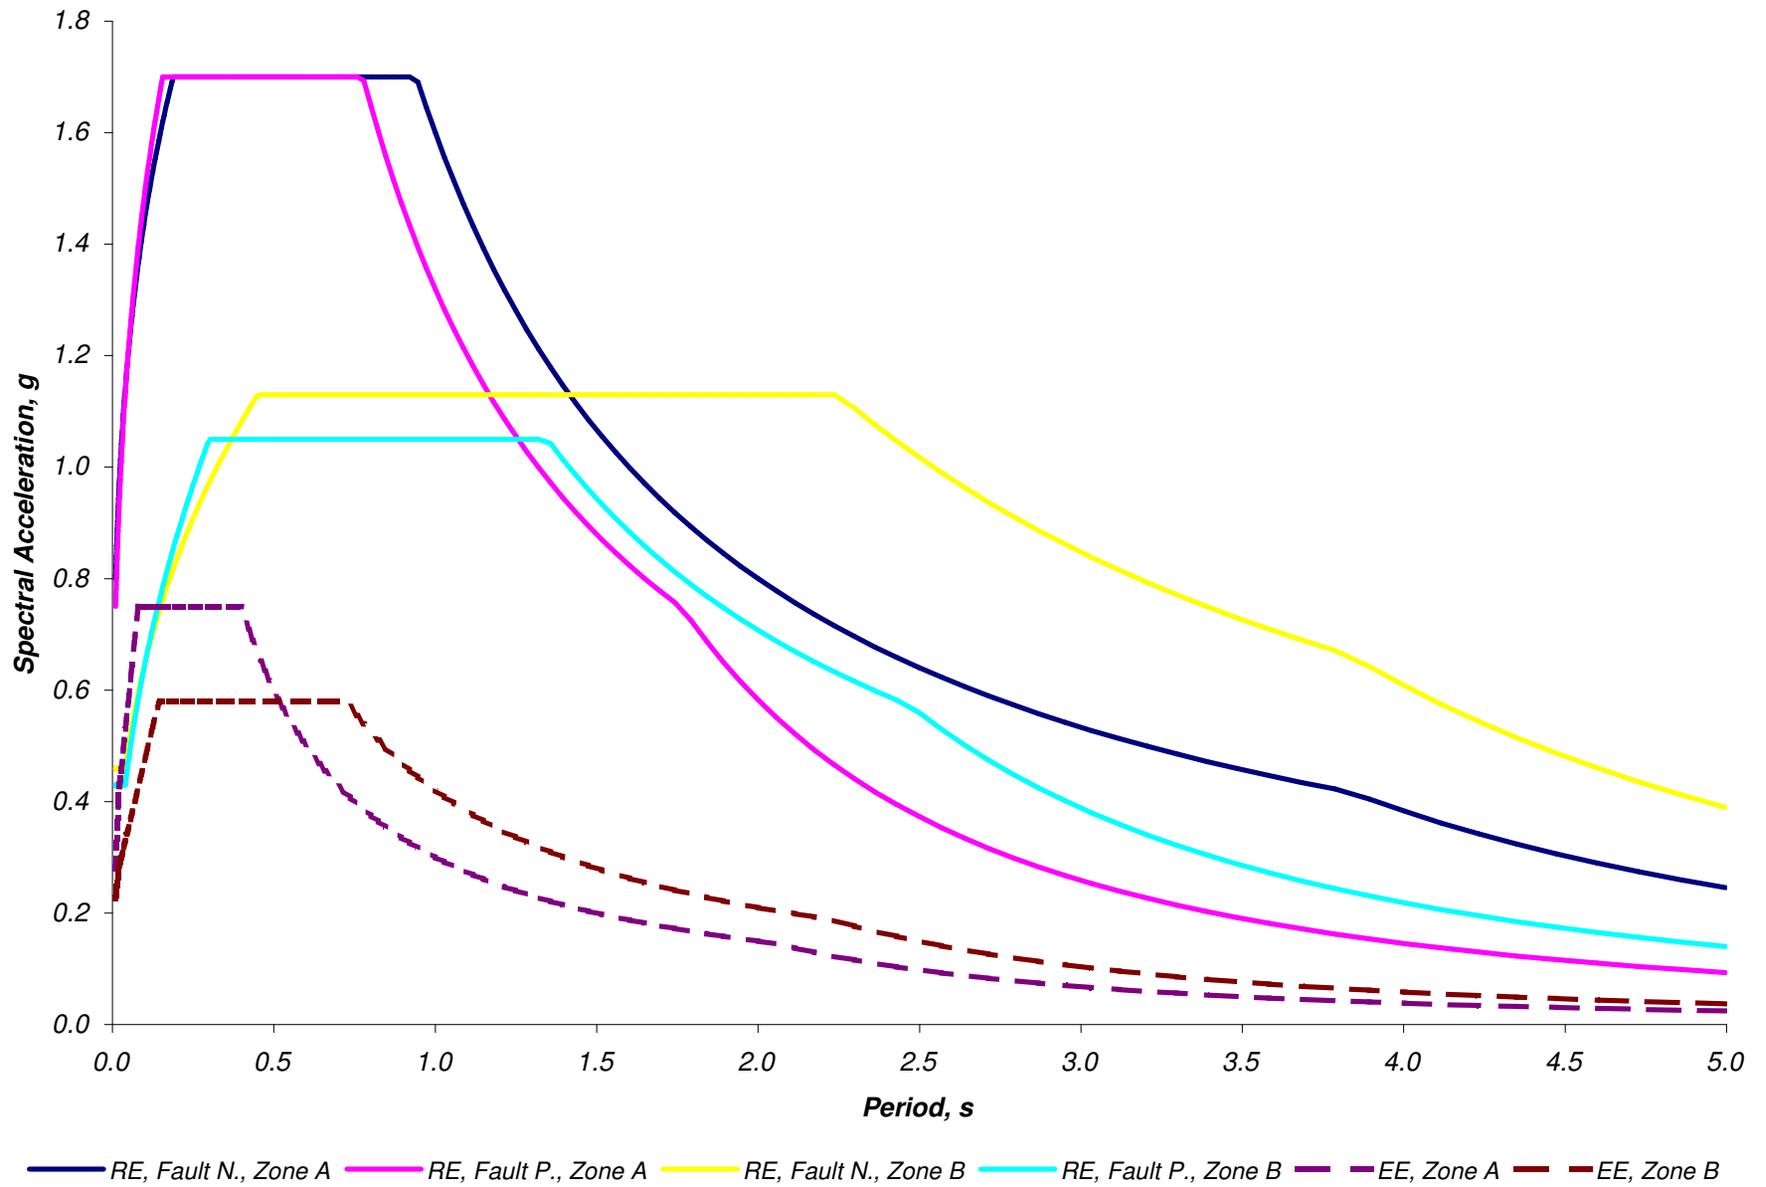
Figure D.3a, Acceleration spectra for horizontal motions, rare and expected earthquakes

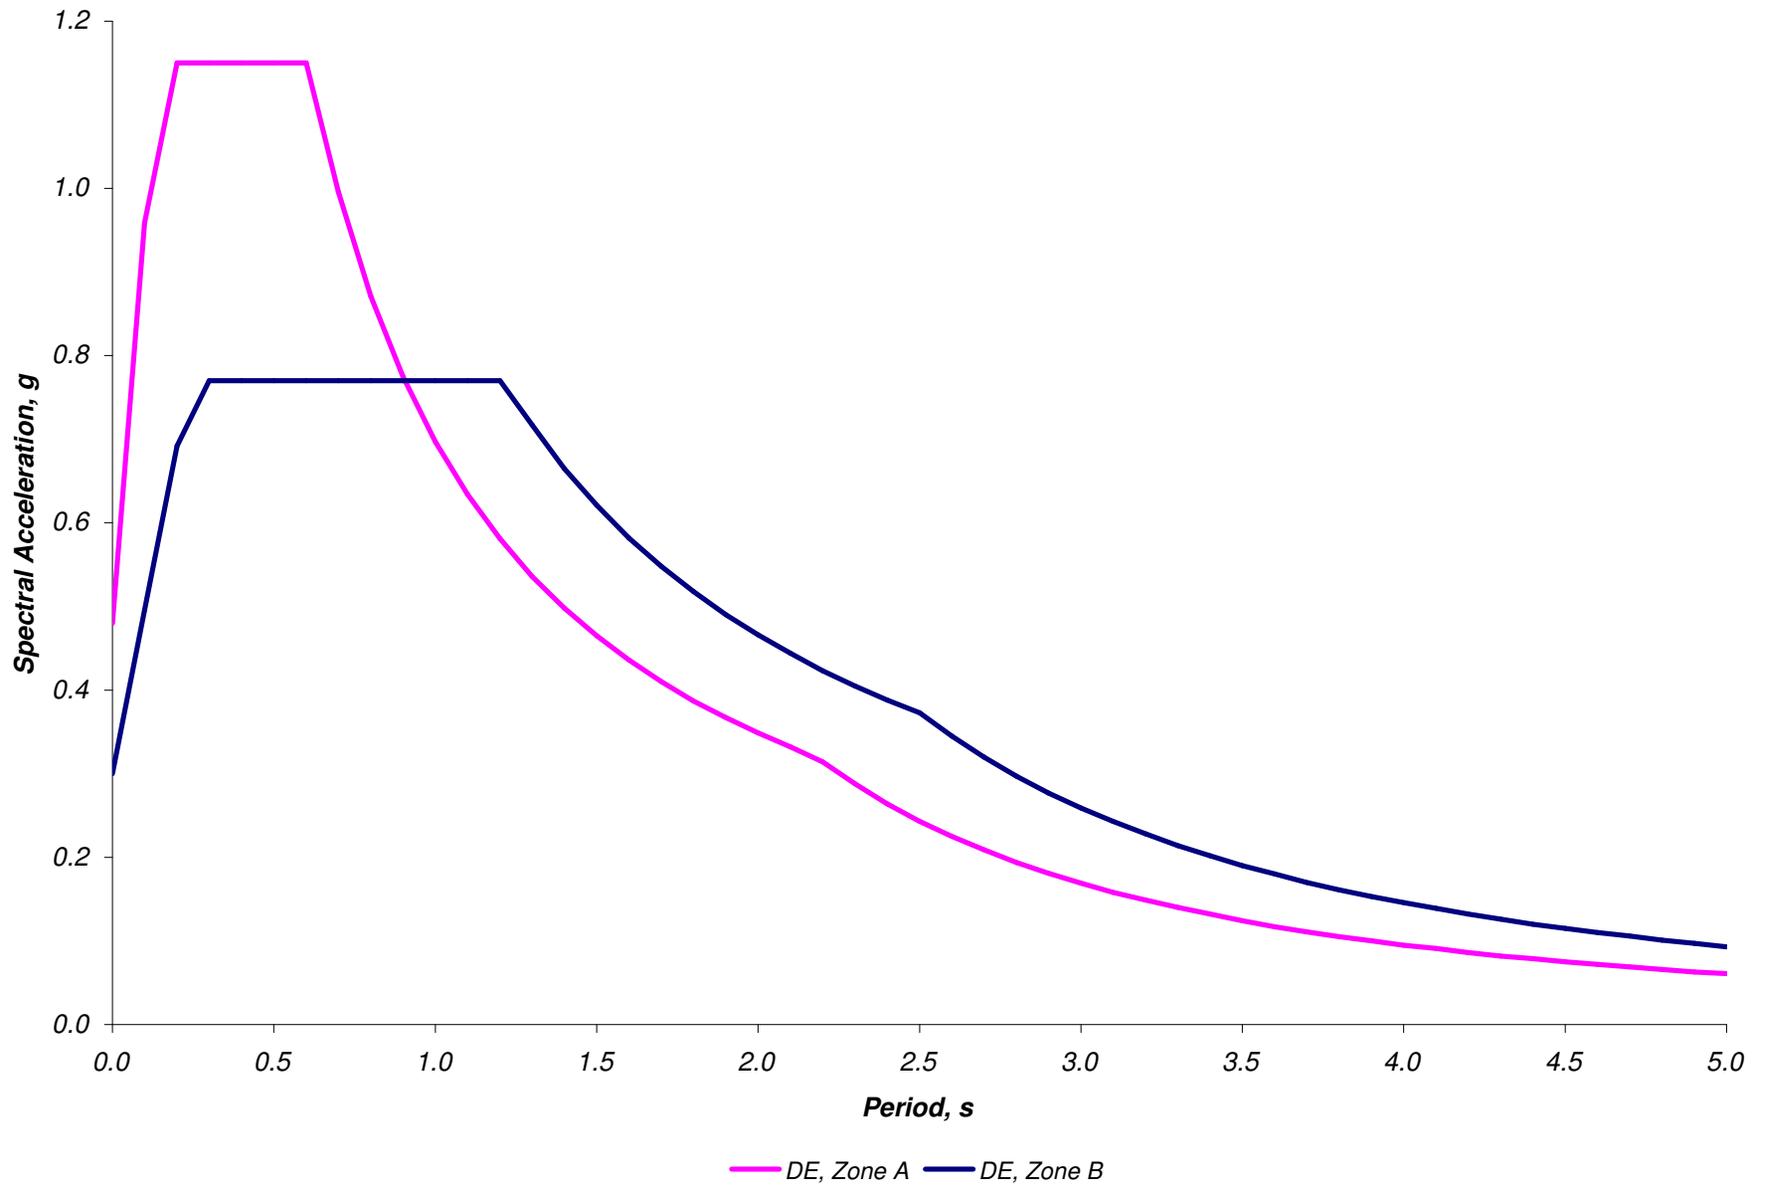
Figure D.3b, Acceleration spectra for horizontal motions, design earthquake

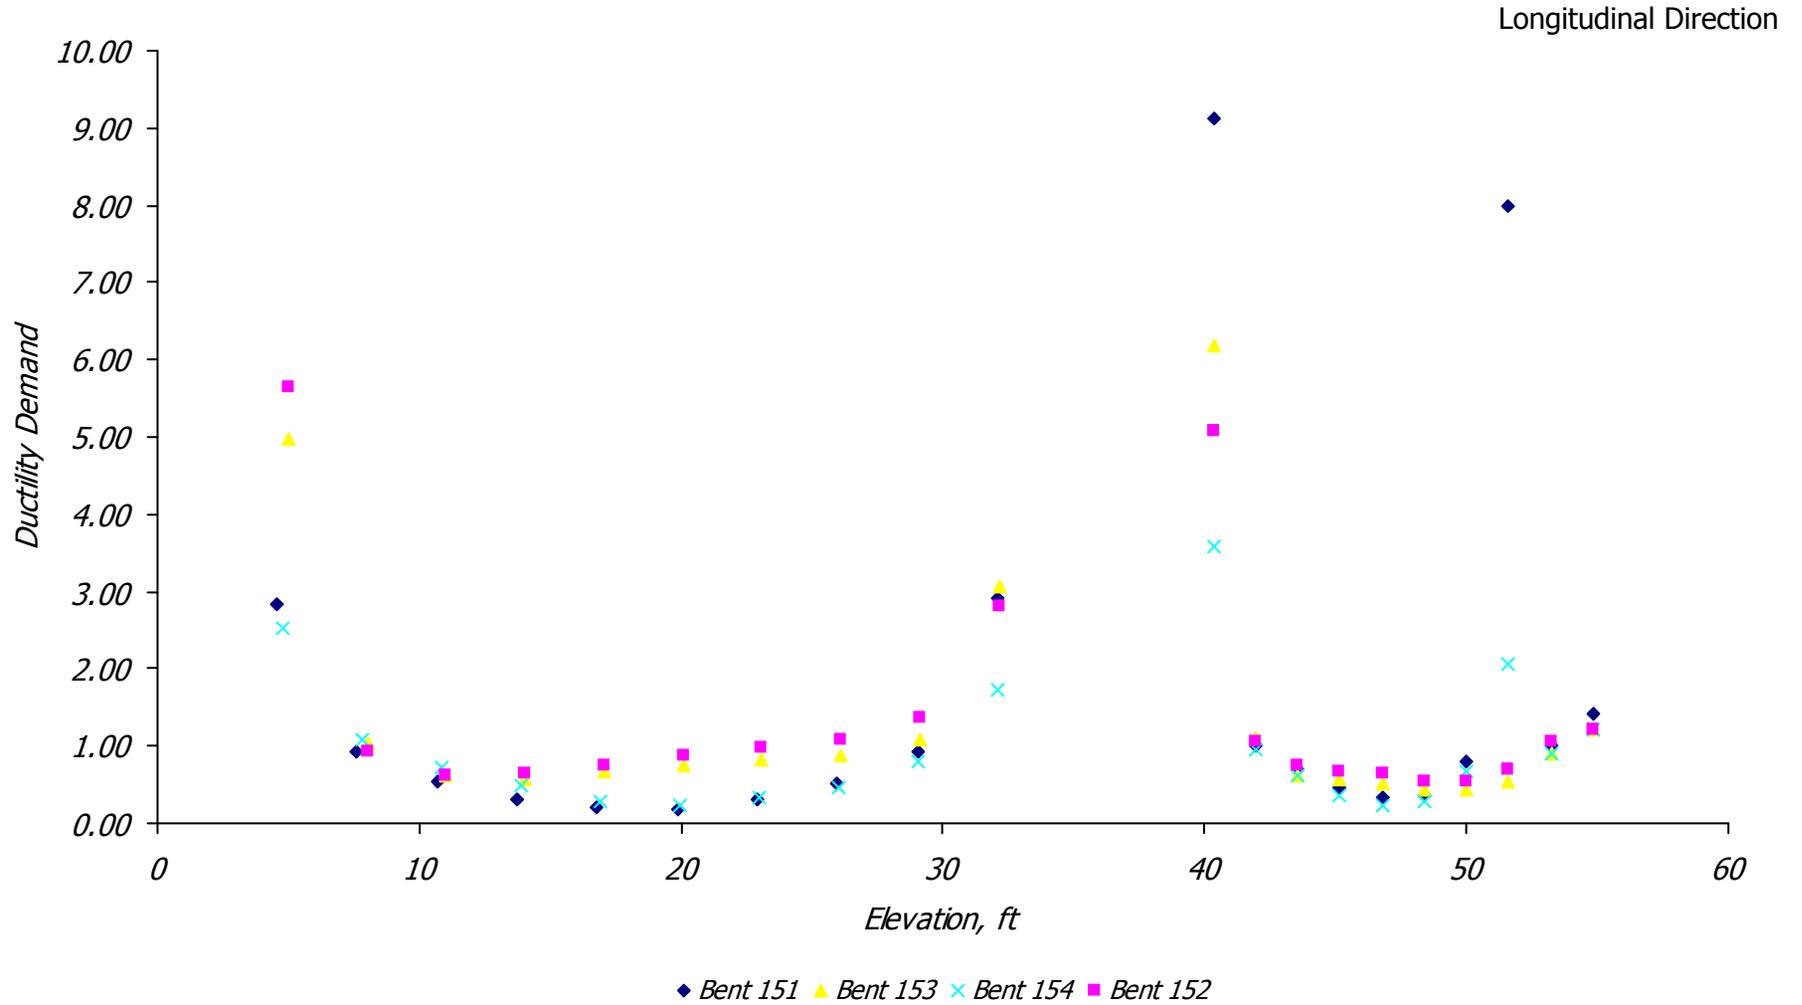
Figure D.6a Column curvature ductility demand, retrofitted structure, rare earthquake, longitudinal direction

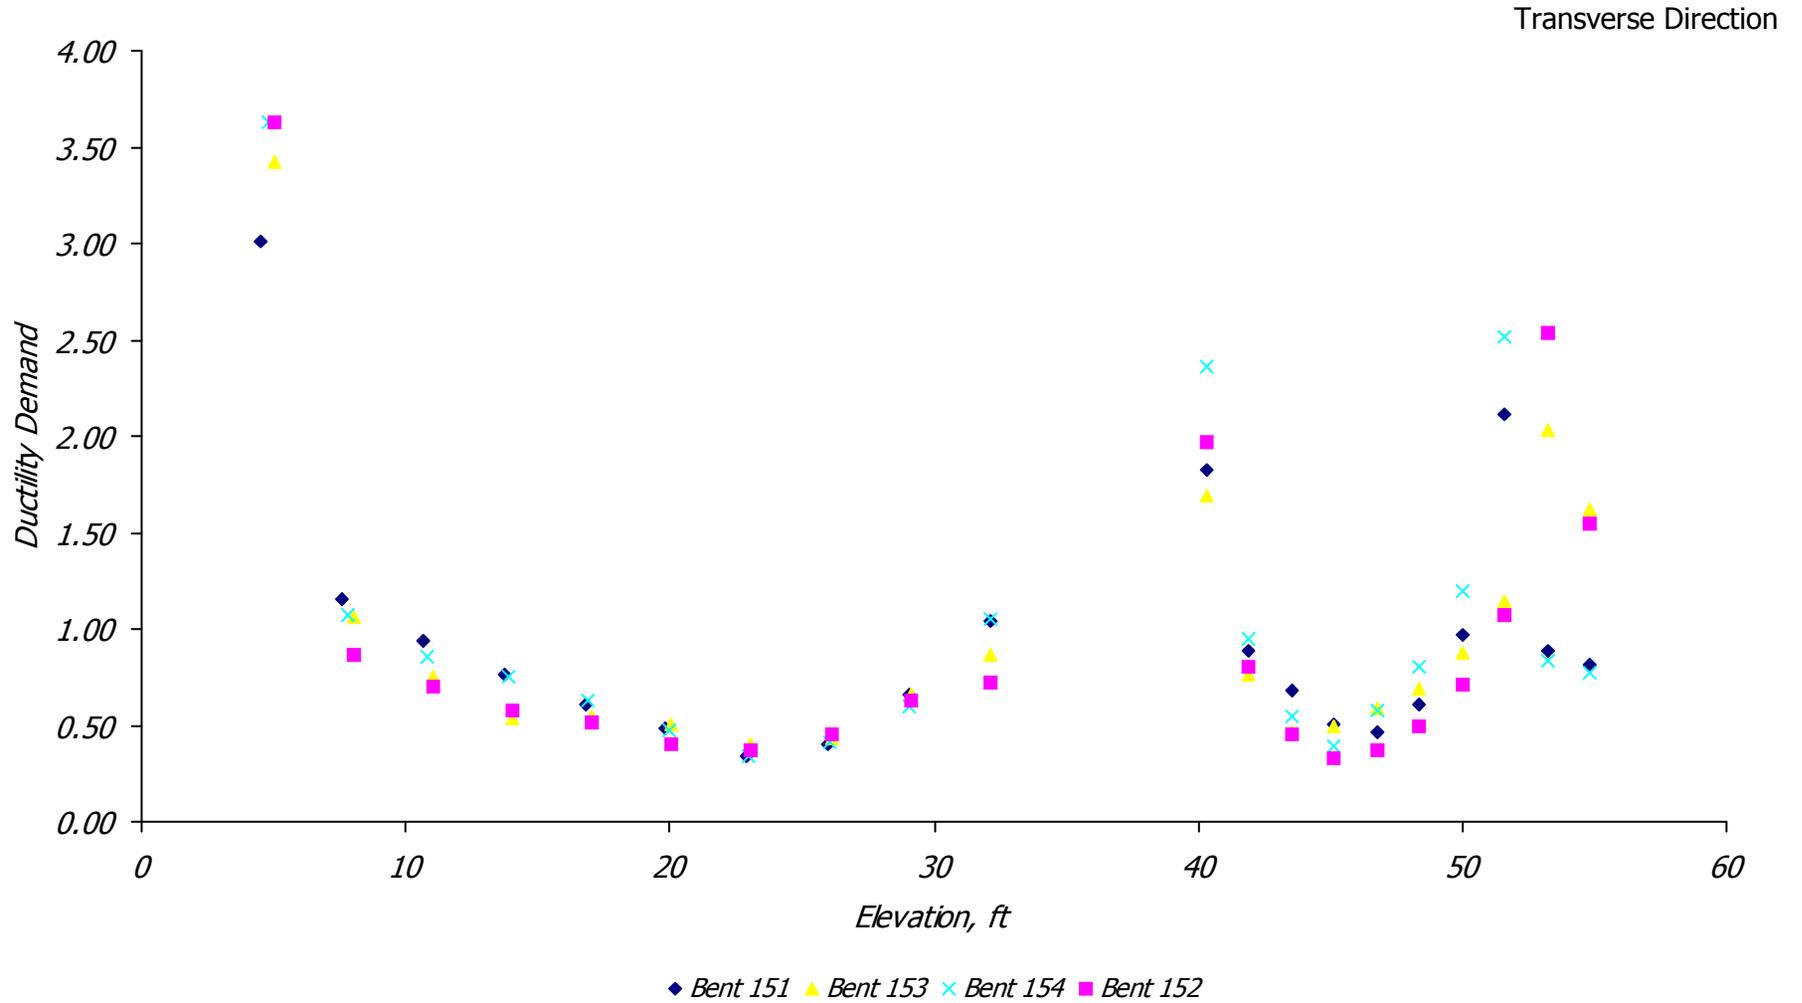
Figure D.6b Column curvature ductility demand, retrofitted structure, rare earthquake, transverse direction
