ALASKAN WAY VIADUCT

EVALUATION OF GRAY'S RETROFIT PROPOSAL

Prepared for the
Washington State Department of Transportation

By
T.Y. Lin International

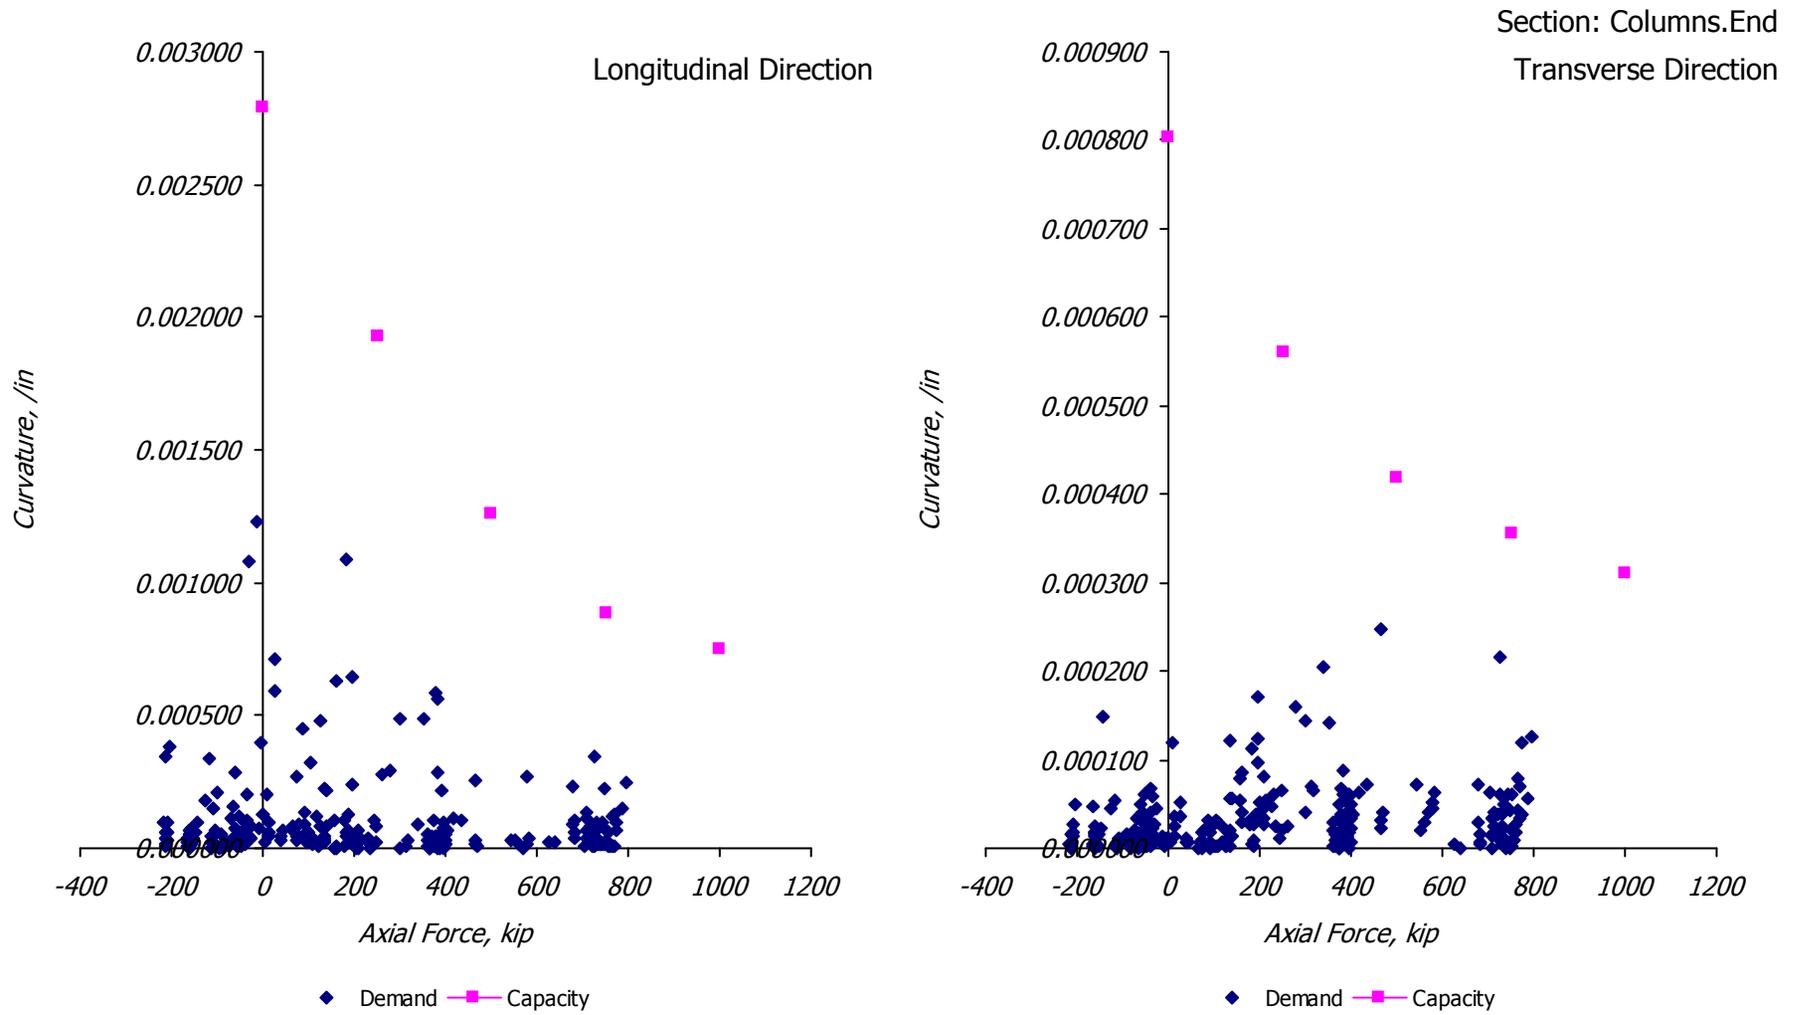
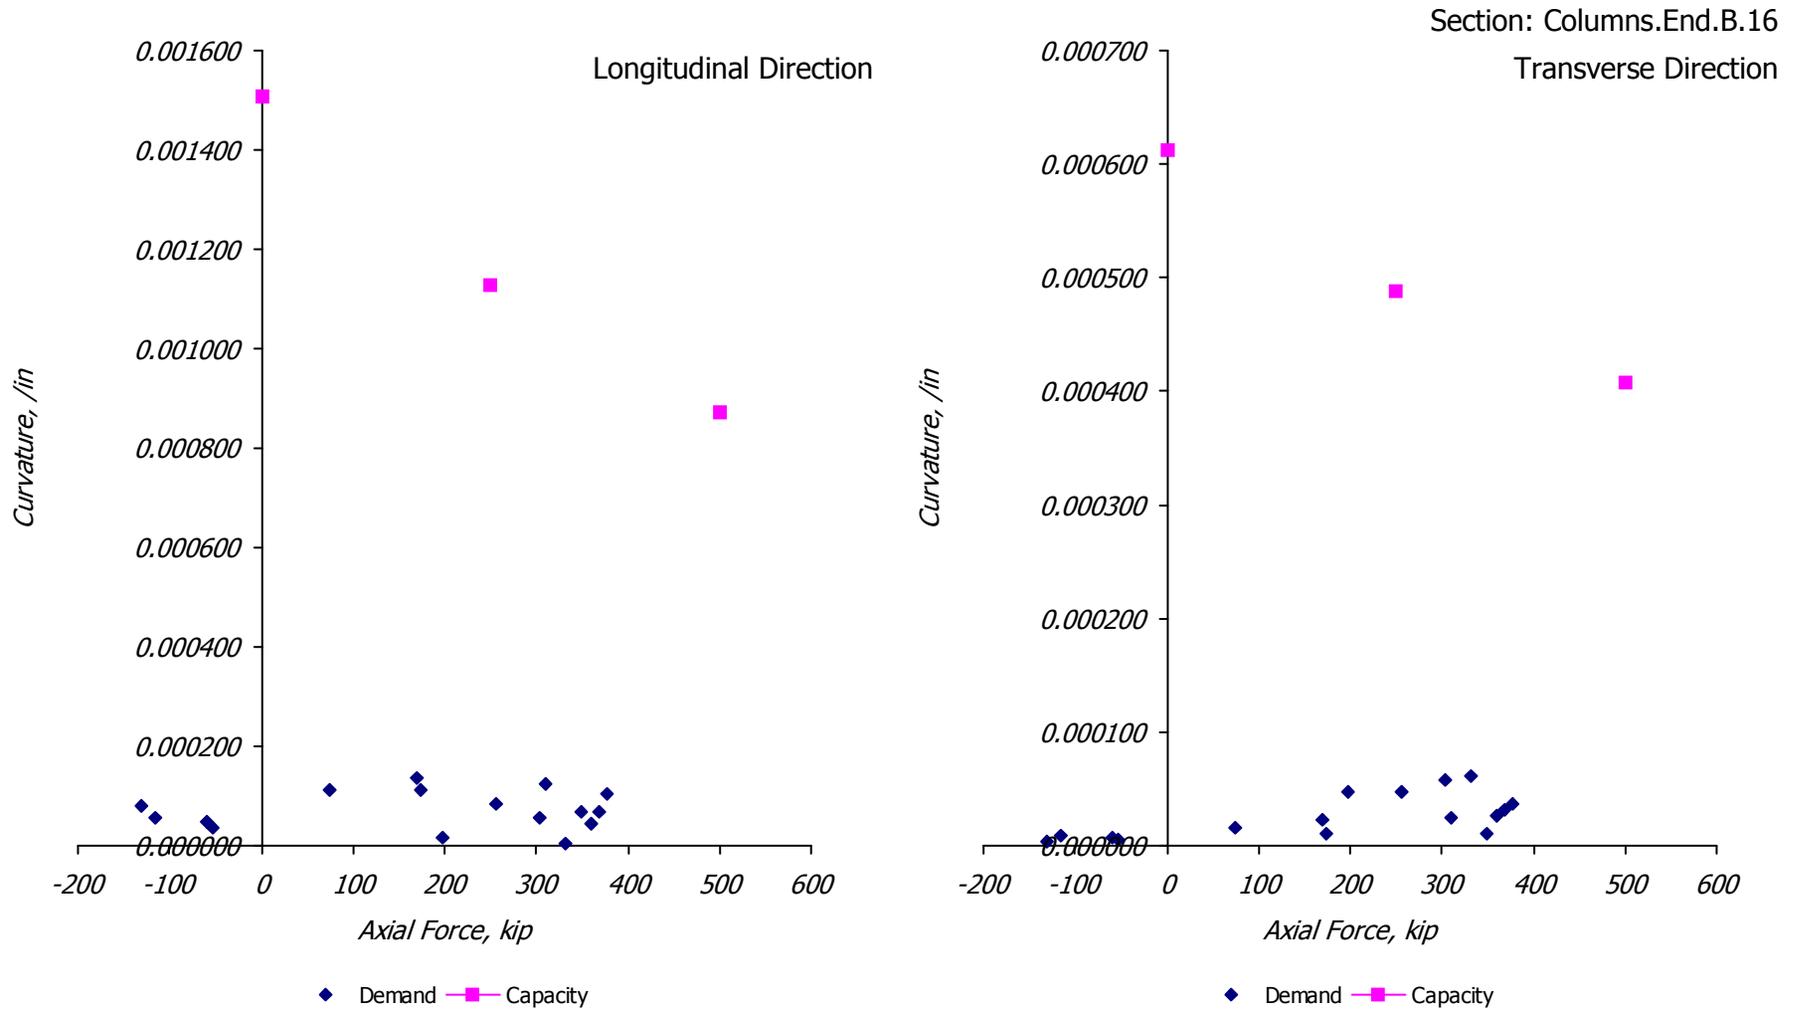
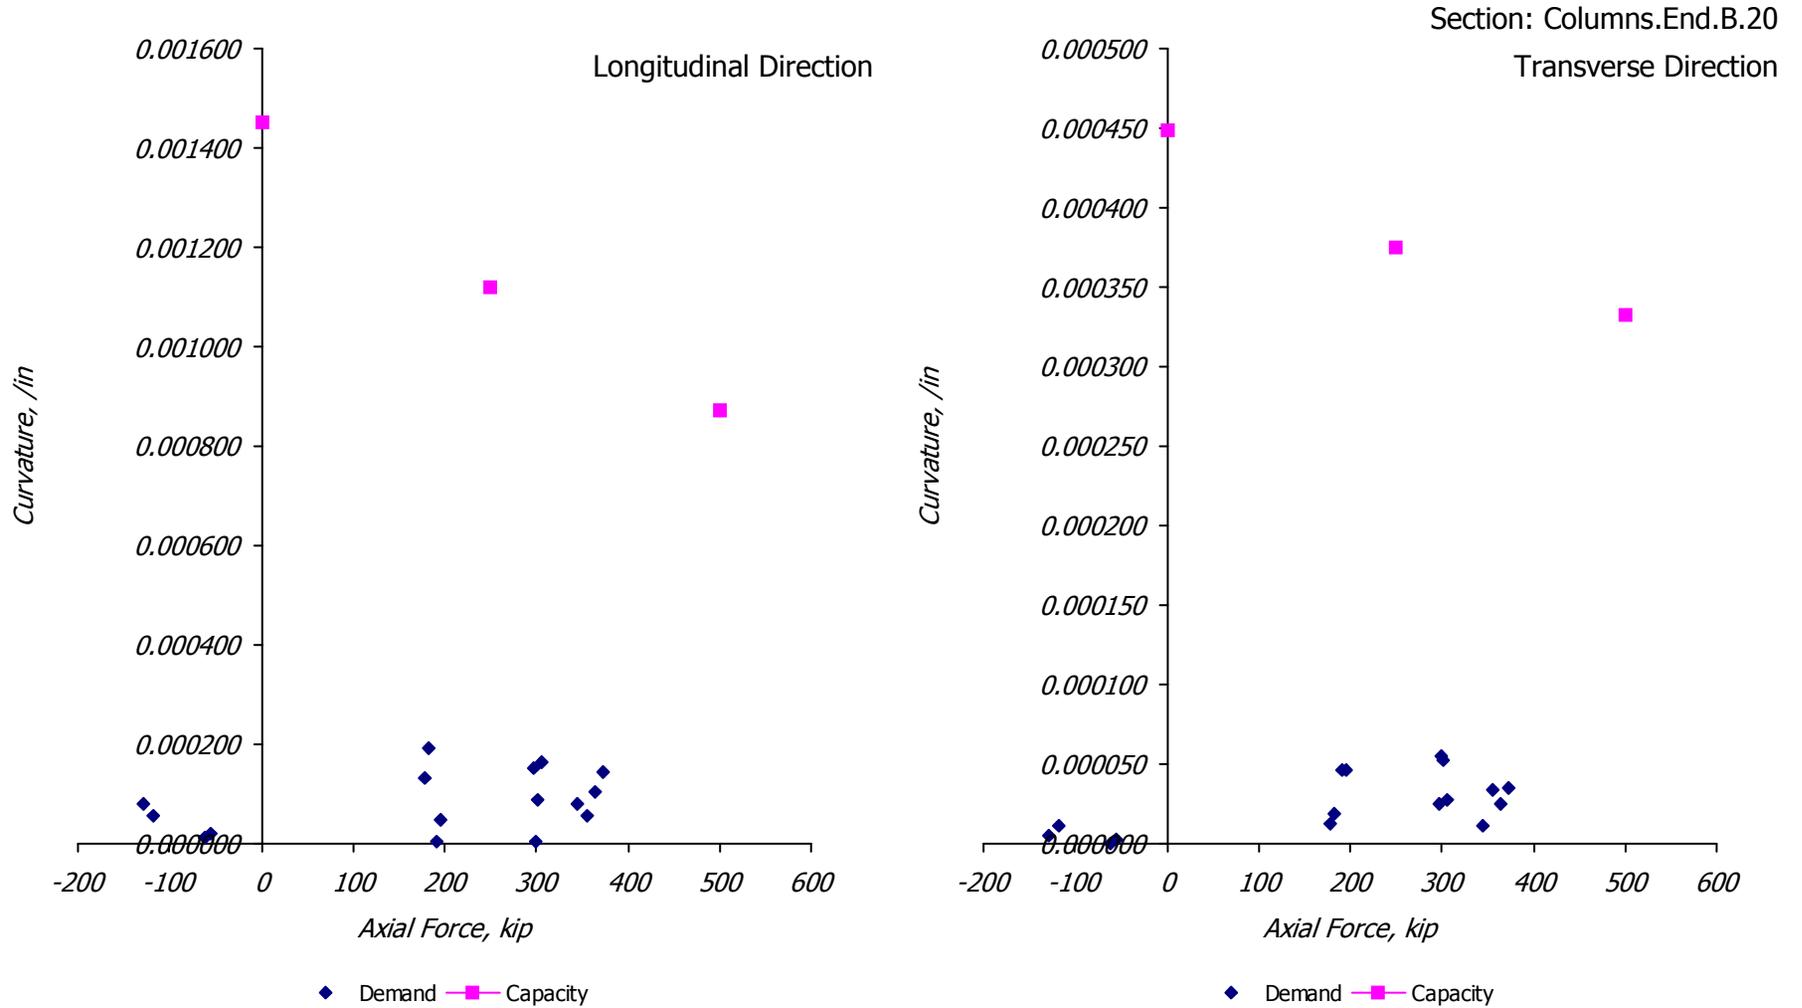
Figure D.7 Column curvature versus axial force, retrofitted structure, rare earthquake, end bents

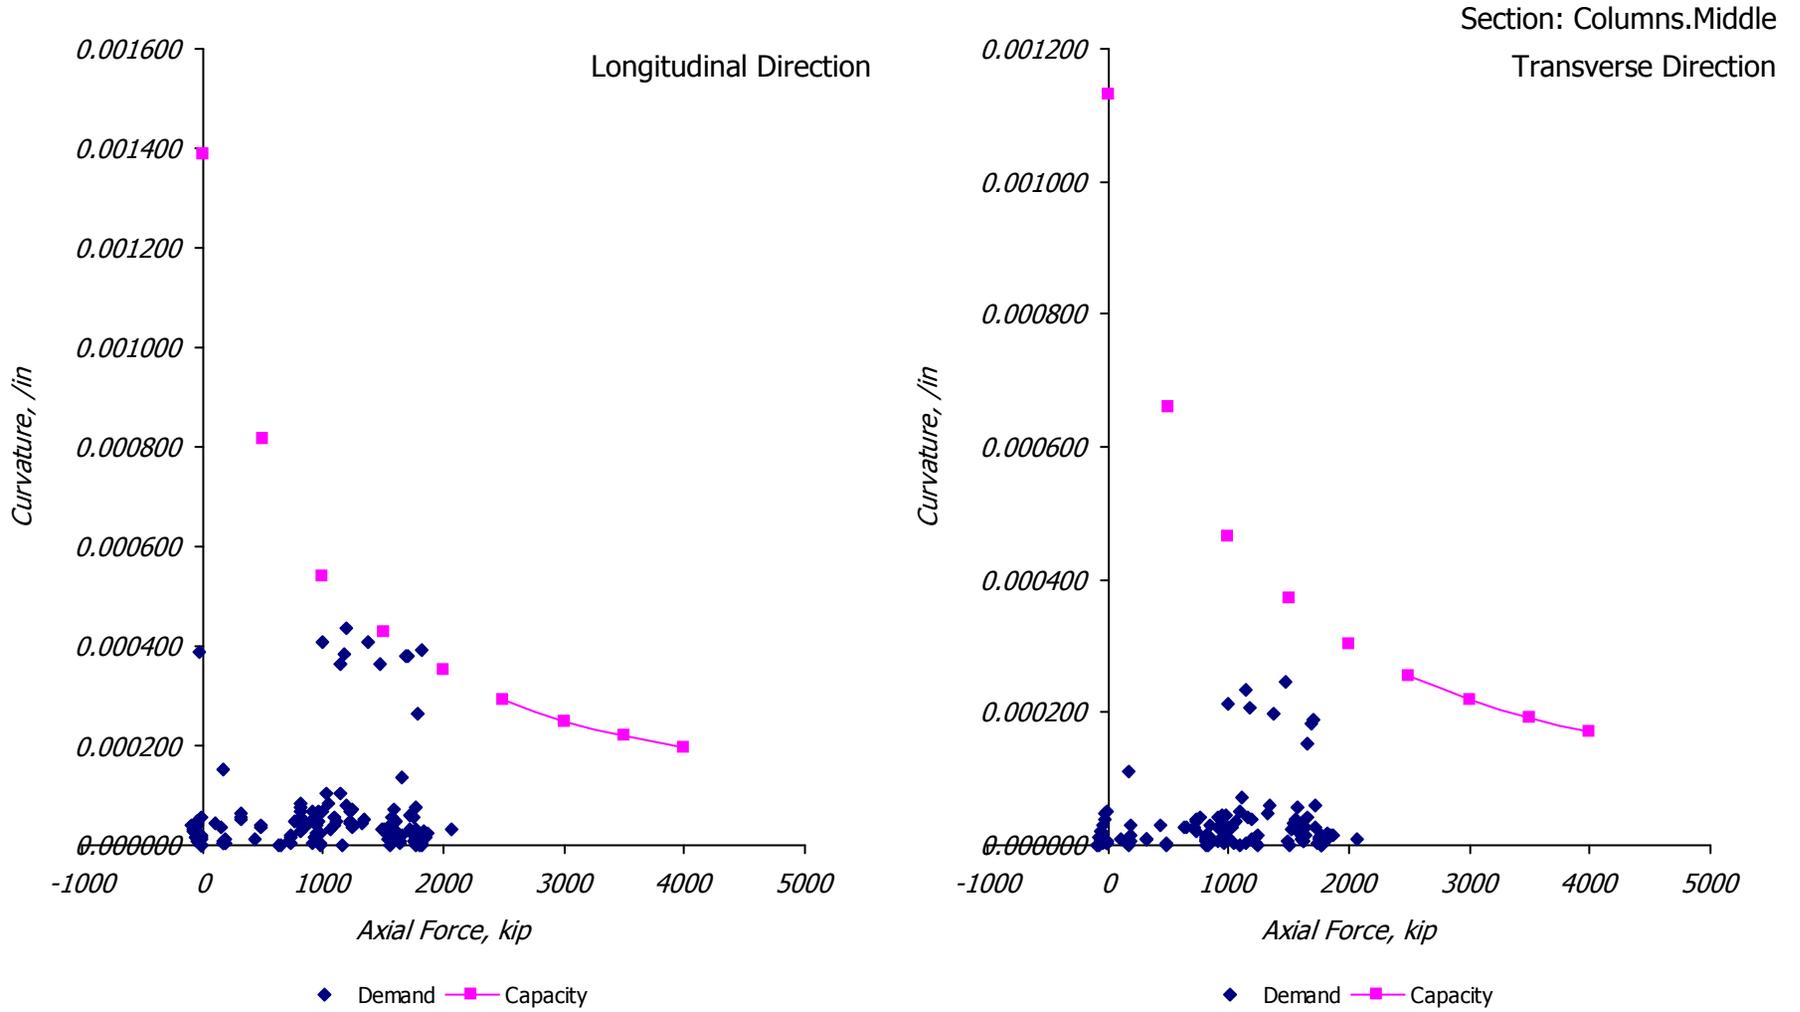
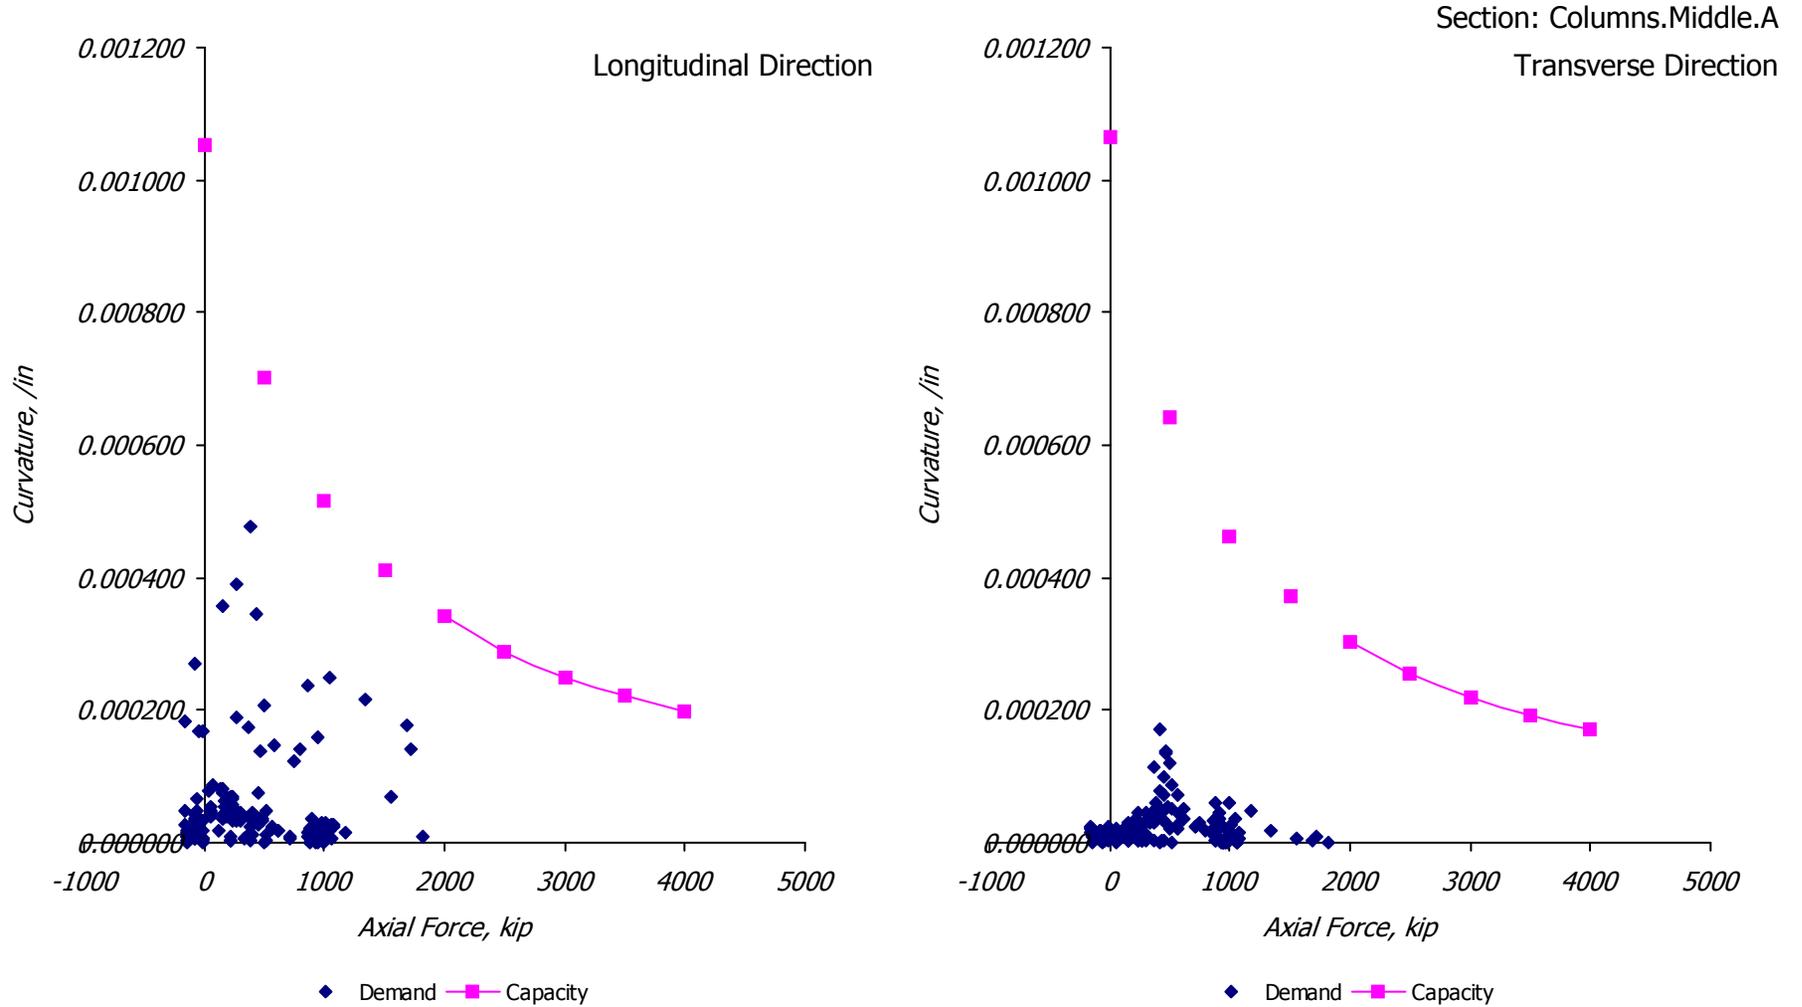
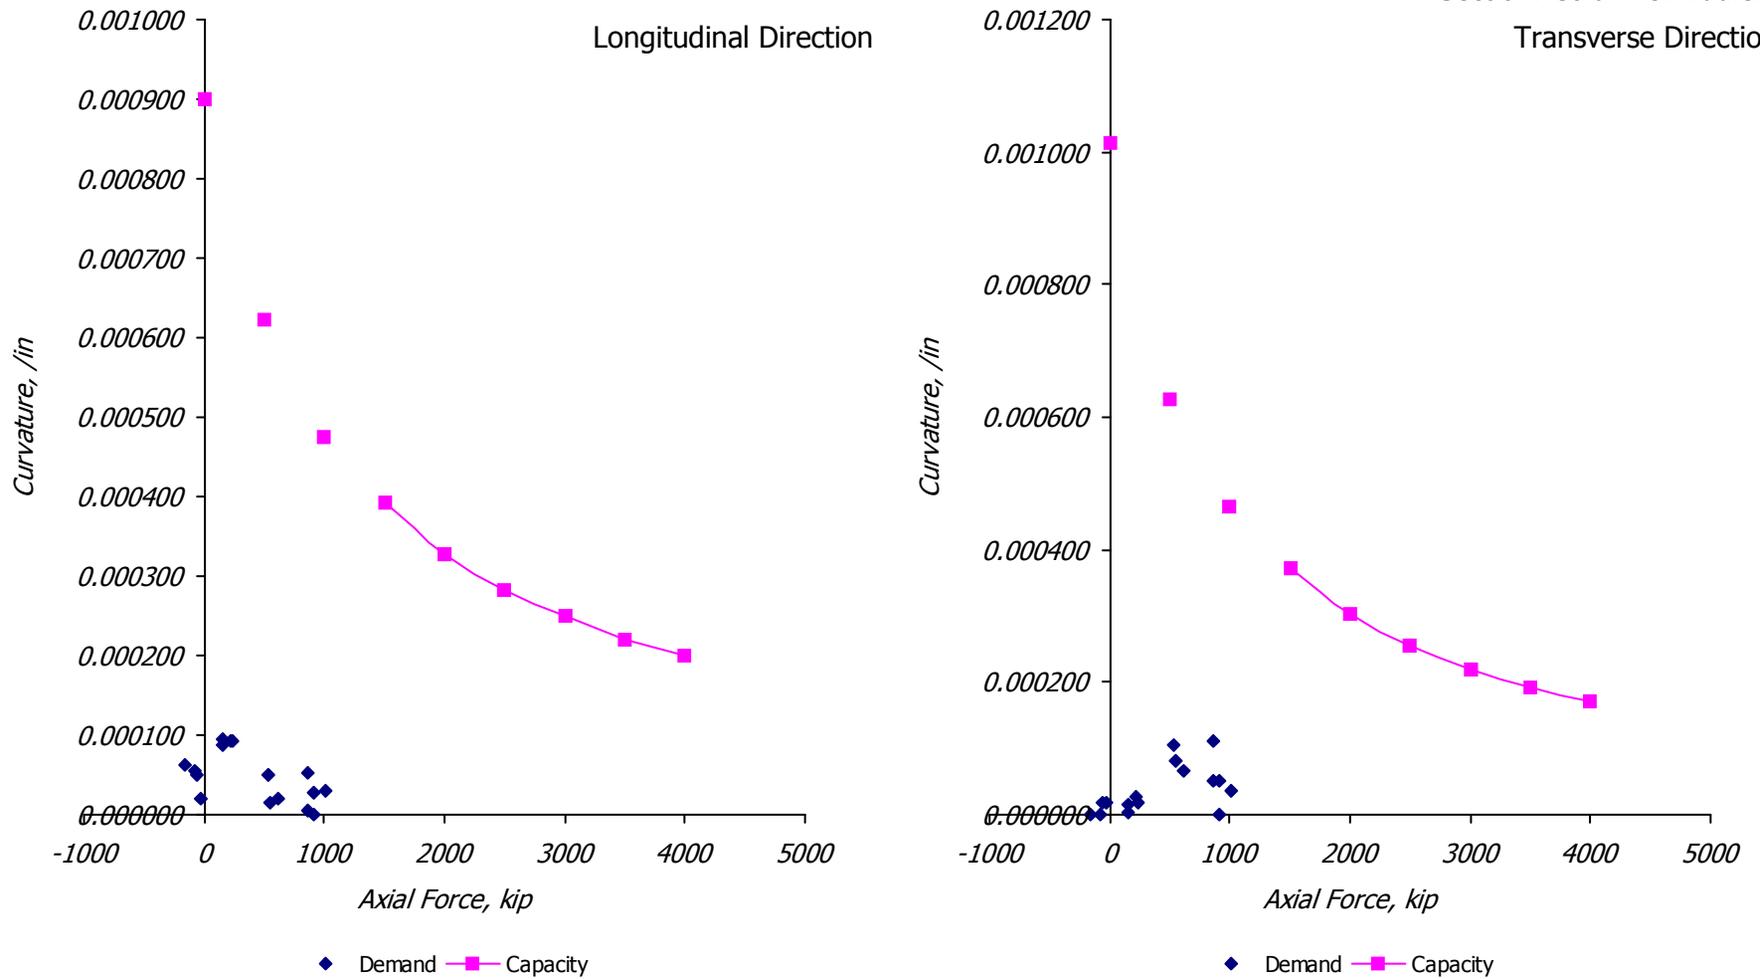
Figure D.8 Column curvature versus axial force, retrofitted structure, rare earthquake, middle bents

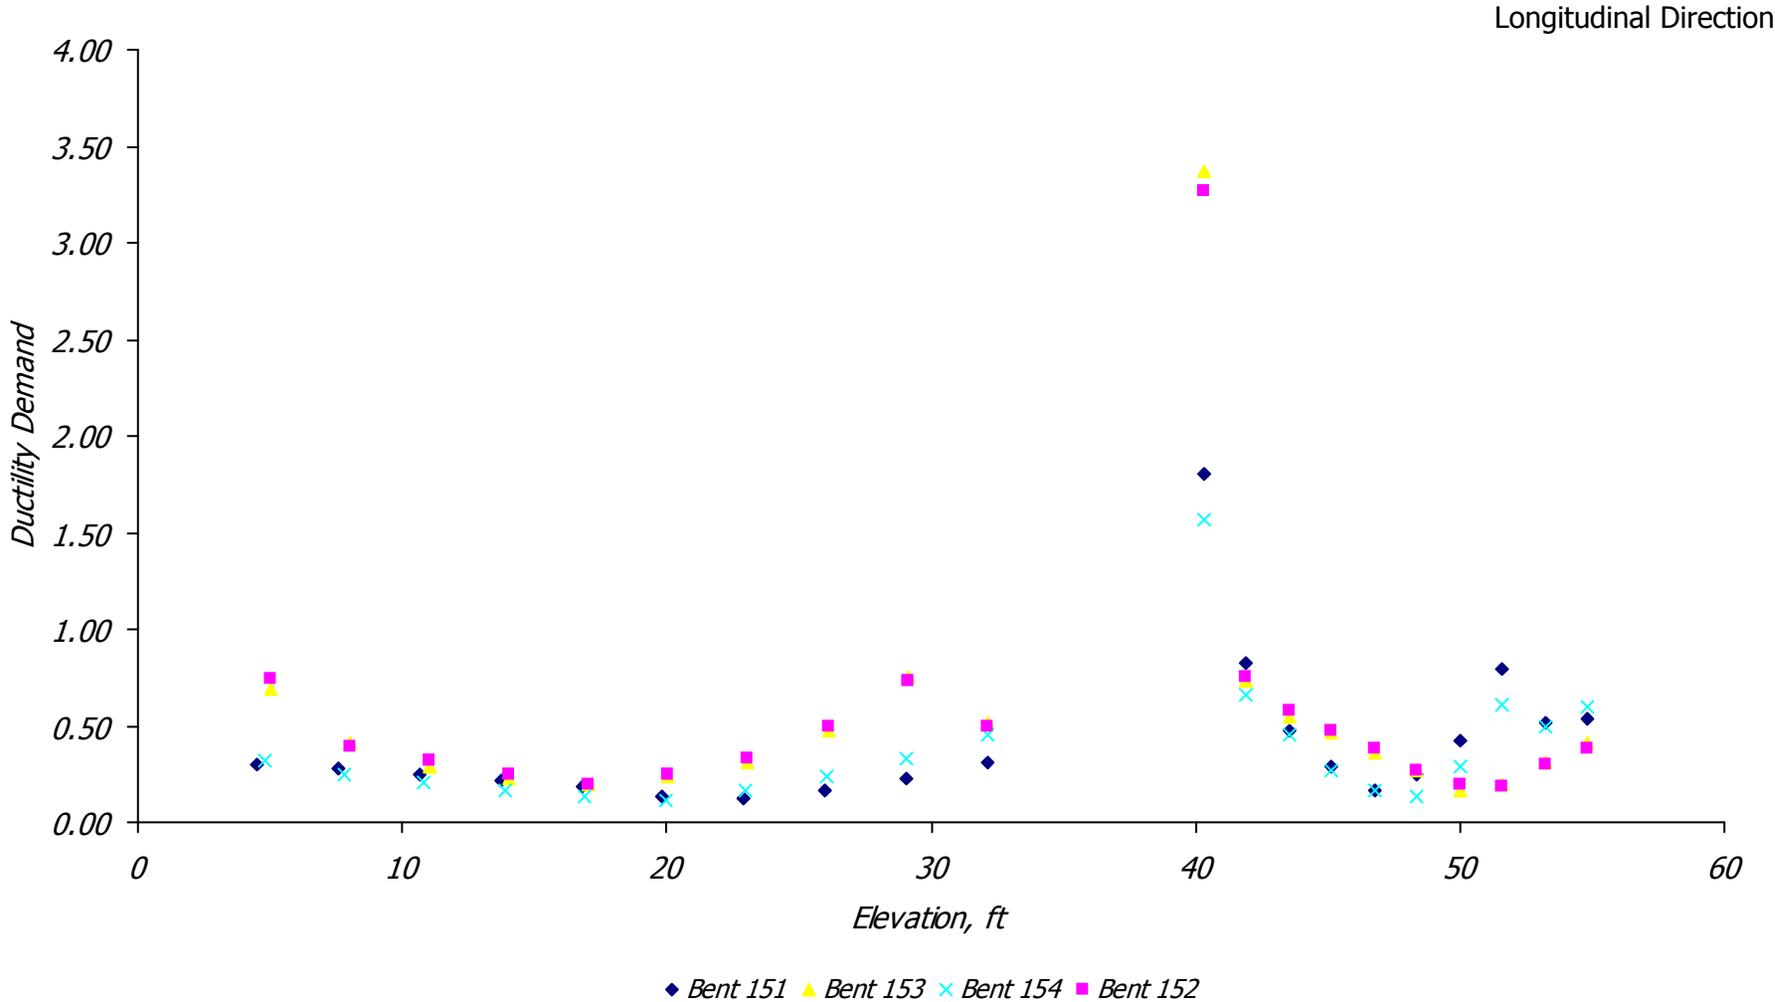
Figure D.9a Column curvature ductility demand, retrofitted structure, design earthquake, longitudinal direction

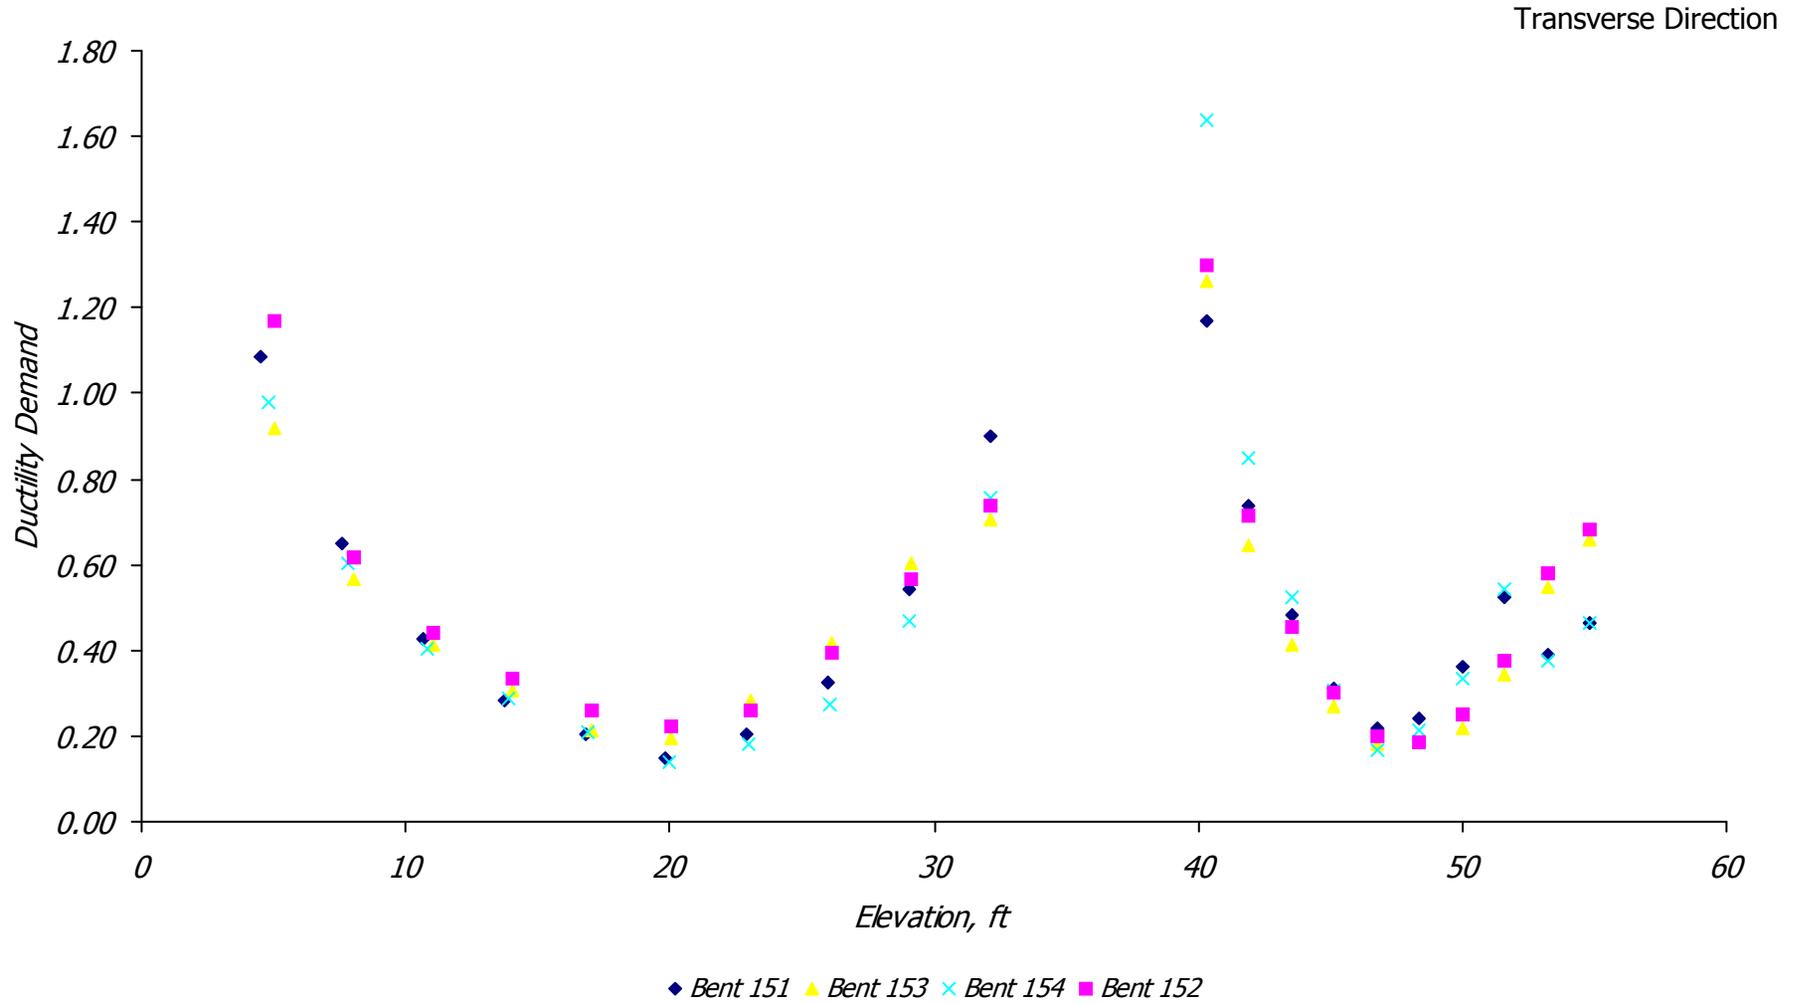
Figure D.9b Column curvature ductility demand, retrofitted structure, design earthquake, transverse direction

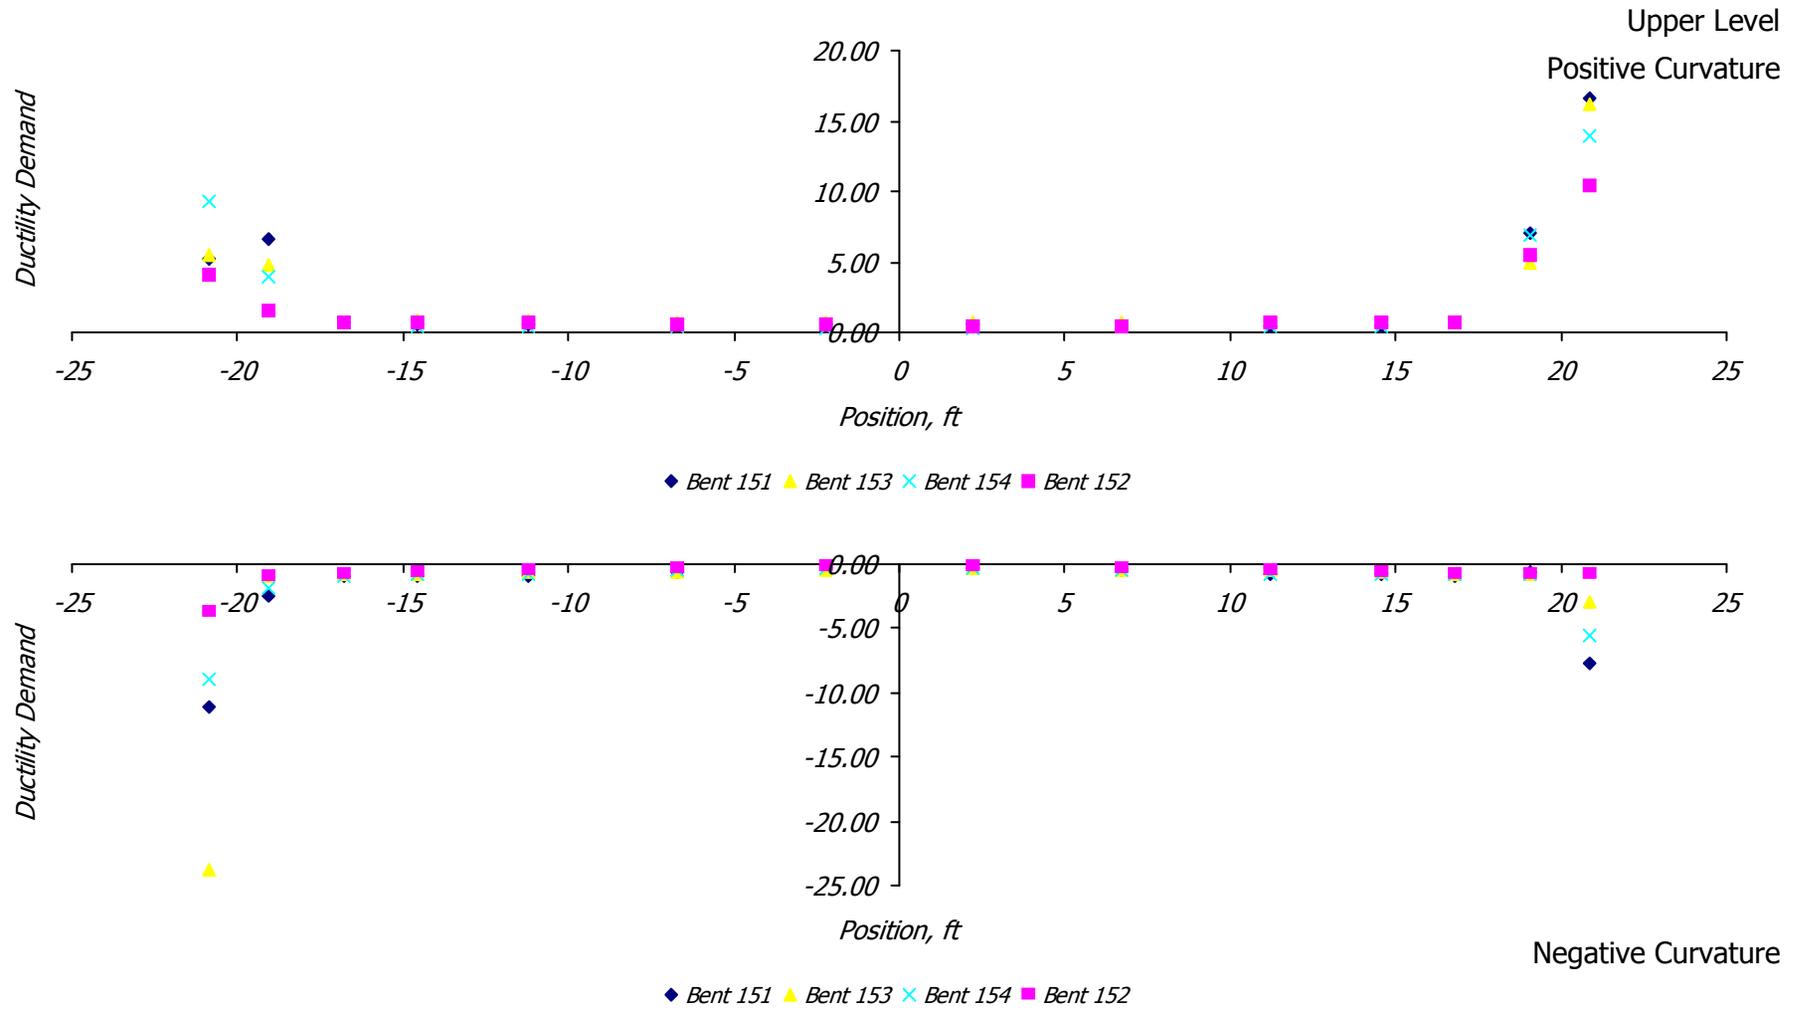
Figure D.10a Floorbeam curvature ductility demand, retrofitted structure, rare earthquake, upper level

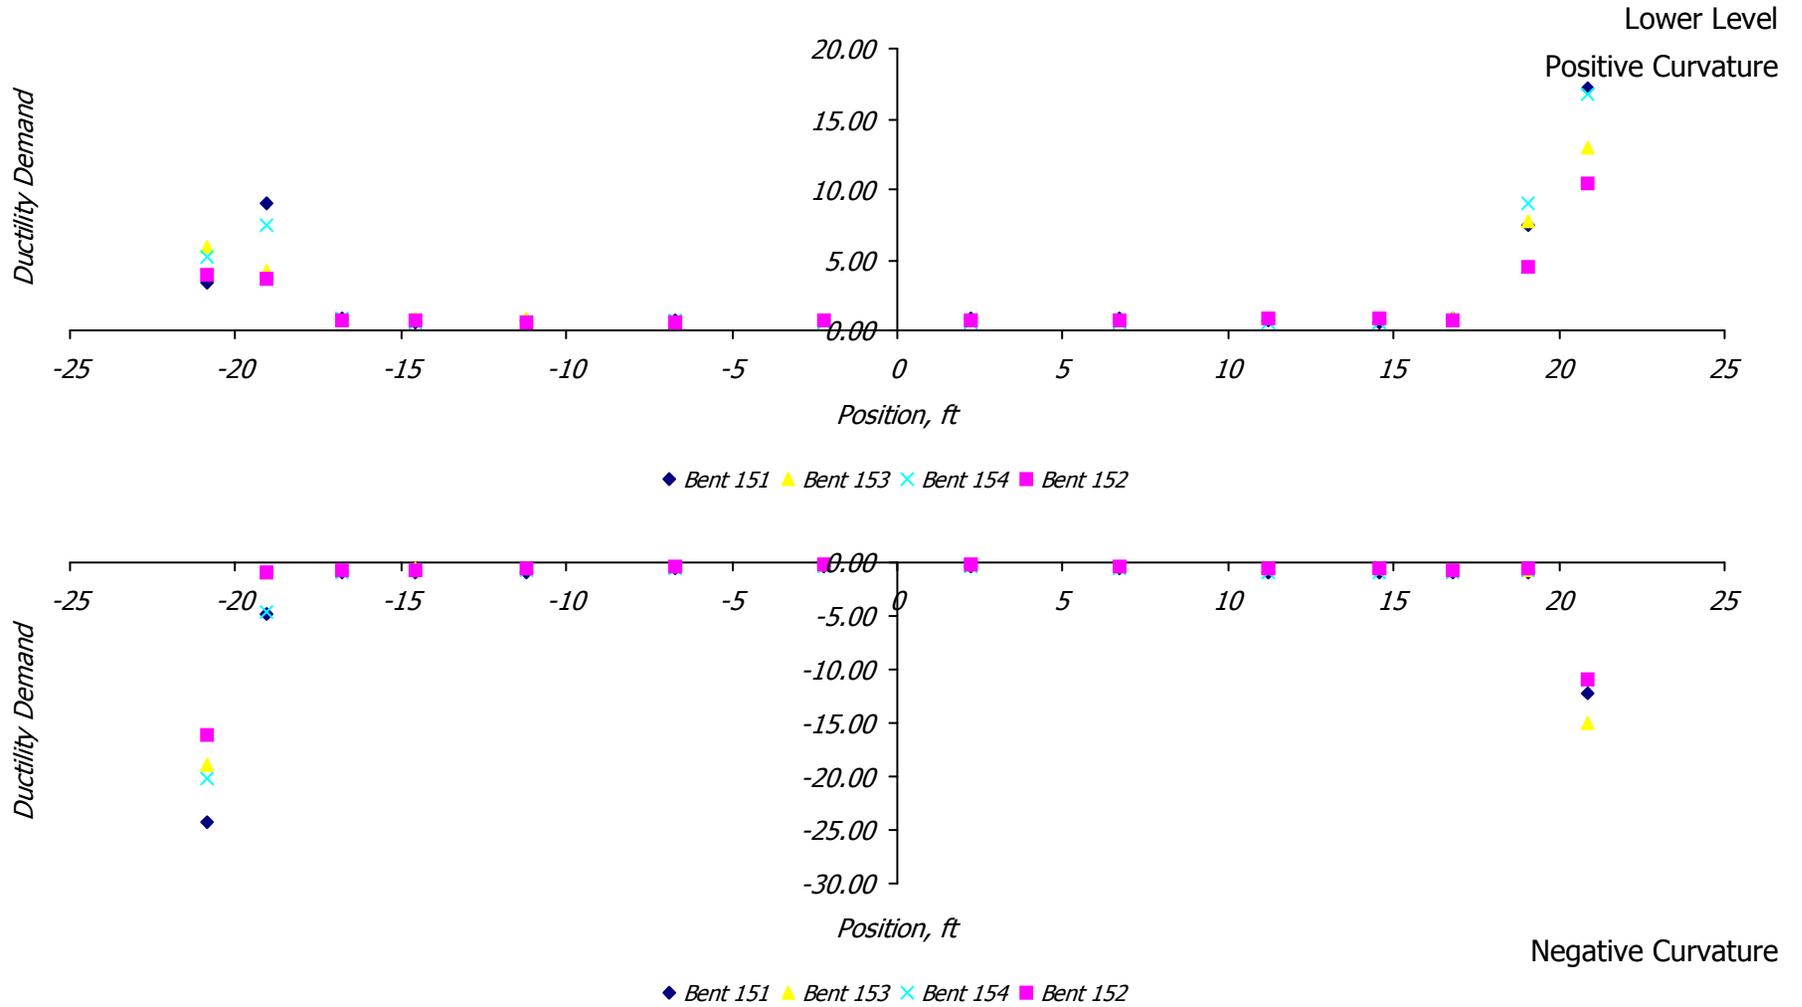
Figure D.10b Floorbeam curvature ductility demand, retrofitted structure, rare earthquake, lower level

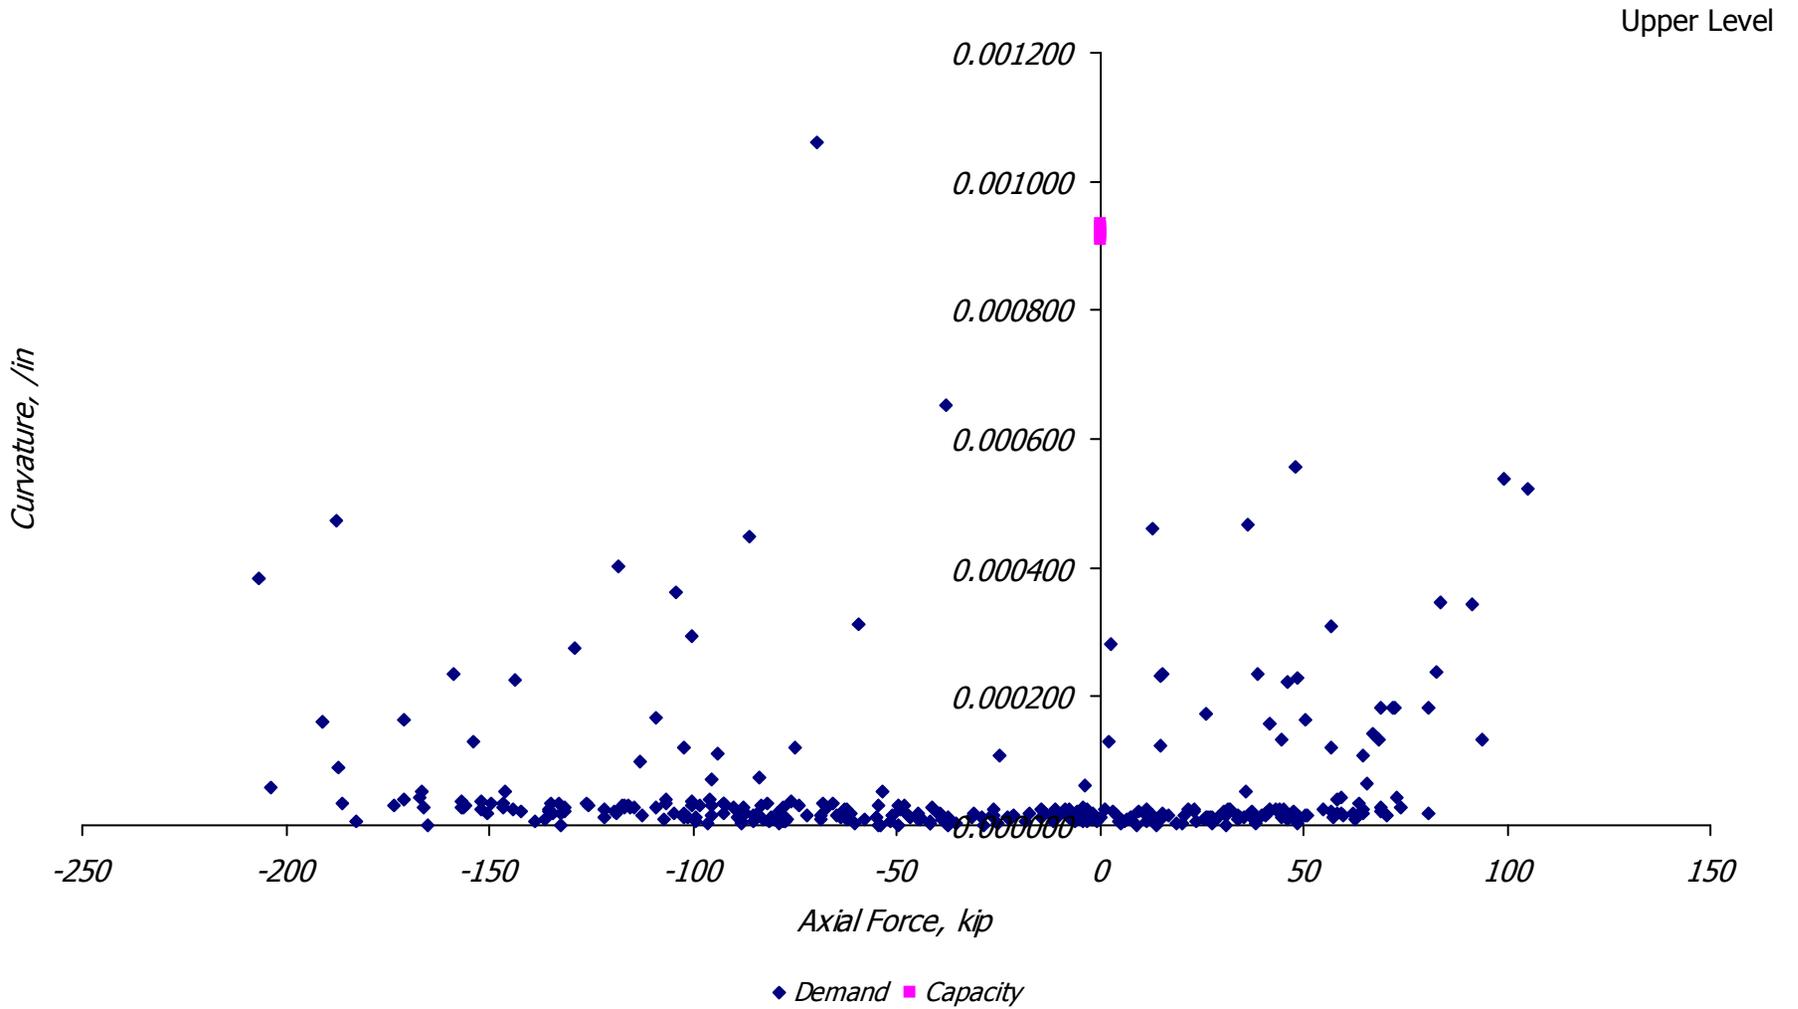
Figure D.11a Floorbeam curvature versus axial force, retrofitted structure, rare earthquake, upper level

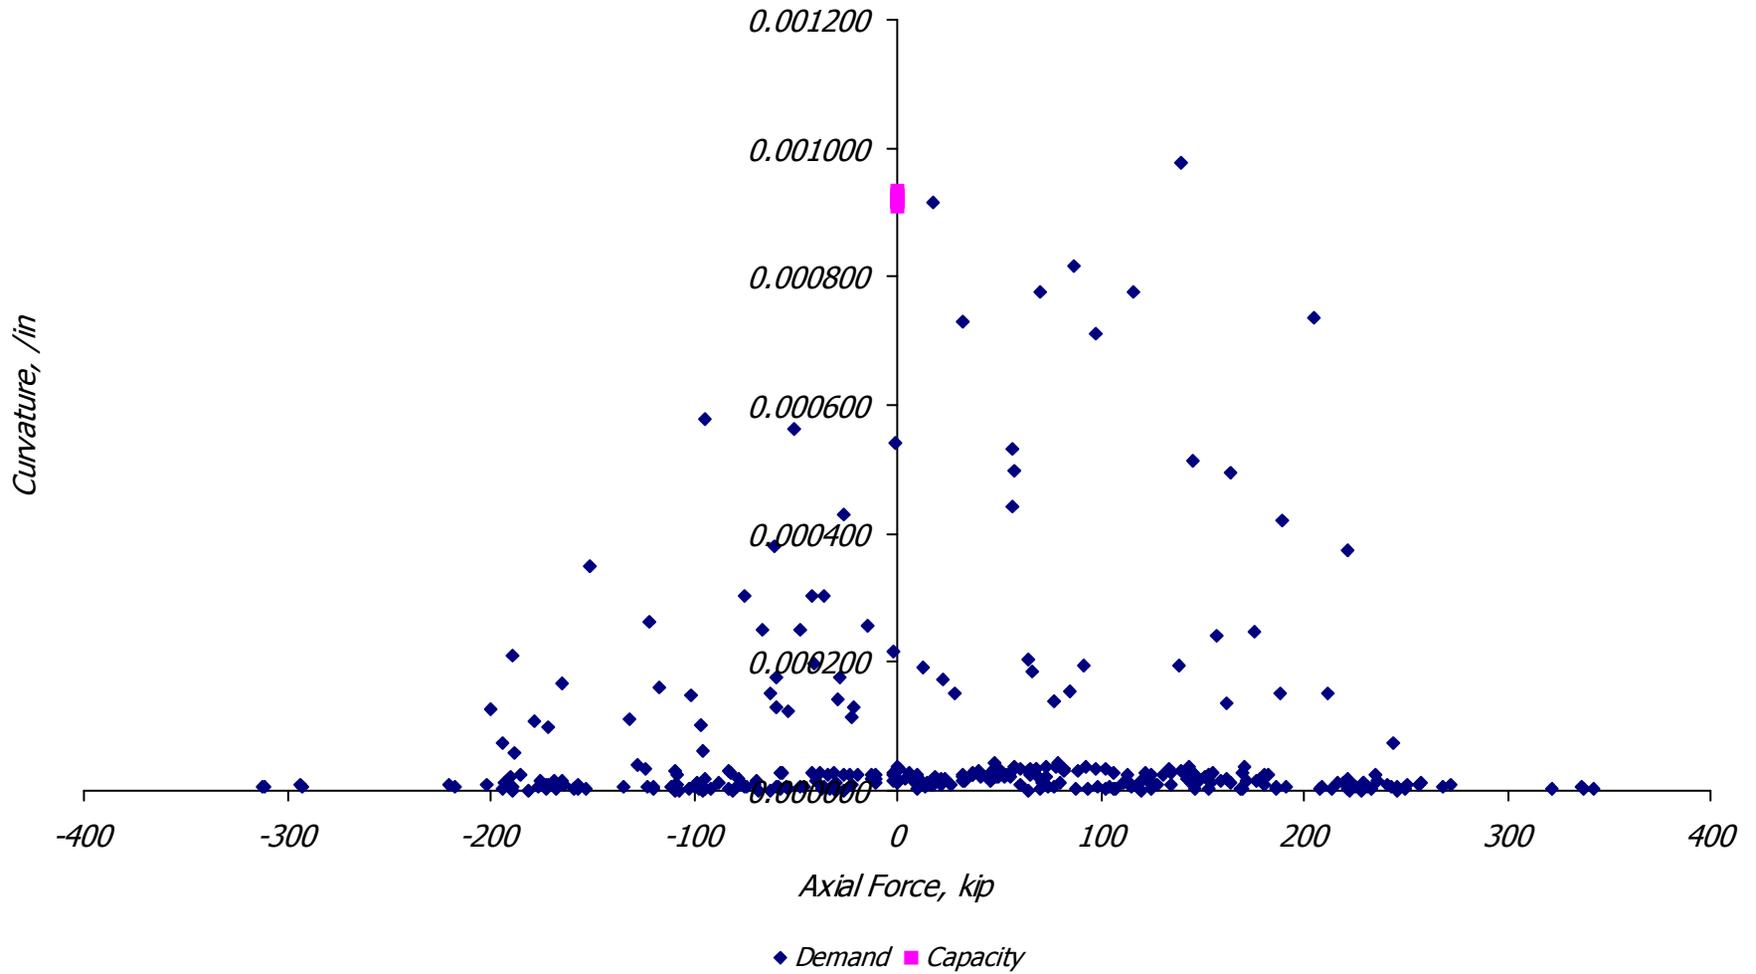
Figure D.11b Floorbeam curvature versus axial force, retrofitted structure, rare earthquake, lower level
