ALASKAN WAY VIADUCT

EVALUATION OF GRAY'S RETROFIT PROPOSAL

Prepared for the
Washington State Department of Transportation

By
T.Y. Lin International

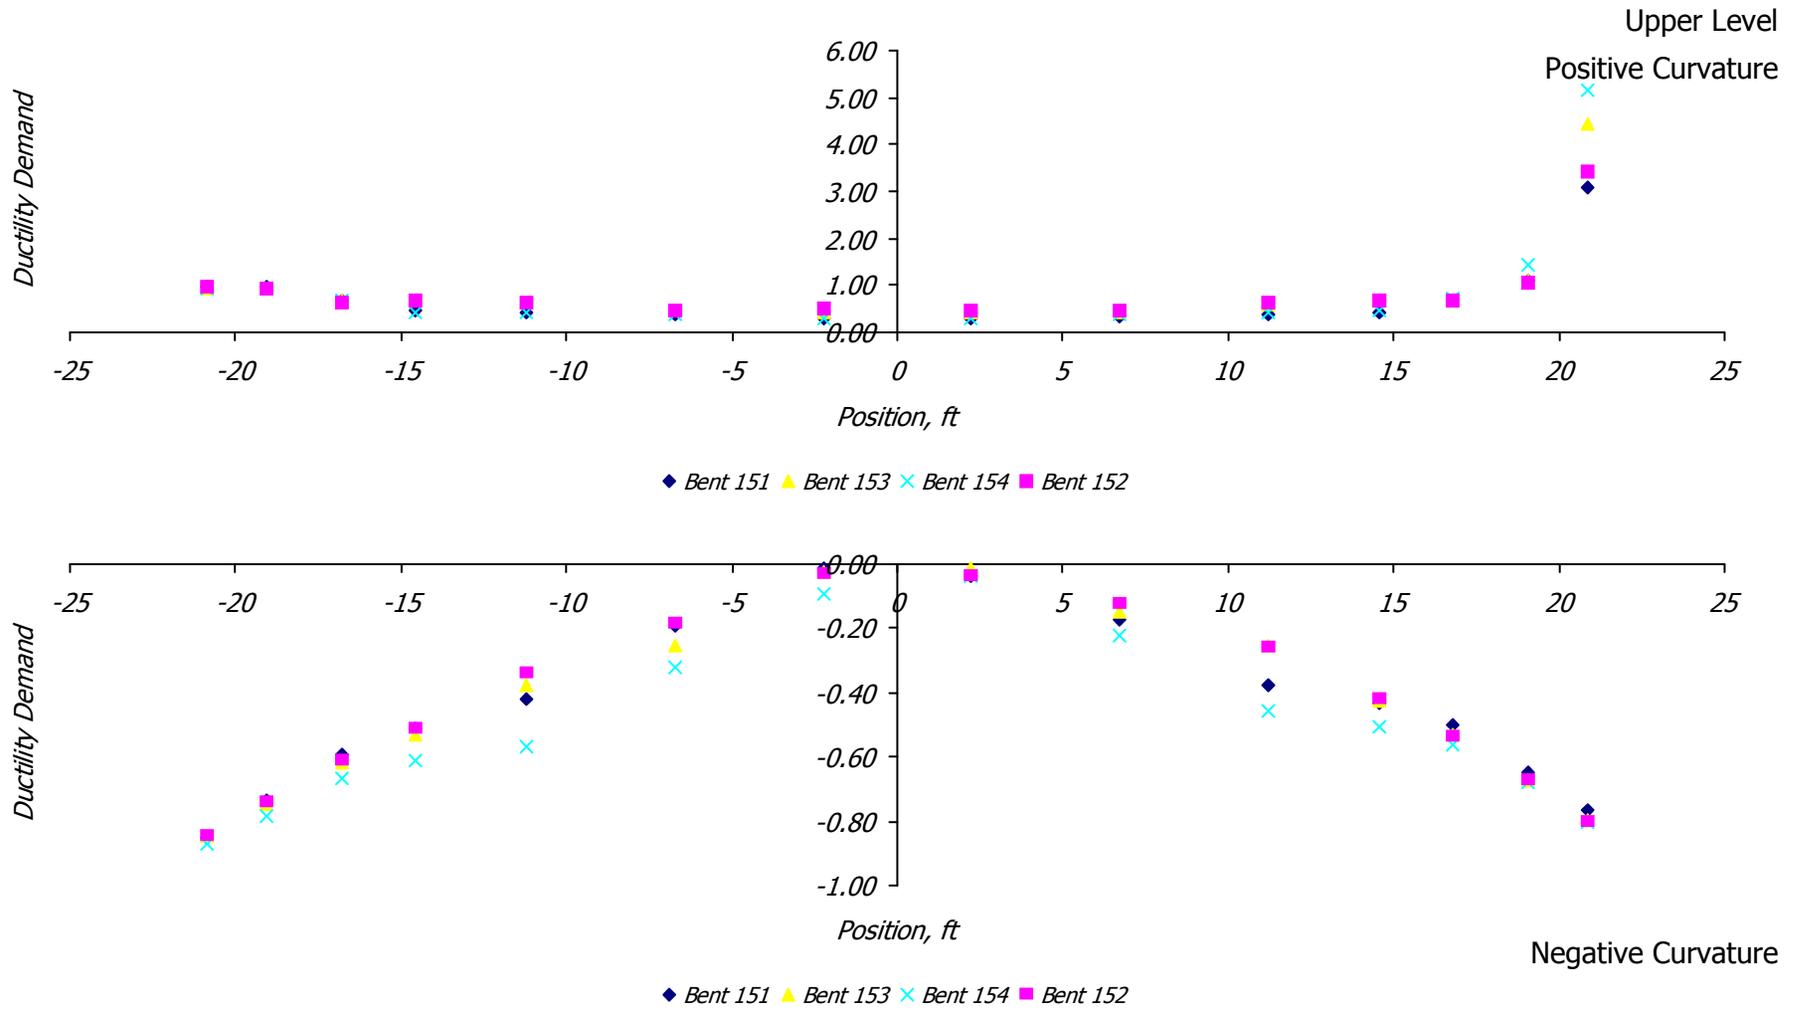
Figure D.12a Floorbeam curvature ductility demand, retrofitted structure, design earthquake, upper level

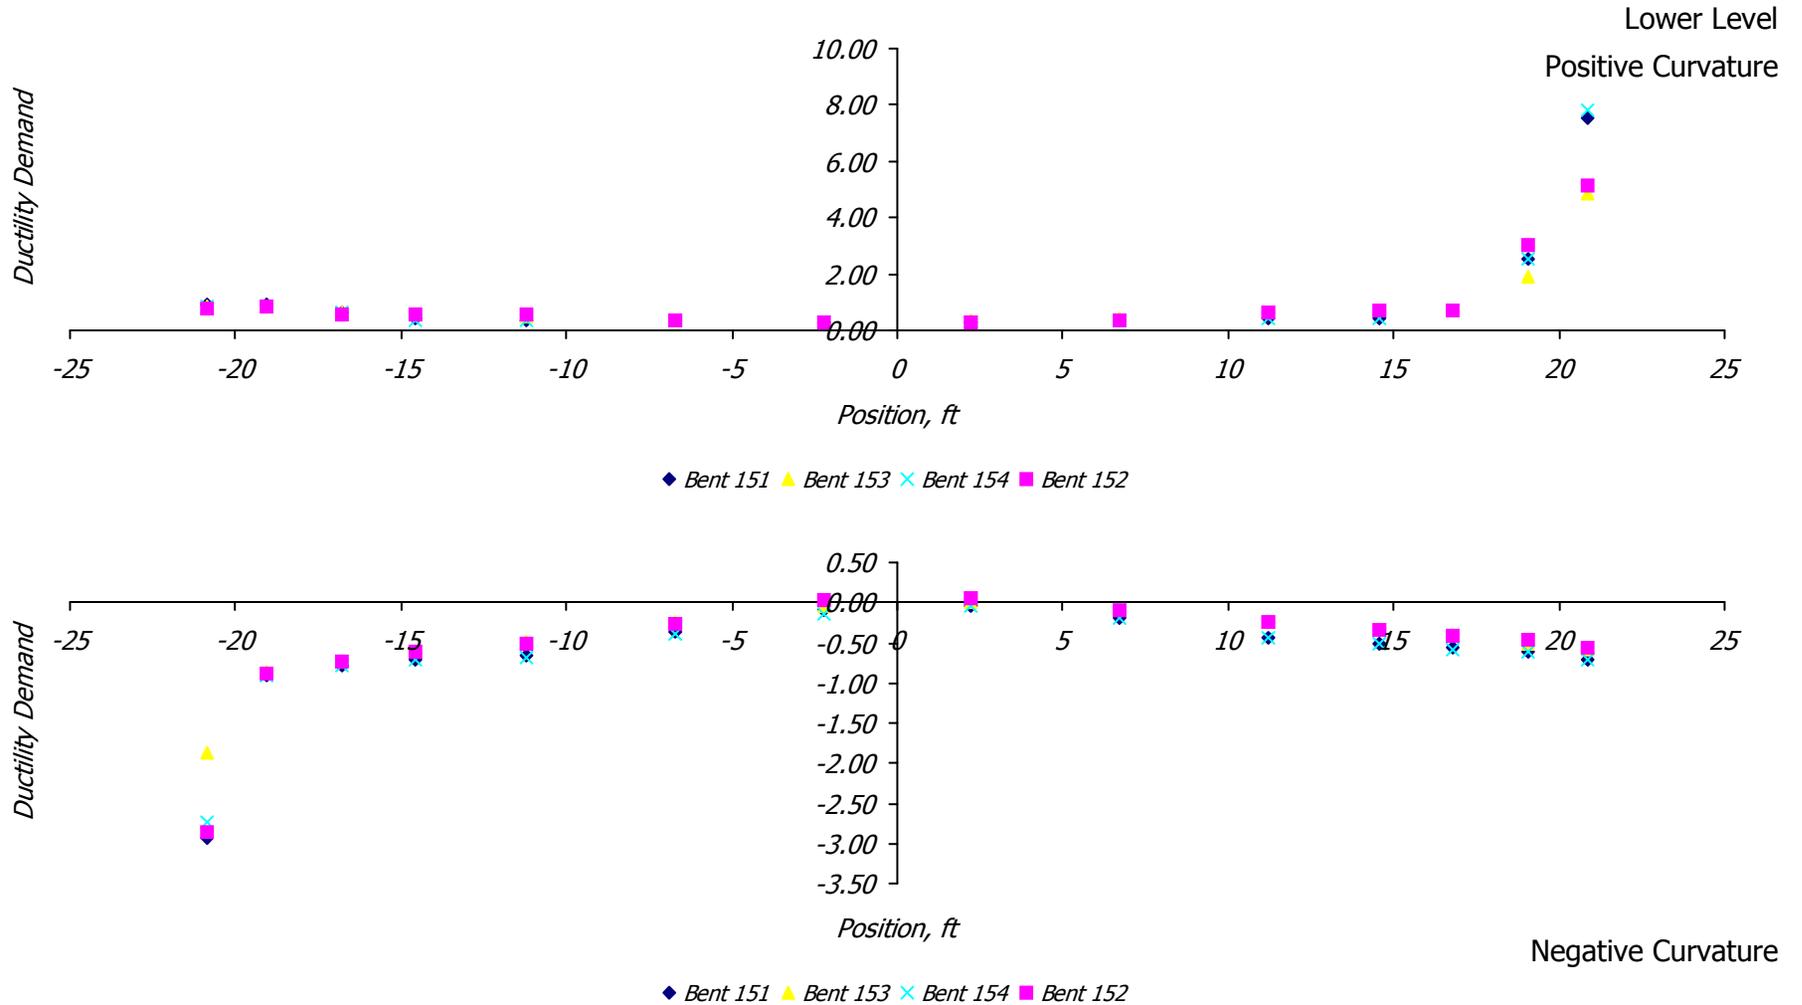
Figure D.12b Floorbeam curvature ductility demand, retrofitted structure, design earthquake, lower level

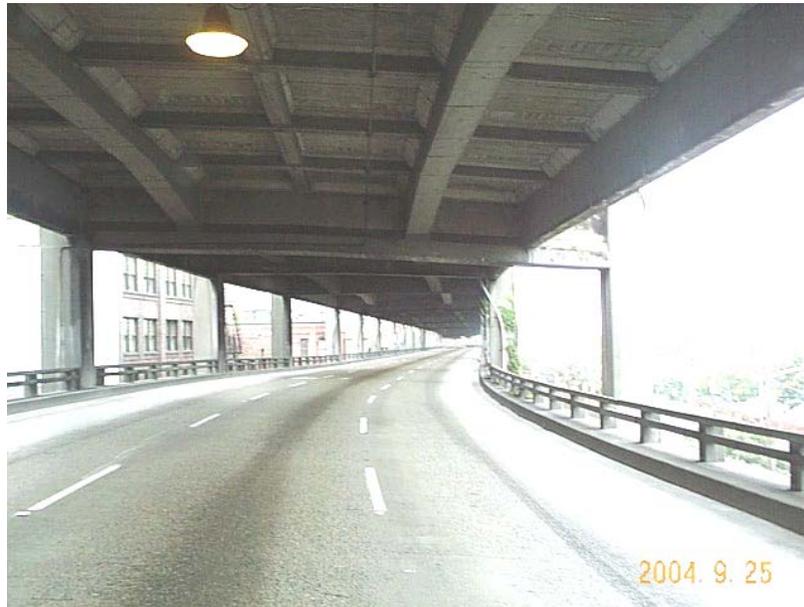
The two types of frames have similar elastic and dynamic properties. However, the reinforcement, structural detailing (splice, connections) differs between the two frames. As such, the expected seismic performance of the frames in the inelastic range and possible modes of failure would also vary between the frames. Since the scope of the analysis in this report is to limit the extent of nonlinear behavior by adding supplementary damping to the system, it would suffice to perform analysis on one of the frame types. As such, for the remainder of this report, the discussion is limited to typical SED frames. Figure 3 present a photograph of a SED framing.

Figure 3. Photograph of typical SED frames

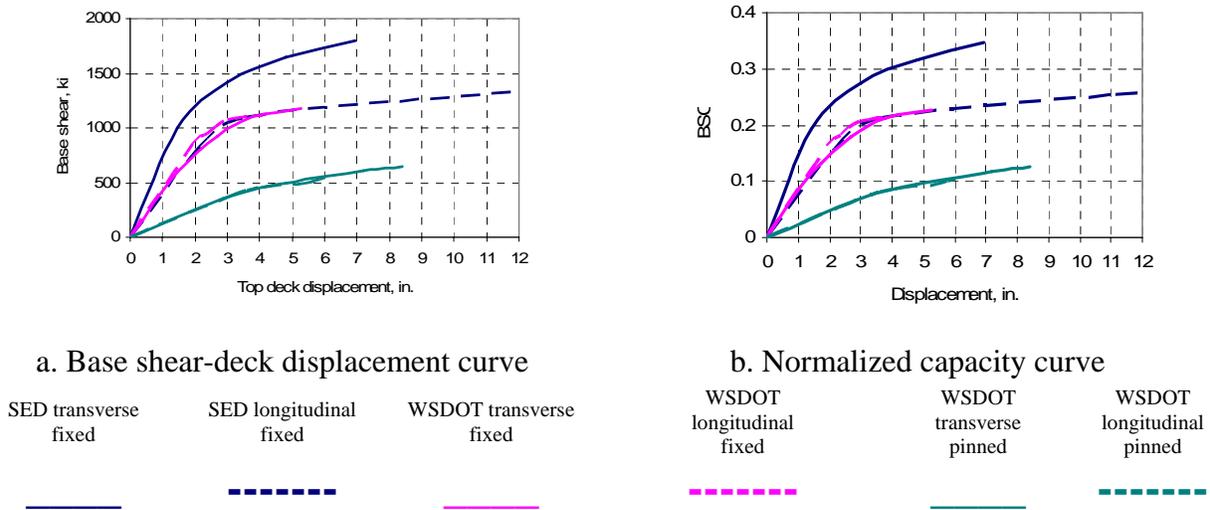
Pushover analysis was conducted to evaluate the capacity of frames. Only ductile flexural hinges were included in the model. Figure 4 presents the normalized pushover curves. The Eberhard 1995a and 1995b data were converted from base shear to base shear coefficient, BSC, (dividing by weight of the frame of 5,200 kips). The pushover curves are shown in Figure 4. Results for SED and WSDOT units in longitudinal and transverse directions are shown in Figure 4. For the SED unit only pinned base condition was evaluated; for WSDOT unit both support conditions were investigated. Since the frames respond primarily in the first mode, the pushover curves can also be considered as spectral displacement-spectral acceleration capacity curves.

Figure 4. Pushover curves, Eberhard 1995a and 1995b

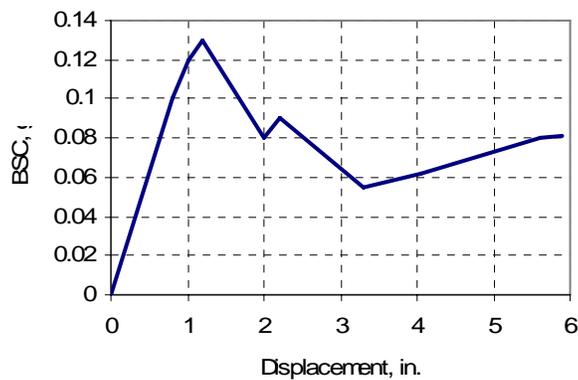
Parsons Brinckerhoff Quade & Douglas (PBQD 2002) assessed the seismic performance of the viaduct and looked at retrofit and replacement options. They conducted a pushover analysis of a specific frame. The pushover curve is shown in Figure 5. PBQD 2002 does not provide specifics of their analysis. However, from their pushover curve it appears that strain hardening, loss of strength in hinges were included in the model. From the level of BSC, it seems that their model used spring supports—and a period of 1.5 sec—similar to a value used by TY Lin 2001.

Figure 5. Capacity pushover curve for Bent #152, PBQD 2002

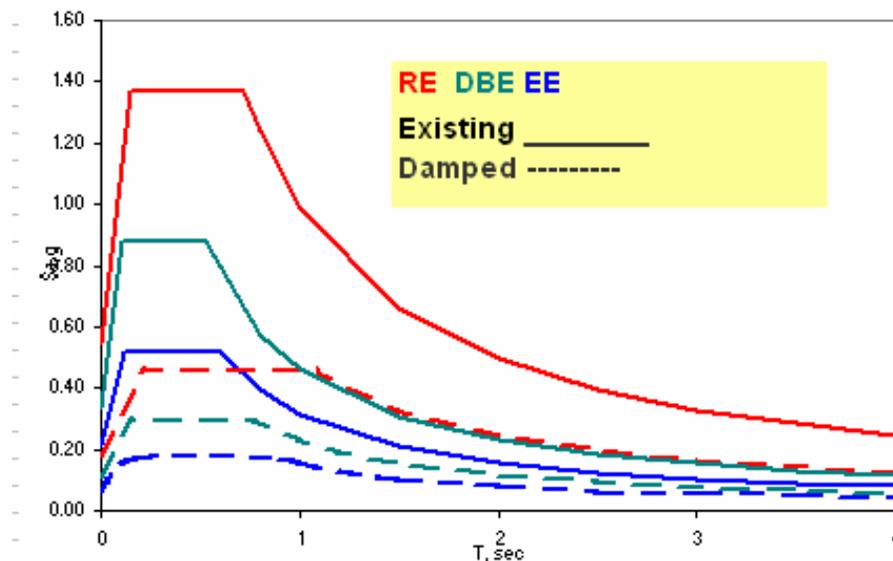
Note that if this level of high damping was achieved, the response of the viaduct would then meet the seismic objectives, because the RE acceleration would then equal to or be less than the spectral ordinates computed from the accelerations causing maximum response at that period from the three recording stations during the Nisqually ground motion. The effectiveness of added damping was also noted by PBQD 2002 when they discussed energy dissipation capacity. The only difference being that PBQD 2002 discussed energy dissipated provided by new designed and detailed ductile concrete members.

Figure 10. Original and damped response spectra

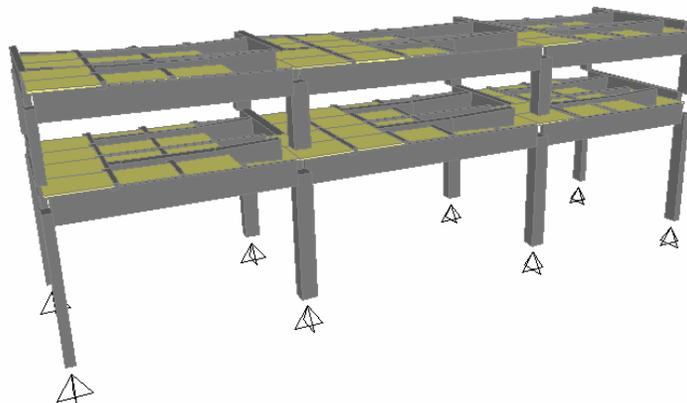
Program SAP2000 (CSI 2006) was used to prepare mathematical models for the building. A typical three-span frame designed by SED was modeled and shown in Figure 12. The member sizes and frame geometry were selected per structural plans.

Figure 12. Three-dimensional model of the building

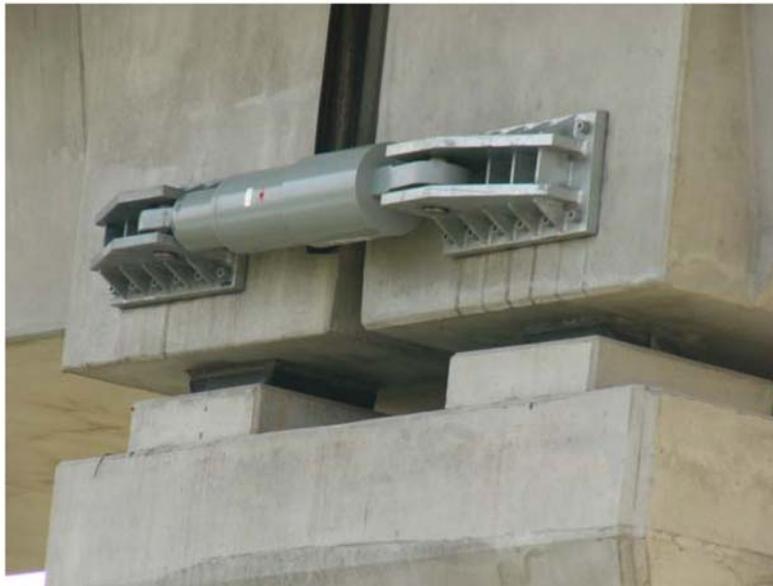
In the longitudinal direction, there is a nominal 1.5-in. wide gap between adjacent frames. To mitigate pounding problem, shock-transmission units, such as the one shown in Figure 16 can be used to limit the differential movement between the viaduct frames.

Figure 16. Shock transmission unit (Taiwan High Speed Rail viaduct)
