Attachment 3

Visual Quality Assessment Matrix

SR 520, I-5 to Medina: Bridge Replacement and HOV Project

VISUAL QUALITY ASSESSMENT

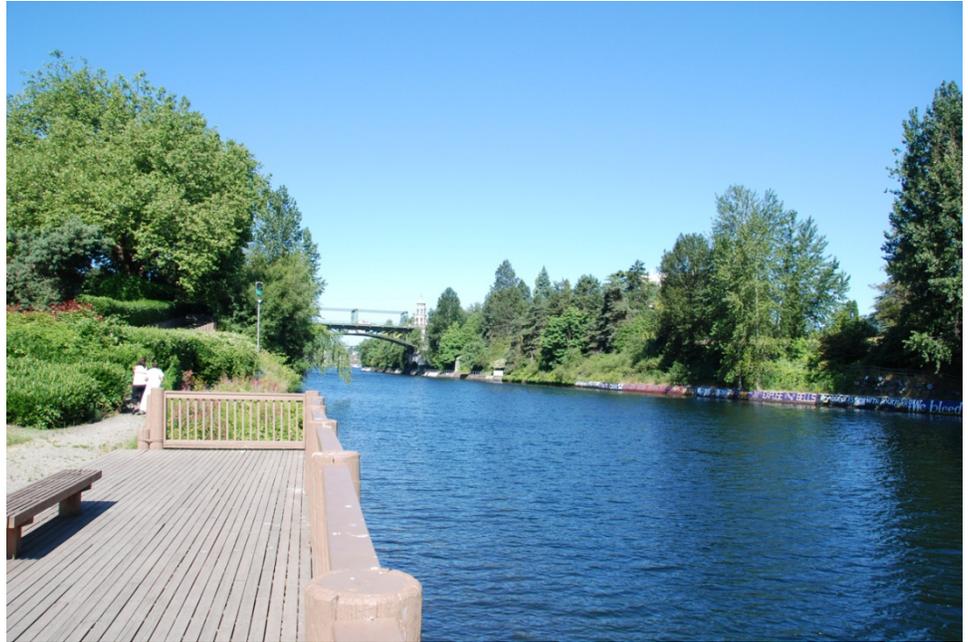
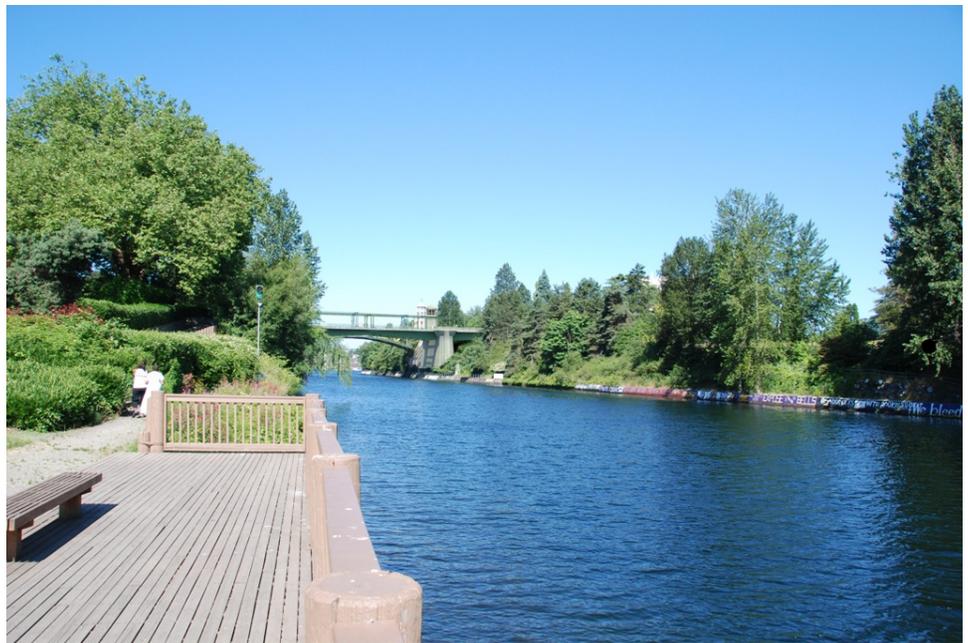
Exhibit 2-26. Montlake Bascule Bridge—Viewpoint 25 (update to Exhibit 2-26 of 2009 discipline report)

- Historic bascule draw bridge
- Water link between Lake Washington and Portage Bay
- High volumes of recreational boat traffic
- Mature vegetation lines both side of channel

- Second bascule draw bridge in front of Montlake Bridge
- Design and aesthetic treatments to be determined with Department of Archaeology and Historic Preservation

Looking west along the Montlake Cut from northeast corner of East Montlake Park

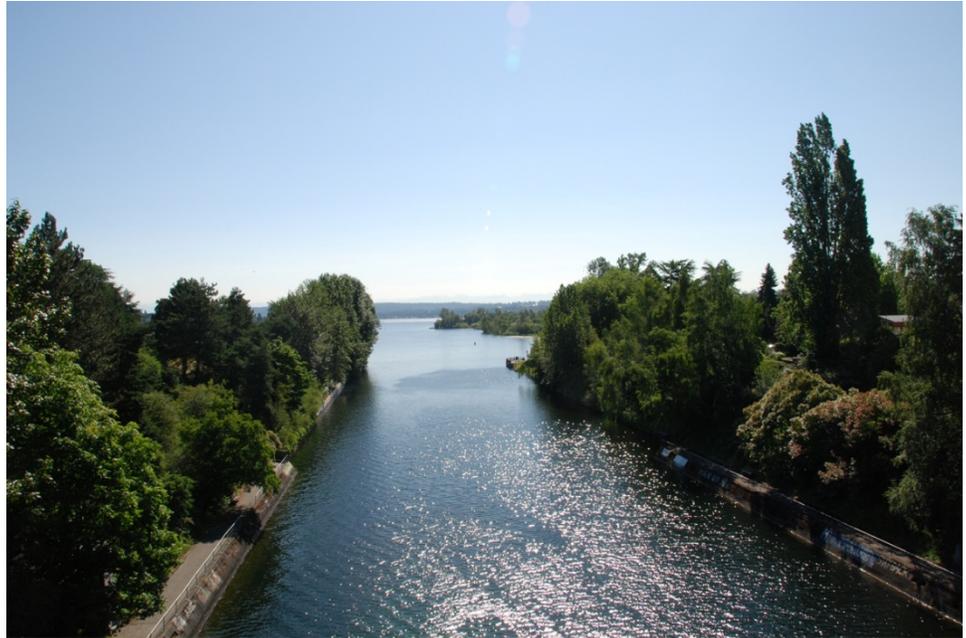
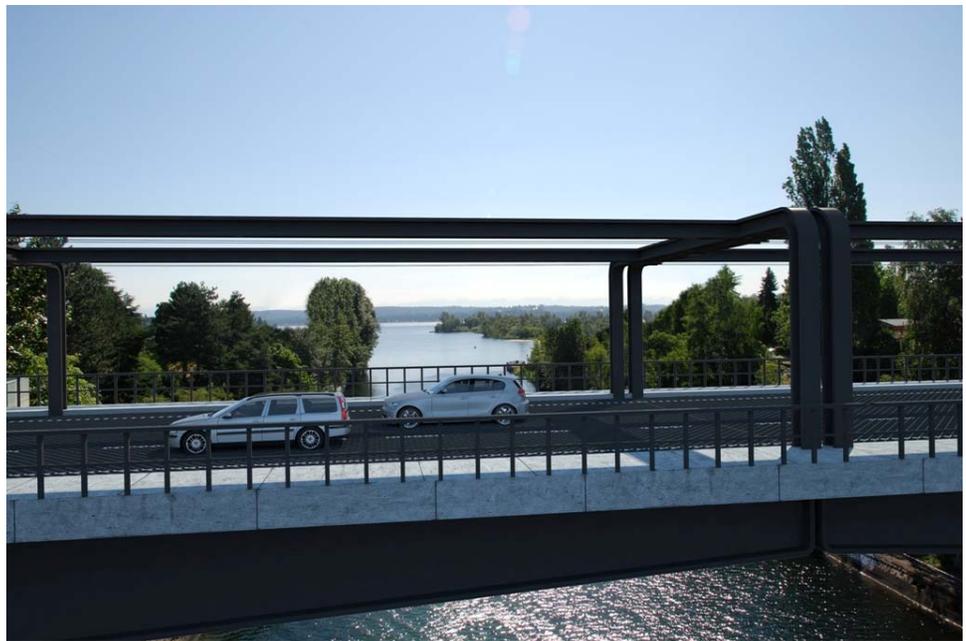
Exhibit 2-27. Montlake Bascule Bridge—Viewpoint 26 (update to Exhibit 2-27 of 2009 discipline report)

- Historic water link between Lake Washington and Portage Bay
- High volumes of boat traffic
- Mature vegetation lines both side of channel
- Union Bay in middle ground and Cascade Mountains in background

- New bascule draw bridge just east of existing Montlake Bridge
- Design and aesthetic treatments to be determined with Department of Archaeology and Historic Preservation

Looking east along the Montlake Cut toward Union Bay from east side of Montlake Bridge

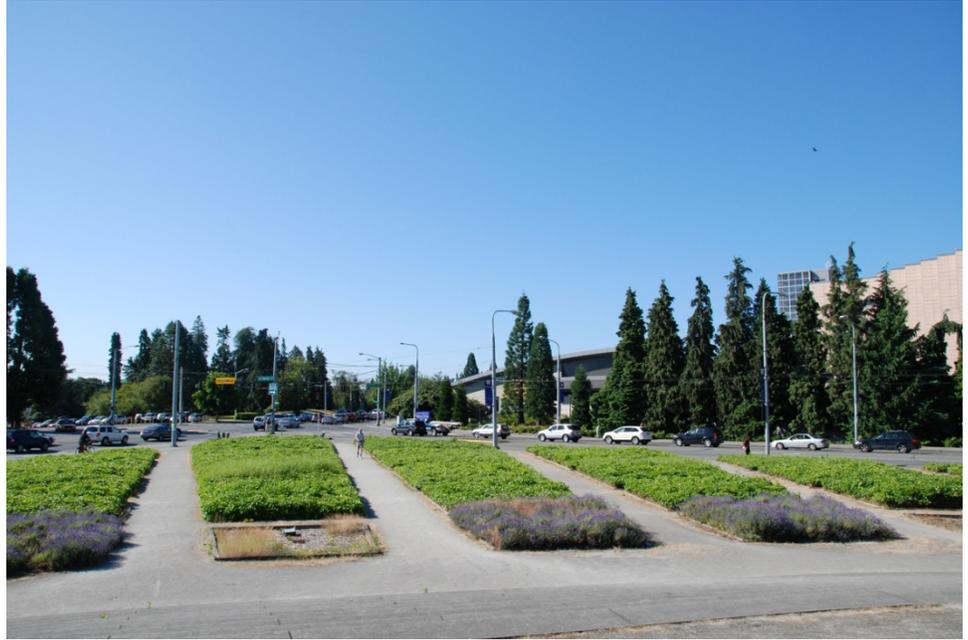
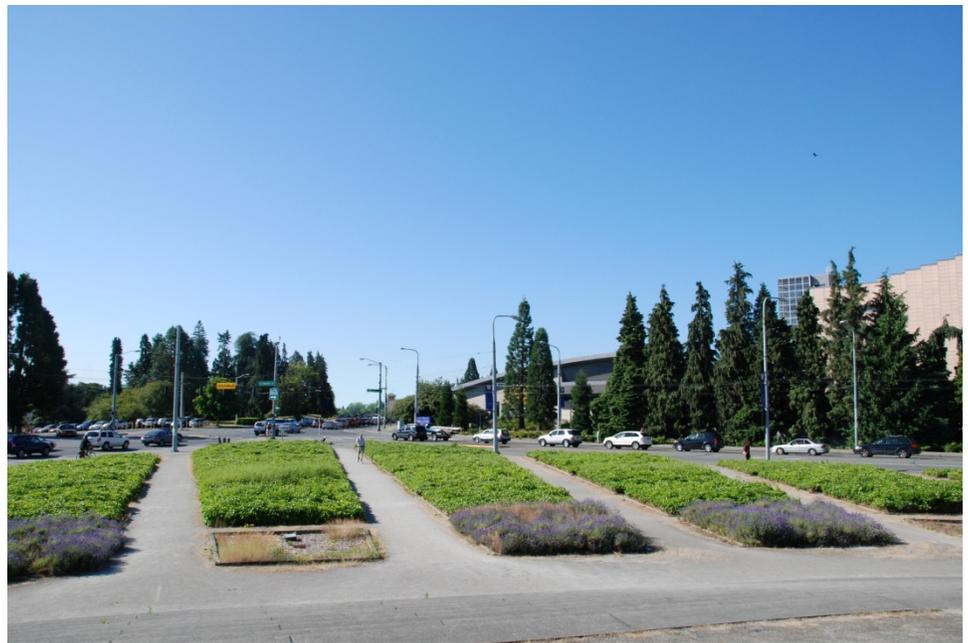
Exhibit 2-28. Montlake Triangle—Viewpoint 27 (update to Exhibit 2-10 of the 2009 discipline report)

- Physical terminus of historic Olmsted Rainier Vista
- Photograph taken prior to removal of specimen trees in UW Open Space for U Link
- University of Washington Medical Center and Husky Stadium

- Tower of new bascule draw bridge in distance
- Sound Transit U Link transit stop just outside left side of photograph

Looking southeast toward Montlake Bridge and Mount Rainier

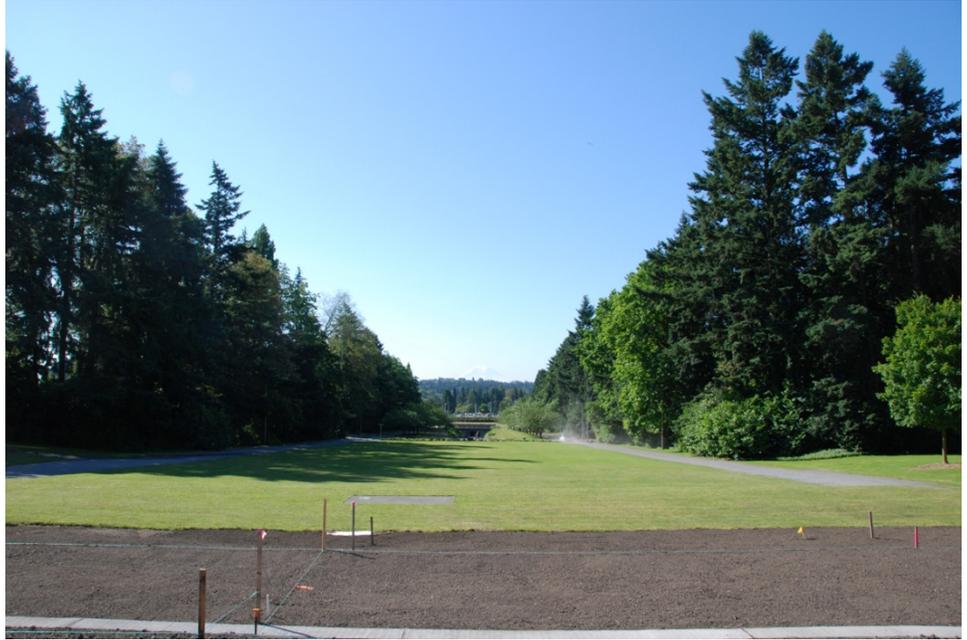
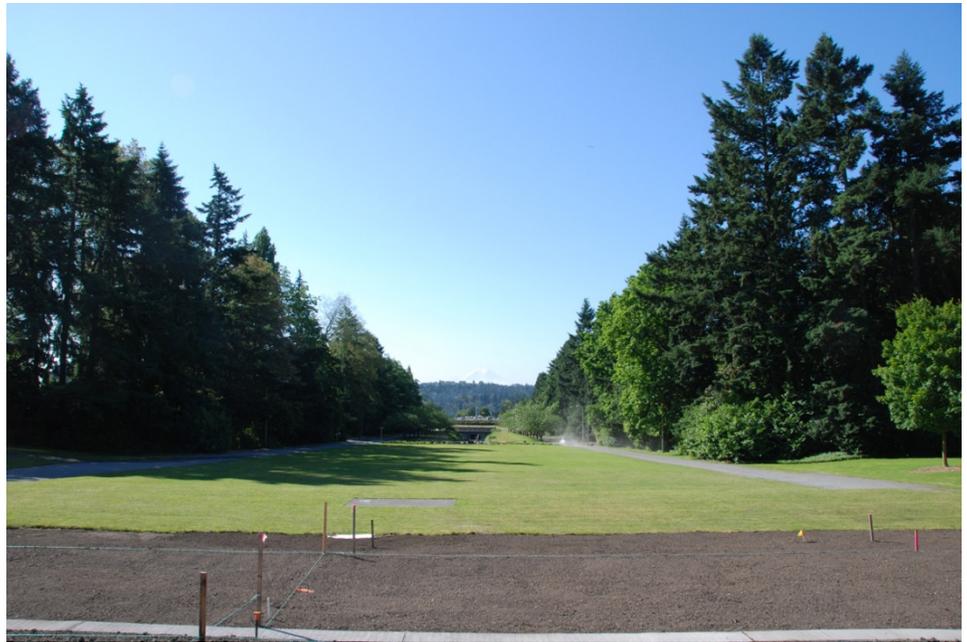
Exhibit 2-29. Drumheller Fountain—Viewpoint 28 (update to Exhibit 2-28 of the 2009 discipline report)

- Historic Olmsted Rainier Vista
- Flowering cherry trees and mature conifer borders
- Entrance to Triangle parking garage visible in lower center

- Removal of specimen trees on Montlake Cut near second bascule draw bridge

Looking southeast along Rainier Vista toward Montlake Triangle and Mount Rainier

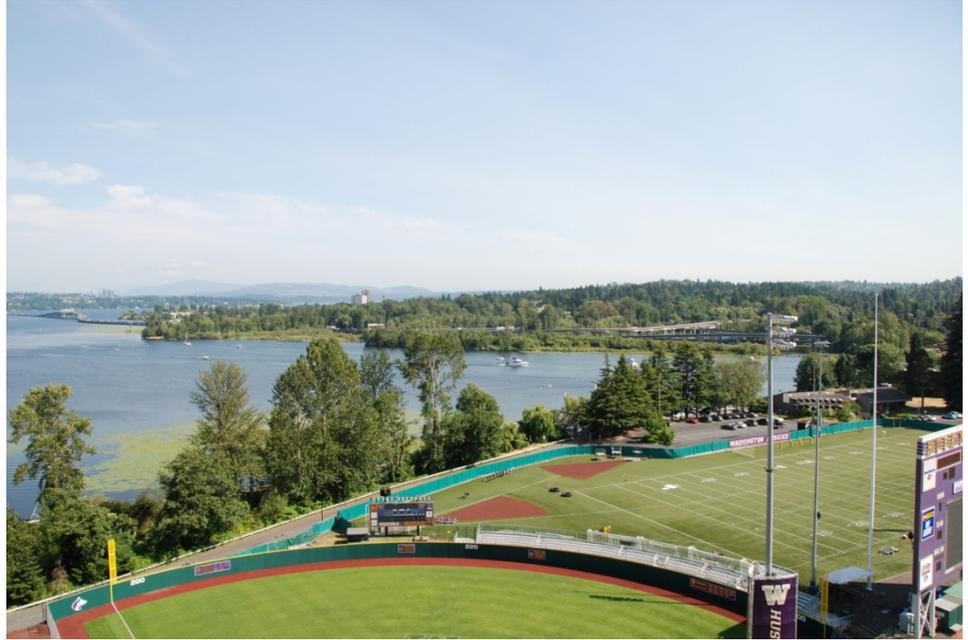
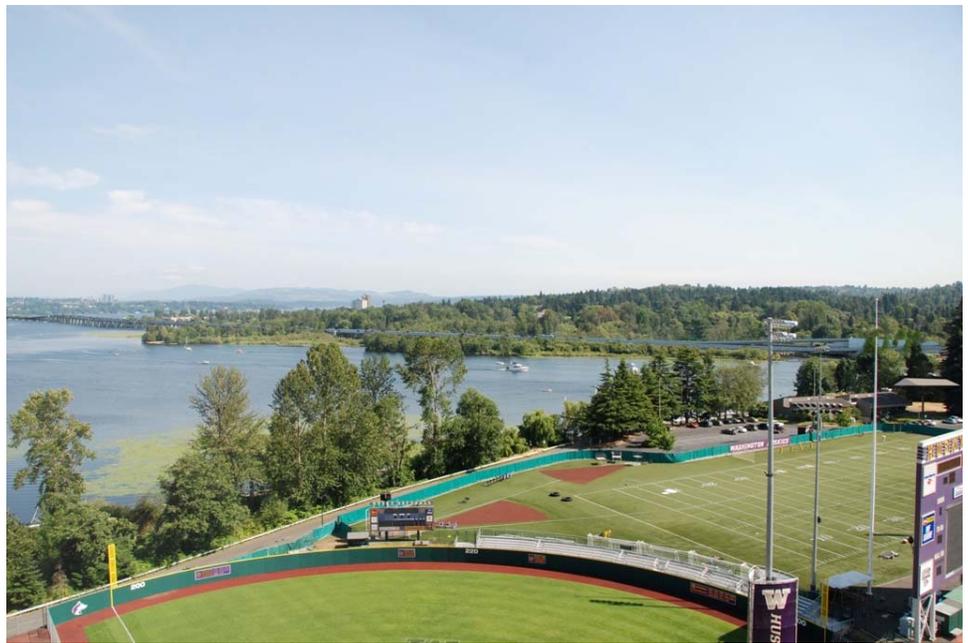
Exhibit 2-30. Husky Stadium, northeast benches—Viewpoint 29 (update to Exhibit 2-29 of the 2009 discipline report)
Looking southeast toward Union Bay and Lake Washington

- Views to Union Bay, Madison Park, and Lake Washington
- Boat traffic
- Washington Park Arboretum in middle distance
- Evergreen Point Bridge and approaches in far distance

- 6-lane bridge
- Higher and wider Evergreen Point Bridge
- High rise bridge straightened and realigned 190 feet north at west end

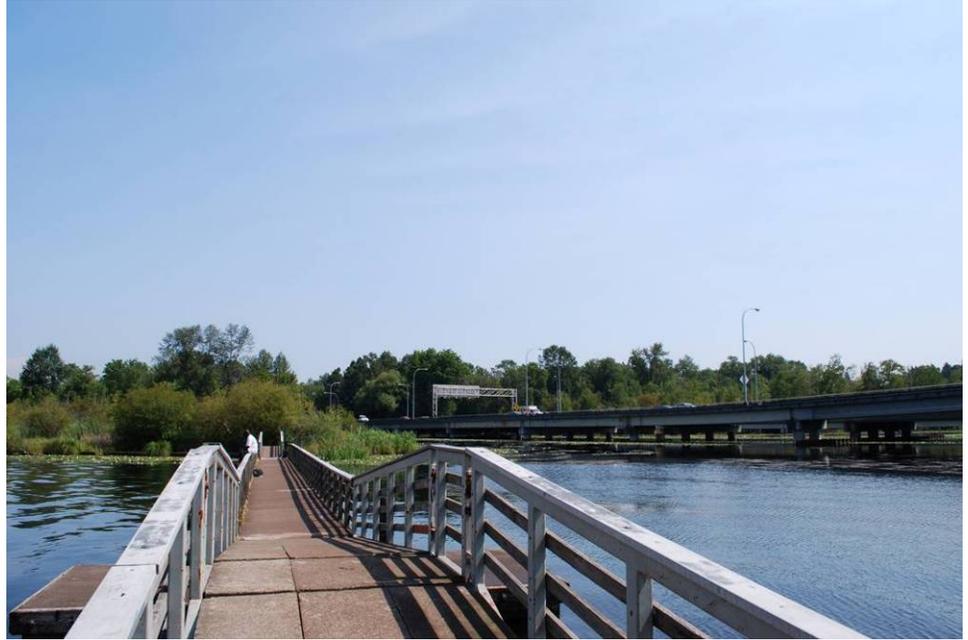
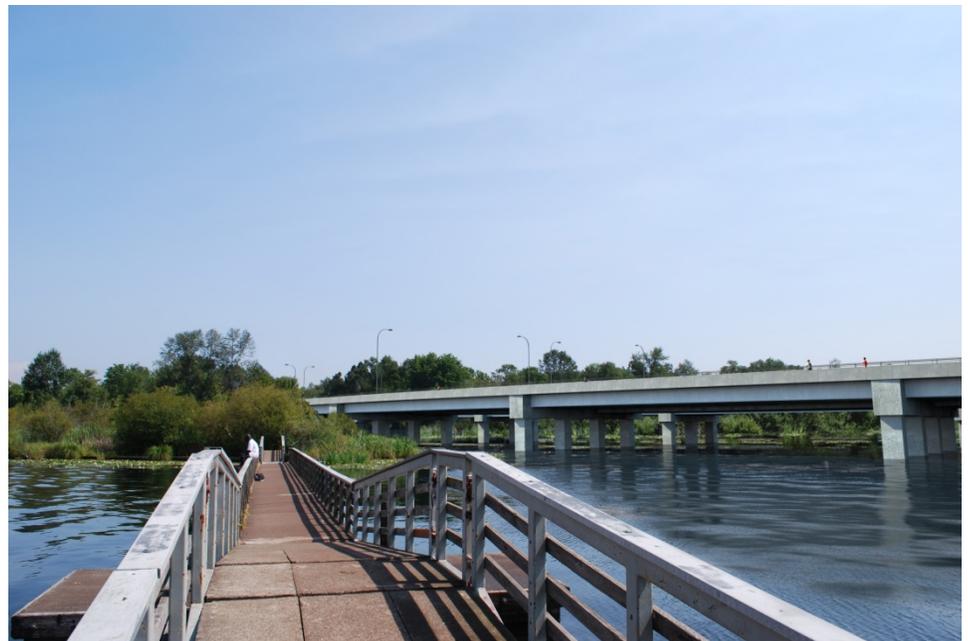
Exhibit 2-31. Marsh Island Trailhead at MOHAI—Viewpoint 32

- 4-lane west approach bridge running parallel to Marsh Island
- Beginning of Arboretum Waterfront Trail
- Marsh Island in middle distance

- 6-lane west approach bridge

Looking east along Marsh Island boardwalk between MOHAI site and Marsh Island

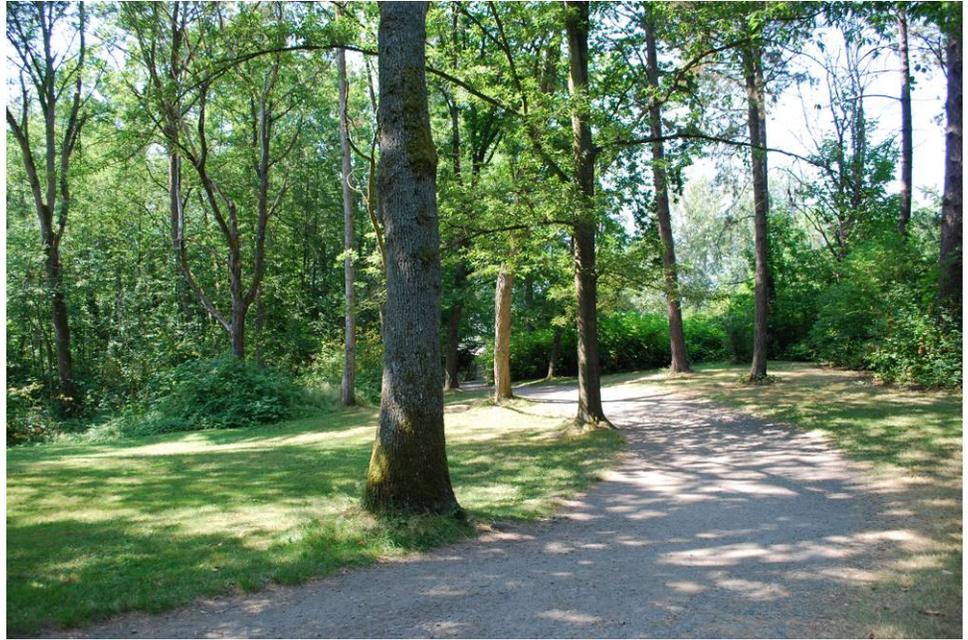
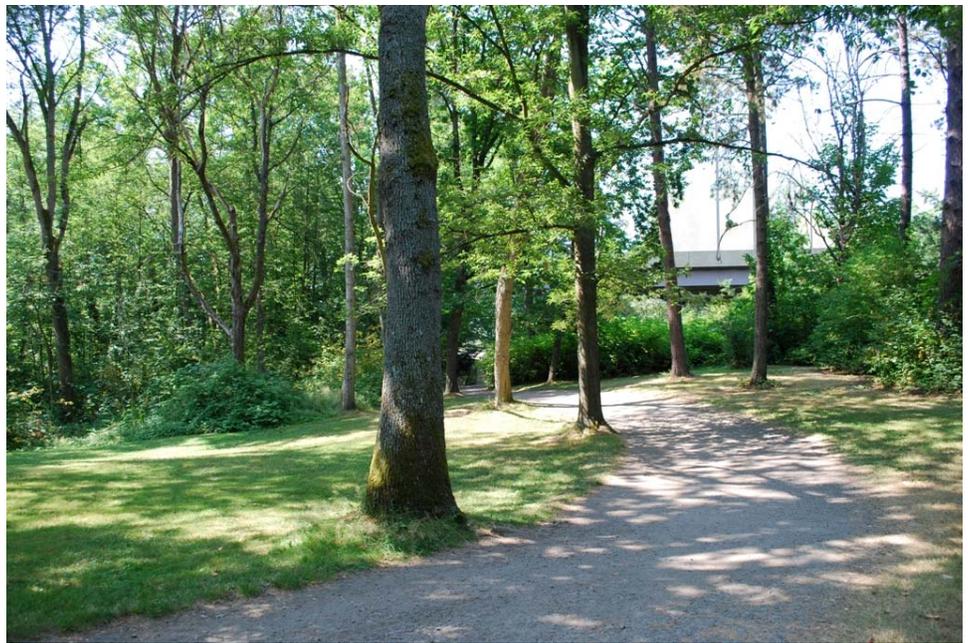
Exhibit 2-32. Foster Island Trail, south of SR 520— Viewpoint 35

- Foster Island Trail south of SR 520
- Pedestrian tunnel to north Foster Island just visible in center of image, to right of large foreground tree

- 6-lane bridge
- 4 foot high traffic barriers
- Wider pedestrian under-crossing

Looking northwest from south branch of Foster Island Trail toward SR 520

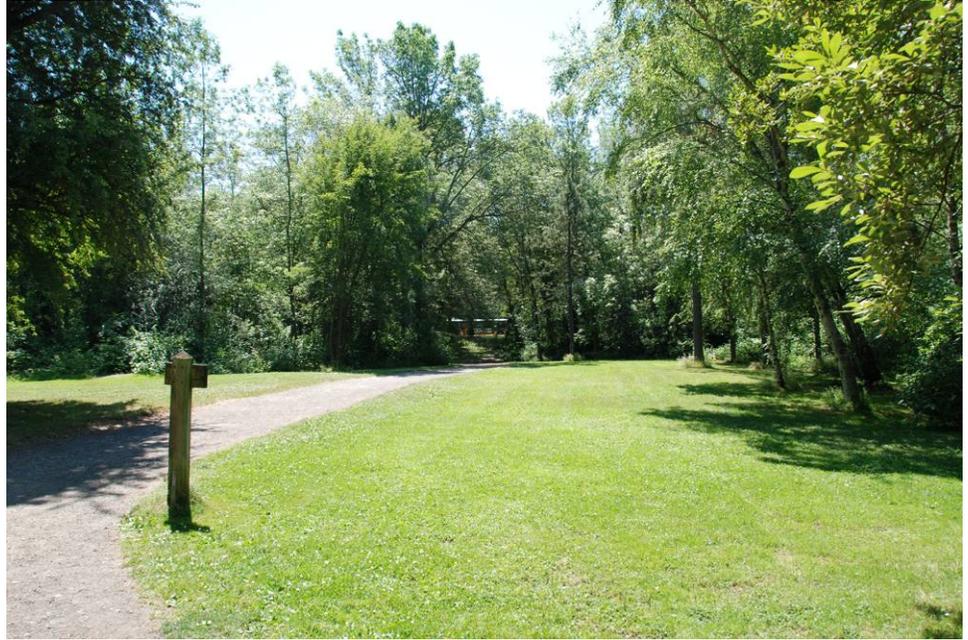
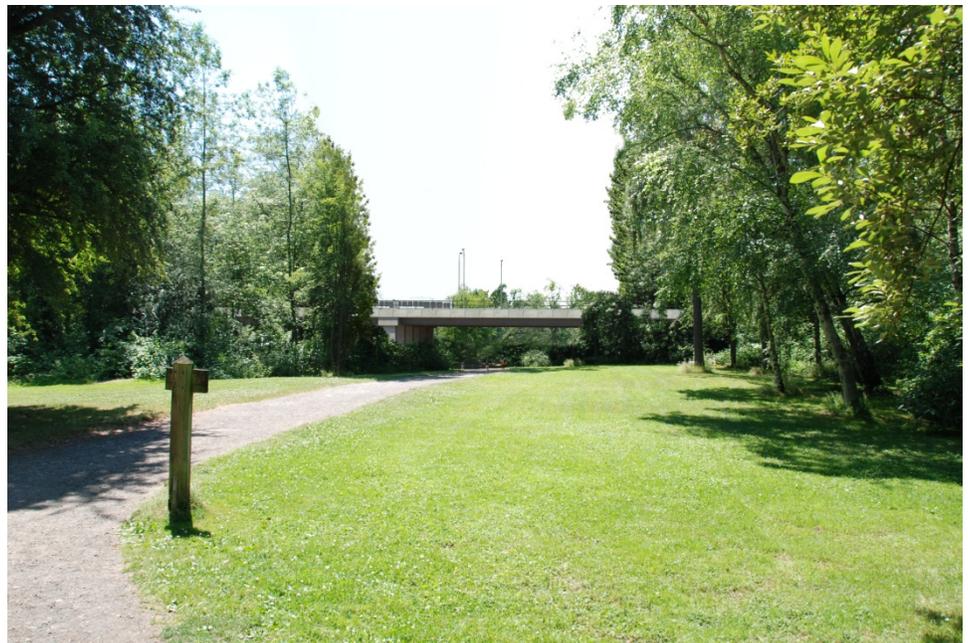
Exhibit 2-33. Foster Island Trail north of SR 520—Viewpoint 37

- SR 520 (bus is just visible) screened by mature roadside trees and shrubs

- Roadside plantings still young; will screen part of the bridge when mature
- Improved connections between north and south Foster Island

Looking south from north Foster Island along the trail toward SR 520

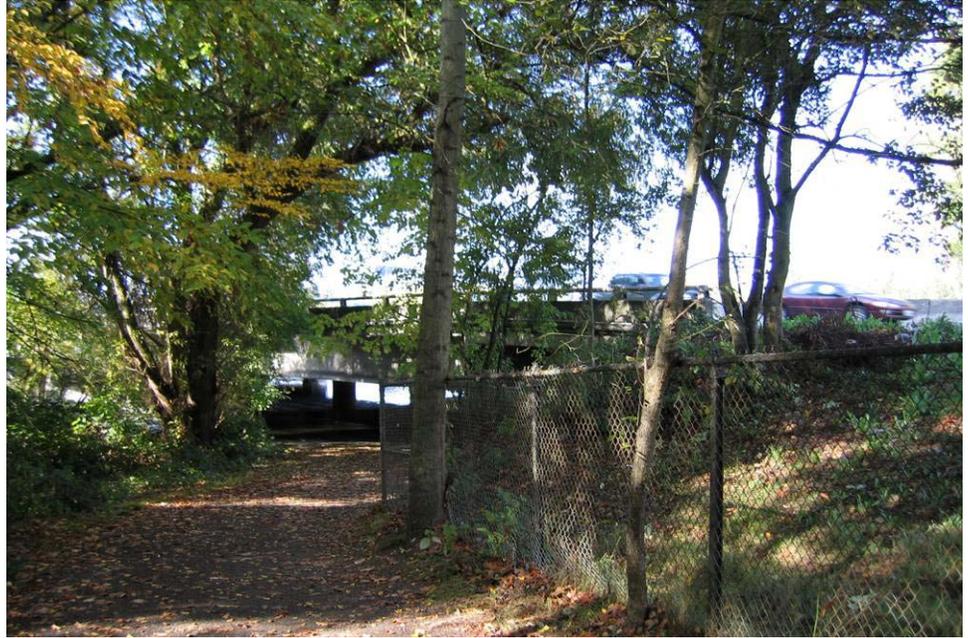
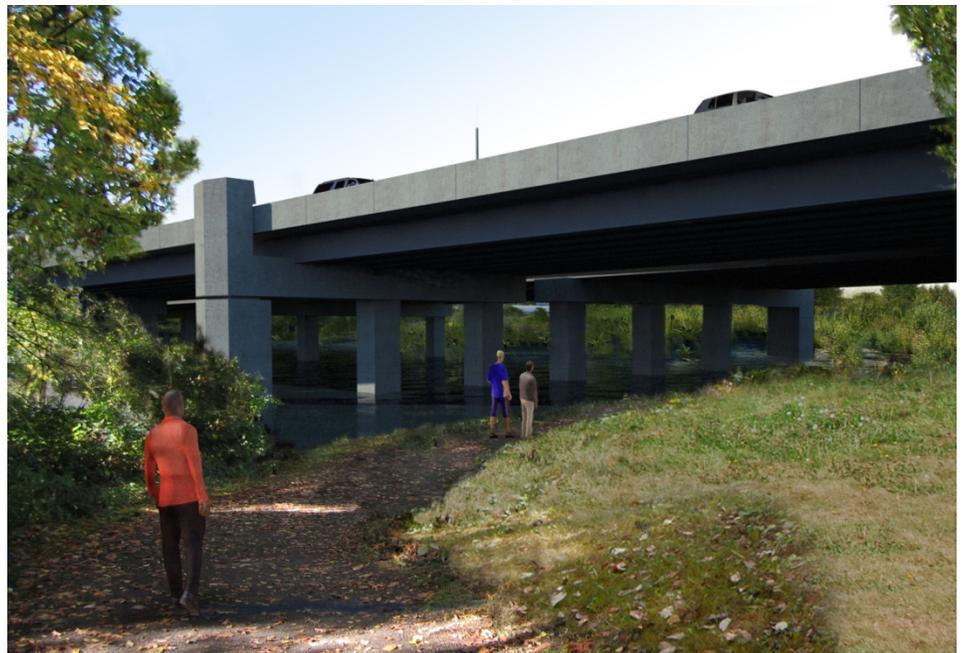
Exhibit 2-34. Foster Island Trail Pedestrian Tunnel—Viewpoint 36

- Approach to pedestrian tunnel under west side of 4-lane bridge
- Chain link fence marking right-of-way boundary
- Compacted earth trail and Union Bay shoreline

- New west approach bridge pedestrian and bicycle path

Looking northwest at south entrance of Foster Island pedestrian tunnel under SR 520

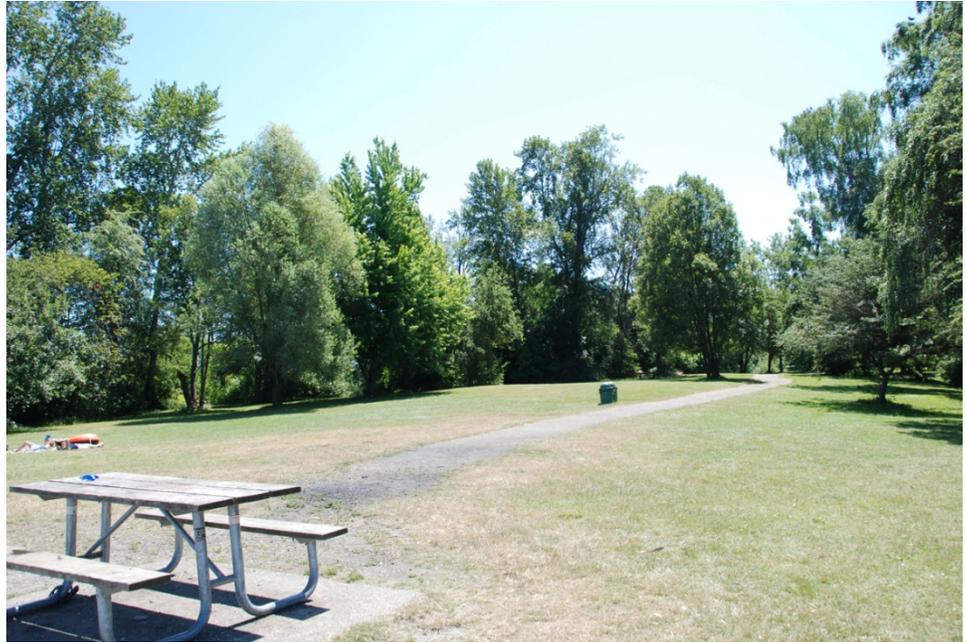
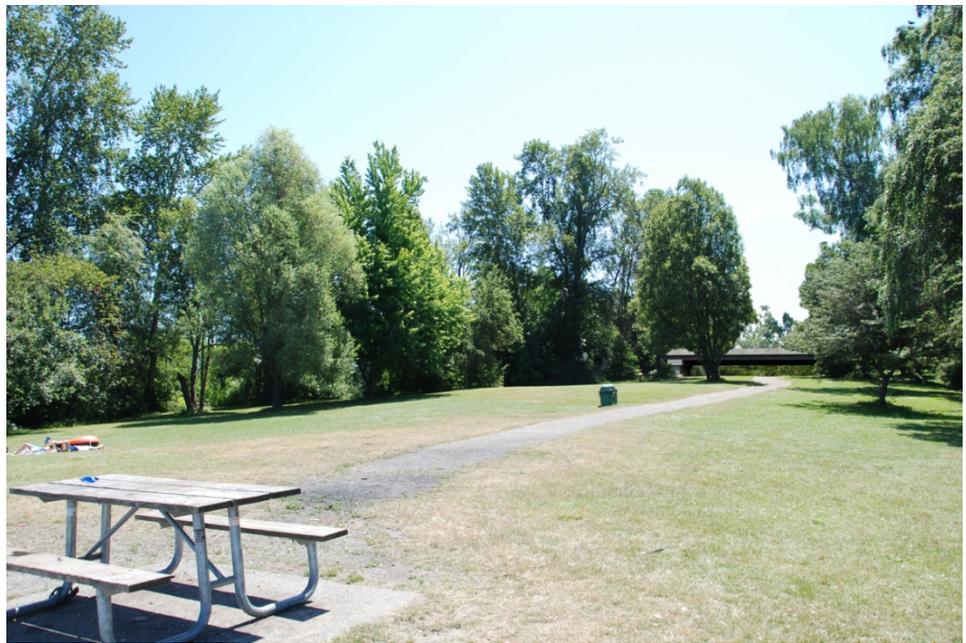
Exhibit 2-35. Picnic and swimming area on North Foster Island—Viewpoint 38 (update to Exhibit 2-36 of the 2009 discipline report)

- North Foster Island picnic area at shoreline
- Mature woods

- 6-lane bridge at 13 to 15 feet above ground
- No change to North Foster Island

Looking south from north Foster Island shoreline toward SR 520

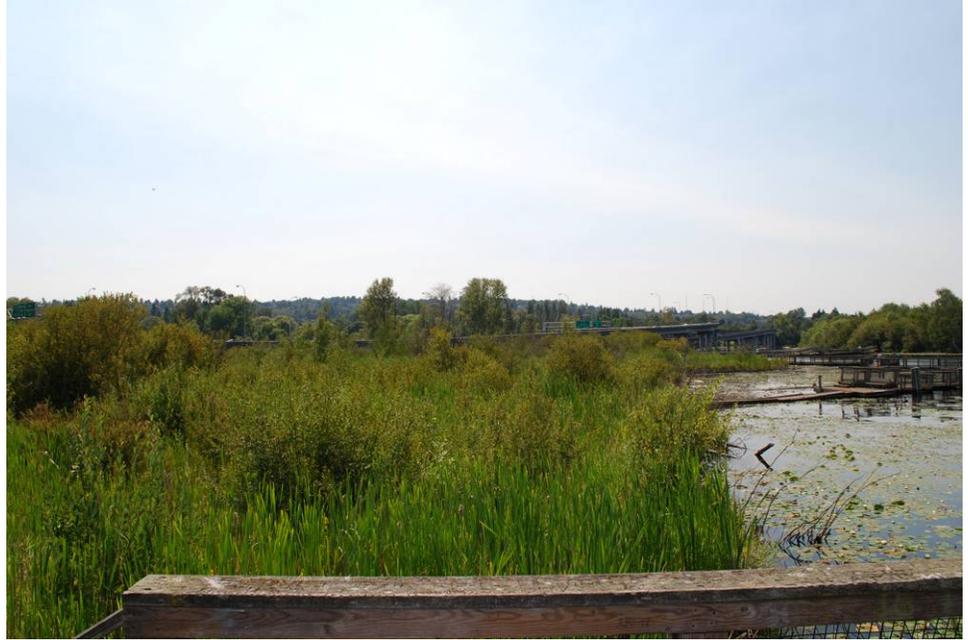
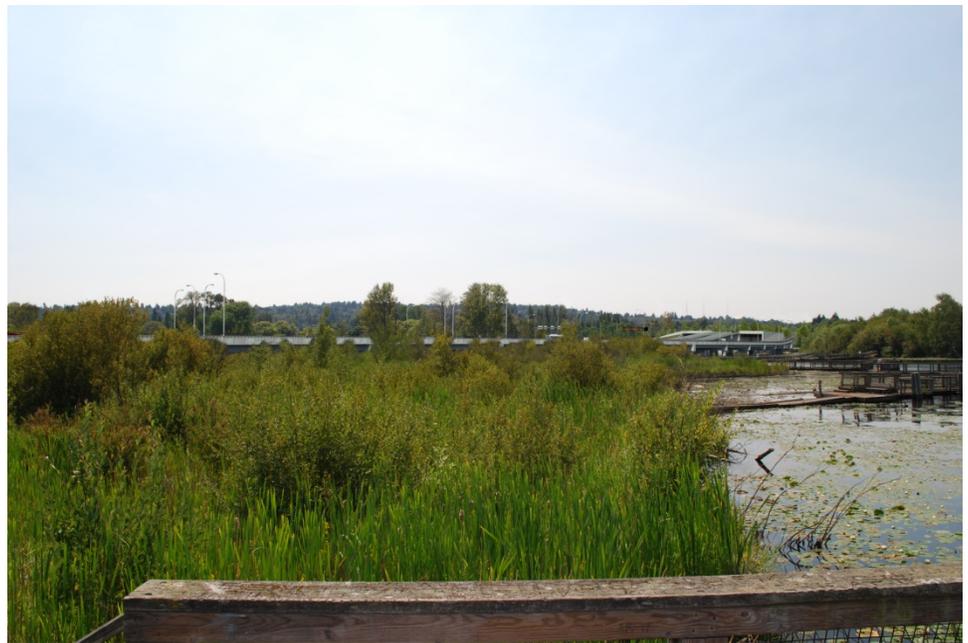
Exhibit 2-36. Observation deck on Foster Island Trail—Viewpoint 39
Looking southwest across Foster Island marsh toward Montlake

- Arboretum Waterfront Trail on boardwalks between Foster Island and Marsh Island
- Dense marsh vegetation

- 6-lane west approach bridge
- East portal of Montlake lid visible in distance

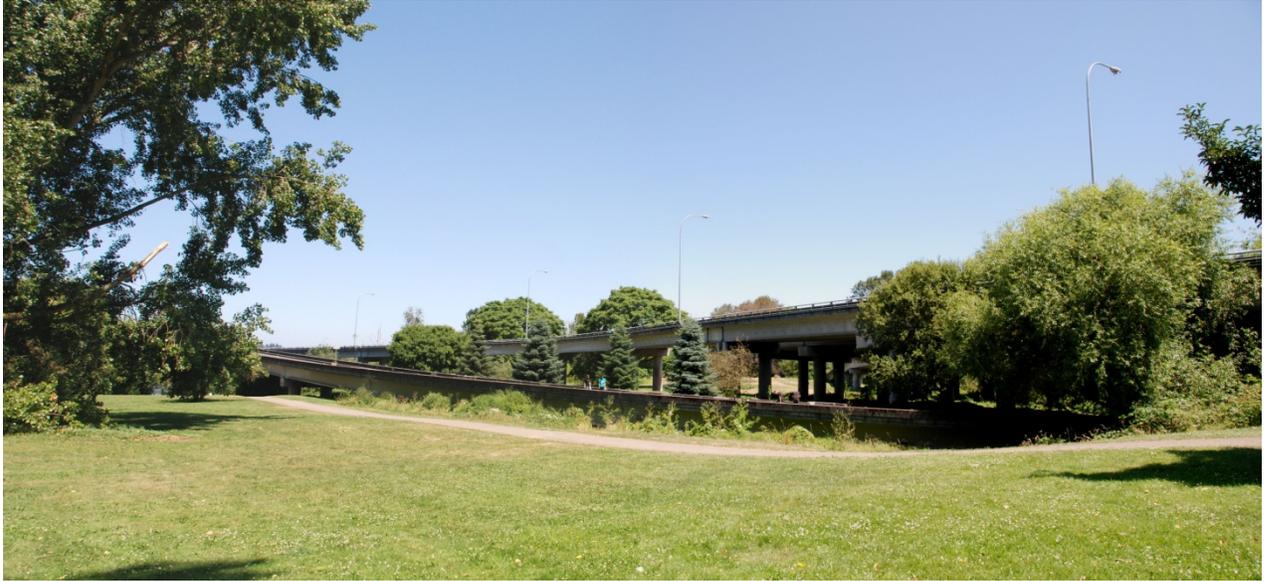
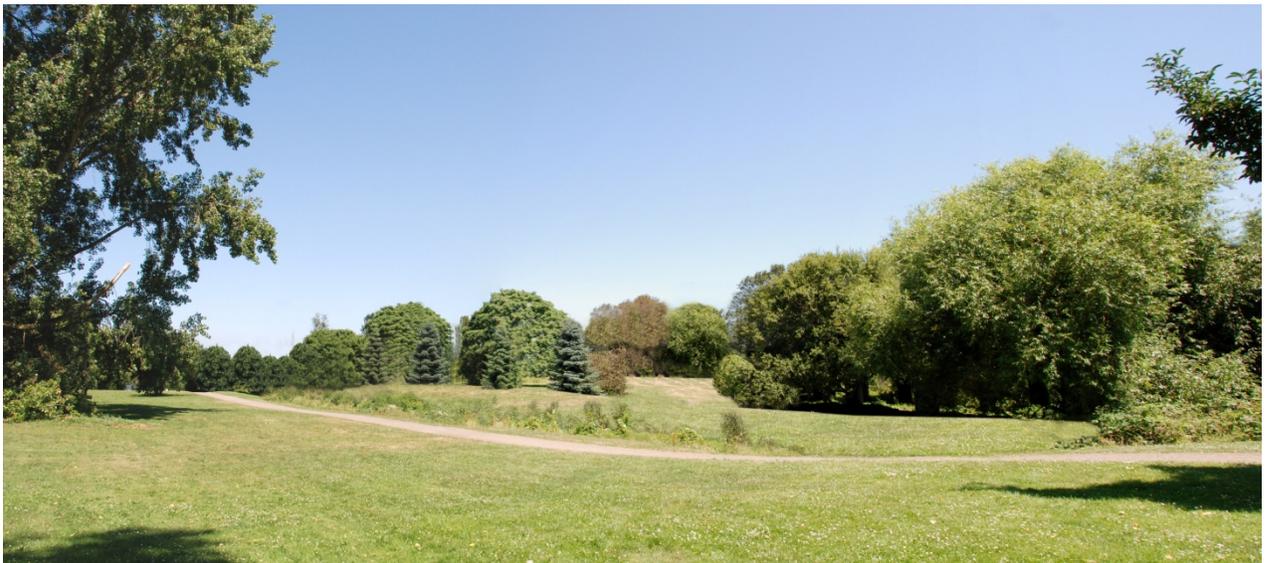
Exhibit 2-37. Lake Washington Boulevard off-ramps—Viewpoint 33

- R. H. Thompson Ramps
- WSDOT “peninsula” used for passive recreation
- Informal trail to shoreline

- Ramps removed
- Mature trees protected

Looking northeast and east across WSDOT peninsula at Lake Washington Boulevard ramps

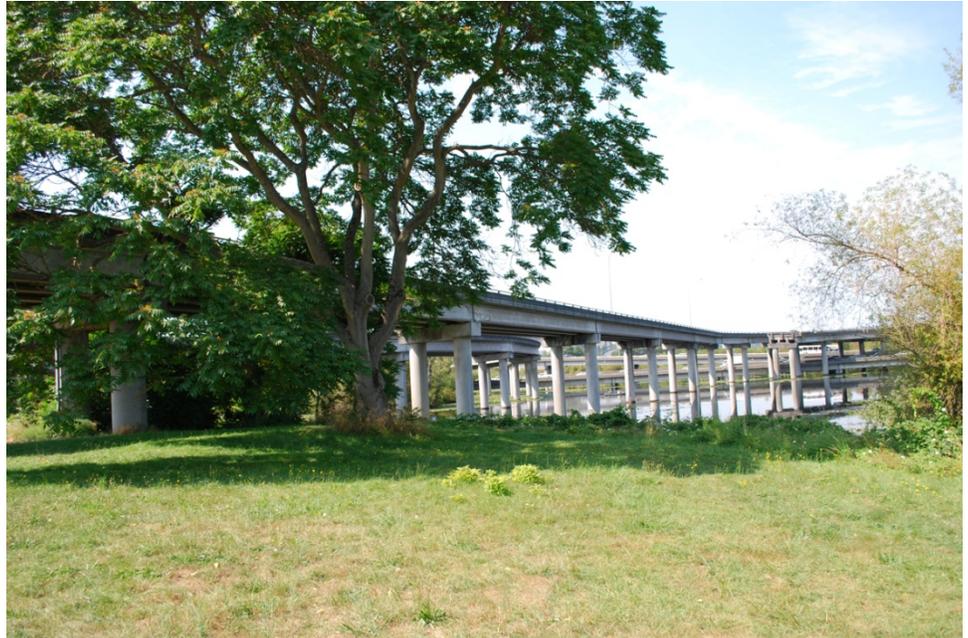
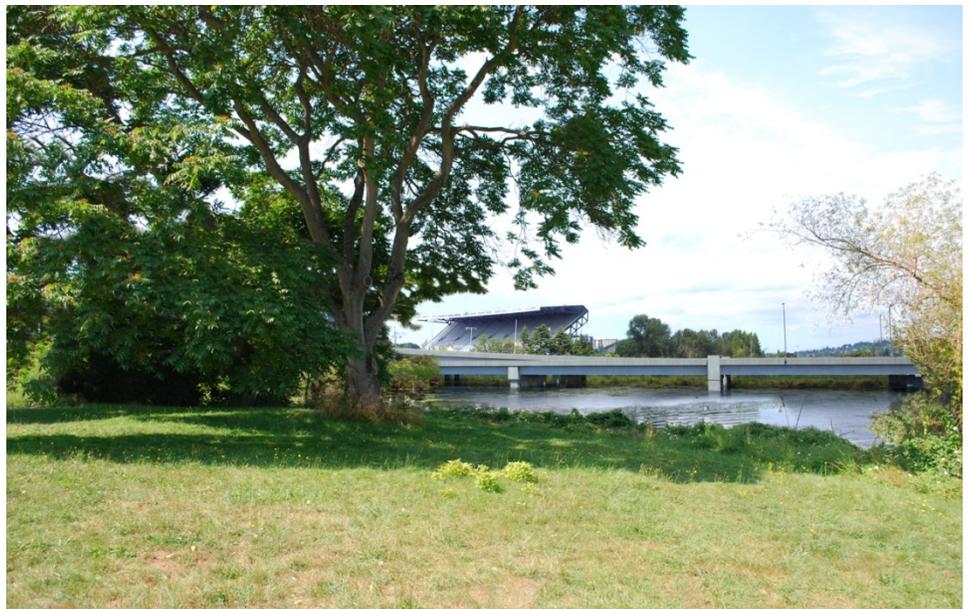
Exhibit 2-38. WSDOT peninsula north of Arboretum ramps—Viewpoint 34

- Lake Washington Boulevard east-bound on-ramps
- Informal recreation uses

- Lake Washington Boulevard and R. H. Thompson ramps removed
- 6-lane west approach bridge in middle distance
- View of Husky Stadium in distance

Looking west across WSDOT peninsula toward Husky Stadium

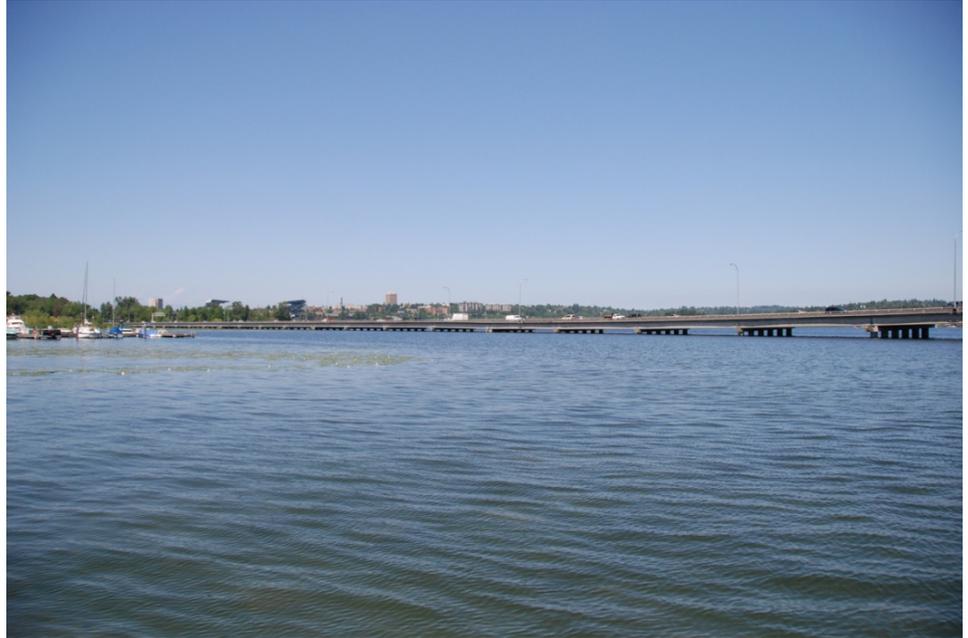
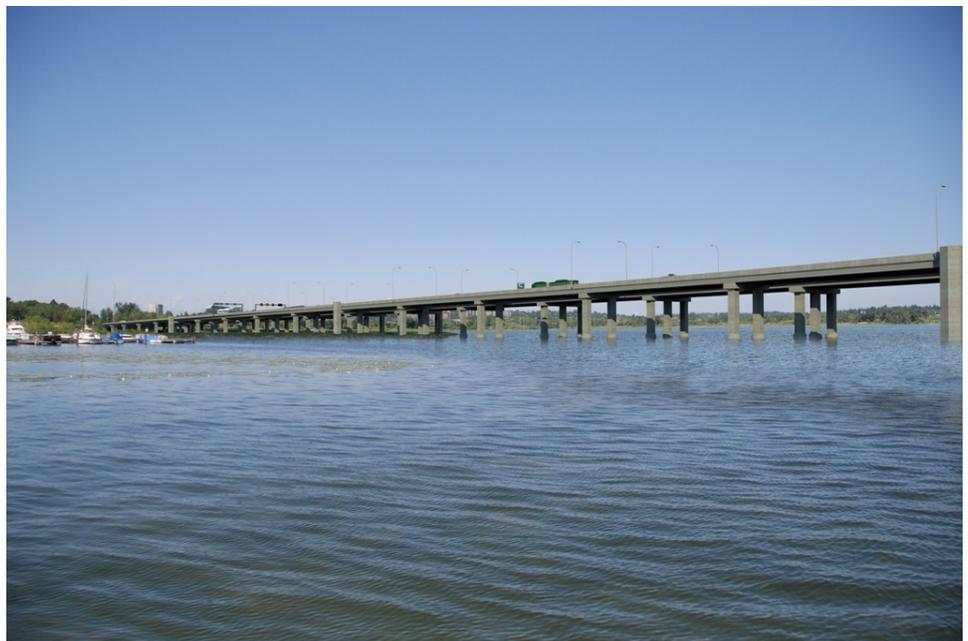
Exhibit 2-39. Edgewater Apartments in north Madison Park—Viewpoint 40 (update to Exhibit 2-17 of the 2009 discipline report)
Looking northwest toward SR 520 West Approach Bridge and Husky Stadium

- 4-lane bridge
- View of south Union Bay
- Column spacing at 100 feet on center
- Husky Stadium in distance (left of center)
- Boat traffic

- Wider and higher 6-lane bridge
- More open view into north Union Bay
- Column spacing at 250 feet on center
- ITS gantry (visible in front of Husky Stadium roof line)

Transit bus on bridge (center)

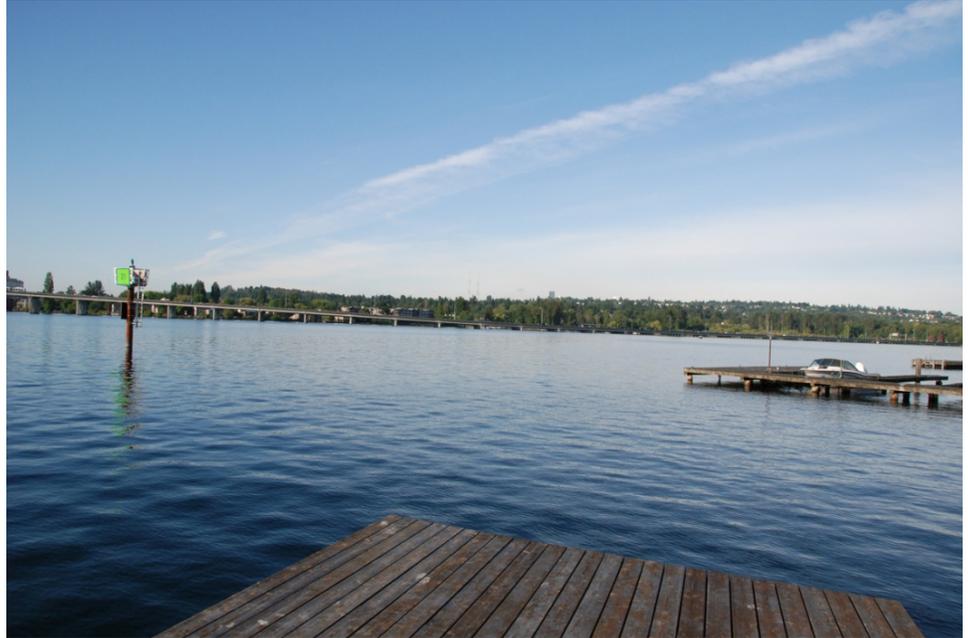
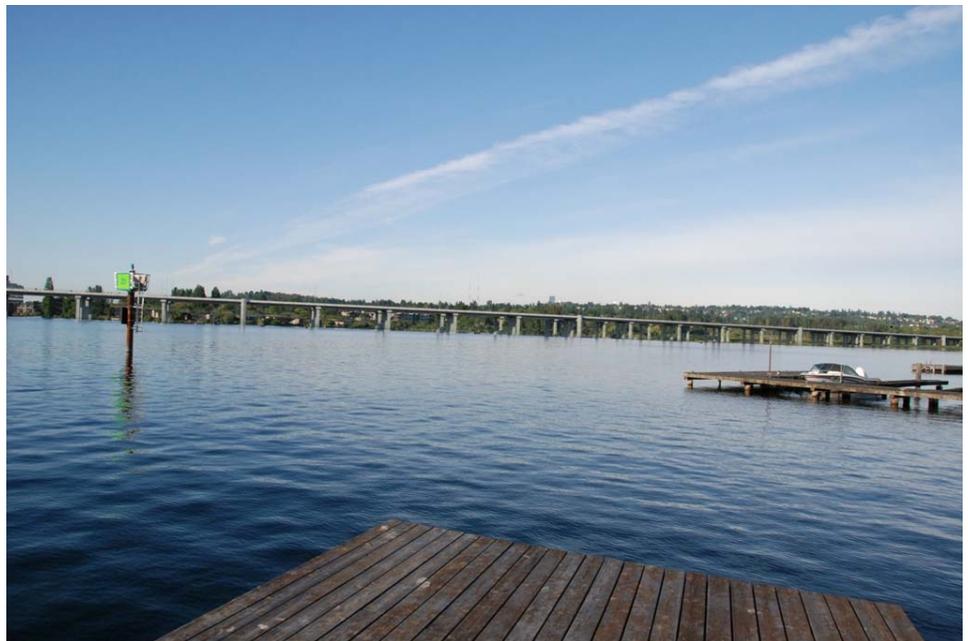
Exhibit 2-40. Webster Point in Laurelhurst—Viewpoint 41 (update to Exhibit 2-41 of the 2009 discipline report)

- Side view (profile) of West Approach Bridge
- View of north Union Bay
- View of North Madison Park and Arboretum in background
- Private docks in foreground

- Wider and higher 6-lane bridge
- Bridge realigned to north
- West Approach Bridge more visible due to height and obscures view of Seattle shoreline

Looking southwest from private dock toward West Approach Bridge

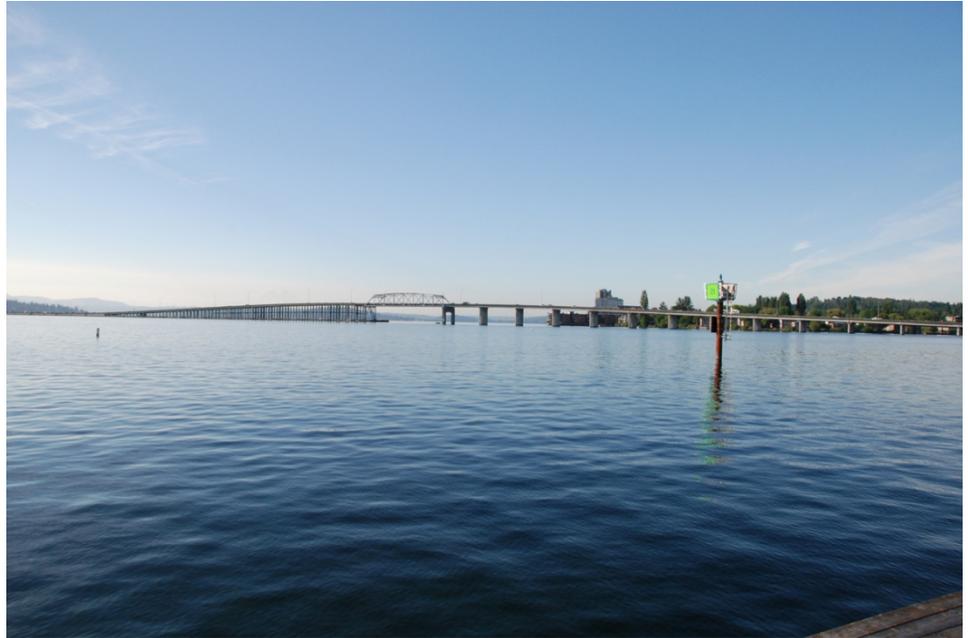
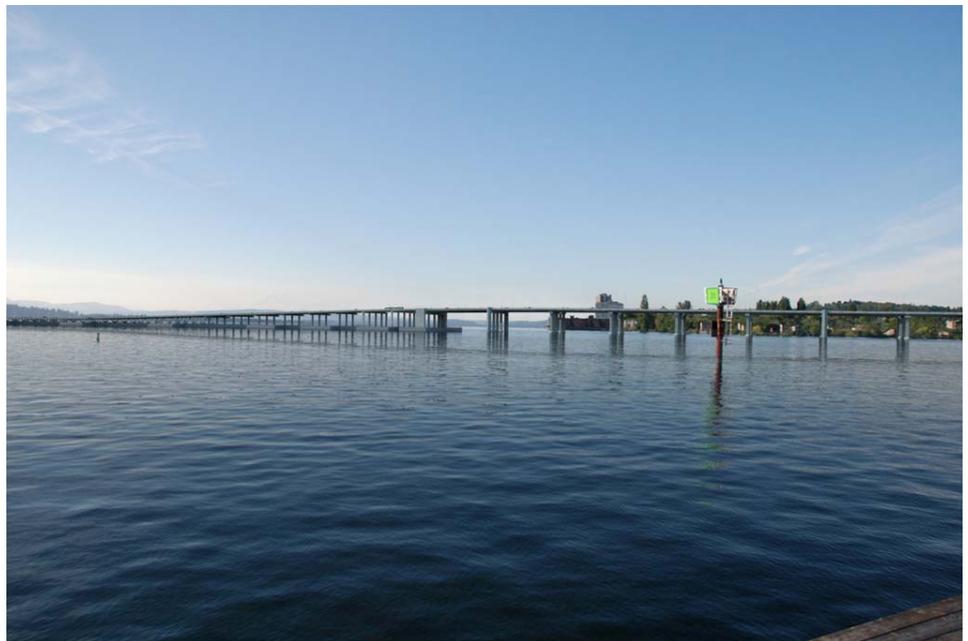
Exhibit 2-41. Webster Point in Laurelhurst—Viewpoint 42 (update to Exhibit 2-39 of the 2009 discipline report)

- Side view (profile) of west high rise with overhead truss structures
- Column spacing at 100 feet on center
- View of Lake Washington
- North Madison Park visible in distance behind West Approach Bridge

- West high rise and West Approach Bridge realigned 190 feet north (toward viewer)
- No overhead truss
- Bridge more noticeable due to increased height and closer proximity

Looking southeast across Union Bay toward Madison Park and West Approach Bridge
