Attachment 3

Visual Quality Assessment Matrix

SR 520, I-5 to Medina: Bridge Replacement and HOV Project

VISUAL QUALITY ASSESSMENT

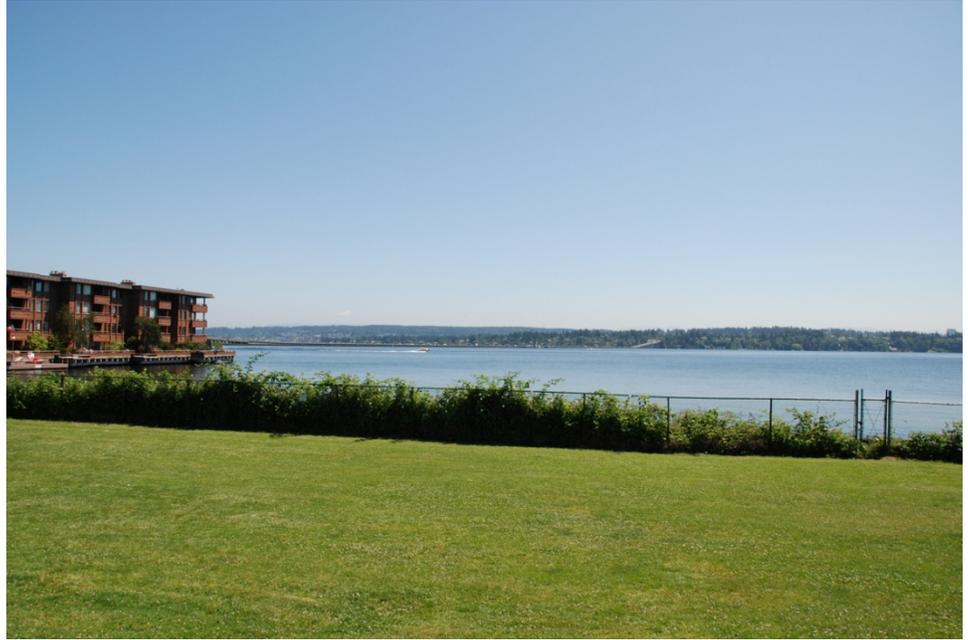
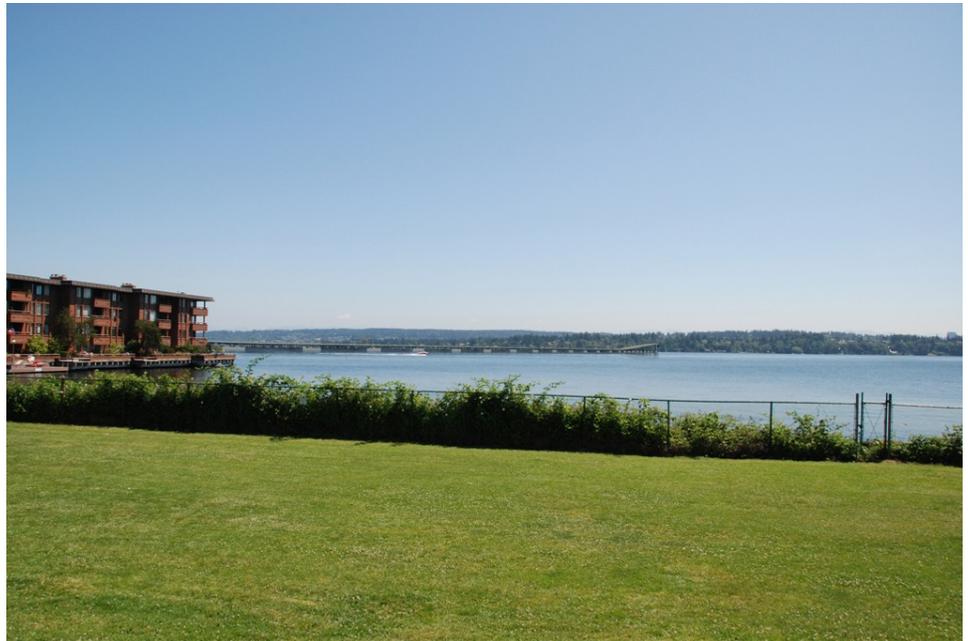
Exhibit 2-42. Lynn Street Park in Madison Park—Viewpoint 42 (update to Exhibit 2-38 of the 2009 discipline report)

- Shoreline park in Madison Park
- Evergreen Point Bridge and East Approach
- Road deck approximately 8 feet above water
- Medina shoreline in distance
- Cascade Mountains far in distance

- Road deck approximately 20 feet above water
- Slight increase in visibility of floating bridge

Looking northeast across Lake Washington at Evergreen Point Bridge

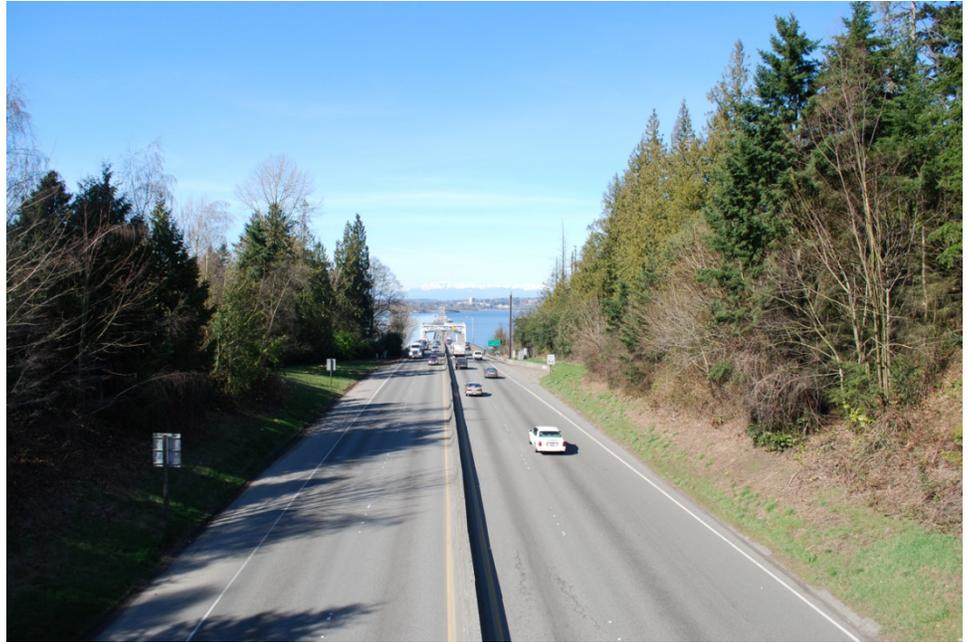
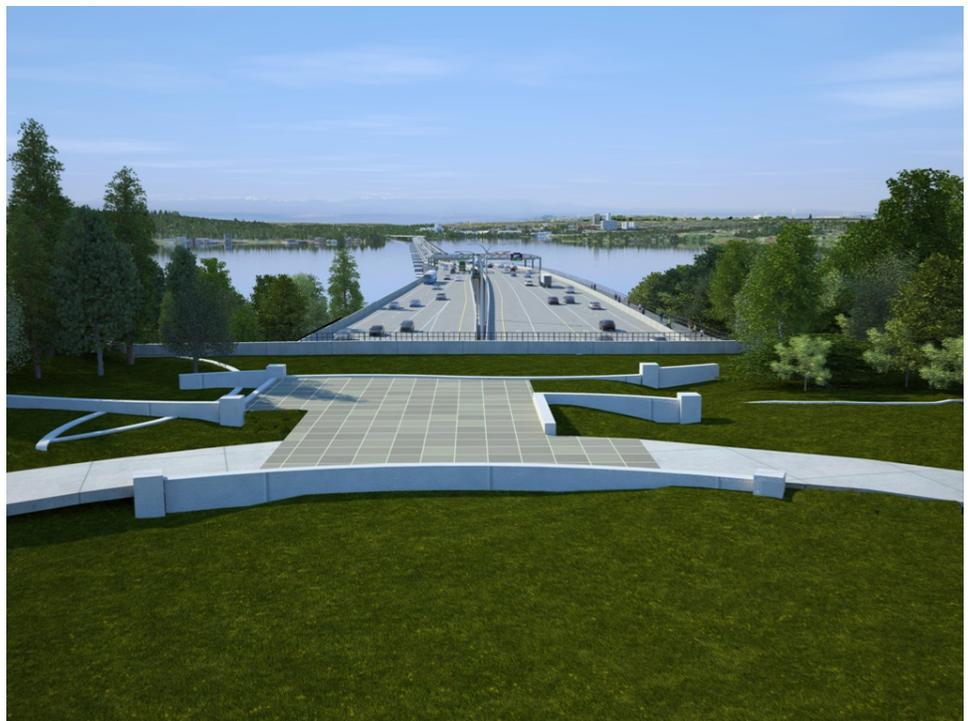
Exhibit 2-43. Midway on west side of Evergreen Point Road (76th Avenue NE) bridge—Viewpoint 43 (update of Exhibit 2-40 of 2009 discipline report)

- 4-lane mainline
- Overhead truss structure of East Approach
- Mature vegetation along both side of roadway
- Narrow views of Olympic Mountains and Lake Washington

- 500-foot lid at Evergreen Point Road
- Wider and higher 6-lane Evergreen Point bridge
- Evergreen Point bridge realigned 160 feet north on east end
- ITS structure visible in middle distance
- More open views across Lake Washington

Looking west across the west part of the Evergreen Point lid at floating bridge and Lake Washington

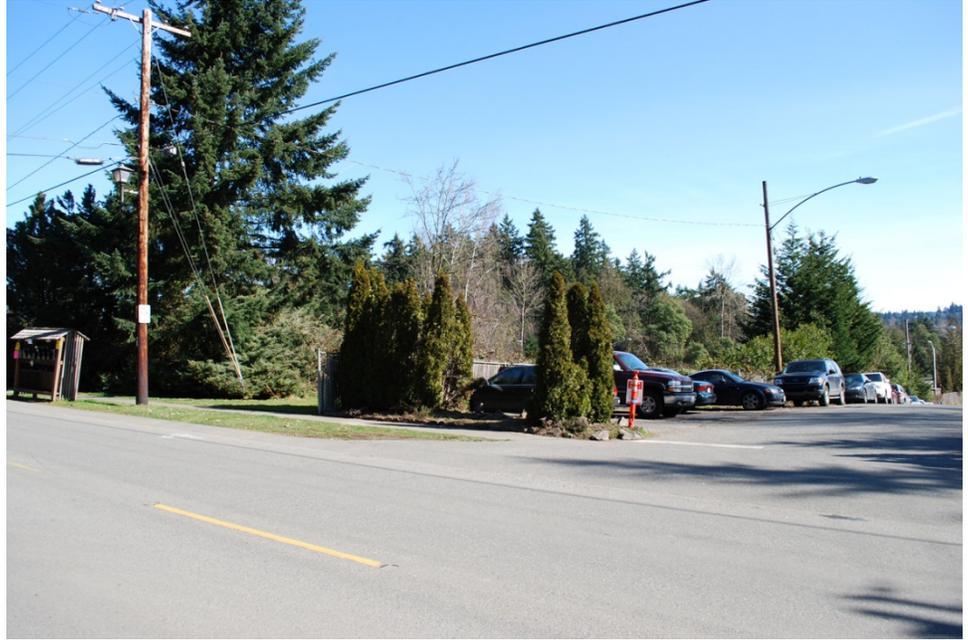
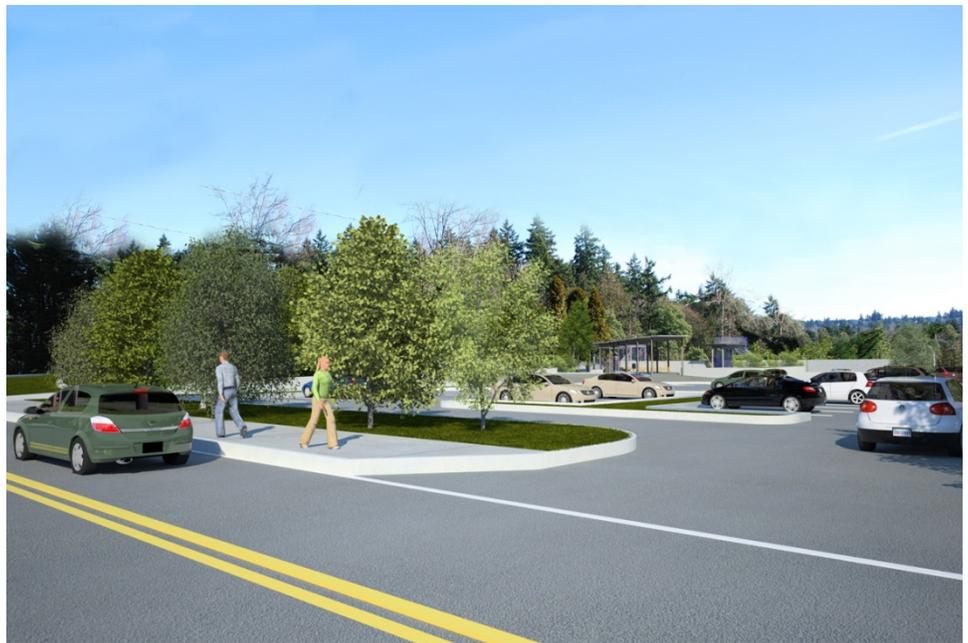
Exhibit 2-44. Evergreen Point Road NE near park-and-ride—Viewpoint 44 (update to Exhibit 2-41 of 2009 discipline report)
Looking across Evergreen Point Road NE and park-and-ride

- Two-lane Evergreen Road bridge over SR 520
- Paved park and ride at SE corner of bridge
- Access to bus stop
- Adjacent to Bellevue Christian School/ Three Points Elementary

- Approx. 60-stall Park and Ride
- 500-foot landscaped lid
- Access to center transit stops from lid
- Elevator towers and safety walls in middle distance
