RE: SR 202 Improvement Project: SR 520 to Sahalee Way
 WDFW HPA Permit **100299-8**

The Washington State Department of Transportation completed monitoring of the site on August 23rd, 2010 to determine survival of planted species for compliance with the above-listed HPA.

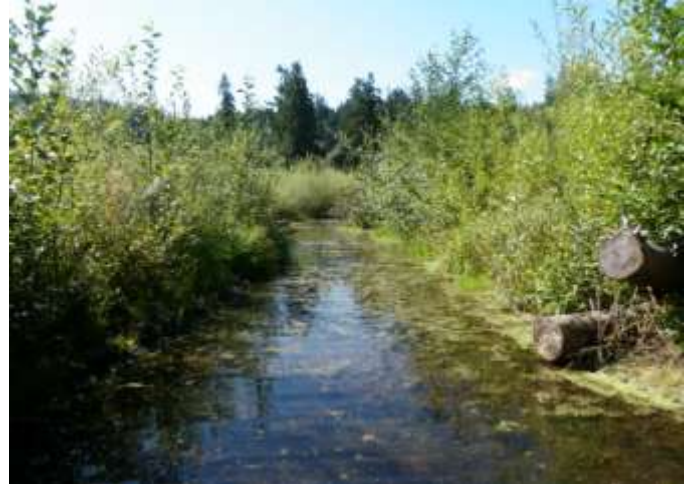
Photo 1 Turple Backwater Channel

Species present include Pacific willow (*Salix lucida* ssp. *lasiandra*) and Sitka willow (*Salix sitchensis*) (Photo 1). Most plantings showed vigorous growth and were approximately three meters tall at the time of monitoring. Signs of beaver activity were observed, nevertheless impacted plantings exhibited new growth.

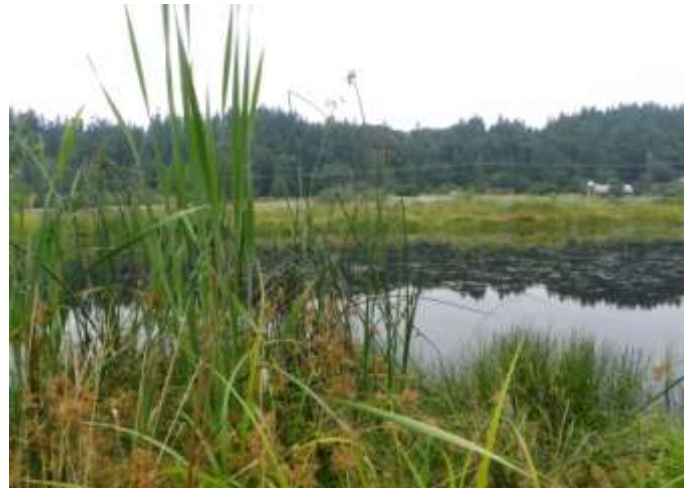
Photo 2 Happy Valley Backwater Channel

The water level of the backwater located at the SR 202 Happy Valley Mitigation site (Location #4) was especially high at the time of monitoring (Photo 2). As a result, there may be original plantings below the water line that were not included in this count.
