Alaskan Way Viaduct REPLACEMENT PROGRAM

July 2015

Repairing and enhancing the SR 99 tunneling machine

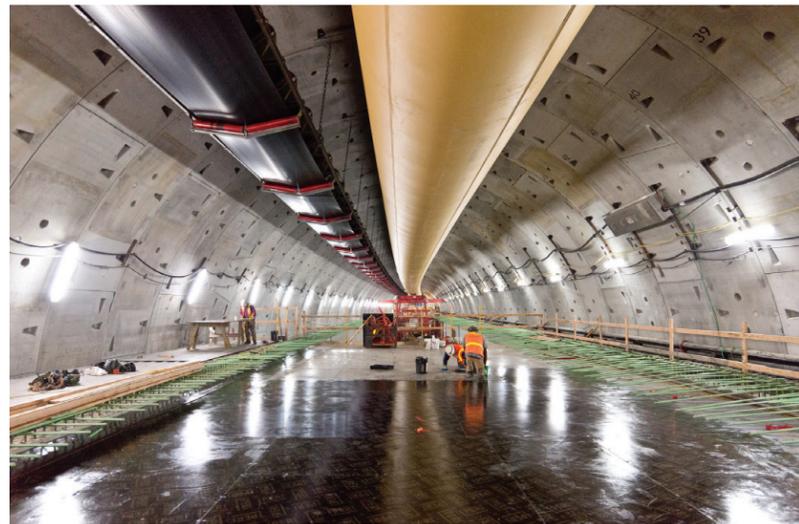
Construction of the roadway within the tunnel.

While crews repair the tunneling machine, significant work continues elsewhere along the SR 99 corridor. Crews are building ramps and highway connections at the tunnel's future north and south portals, and have built approximately 450 feet of double-deck roadway within the tunnel.

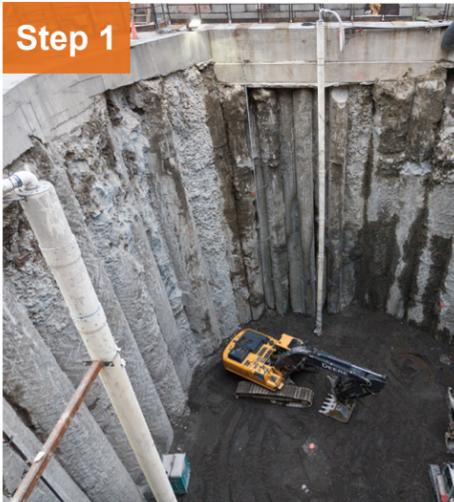
Build a 120-foot-deep access pit in front of the machine.

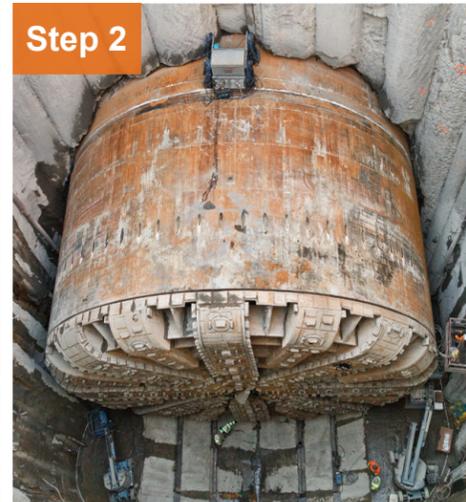
Drive the machine through the wall of the pit.

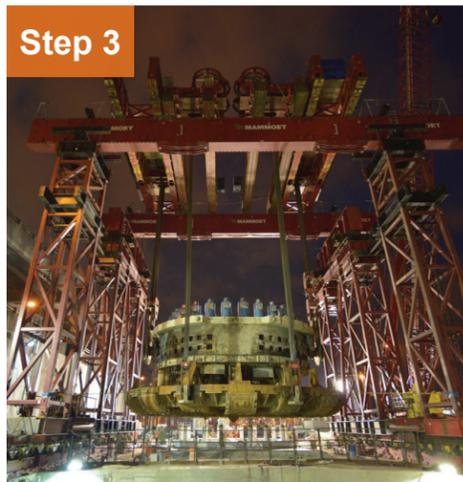
Lift the 2,000-ton front end of the machine to the surface for repairs.

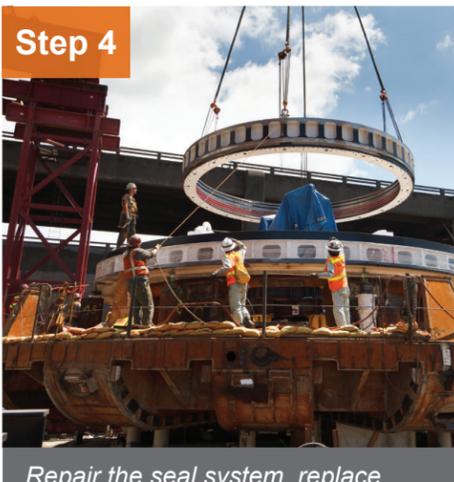
Repair the seal system, replace the main bearing and make enhancements to the machine.

- **New main bearing:** The main bearing allows the machine's cutterhead to rotate. The original main bearing is being replaced with a spare bearing that, per the tunnel contract, STP manufactured prior to the start of tunneling.

- **New seal system:** The seal system protects the main bearing from potentially damaging material like dirt and grit. STP is installing a new seal system that is more robust and easier to access from within the machine.

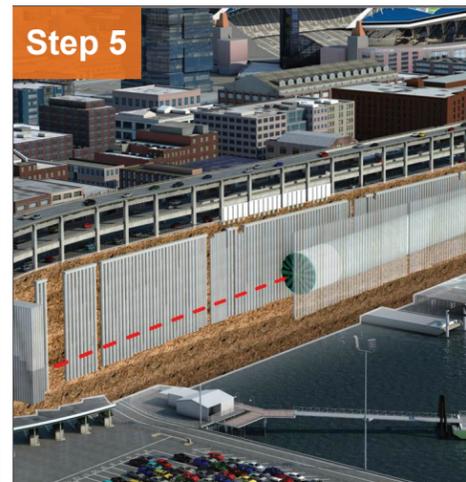
Reassemble the machine and resume tunneling.

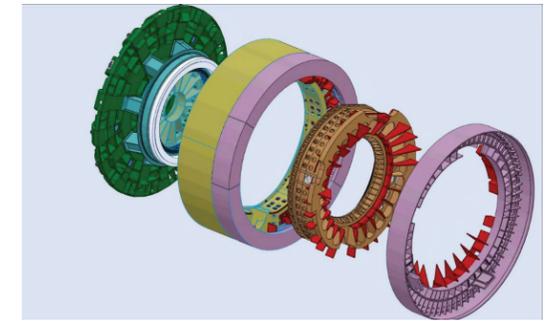
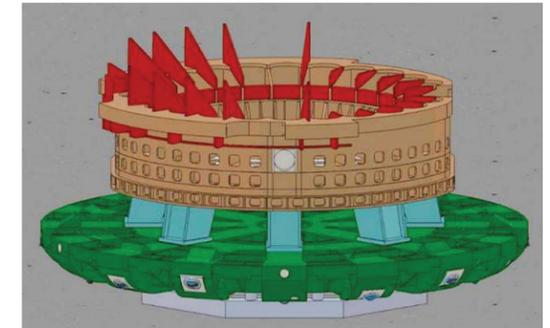
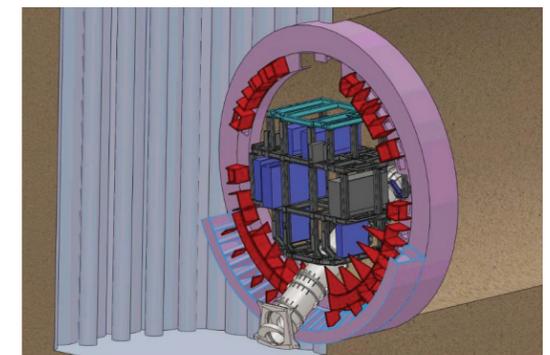
Red indicates steel that is being added to strengthen the machine. An animation and additional details of STP's repair plan is available at www.alaskanwayviaduct.org.

- **Enhanced monitoring systems:** Enhanced monitoring systems will alert crews of potential issues during mining.
- **Reinforcing steel:** New steel will strengthen the machine to protect its interior systems.

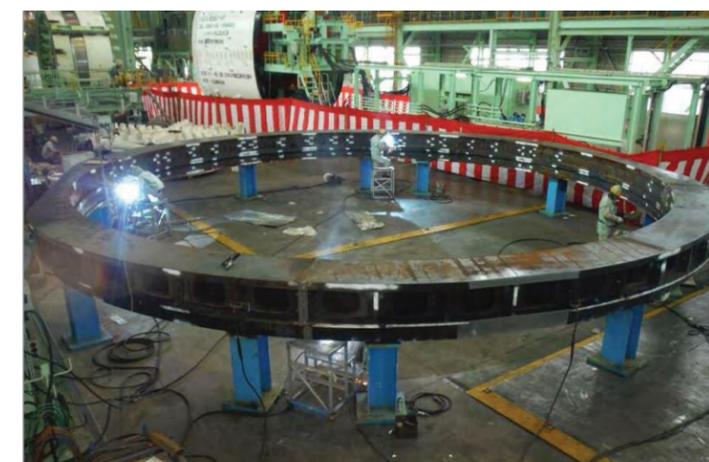
Crews in Osaka, Japan fabricate a new bearing block for the machine in June 2014.

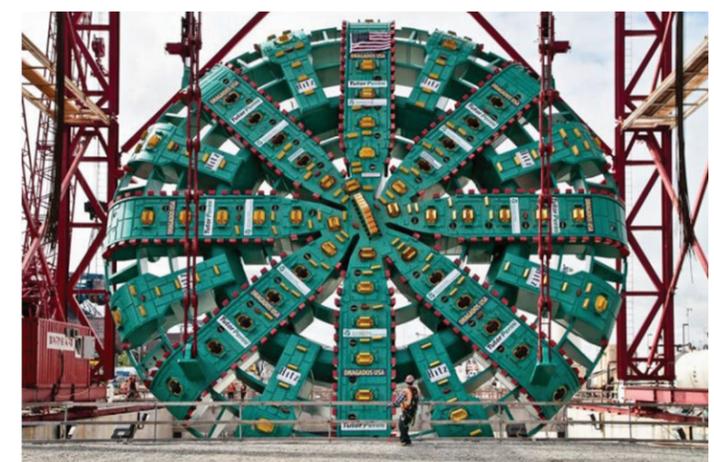
Some of the openings in Bertha's five-story-tall cutterhead are being modified as part of STP's plan to resume tunneling.

- Modifications to openings on the cutterhead.
 - New wear-resistant steel on the cutterhead.
 - An improved soil conditioning injection system.
 - Lengthened agitator arms for mixing excavated soil in the chamber behind the cutterhead.
