# technotes

“tech notes” are a product of the State Materials Laboratory to share design and construction technology gained from projects done through WSDOT. This issue is from the Pavements Branch discussing longitudinal joint construction techniques.

## Longitudinal Joint Construction Techniques

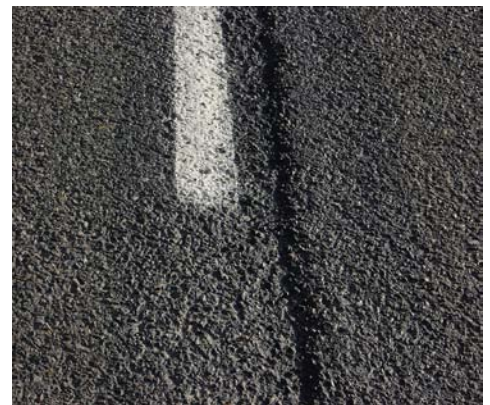
Image 1 - Joint in Washington with raveling and cracking present

Distresses caused by poor longitudinal joint construction can result in the premature failure of multilane hot mix asphalt (HMA) pavements. These distresses are often in the form of raveling and eventually cracking (Image 1). The cause is attributed to relatively low density and surface irregularity at the joint. Low density at the joint is not unusual since the edge of the lane first paved (cold lane) is unconfined. The subsequent lane (hot lane) has a confined edge and therefore tends to have a higher density, but still does not typically meet the minimum requirements. Because these irregularities exist, techniques for proper construction should be identified and used to ensure improved performance and longer lasting pavements.

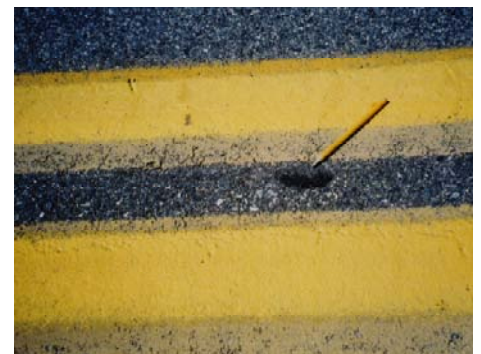
Image 2 - Rubberized joint material

Longitudinal joints constructed using rubberized joint material (Image 2) gave the best performance with no significant cracking, closely followed by the cutting wheel. However, the quality of the joint with the cutting wheel is dependent upon the skill of the operator.

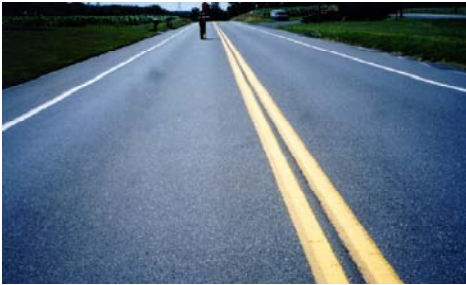
Image 3 - Rolling from hot side 6 inches away from joint

The test section that constructed the joint by rolling from the hot side 6 inches away (Image 3) and the New Jersey wedge also performed well with no significant cracking. However, the section with New Jersey wedge (without a notch) showed raveling 2 to 3 inches wide at the joint.

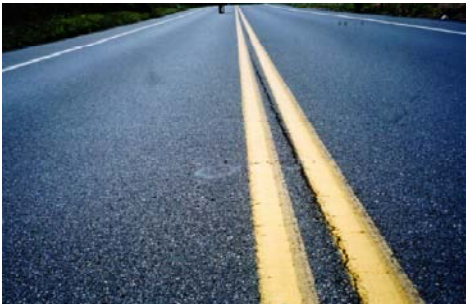
Image 4 - Joint maker

Test sections using the edge-restraining device, joint maker (Image 4), rolling from hot side (Image 5), and rolling from cold side (Image 6) developed cracking at the longitudinal joint anywhere from 35 to 99 percent of the test section.

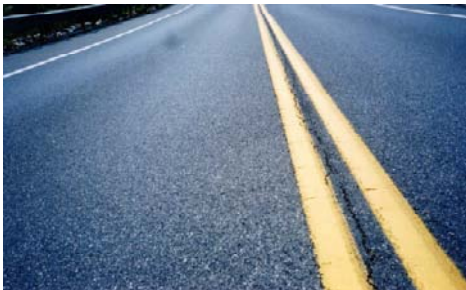
Image 5 - Rolling from hot side

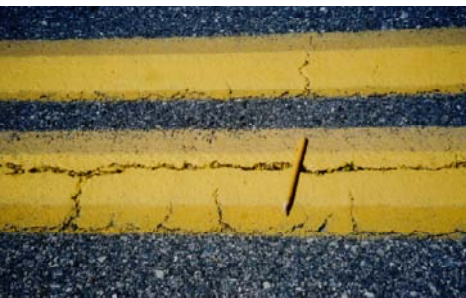
Image 6 - Rolling from the cold side

Overall performance of rolling from the cold side resulted in a wider and deeper crack than compared to rolling from the hot side.
