1. Report No.	2. Government Accession No.	3. Recipient's Catalog No.	
4. Title and Subtitle <b>ALTERNATE METHODS OF AVALANCHE CONTROL - INTERIM REPORT</b>		5. Report Date <b>July 1976</b>	6. Performing Organization Code

ALTERNATE METHODS OF AVALANCHE CONTROL

INTERIM REPORT

Research Project Y-1637 Phase 2

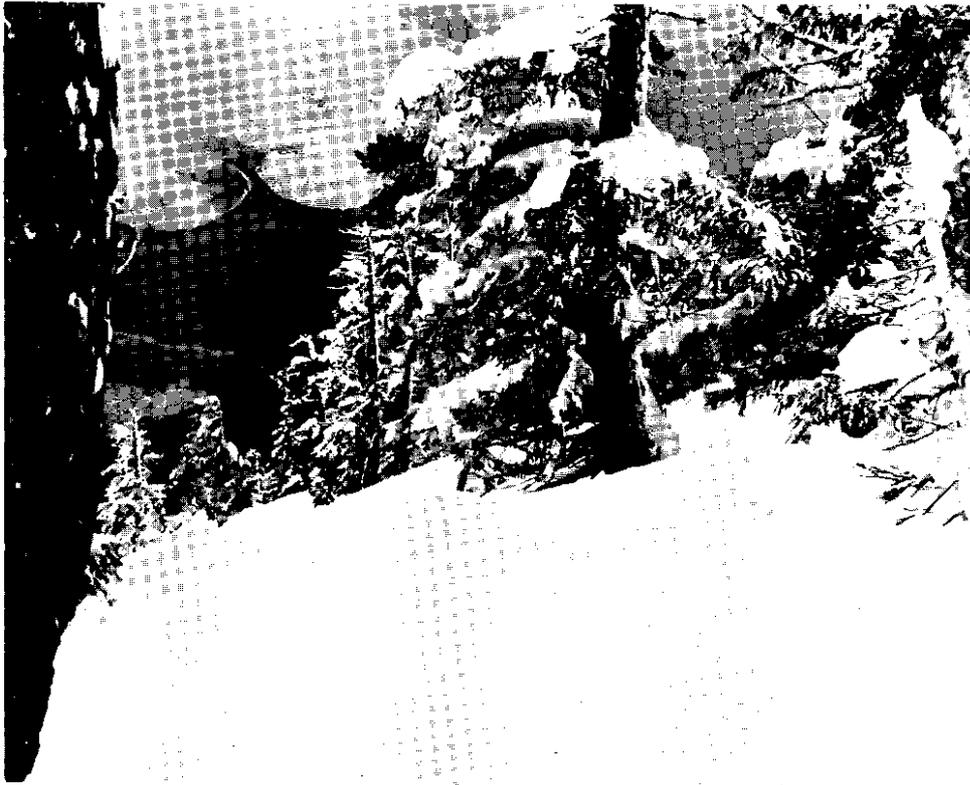
Figure 2. Air bag site at the East Side Snowshed avalanche release zone, Snoqualmie Pass, Washington. The broken snow is a result of bag inflation during a test on 1/8/76.

The expanding bags acted on the snowpack in similar fashion for both control missions. Snow fractured above the bags and a slab, about 18" thick, was lifted and tilted downslope. In the first instance, six " of new, soft snow slid from the tilted snow table onto the slope. In the second instance, a boot push sent the entire slab of wet, heavy snow onto the slope.

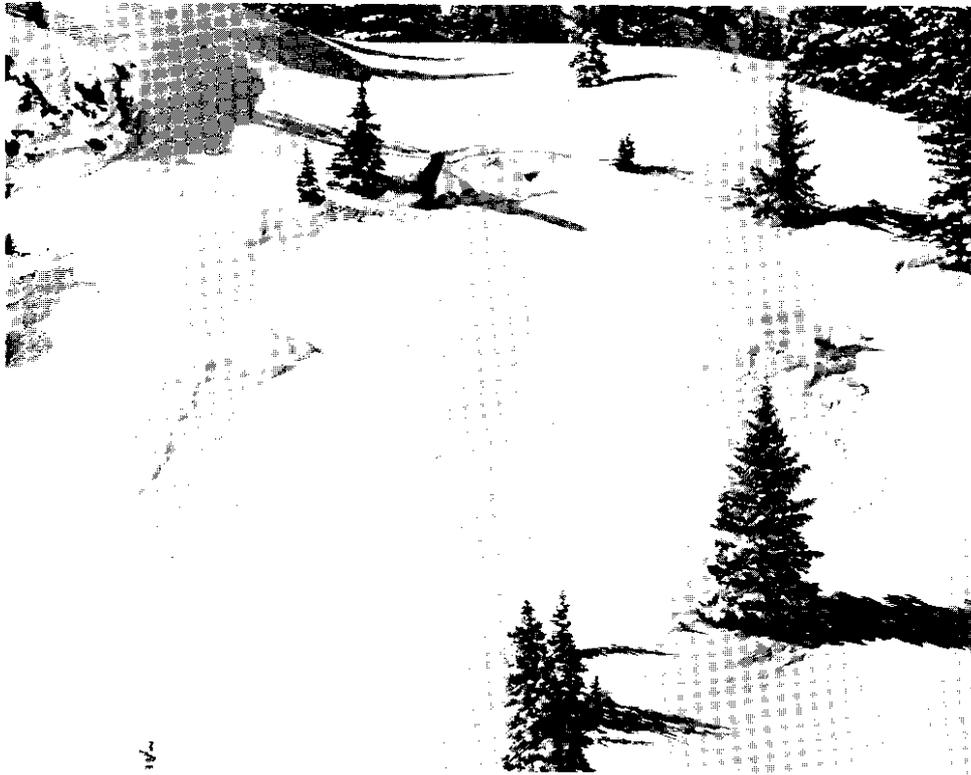
Figure 4. Air bag site at the Silver Ledge Mine Avalanche Path, Red Mountain Pass. Inflation test in stable snow on 3/23/76.

A new test site was established just south of Red Mountain Pass for the winter of 1975/76. This was at the lower release point of the Silver Ledge Mine avalanche which regularly falls onto the highway. It was chosen as a small and accessible test site to determine the effectiveness of air bags for direct release of avalanches by initiating slab fracturing. Two bags were placed at the normal fracture line of this release point, which is well-known from frequent artillery control of the Silver Ledge path. Figure 4 illustrates this test site as seen from the highway through a telephoto lens. This photograph was taken on March 23 when a test inflation was carried out during stable snow conditions, leading to rupture and displacement of the snow cover above each bag.

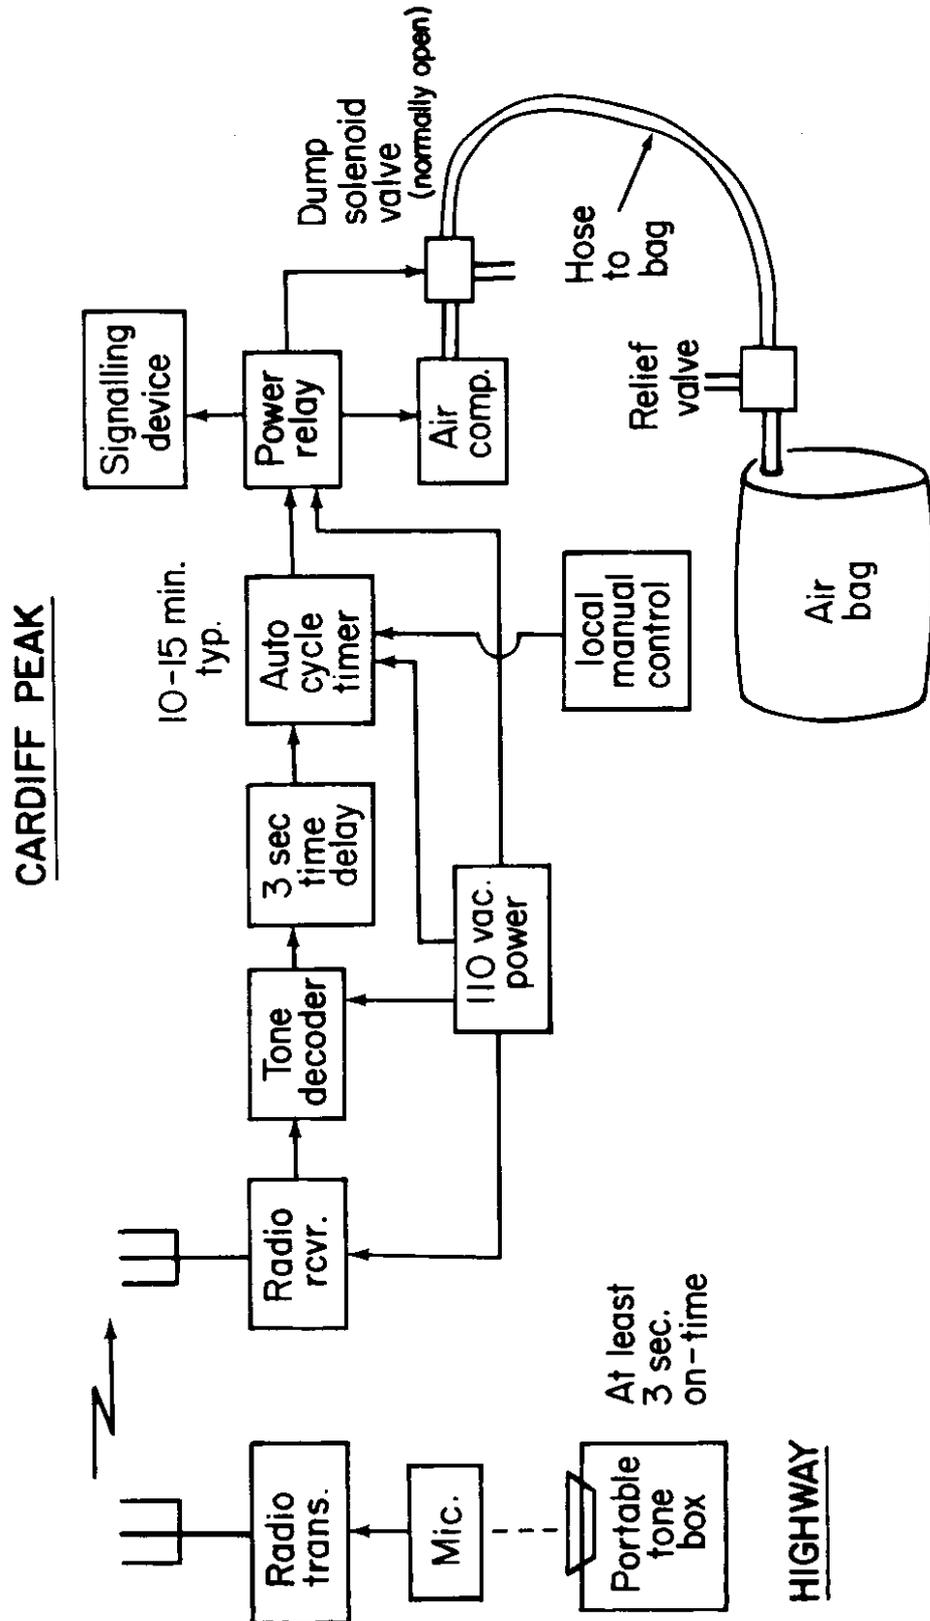
Figure 5. Block diagram of the air bag control system designed for the U.S. Forest Service at Alta, Utah.

The control system proved entirely satisfactory. It can readily be adapted to any short-wave radio communication system and the degree of security can be adjusted at the time of design by selecting the appropriate degree of complexity for the tone coding system. The same control principle can also be used over land lines or commercial telephones. Further

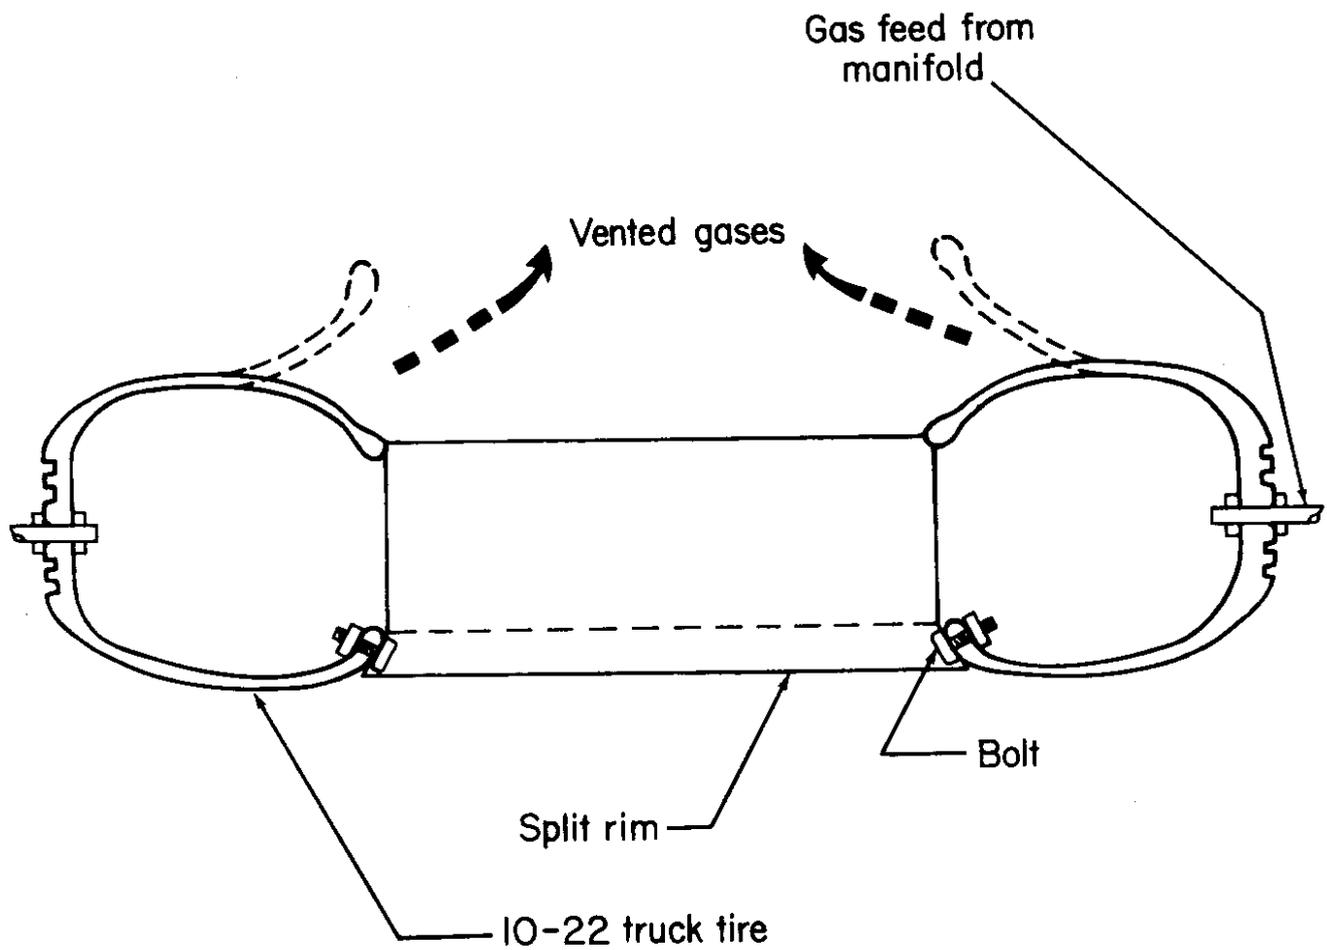
Figure 3. Configuration of the tire gas exploder used at the Longfellow test site, Red Mountain Pass, Colorado, during the 1975/76 winter test season. Not shown are the cable tie points for anchors welded to the inside of the rim. An improved version for use in 1976/77 will use an inner manifold feeding the gas through the rim wall.

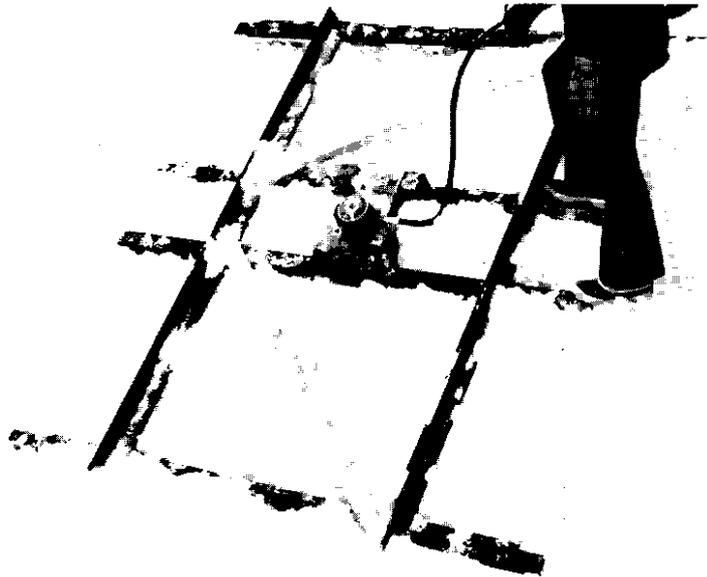
Figure 1. Vibrolator attached to heavy aluminum frame for use as vibrator test unit at Little Windy cutbank near Stevens Pass, Washington.

The driving unit for this vibrator assembly was a commercial unit called a "Vibrolator" which is attached to railroad cars to aid the free flow of loose materials such as gravel when the car is emptied. Its operation depends on an air motor to rotate a heavy eccentric weight. The vibrolator was welded to a 2" angle iron and bolted to a grid of 8' long, 4" wide aluminum angle "L" pieces. The grid consisted of four elements in parallel, anchored by two cross elements. Two diagonals of aluminum channel

were attached to give the grid system rotational rigidity. Total weight of the unit was about 300 pounds. Total surface area parallel to the snow was about 1350 square inches. Surface area for transferring lateral vibrational energy was about the same as that normal to the snow. This device is illustrated in Figure 1.

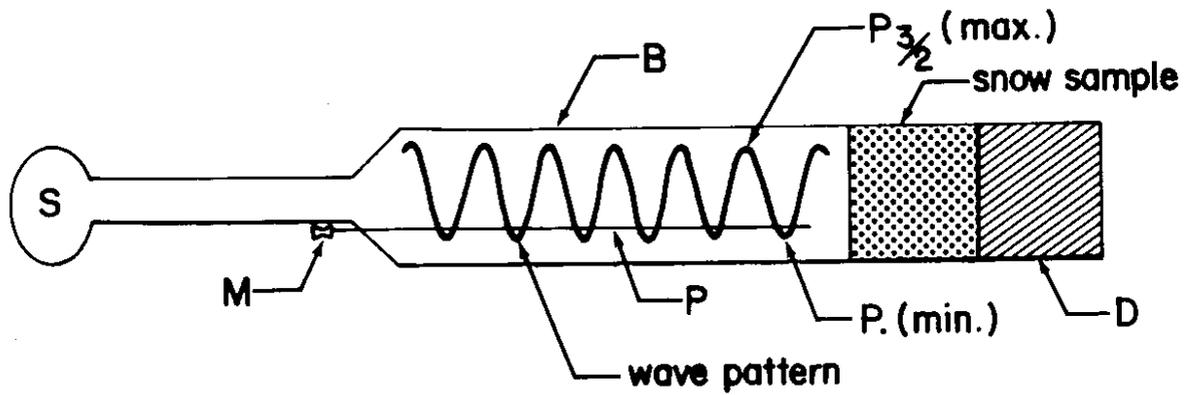
Figure 1. Constant length impedance tube.

- D = massive piston
- B = seamless tube
- P = probe tube
- M = microphone
- S = sound source

A sound field is set up in the impedance tube as the result of wave interference to yield successive maxima and minima. The probe microphone observes the sound pressure at varying distances from the surface of the sample. The impedance is determine from  $Z = R + iX$

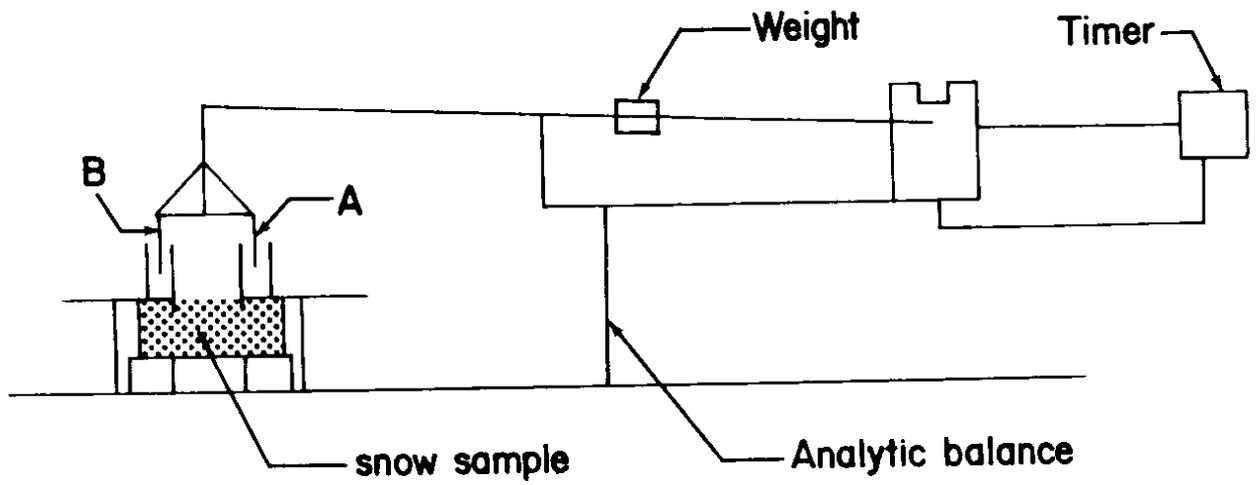
Figure 2.

A = kerosene seal  
B = cylinder

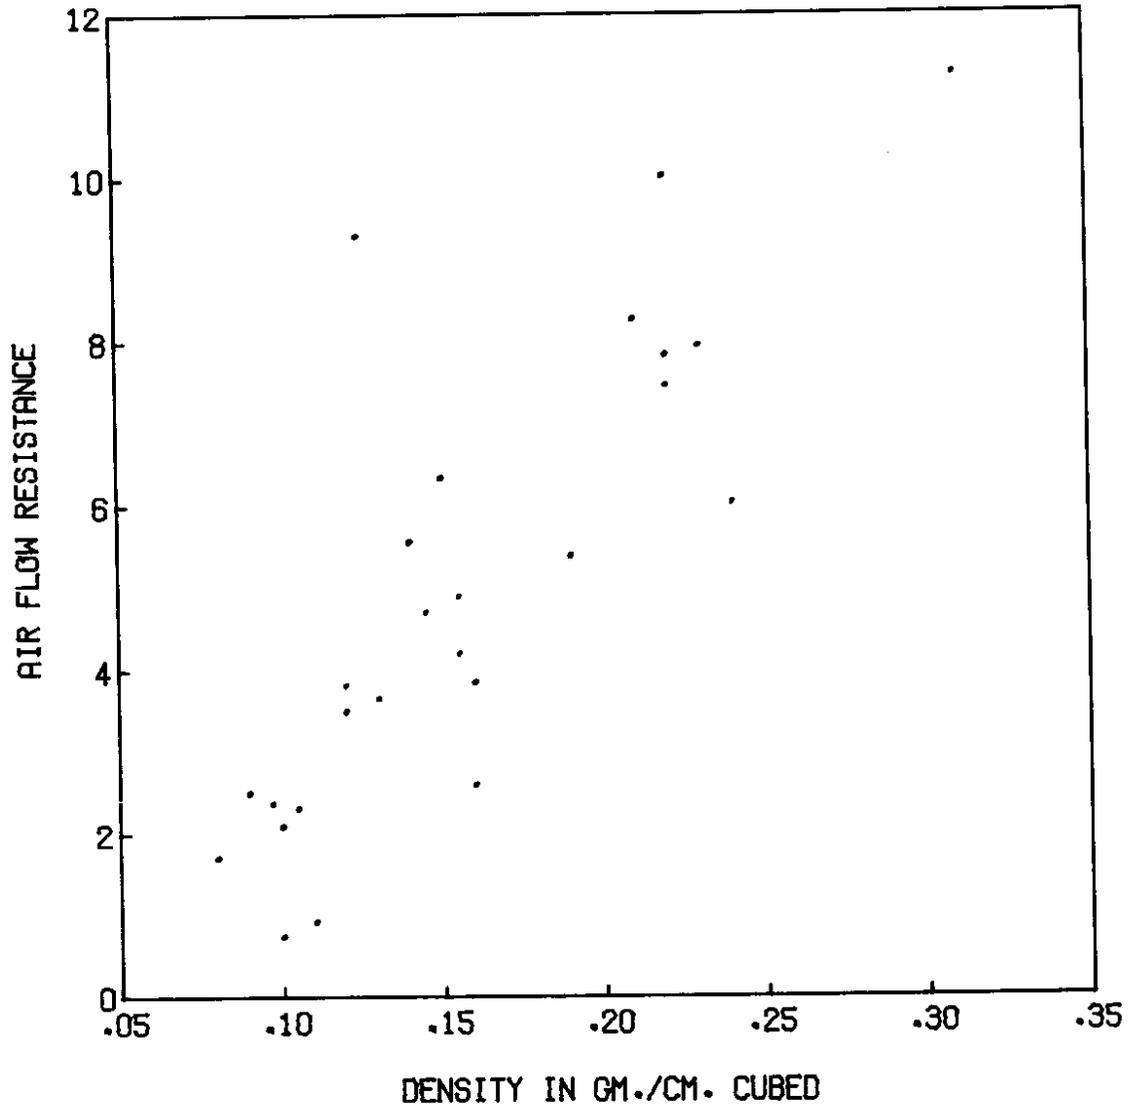
Figure 3. Air flow resistance of snow gm/cm<sup>3</sup>-sec. vs. snow density.

As can be seen in Figure 3  $\Sigma$  increases with density. The scatter of values indicates that flow resistance is not only dependant on density but also on the internal structure of the snow.

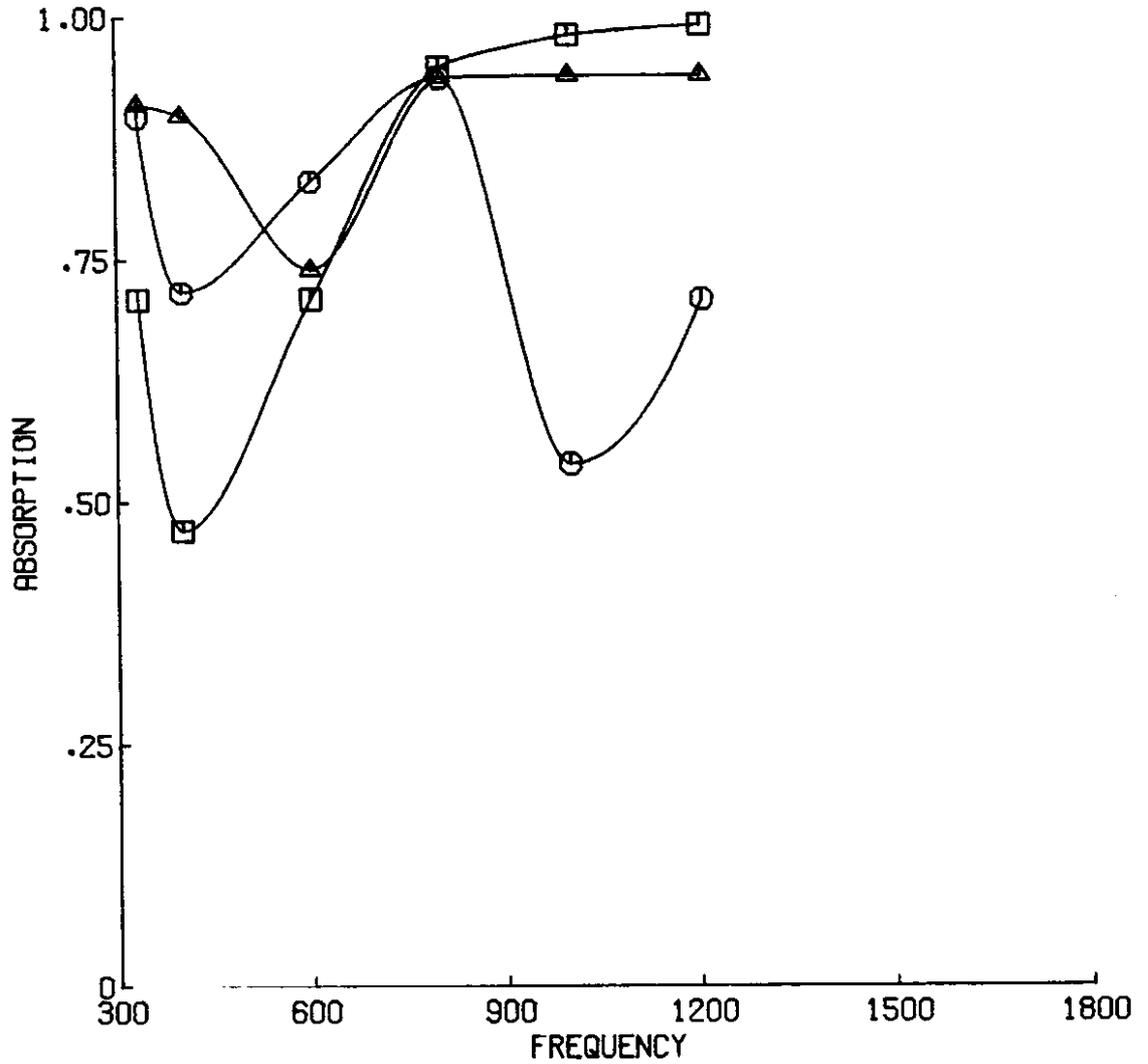
Figure 4.

MT. BAKER RESULTS WINTER 1976

- FREQ1 VERSUS ABS1 6 VALUES
- FREQ2 VERSUS ABS2 6 VALUES
- △ FREQ3 VERSUS ABS3 6 VALUES

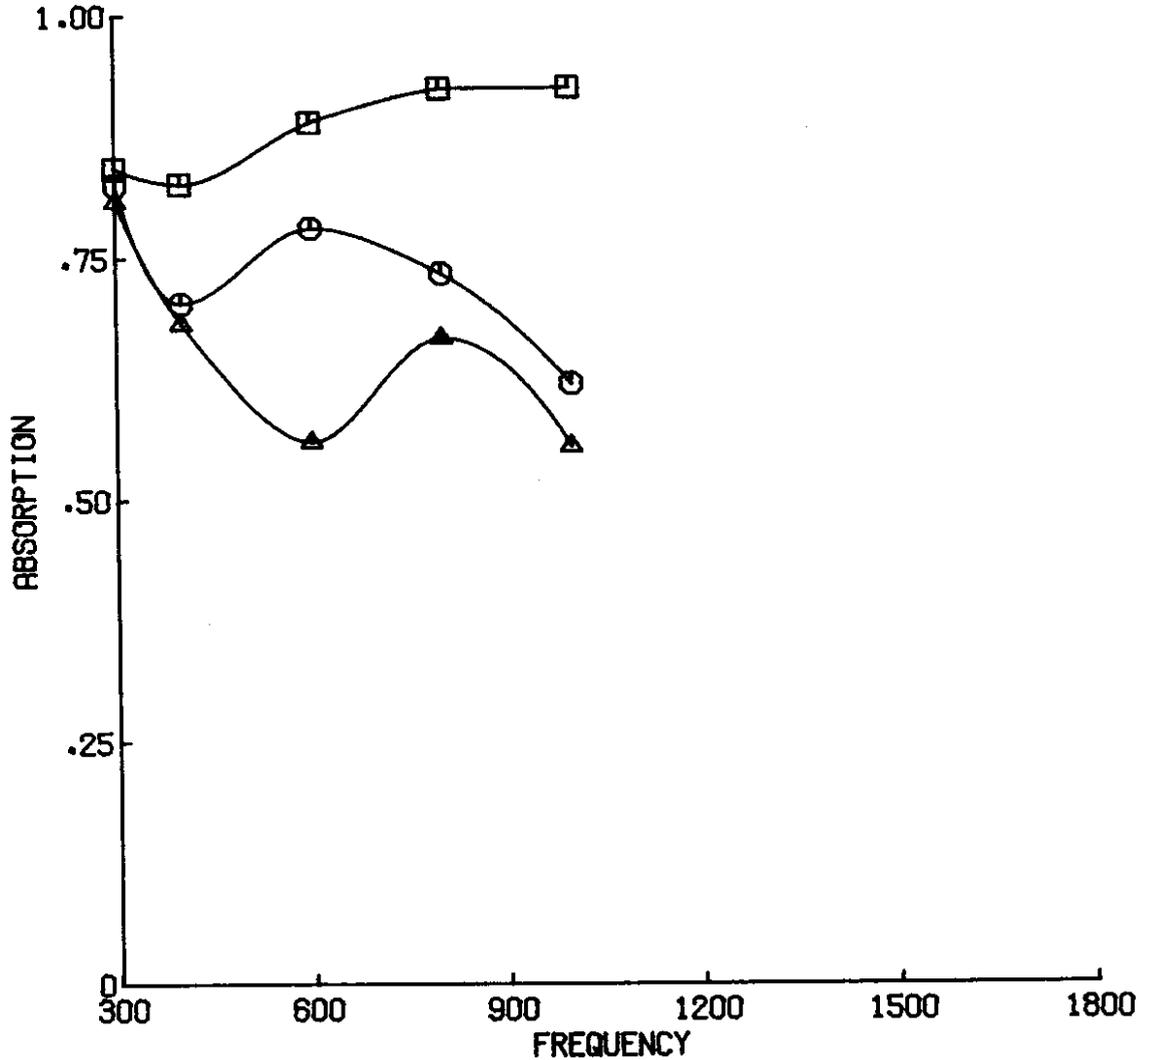
Figure 5

MT. BAKER RESULTS WINTER 1976

- FREQ1 VERSUS ABS1 5 VALUES
- FREQ2 VERSUS ABS2 5 VALUES
- ▲ FREQ3 VERSUS ABS3 5 VALUES

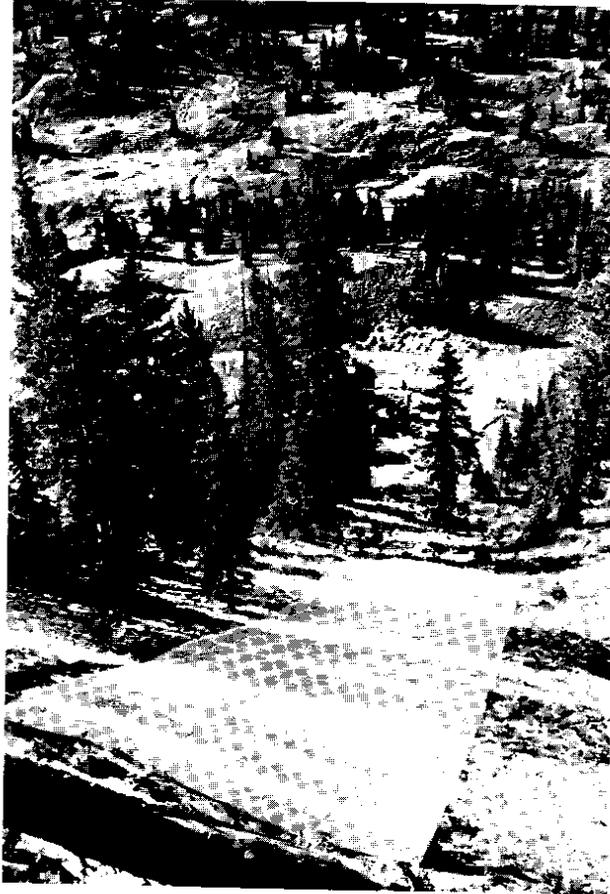
Figure 1. White polyethylene plastic sheet installed in release zone of Longfellow Avalanche Path, Red Mountain Pass, Colorado.

Two areas of the Longfellow site release zone adjacent to the gas exploder installations (see Chapter II) were used to test the effects of plastic sheets. One of these sheets was white plastic, 8 x 33 meters in extent and oriented with the long axis in the fall line; second one was similar except that it was black. The white sheet pictured in Figure 1 was the only one to survive the early-winter winds. A third site was at the

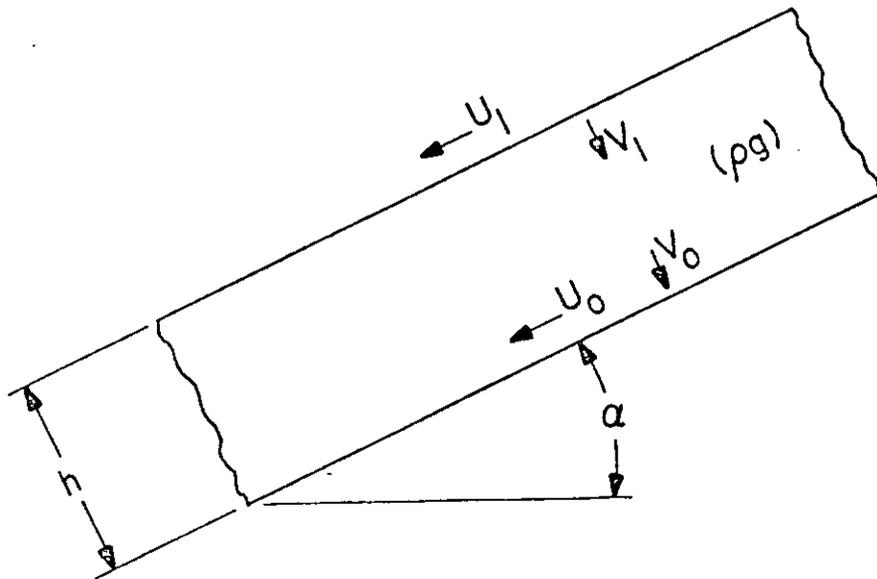
Figure 1. Neutral zone parameters.

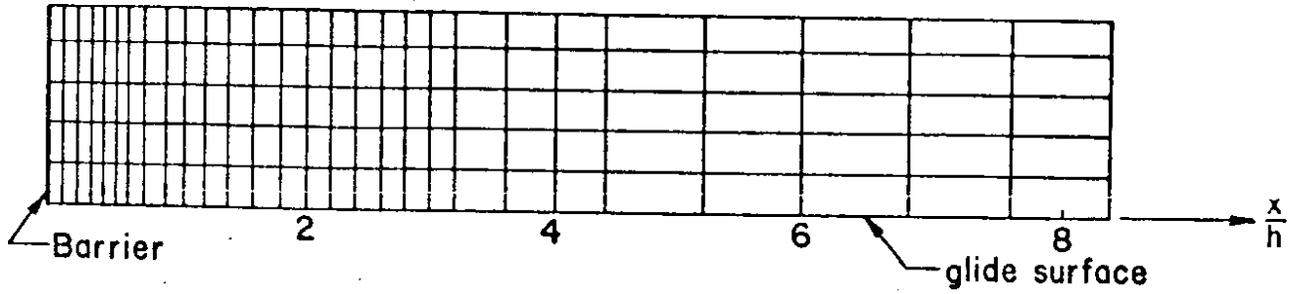
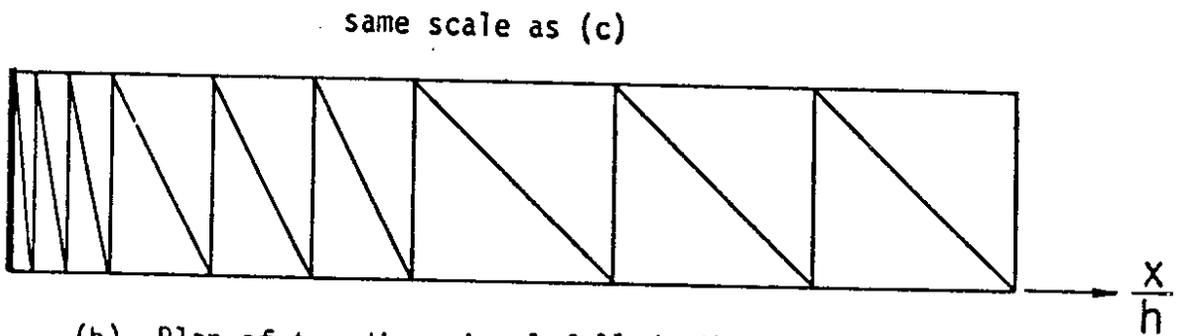
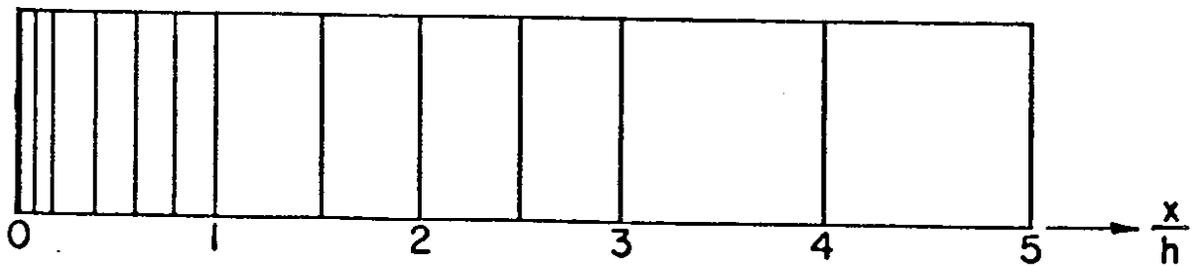
(a) Elevation of two dimensional arrangement.

(b) Plan of two dimensional full depth arrangement.

(c) Elevation of one dimensional full depth arrangement.

Figure 2. Element arrangements for continuous barriers.

Results of 16 one dimensional problems are compared with the two dimensional empirical expression for  $C_1$  in Figure 3. The element arrangement used is shown in Figure 2c. Values of  $C_1$  are as much as 8 percent higher and an average of 4 percent higher than the one dimensional solution. The actual two dimensional results are, on average, only 2 percent higher than the one dimensional results. Glide behavior and the pressure distribution are nearly identical to that of the two dimensional solution if the value for  $C_1$  is adjusted a few percent.

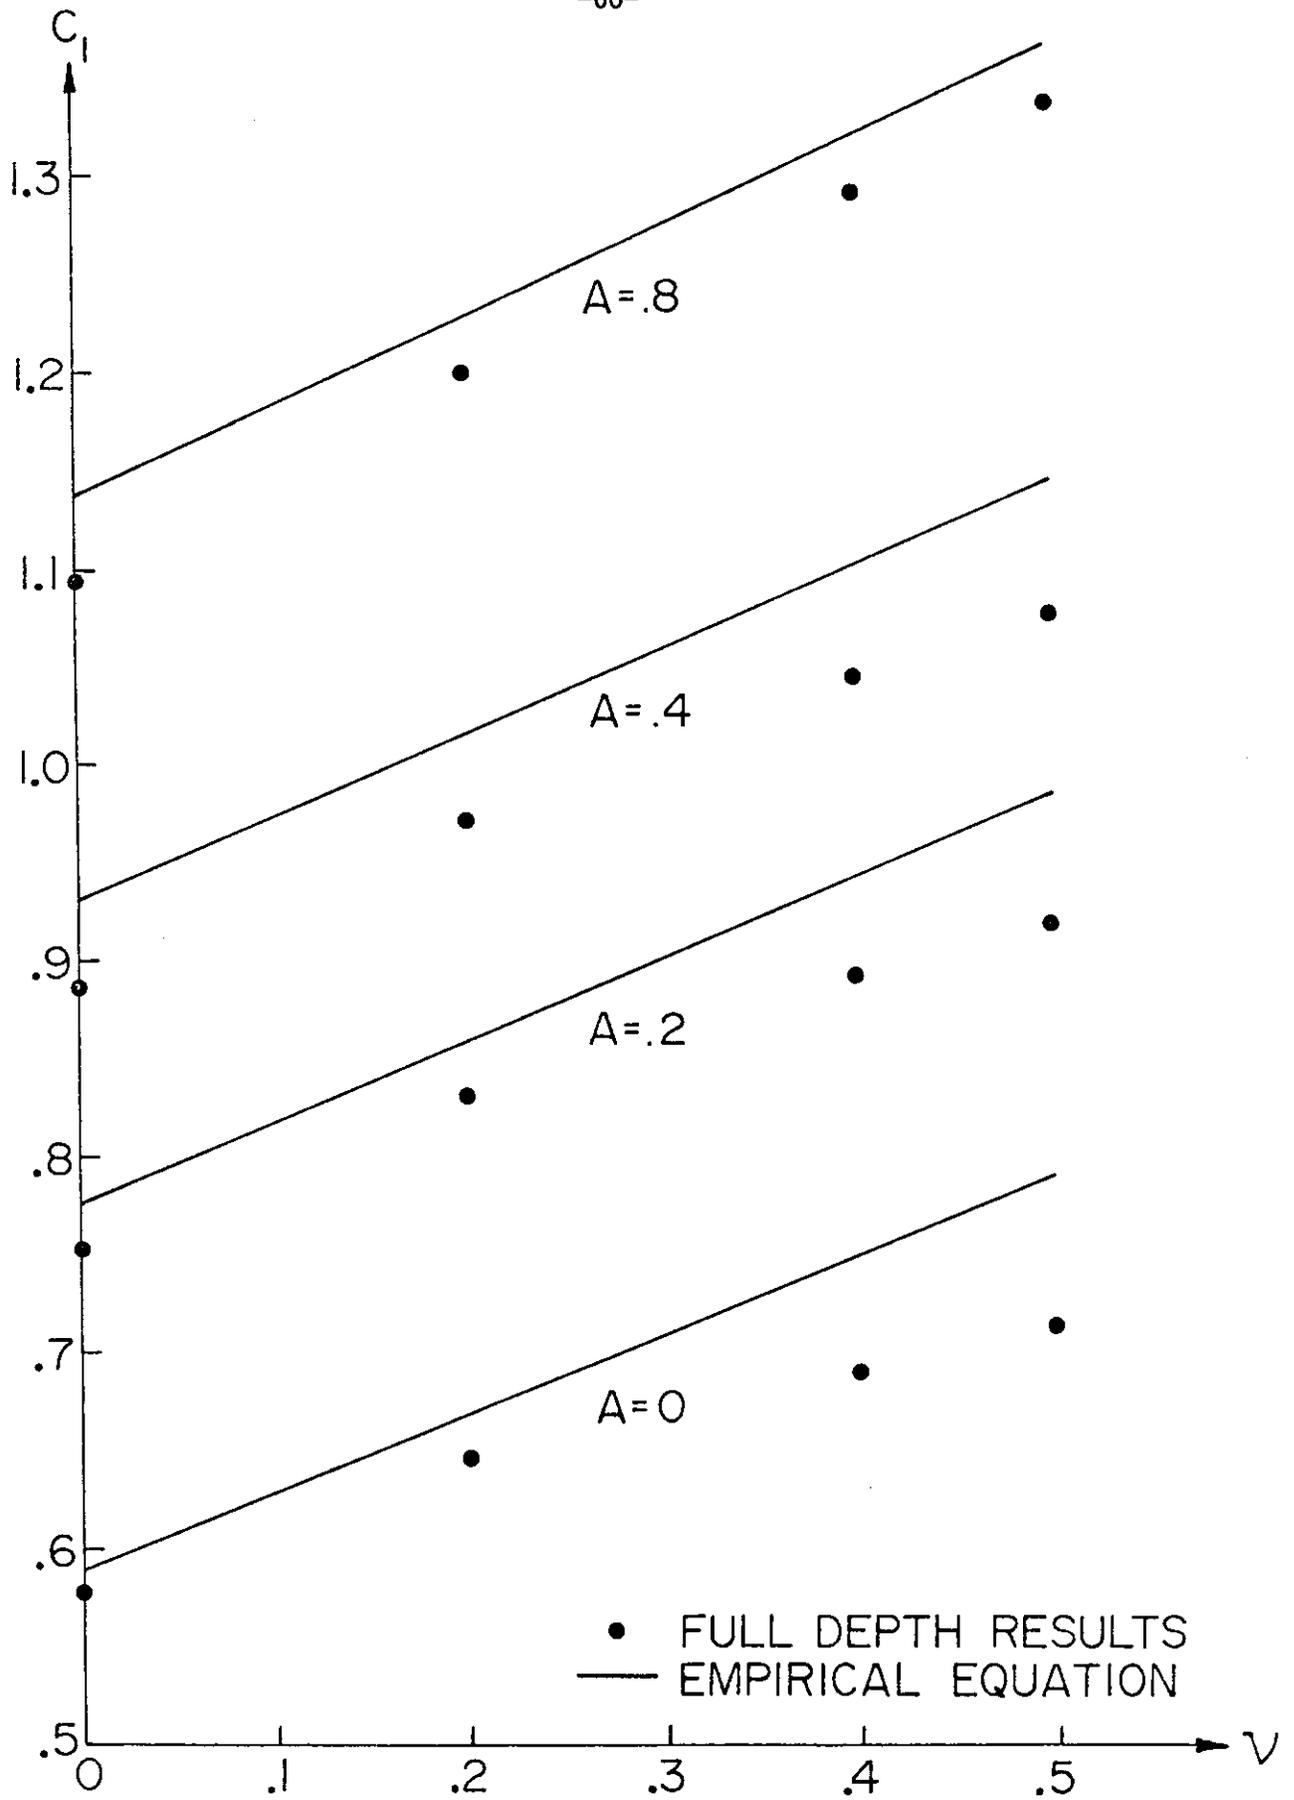
Figure 3. Comparison of empirical and full depth solutions.

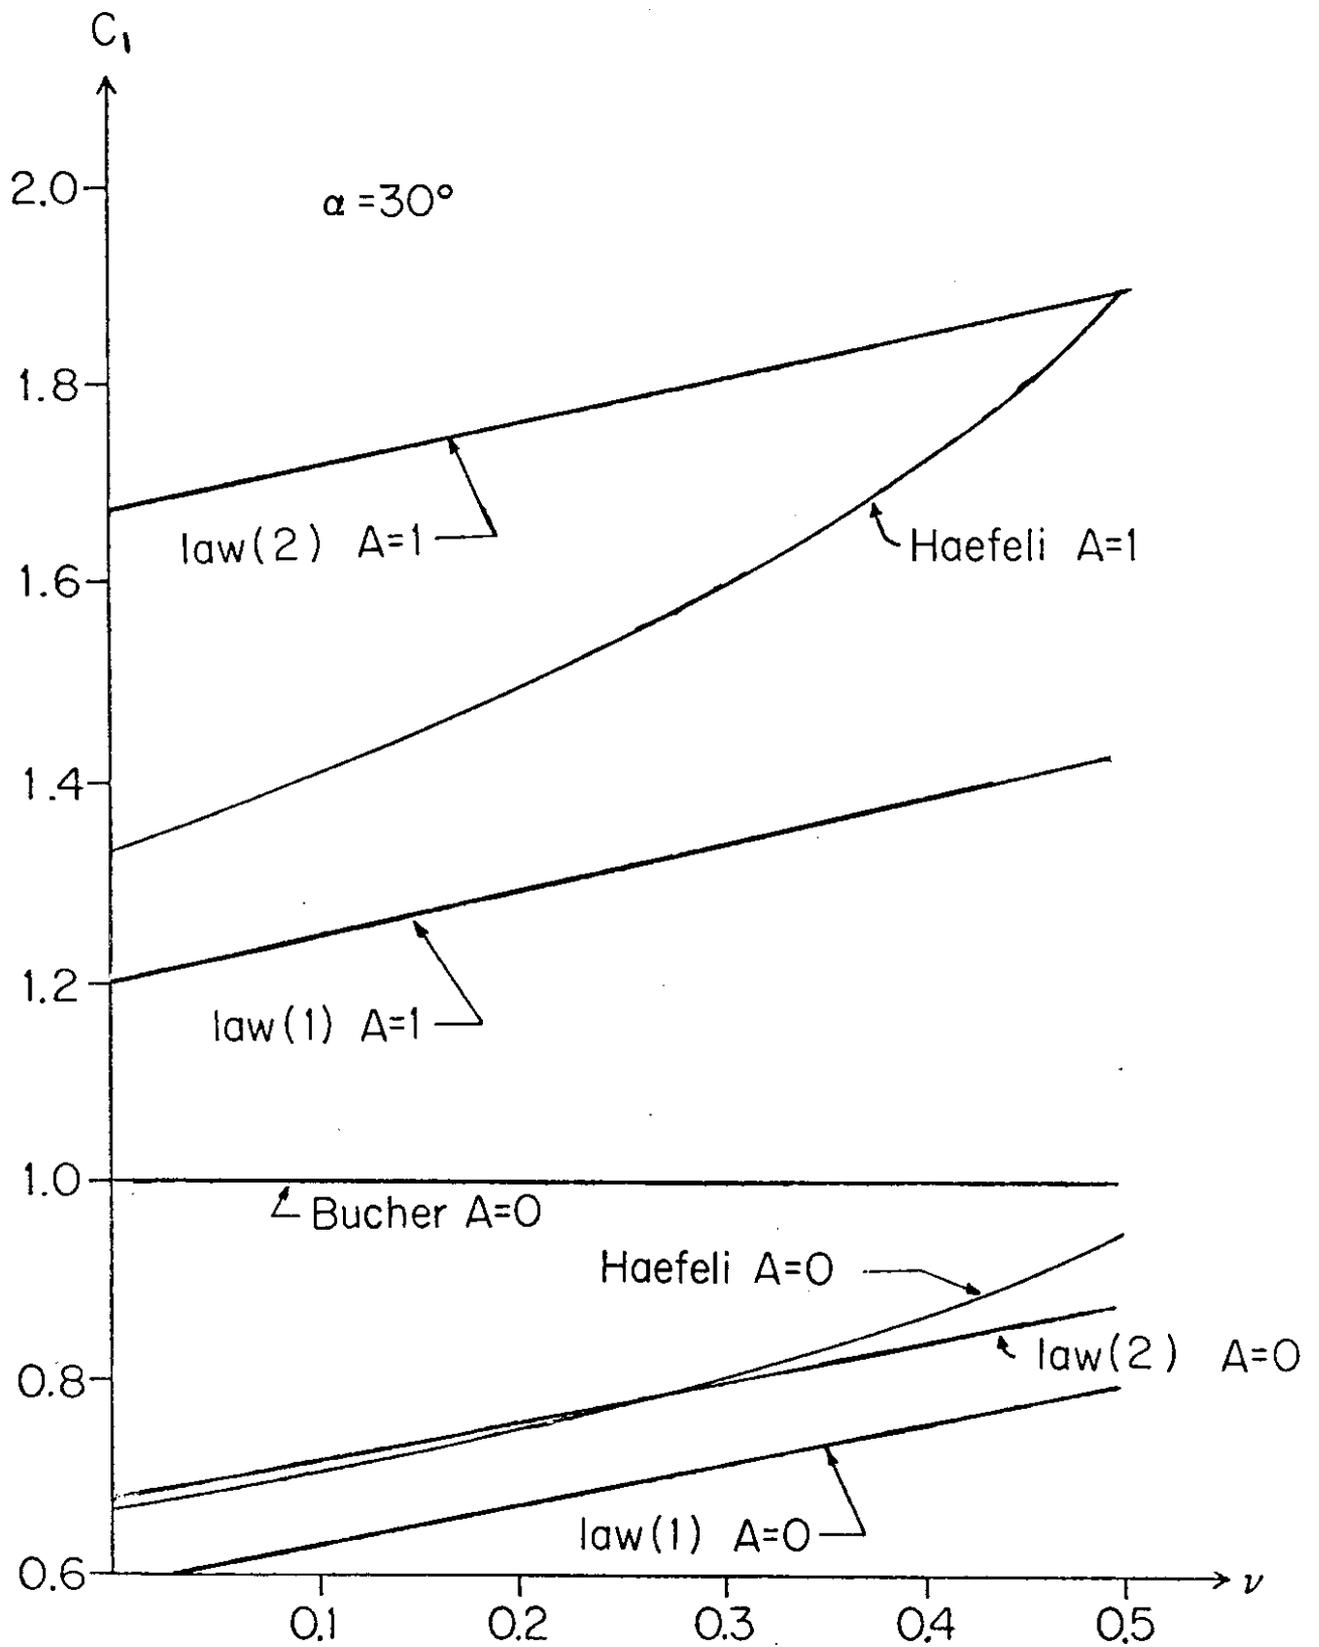
Figure 4. Comparison of empirical and analytical solutions

for Haefeli's, Bucher's and the empirical for a slope angle of 30 degrees. Values of  $C_1$  are given for both constitutive laws.

Bucher's formulation applies only to the case of  $A = 0$  and assumes incompressibility. However, it contains a term to account for variations in snow type. For old compact snow this can be expressed as  $C_1 = 1$  which is greater than empirical  $C_1$  for all cases of zero glide for law (1). Bucher assumed a realistic, asymptotic, glide velocity profile. Figure 4 compares  $C_1$  values

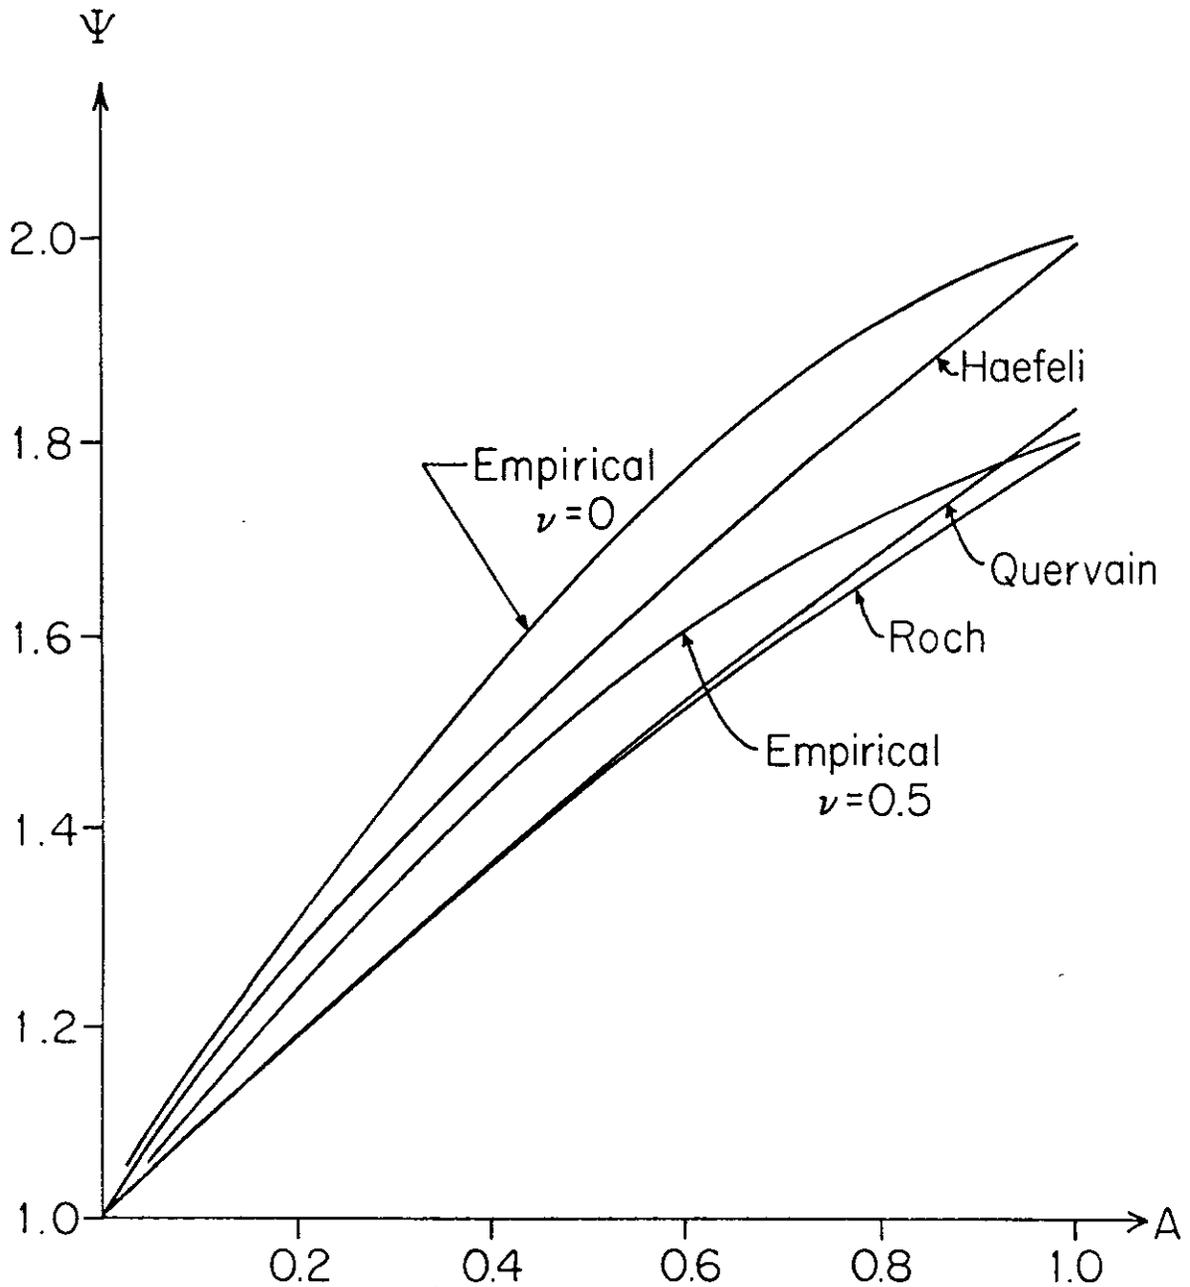
Figure 5. Comparison of gliding functions.

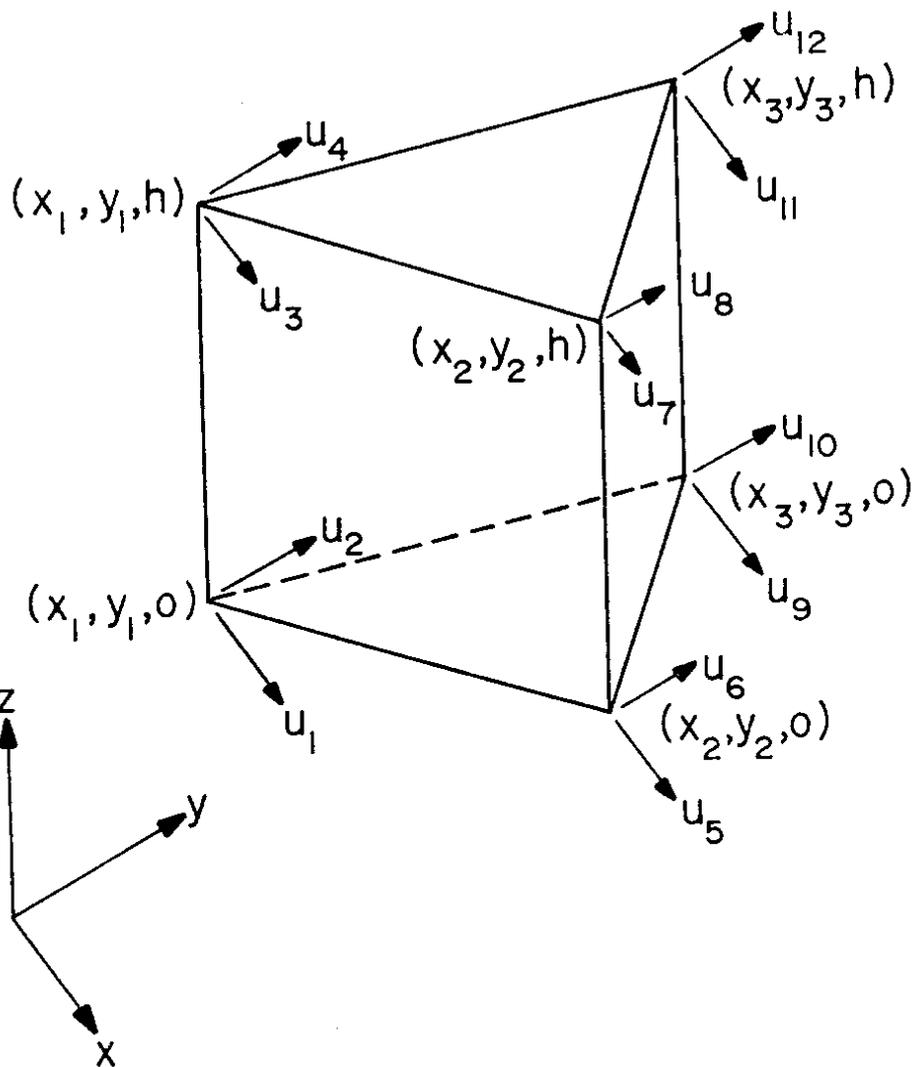
Figure 6. General solution method element.

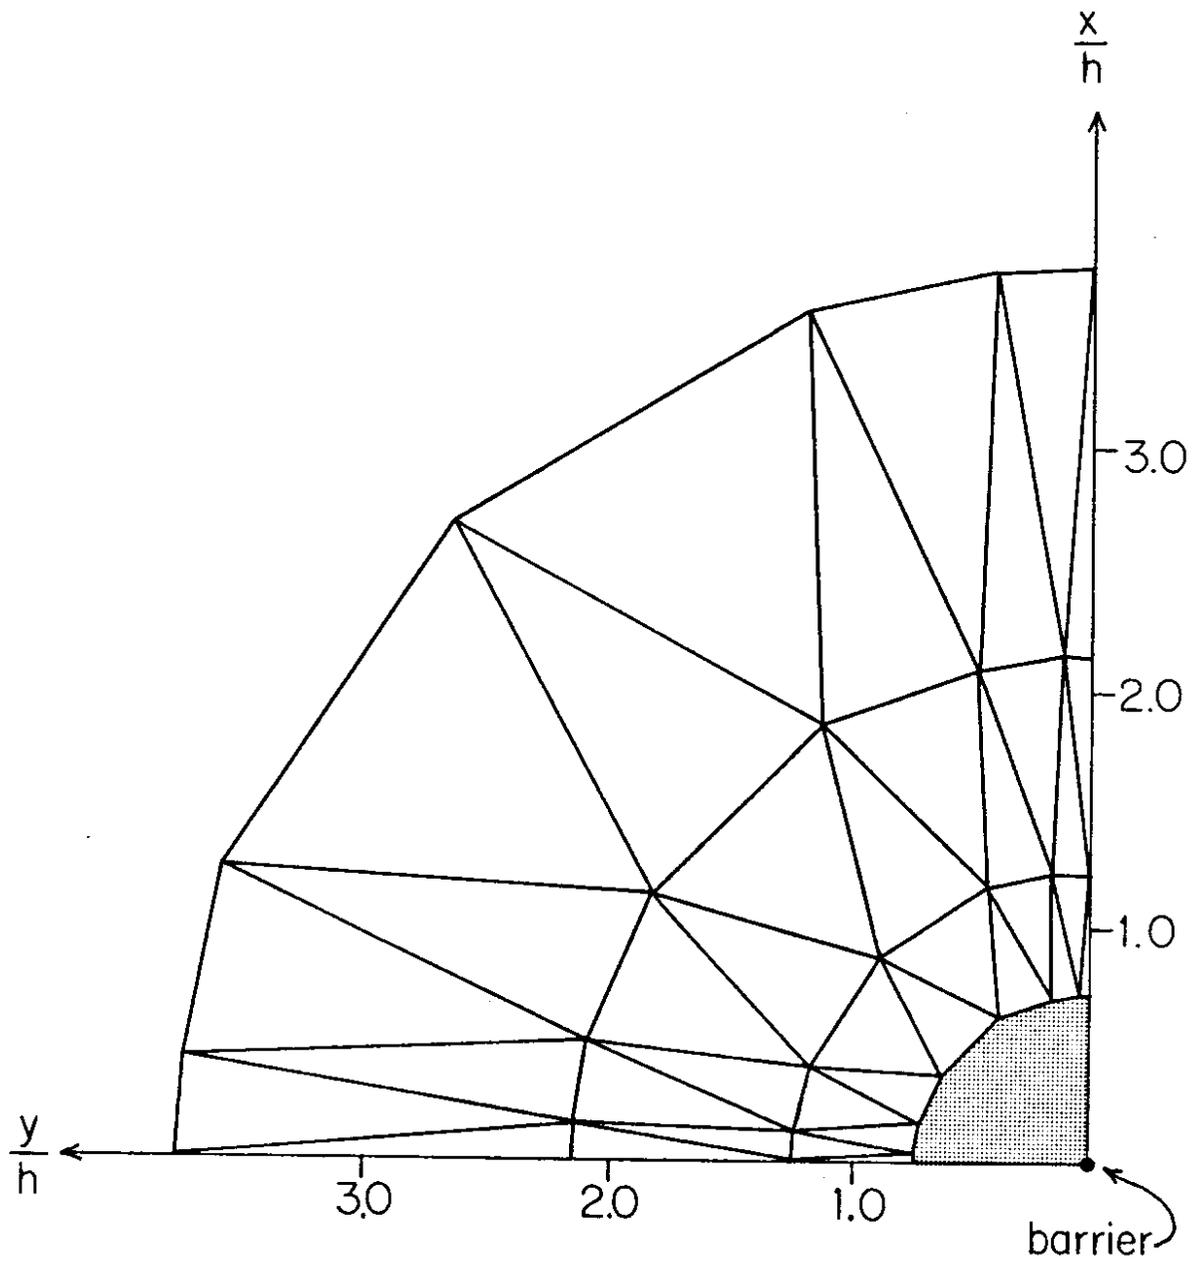
Figure 7. Element arrangement for pole barriers. Shaded area contains 81 similar elements diminishing in size.

A pole barrier is a line barrier normal to the slope. Figure 7 shows the 120 element arrangement that was used for pole barrier problems. It is necessary to have very small elements near the pole. Arrangements with larger elements gave larger forces and smaller velocities. Most x direction

velocity components from the arrangement of Figure 7 varied less than 3 percent from those of an arrangement with 86 elements. Since real poles will be of finite size, it is felt that further refinement is not warranted.
