1. Report No.	2. Government Accession No.	3. Recipient's Catalog No.	
4. Title and Subtitle <b>ALTERNATE METHODS OF AVALANCHE CONTROL - INTERIM REPORT</b>		5. Report Date <b>July 1976</b>	6. Performing Organization Code

ALTERNATE METHODS OF AVALANCHE CONTROL

INTERIM REPORT

Research Project Y-1637 Phase 2

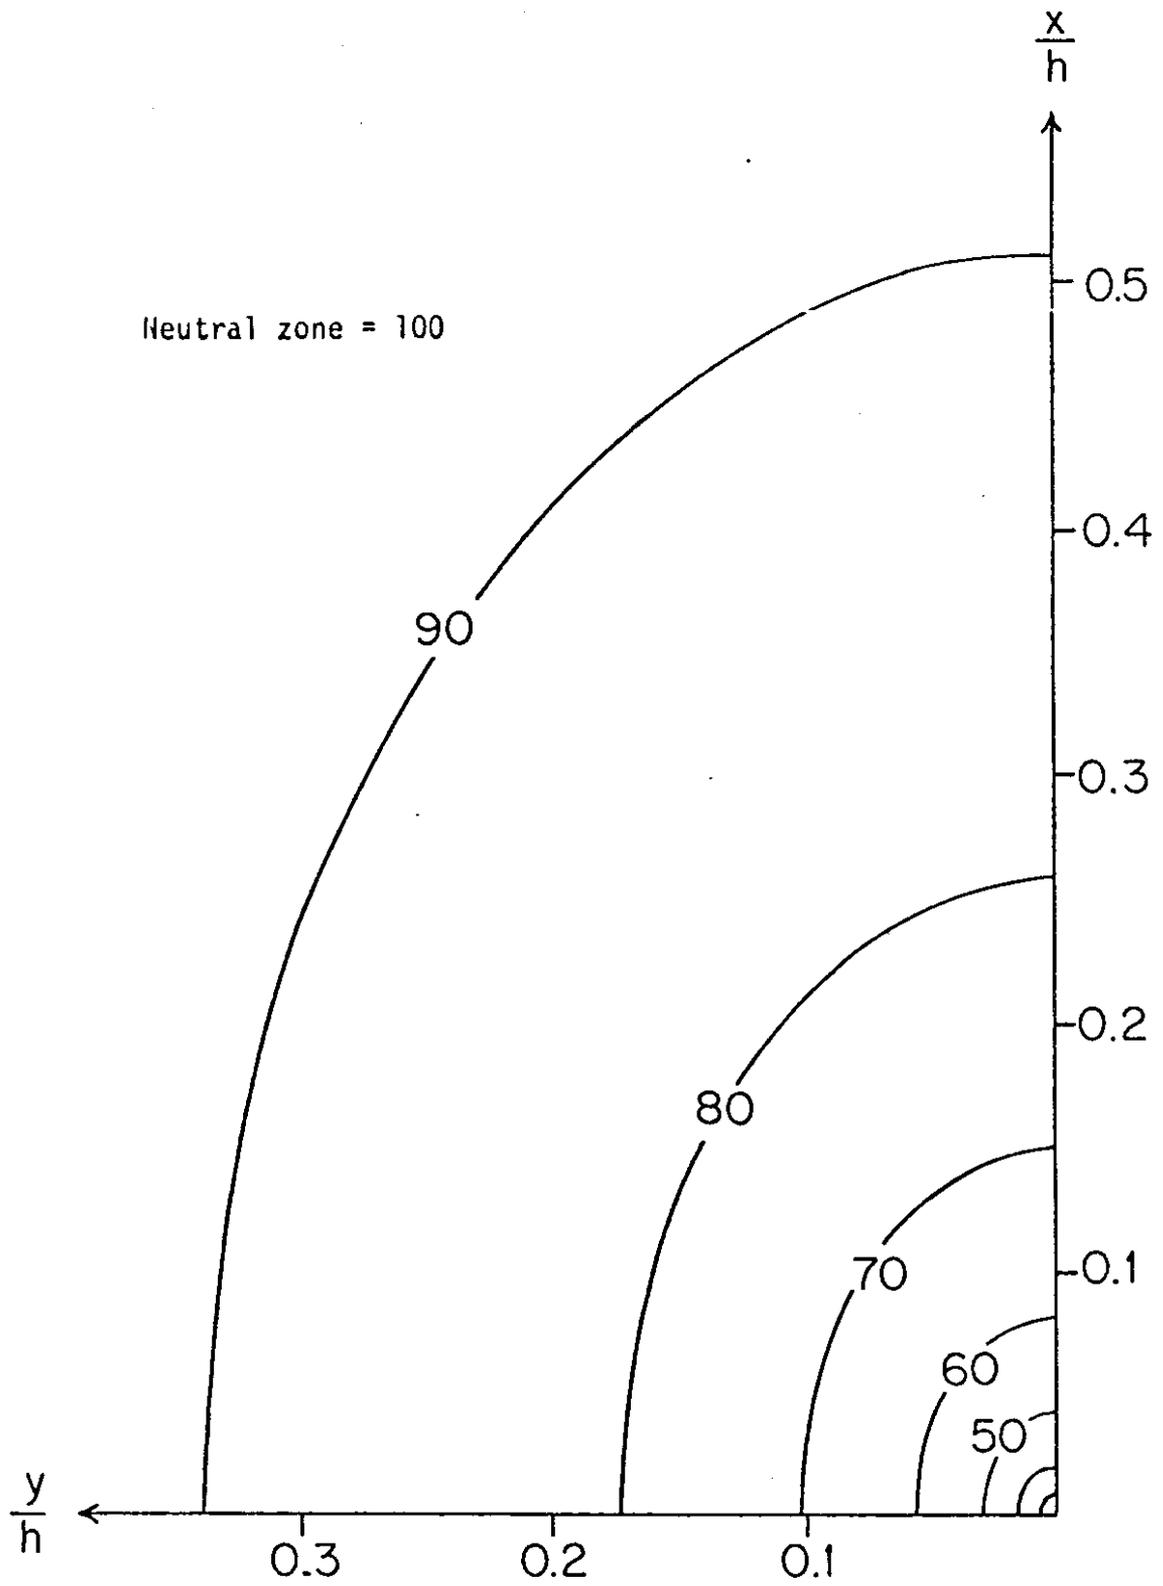
Figure 8. Approximate contours of  $x$  velocities and  $\tau_{xz}$  for pole barrier where  $A = \nu = .2$

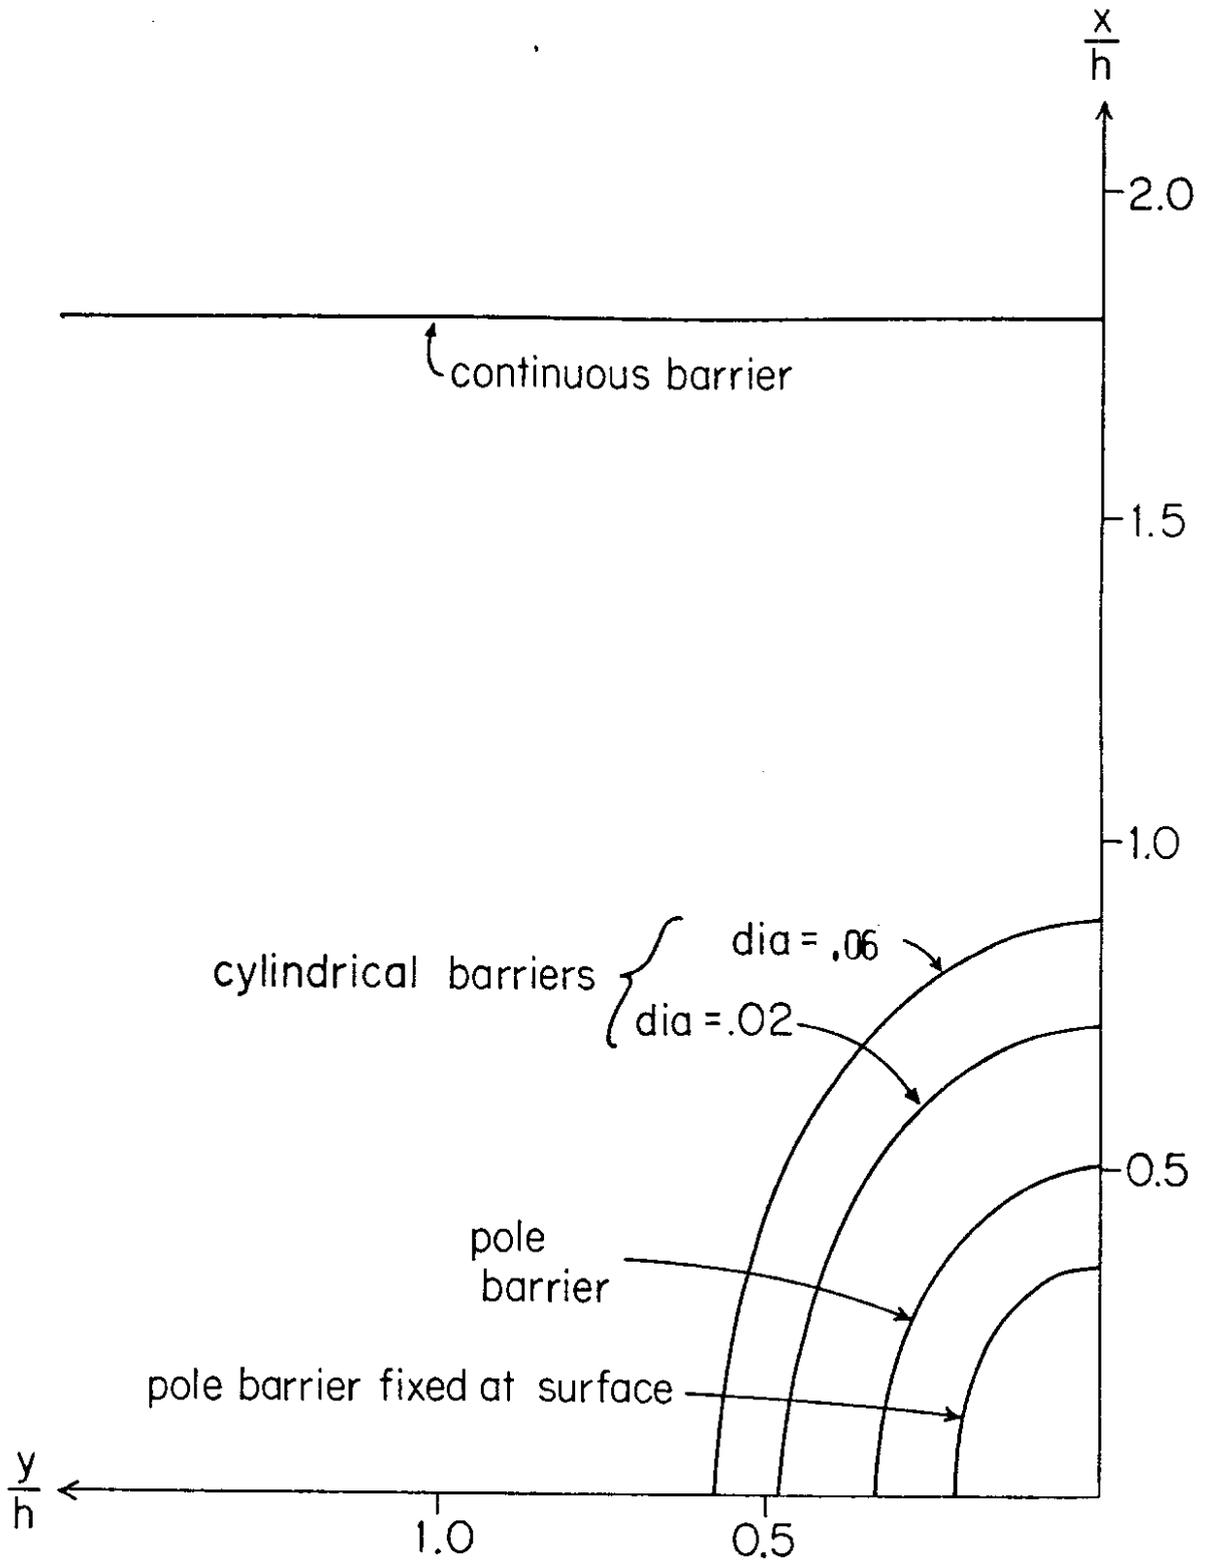
Figure 9. Approximate 90 percent contours for various barriers where  $A = \nu = .2$ .

than that of the completely rigid pole barrier. Figure 9 compares the 90 percent of the neutral zone values for several types of problems.

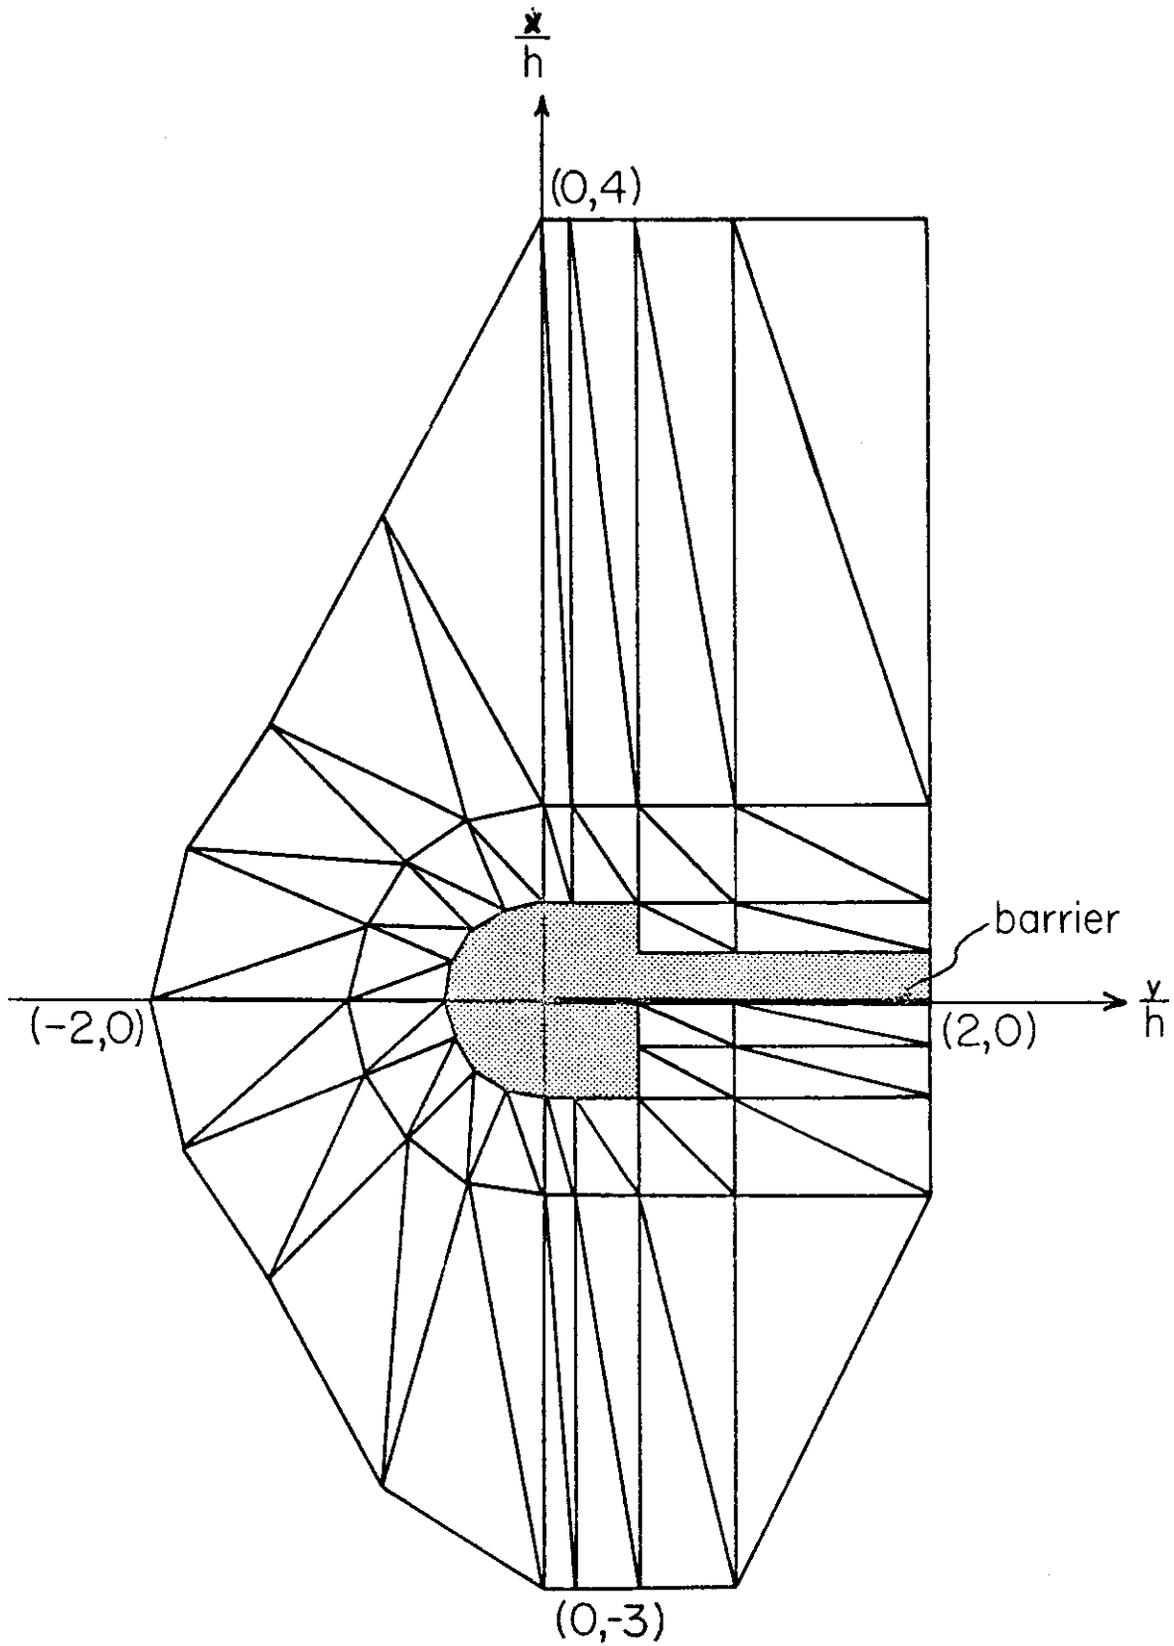
Figure 10. Arrangement used for discontinuous barrier. Shaded area contains 105 similar elements diminishing in size.

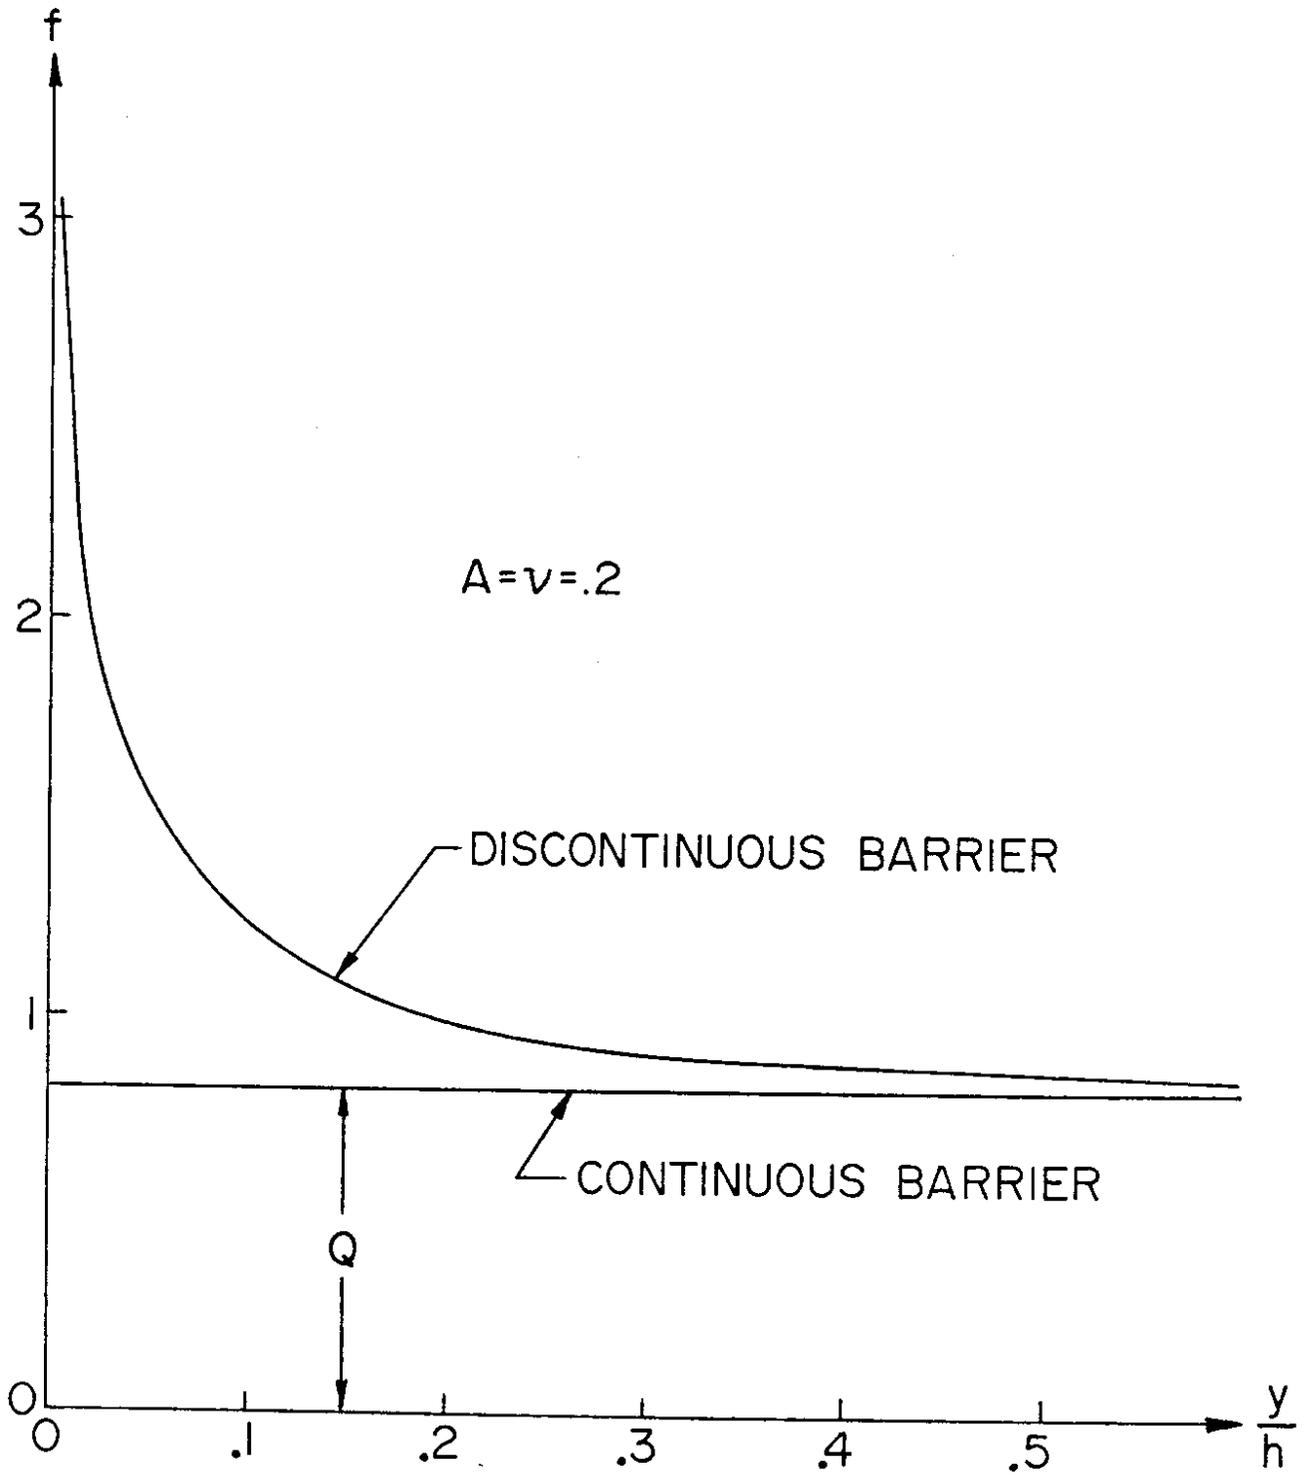
Figure 11. Force intensity near the end of a discontinuous barrier.

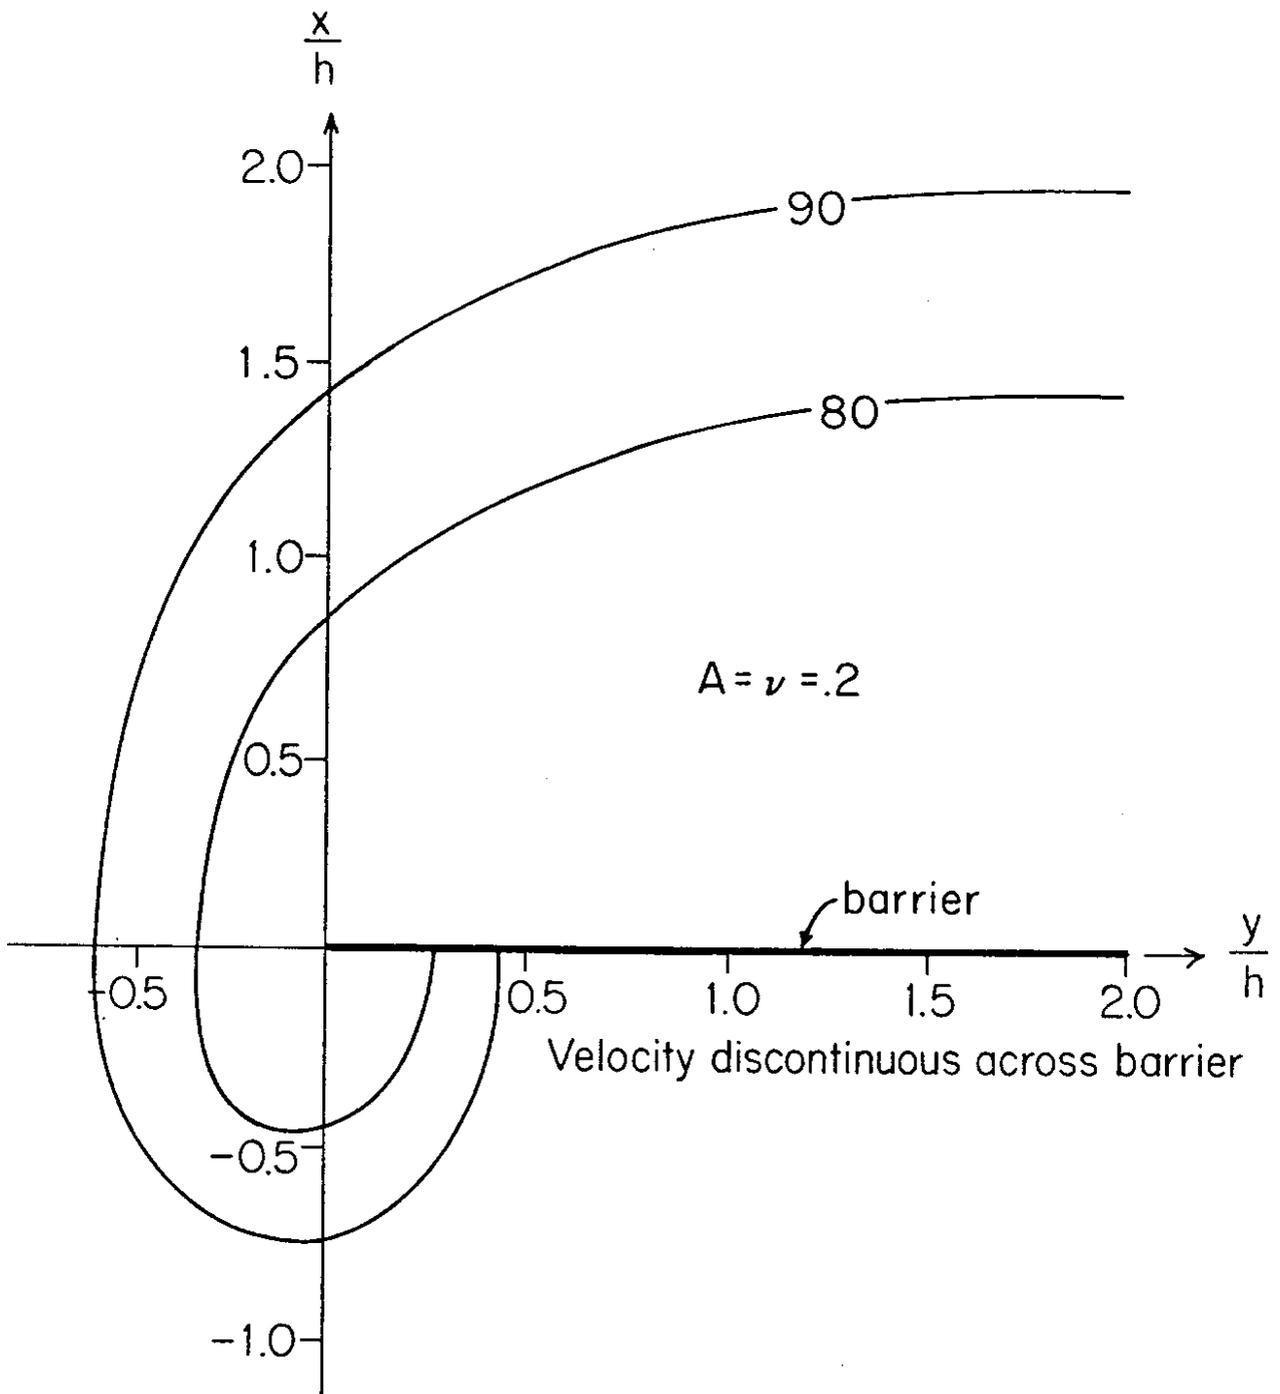
Figure 12. Contours of 80 and 90 percent near the end of a discontinuous barrier.
