Evaluation of Induction Loop Installation Procedures in Flexible Pavements

WA-RD 76.1

February 1985

FINAL REPORT

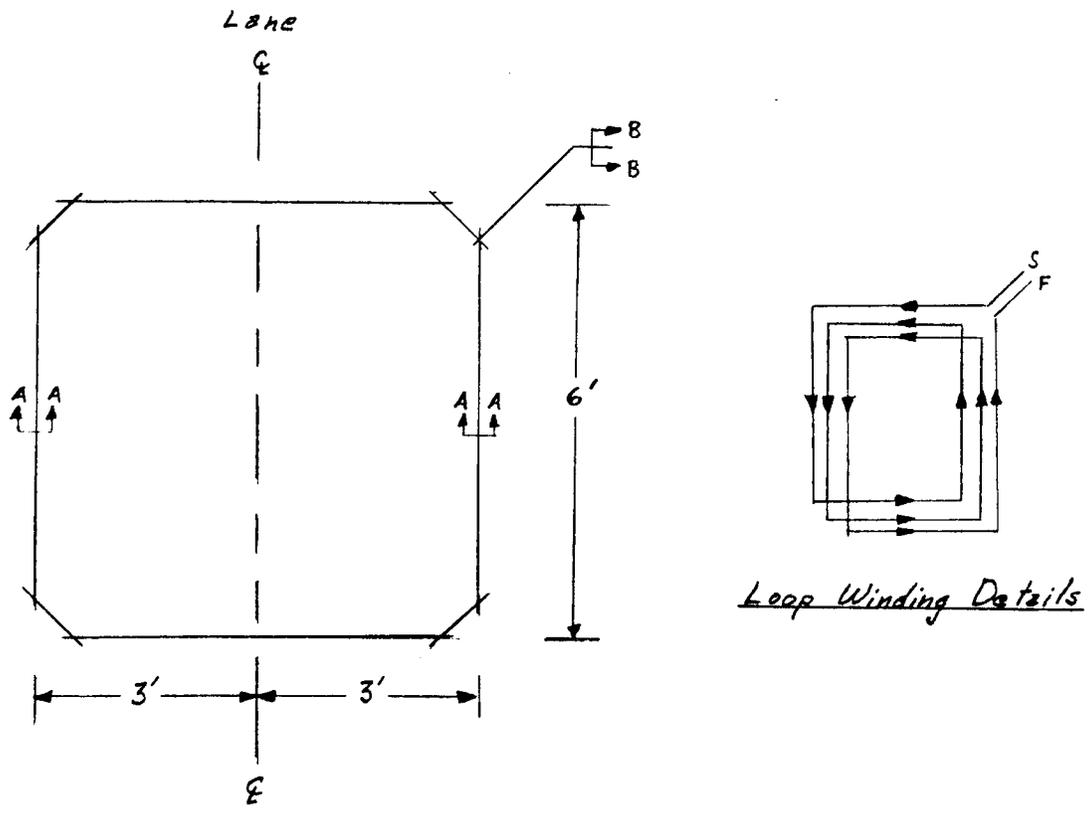
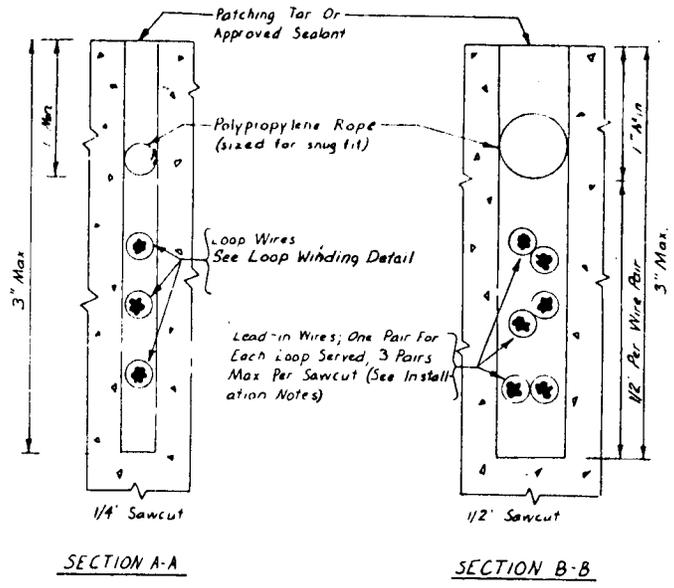
Figure 1. Example of Induction Loop Details.

Sawcut Details

Figure 1 began being used in the early 1960's (1). An electromagnetic field is created around the loop area in the 20 to 200 KHz frequency range. Vehicles in the area absorb some of the energy which increases the resonant frequency of the loop. Electronics in the control circuitry sense the change in phase, frequency, or impedance and actuate the signal or counter. DeLaski (1) noted that these systems are very flexible and dependable. They are currently the most widely used detection systems.

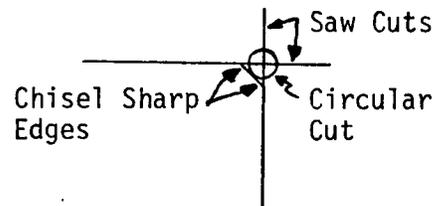
Figure 3. Method to Reduce Stress Concentrations at Corners.

CURRENT METHOD OF
CORNER-CUTTING CAN
CAUSE PAVEMENT DISTRESS

THIS METHOD REDUCES THE
NUMBER OF SAW CUTS

Hale (11) cited problems with corner cutting the loop slots. The triangle formed by saw cuts creates increased stress concentration in these areas of the pavement. The pavement within these triangle are stressed to failure much sooner than the surrounding pavement. To alleviate this, it was suggested that two inch diameter holes be drilled at the corners and the radii of the holes be chiseled out to form rounded corners for the wire. This is illustrated in Figure 3. Hale (11) also noted the importance of having slack in the wire at corners to accommodate pavement movement.

altered. This gives rise to stress concentration at the point of discontinuity (saw cut). Thus, the installation of induction loops may cause pavement failures which are blamed for the induction loop failures. An appropriate analogy might be to saw a structural beam through 3/4 of its thickness from the top and expecting it to hold the design load. In instances where an induction loop is to be installed in conjunction with a pavement overlay, the induction loop should be placed and sealed in the existing surface prior to the application of the overlay.

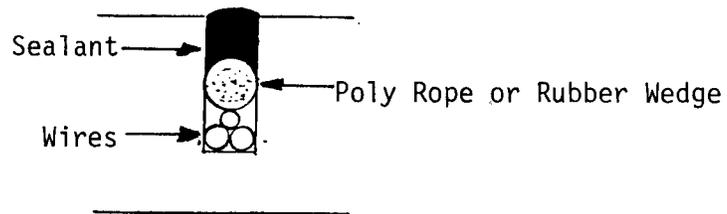
Figure 4. Methods of Sealant Application.

4b. Total Encapsulation.

4c. Conduit Method

The success or failure of an induction loop system is largely dependent upon the method and material used to hold the loop in place. There are three general methods used to hold loop wires in place: 1) partial encapsulation, 2) total encapsulation, and 3) the conduit method. These are illustrated in Figure 4. The current WSDOT procedure calls for using the conduit method. De Laski (1) does not recommend the use of the conduit method although no evidence was presented to show that it was any worse than the other methods. Instead, he favors the encapsulation of loop wires because of the "tough-but-rubbery" nature of recently developed loop sealers.
