1. REPORT NO.  WA-RD-115.1	2. GOVERNMENT ACCESSION NO.	3. RECIPIENT'S CATALOG NO.	
4. TITLE AND SUBTITLE EVALUATION OF DELINEATION SYSTEMS FOR TEMPORARY TRAFFIC BARRIERS	5. REPORT DATE May 1987		6. PERFORMING ORGANIZATION CODE

**EVALUATION OF DELINEATION SYSTEMS  
FOR TEMPORARY TRAFFIC BARRIERS  
IN WORK ZONES**

**Final Report**  
**DOT-FH-11-8007**  
**Task Order No. 17**

**May 1987**

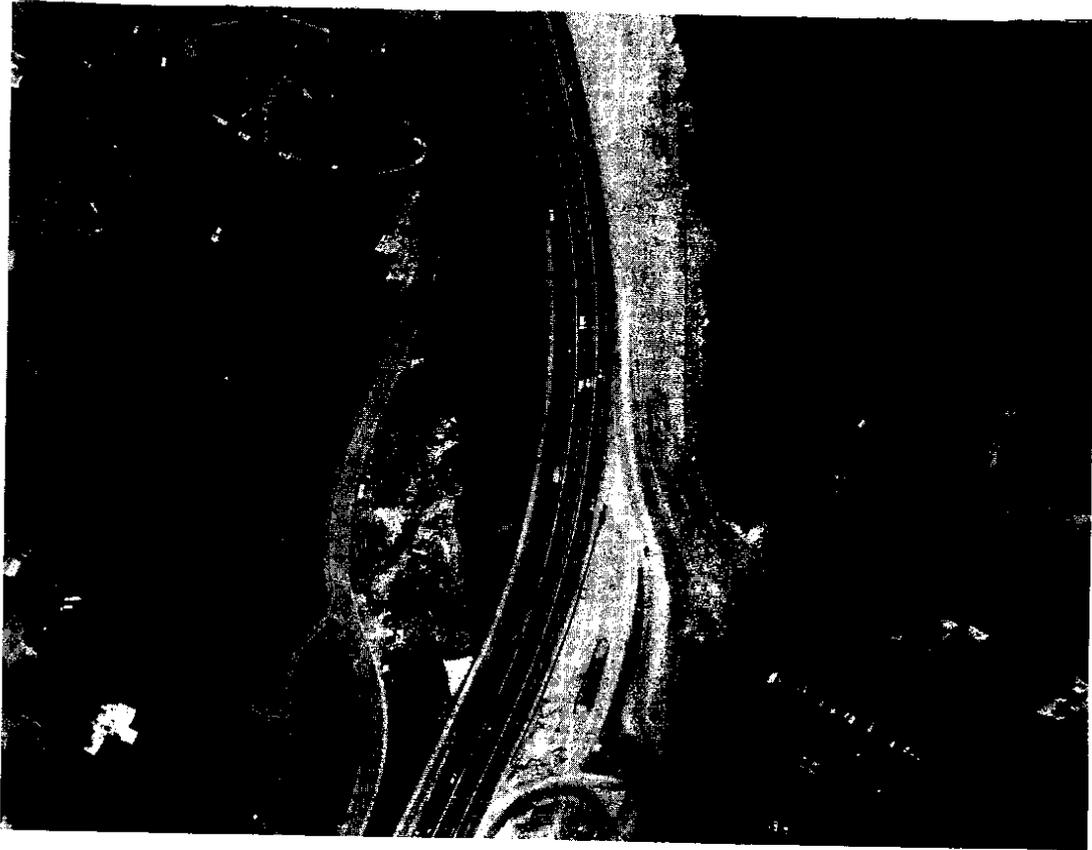
Figure 4-2. Location #1

Central Angle ( $\Delta$ )	35° 14' 31" Right
Radius (R)	1,200 ft.
Tangent (T)	381.15 ft.
Curve Length (L)	738.11 ft.
Grade	+1.76%
Normal Pavement Crown	$\pm$ 2.00%
Full Super-elevation	4%
Length of Location	1,000 ft.

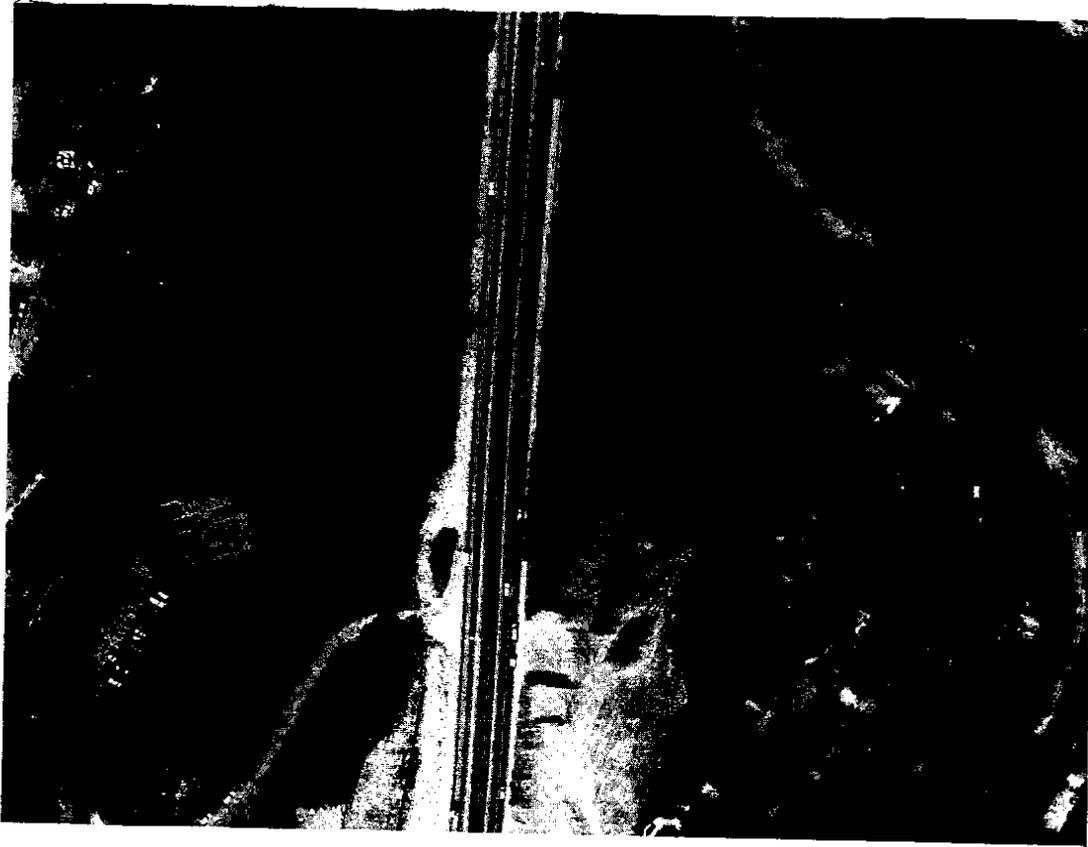
Figure 4-3. Location #2

Tangent	
Grade	+2.57%
Normal Pavement Crown	±2.00%
Length of Location	1,000 ft.

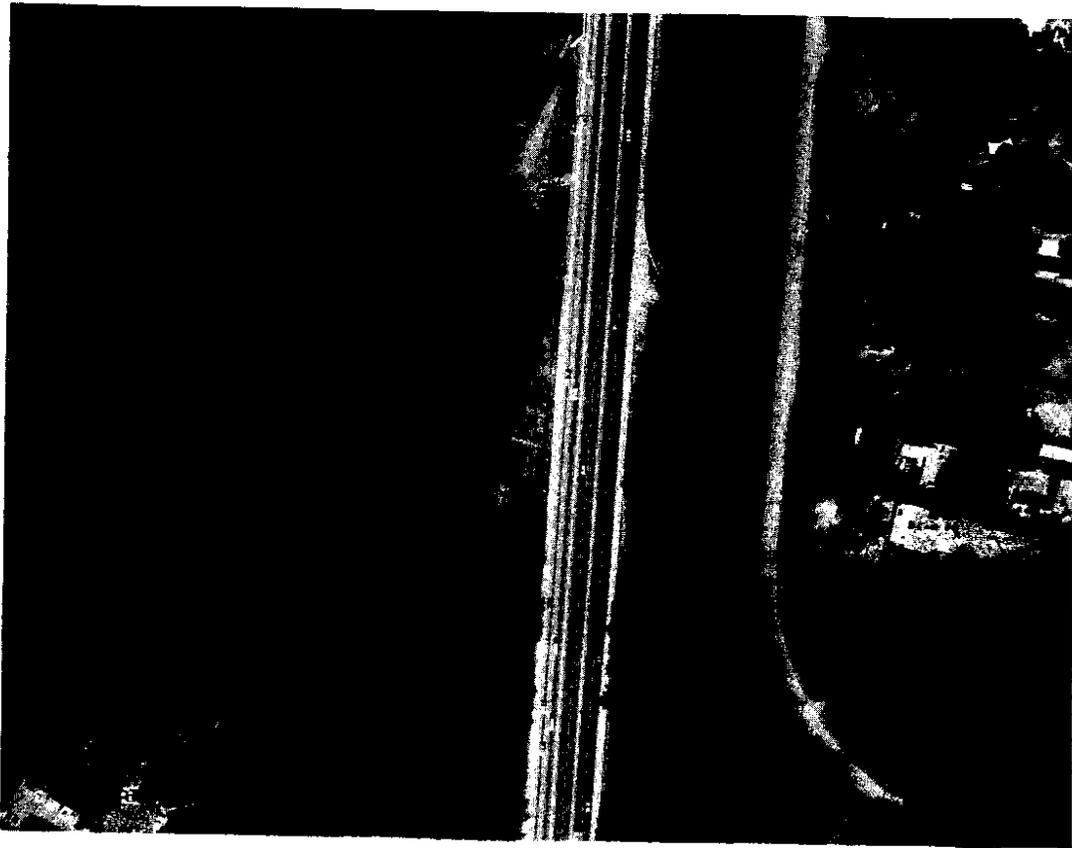
Figure 4-4. Location #3

Tangent Section	
Grade	-.60%
Normal Pavement Crown	±2.00%
Length of Location	1,000 ft.

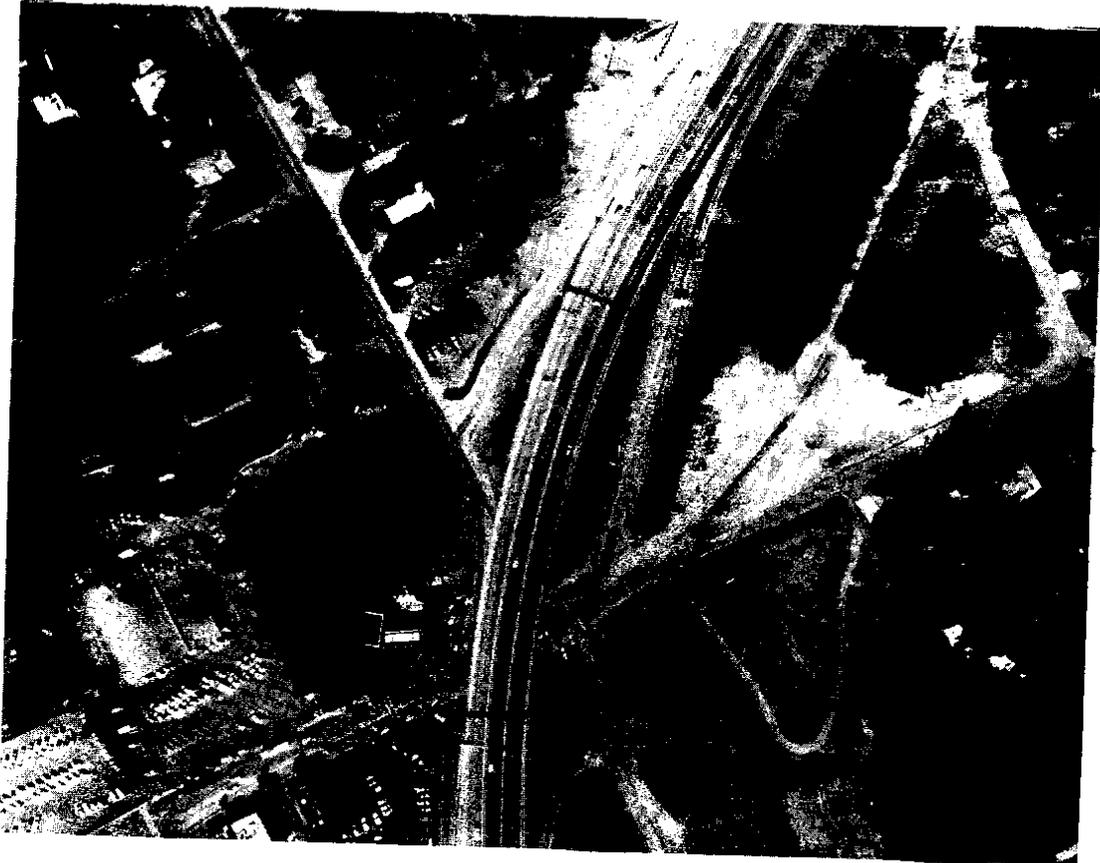
Figure 4-7. Location #6

Central Angle ( $\Delta$ )	30° 13' 31" Right
Radius (R)	1,910 ft.
Tangent (T)	515.81 ft.
Curve Length (L)	1,007.56 ft.
Grade	+1.40%
Normal Pavement Crown	$\pm$ 2.00%
Full Super-elevation	4%
Length of Location	1,000 ft.
