1. REPORT NO. WA-RD 357.1	2. GOVERNMENT ACCESSION NO.	3. RECIPIENT'S CATALOG NO.
4. TITLE AND SUBTITLE Seismic Performance of Bridge Columns with Interlocking Spiral Reinforcement	5. REPORT DATE September 1994

Research Project GC 8720-14
Column Confinement Reinforcement

**SEISMIC PERFORMANCE OF BRIDGE COLUMNS WITH
INTERLOCKING SPIRAL REINFORCEMENT**

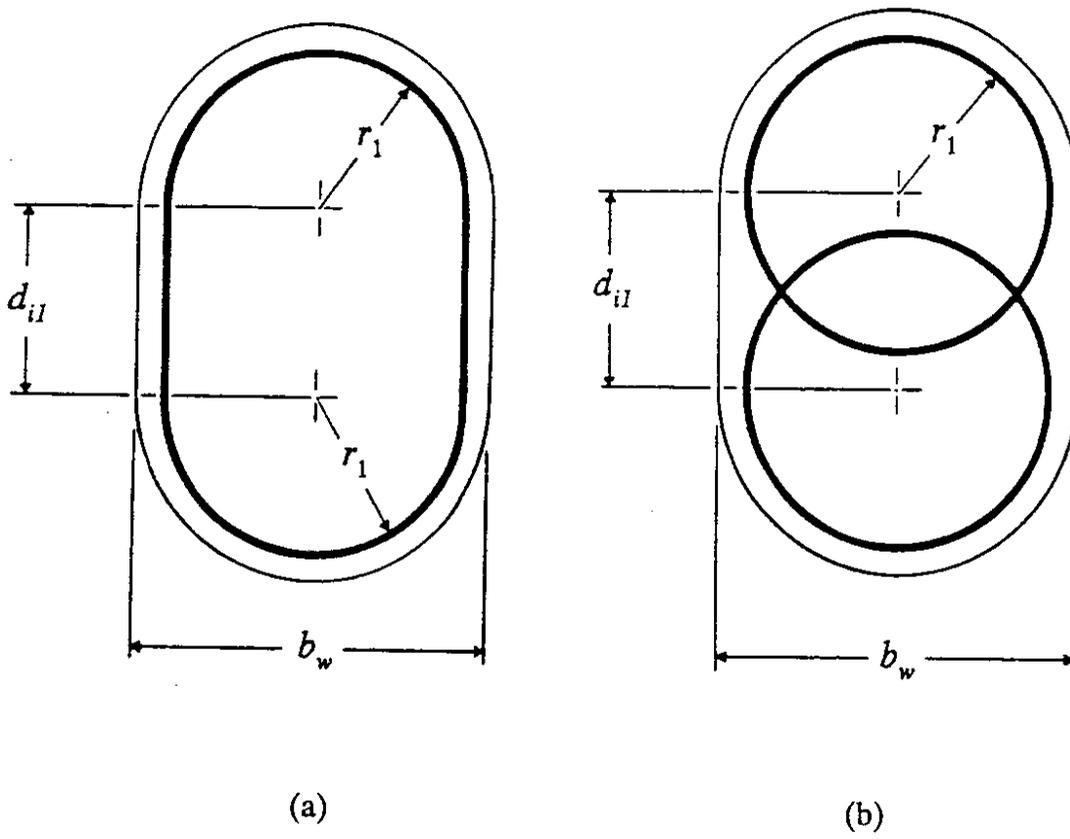
Figure 1 Effective transverse reinforcement under shear loading.

where A_{sp} is the cross-sectional area of one spiral bar, f_{yh} is the yield stress of the spiral and s is the center-to-center spiral spacing. The second method assumes that all portions of the spiral reinforcement reach yield and are therefore effective against

shear, as shown in Figure 1b. The expression for shear carried by the transverse reinforcement can then be expressed as

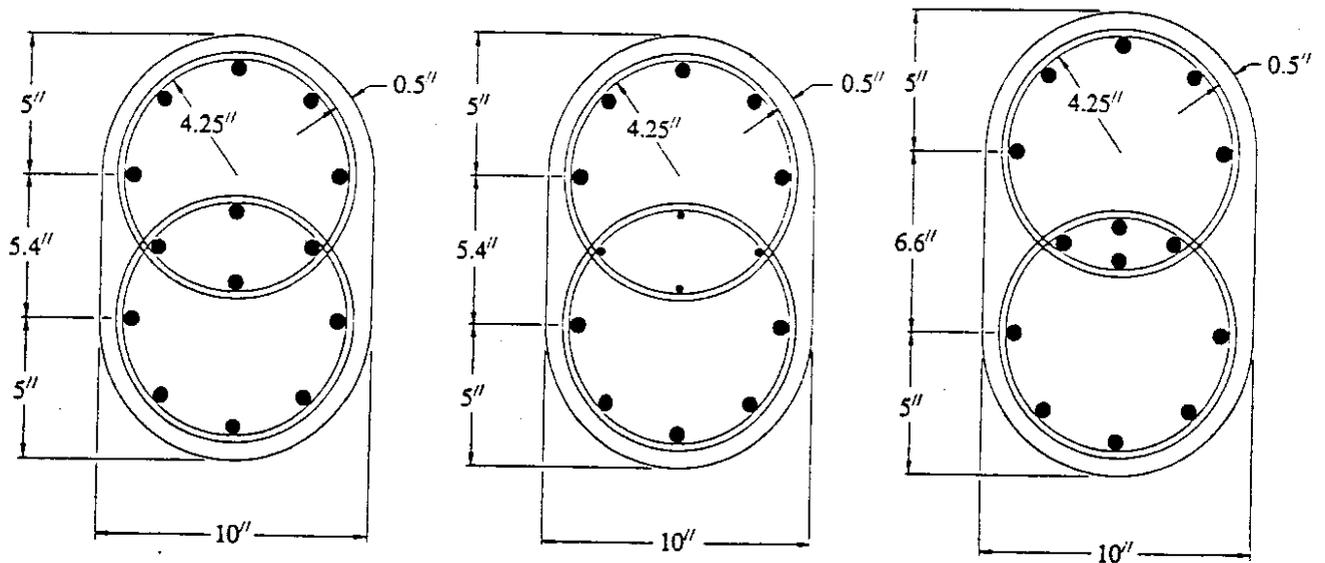
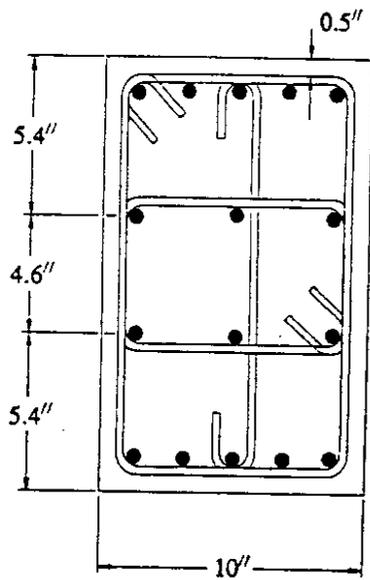
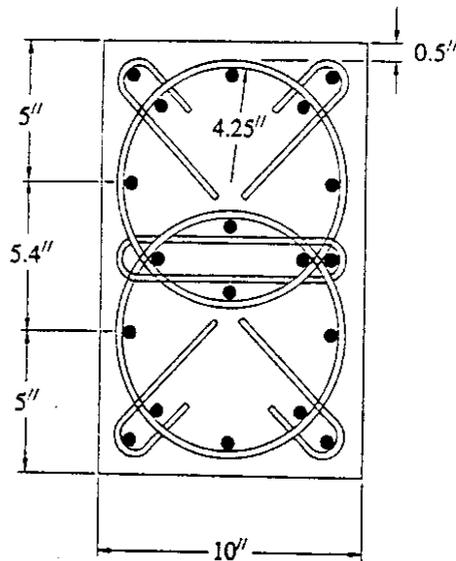
Columns 1,5, and 8

Column 4

Column 3

Columns 6 and 7

Column 2

Figure 2 Column cross-sections and reinforcement layout.

All reinforcement in the 1/5-scale specimens was Grade 60. The ties and spirals were constructed of No. 2 deformed rebar. The column longitudinal steel consisted of No. 4 rebar in the flexural specimens and No. 5 rebar in the shear and torsion specimens, except for Column 4 which had No. 2 rebar in the interlock zone.

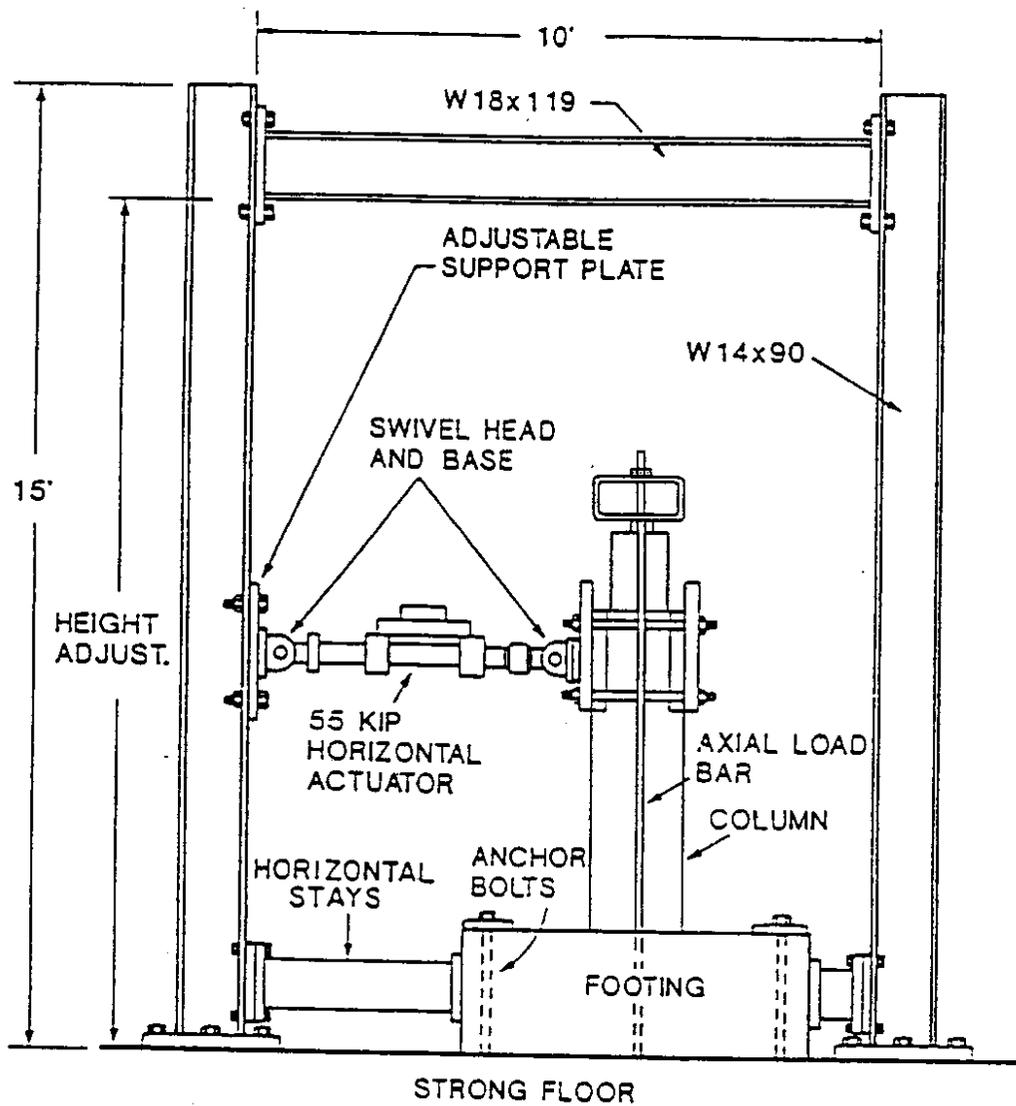
Figure 3 Test setup.

The test setup for the 1/5-scale shear and flexure specimens is shown in Figure 3. The footing of the test specimen was anchored to a laboratory strong floor. Lateral load was applied using a 55-kip actuator operated under displacement control. Axial load was applied to the top of the column using a 200-kip jack. An axial load of approximately $0.09 f'_c A_g$ was applied to all specimens except that used in the torsion test, which had no axial load. The axial loading system resulted in the axial load varying during testing by approximately $\pm 6\%$.

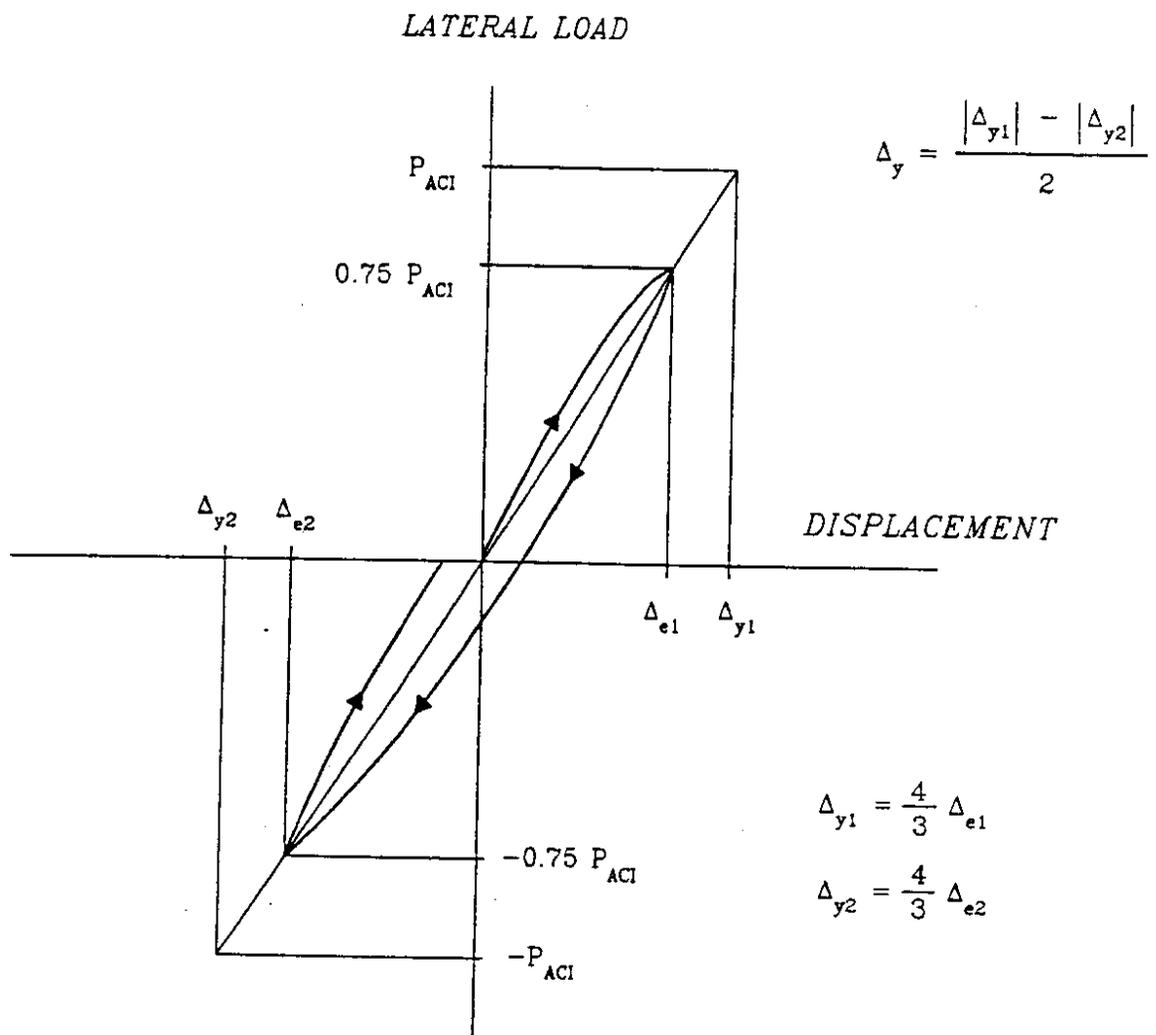
Figure 4 Determination of specimen yield displacement.

The method for determining the yield displacement for the 1/5-scale specimens is illustrated in Figure 4. The theoretical ACI ultimate moment strength (M_{ACI}) of each column was determined using strain compatibility methods. The column was then subjected to $\pm 75\% M_{ACI}$ under load control and the corresponding deflections of $\pm \Delta_e$ were recorded. The yield displacement (Δ_y) was determined using the equation shown in Figure 4. The specimens were subjected to a simulated seismic loading pattern consisting of increasing multiples of Δ_y in order to demonstrate the ductility and hysteretic behavior of the test specimens. The loading pattern for the flexure specimens consisted of two cycles at displacement ductility

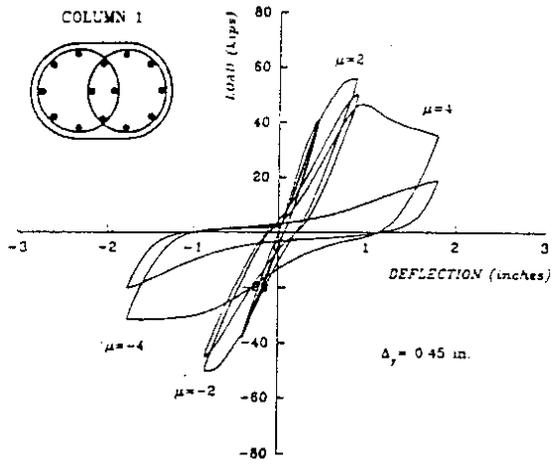
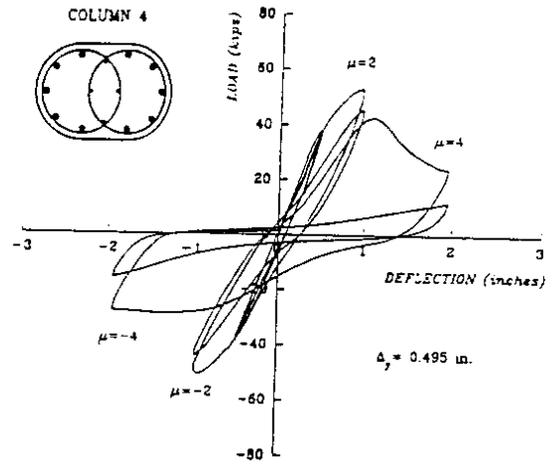
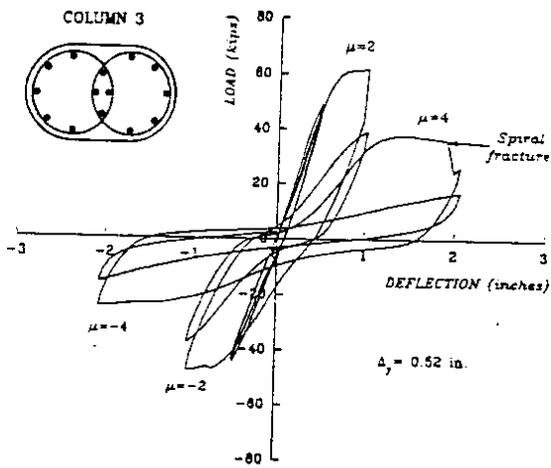
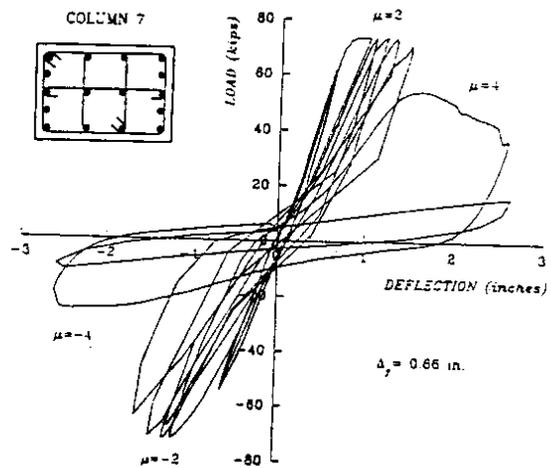
Figure 6 Load-displacement curves for the shear test specimens.

of displacement ductility past the first cycle to $\mu = +2$. The fracture point of the spiral reinforcement is indicated by the near vertical drop in lateral load on the first cycle to $\mu = +4$.

the tie. Similar damage to the end returns on the internal ties and cross-ties also occurred. The load deflection plot for Column 7 is shown in Figure 6d. Although influenced by the increased number of cycles used at $\mu = \pm 2$, the graph reveals rapid deterioration in the load carrying capacity of the specimen at $\mu = \pm 4$, as described earlier. The two sharp drops in load at deflections of approximately 2.0 in. and 2.5 in. on the first cycle to $\mu = \pm 4$ correspond to sudden unraveling of rectangular tie end returns.

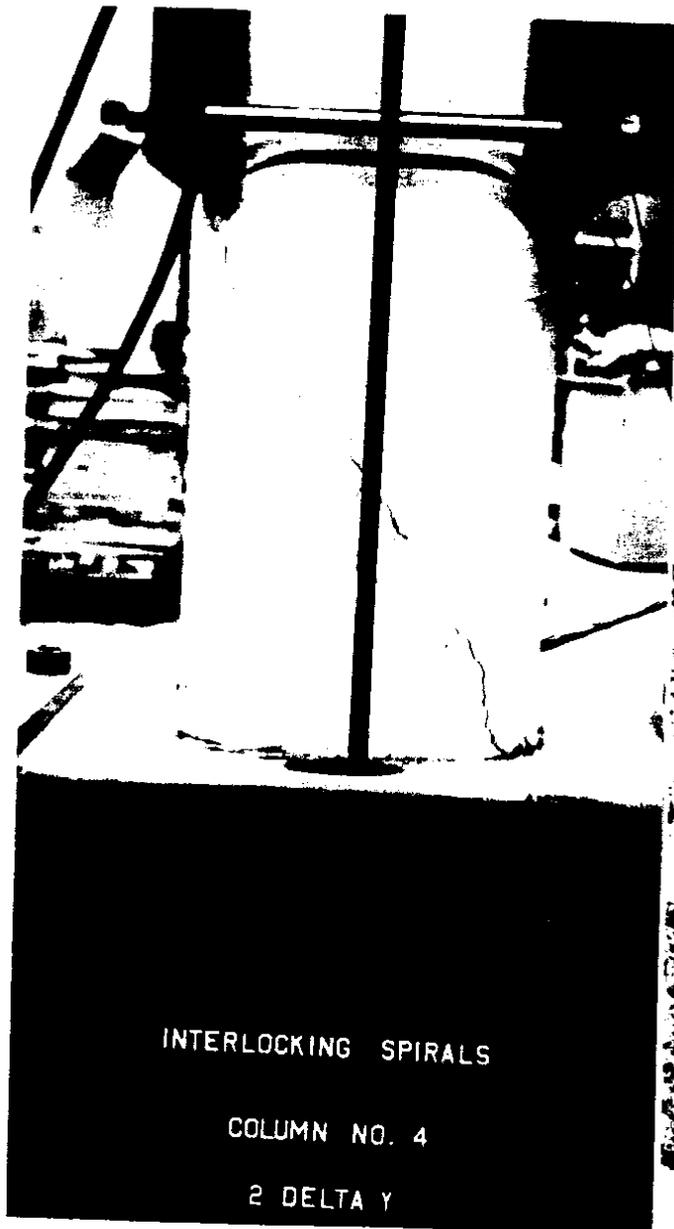
Figure 7 Photographs of Column 4 showing (a) crack patterns at $\mu = \pm 2$ and (b) nominal interlock bar after testing.

However, the crack widths in Column 4 were larger than those in Column 1 at $\mu = \pm 2$, as shown in Figure 7a. Spalling of the cover concrete started early in the $\mu = \pm 4$ cycle, followed by core fragmentation and spiral straightening. The two nominal interlock bars on the transverse faces of the column displayed significant amounts of deformation due to tensile forces acting on the spiral reinforcement arising from shear on the column. A post-test photograph of one of the nominal interlock bars is shown in Figure 7b. The load-deflection curve for Column 4, shown in Figure 6b, reflects the physical behavior described previously. Moderate degradation occurs for $\mu \leq \pm 2$, followed by severe degradation at $\mu = \pm 4$ due to core fragmentation and longitudinal reinforcement damage.

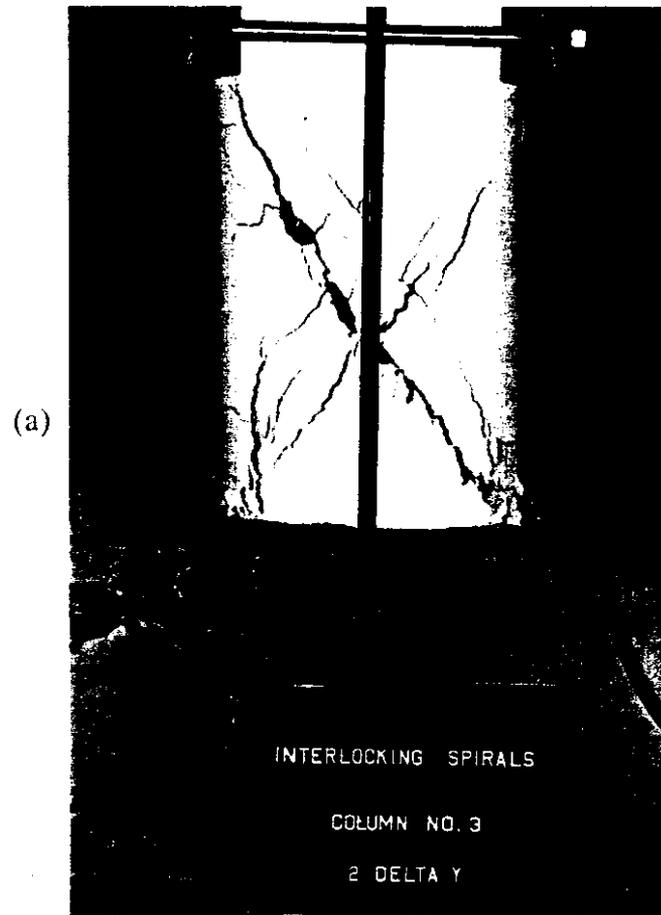
Figure 8 Photographs of Column 3 showing (a) crack patterns at $\mu = \pm 2$ and (b) rupture of the spiral reinforcement.

Column 3 was constructed with an overlap percentage of 15 to examine the minimum overlap of 14.3% recommended by Caltrans (1). All of the longitudinal bars in the interlock zone were the same size as the bars used in the rest of the specimen. The initial cracking load and crack pattern exhibited in this specimen was similar to that described for Columns 1 and 4. However, crack widths in Column 3 at $\mu = \pm 2$, shown in Figure 8a, were significantly larger than those encountered in the previous two tests at the same level of displacement. Spalling of cover concrete in this specimen commenced in the latter stages of the $\mu = \pm 2$ cycle and continued into the final two cycles at $\mu = \pm 4$. Rupture of the spiral reinforcement, shown in Figure 8b, occurred on the first cycle to $\mu = +4$ at approximately 93% of full cycle displacement. The load-deflection plot for Column 3 is shown in Figure 6c. Decreases in the load carrying capacity of the column are detectable at every level

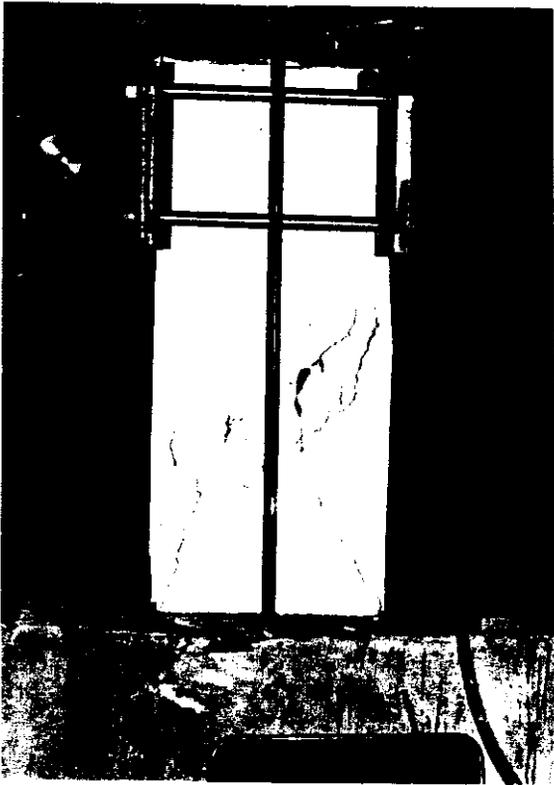
Figure 9 Photographs of Column 7 showing (a) crack patterns at $\mu = \pm 2$ and (b) the rectangular tie end returns after testing.

Rectangular ties and cross-ties were used as transverse reinforcement in Column 7 in order to compare the performance of a conventionally reinforced column to one utilizing the interlocking spiral detail (Column 1). A modified testing procedure was used for Column 7 due to limitations encountered in the capacity of the testing equipment. The first two cycles at $\mu = \pm 1$ were accomplished without any alterations to the testing procedure or equipment. However, the load required to attain a displacement corresponding to $\mu = \pm 2$ was beyond the range of the 55-kip hydraulic actuator. After two failed attempts to reach $\mu = +2$ with normal testing procedures, the specimen was relieved of all axial load and cycled manually to produce strength deterioration until the desired displacement was obtained. A photograph showing crack patterns at $\mu = \pm 2$ is shown in Figure 9a. For the cycle to $\mu = \pm 4$, axial load was returned to the specimen and normal procedures for controlling the lateral load and displacement were resumed. Degradation of Column 7 occurred rapidly in the final two cycles at $\mu = \pm 4$. The core concrete was reduced to rubble at this stage due to the loss of confinement, and possibly also due to the increased number of load cycles imposed on this specimen. A post-test photograph of one of the rectangular ties in Column 7 is shown in Figure 9b. The bend angle on the end return has rotated from an original position of 135 degrees to approximately 90 degrees, resulting in a partial loss of the confinement capability of

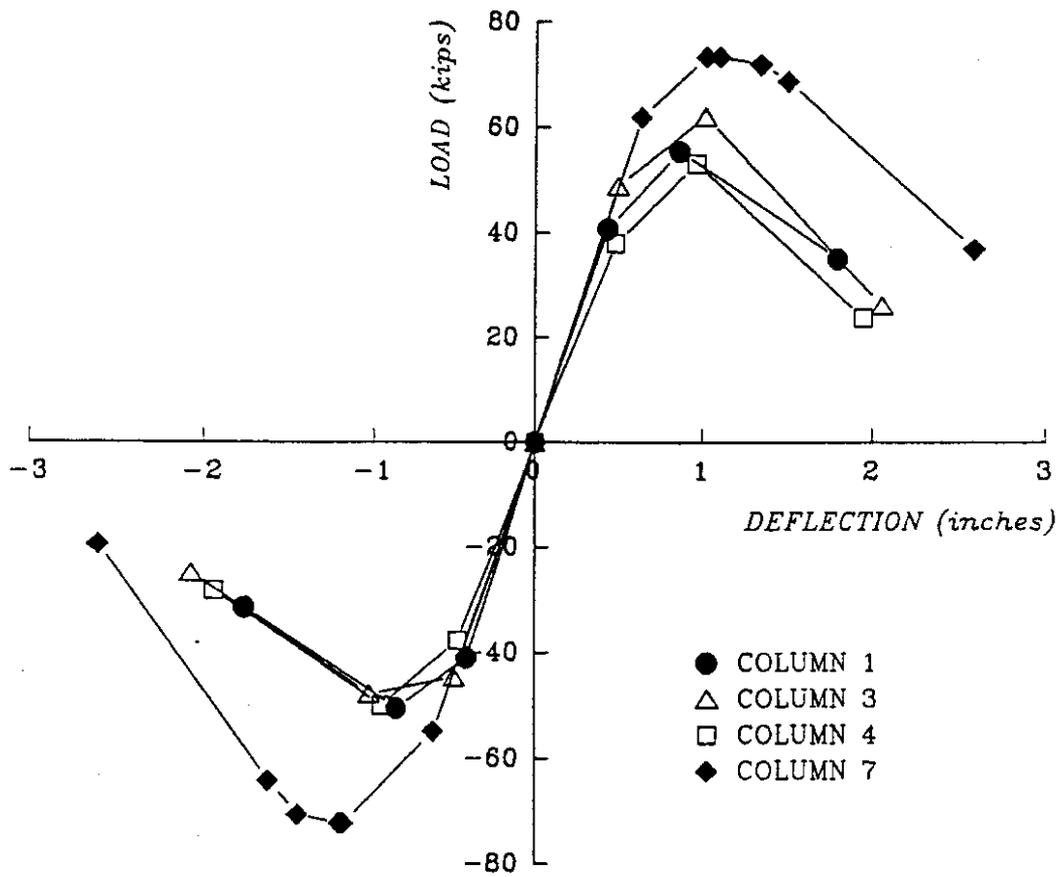
Figure 10 Lateral load-deflection envelope curves for the shear test specimens.

A graph displaying load-deflection envelope curves for each of the four 1/5-scale shear test specimens is shown in Figure 10. Points on the graph represent the peak load carried by each specimen at successive levels of displacement ductility, μ . By representing the data in this manner, it is possible to directly compare the degradation characteristics inherent to each column. Comparison of the load-deflection data indicates that the reduction in load carrying capacity for Columns 3 and 4 was greater than that for Column 1 at similar levels of displacement ductility. The load-deflection envelope curve for Column 7 reveals a degradation in load carrying capacity that is comparable to that in Columns 3 and 4 and is significantly greater than the degradation in Column 1. However, it is important to note that the testing procedure used for Column 7 was different from that used in the rest of the tests.

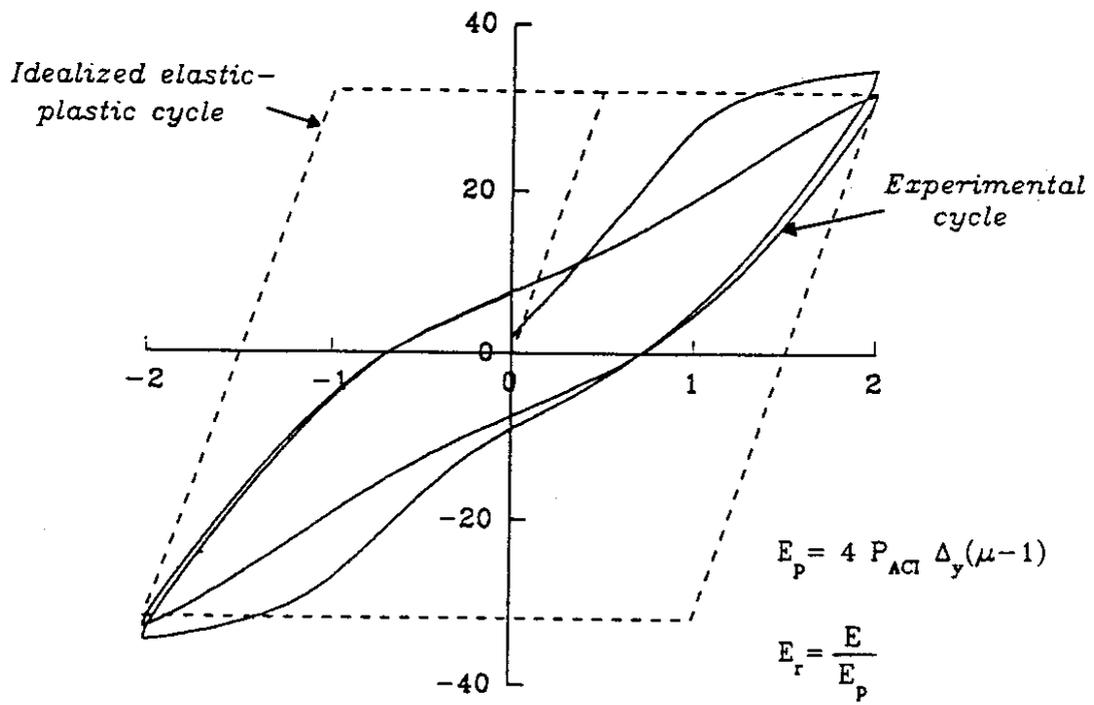
Figure 11 Definition of energy dissipation ratio, E_r .

A definition of energy dissipation is outlined in Figure 11. The area enclosed by an experimental load-deflection curve (E) for a structural member is equal to the energy dissipated in the member through inelastic displacements. When this value is divided by the area enclosed by an idealized elastic-plastic member (E_p), the result is an efficiency factor for energy dissipation in that particular member (E_r). A plot of energy dissipation ratio, E_r , versus displacement ductility factor, μ , for Columns 1, 3 and 4 is shown in Figure 12. Comparison of this data reveals that Column 1 is slightly more efficient than Column 3 and significantly higher in efficiency than Column 4 with respect to energy dissipation. Data for Column 7 was not included in Figure 15 due to the difference in testing procedure.

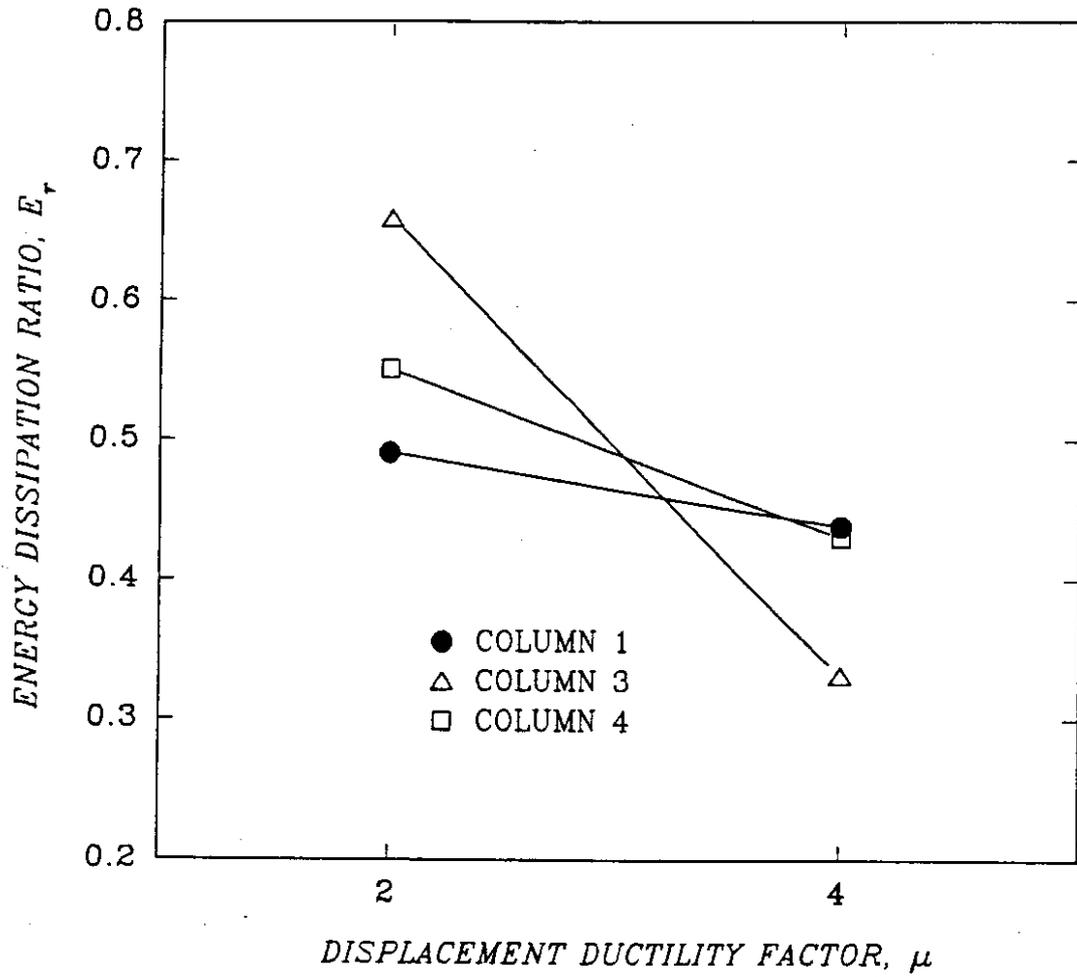
Figure 12 Energy dissipation ratio versus displacement ductility for shear specimens.

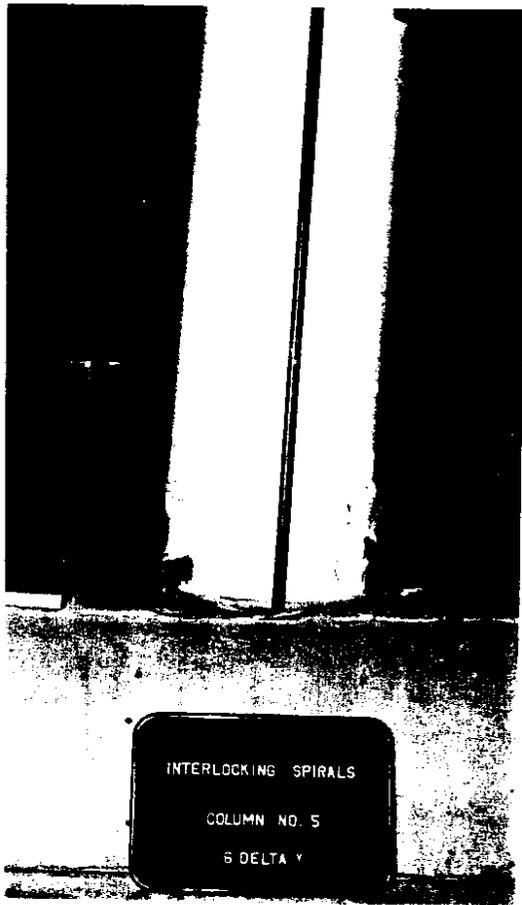
Figure 13 Photographs of Column 5 showing (a) damage at $\mu = \pm 6$ and (b) buckling of the longitudinal reinforcement.

The interlocking spiral detail used in Column 5 consisted of a spiral overlap percentage of 25 in an oval-shaped cross-section. Flexure cracks initially appeared in Column 5 at a lateral load of approximately 15 kips. At $\mu = \pm 1$, shear and flexure-shear cracks formed along the entire height of the specimen at intervals of approximately 3 in. to 4 in. Although these cracks persisted throughout the duration of the test, the primary mode of failure in the specimen remained flexural in nature. Crushing of the concrete on the extreme load-bearing faces of the specimen just

above the top of the footing occurred at $\mu = \pm 4$ and eventually led to spalling in these areas at $\mu = \pm 6$, as shown in Figure 13a. On the final cycle to $\mu = +6$, the longitudinal bar shown in Figure 13b buckled outward between two sections of spiral reinforcement. Further cycling of the specimen resulted in fracture of this bar at $\mu = -8$ due to fatigue stress. The load-displacement curve for Column 5 is shown in Figure 14a. Except for the sharp drop in lateral load at the point of longitudinal bar fracture, the load carrying capacity of the specimen remains nearly constant throughout the test.

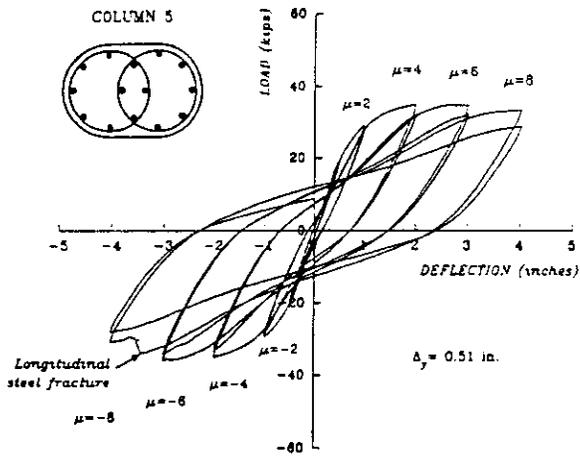
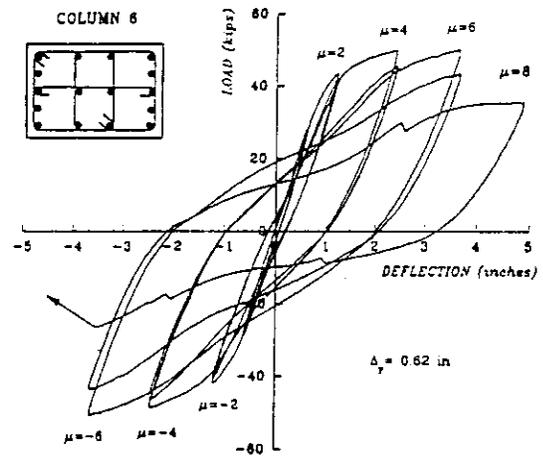
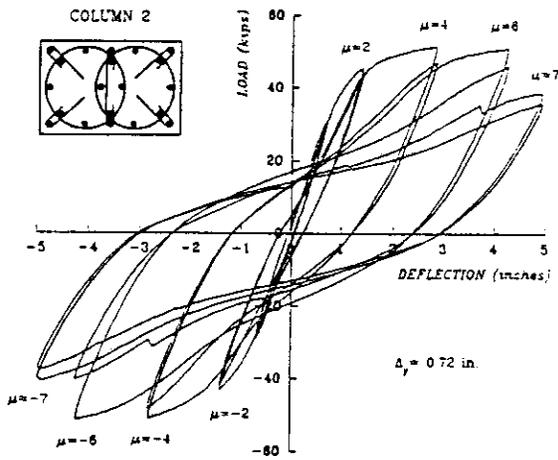
Figure 14 Load-displacement curves for the flexural test specimens.

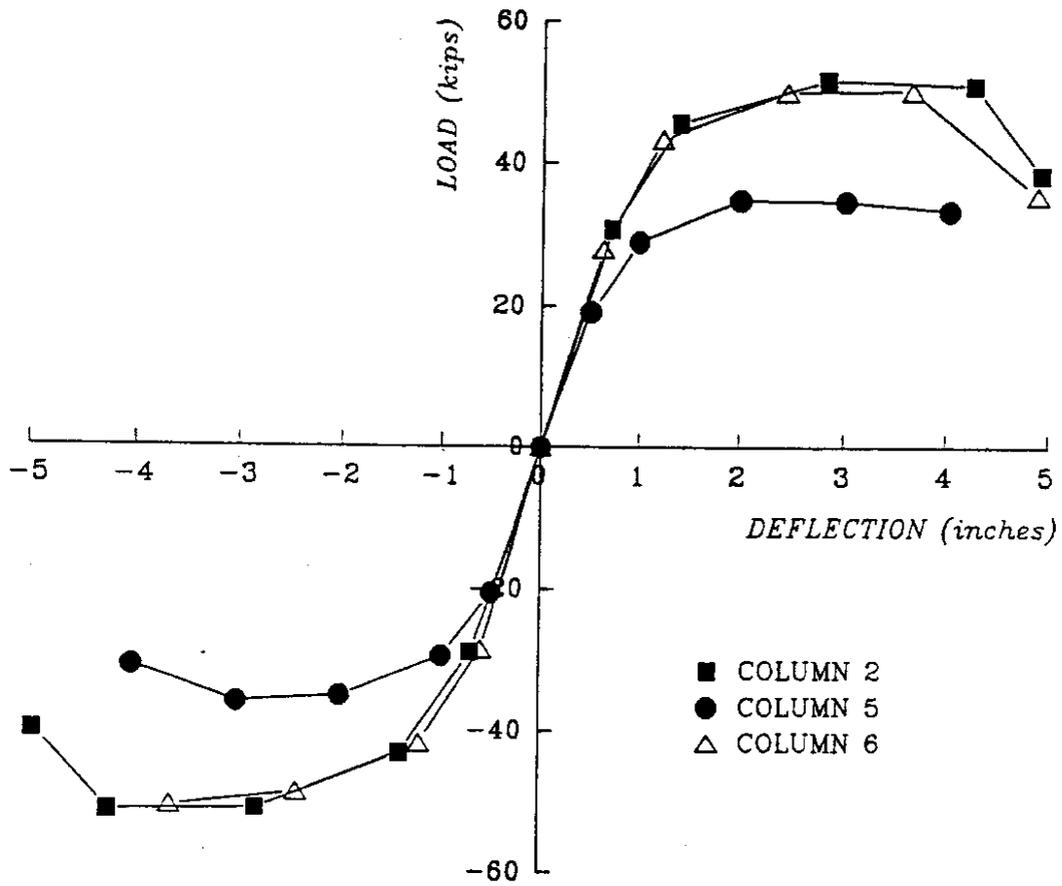
Figure 16 Lateral load-deflection envelope curves for flexural test specimens.

The load-deflection envelope curves for all of the 1/5-scale flexure specimens are shown in Figure 16. The degradation in peak load carrying capacity for Column 5 from $\mu = +4$ to $\mu = +8$ is 1.4 kips or 4.0%. In comparison, the capacity of Column 6 increases slightly through $\mu = \pm 6$, then drops 14.6 kips or 29.1% at $\mu = \pm 8$. This data indicates that Column 5 maintained a higher percentage of peak load than Column 6 at similar levels of displacement ductility. The degradation in load carrying capacity for Column 2 from $\mu = +4$ to $\mu \approx +7$ is 13.2 kips, or 25.6%, and is primarily the result of unconfined longitudinal bar fracture.

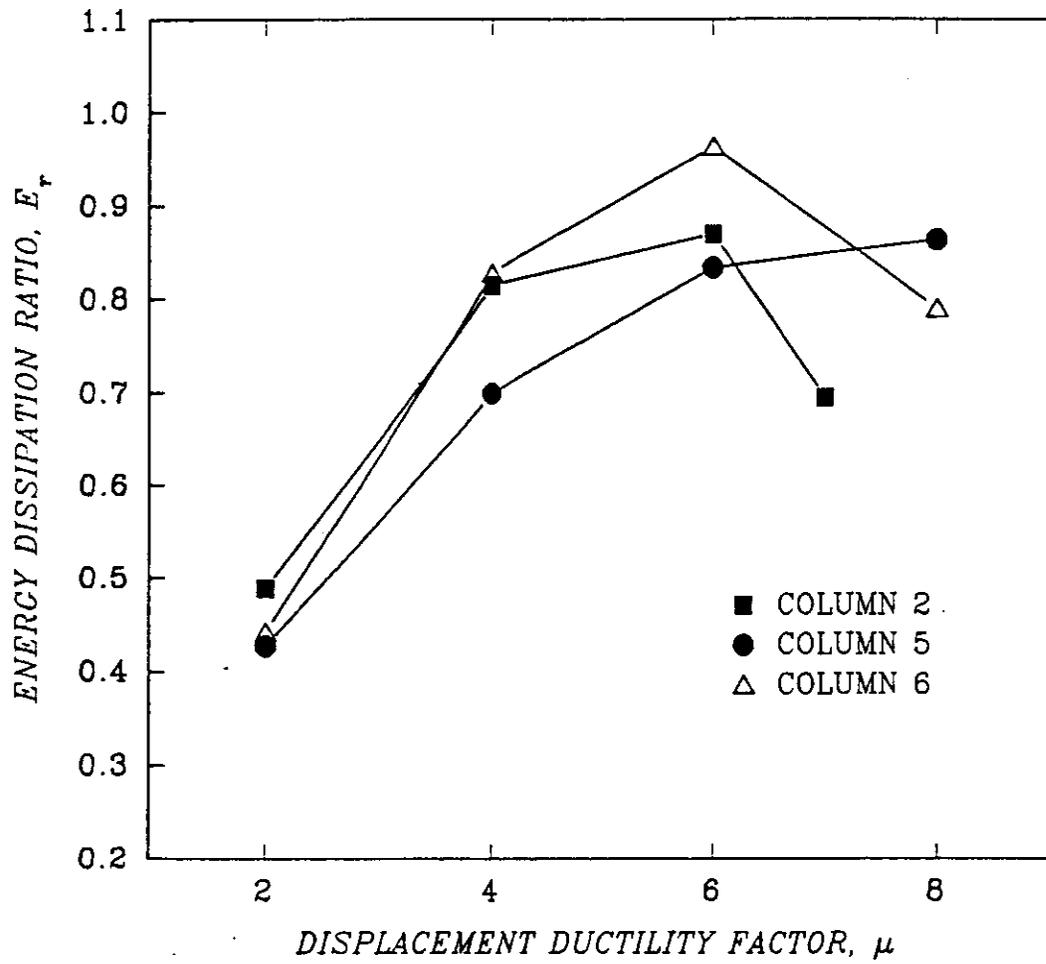
Figure 17 Energy dissipation ratio versus displacement ductility for flexure specimens.

A plot of energy dissipation ratio, E_r , versus μ for Columns 2, 5 and 6 is shown in Figure 17. The energy dissipation of Column 5 increases at each successive

level of μ , while Column 6 displays a decrease of 18.1% from $\mu = \pm 6$ to $\mu = \pm 8$. A comparison of the two specimens indicates that Column 5 is more efficient than Column 6 with respect to energy dissipation. The increase in E_r for Column 2 from $\mu = \pm 4$ to $\mu = \pm 6$ is significantly lower than that for Columns 5 and 6 due to advanced buckling of the longitudinal steel. Fracture of the unconfined longitudinal bars and unraveling of the anchors holding them in place resulted in a 20.1% decrease in E_r at $\mu \approx \pm 7$.

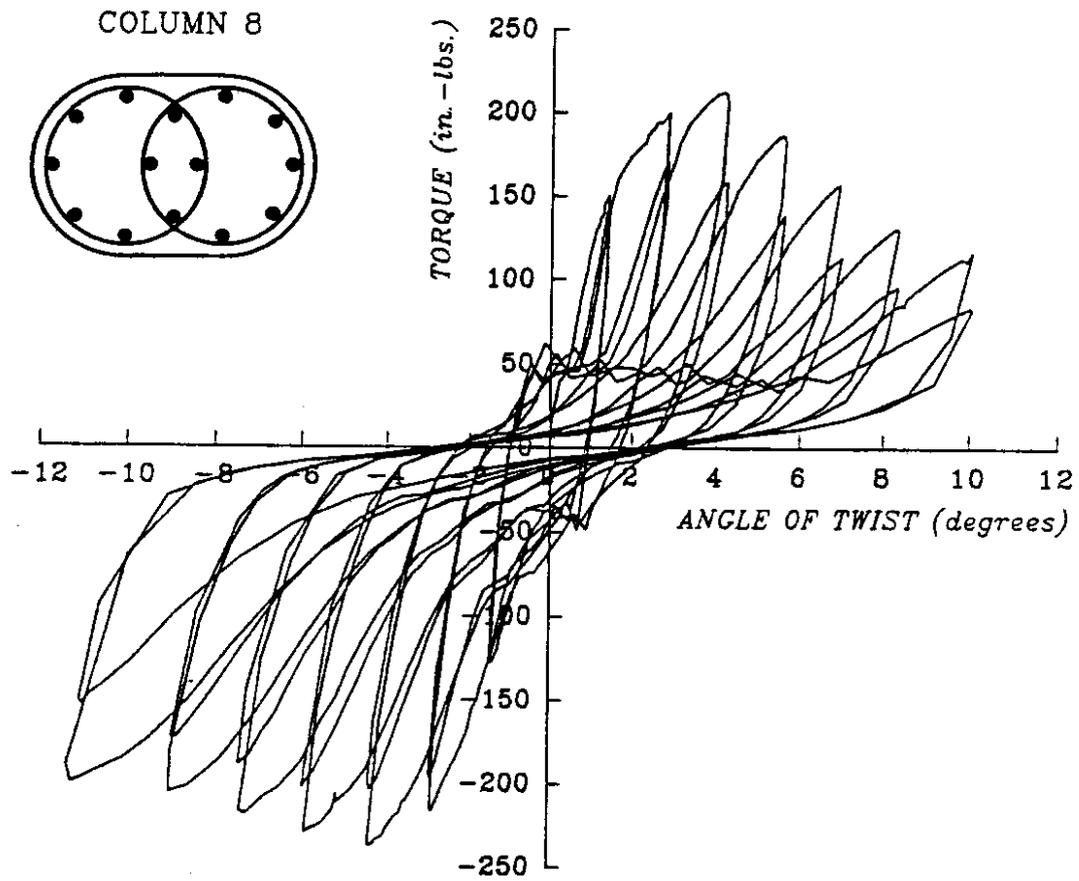
Figure 18 Torque-twist curve for Column 8.

The torque-twist curve for Column 8 is shown in Figure 18. The data displayed in the graph includes corrections for rotations in the loading collar and actuator and translations parallel and perpendicular to the plane of the reaction frame. The most prominent characteristic depicted in this graph is the difference in specimen degradation at positive and negative values of rotation. For positive values of rotation, the degradation in peak torque-carrying capacity for Column 8 is approximately 47%. In contrast, the deterioration in the capacity of the specimen for negative values of rotation is only 12%.

tends to tighten around the concrete core when twisted in one direction and separate from the core when twisted the opposite direction. The orientation of the spirals in Column 8 were such that a twist in the clockwise direction (negative rotation on the graph) resulted in tightening of the spiral, while a counter-clockwise twist (positive rotation on the graph) resulted in unwinding of the spiral. Strain gage readings on the spiral reinforcement and visual observation of separation of the spiral reinforcement from the concrete core during counter-clockwise loading supports this hypothesis of a winding/unwinding mechanism.

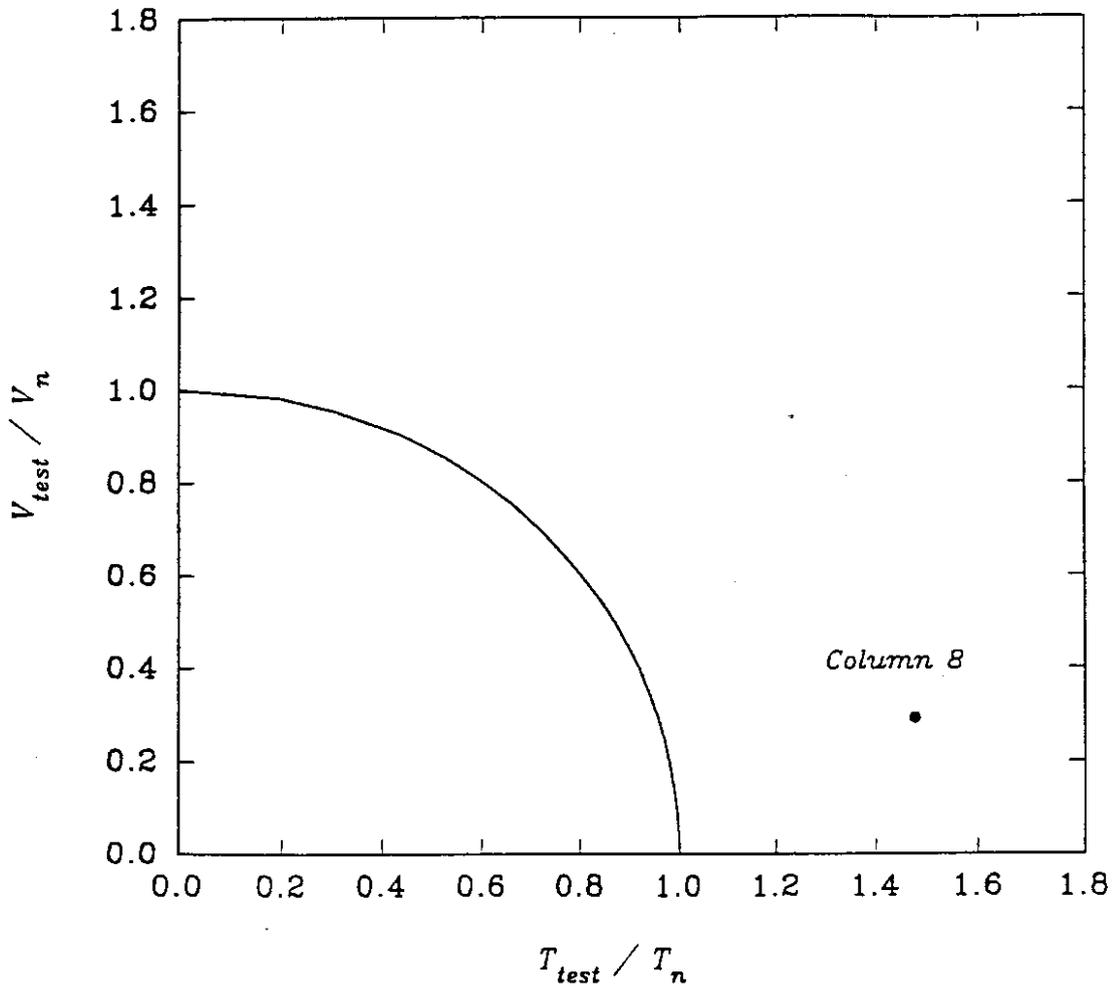
Figure 19 Shear-torsion interaction curve for Column 8.

A graph displaying the results from Column 8 with respect to shear and torsion interaction is shown in Figure 19. The procedure used for calculating the shear strength of Column 8 was the same as that used for the shear test specimens, i.e. the procedure developed by Tanaka and Park (2). The torsional strength for Column 8 was calculated using the procedures in ACI 318-89 (3) for rectangular beams. With respect to the shear and torsional strengths, it can be seen in the graph that the majority of the load applied to Column 8 was torsional in nature. The overstrength displayed for Column 8 is approximately 48%. The procedures for calculating the torsional strength of the oval column with interlocking spirals, while apparently conservative, are likely to be inexact. Further research into the behavior of interlocking spiral columns subjected to torsional load needs to be conducted, particularly in regard to rotation-direction bias resulting in unwinding of the spirals.
