Final Technical Report
Research Project Agreement No. T9233, Task 41
Seismic Vulnerability of the Alaskan Way Viaduct Phase II

**SEISMIC VULNERABILITY OF THE ALASKAN
WAY VIADUCT: GEOTECHNICAL
ENGINEERING ASPECTS**

July 1995

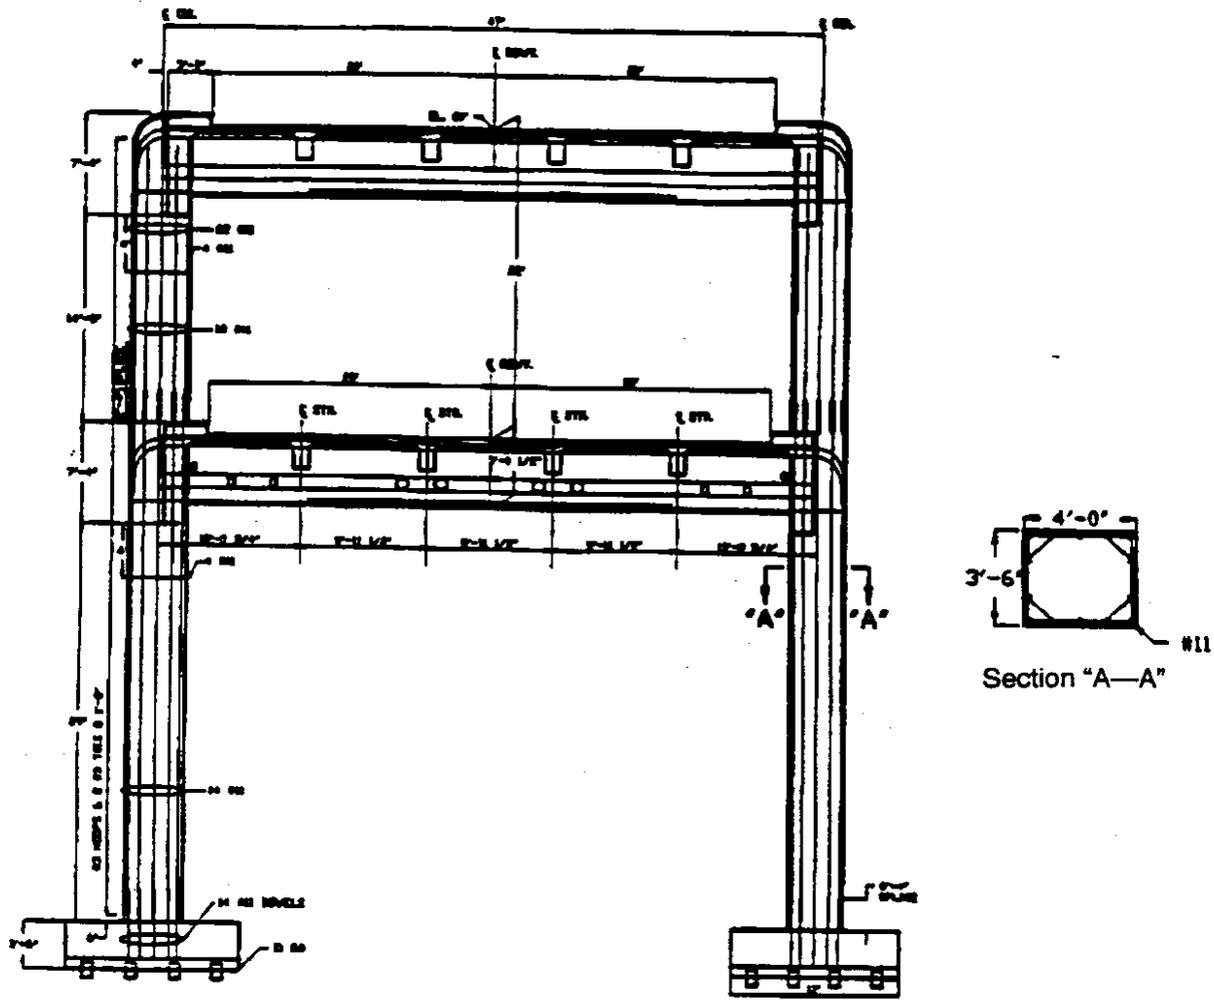
Transverse Elevation of Interior Bent

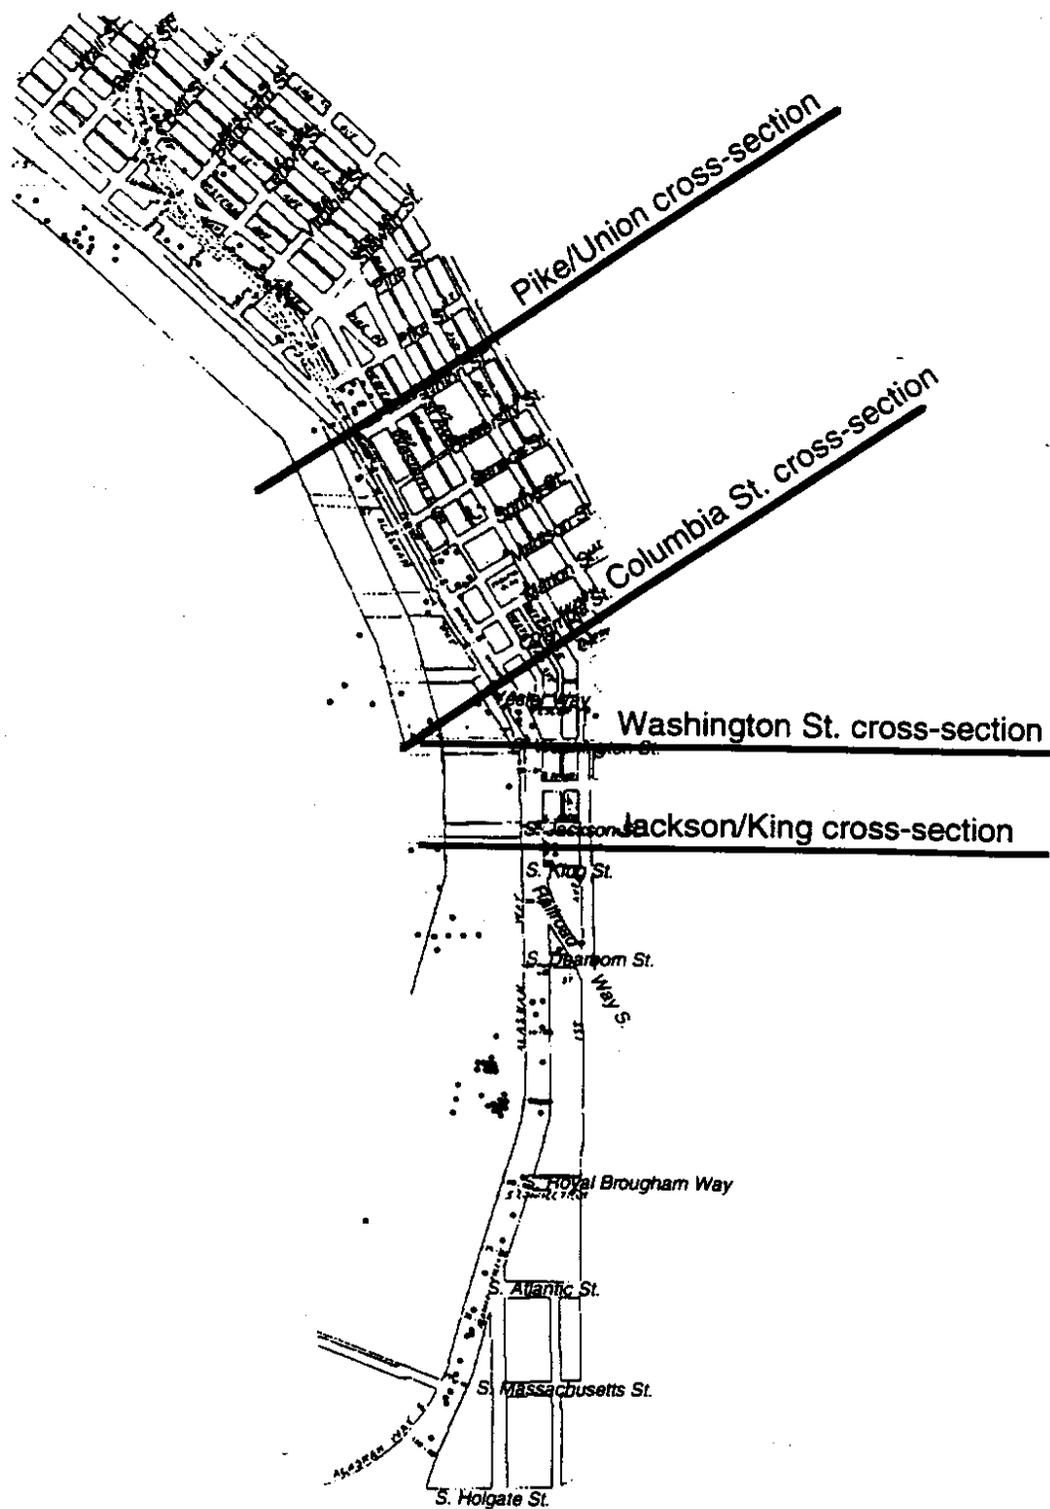
Figure 2.4. Locations of Available Boring Logs in the Vicinity of the Alaskan Way Viaduct

Department of Transportation (WSDOT) and were incorporated into a database of subsurface conditions developed for this project. Because these borings provided a limited view of the subsurface conditions beneath the Viaduct, the database was supplemented with data available from other borings drilled in conjunction with various construction projects located near the Viaduct. Those borings from the resulting database that provided the most comprehensive information and that could be located accurately are shown in Fig. 2.4. Subsurface conditions from borings aligned roughly perpendicular to the Viaduct were compiled at four locations: Columbia Street, the vicinity of Jackson and King Streets, the vicinity of Union and Pike Streets, and Washington Street. The locations of these transverse sections are also shown in Figure 2.4.

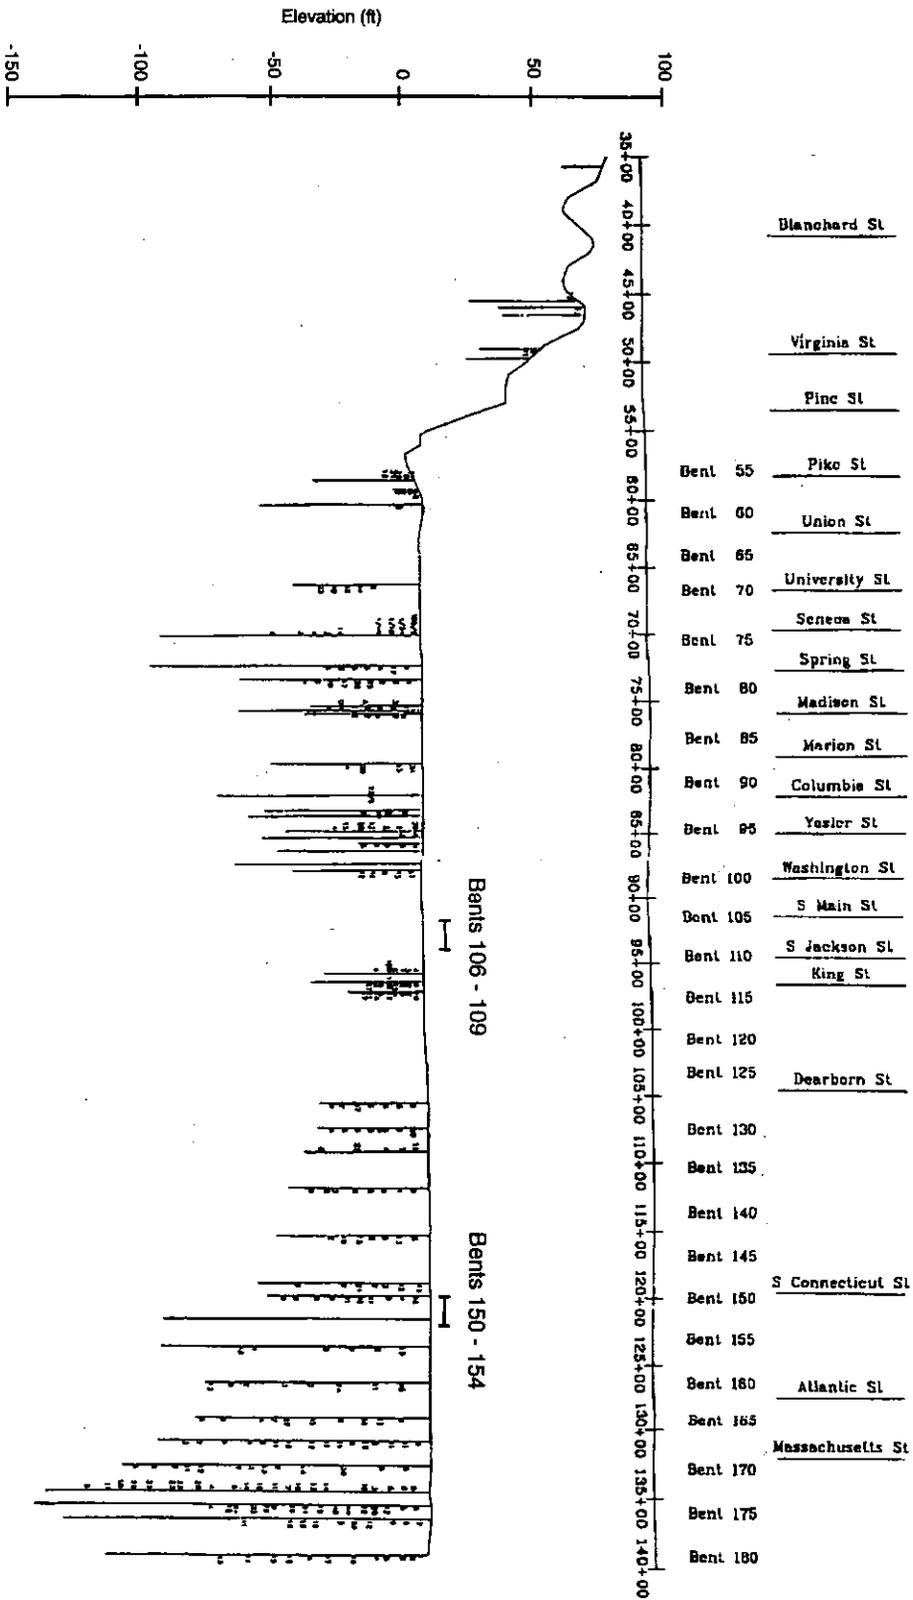
Figure 2.5. Longitudinal profile along the centerline of the Alaskan Way Viaduct. Locations are indicated by cross streets, bent numbers, and station numbers. Standard penetration resistances are indicated adjacent to borings, where available.

surface. South of Yesler Street, similar waterfront fills were encountered from the ground surface to depths of 10 to 70 feet (3 to 21.3 m). In this area, however, the waterfront fills were underlain by a soft, loose, natural tideflat deposit. The thickness of the tideflat deposit varied from about 0 to 20 feet (0 to 6.1 m) between Yesler Street and about Dearborn Street, but increased rapidly south of Dearborn Street to a maximum thickness of approximately 100 feet (30.5 m) near the southern end of the Viaduct. The tideflat deposit was also described as clean to silty fine sand and sandy silt. The tideflat deposit appeared, from the descriptions given in the boring logs, to be somewhat siltier but otherwise similar to the waterfront fills. A subsurface profile showing the locations and the measured SPT-values of the borings used for subsurface characterization along the alignment of the Alaskan Way Viaduct is shown in Figure 2.5. The transverse sections are shown in Figures 2.6-2.9.

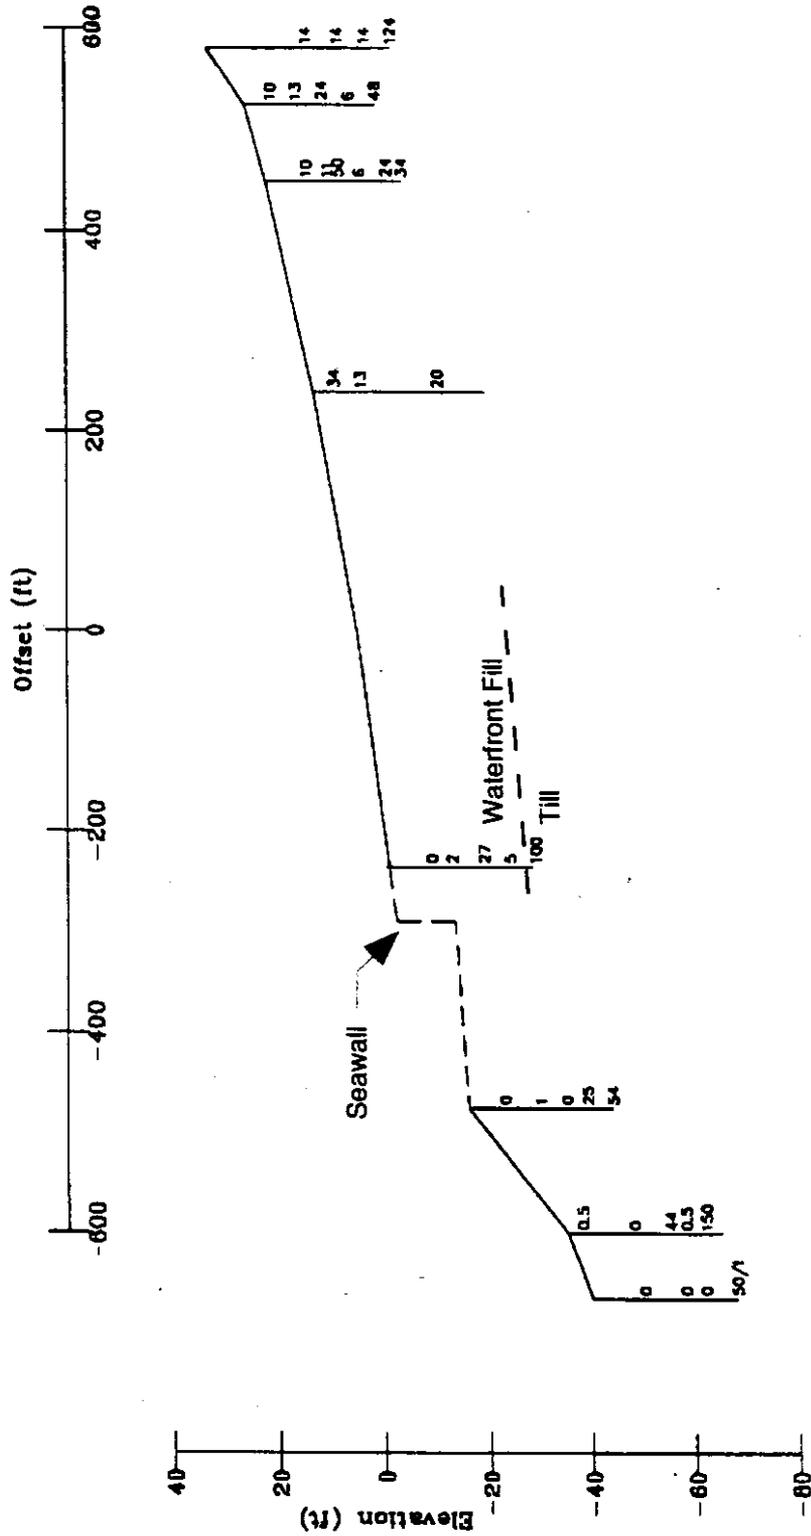
Figure 2.7. Soil Profile at Columbia Street Cross-Section. Standard penetration resistances are indicated adjacent to borings, where available. Offset is measured from approximate centerline of Alaskan Way Viaduct.

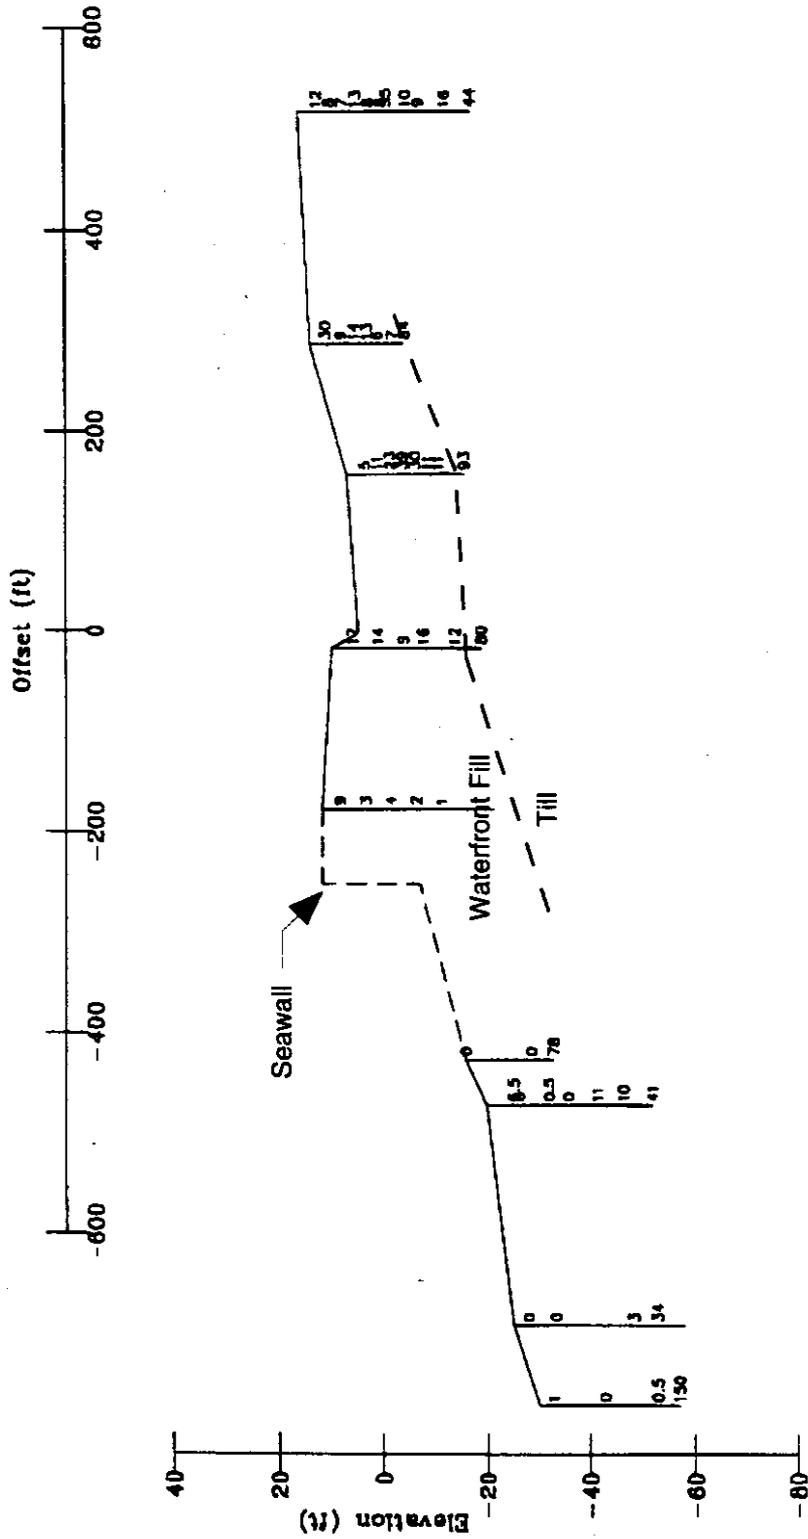
Figure 2.8. Soil Profile at Washington Street Cross-Section. Standard penetration resistances are indicated adjacent to borings, where available. Offset is measured from approximate centerline of Alaskan Way Viaduct.

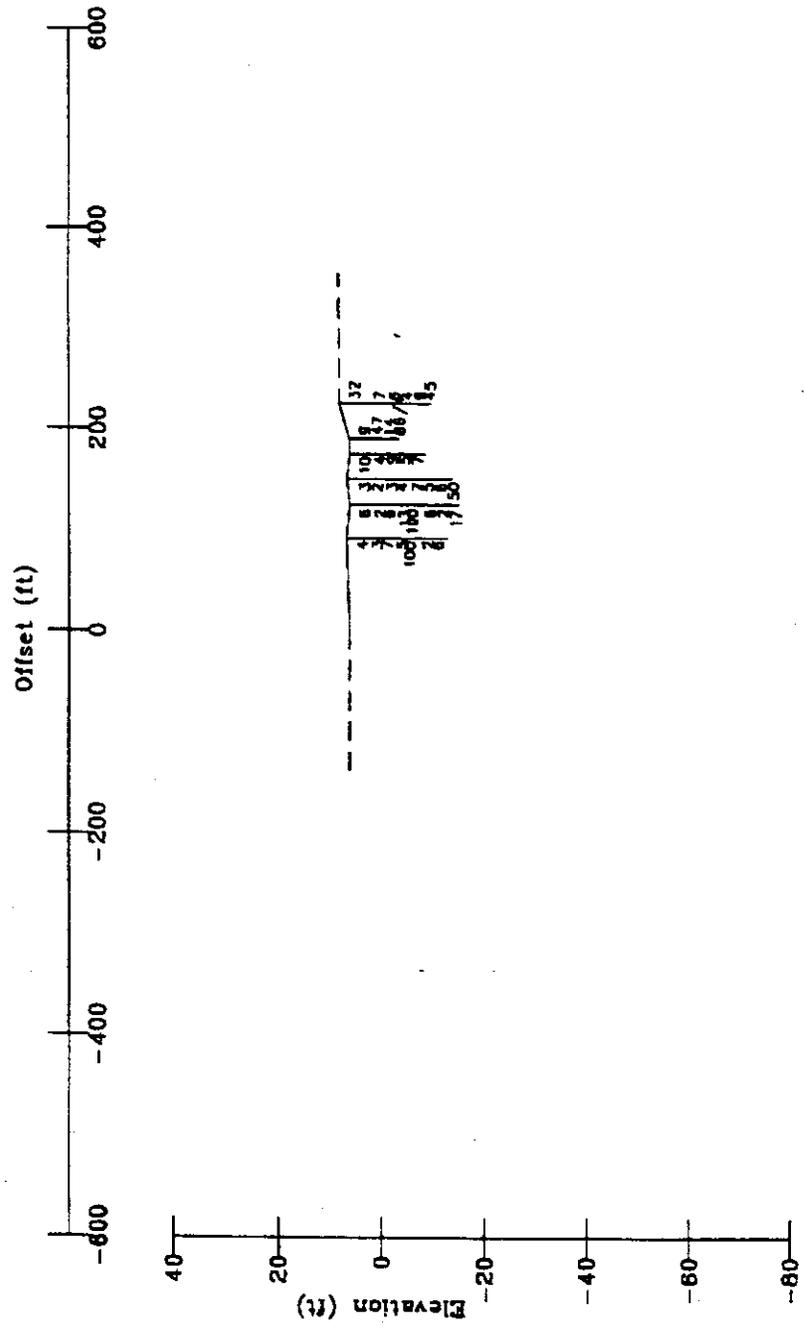
Figure 2.9. Soil Profile at Jackson/King Cross-Section. Standard penetration resistances are indicated adjacent to borings, where available. Offset is measured from approximate centerline of Alaskan Way Viaduct.

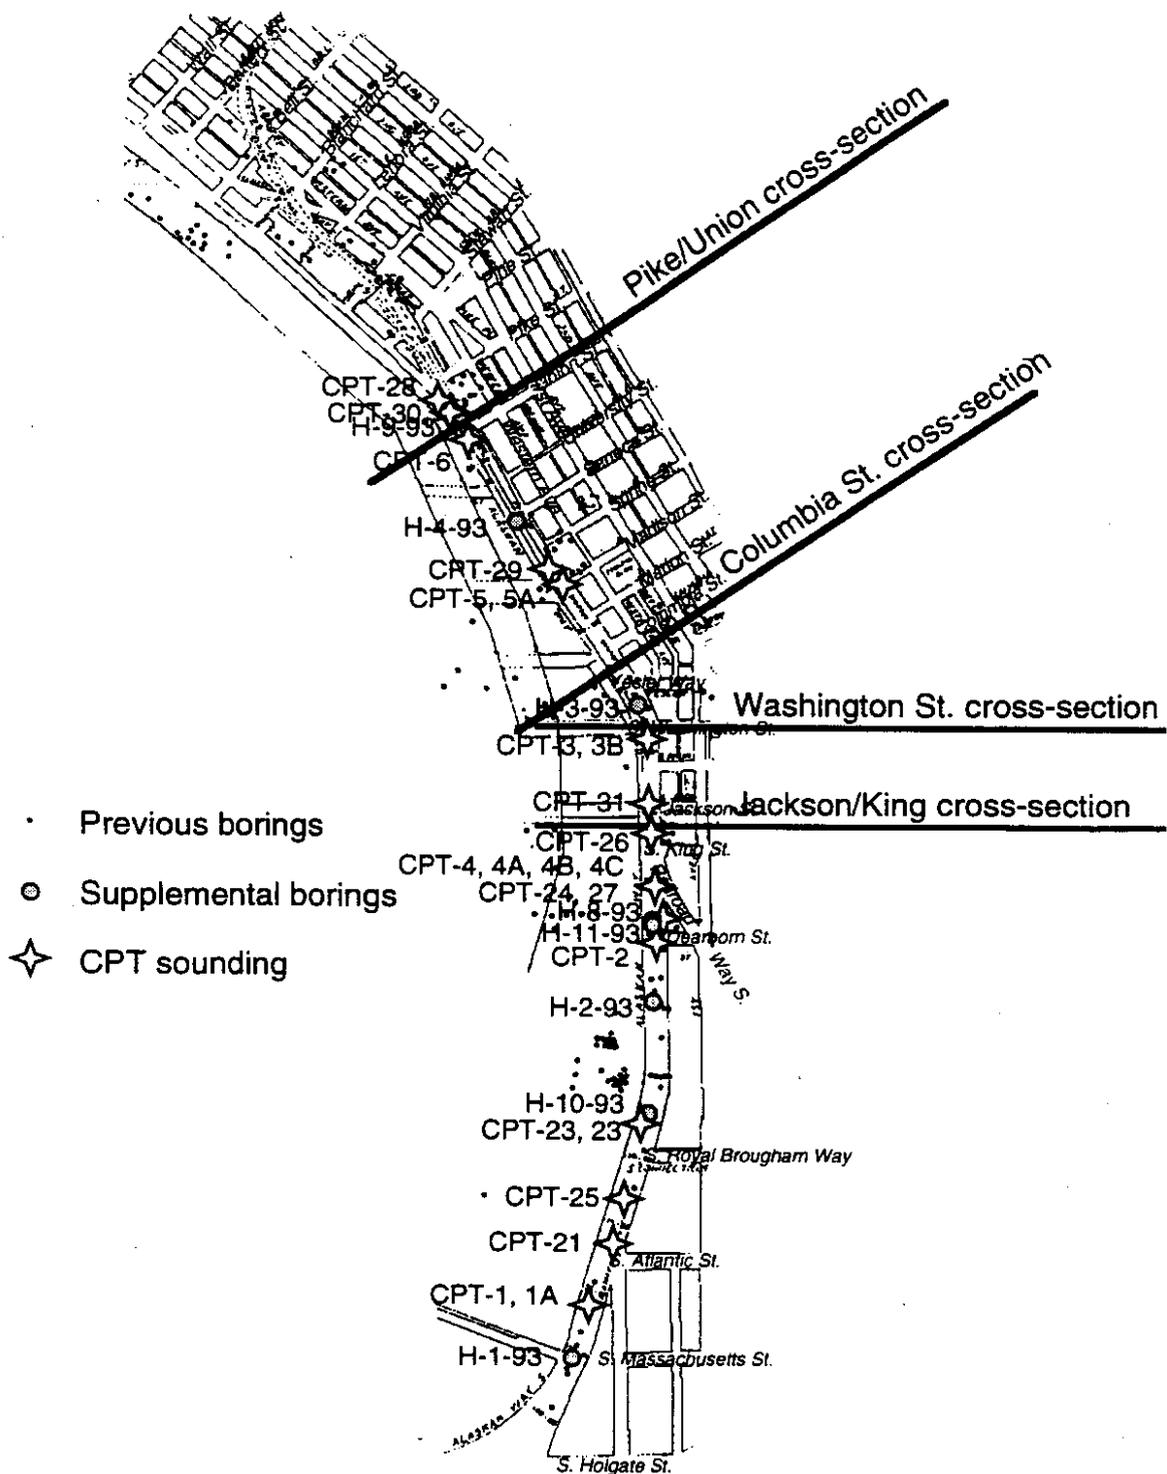
Figure 2.10. Locations of Boring and Insitu Tests in Supplemental Subsurface Investigations. Downhole shear wave velocity tests were conducted in Borings H-9-93 and H-10-93. Seismic cone surveys were conducted in all CPT soundings except CPT-23.

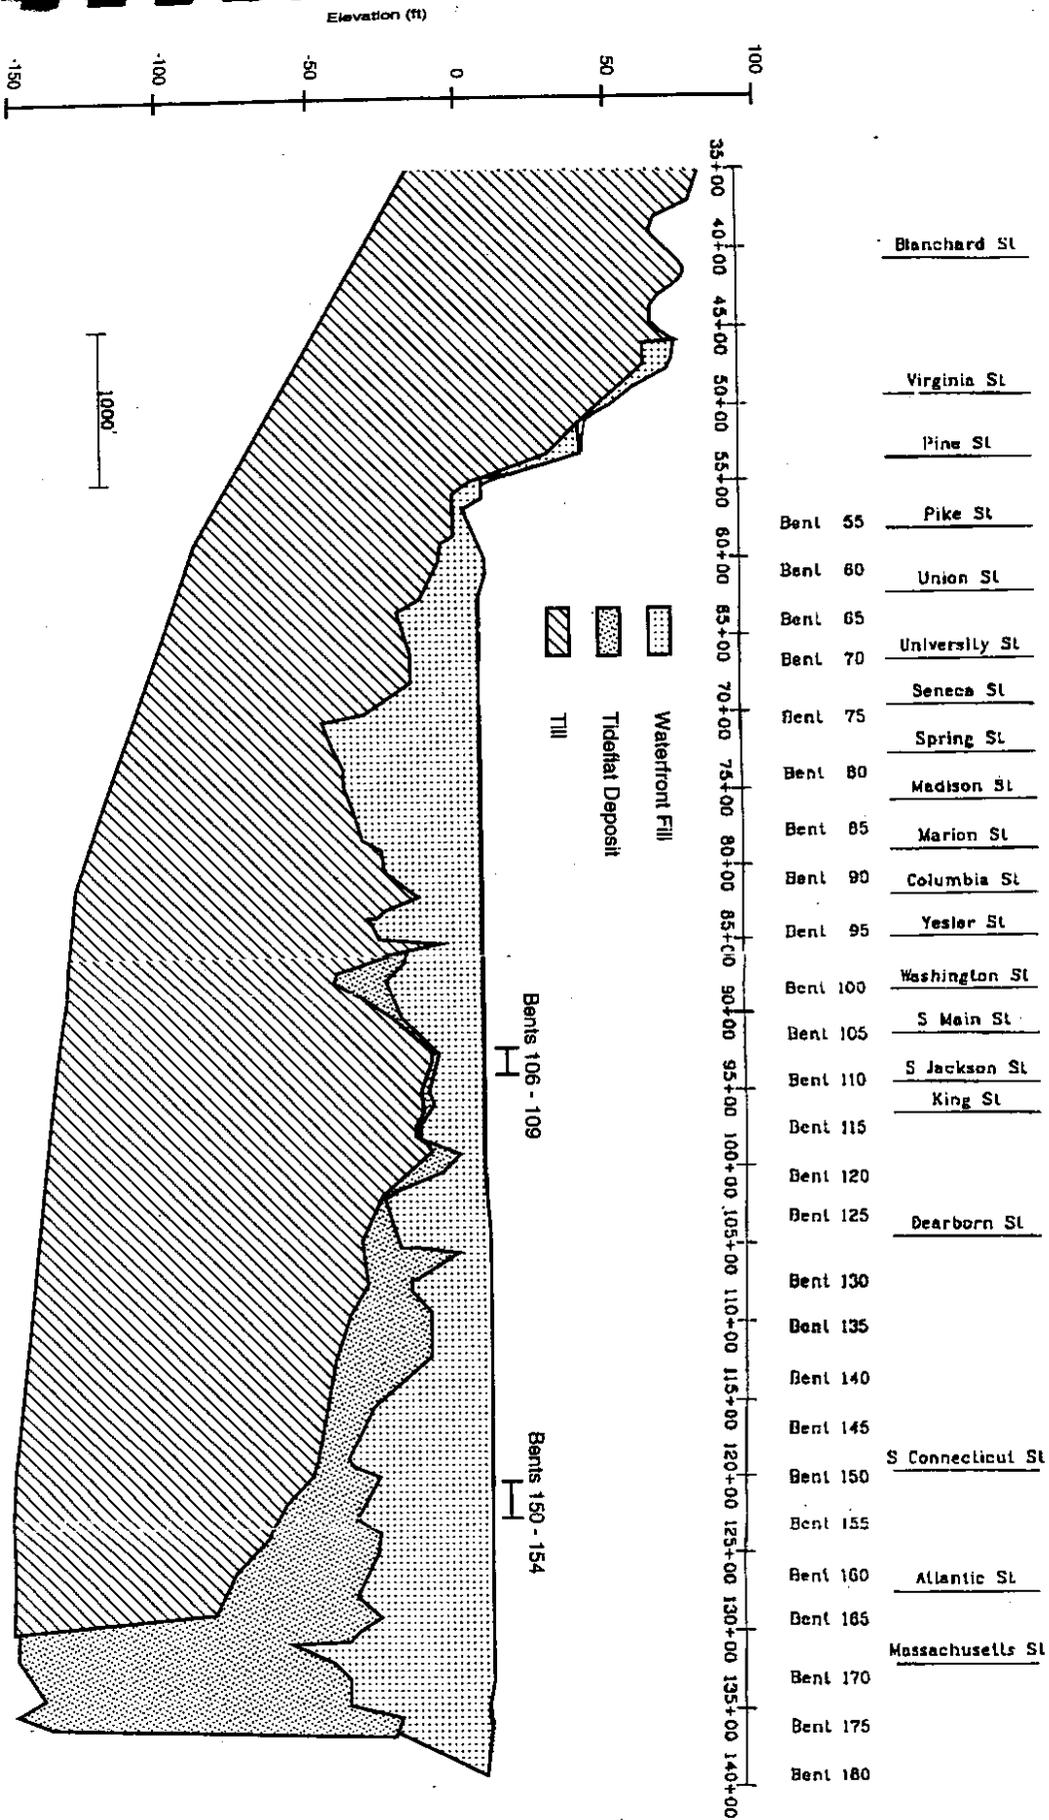
Figure 2.14. Soil Profile along the Length of the Alaskan Way Viaduct as Inferred from Results of Previous and Supplemental Subsurface Investigations

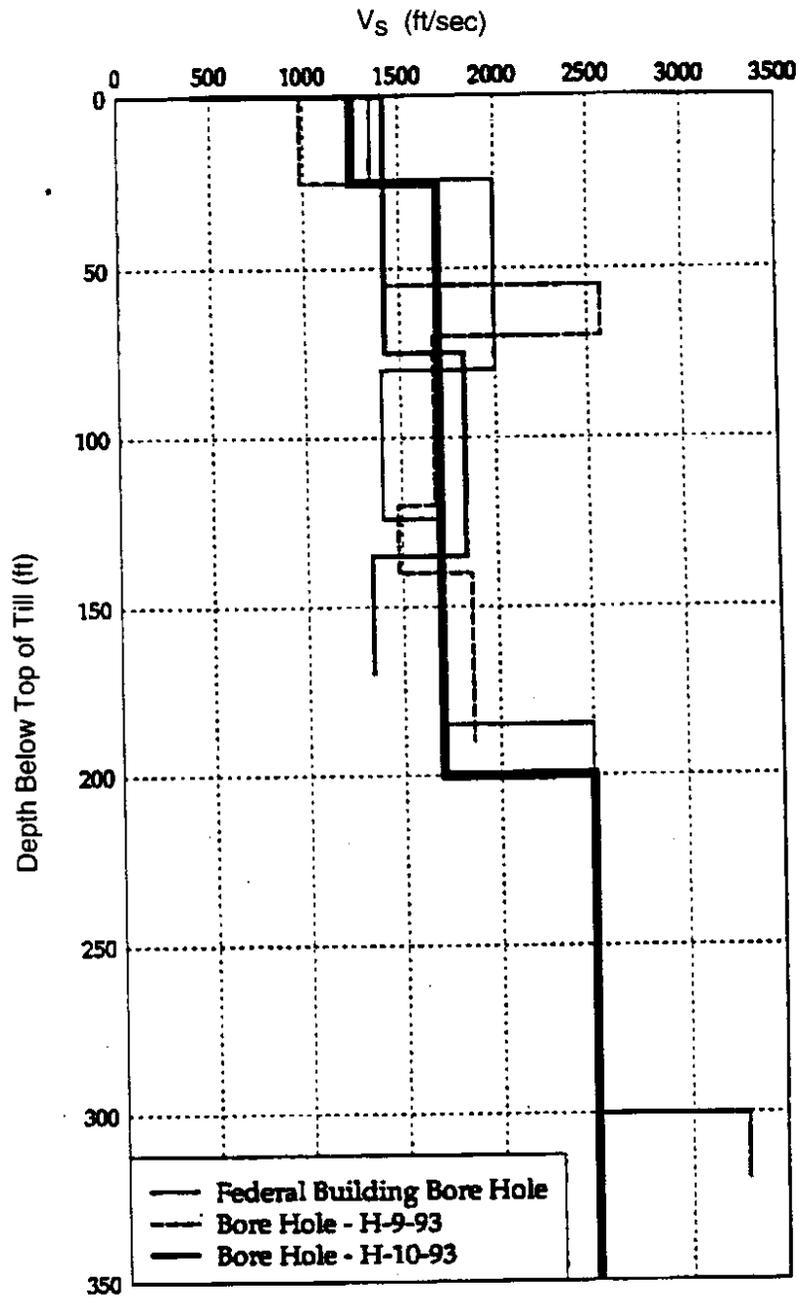
Figure 2.21. Variation of Measured Shear Wave Velocity in Till from Previous and Supplemental Subsurface Investigations (Thick solid line represents average shear wave velocity profile used in analyses.)

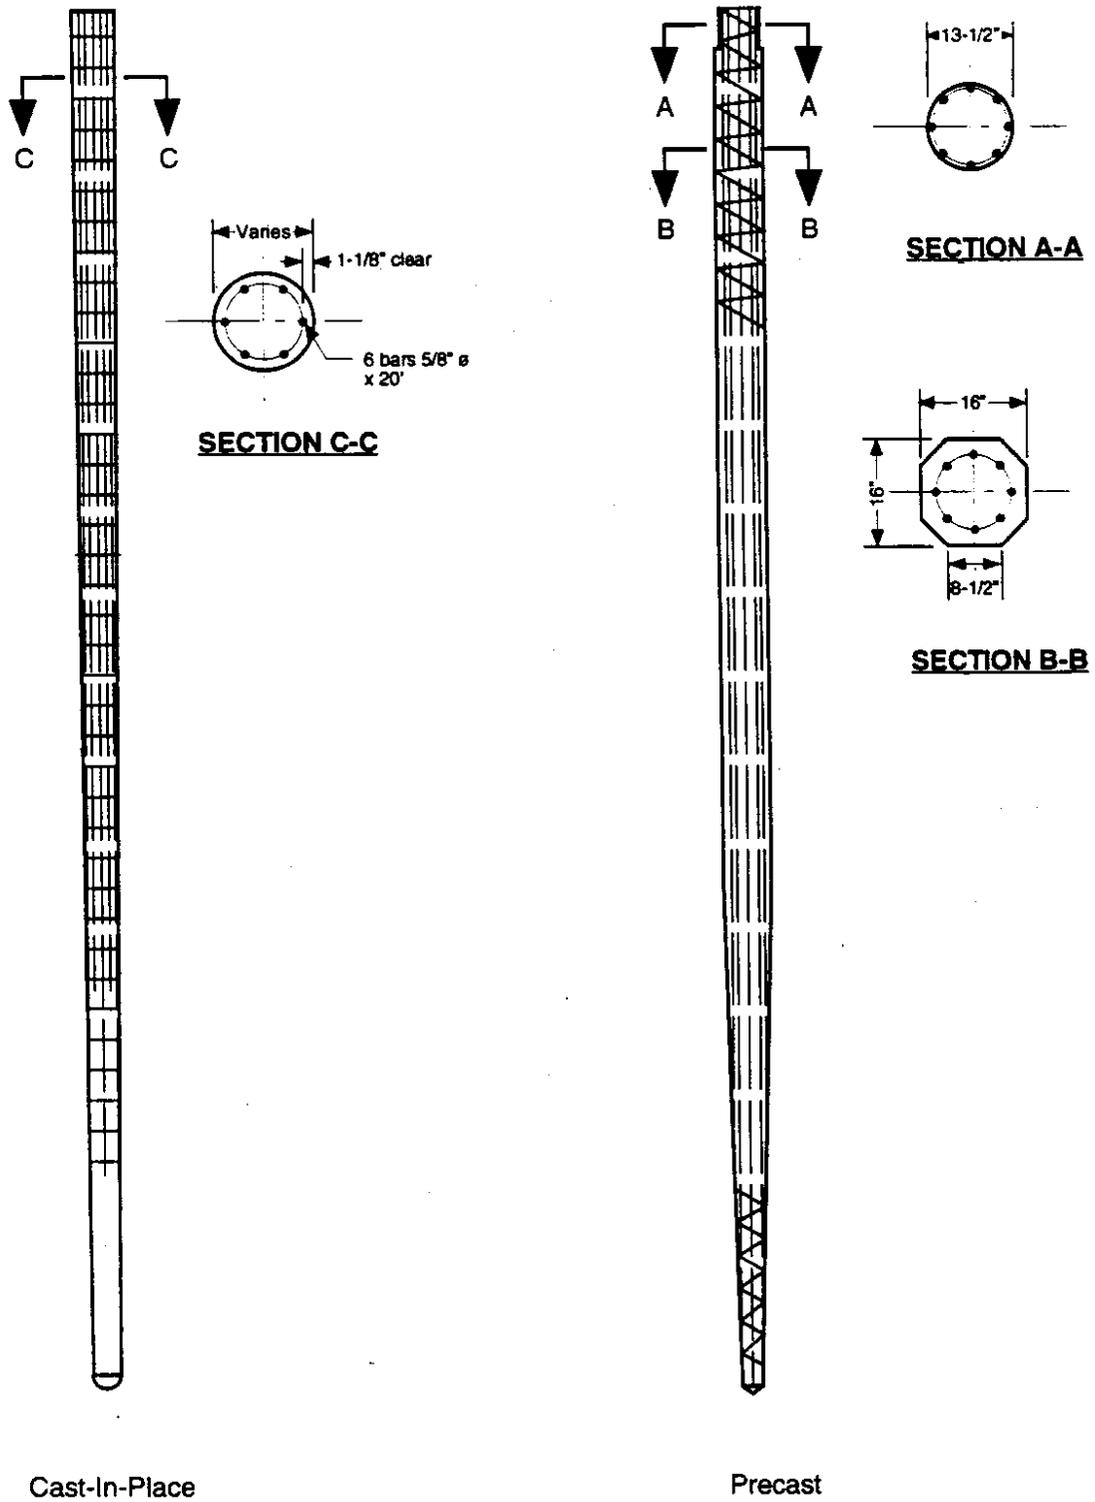
Figure 3.1. Concrete Piles

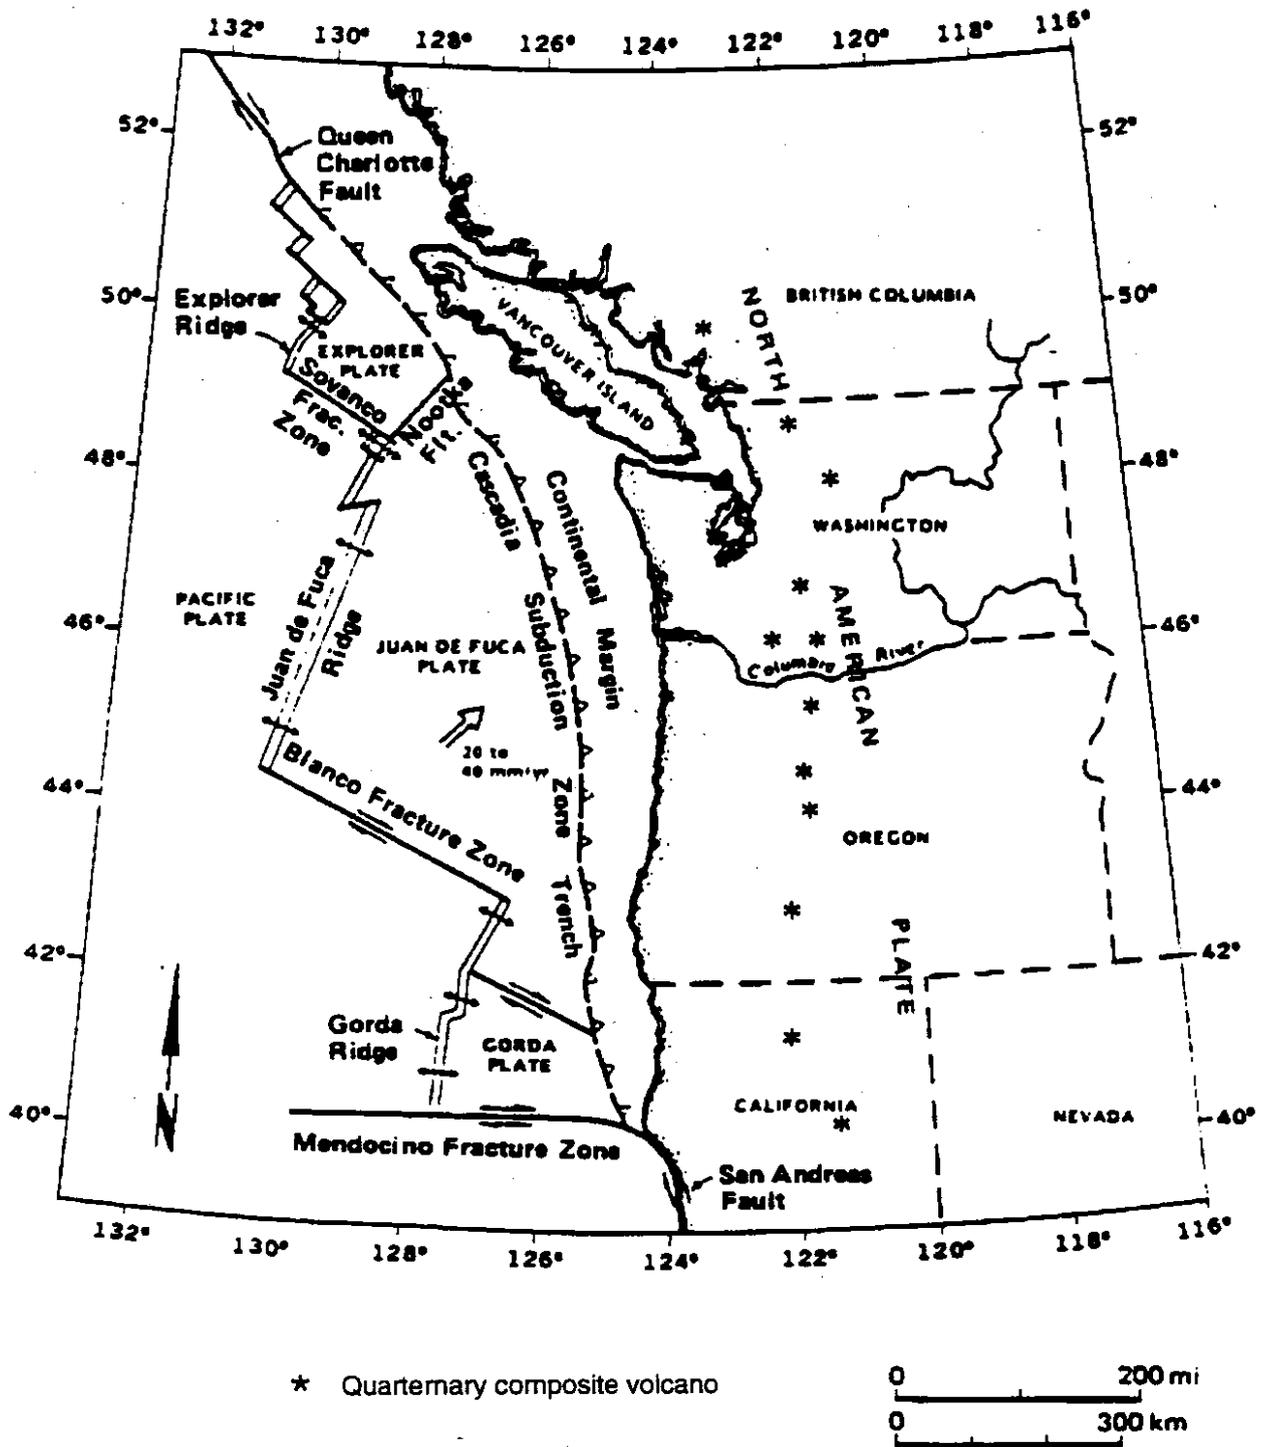
Figure 4.1. Geometry of Tectonic Plates in the Pacific Northwest (The Juan De Fuca Plate is subducting beneath the North American Plate beneath the coasts of Washington and Oregon) (after McCrumb et al., 1989)

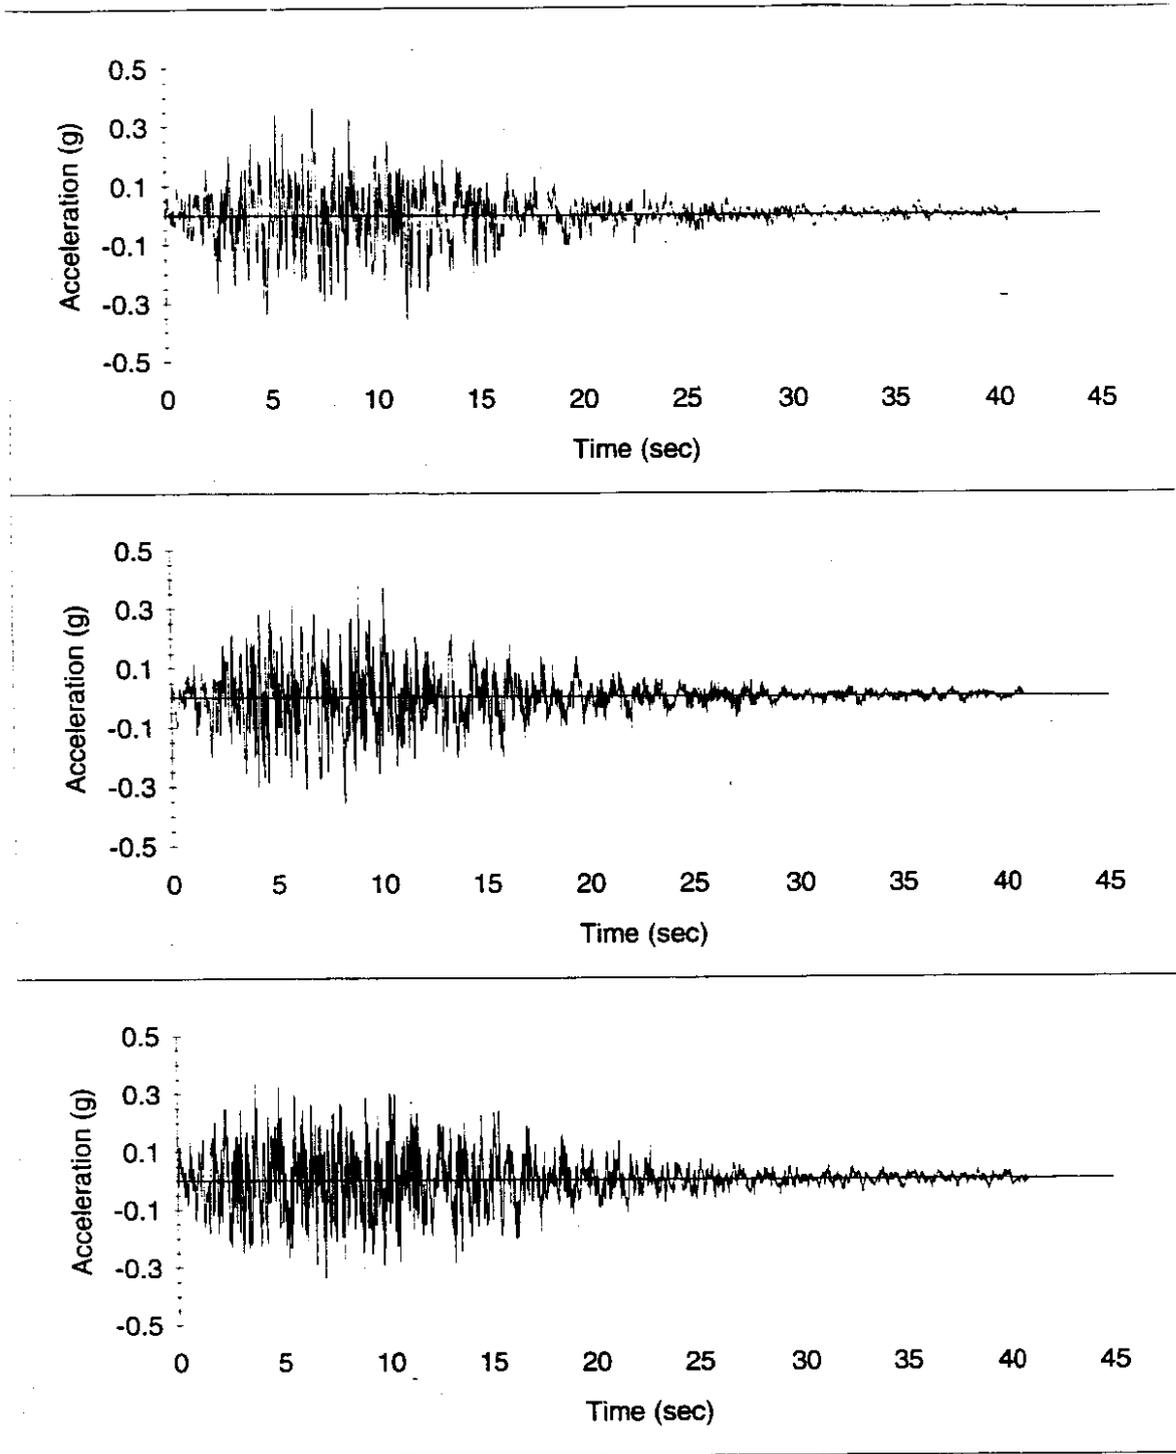
Figure 4.3. Bedrock Outcrop Motions from PSHA and Deconvolution Analyses

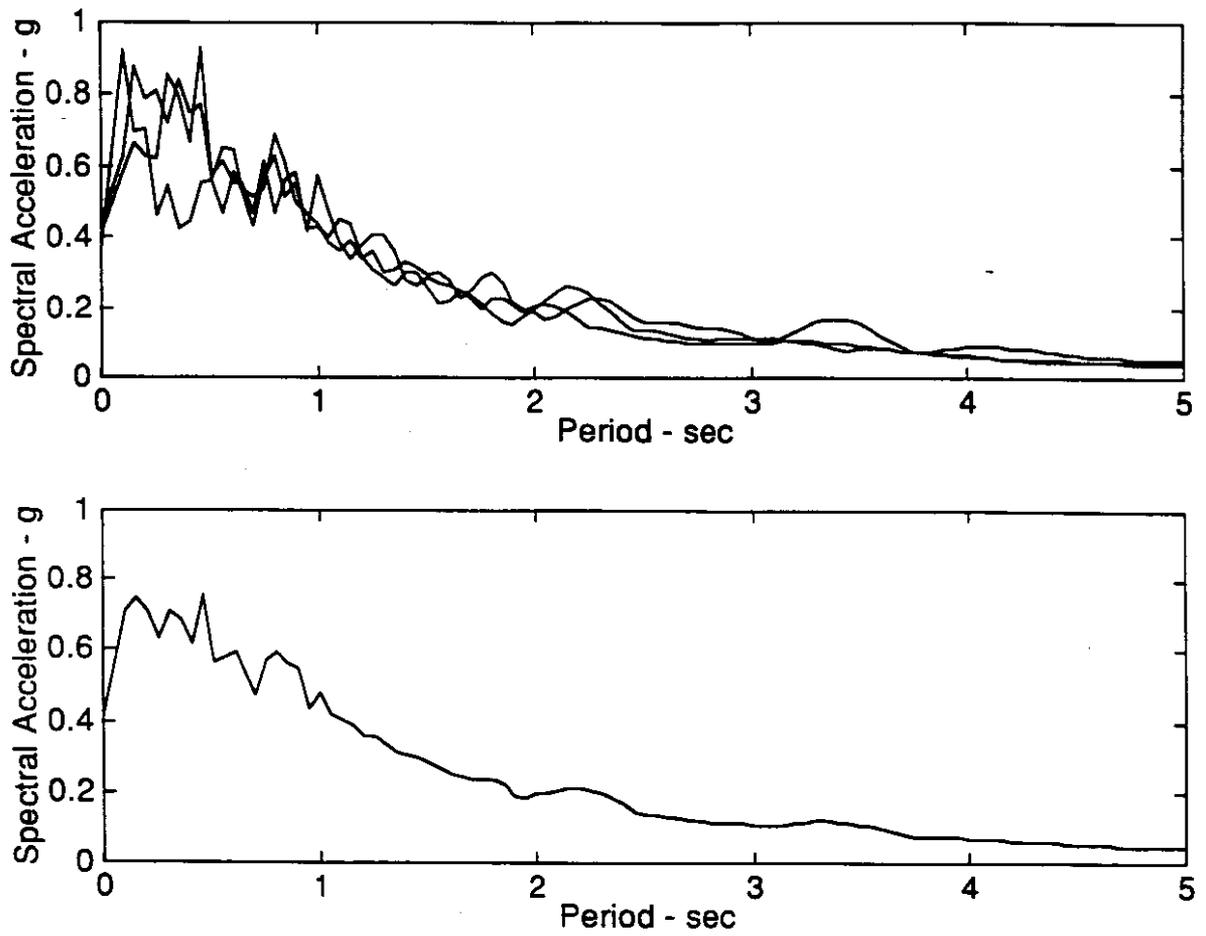
Figure 4.4. Response Spectra (5% damping) for Bedrock Outcrop Motions: (a) Individual Motions, and (b) Average of Individual Motions.

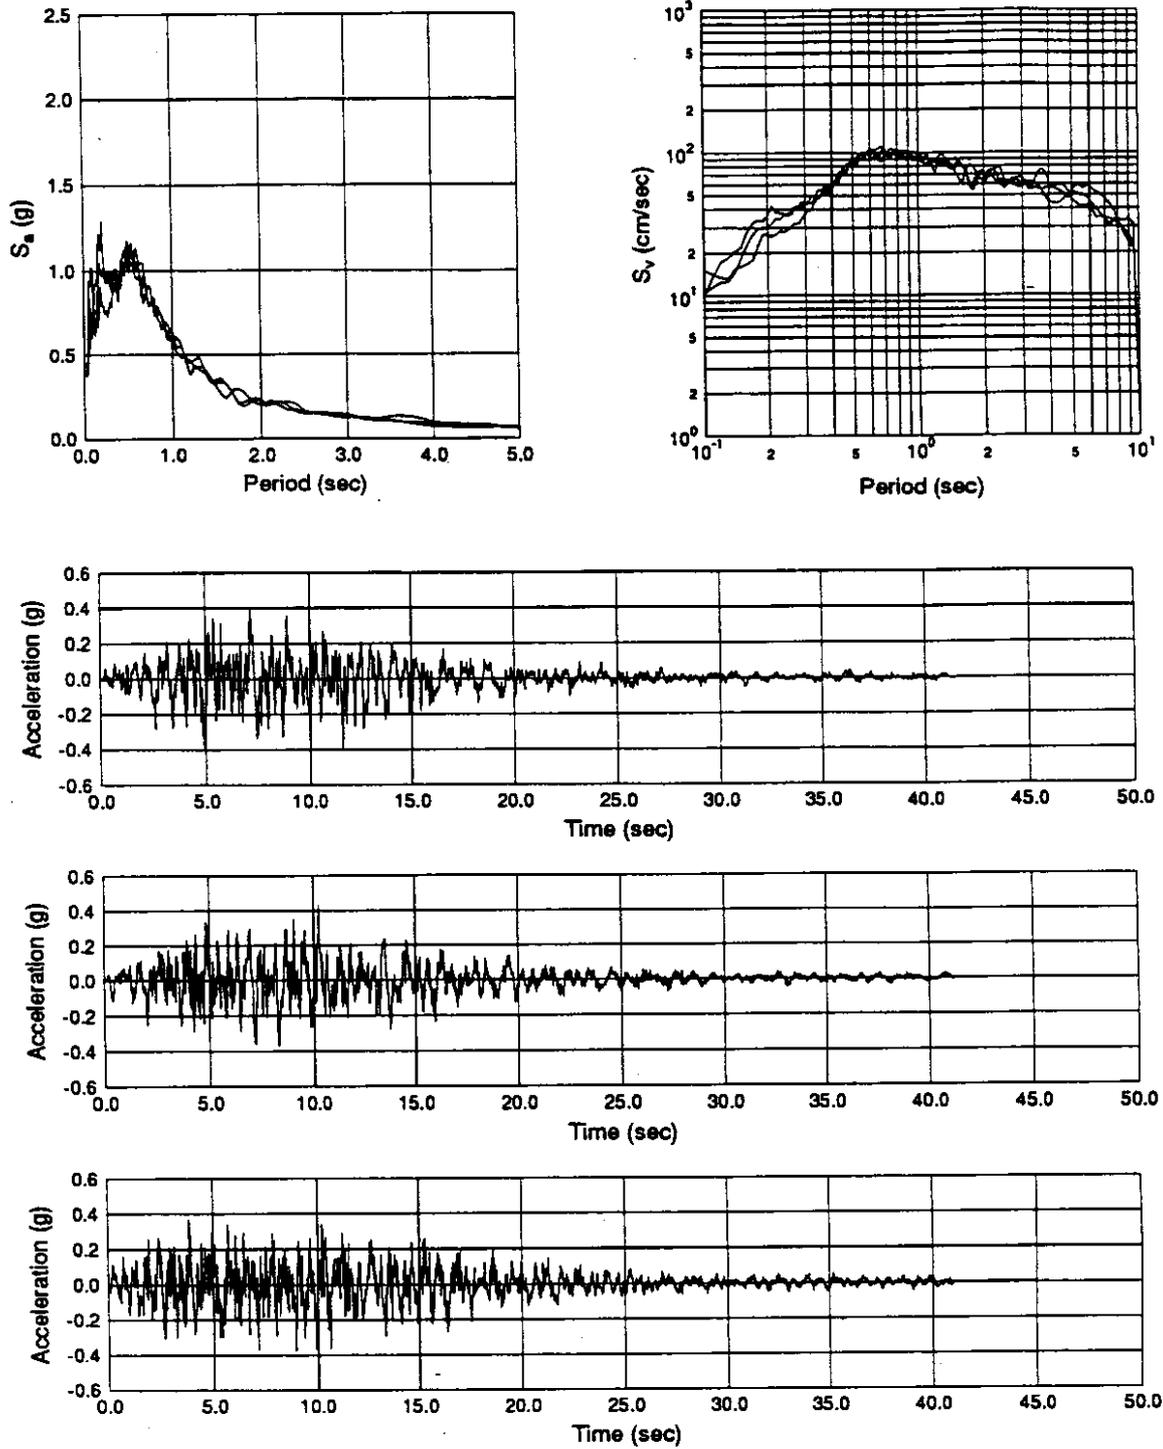
Figure 4.5. Ground Surface Response Spectra and accelerograms for Soft Soil Thickness of 0 Ft.

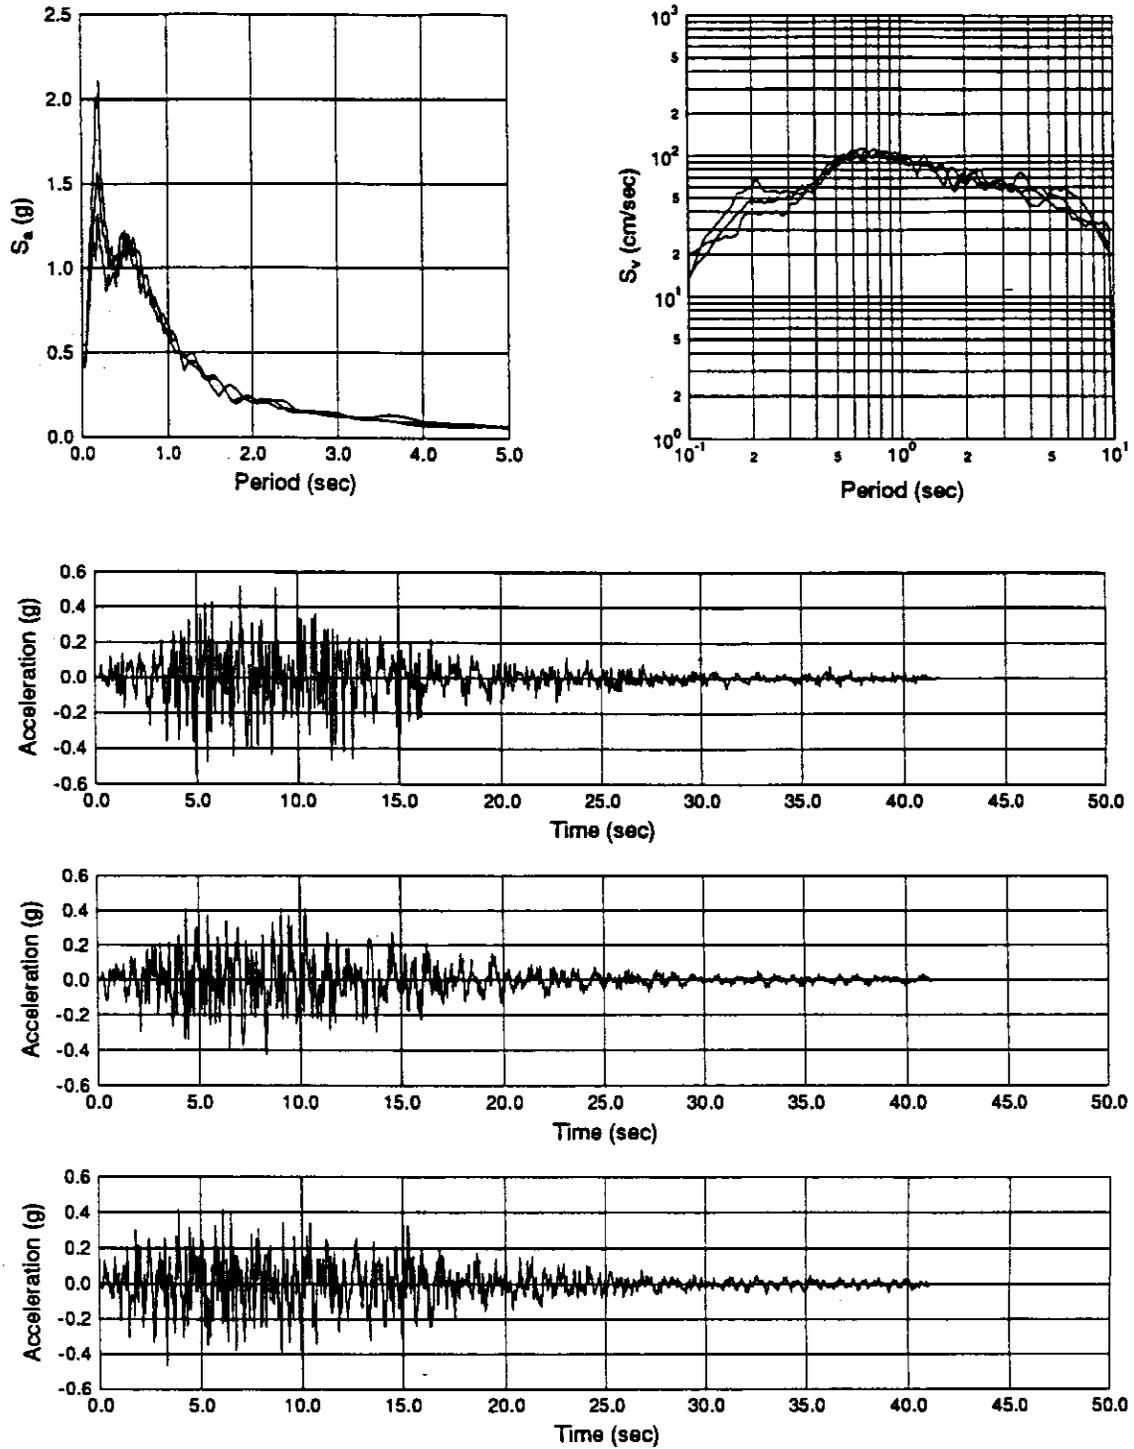
Figure 4.6. Ground Surface Response Spectra and accelerograms for Soft Soil Thickness of 10 Ft.
