Final Technical Report
Research Project Agreement No. T9233, Task 41
Seismic Vulnerability of the Alaskan Way Viaduct Phase II

**SEISMIC VULNERABILITY OF THE ALASKAN
WAY VIADUCT: GEOTECHNICAL
ENGINEERING ASPECTS**

July 1995

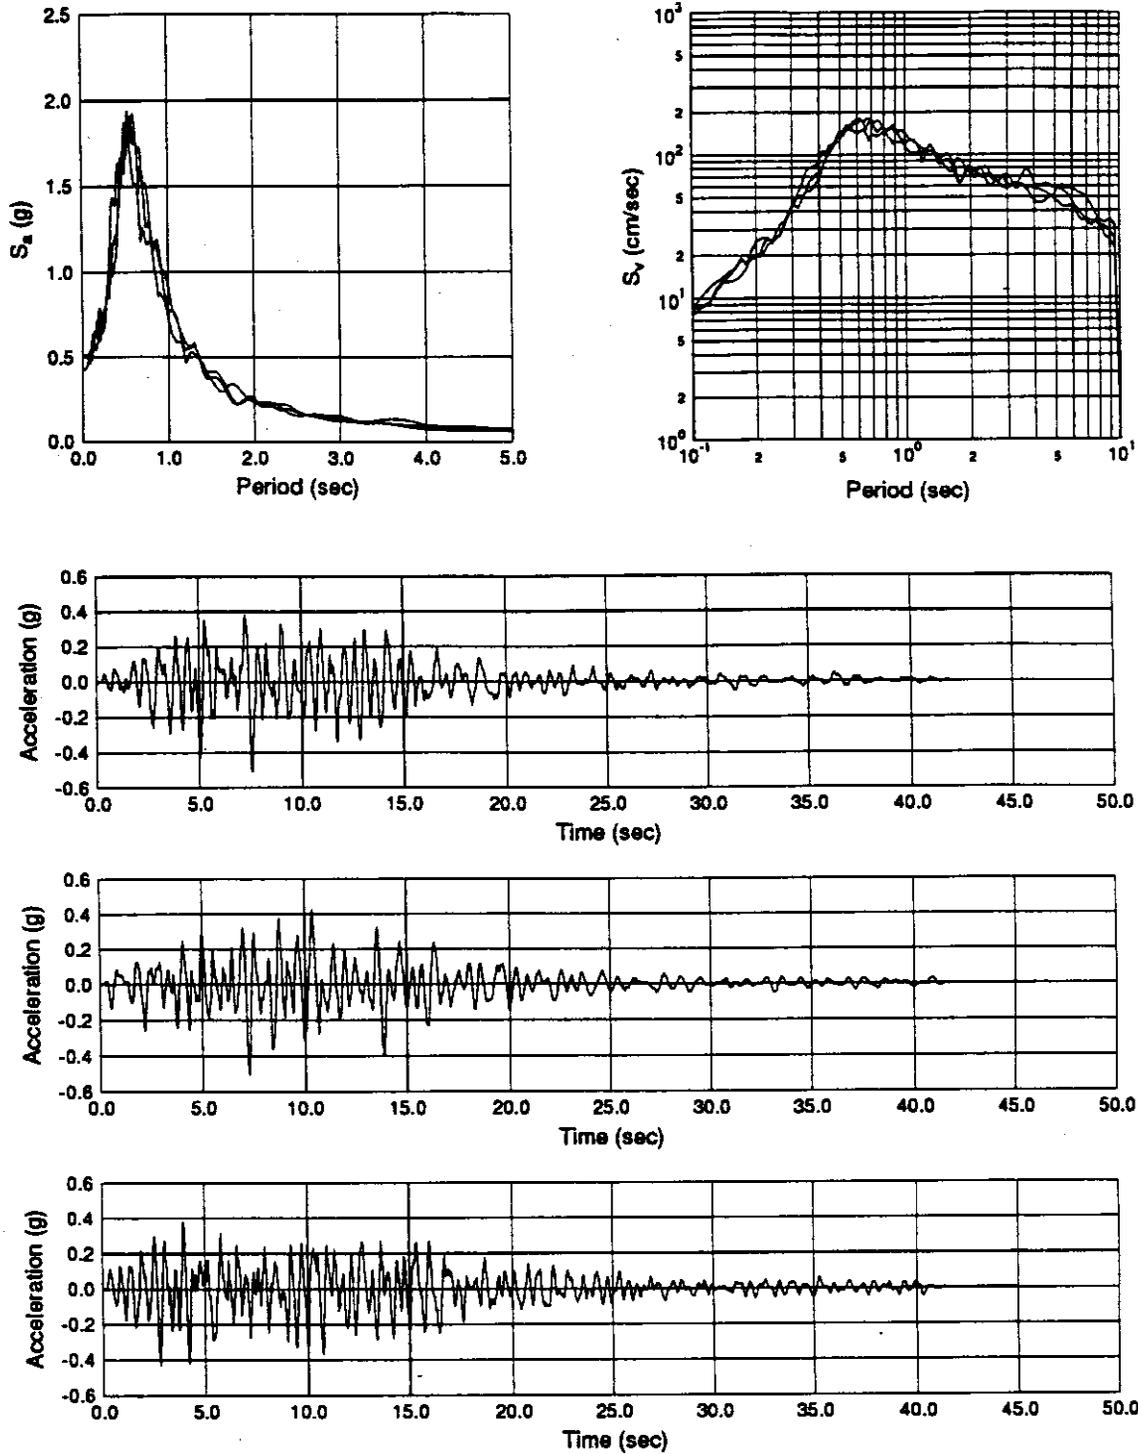
Figure 4.7. Ground Surface Response Spectra and accelerograms for Soft Soil Thickness of 20 Ft.

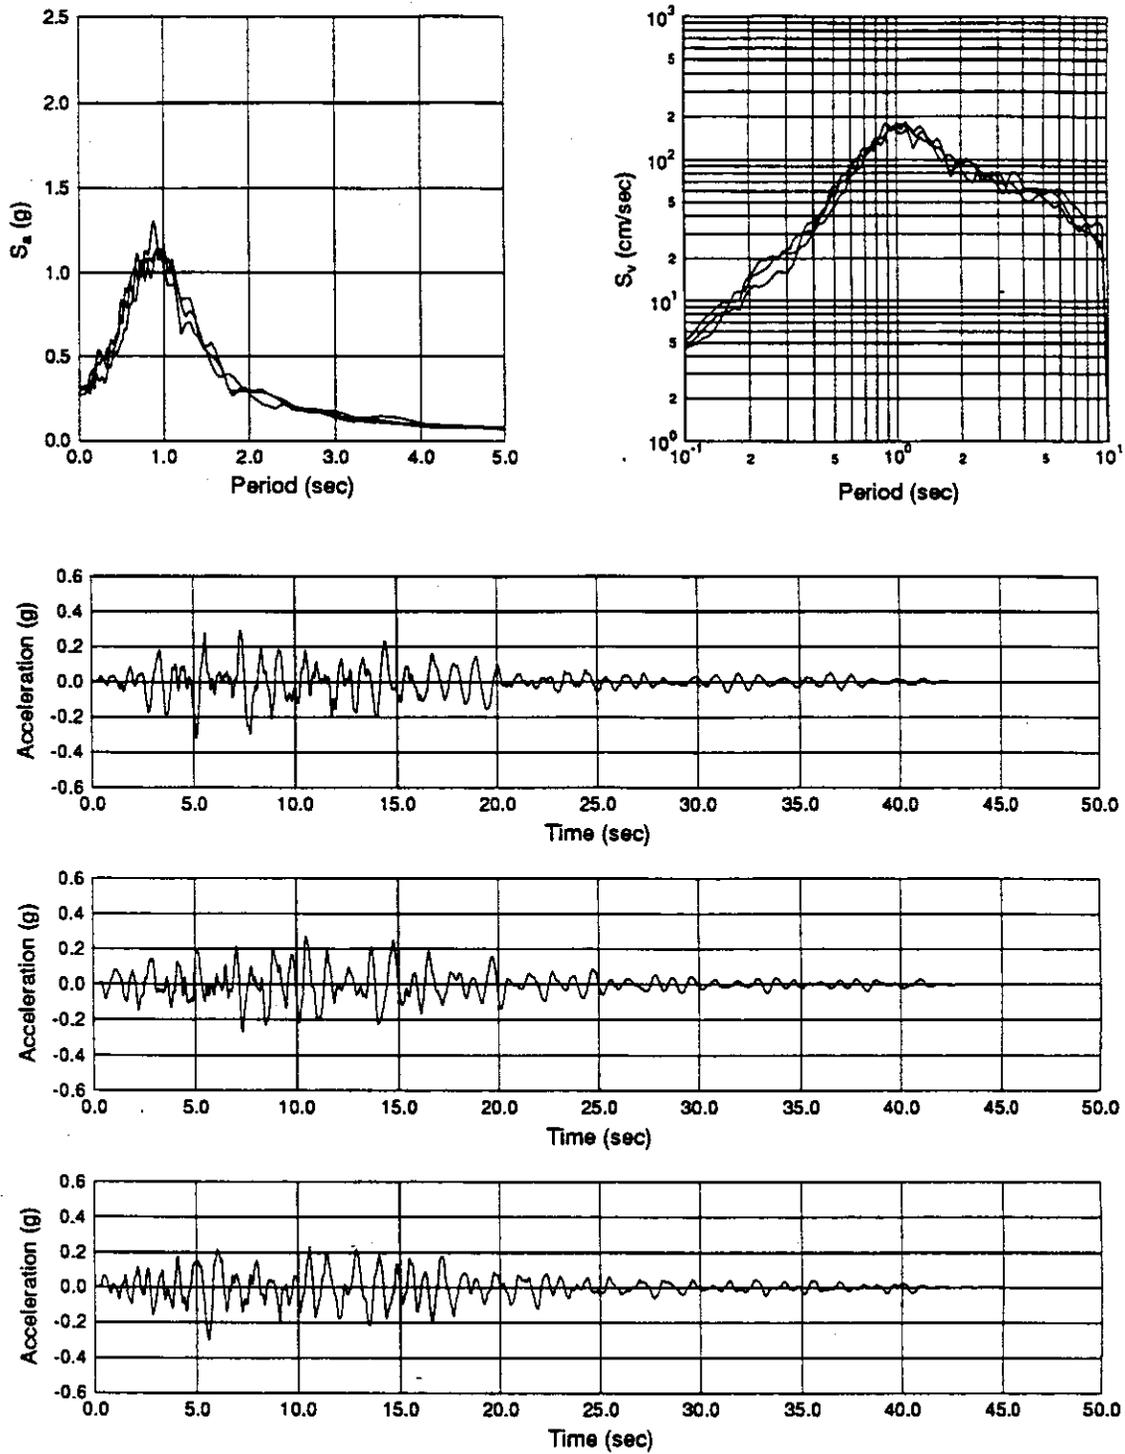
Figure 4.8. Ground Surface Response Spectra and accelerograms for Soft Soil Thickness of 30 Ft.

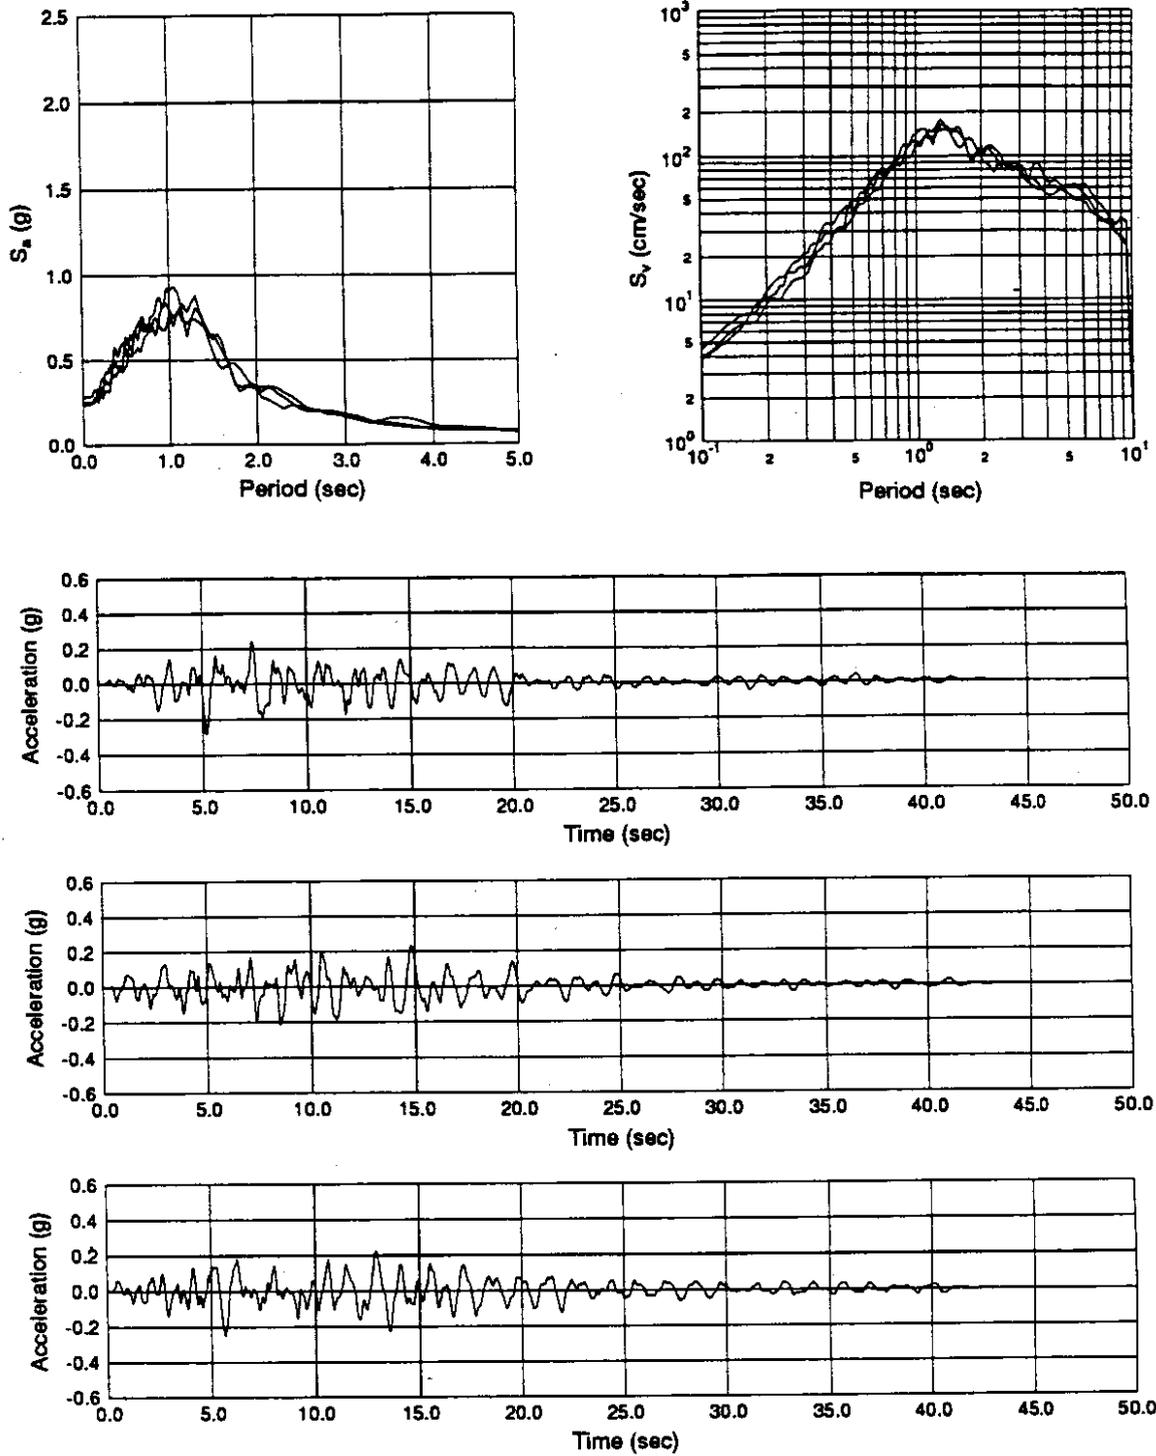
Figure 4.9. Ground Surface Response Spectra and accelerograms for Soft Soil Thickness of 40 Ft.

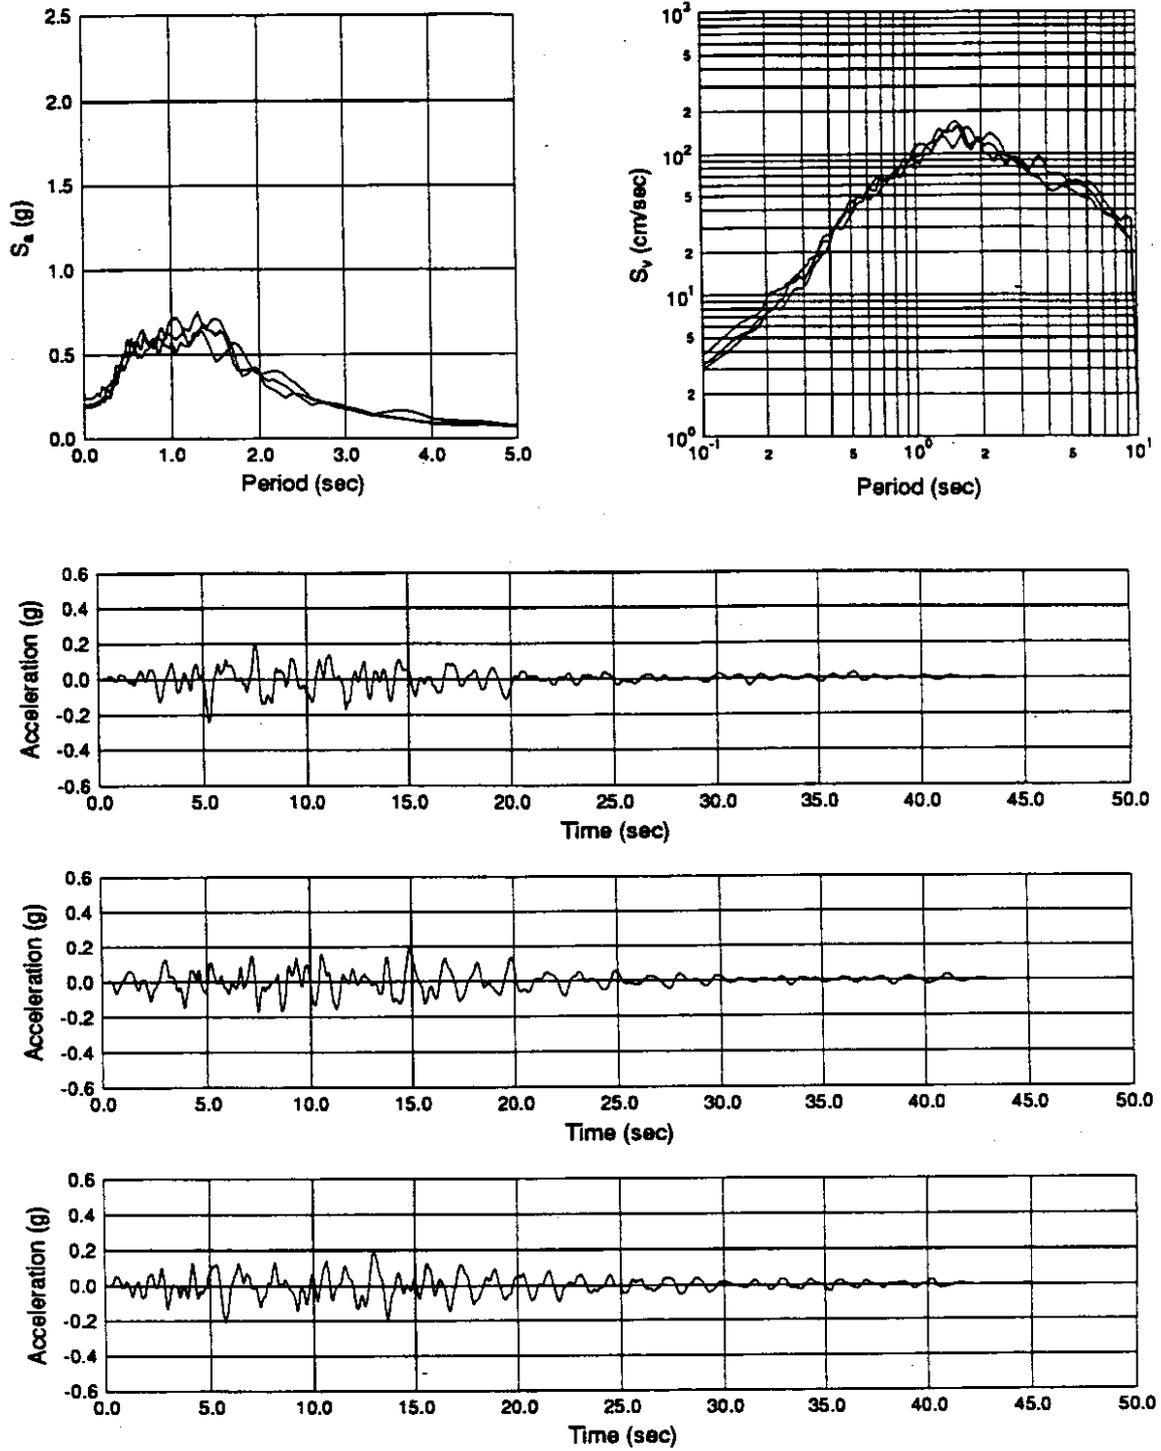
Figure 4.10. Ground Surface Response Spectra and accelerograms for Soft Soil Thickness of 50 Ft.

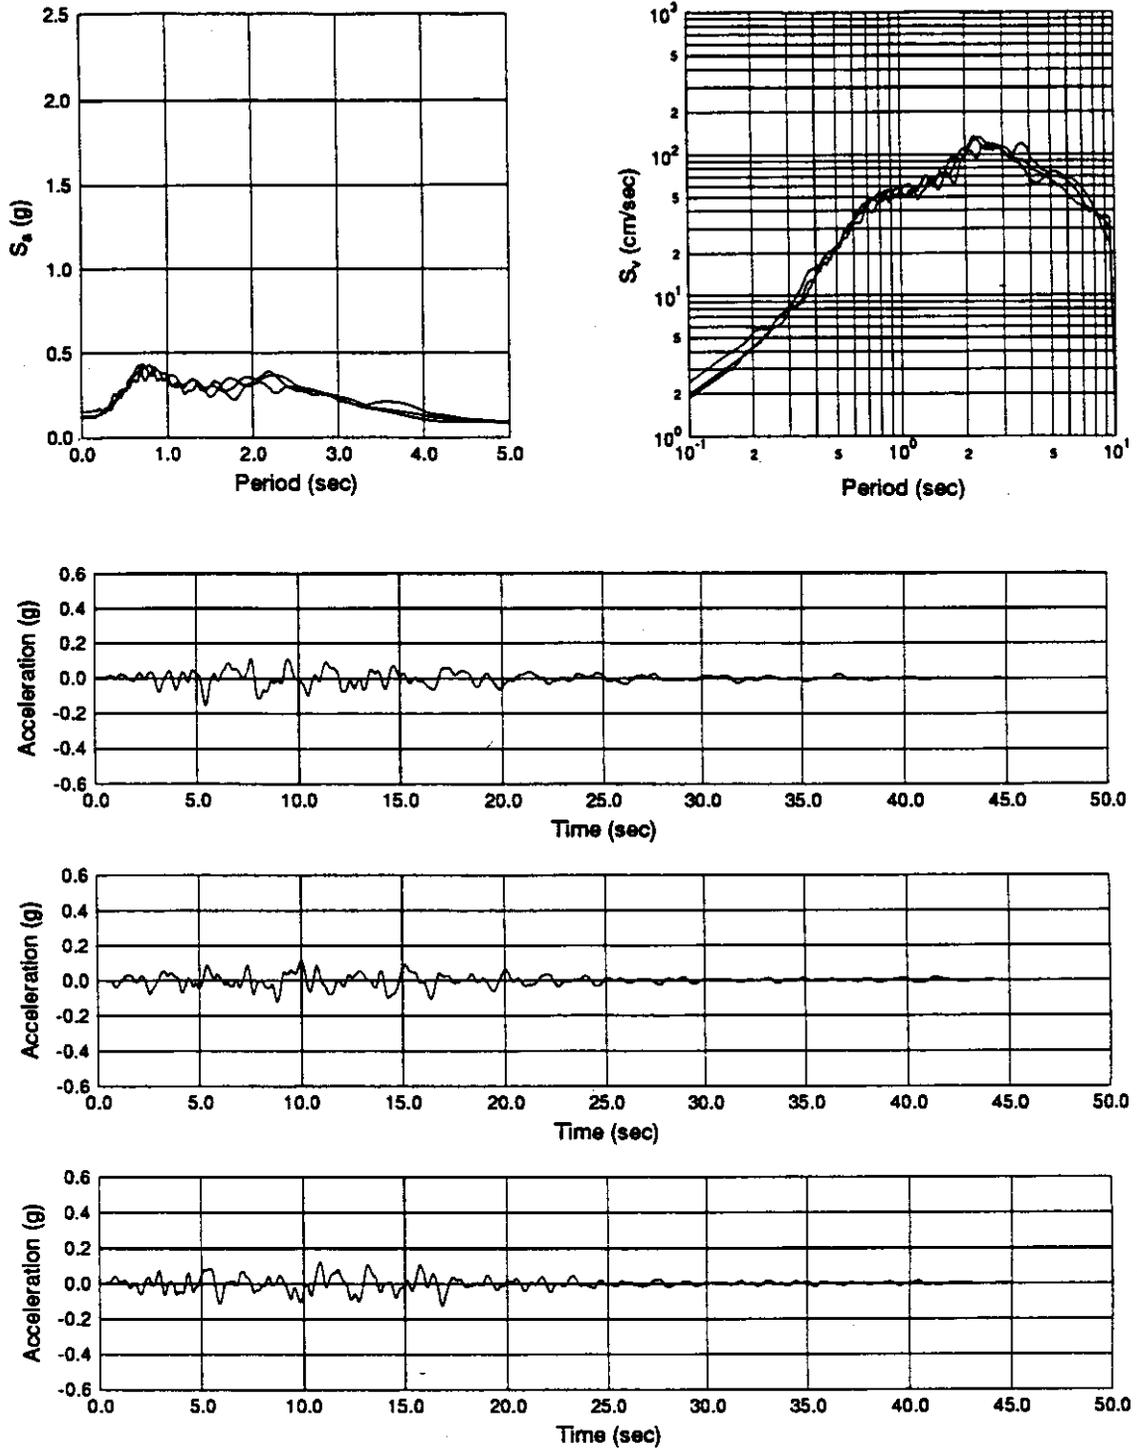
Figure 4.12. Ground Surface Response Spectra and accelerograms for Soft Soil Thickness of 80 Ft.

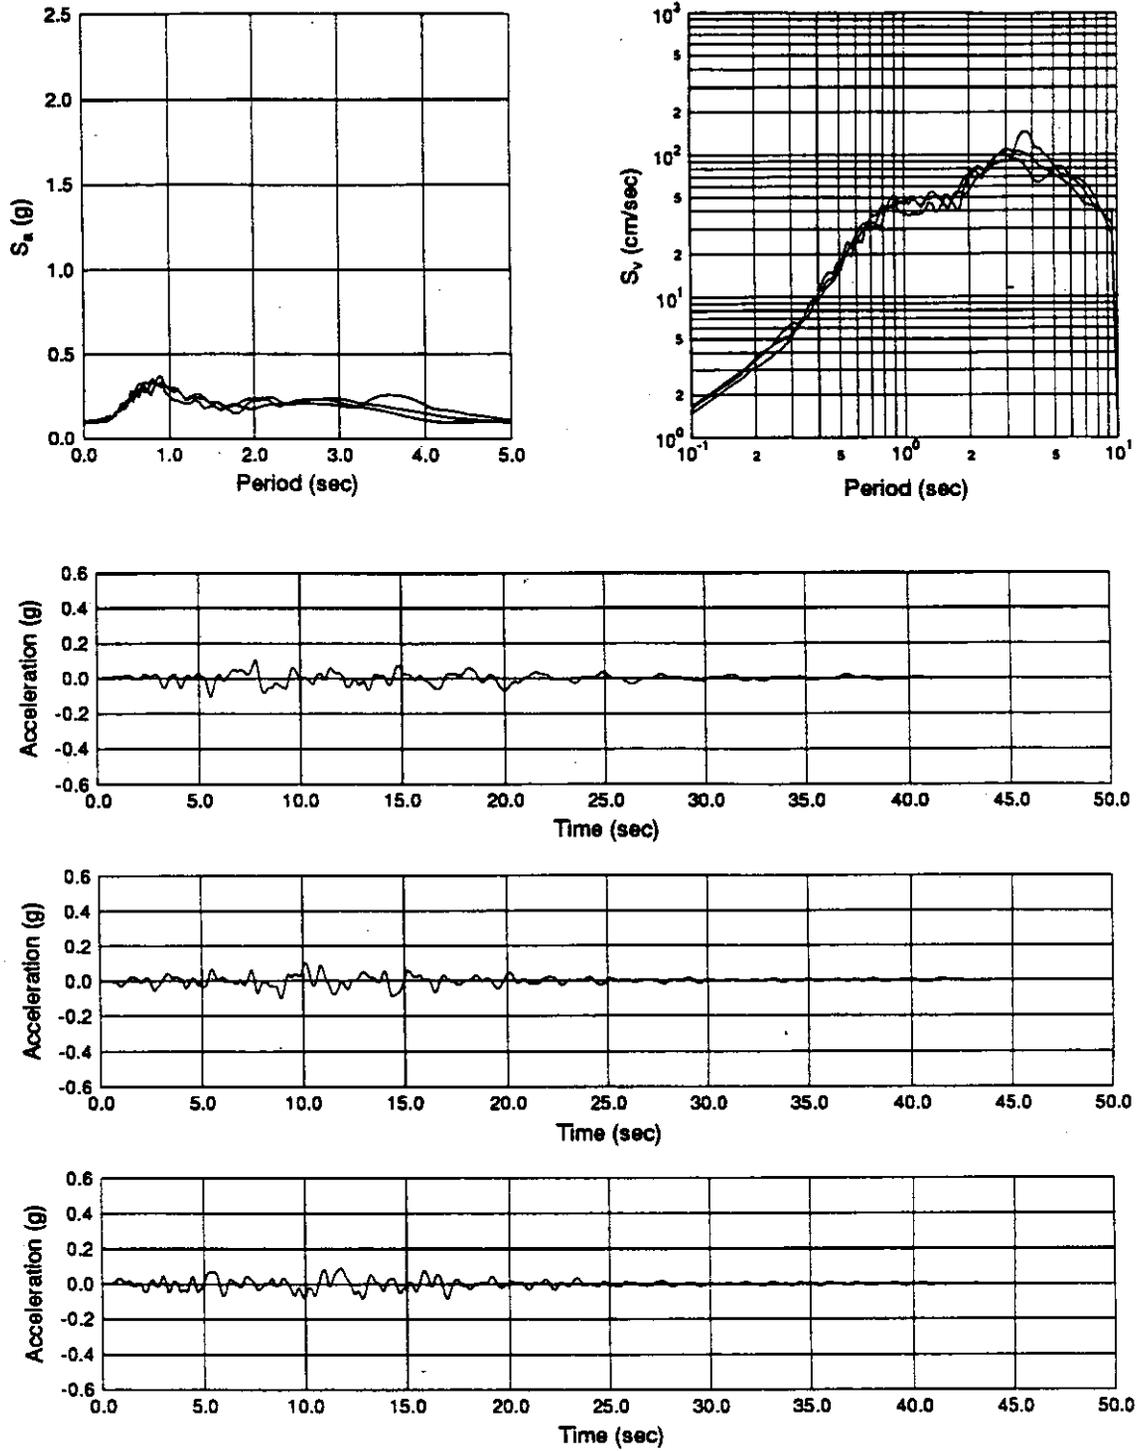
Figure 4.13. Ground Surface Response Spectra and accelerograms for Soft Soil Thickness of 100 Ft.

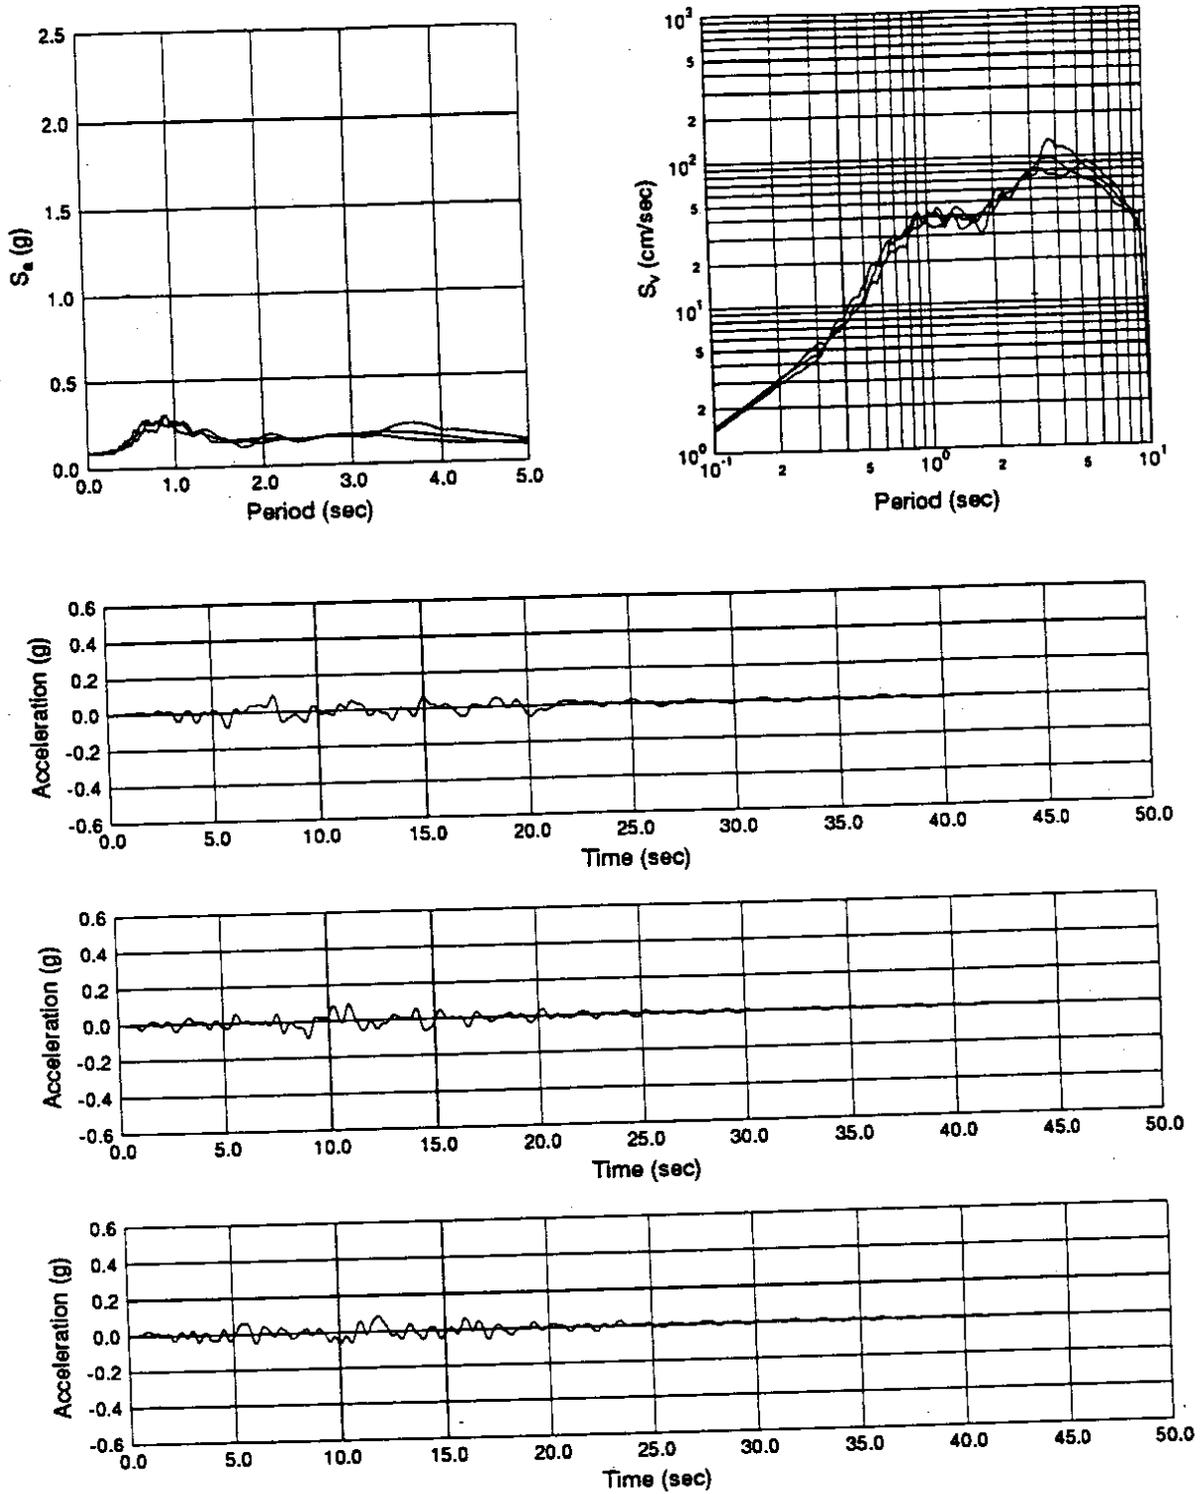
Figure 4.14. Ground Surface Response Spectra and accelerograms for Soft Soil Thickness of 120 Ft.

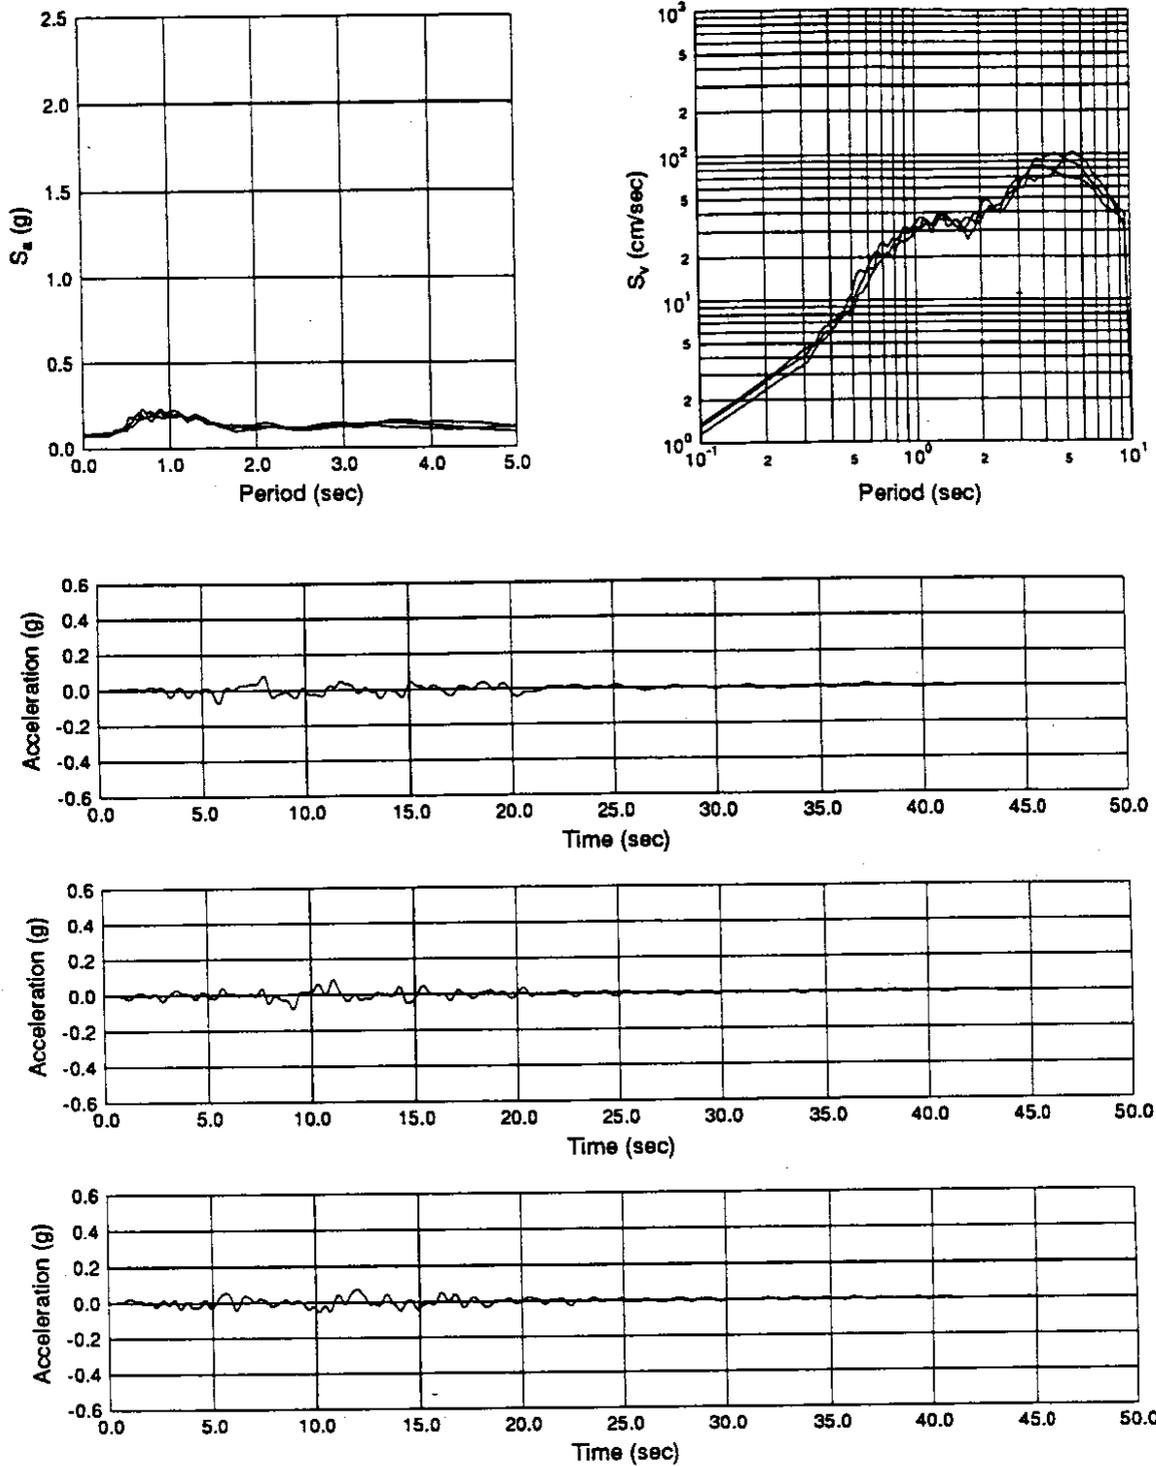
Figure 4.15. Ground Surface Response Spectra and accelerograms for Soft Soil Thickness of 140 Ft.

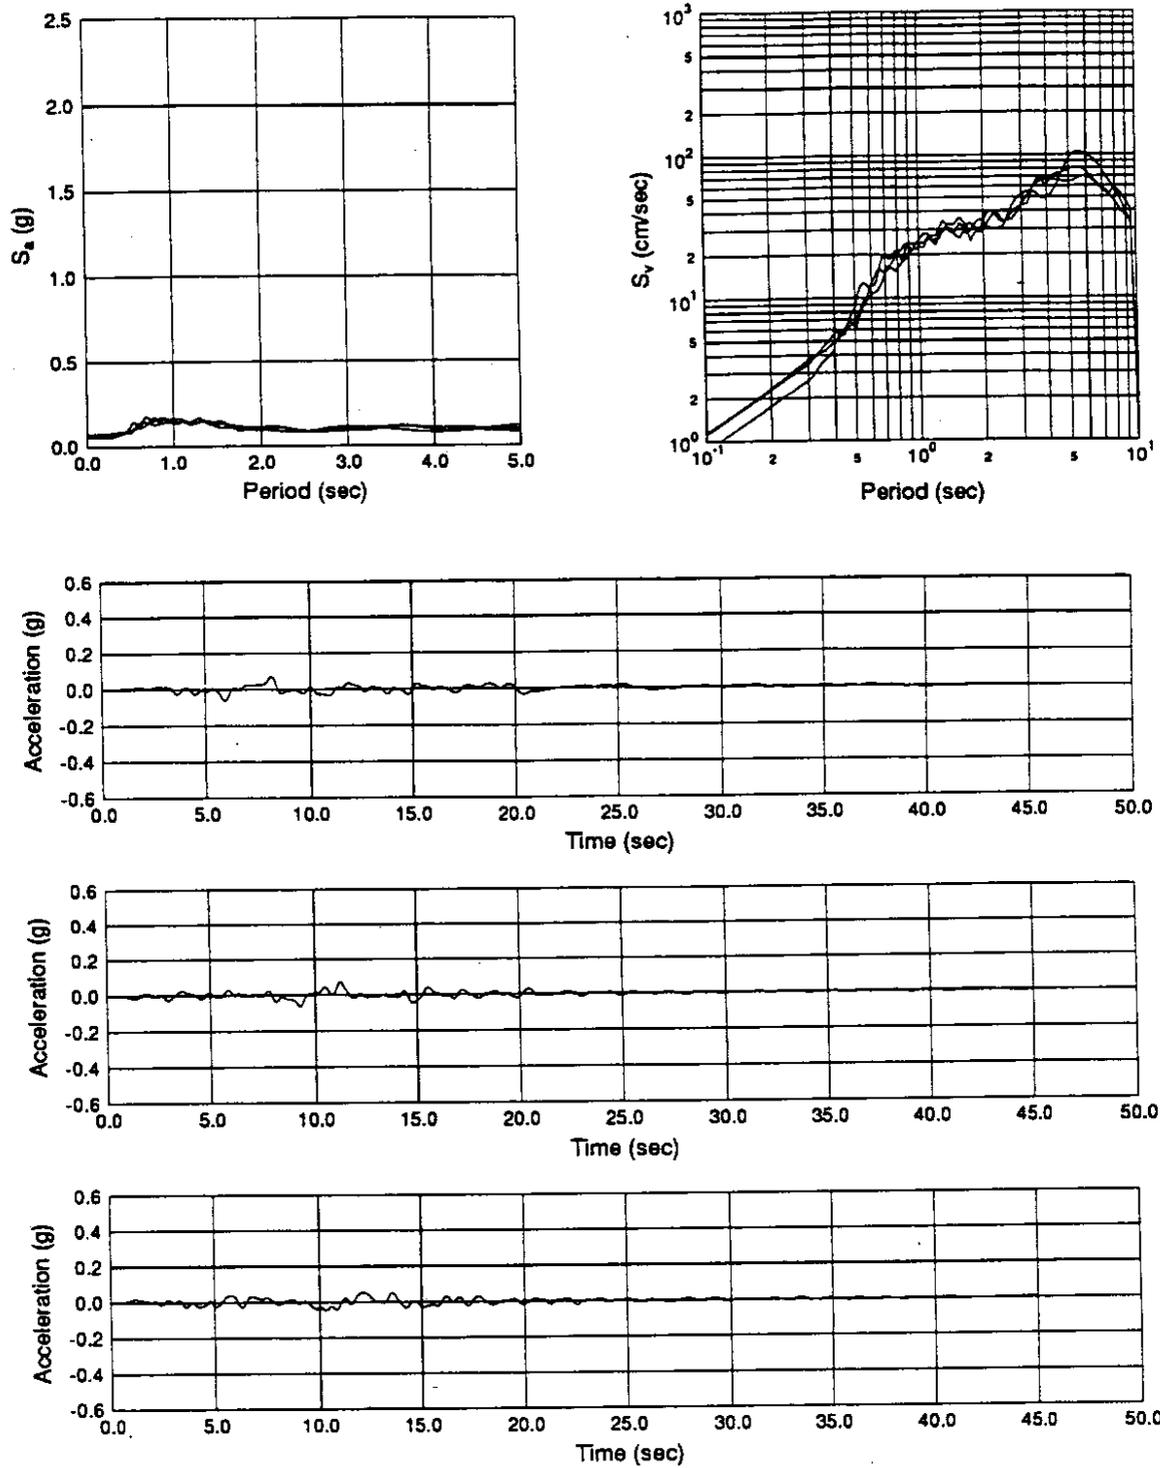
Figure 4.16. Ground Surface Response Spectra and accelerograms for Soft Soil Thickness of 170 Ft.

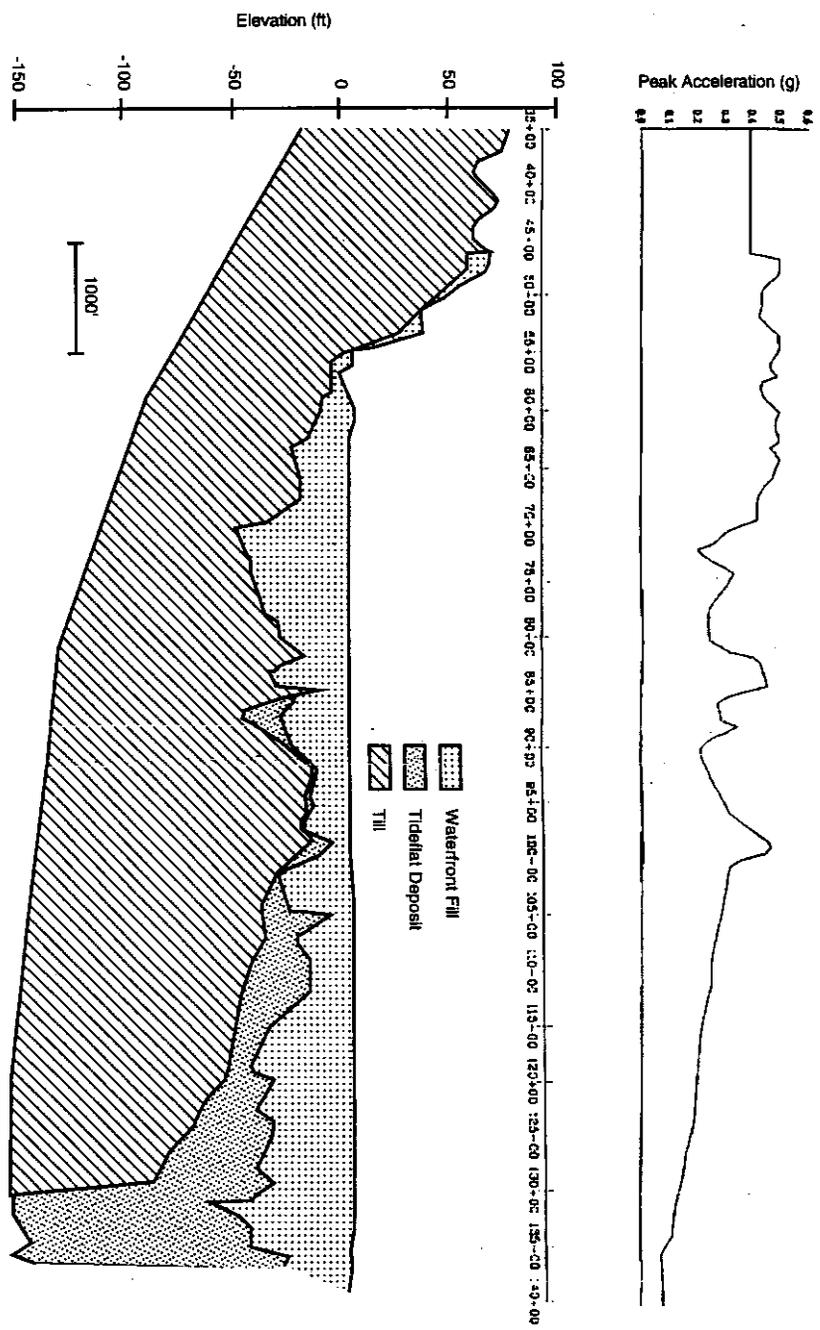
Figure 4.17. Variation of Computed Peak Ground Surface Acceleration along the Length of the Alaskan Way Viaduct

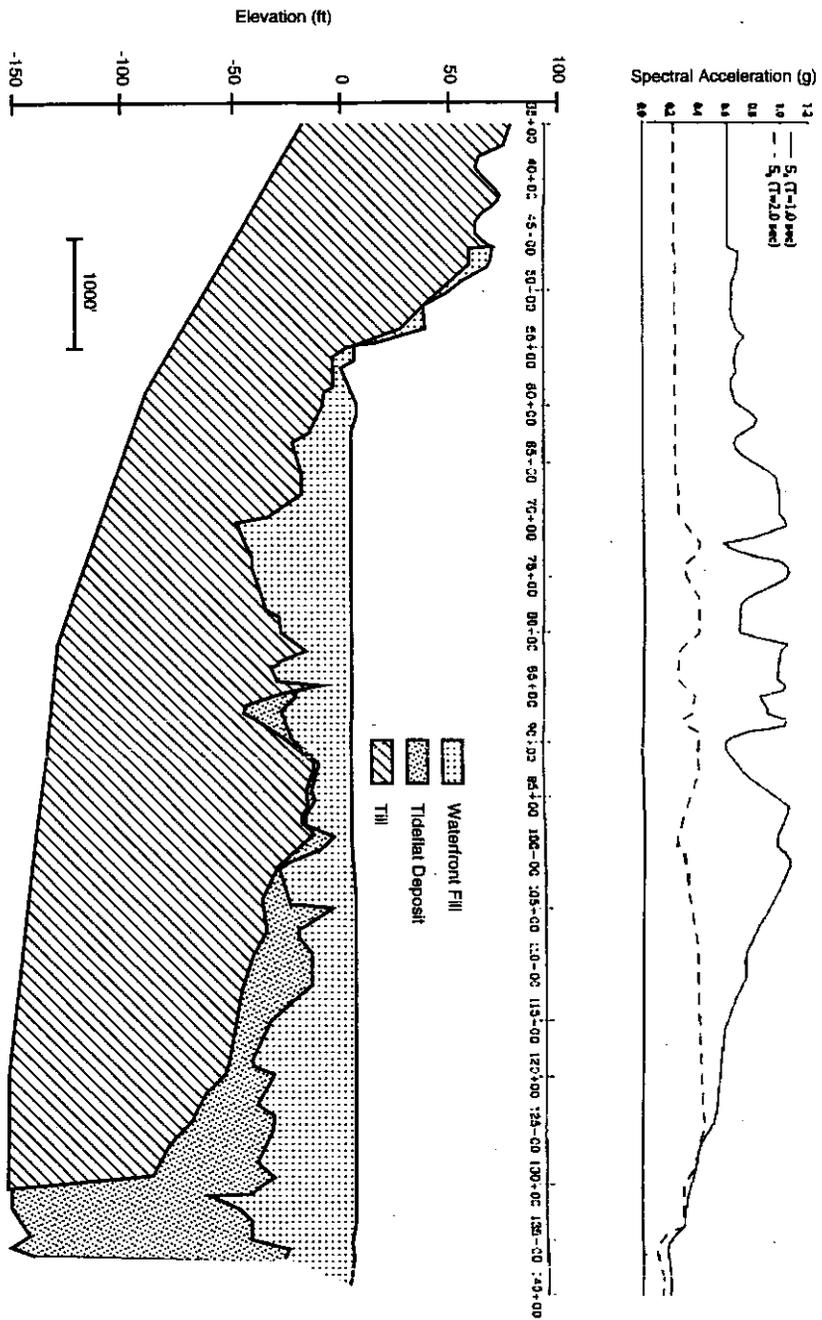
Figure 4.18. Variation of Computed Spectral Acceleration for $T = 1.0$ Sec and $T = 2.0$ Sec along the Length of the Alaskan Way Viaduct

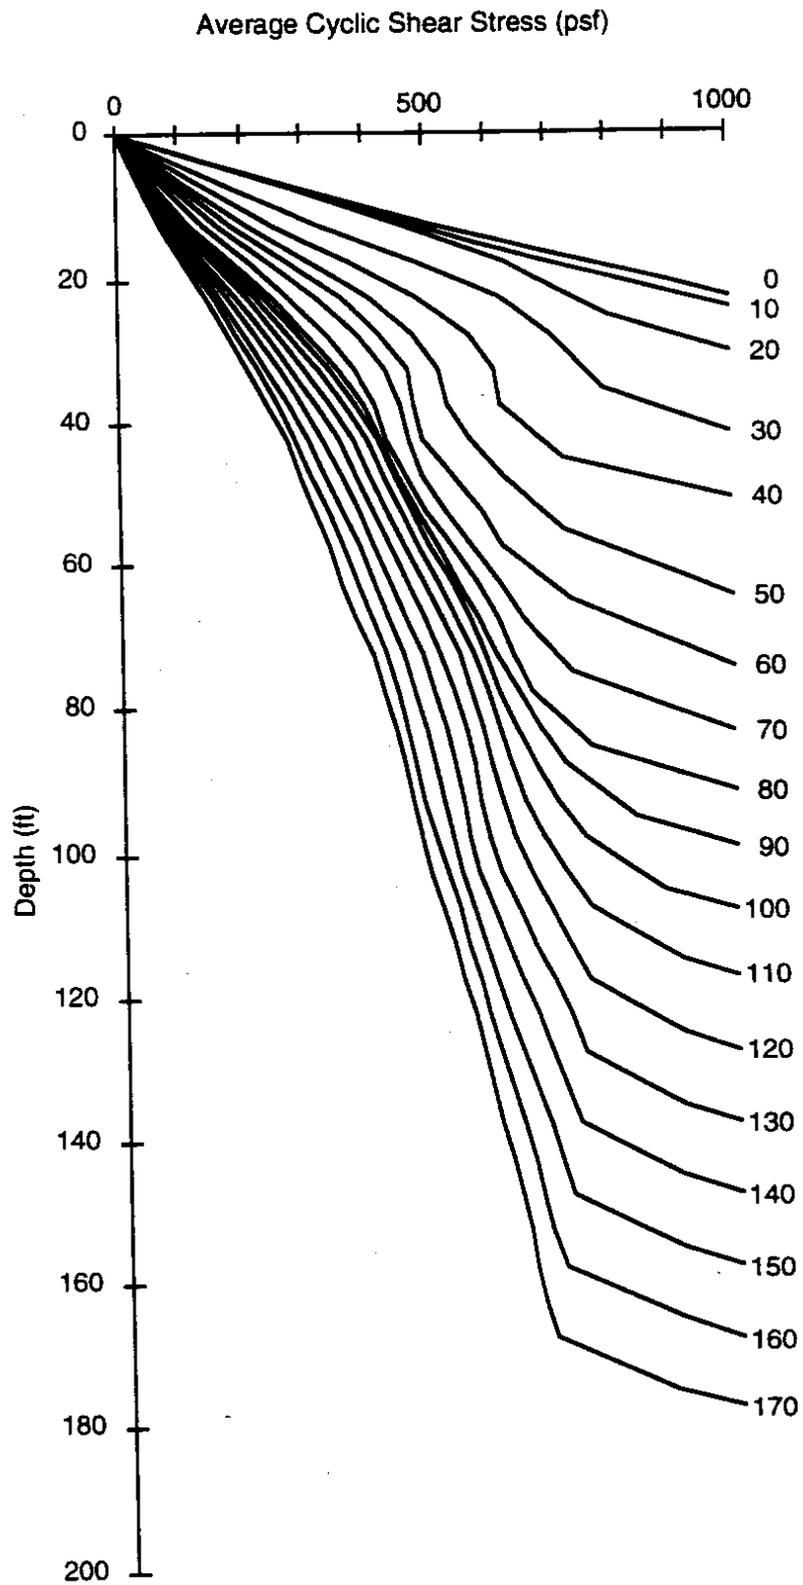
Figure 4.19. Variation of Computed Average Cyclic Shear Stress with Depth for Various Soft Soil Thicknesses

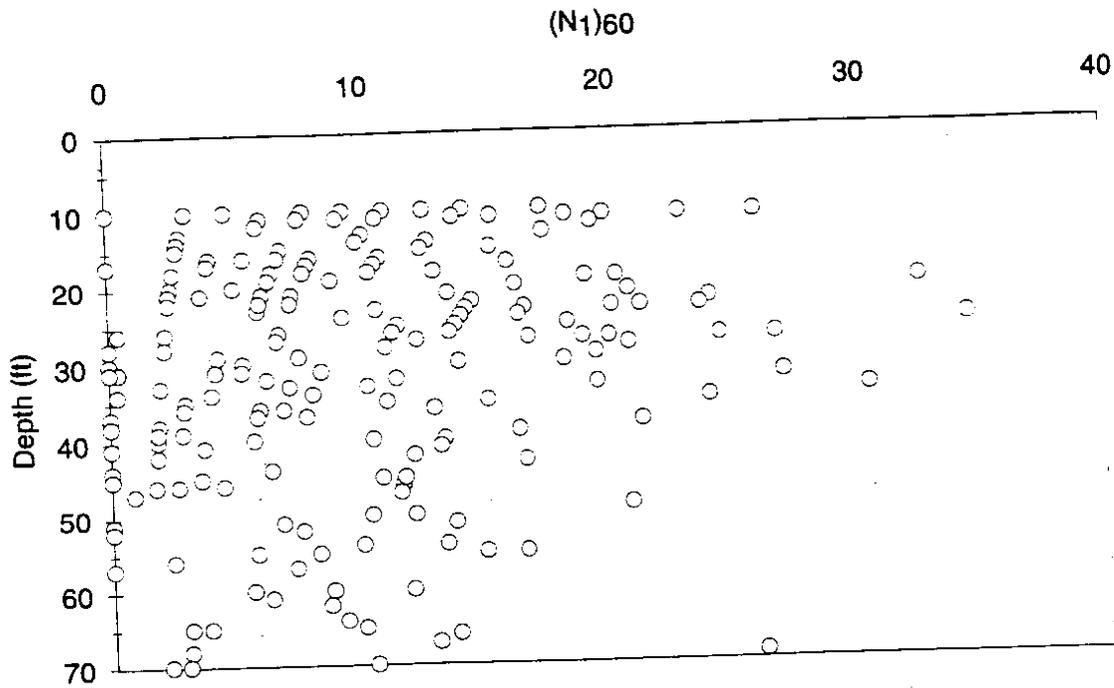
Figure 6.2. Corrected SPT Resistances Used for Liquefaction Analyses of Saturated Soils

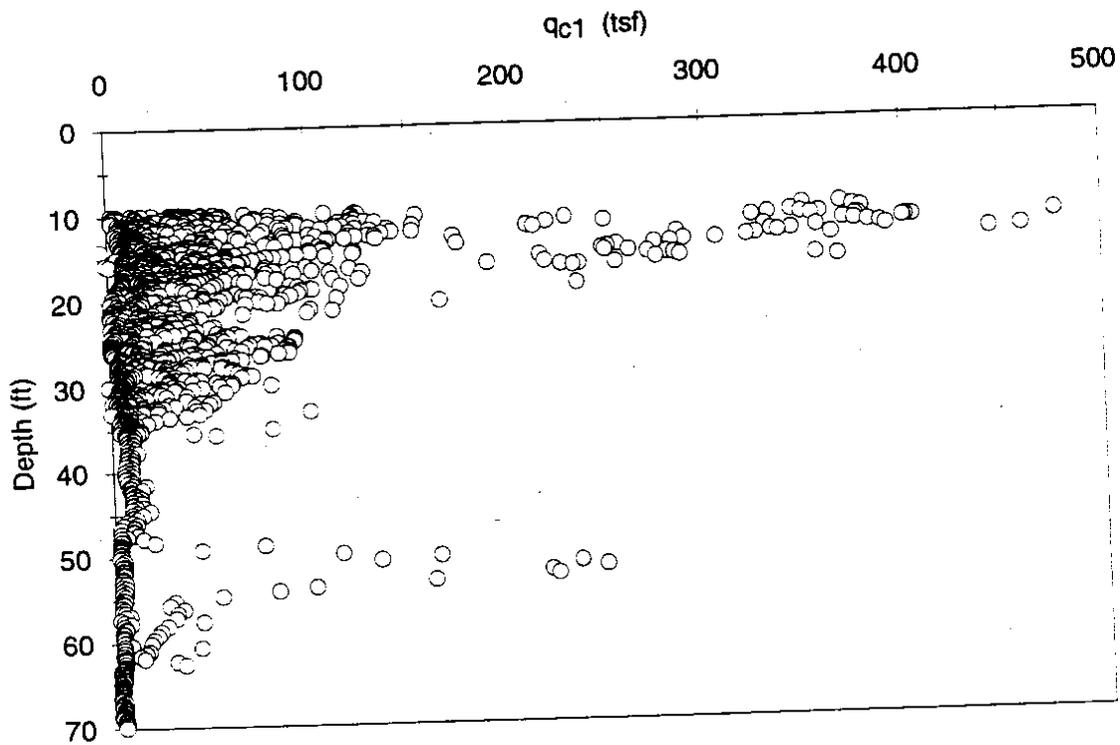
Figure 6.3. Corrected CPT Tip Resistances Used for Liquefaction Analyses of Saturated Soils

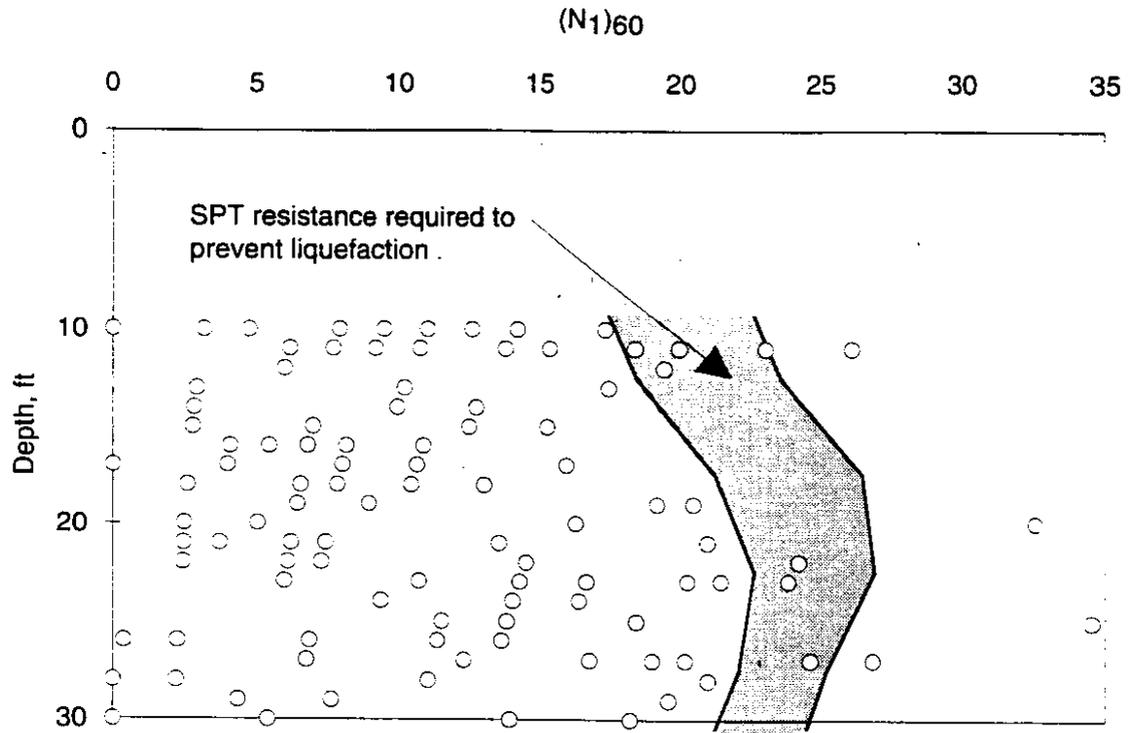
Figure 6.6. Comparison of Measured SPT Resistances with SPT Resistance Required to Resist Liquefaction for 30 Ft Soft Soil

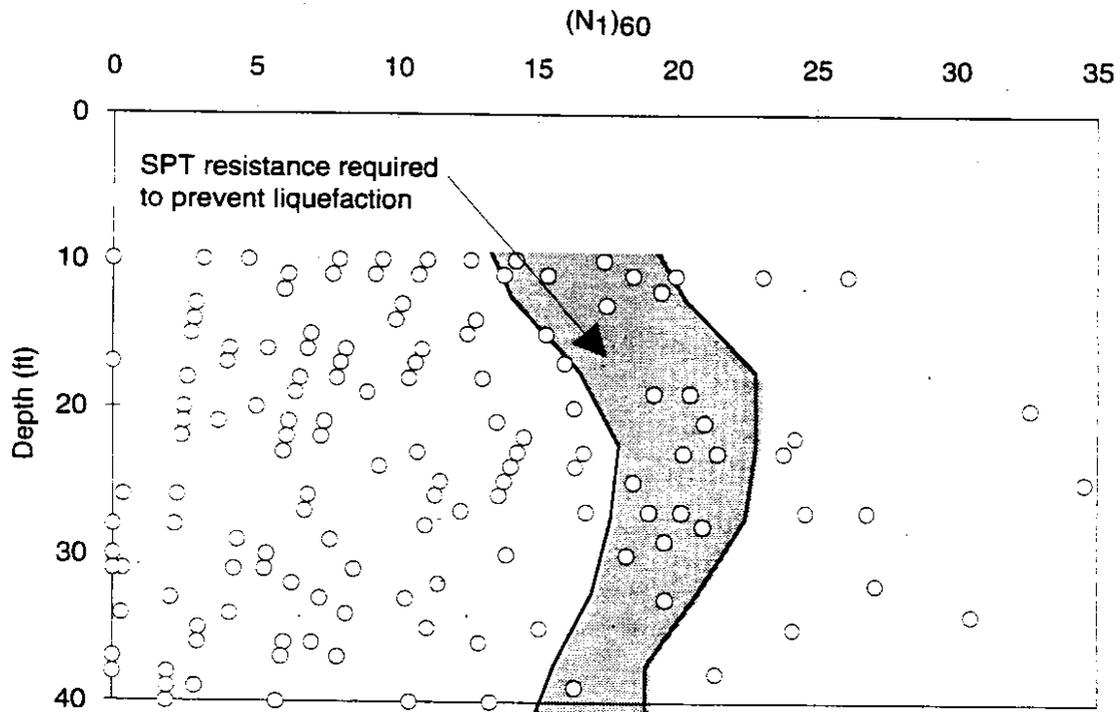
Figure 6.7. Comparison of Measured SPT Resistances with SPT Resistance Required to Resist Liquefaction for 40 Ft Soft Soil

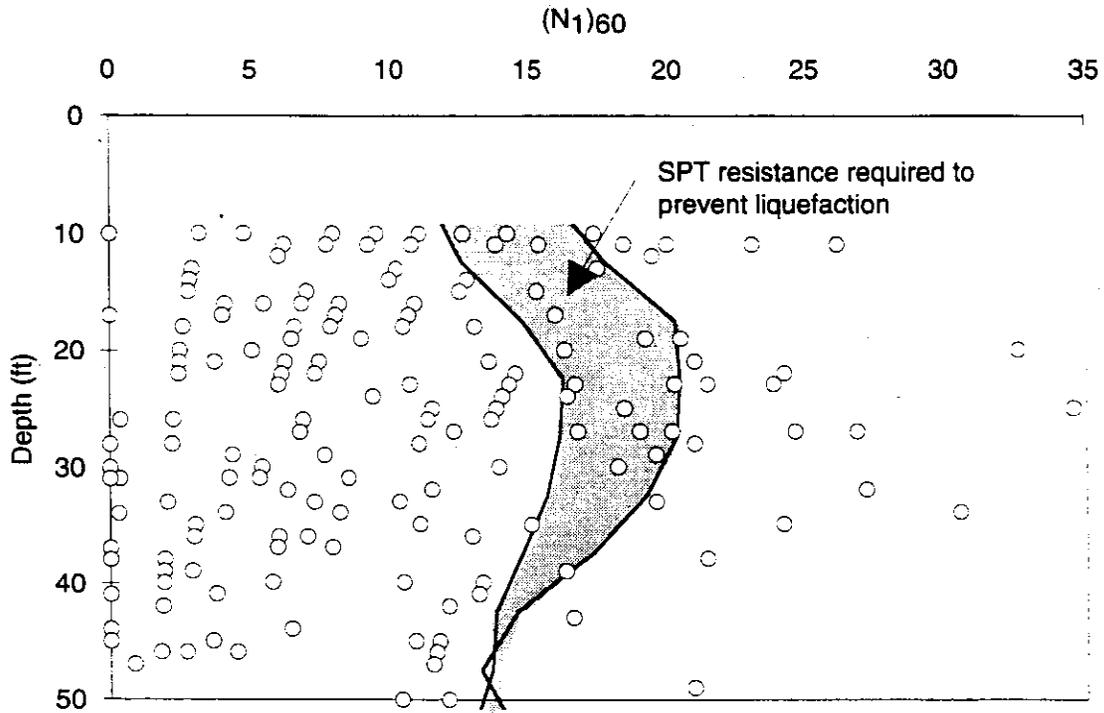
Figure 6.8. Comparison of Measured SPT Resistances with SPT Resistance Required to Resist Liquefaction for 50 Ft Soft Soil
