Final Technical Report
Research Project Agreement No. T9233, Task 41
Seismic Vulnerability of the Alaskan Way Viaduct Phase II

**SEISMIC VULNERABILITY OF THE ALASKAN
WAY VIADUCT: GEOTECHNICAL
ENGINEERING ASPECTS**

July 1995

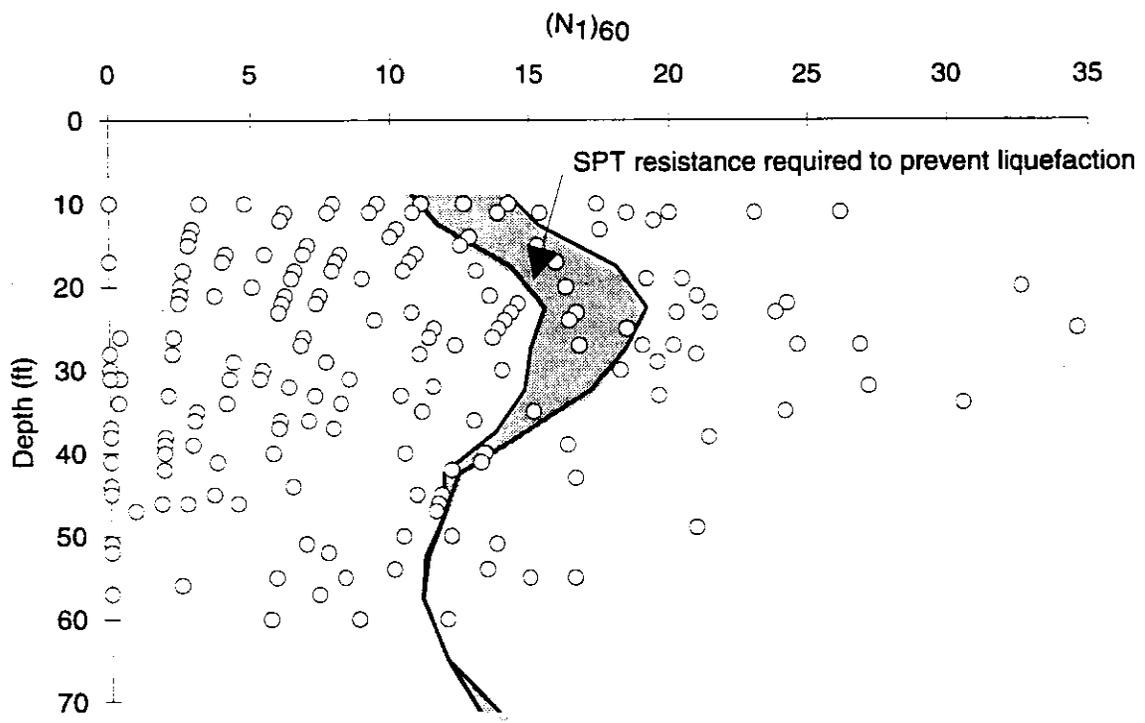
Figure 6.9. Comparison of Measured SPT Resistances with SPT Resistance Required to Resist Liquefaction for 60 Ft Soft Soil

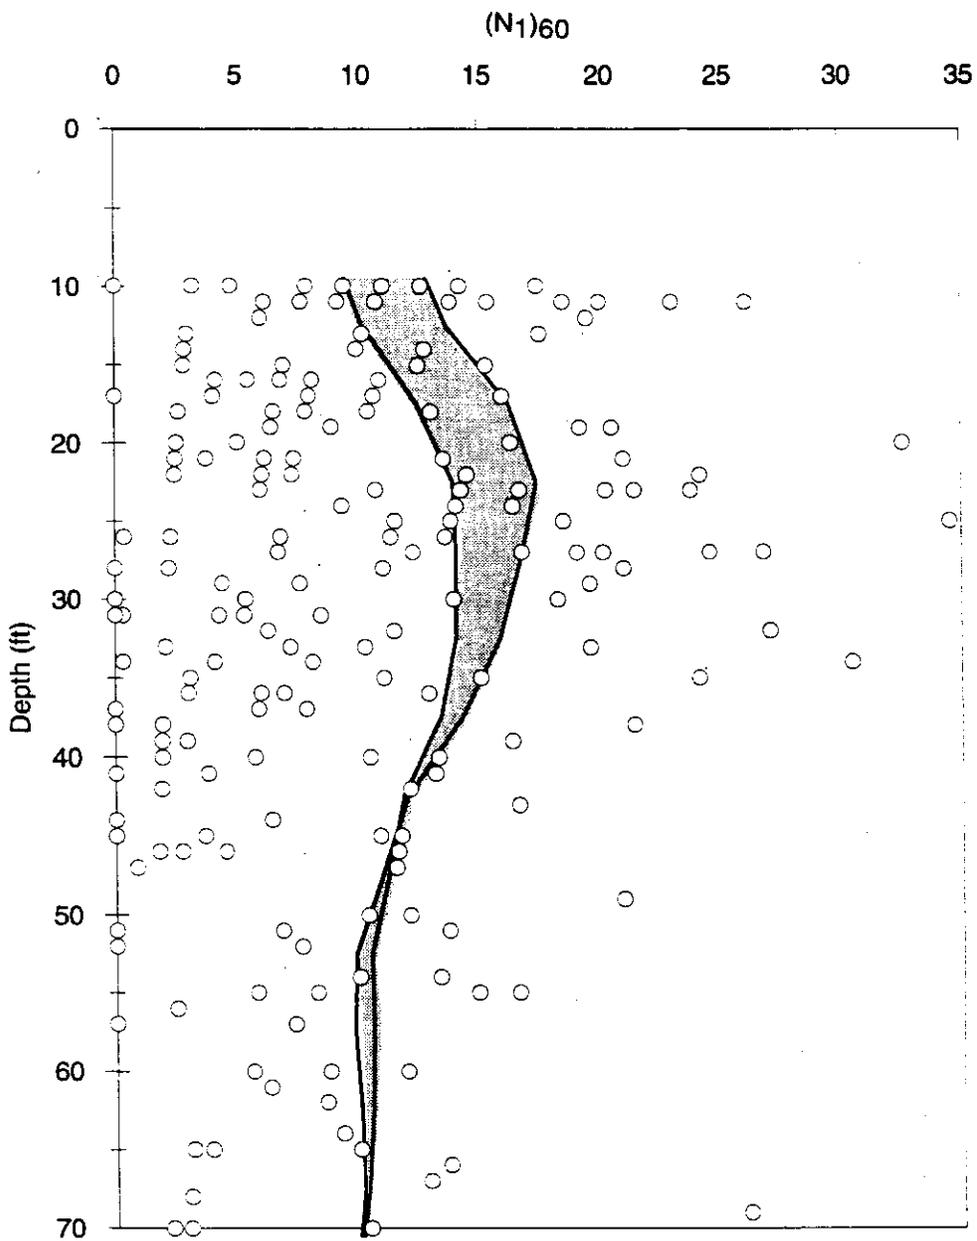
Figure 6.10. Comparison of Measured SPT Resistances with SPT Resistance Required to Resist Liquefaction for 70 Ft Soft Soil

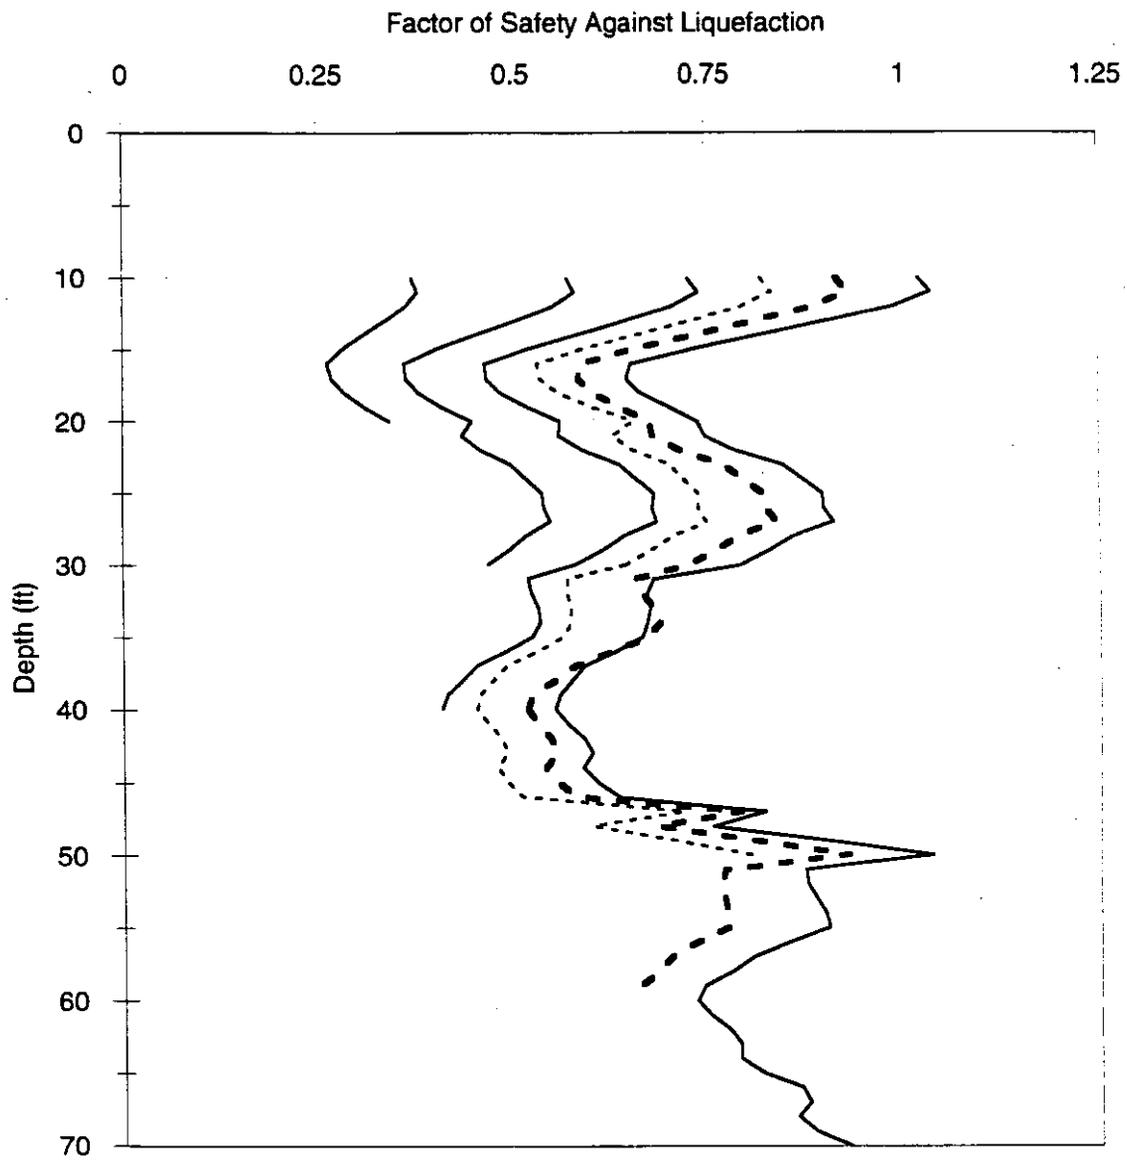
Figure 6.11. Variation of Average Factor of Safety Against Liquefaction with Depth for Design-Level Ground Motions

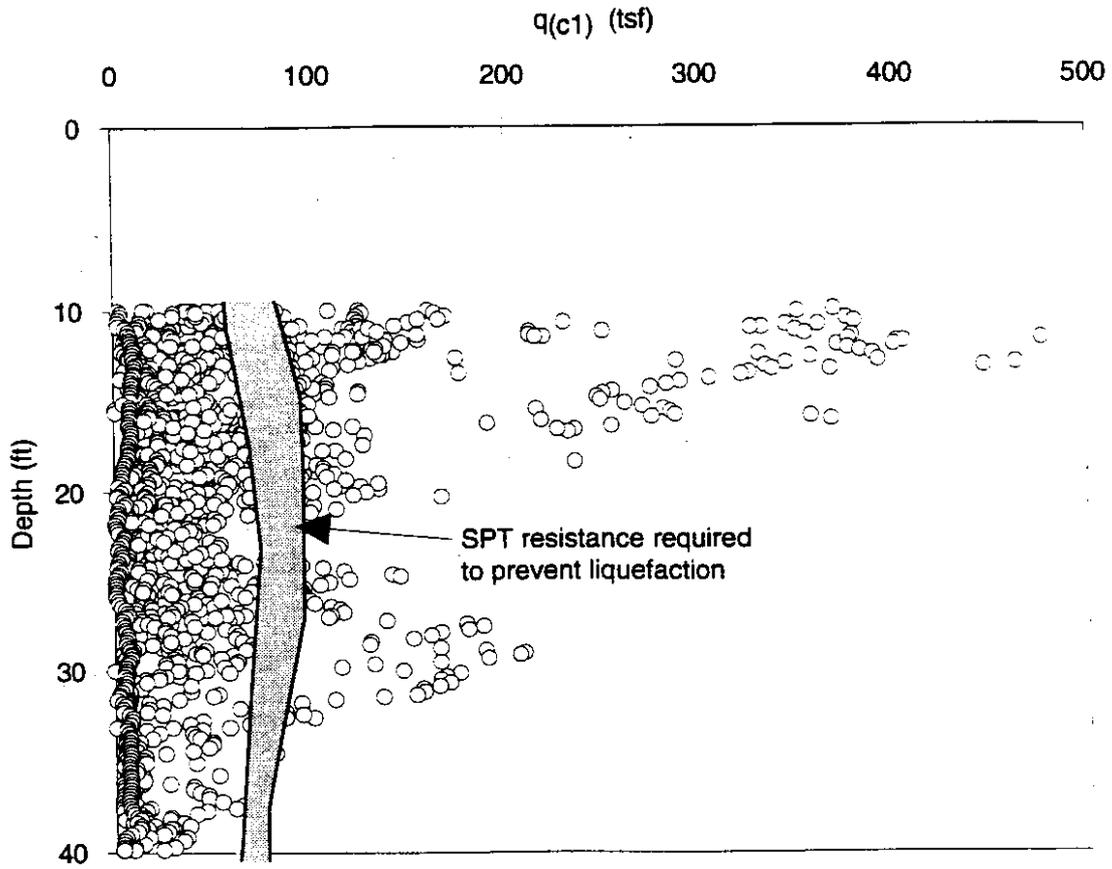
Figure 6.14. Comparison of Measured CPT Resistances with CPT Resistance Required to Resist Liquefaction for 40 Ft Soft Soil

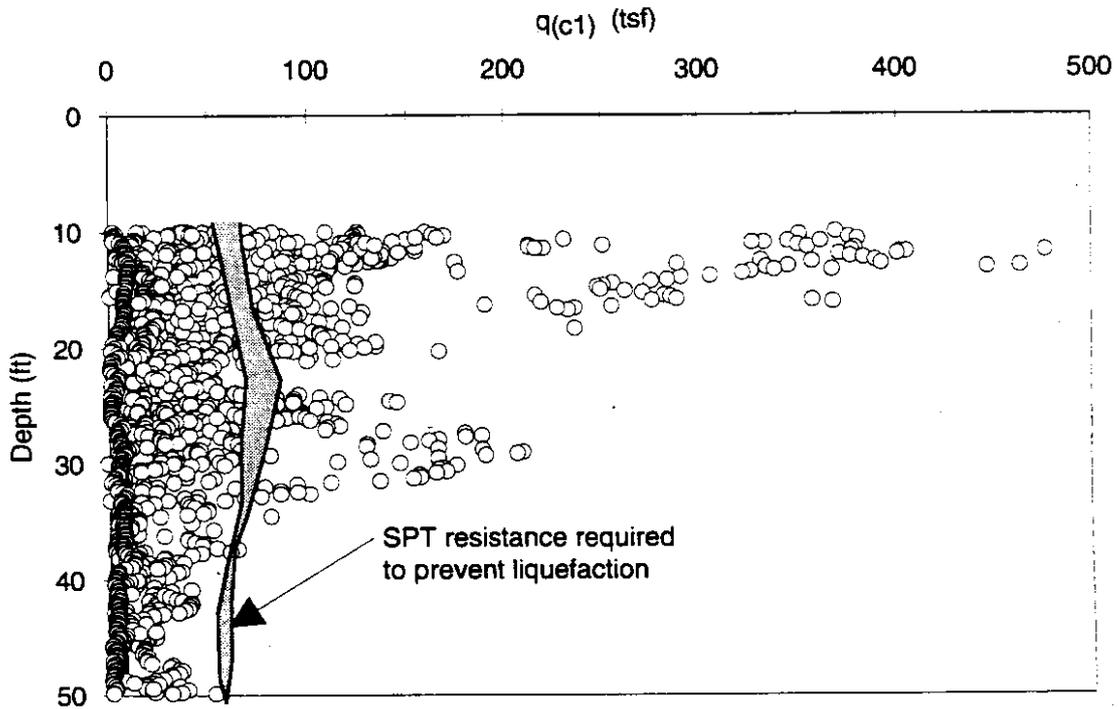
Figure 6.15. Comparison of Measured CPT Resistances with CPT Resistance Required to Resist Liquefaction for 50 Ft Soft Soil

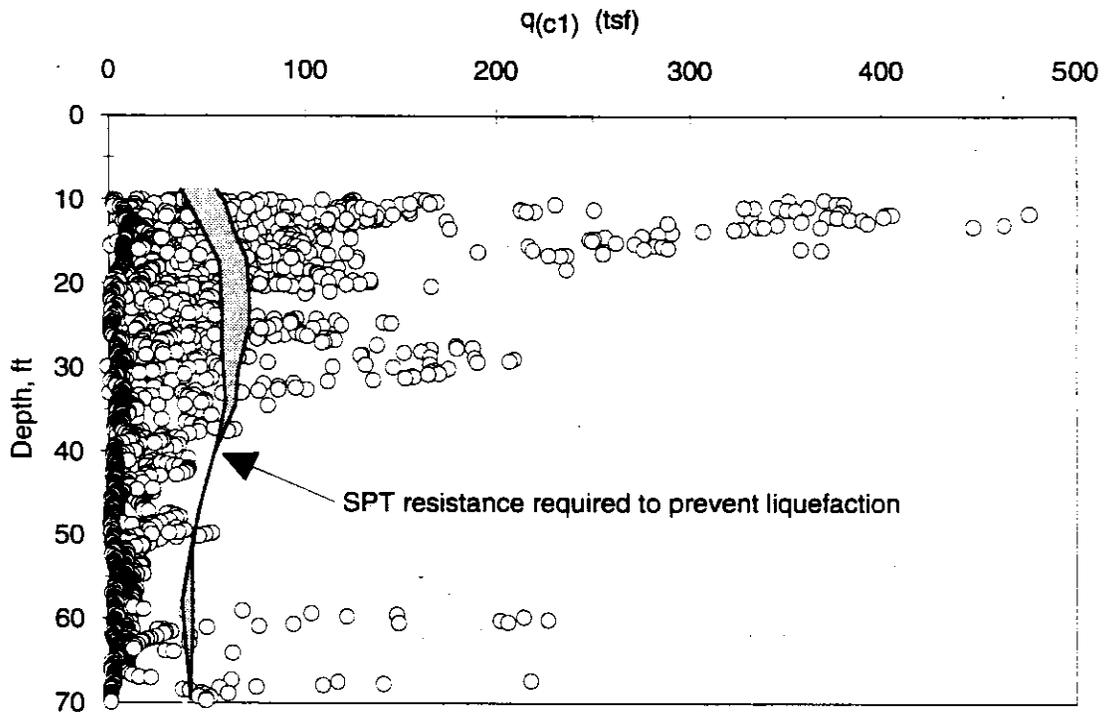
Figure 6.17. Comparison of Measured CPT Resistances with CPT Resistance Required to Resist Liquefaction for 70 Ft Soft Soil

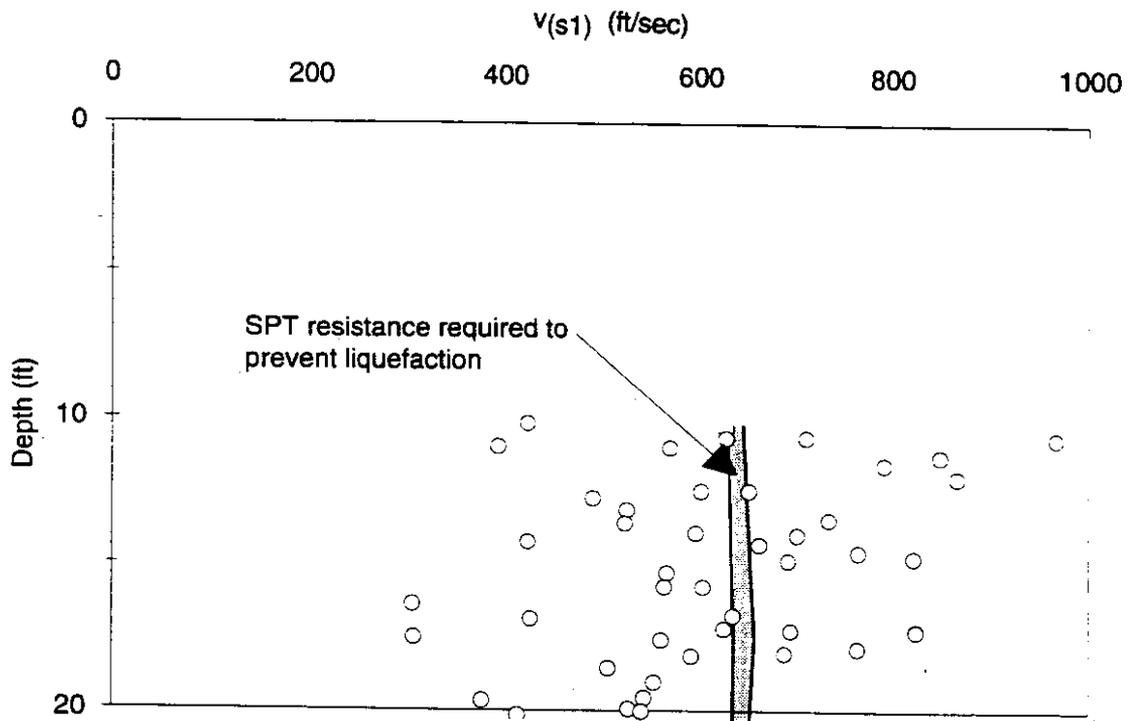
Figure 6.18. Comparison of Measured Shear Wave Velocities With Shear Wave Velocities Required to Resist Liquefaction for 20 Ft Soft Soil

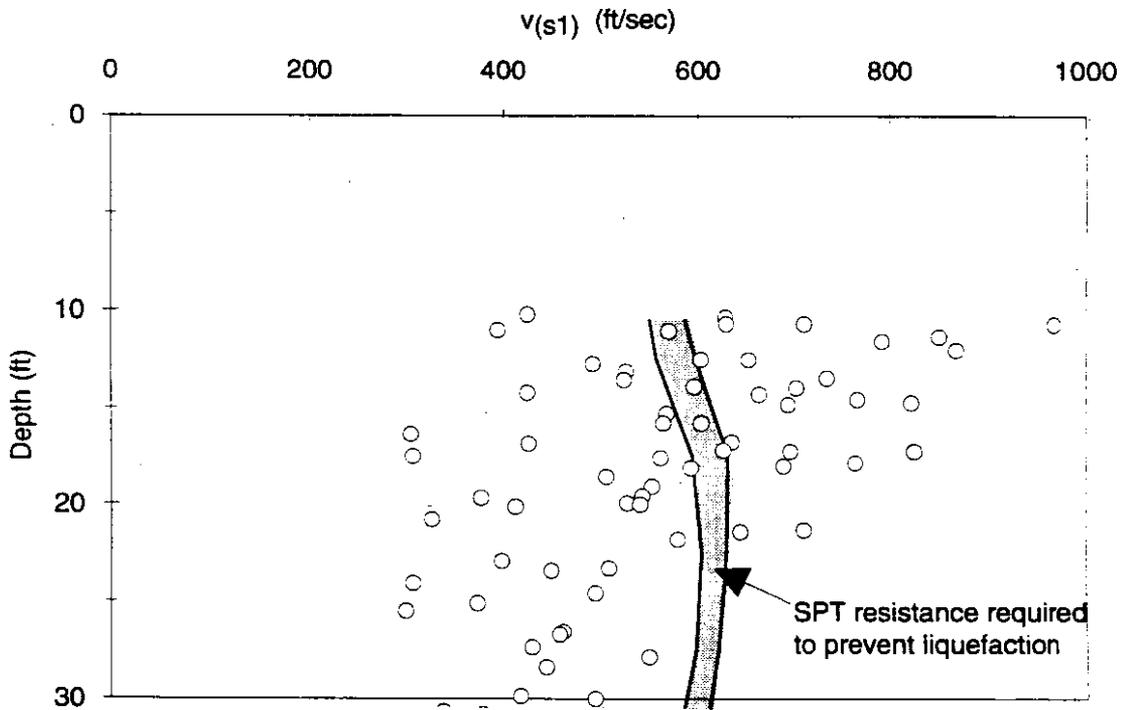
Figure 6.19. Comparison of Measured Shear Wave Velocities with Shear Wave Velocities Required to Resist Liquefaction for 30 Ft Soft Soil

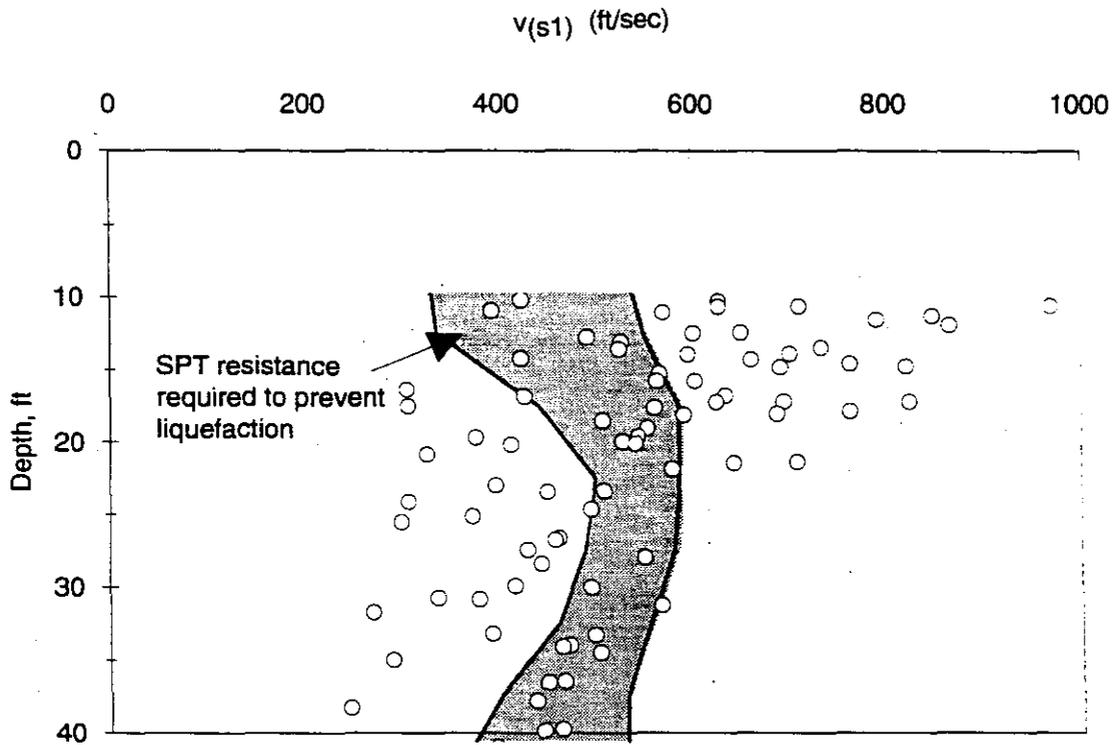
Figure 6.20. Comparison of Measured Shear Wave Velocities with Shear Wave Velocities Required to Resist Liquefaction for 40 Ft Soft Soil

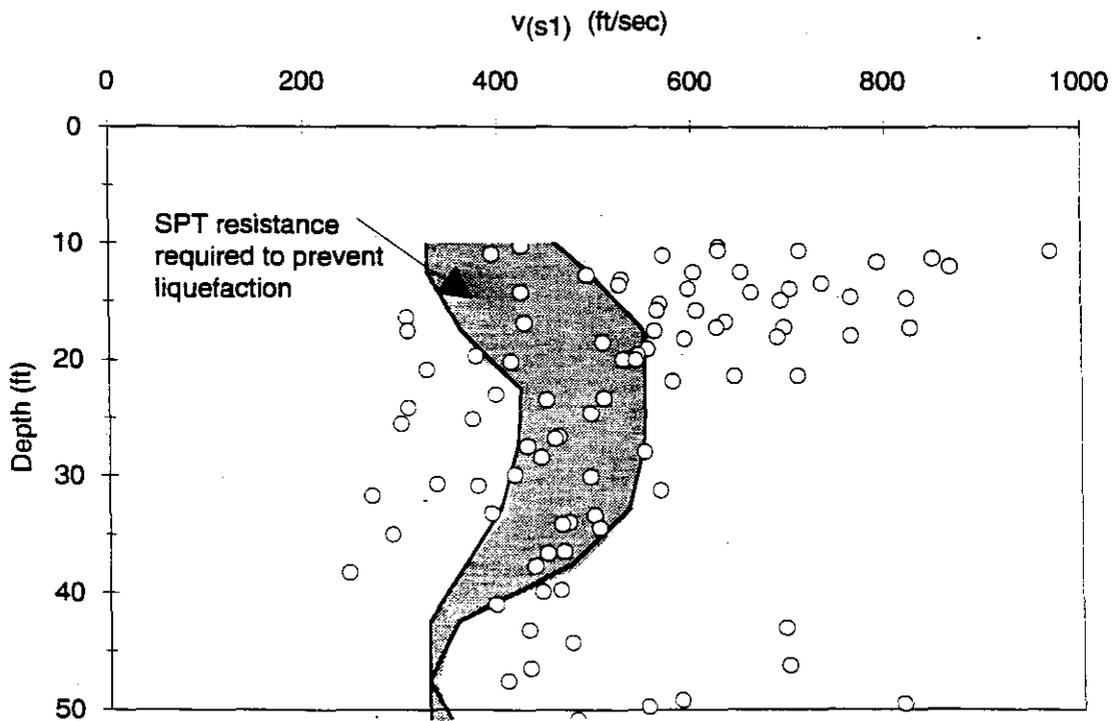
Figure 6.21. Comparison of Measured Shear Wave Velocities with Shear Wave Velocities Required to Resist Liquefaction for 50 Ft Soft Soil

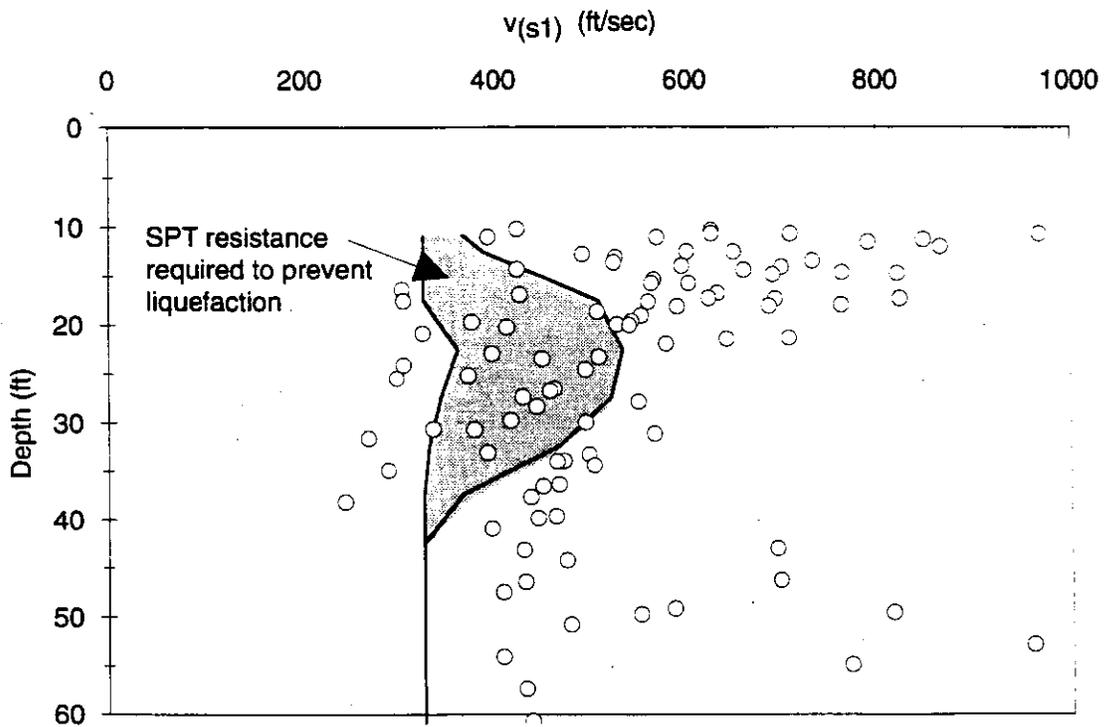
Figure 6.22. Comparison of Measured Shear Wave Velocities with Shear Wave Velocities Required to Resist Liquefaction for 60 Ft Soft Soil

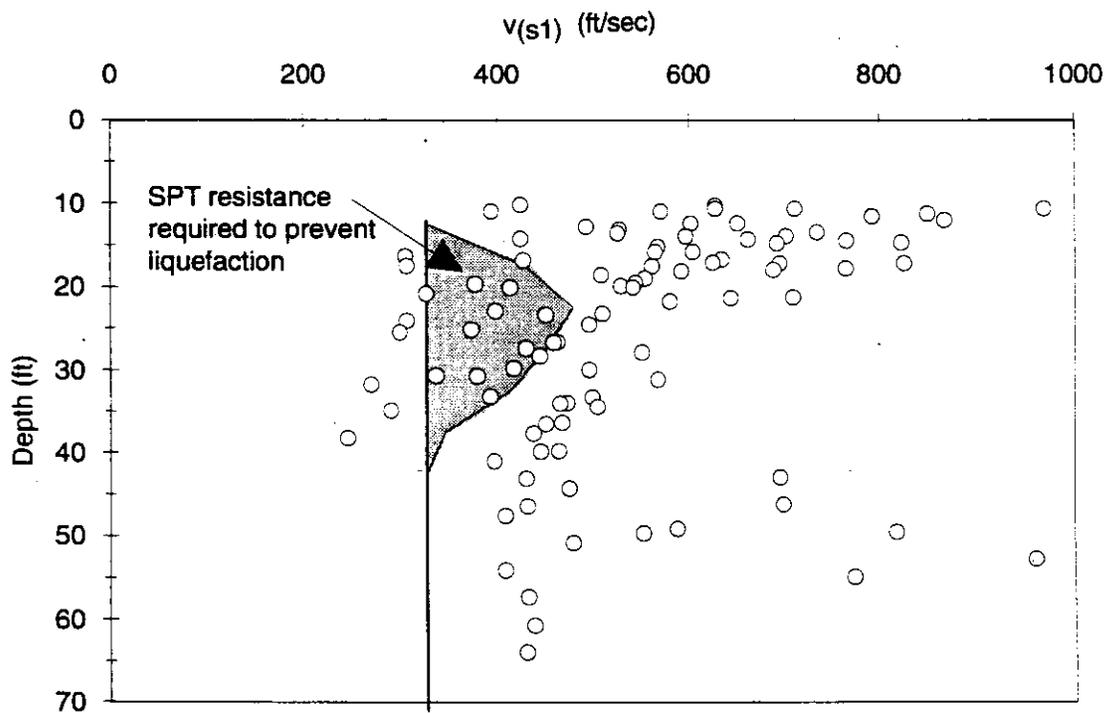
Figure 6.23. Comparison of Measured Shear Wave Velocities with Shear Wave Velocities Required to Resist Liquefaction for 70 Ft Soft Soil

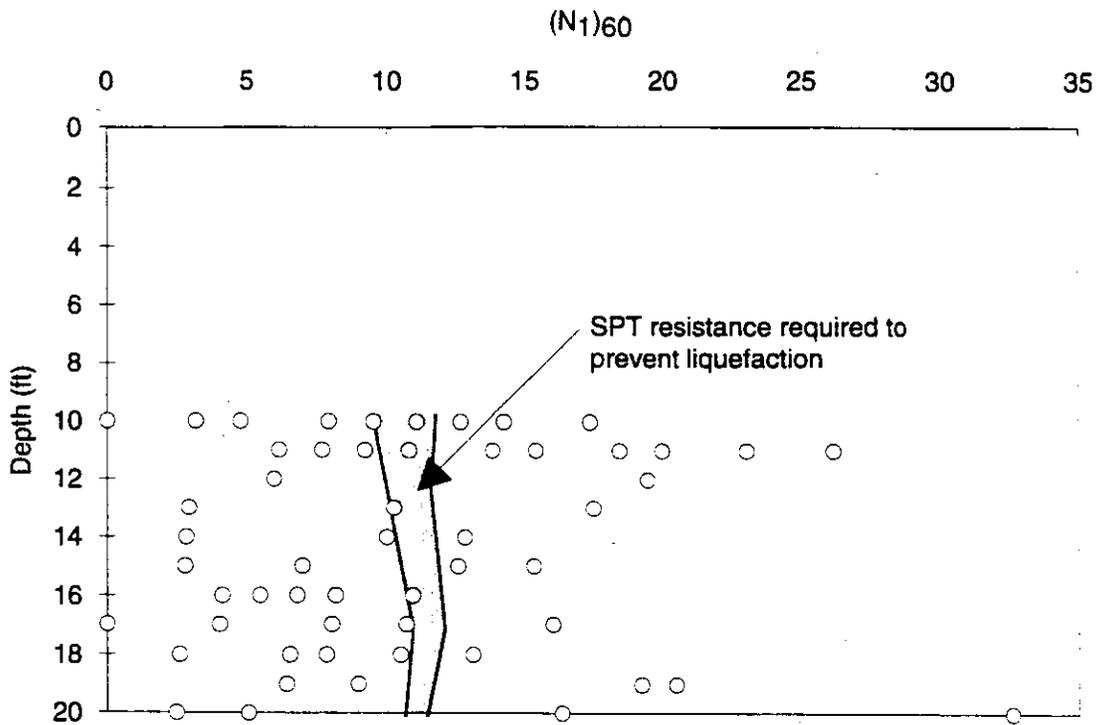
Figure 6.24. Comparison of Measured SPT Resistances with SPT Resistance Required to Resist Liquefaction for 20 Ft Soft Soil for the 1965 Seattle Earthquake Motion

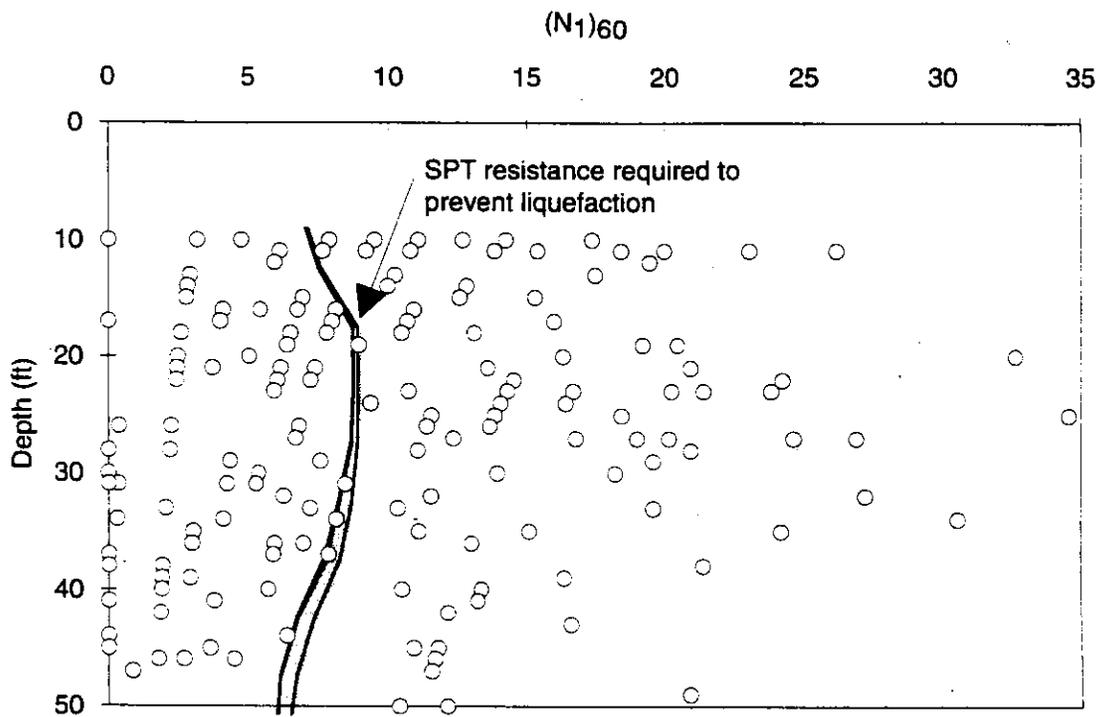
Figure 6.27. Comparison of Measured SPT Resistances with SPT Resistance Required to Resist Liquefaction for 50 Ft Soft Soil for the 1965 Seattle Earthquake Motion

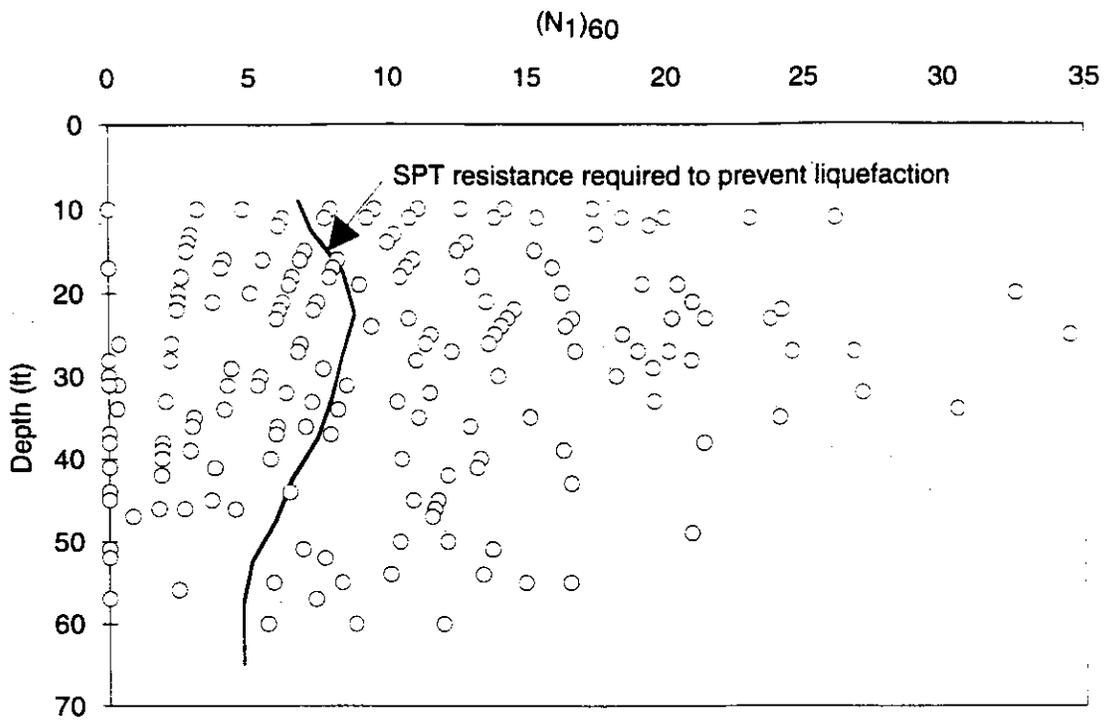
Figure 6.28. Comparison of Measured SPT Resistances With SPT Resistance Required to Resist Liquefaction for 60 Ft Soft Soil for the 1965 Seattle Earthquake Motion

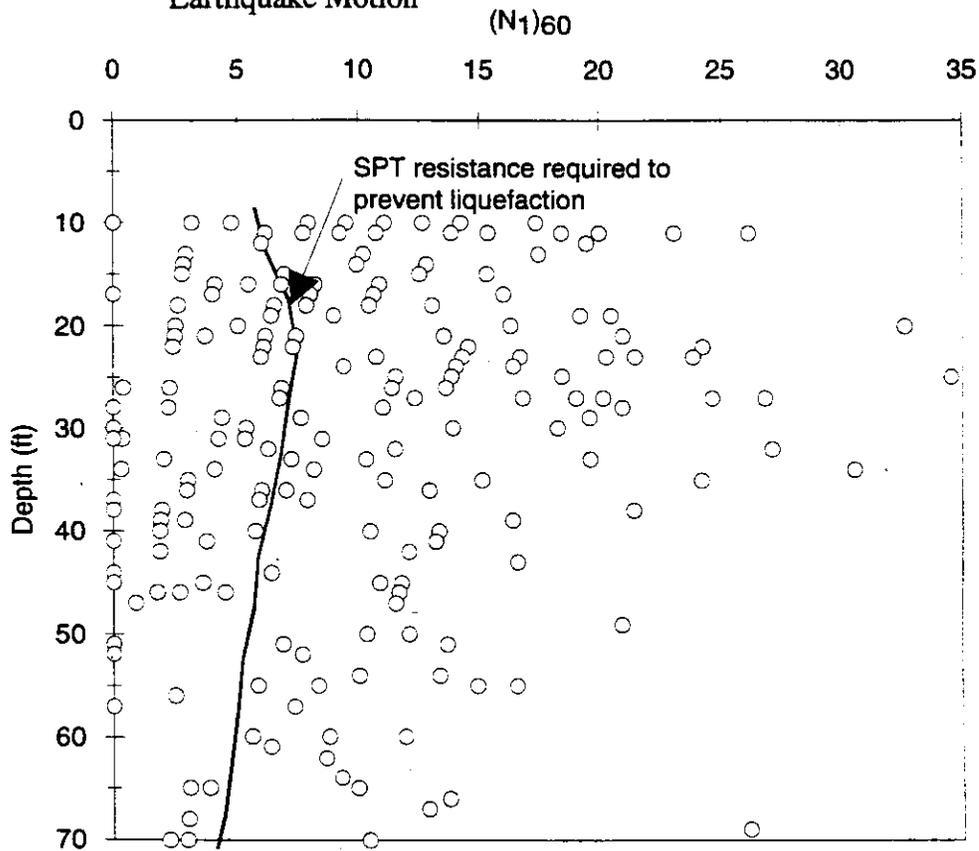
Figure 6.29. Comparison of Measured SPT Resistances with SPT Resistance Required to Resist Liquefaction for 70 Ft Soft Soil for the 1965 Seattle Earthquake Motion

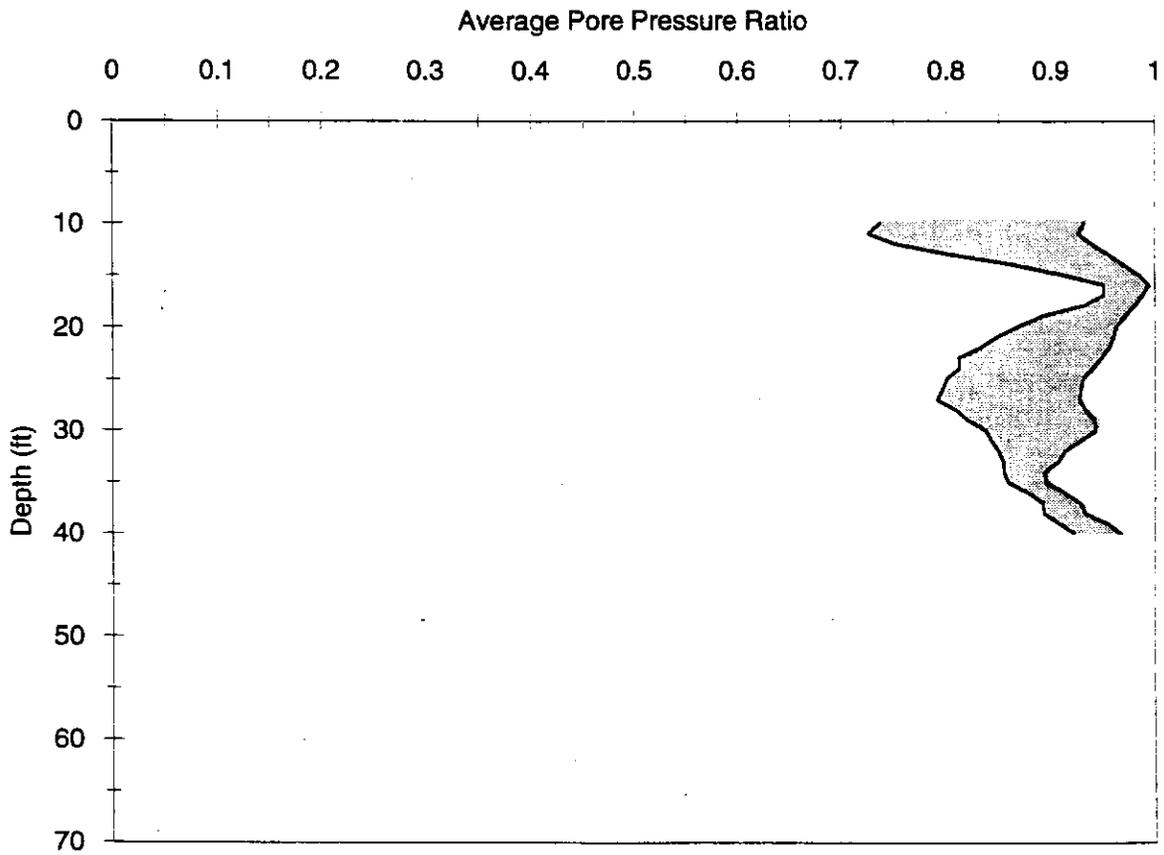
Figure 6.33. Variation of Average Peak Pore Pressure Ratio with Depth for 40 Ft Soft Soil

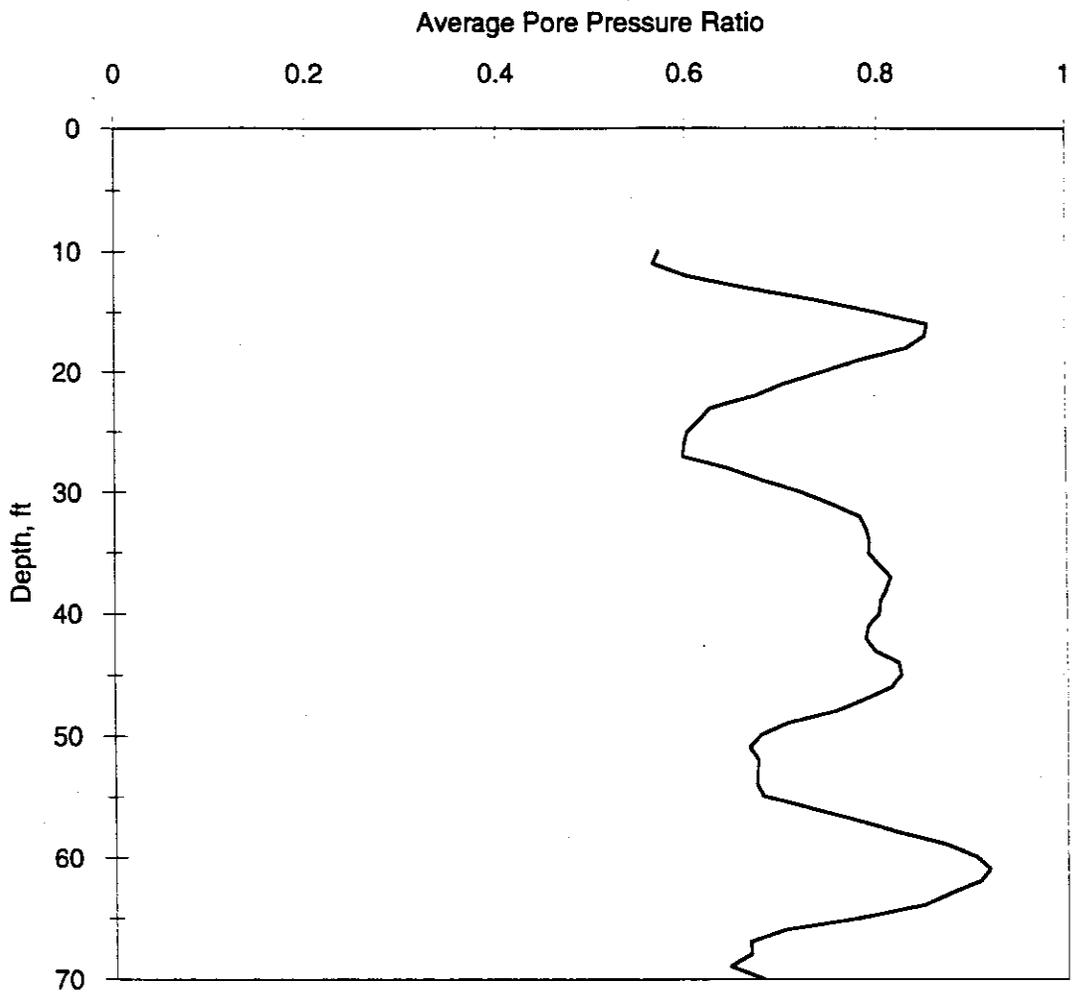
Figure 6.36. Variation of Average Peak Pore Pressure Ratio with Depth for 70 Ft Soft Soil

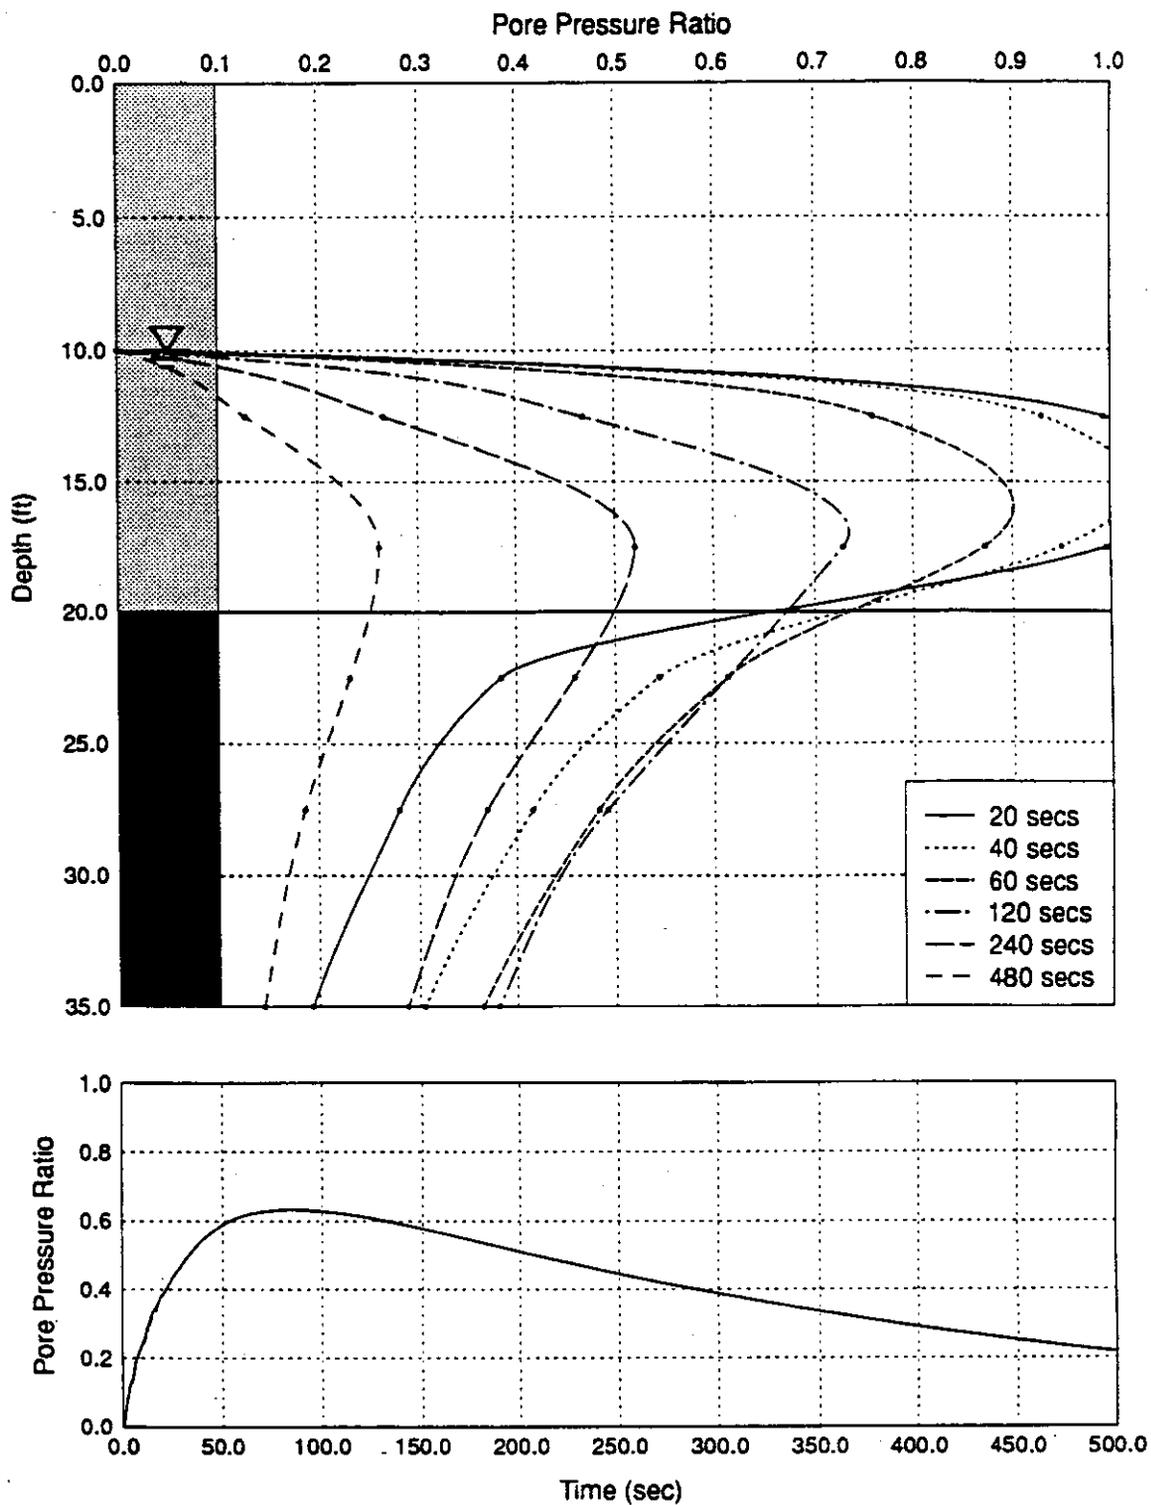
Figure 6.37 (a) Variation of Pore Pressure Ratio with Depth at Different Times after the Beginning of Earthquake Shaking for 20 Ft Soft Soil, and (B) Variation of Pore Pressure Ratio with Time in the Vicinity of the Tips of the Existing Pile Foundations (2.5 Ft Below Top of Till)

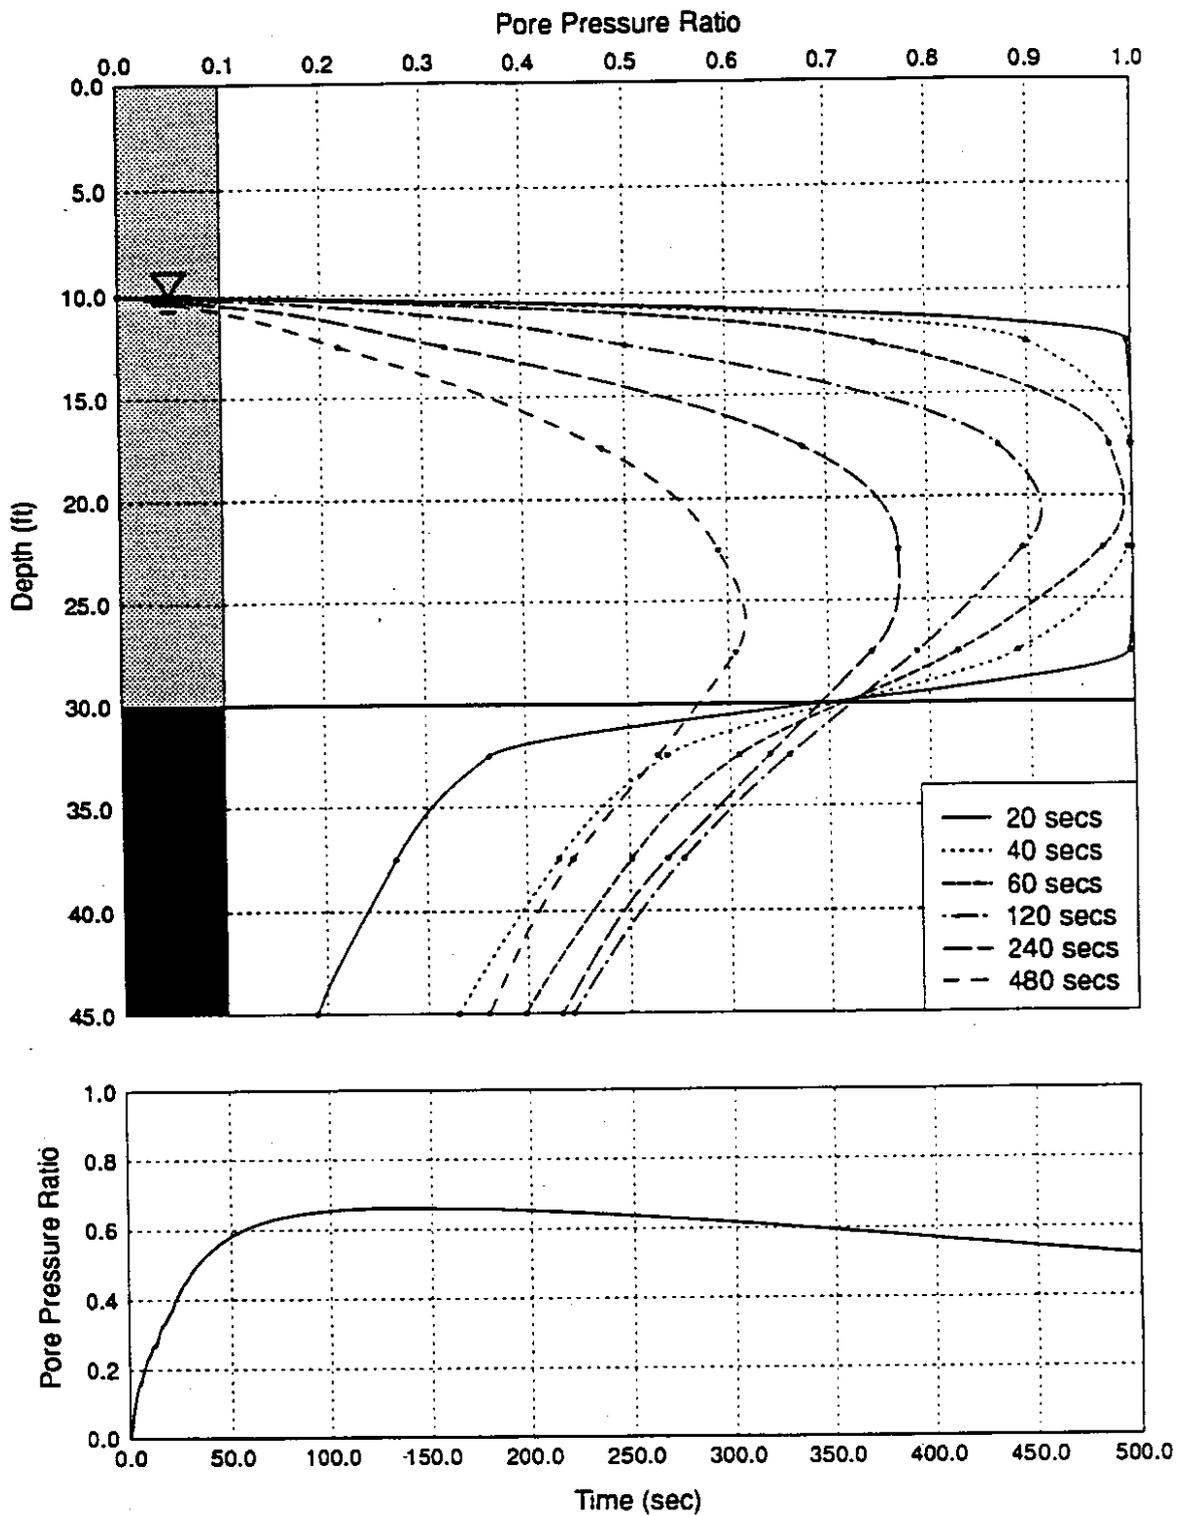
Figure 6.38 (a) Variation of Pore Pressure Ratio with Depth at Different Times after the Beginning of Earthquake Shaking for 30 Ft Soft Soil, and (B) Variation of Pore Pressure Ratio with Time in the Vicinity of the Tips of the Existing Pile Foundations (2.5 Ft Below Top of Till)

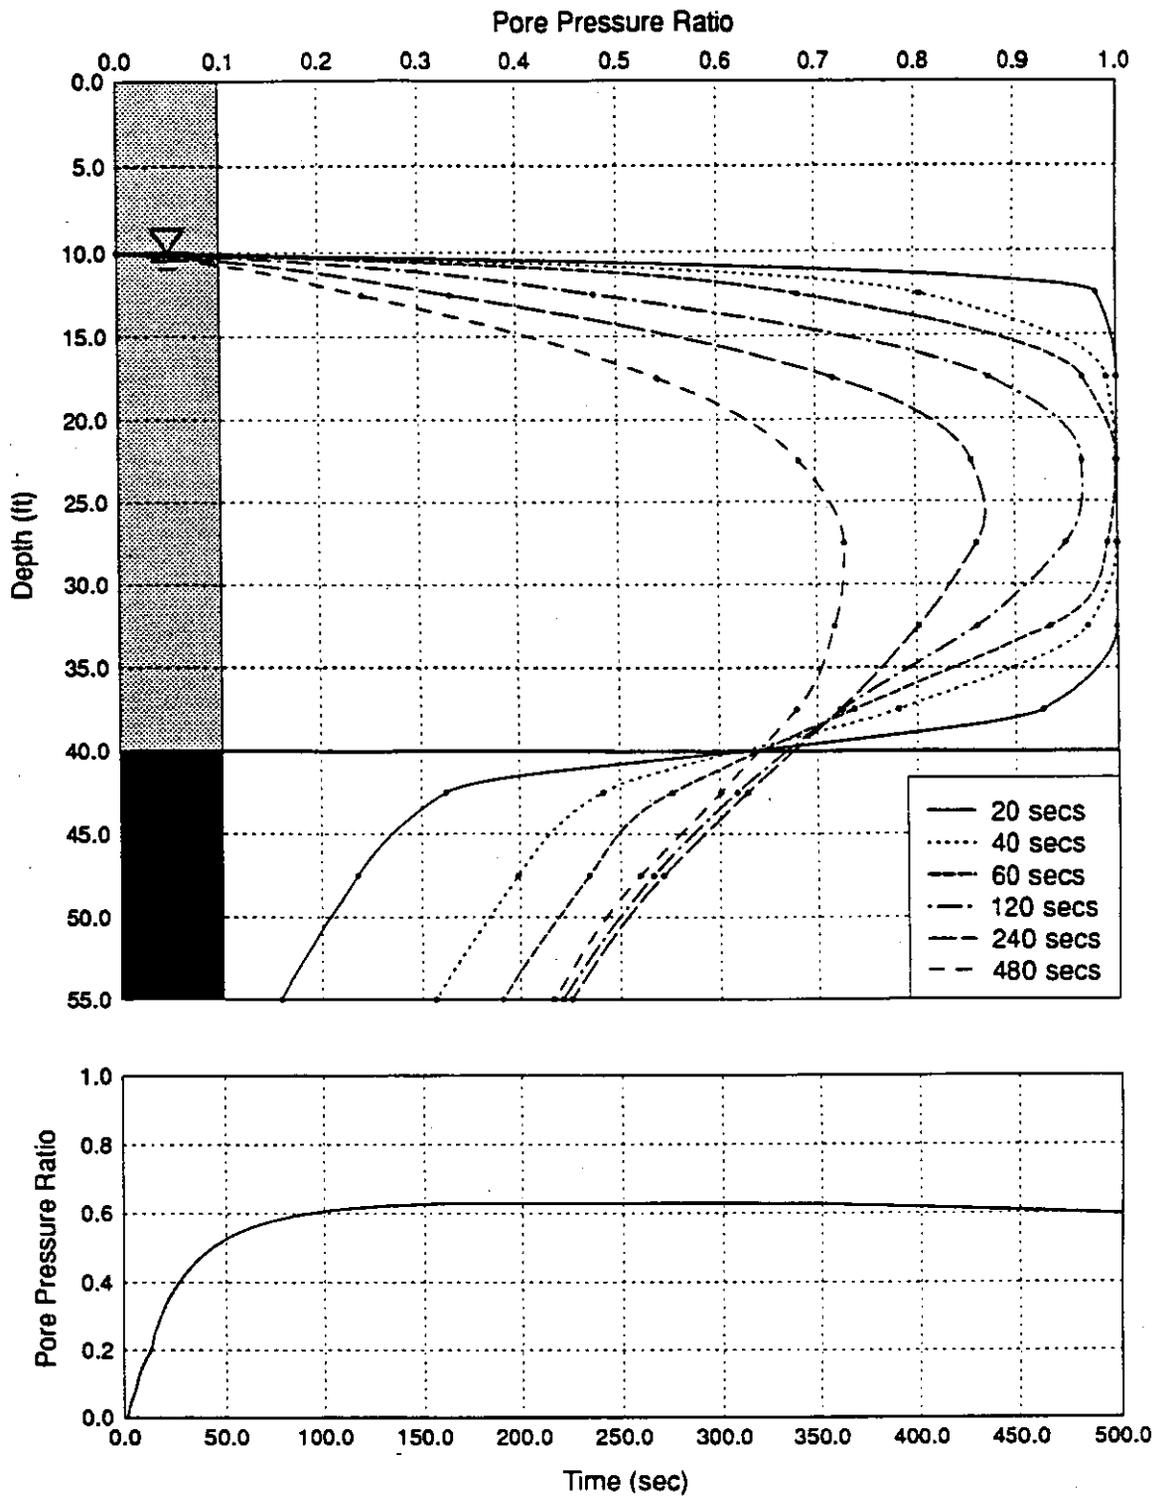
Figure 6.39 (a) Variation of Pore Pressure Ratio with Depth at Different Times after the Beginning of Earthquake Shaking for 40 Ft Soft Soil, and (B) Variation of Pore Pressure Ratio with Time in the Vicinity of the Tips of the Existing Pile Foundations (2.5 Ft Below Top of Till)
