Final Technical Report
Research Project Agreement No. T9233, Task 41
Seismic Vulnerability of the Alaskan Way Viaduct Phase II

**SEISMIC VULNERABILITY OF THE ALASKAN
WAY VIADUCT: GEOTECHNICAL
ENGINEERING ASPECTS**

July 1995

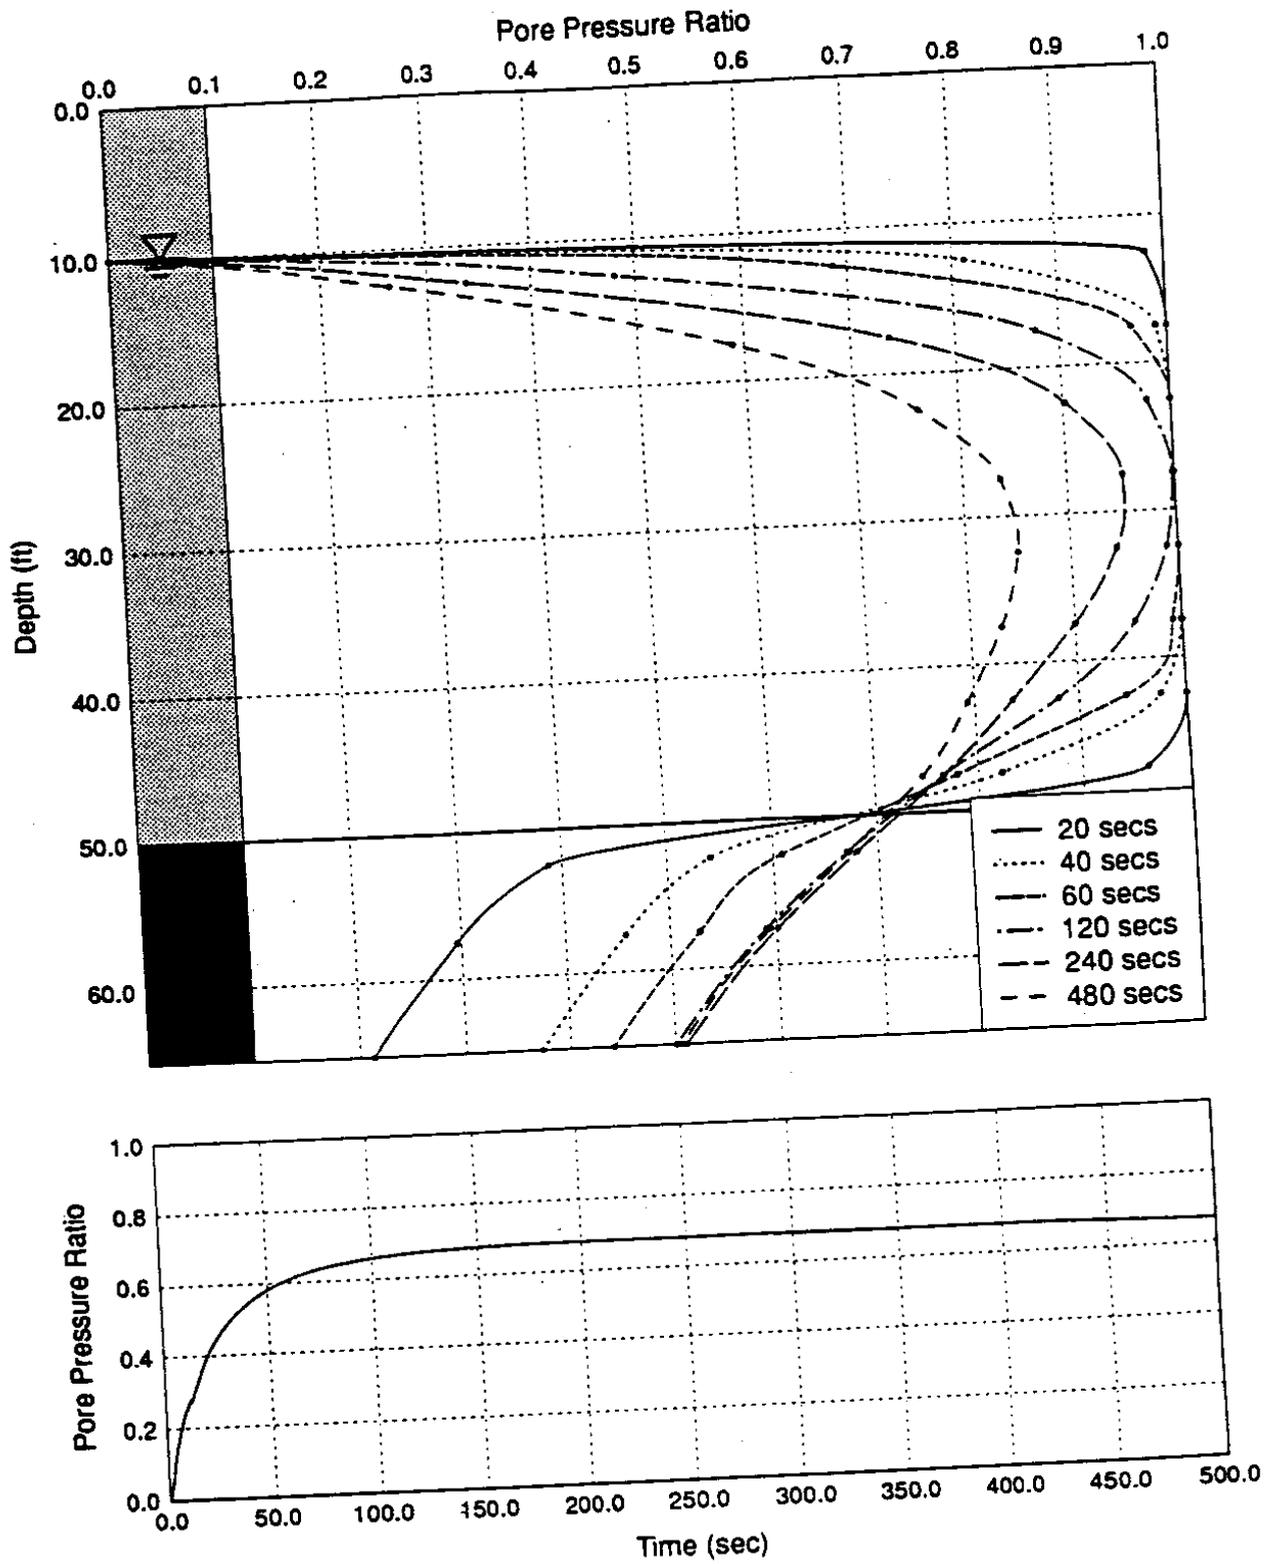
Figure 6.40 (a) Variation of Pore Pressure Ratio with Depth at Different Times after the Beginning of Earthquake Shaking for 50 Ft Soft Soil, and (B) Variation of Pore Pressure Ratio with Time in the Vicinity of the Tips of the Existing Pile Foundations (2.5 Ft Below Top of Till)
