WATER QUALITY IMPACTS ASSOCIATED WITH LEACHATES  
FROM HIGHWAY WOODWASTES EMBANKMENTS

INTERIM REPORT  
September 1980

WA-RD-39.1

A report prepared for the  
Washington State Department of  
Transportation Highway Runoff Water  
Quality Research Project

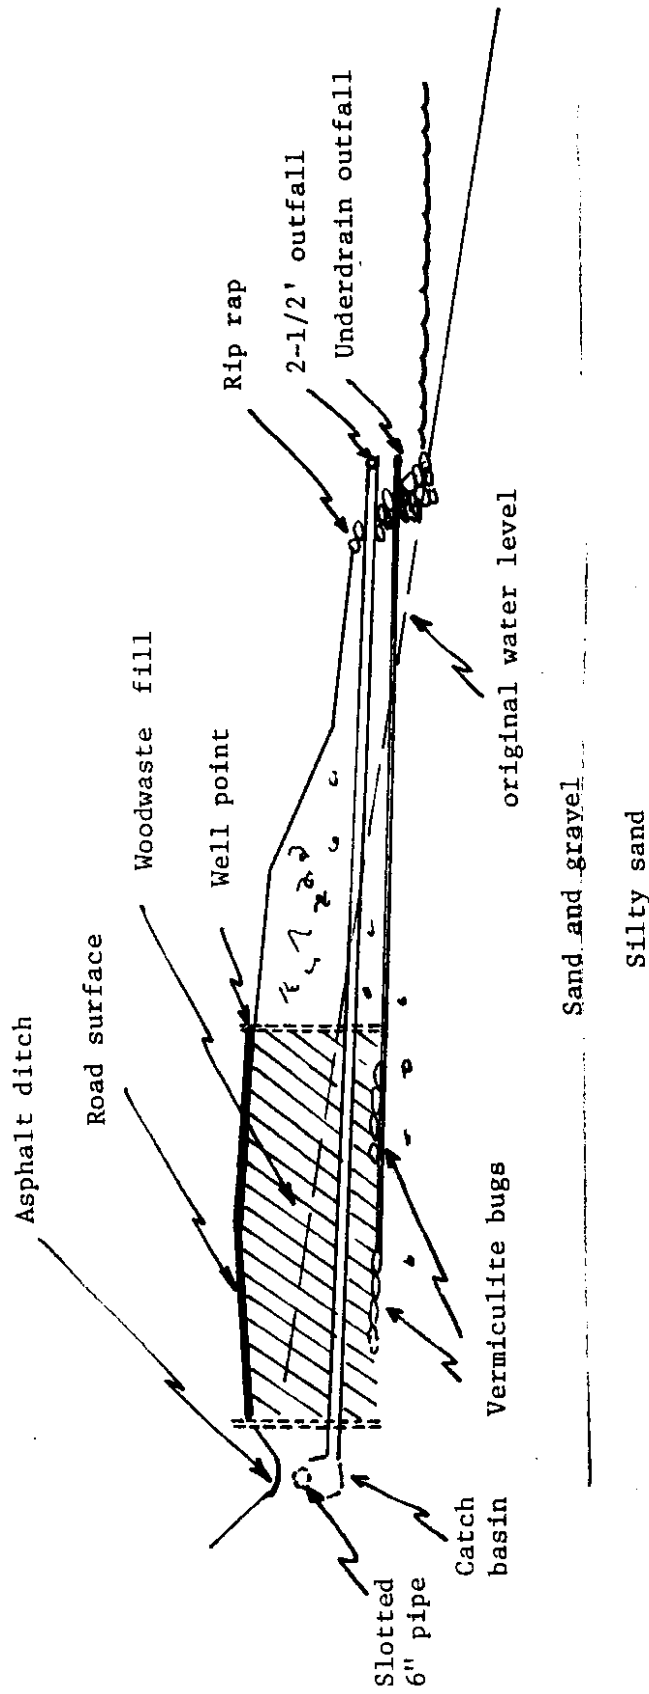
Figure 2. Schematic of woodwaste embankment site.

The fill was installed to replace native material subject to periodic slides due to high groundwater and poor soil characteristics. Figure 2 illustrates the hydrology and soil characteristics and a cross-section of the fill. In some sections, portions of asphalt overlays were found during excavation to exceed 3.0 m (10 ft.) in thickness. Construction of the site was initiated in December, 1978, and took approximately one month to complete. An underdrain system of small, perforated pipes encased in polyurethane foam bags filled with vermiculite is installed at the base of the fill. The perforated pipe is then connected to a 7.6 cm (3 inch) carrier pipe, which ultimately discharges collected leachate through an outfall onto the rocky

beach adjacent to the fill. Samples of leachate from the underdrain system are obtained by collecting them from the end of the outfall located on the adjacent beach face. A 15.2 cm (6 inch) diameter slotted PVC pipe located on the east side of the fill collected some leachate as well. Surface water runoff from a paved ditch was mixed with the leachate and discharged through a 0.76 m (2.5 ft.) corrugated metal pipe out onto the beach face just above the 7.6 cm outfall.

Groundwater levels in the immediate vicinity of the fill were monitored using monitoring wells made of PVC pipe driven vertically to depths below the base of the fill.

During the final stages of construction at the site, a gas-sampling device was installed in the side slope to monitor gases within the fill. The device consists of a 2.22 cm. (7/8 inch) I.D. x 1.8 m. (6 ft.) long iron pipe perforated with holes. A beveled steel point was attached to the casing to serve as a cutting edge when inserted in the fill. A silver solder seal was fused between 0.95 cm. (3/8 inch) copper tubing and the other end of the pipe. The copper tubing was attached to a gas-tight brass valve.

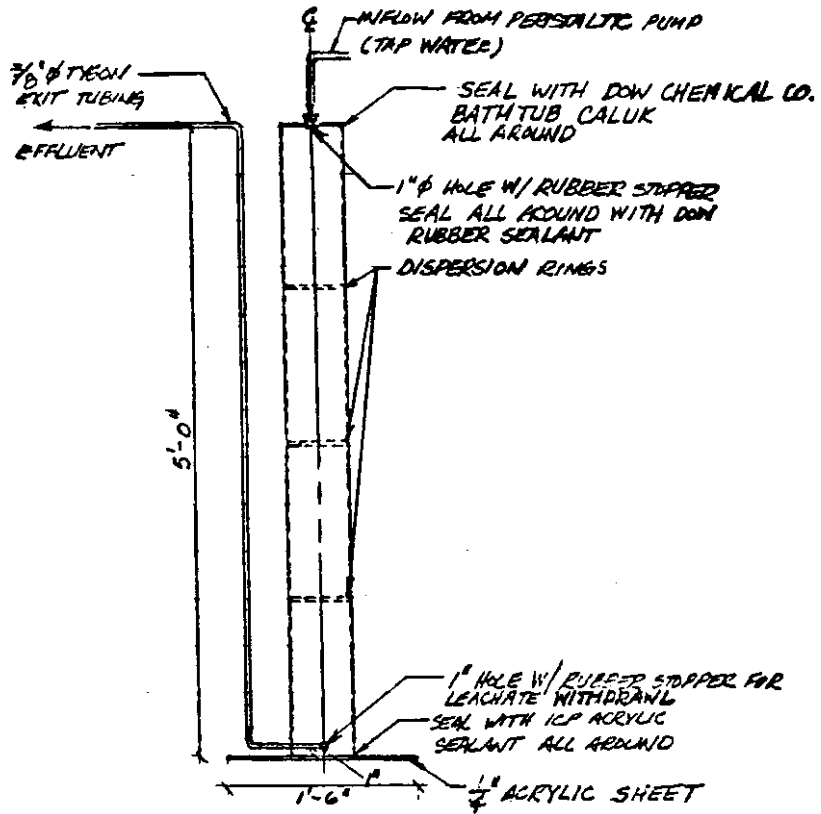
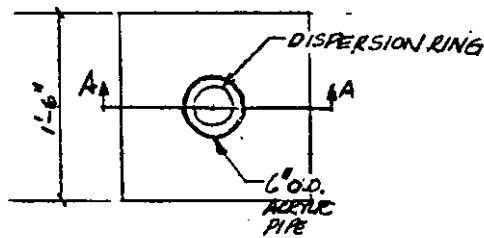
Figure 3. Schematic of Laboratory column.

Laboratory columns were cylindrical acrylic, 1.52 m. (5 ft.) tall and 15.2 cm. (6 in.) in diameter (Figure 3). Influent and effluent ports were installed on the top and base of the columns, respectively. Attached to the effluent part was 0.95 cm. (3/8 in.) diameter Tygon tubing. The ends of the tubing were elevated to maintain complete submergence of the column. Inside the columns, three dispersion rings were placed in each column at approximately equal spacing to prevent short-circuiting of flow.

Continuous feed of tap water to five columns was accomplished using peristaltic pumps. Two, 37.81 (10 gal.) tanks served as reservoirs from which tap water was pumped to the columns. Due to mechanical failures with some of the pumps, several pumps were utilized during the study.

Packing of the columns was done by hand using a hand-held "tamper" to simulate compaction in the field by construction equipment. After packing, each column was sealed and the contents submerged. Column F, which simulated partially submerged conditions, was allowed to drain and the volume of leachate collected. The remaining five columns were allowed to sit for a period of less than 24 hours, after which water application was initiated on January 23, 1979.

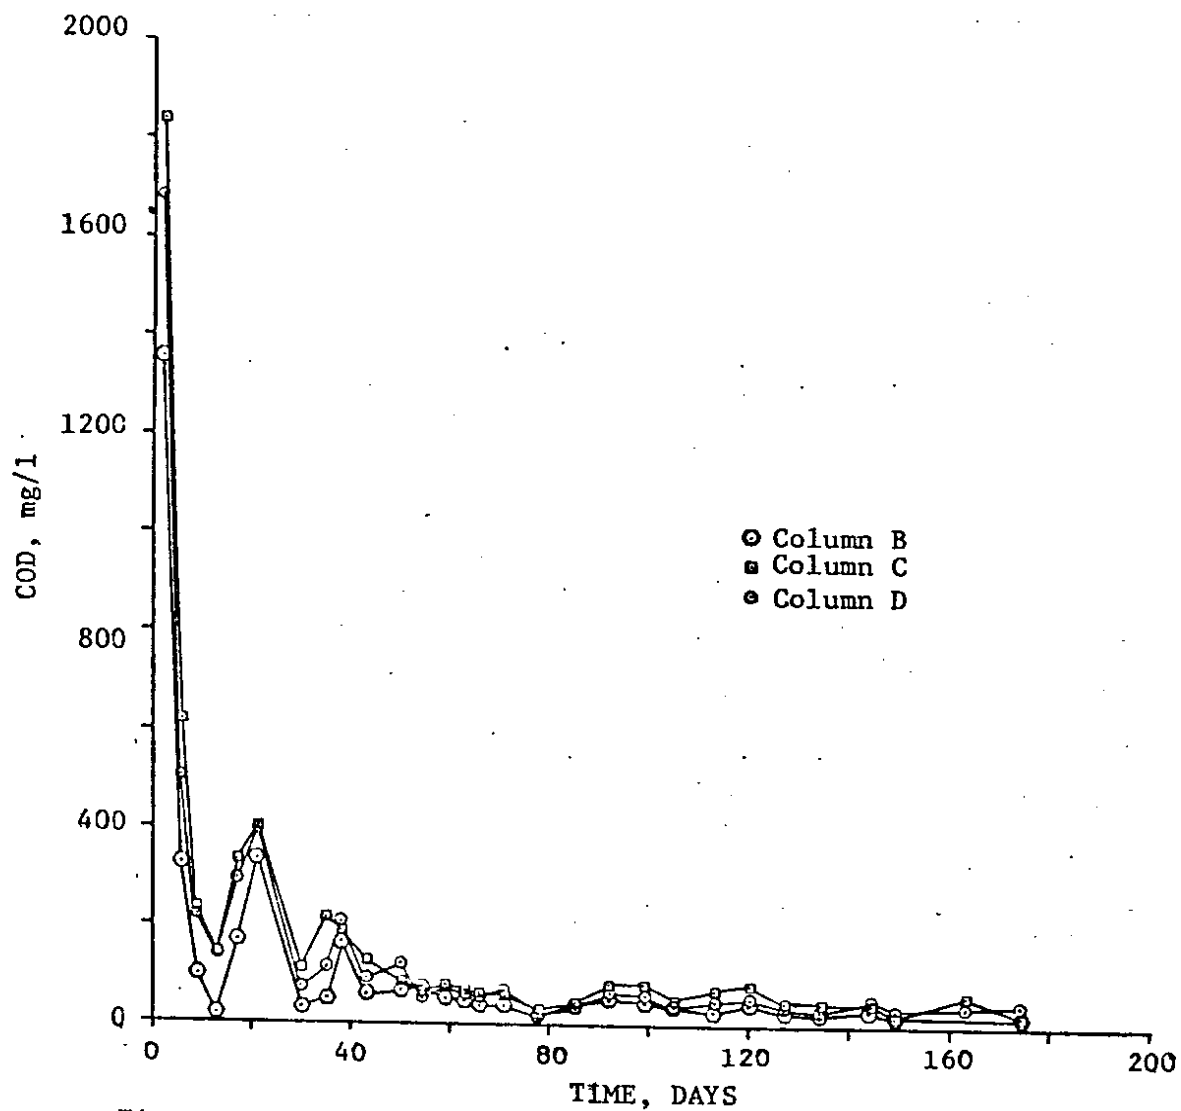
Figure 5. COD concentration vs. time- Columns B,C and D

be attributed in part to contamination during sample collection. Organic pollutant emissions were measured over time using the parameters COD, BOD<sub>5</sub>, and TOC. Figures 4 and 5 illustrate COD concentrations vs. time for laboratory column and SR 302 outfall effluents. The organic strength of the outfall effluent had decreased by an additional 75% by September, 1980 to values of 38 µg/l COD and 13 µg/l TOC.

The data show a rapid leaching of COD in columns leached at high hydraulic loadings, while lower hydraulic loadings result in extended periods during which COD concentrations are high. Peak COD concentrations vary from a low of 1340 mg/l for SR 302 outfall effluent to a high of 2970 mg/l for Column F dosed intermittently to simulate rainfall infiltration.

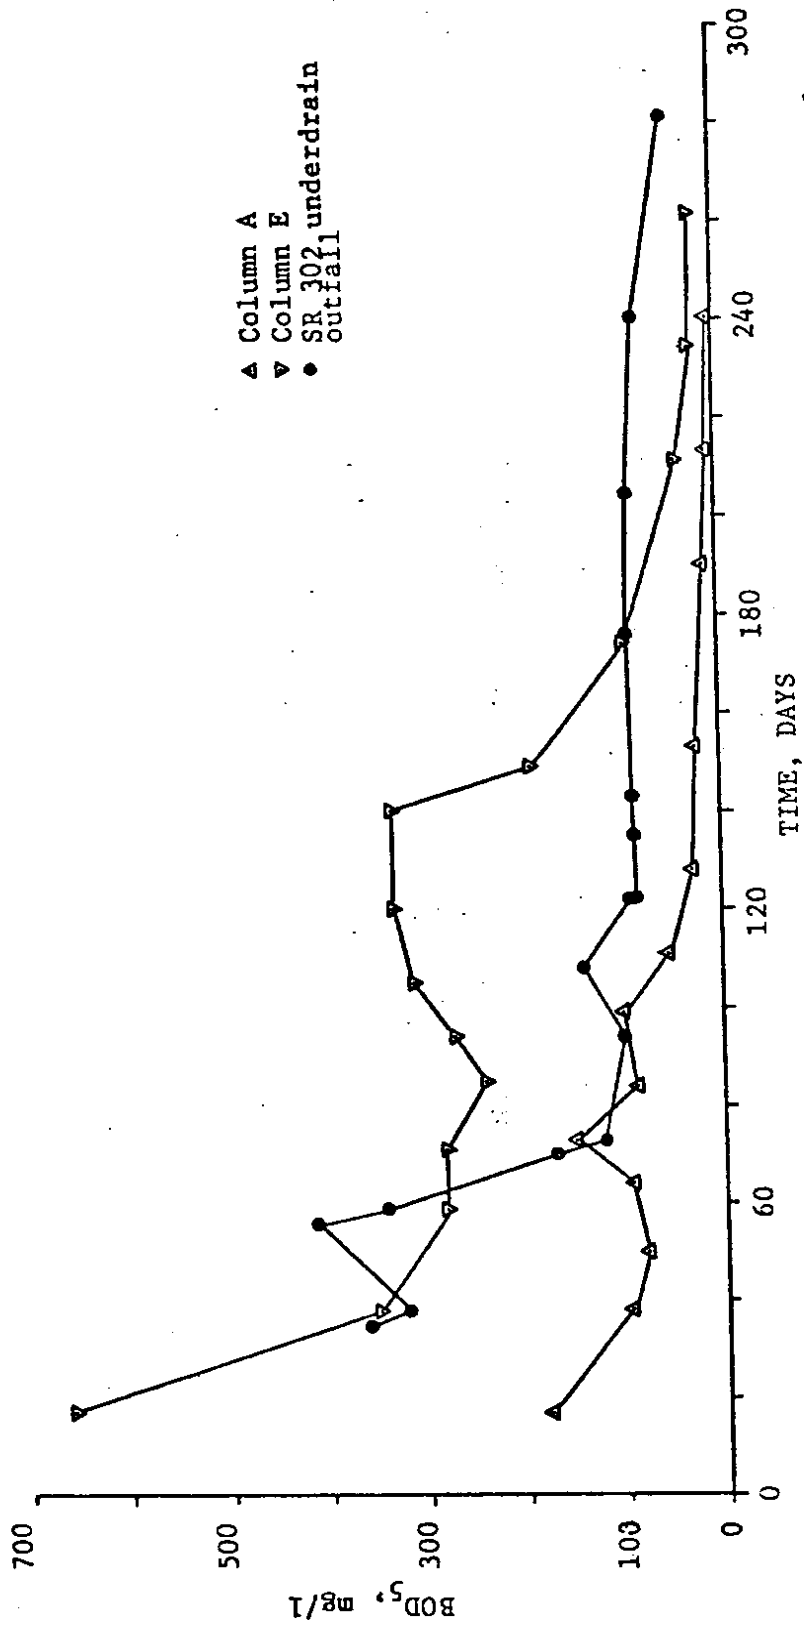
Figure 6. BOD<sub>5</sub> concentration vs. time- Columns A,E and SR 302 underdrain outfall samples

Periodic BOD<sub>5</sub> tests were run on selected samples of laboratory and field leachate samples. Results are presented in Figure 6.
