Bridge No. 12/915

Snake River Bridge Thin Overlay

WA-RD 101.1

Post-Construction Report
April 1987

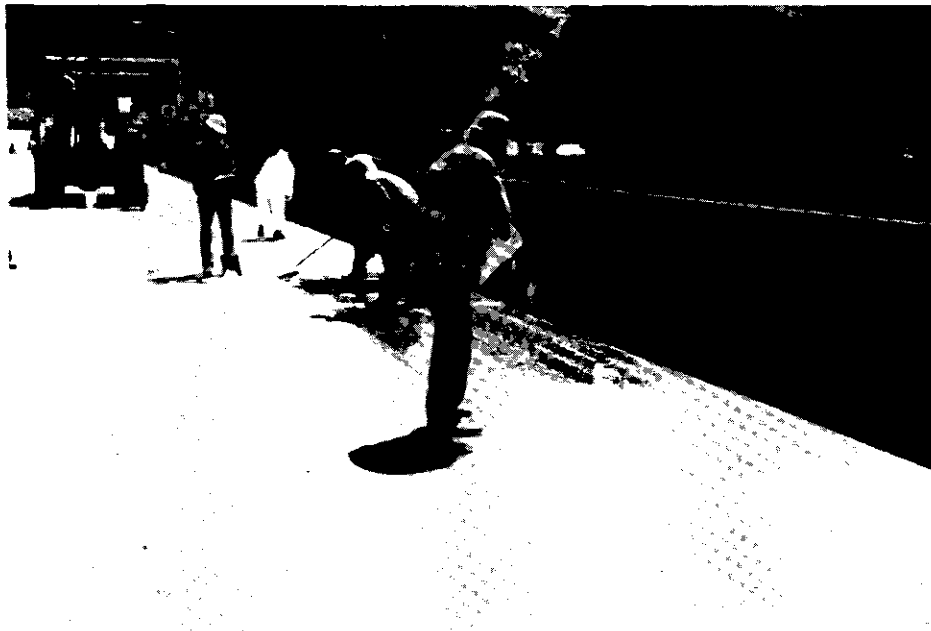
Stage 1 Epoxy Spreading and Aggregate Spreading by Hand

- Laborers filled five gallon buckets with the aggregate and then broadcast the aggregate by hand - similar to "feeding chickens."
- E. Removed excess aggregate from first lift of epoxy surface by sweeping.
