| 4. TITLE AND SUBTITLE<br>EVALUATION OF DELINEATION SYSTEMS FOR<br>TEMPORARY TRAFFIC BARRIERS | | | 5. REPORT DATE<br>May 1987 | | |
| 9. PERFORMING ORGANIZATION NAME AND ADDRESS<br>Washington State Transportation Center<br>135 More Hall, FX-10<br>University of Washington<br>Seattle, WA 98195 | | | 10. WORK UNIT NO. | | |

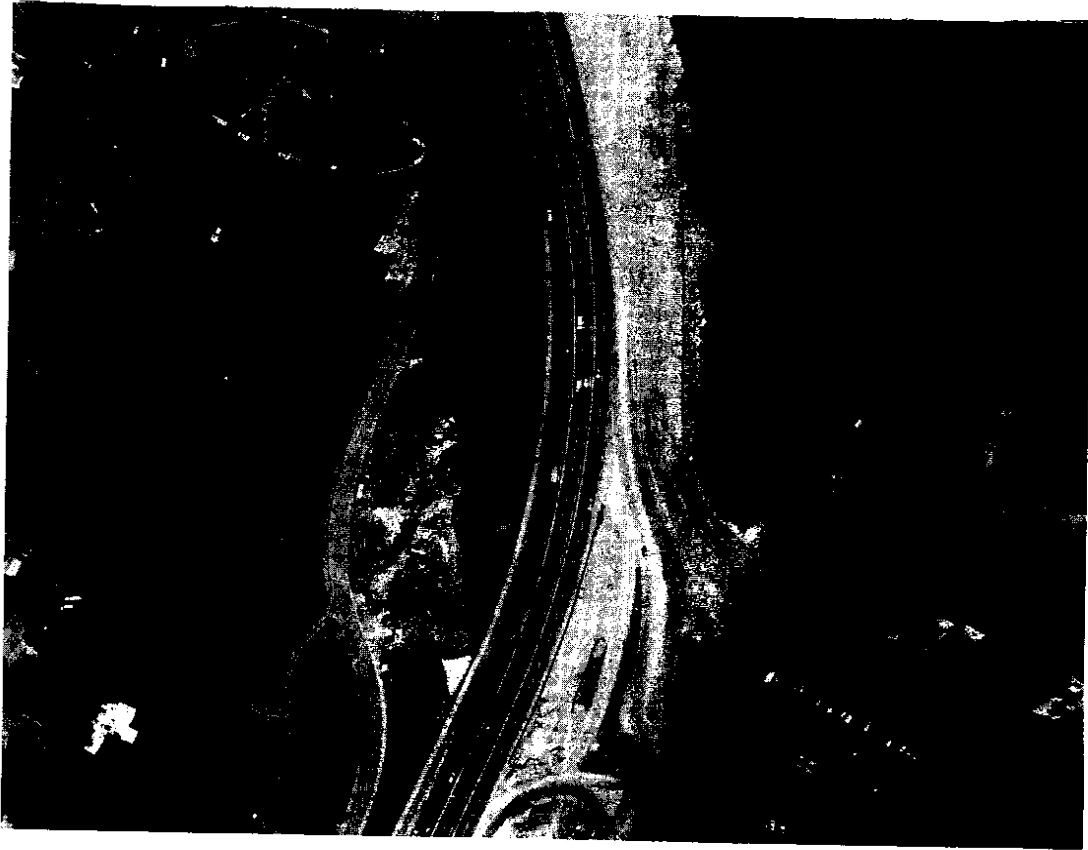
Figure 4-2. Location #1

Curve Data

| Full Super-elevation | 4% |
| Length of Location | 1,000 ft. |

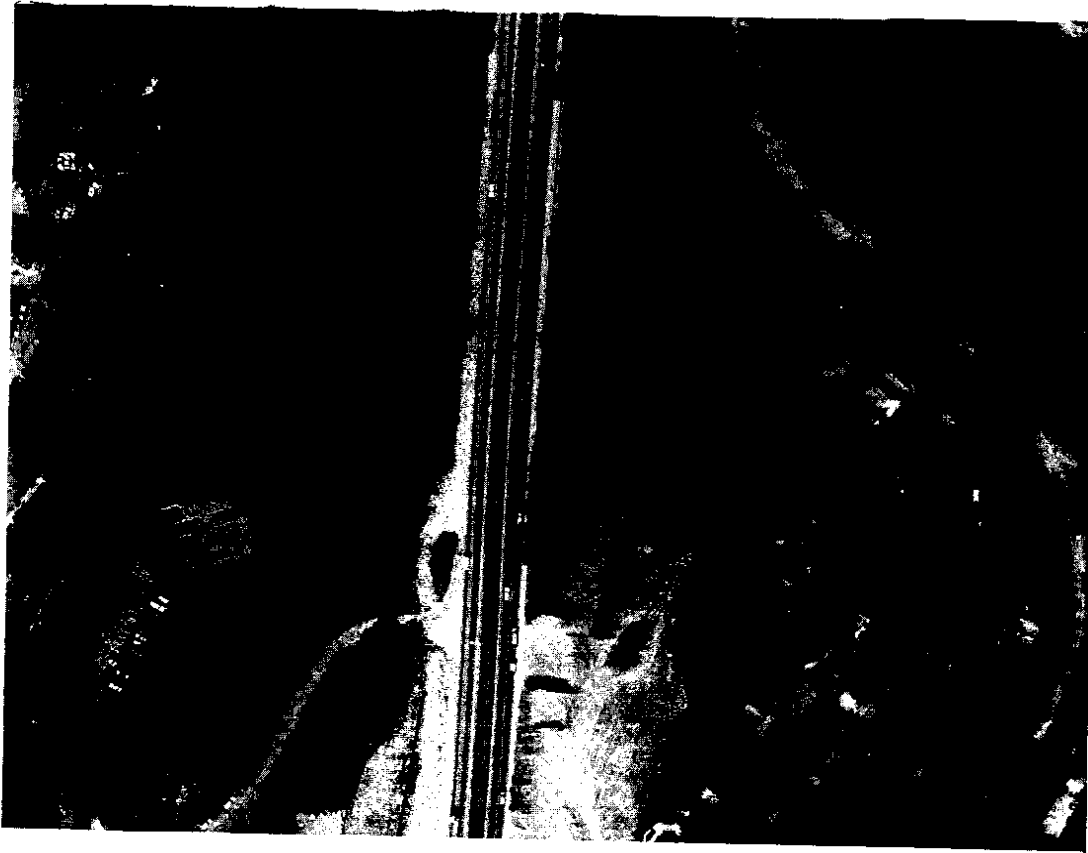
Figure 4-3. Location #2

Curve Data

| Normal Pavement Crown | ±2.00% |
| Length of Location | 1,000 ft. |

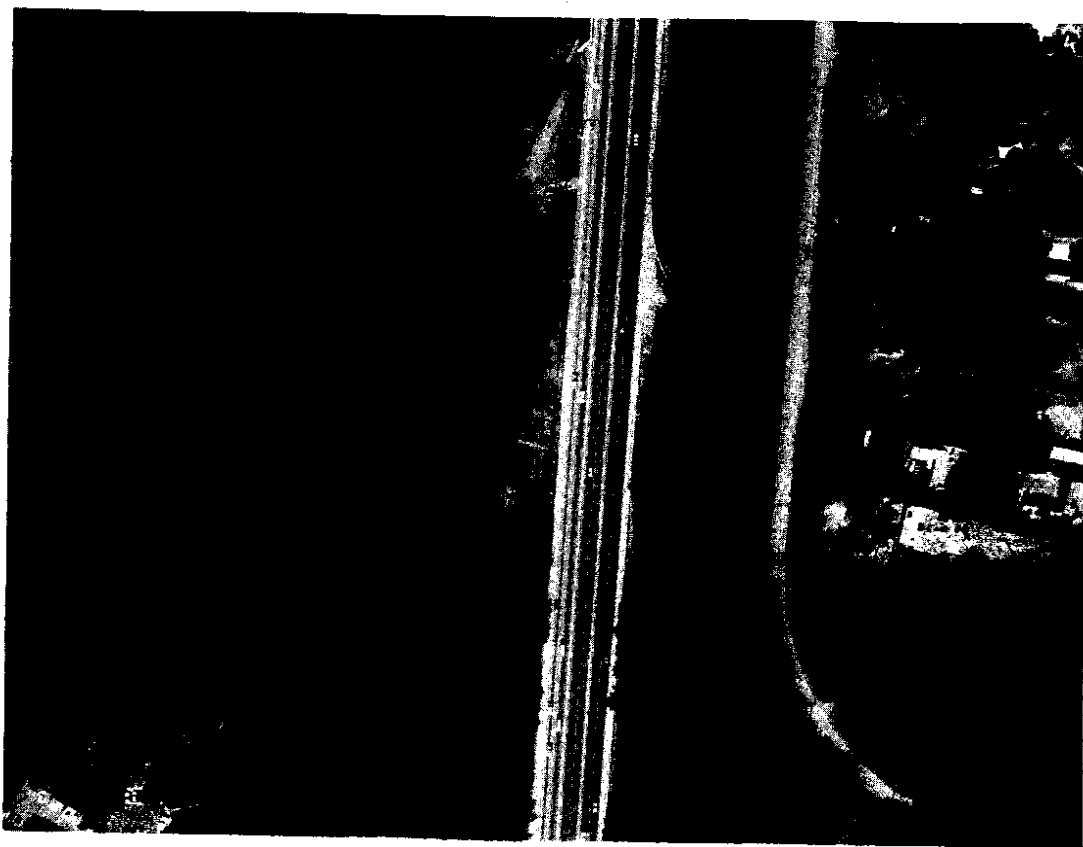
Figure 4-4. Location #3

Curve Data

| Normal Pavement Crown | $\pm 2.00\%$ |
| Length of Location | 1,000 ft. |
