# **Stress Wave Inspection of Bridge Timbers and Decking**

WA-RD 146.1

Final Report  
July 1987

**Washington State Department of Transportation**

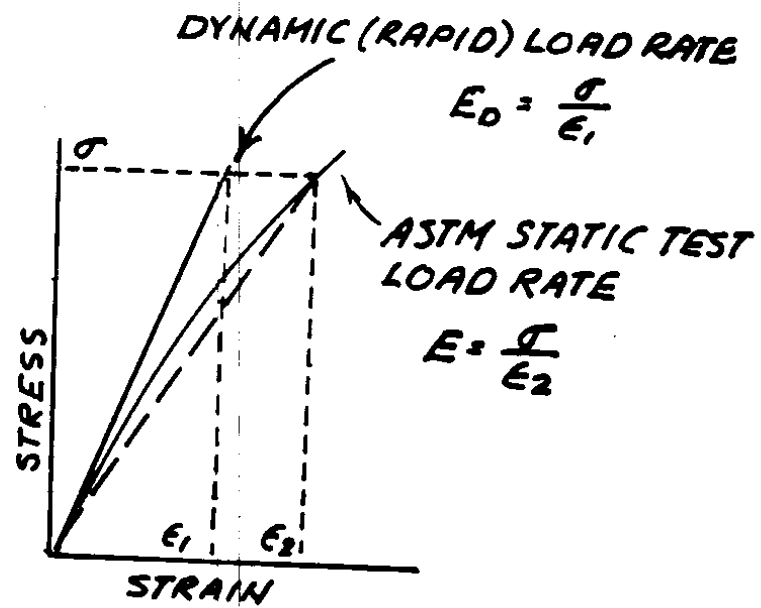
Figure 1. Static and Dynamic Elastic Modulus

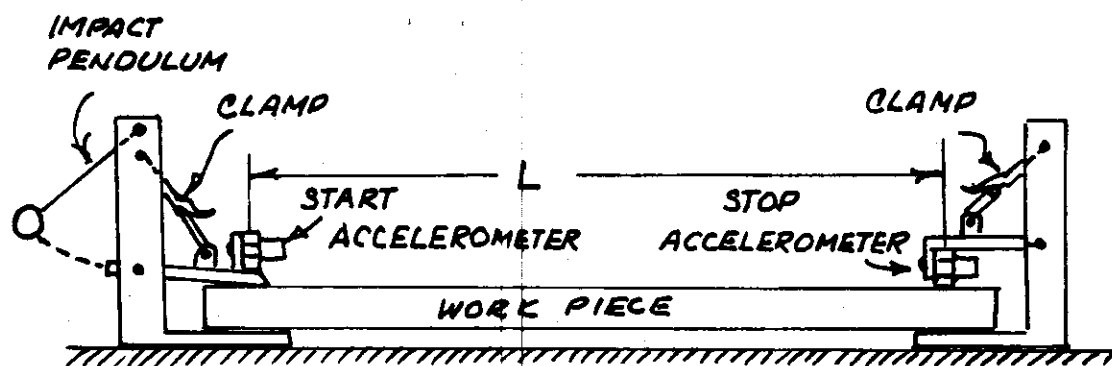
Figure 2. Laboratory Testing Arrangement

The method employs two accelerometers, one to start the timer and the other to stop it. The accelerometers may be placed on the material at a measured spacing, L, to obtain the wave transit time between them. This is shown in Figure 2. This accelerometer arrangement is employed with the Metriguard 239A Stress Wave Timer and is useful in laboratory work, or for industrial applications for measuring stress wave velocity in pieces of discrete length or width. It is not the preferred method for field inspection of highway structures. Instead, an impact tool or hammer with a START accelerometer built into the hammer head has proven more convenient, combining the function of the pendulum in Figure 2 and the START accelerometer. The

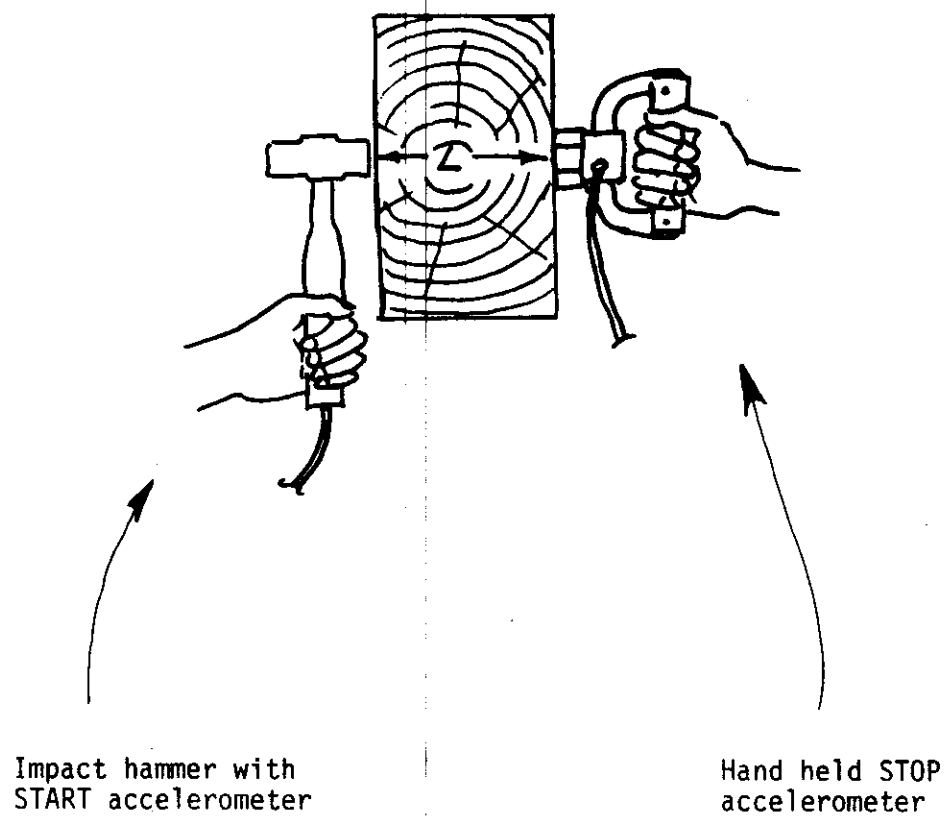
Figure 3. Field Inspection Tools

STOP accelerometer may be clamped to the member or hand held using a grip as shown in Figure 3. The accelerometer must be aligned in the direction of the wave path and has a front end which must face the source of the wave.

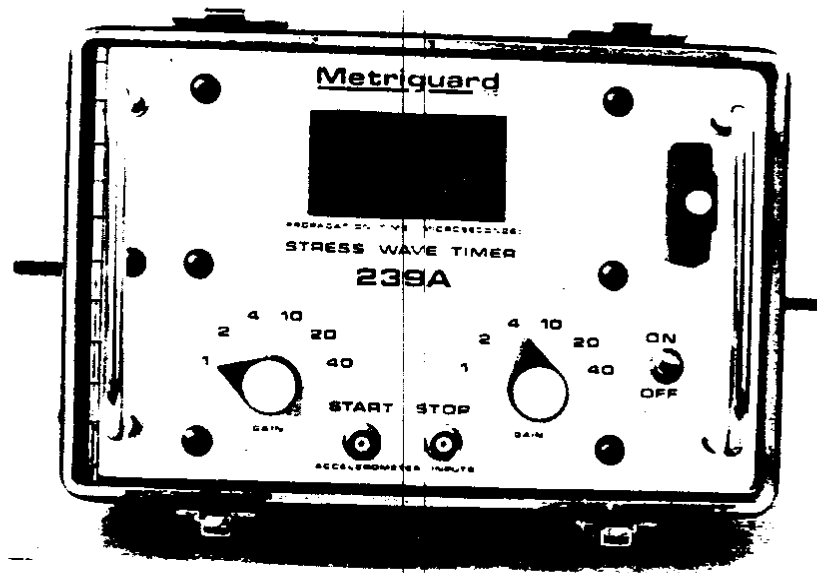
Figure 4. Stress Wave Timer

Another instrument which is often used for stress wave measurement is the James V-Meter. It employs two accelerometers as does the timer shown in Figure 4, but they are somewhat larger. Instead of a pendulum or hammer impactor, the James equipment has a piezoelectric crystal built into one of the accelerometer cases. This crystal can be electrically actuated to cause an impulse and actuate the START accelerometer. These accelerometers are applied to the wood on their broad flat faces. In the form in which they are currently available, they are difficult to align with the stress wave. The broad flat face may not couple well to wood surfaces unless a grease is used to improve the contact. But with some attention to these design problems the equipment should be able to serve the purpose well. Some good research has been reported using the James V-Meter.

The stress wave timer used in this work is the Metriguard 239A Stress Wave Timer. It is shown in Figure 4. It weighs about five pounds and is powered by one 9 volt battery. It displays the time in microseconds (millionths of a second) between actuations of the "start" and "stop" accelerometers, which are connected to it by cables. To check the functioning of the accelerometers, the display includes two black dots which appear when an accelerometer triggers the timer. One dot is for each accelerometer. Should either of these fail to appear on the display the accelerometer or its cable are not functioning correctly. A light tap on the front end of an accelerometer will actuate it for purposes of circuit checking.

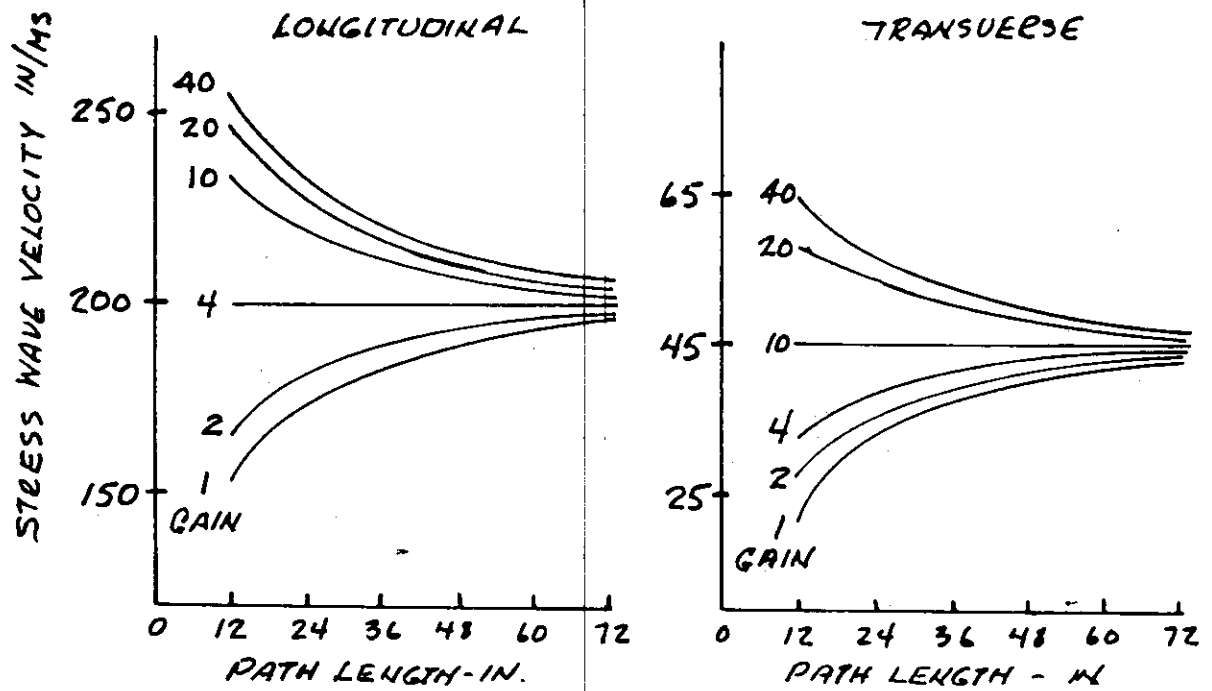
Figure 5. Effect of Gain Setting and Path Length on Stress Wave Velocity

The effect of the GAIN setting is shown in Figure 5 which is based on studies made as a part of this project. For short travel paths the measured stress wave velocity appears to differ from that for longer paths in the same material, unless the STOP accelerometer gain was set at some optimum level. In most inspection work the path length has been less than 20 inches so a very substantial error can occur with improper gain setting. The reason for this has been explained by Metriguard engineers, who had encountered the same phenomenon in other applications.

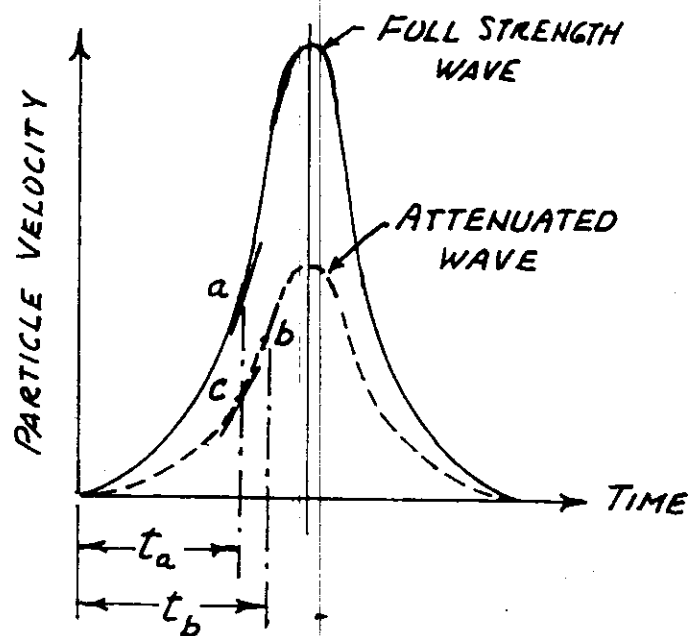
Figure 6. Particle Velocity vs. Time for Full Strength and Attenuated Wave

Figure 6 shows particle velocity versus time after the disturbance begins. The solid curve is for a point near the impacted end where the disturbance is strong. The dashed curve is for a point farther along the wave path where the disturbance is weaker. In this figure it has been attenuated 50%.

At "a" and "b" the slopes of the curves are equal, but "a" occurs at time " $t_a$ " after the wave reaches the START accelerometer and "b" occurs at time " $t_b$ " after the wave reaches the STOP accelerometer position.

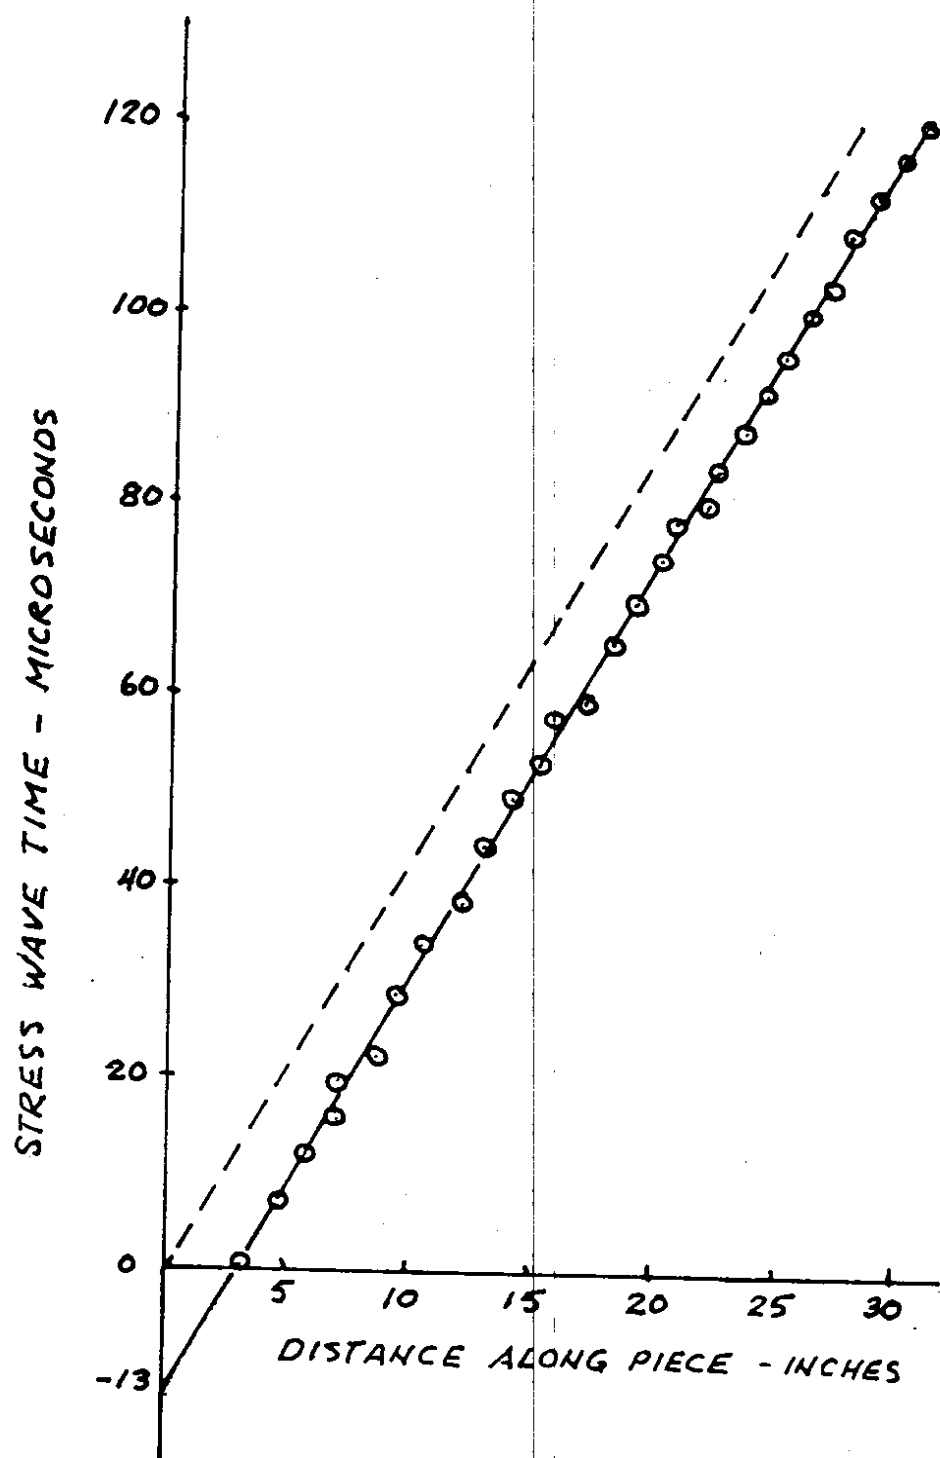
Figure 7. Zero Offset

The timer gain can be calibrated by measuring the time for successively greater path lengths and plotting them as in the example, Figure 7. A gain setting that produces a line passing through the origin is the correct one. If the choice of available gain settings does not give a curve that passes through the origin then a time correction can be made by subtracting the amount of the y-intercept from the observed readings. In the case of the lower curve this would be minus -13, or add 13.

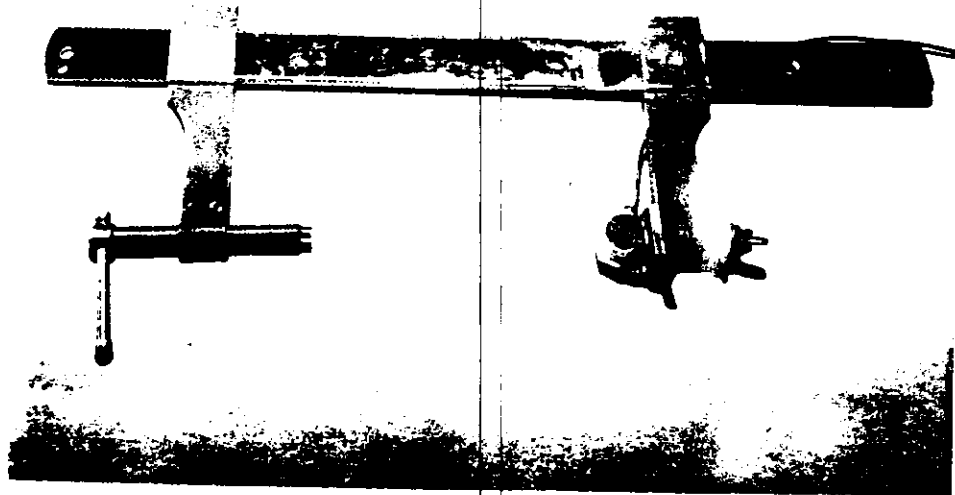
Figure 11. Stop Accelerometer with Adjustable Clamp

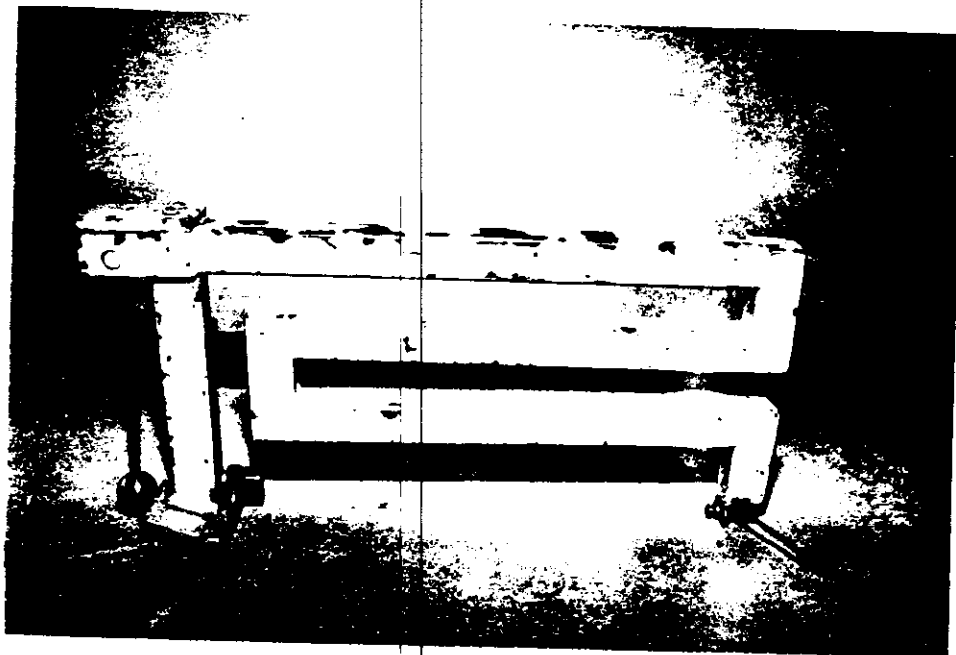
Figure 12. Serpentine Accelerometer Frame

Table 1 gives a steel stress wave velocity of 196 in/ms. Velocity parallel-to-grain in undecayed wood is almost the same. In decayed wood it is about 66 in/ms. So, the serpentine path through the steel should be about three or four times that through the wood, if the tool is to measure the

velocity in decayed wood. As shown in Figure 12 the path length in the steel is adequate.

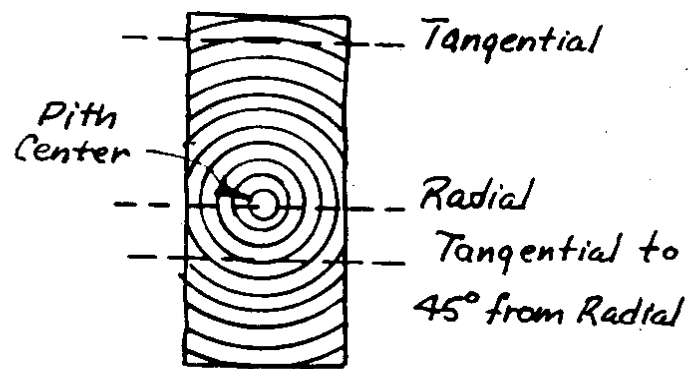
Figure 13. Transverse Stress Wave Paths Through a Rectangular Member

Figure 13 shows possible paths in a pith center (boxed-heart) timber. It may be difficult to know what velocity to expect for paths that do not pass through a pith center, or are not clearly tangent to the annual rings.

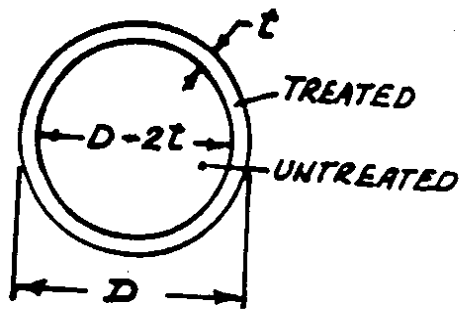
Figure 14. Case I: Velocity and Time for a Treated Wood Pole Without Decay

Referring to Figure 14, the stress wave path is radial. The velocity in the treated part is about 35 in/ms and 53 in/ms in the untreated part. By

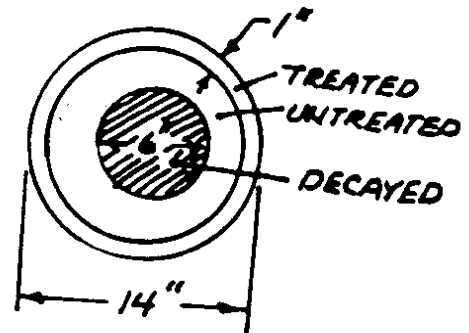
Figure 15. Case II: Velocity and Time for a Treated Wood Pole With Moderate Decay

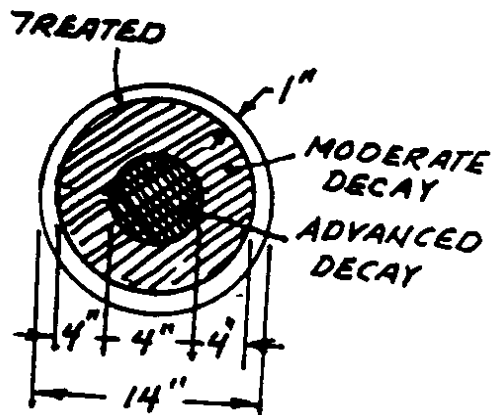
Figure 16. Case III: Velocity and Time for a Treated Wood Pole With Advanced Decay

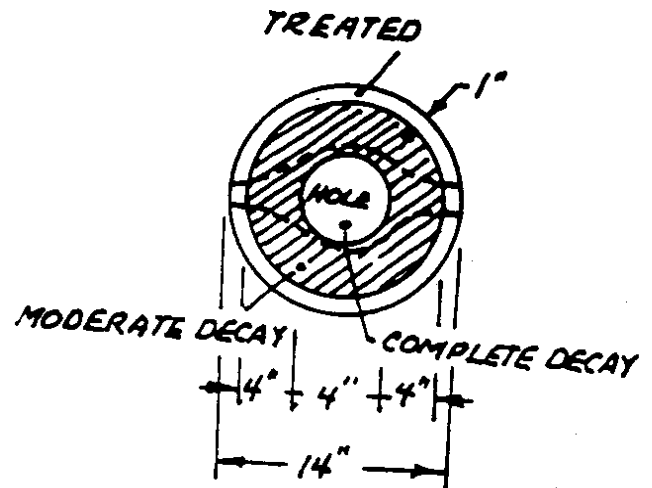
Figure 17. Case IV: Velocity and Time for a Treated Wood Pole With a Decayed Void in the Core

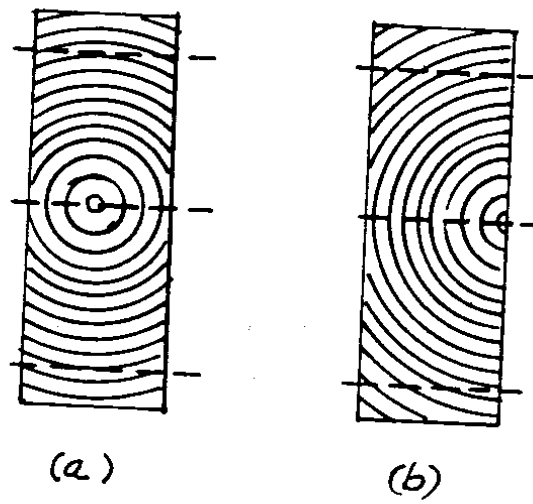
Figure 18. Transverse Stress Wave Paths and Annual Ring Orientation in a Rectangular Member

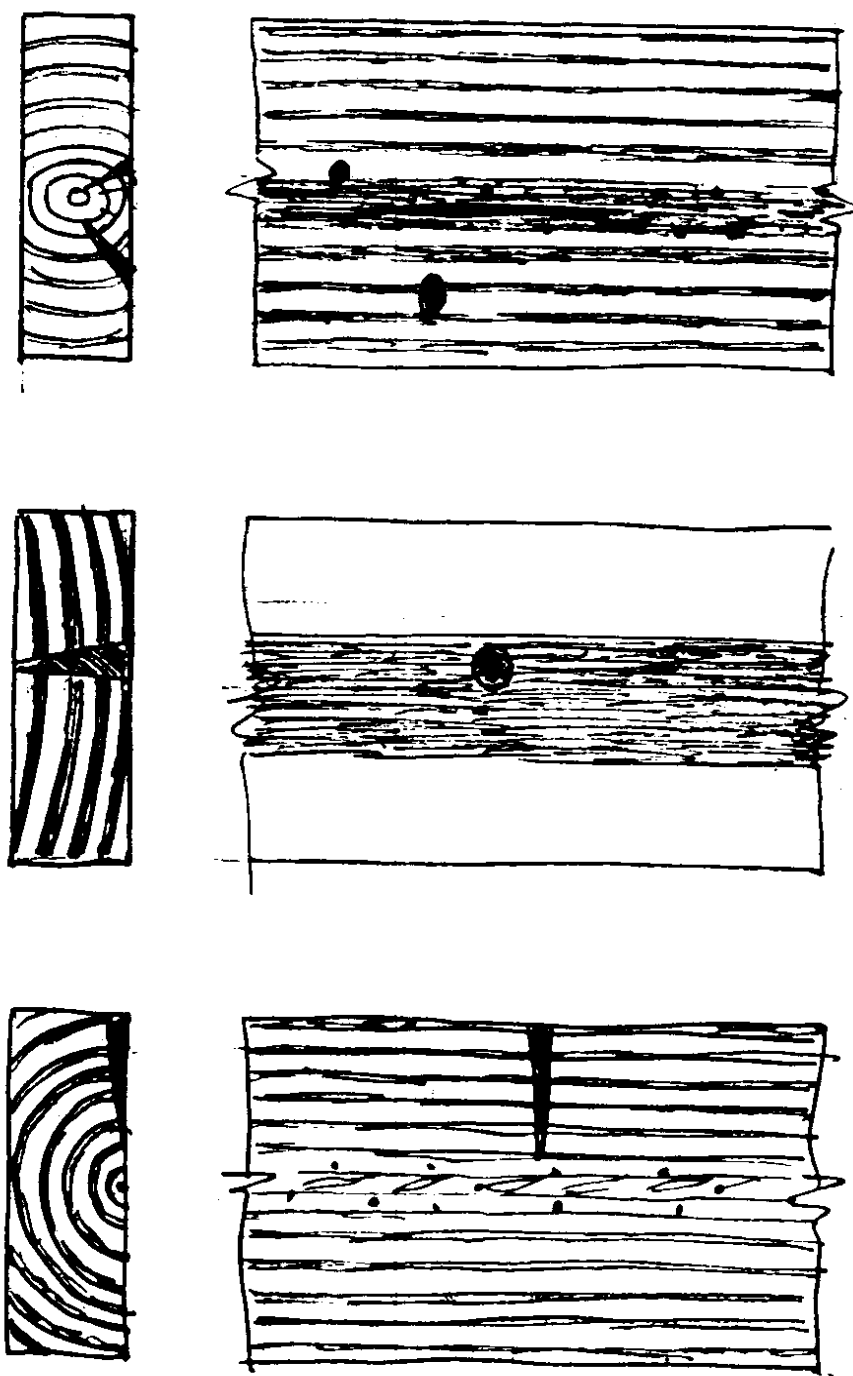
Figure 19. Appearance of Figure as an Aid to Inferring Ring Orientation

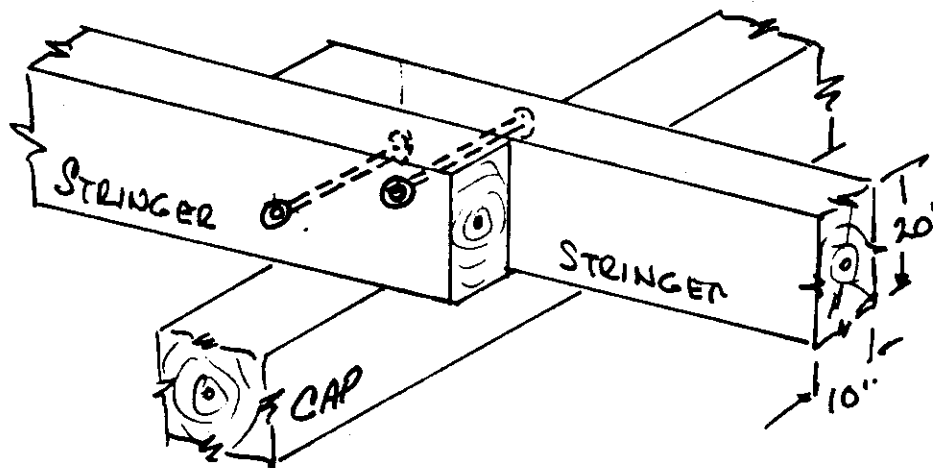
Figure 20. Bolted Lap Joint Between Two Stringers

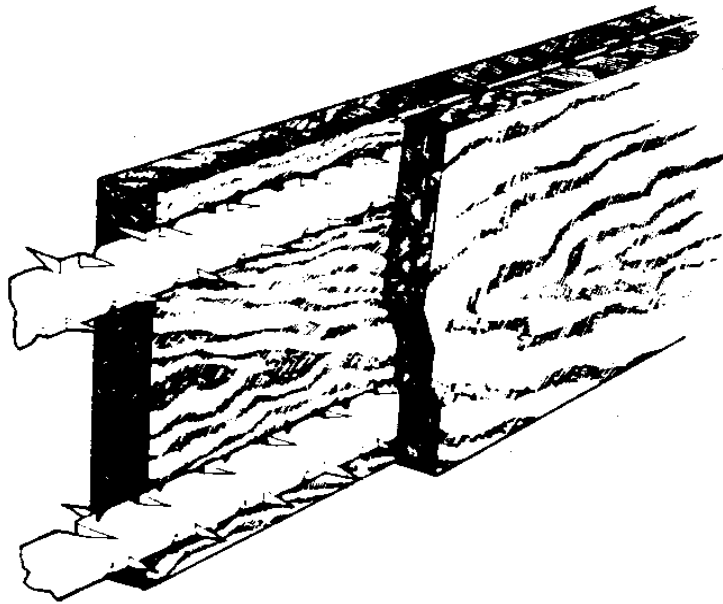
Figure 21. Steel Reinforced Wood Beam

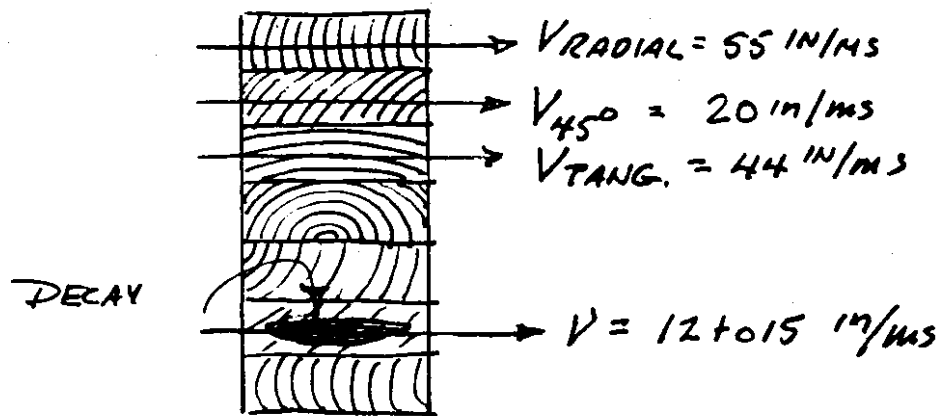
Figure 22. Transverse Stress Wave Velocities in a Glulam Beam

In glulam beams, fungi may have difficulty penetrating glue lines, and the susceptibility of adjacent lamina to decay, may differ. Sometimes decay is confined to particular lamina, but not always. Our experience has been that decay may occur in one lamina without affecting the stress wave velocity in the adjacent lamina.

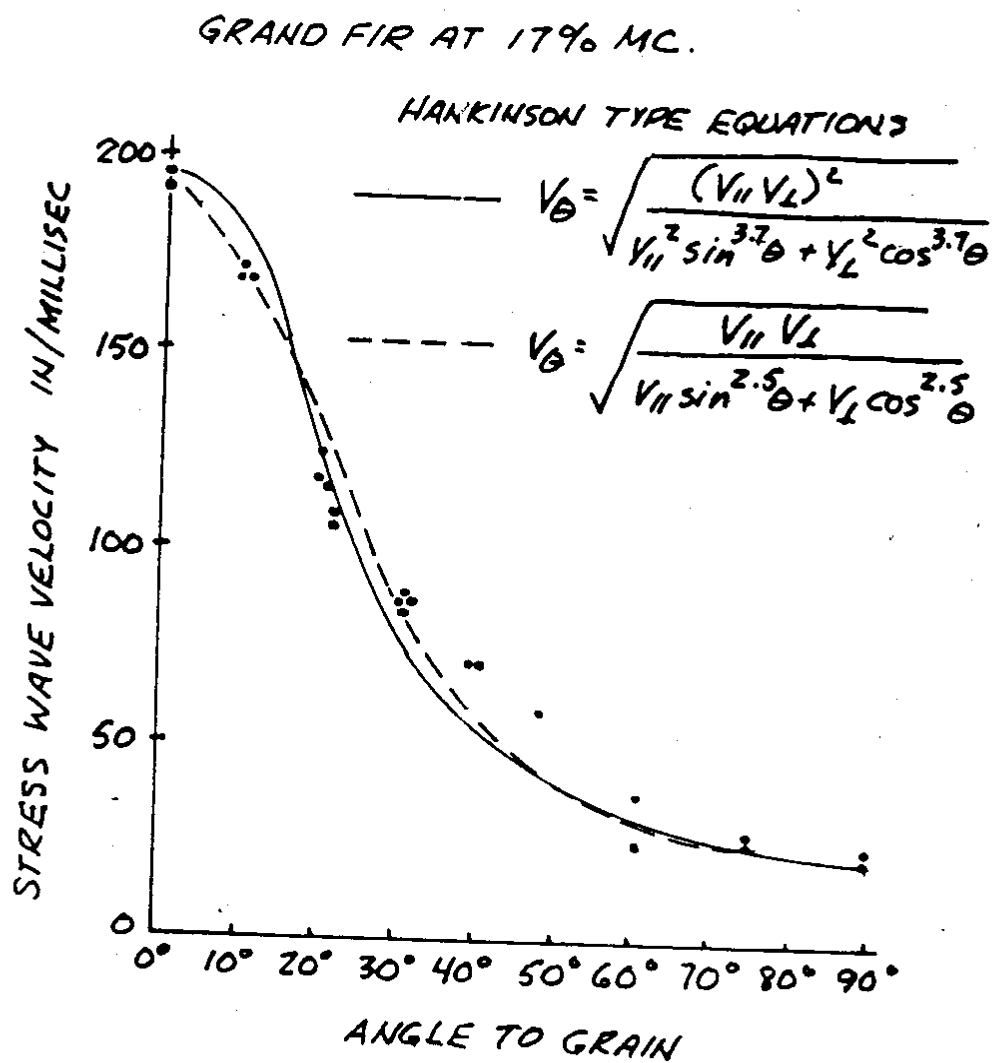
Figure B1. Stress Wave Velocity vs. Angle to Grain of Stress Wave Path in Grand Fir (17% Moisture Content)

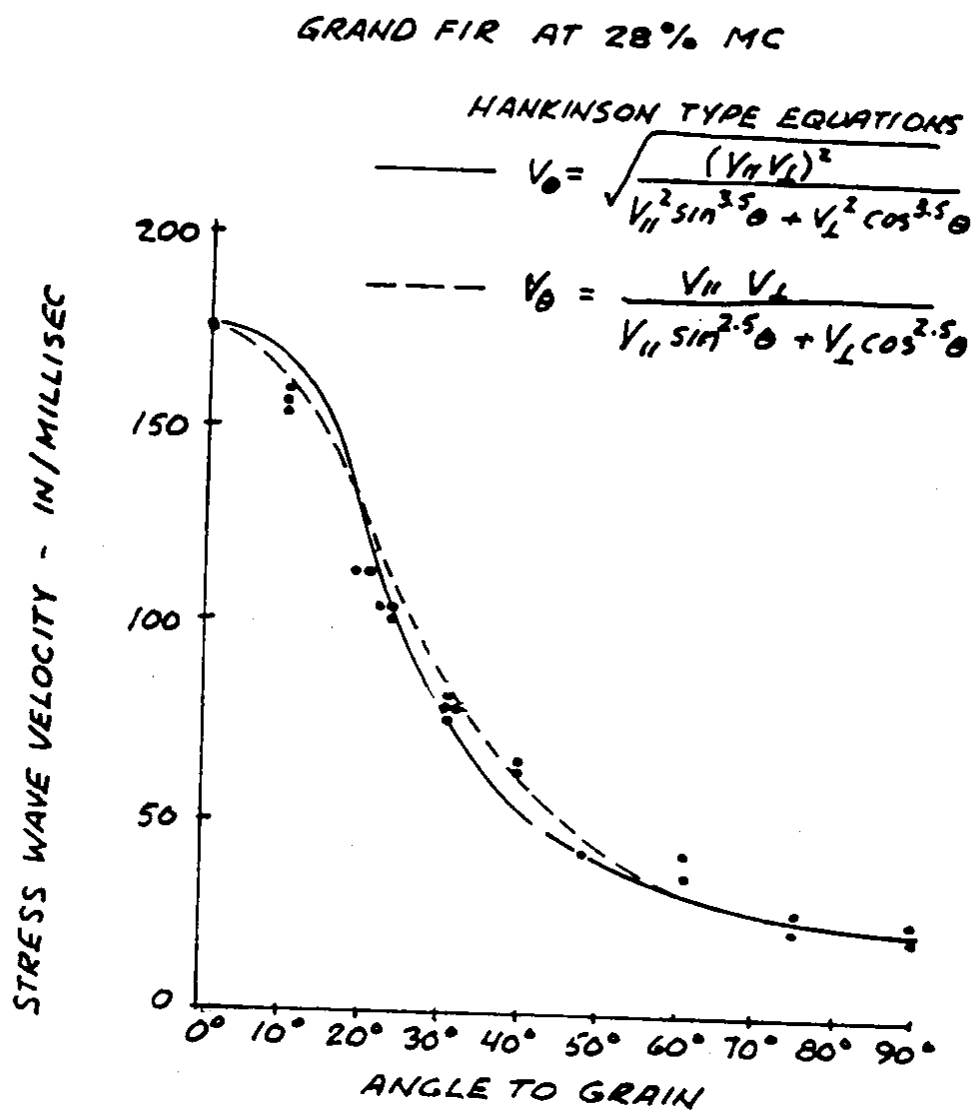
Figure B2. Stress Wave Velocity vs. Angle to Grain of Stress Wave Path in Grand Fir (28% Moisture Content)

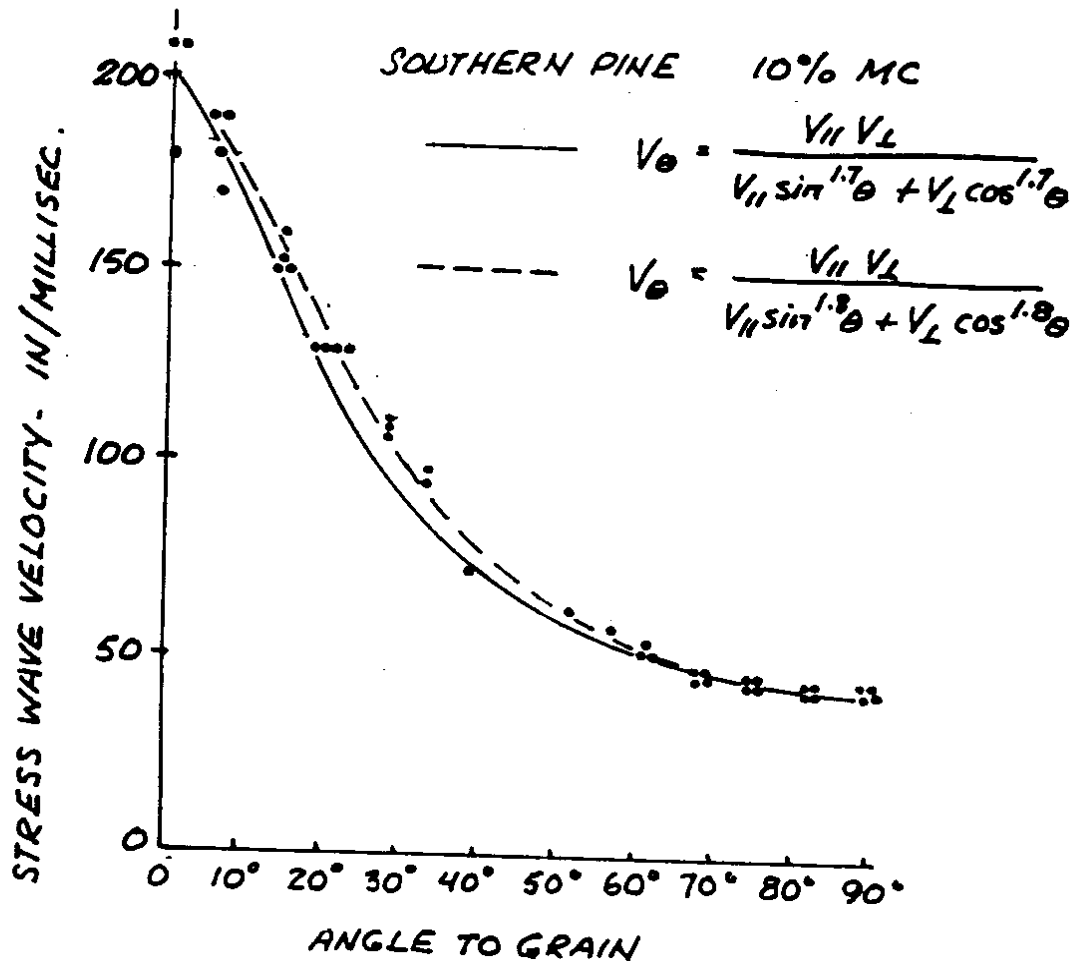
Figure B3. Stress Wave Velocity vs. Angle to Grain of Stress Wave Path in Southern Pine (10% Moisture Content)

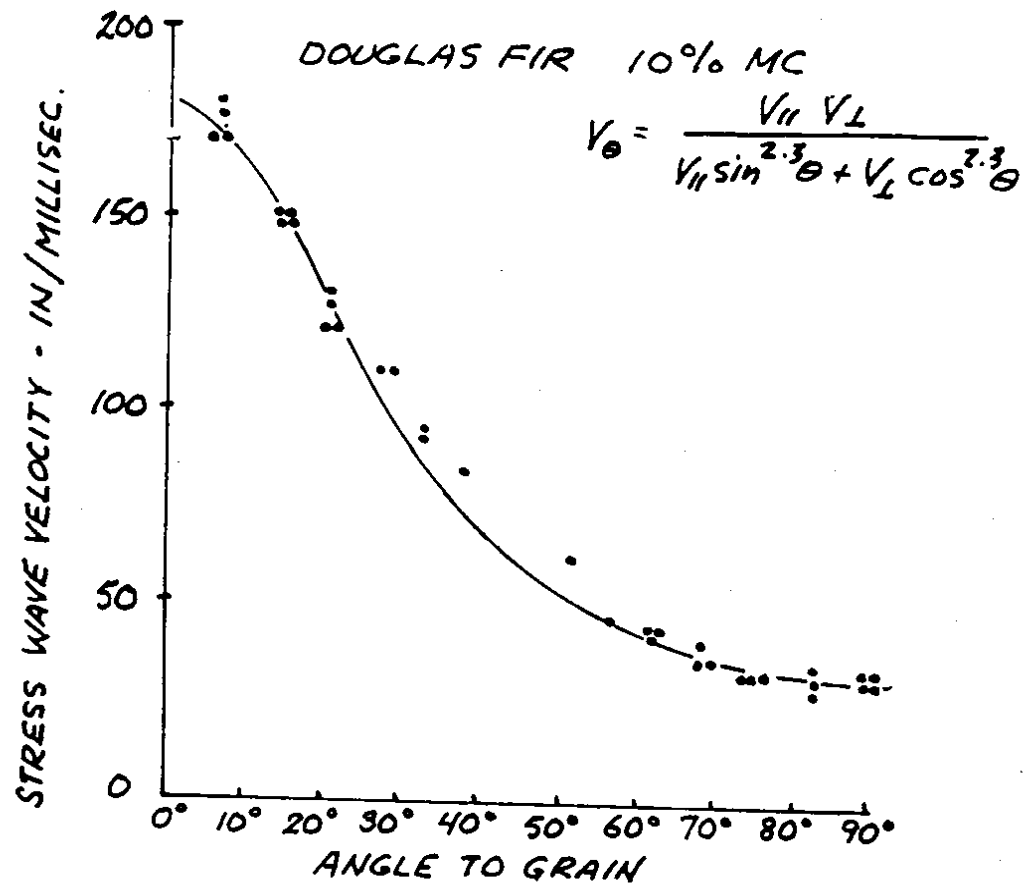
Figure B4. Stress Wave Velocity vs. Angle to Grain of Stress Wave Path in Douglas-fir (10% Moisture Content)

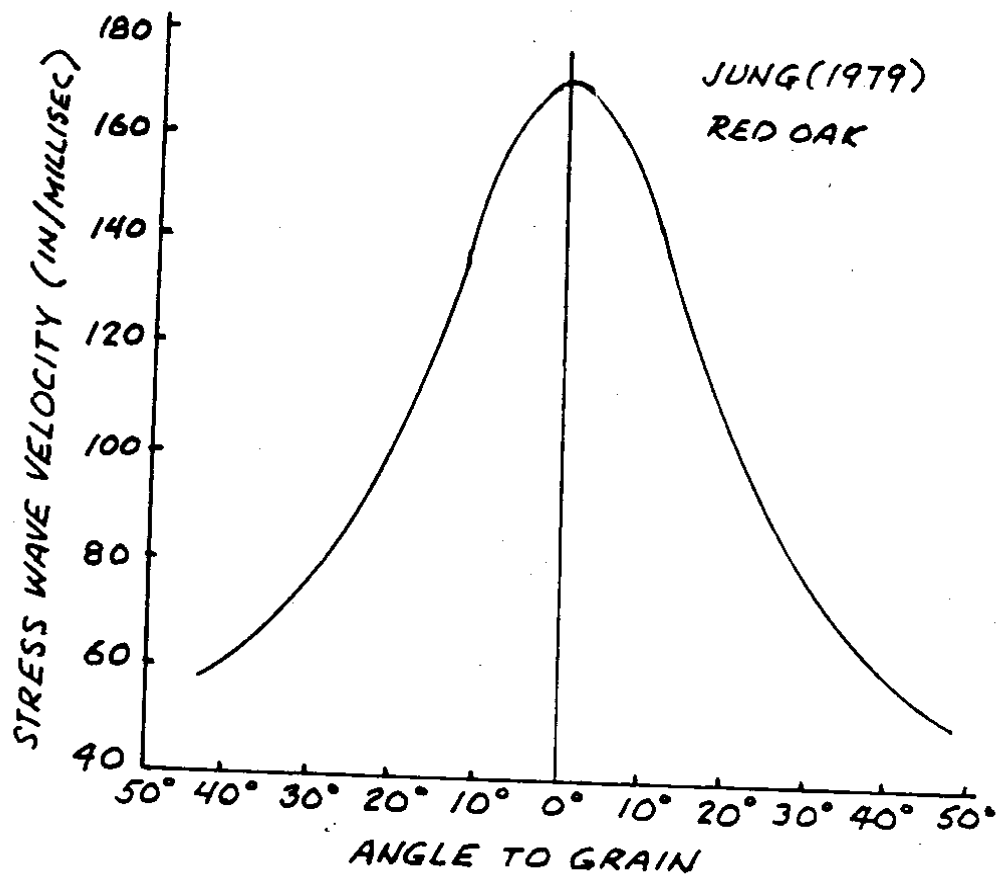
Figure B5. Stress Wave Velocity vs. Angle to Grain in 1/4-inch Thick Red Oak Veneer (Jung)

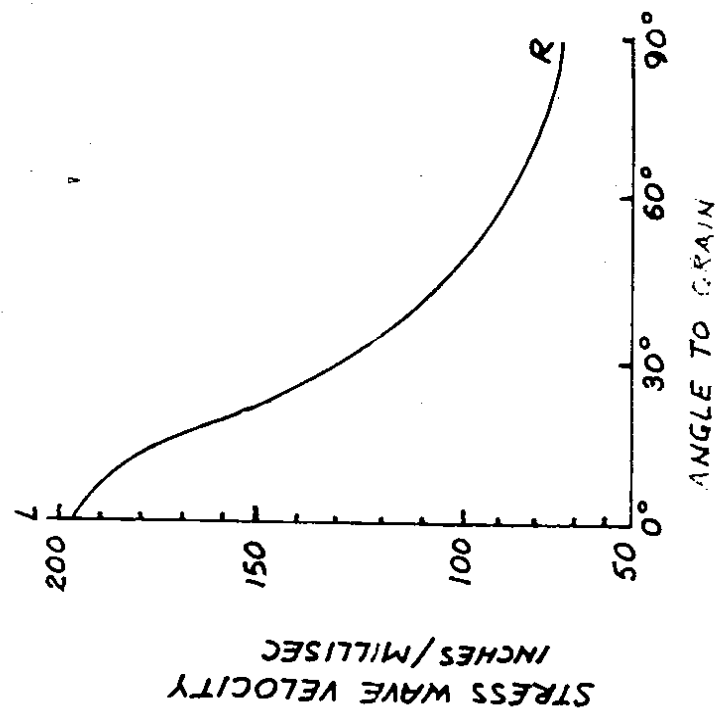
Figure B6. Stress Wave Velocity vs. Angle to Grain, Longitudinal to Radial, for 2-inch Diameter Specimens of Various Species (McDonald)

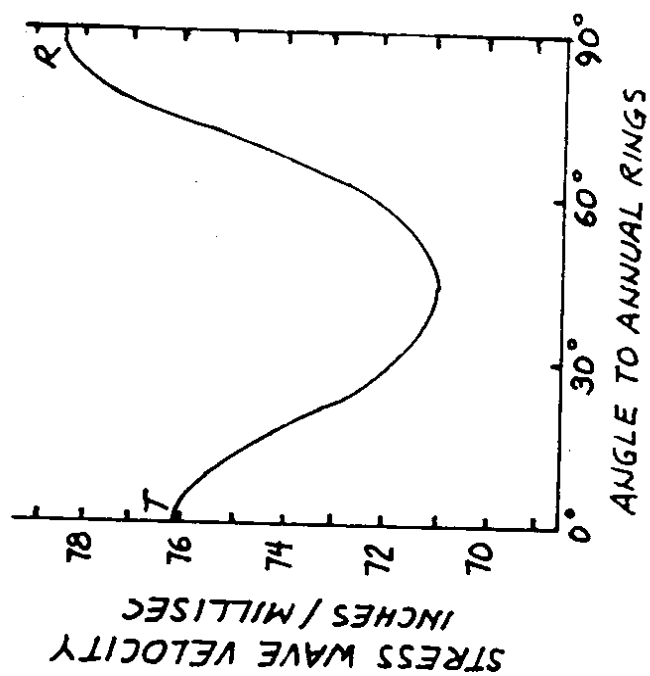
Figure B7. Transverse Stress Wave Velocity vs. Angle to Annual Rings; Tangential (0°) to Radial (90°) for 2-inch Diameter Specimens of Various Species (McDonald)

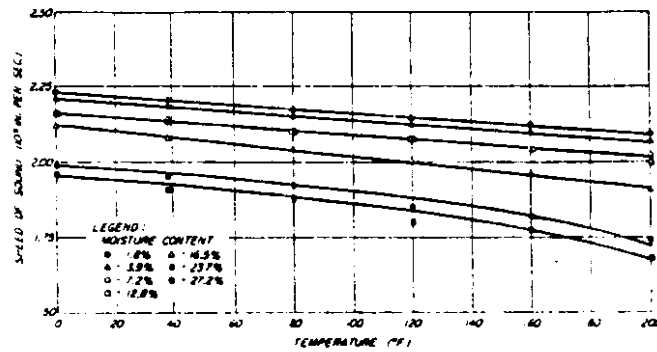
Figure C1. Plot of the Speed of Sound in Douglas-fir as a Function of Temperature for Various Levels of Moisture (James)

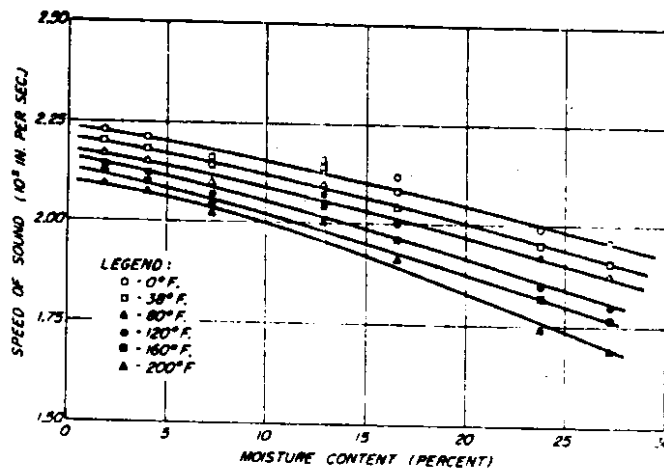
Figure C2. Plot of the Speed of Sound in Douglas-fir as a Function of Moisture Content for Various Temperatures (James)

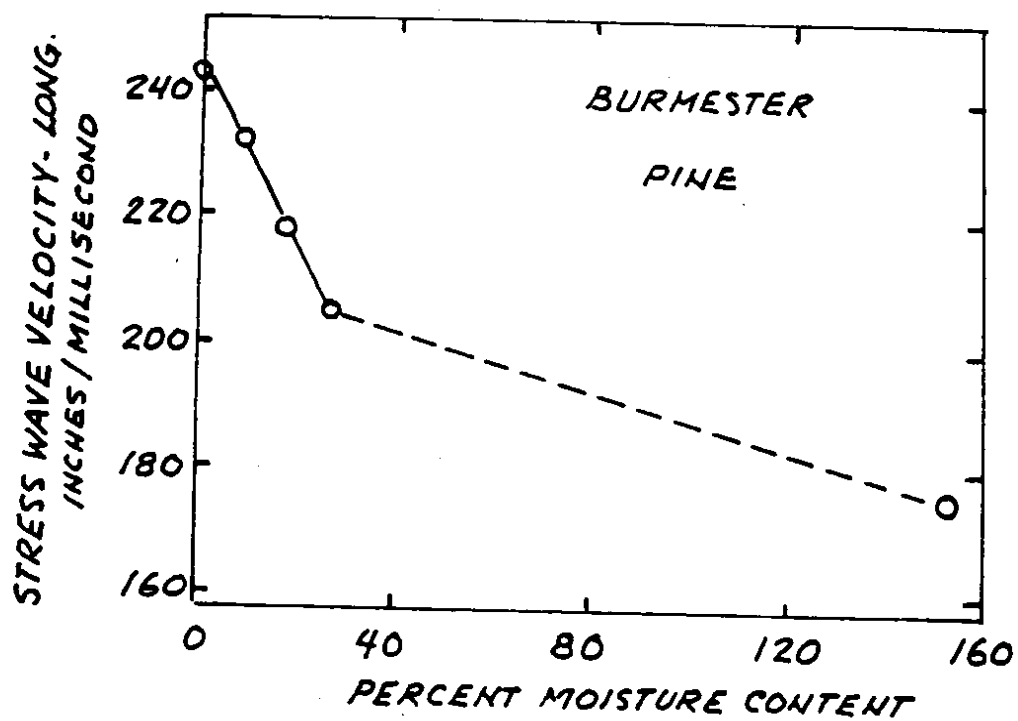
Figure C3. Longitudinal Stress Wave Velocity vs. Moisture Content in Pine (Burmester)

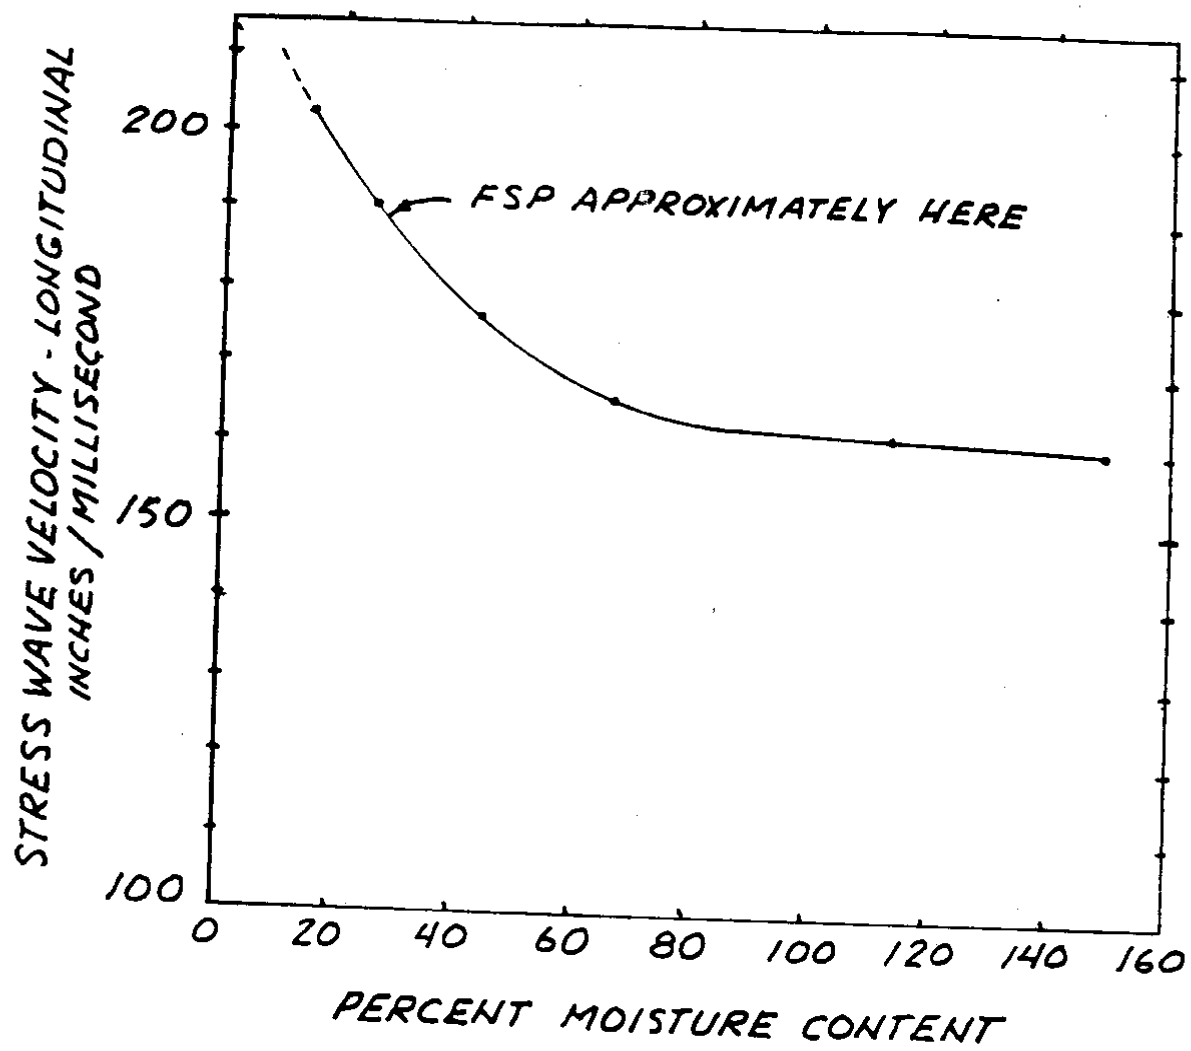
Figure C4. Longitudinal Stress Wave Velocity vs. Moisture Content in Sweetgum (Gerhards)

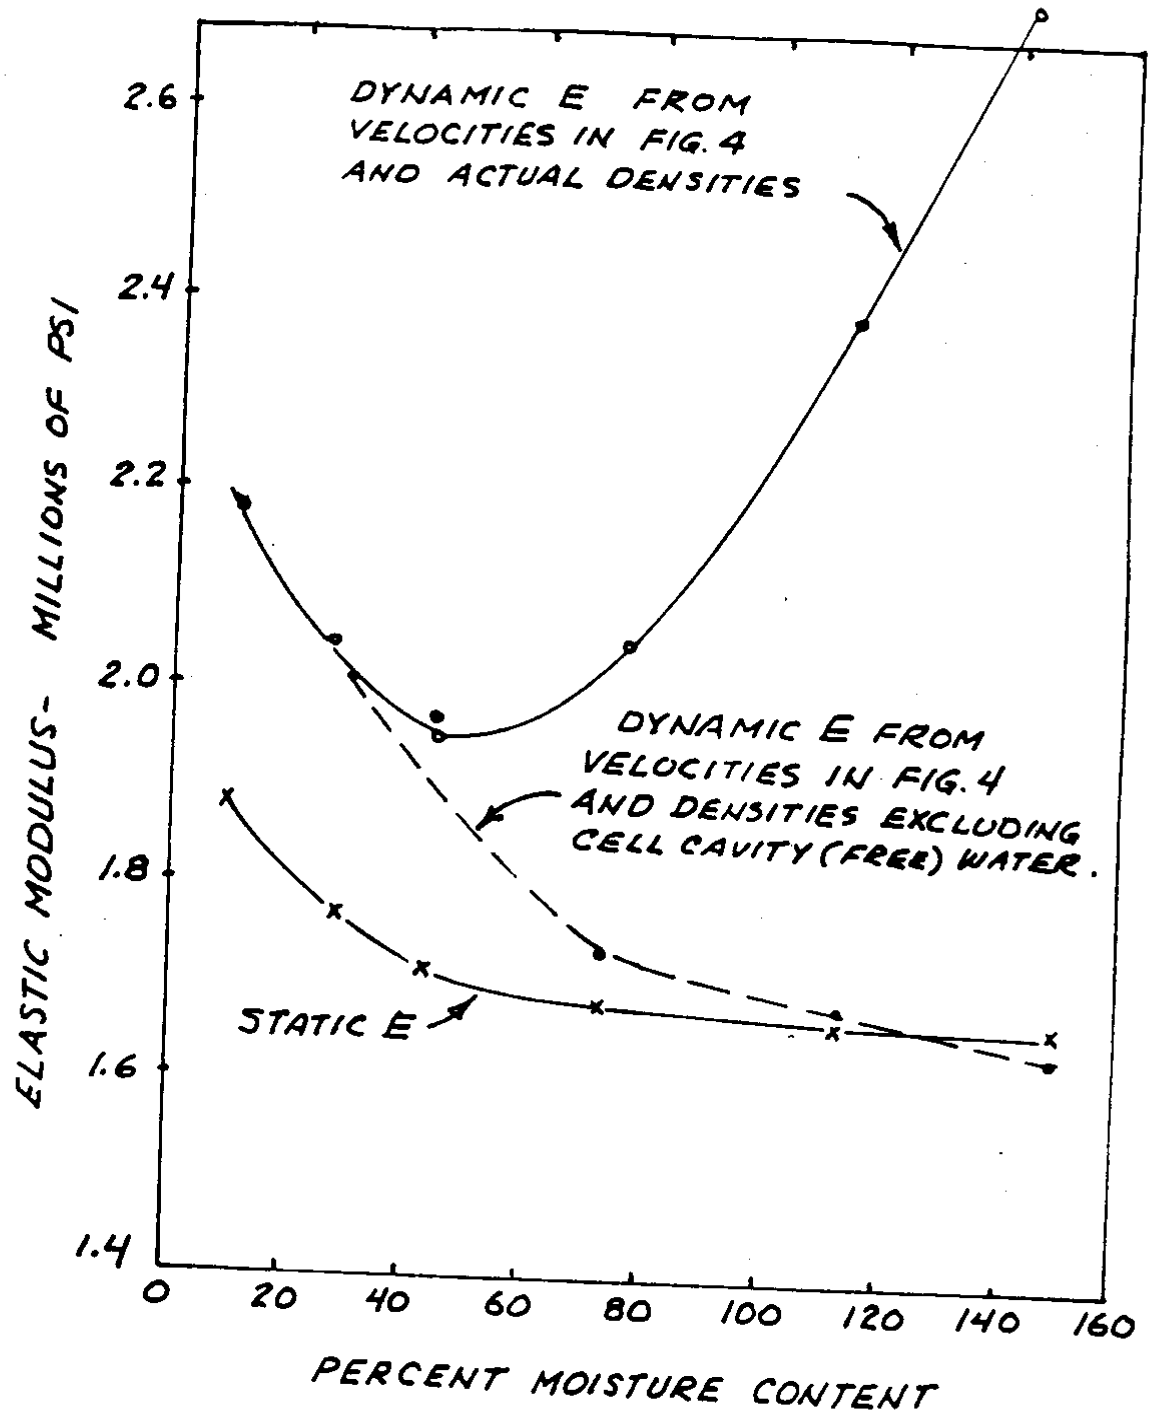
Figure C5. Dynamic Elastic Modulus by Stress Wave Measurement and Static Elastic Modulus (Gerhards)
