# **Stress Wave Inspection of Bridge Timbers and Decking**

WA-RD 146.1

Final Report  
July 1987

**Washington State Department of Transportation**

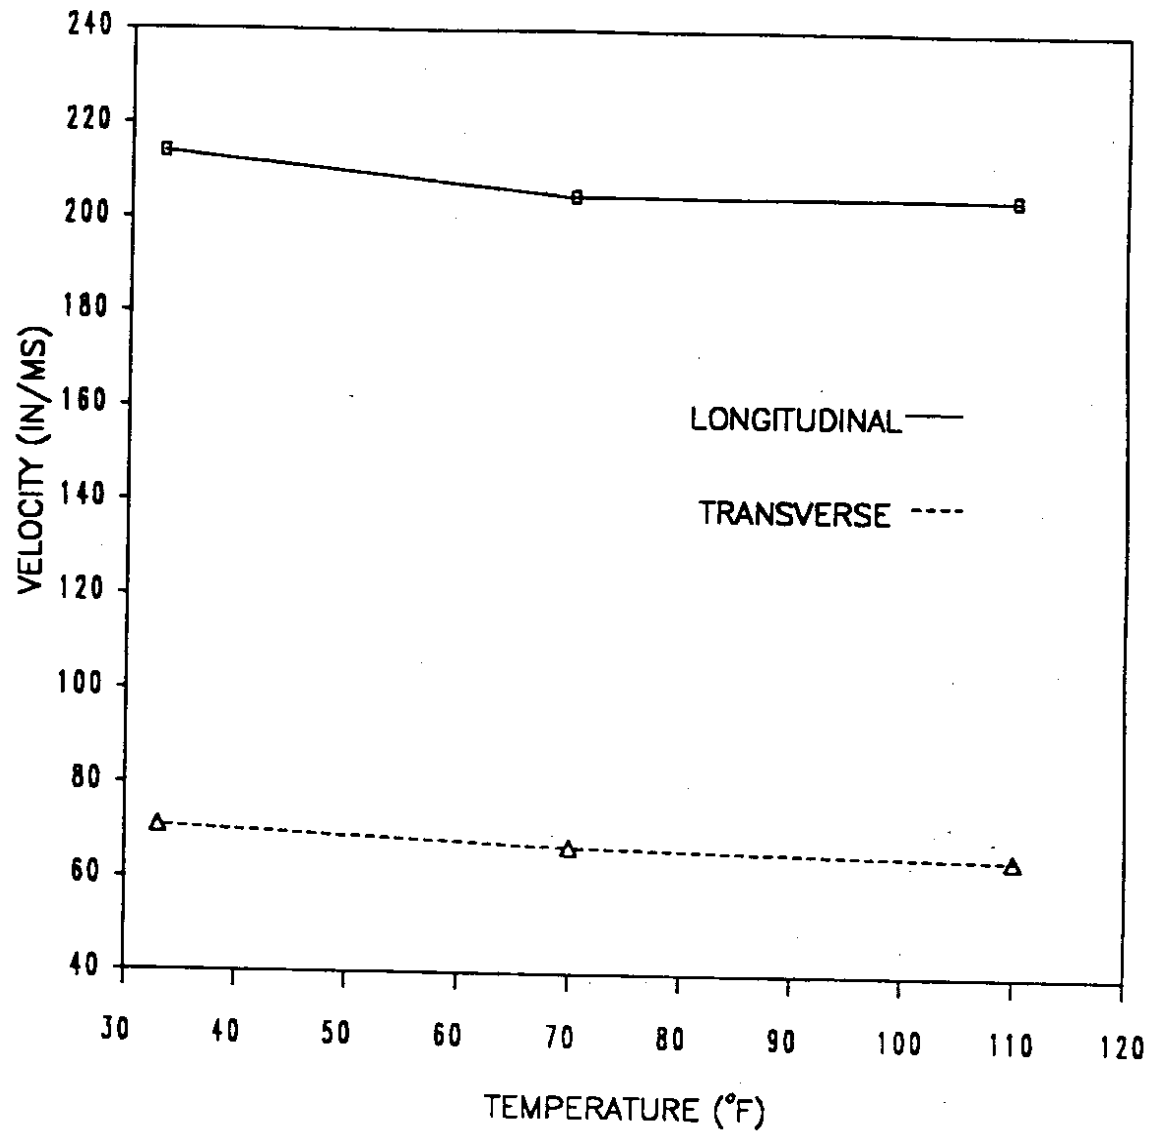
Figure C6. Effect of Temperature on Stress Wave Velocity in Douglas-fir

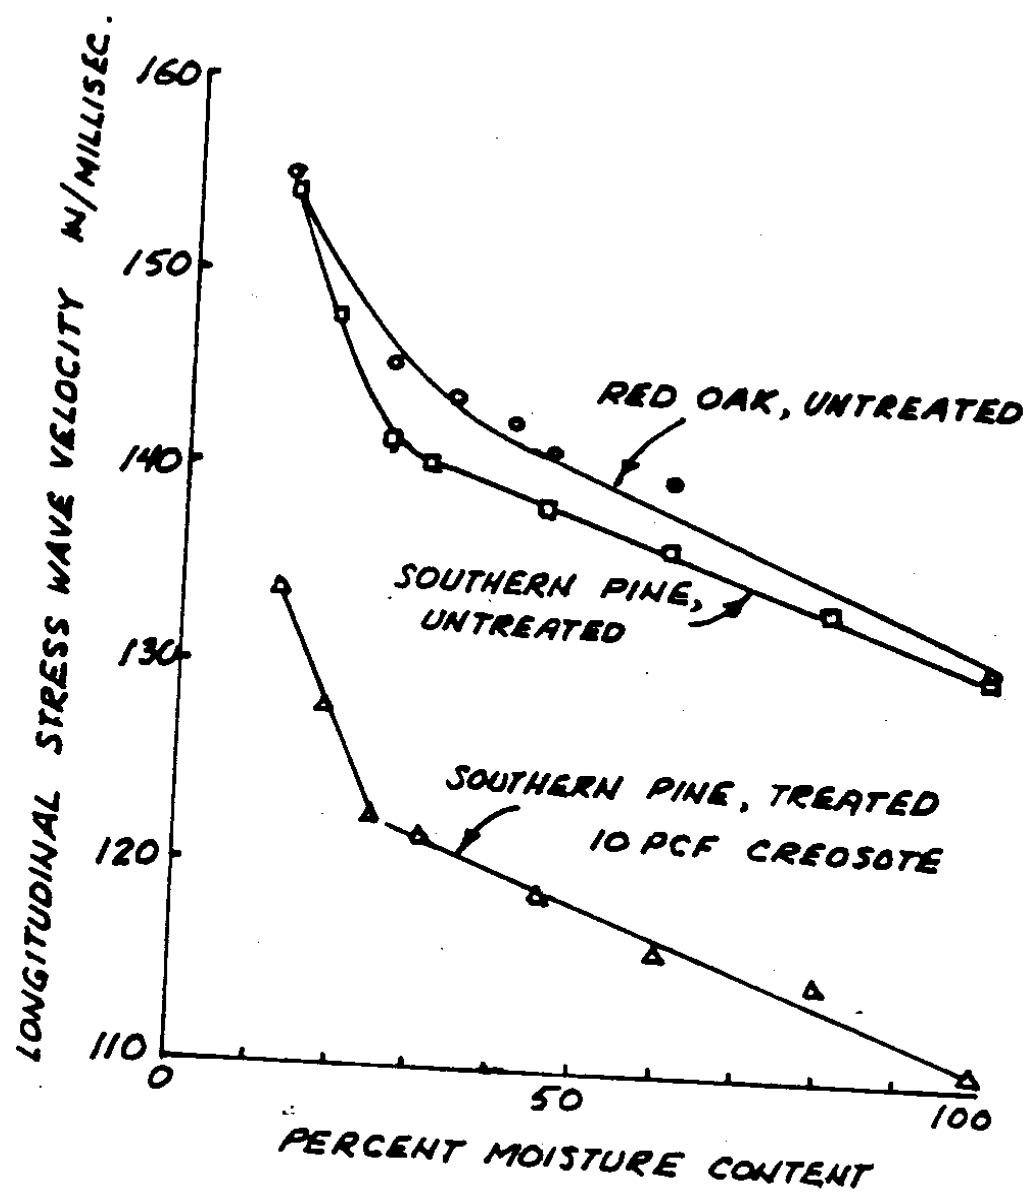
Figure C7. Longitudinal Stress Wave Velocity in Southern Pine and Red Oak Piling (Aggour and Ragab)

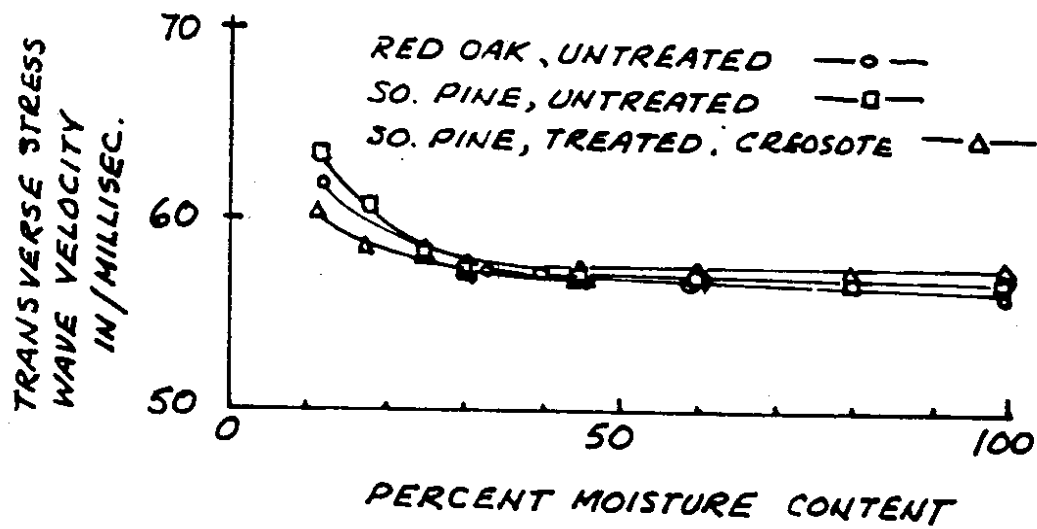
Figure C8. Transverse Stress Wave Velocity in Southern Pine and Red Oak Piling (Aggour and Ragab)

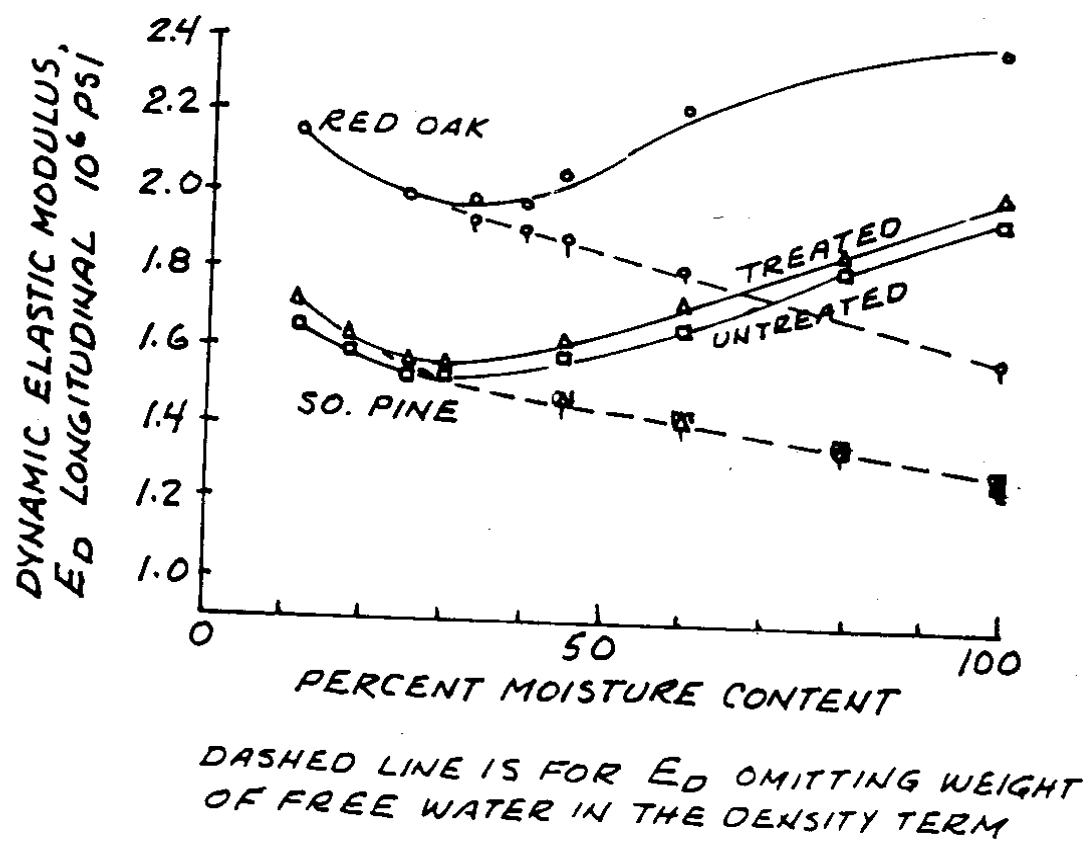
Figure C9. Longitudinal Dynamic Elastic Modulus, Southern Pine and Red Oak Piling (Aggour and Ragab)

Aggour and Ragab obtained values of dynamic E by calculation from density and velocity data, shown in Figures C9 and C10, very much like those of Gerhards in the range above FSP. By discounting the free water in the cell cavities, we plotted the dashed lines. The loss of velocity with rising moisture content above FSP confirms Gerhards results for longitudinal wave paths. In the case of transverse paths the effect is present but small.

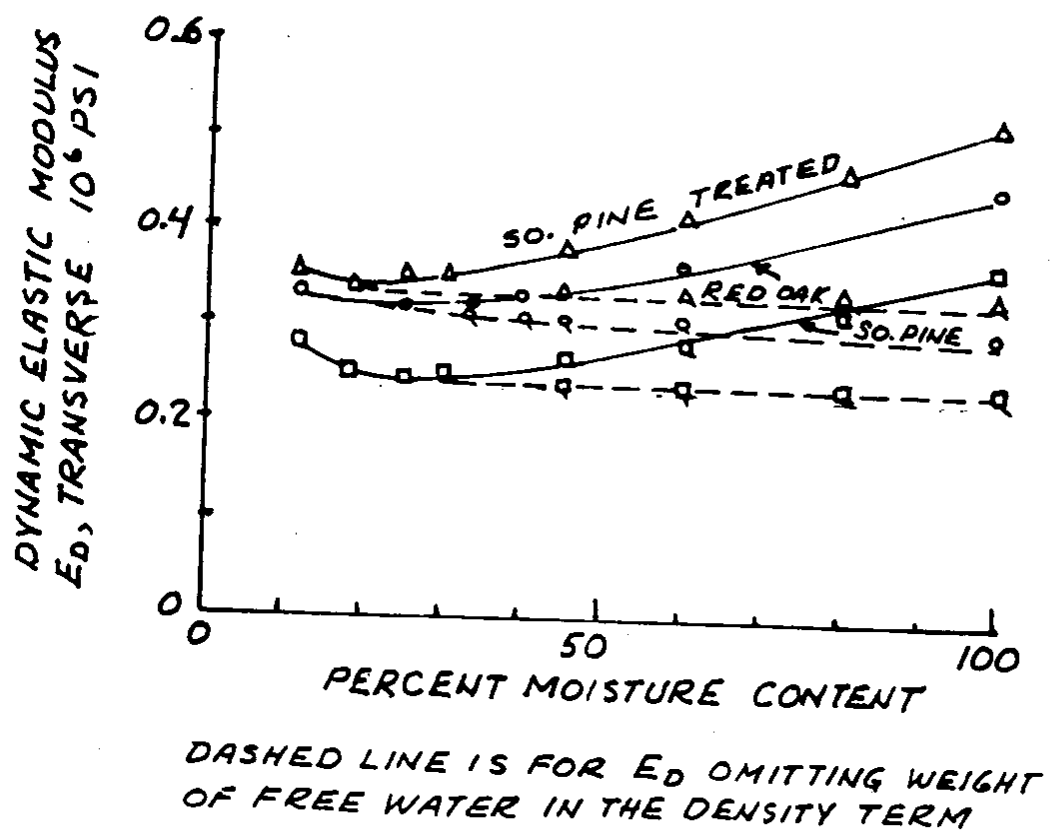
Figure C10. Transverse Dynamic Elastic Modulus, Southern Pine and Red Oak Piling (Aggour and Ragab)

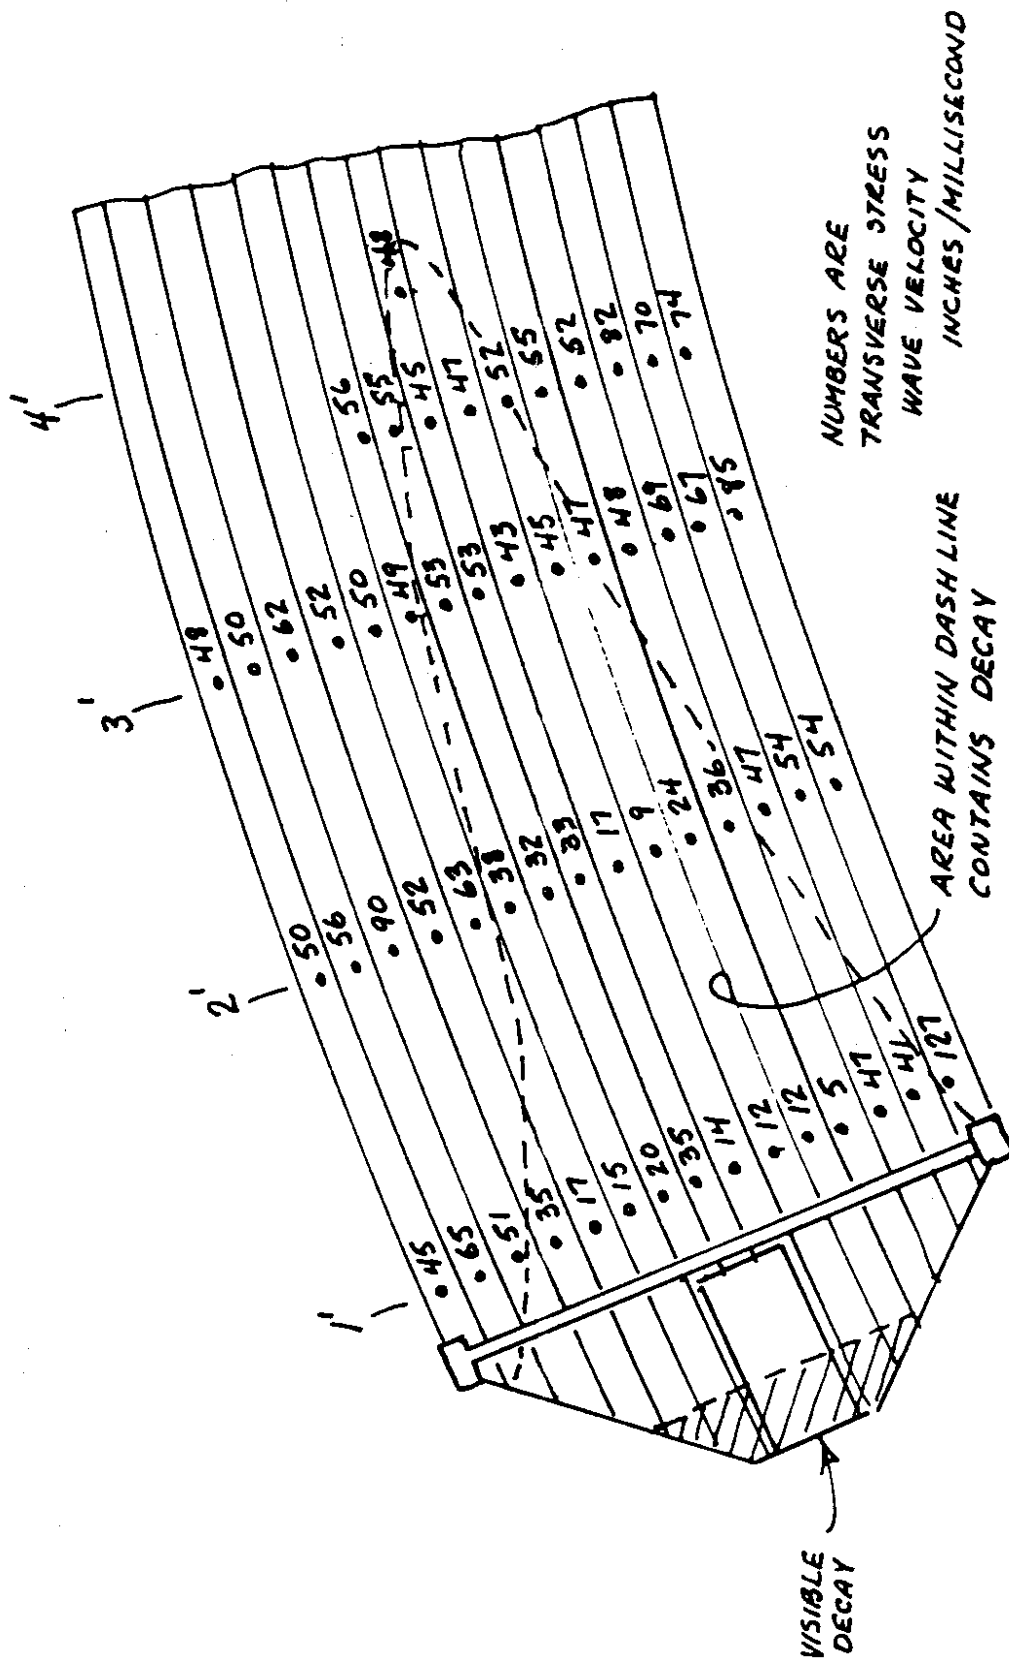
Figure E1. Transverse Stress Wave Velocities in Decayed Glulam Timber (Hoyle and Pellerin)

In 1978 Hoyle and Pellerin reported their use of the method for locating decayed regions in the exposed ends of glued-laminated arches in school buildings. These were Douglas-fir arches and they were not treated with any wood preservative. They were  $5\frac{1}{2}$  inches wide and  $22\frac{1}{2}$  inches deep. A Metriguard Stress Wave Timer was employed. The impulse was generated by a light blow from a hammer which had an accelerometer firmly attached to the head. A second accelerometer was fitted with a hand grip so it could be held firmly against the wood member. We employed this method on the ends of 38 arches, for distances from 5 to 12 feet from the ends, predetermined to be the problem area. Stress wave time was measured transversely, through each lamination, and plotted as in Figures E1 and E2. These values of velocity are a little higher than suggested, because, at the time this work was done, we had not learned to set the "Gain" correctly. Repairs were ordered on the

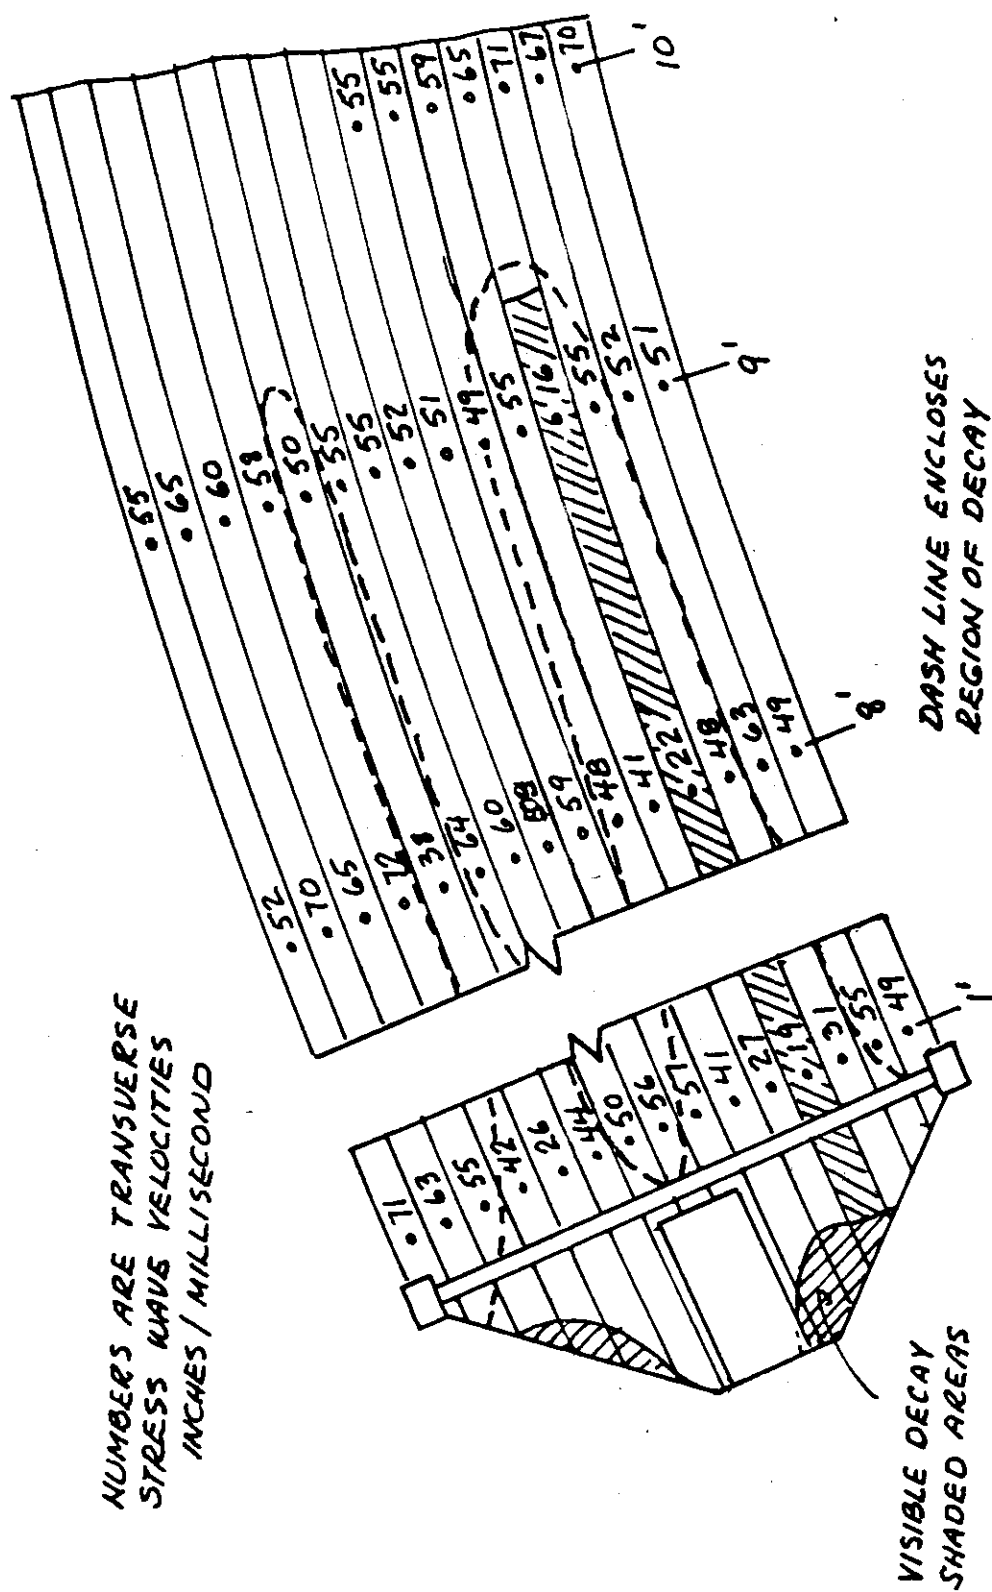
Figure E2. Transverse Stress Wave Velocities in Decayed Glulam Timber (Hoyle and Pellerin)

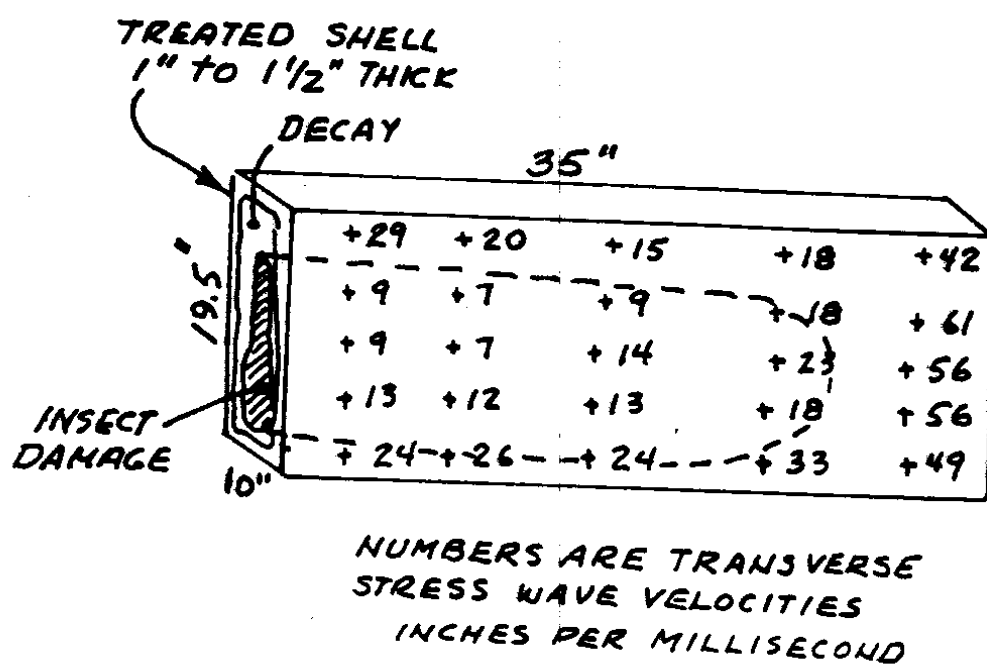
Figure E4. Transverse Stress Wave Inspection of Douglas-fir Timber With Decay and Insect Damage

Figure E3 shows a severely decayed and insect damaged section which was measured with results shown in Figures E4 and E5. The transverse readings in Figure E4 correlated well with the damage. The longitudinal readings in Figure E5 illustrated the superiority of the transverse wave readings. With the impulse applied at the center of the decay-free end (point O) and received at points A, B, C and D we obtained sound wood indications for paths OB (186) and OC (219), and questionable readings for wood quality at OA (132) and OD (108). These longitudinal readings did not discern the damage nearly as well

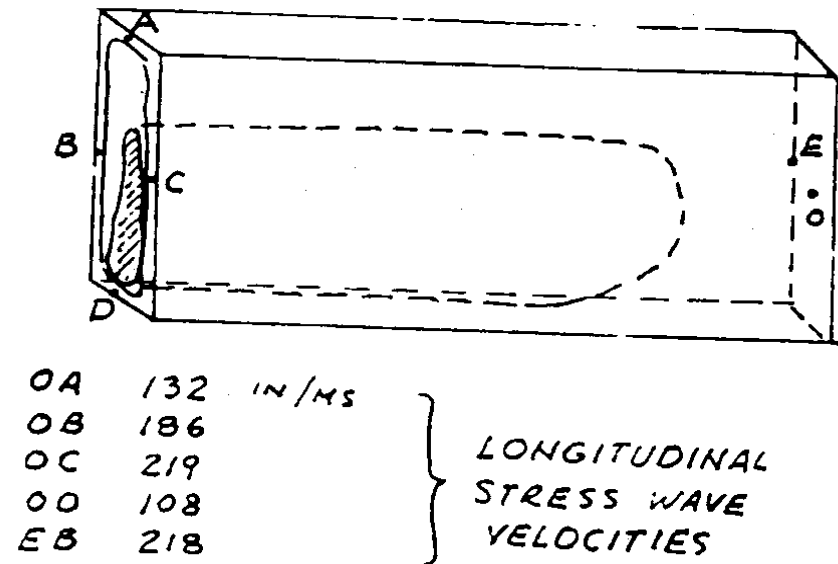
Figure E5. Longitudinal Stress Wave Inspection of Douglas-fir Timber With Decay and Insect Damage

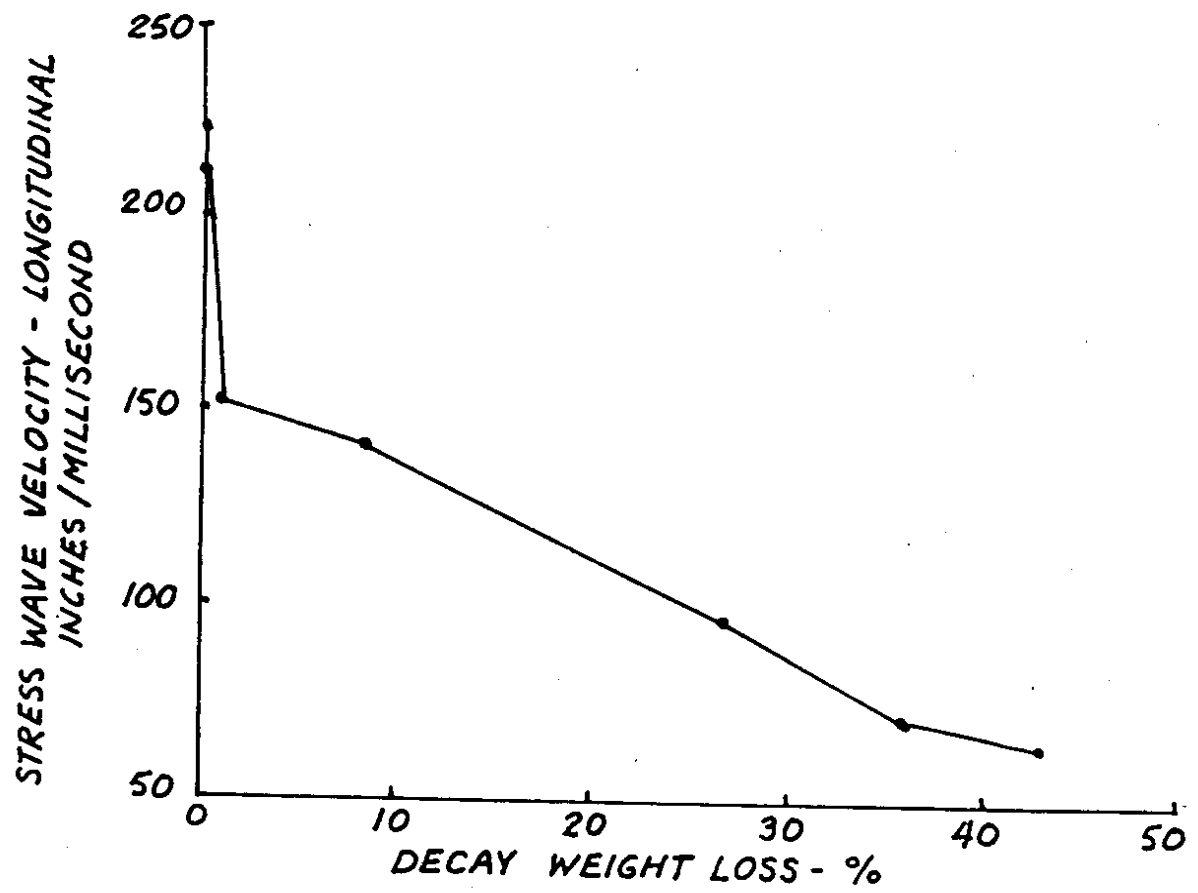
Figure E6. Weight Loss vs. Longitudinal Stress Wave Velocity (Pellerin and Vogt)

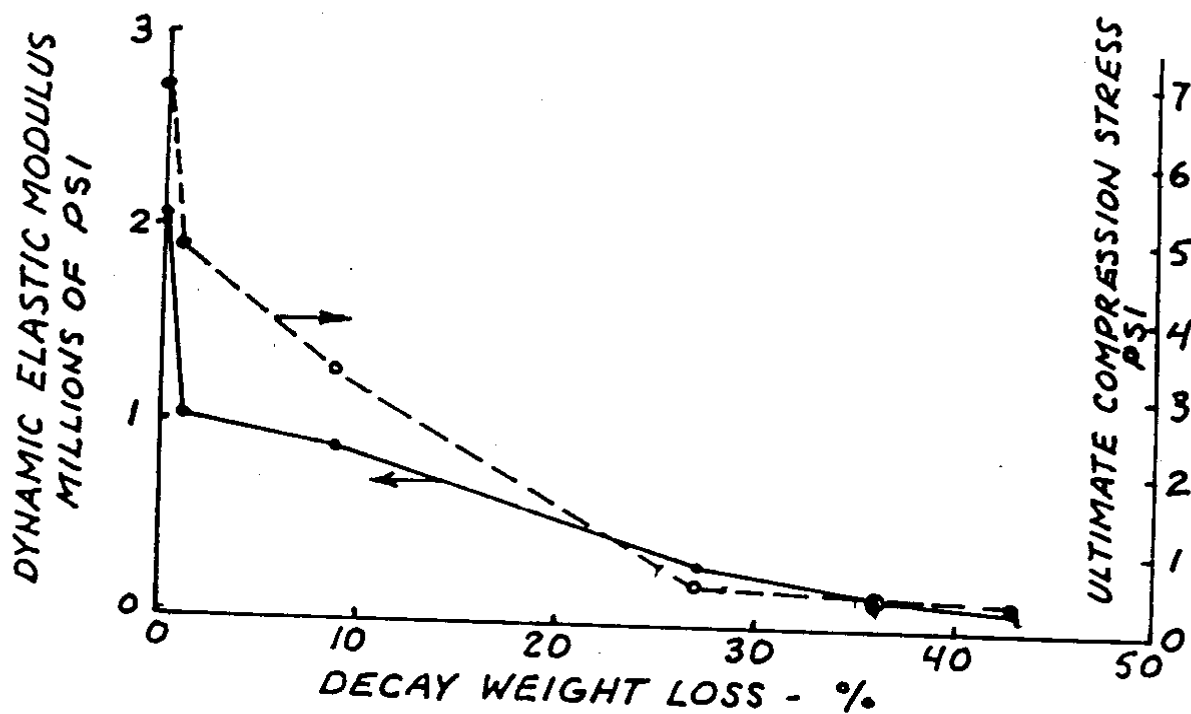
Figure E7. Weight Loss vs. Dynamic Elastic Modulus and Ultimate Compression Strength Parallel to Grain (Pellerin and Vogt)

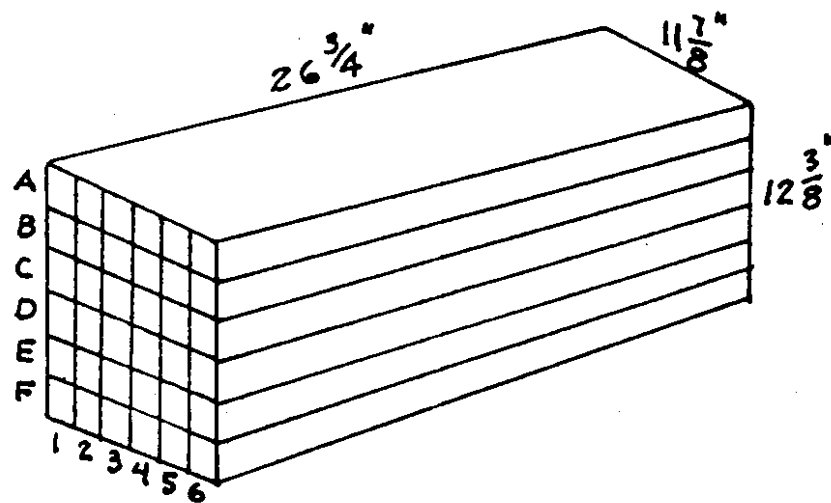
Figure E8. Partially Decayed Timber Used to Develop Information on Longitudinal and Transverse Stress Wave Velocity Options

The timber was then sawed into boards approximately 2 by 12 by 27 inches long and the stress wave velocity was measured in each board, transversely, with results listed in Table E3. The poor condition of boards 5 and 6 is

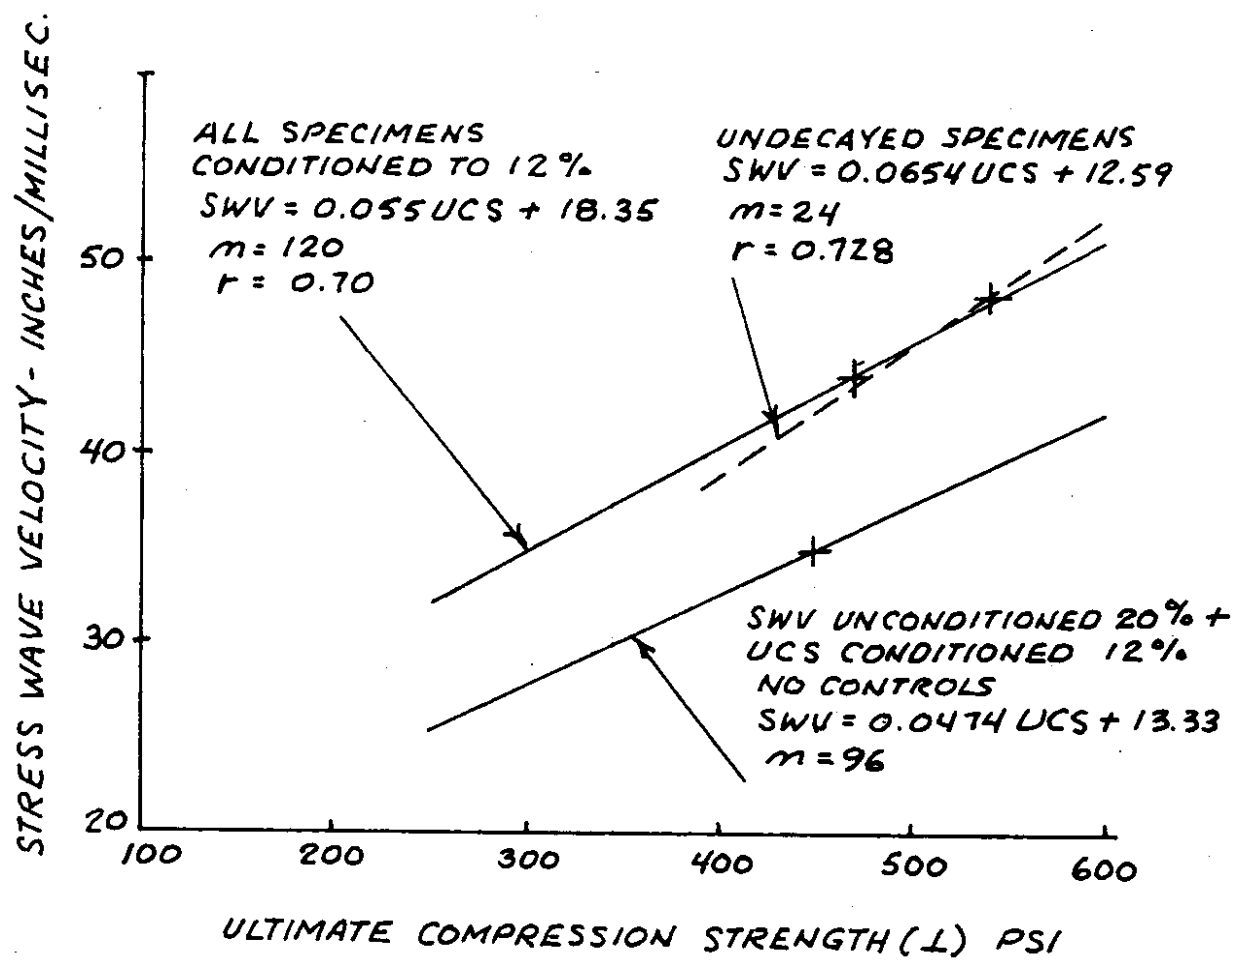
Figure G1. Regressions - Stress Wave Velocity vs. Ultimate Compressive Strength Decayed and Sound Douglas Fir

In Figure G1 we show compression strength as the independent variable because we are attempting to determine the SWV that should be anticipated for the degraded wood. Since the UCS was determined for the conditioned wood, it is logical that the regression lines for all specimens (upper solid line) and controls (dashed line) are close together. The regression line for all specimens with unconditioned SWV (lower solid line) is depressed since the decayed specimens before conditioning were wetter and denser than after

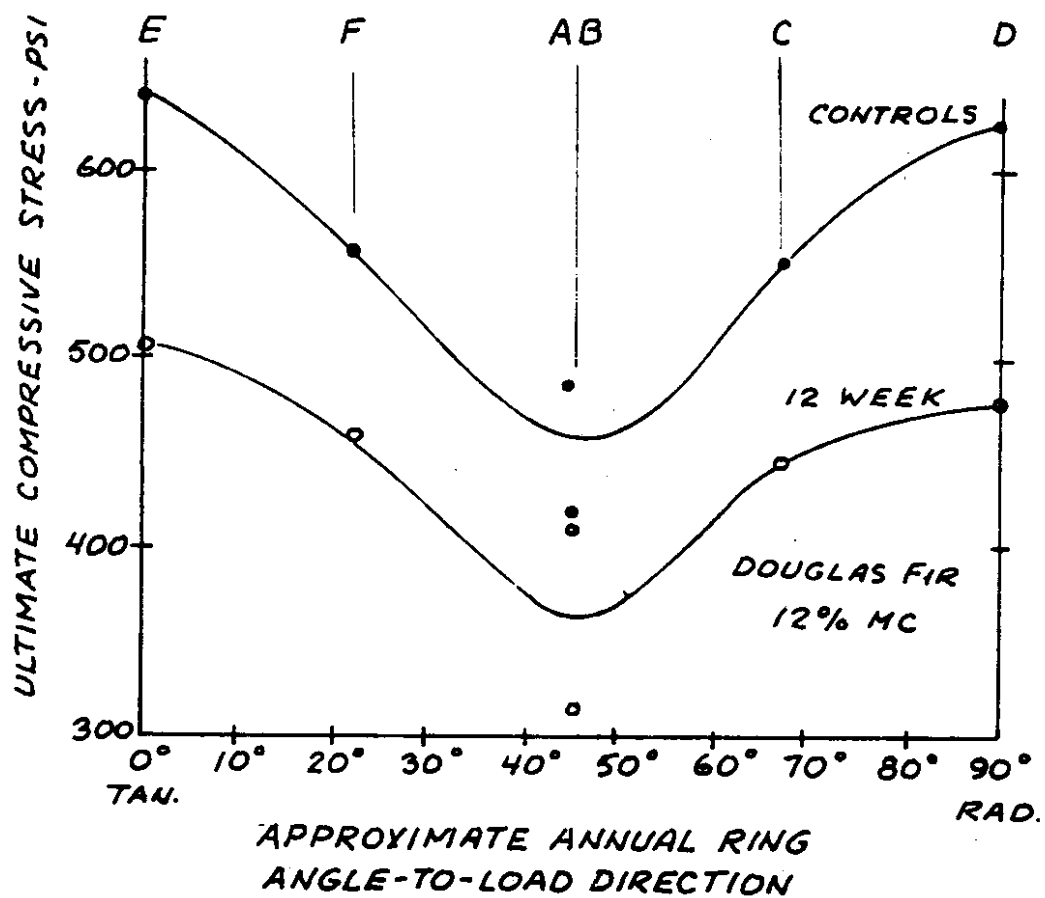
Figure G2A. Ring Orientation vs. UCS for Controls (Undecayed) and 12-Week Exposure (Decayed) Specimens

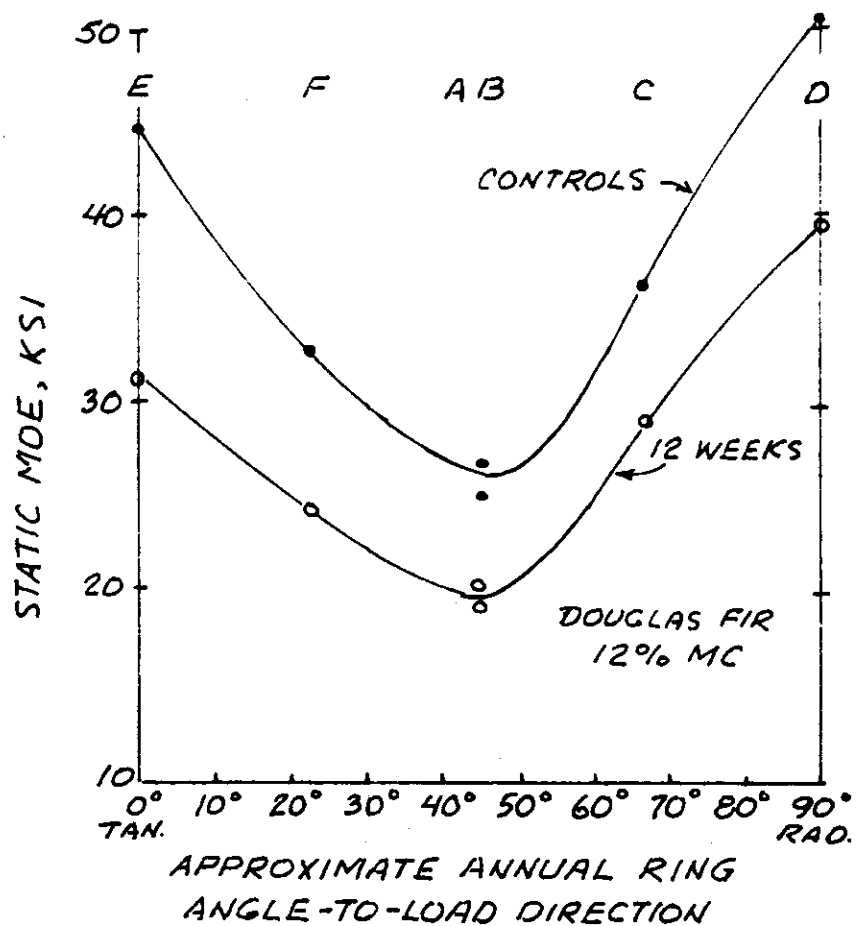
Figure G2B. Ring Orientation vs. Static MOE for Controls (Undecayed) and 12-Week Exposure (Decayed) Specimens

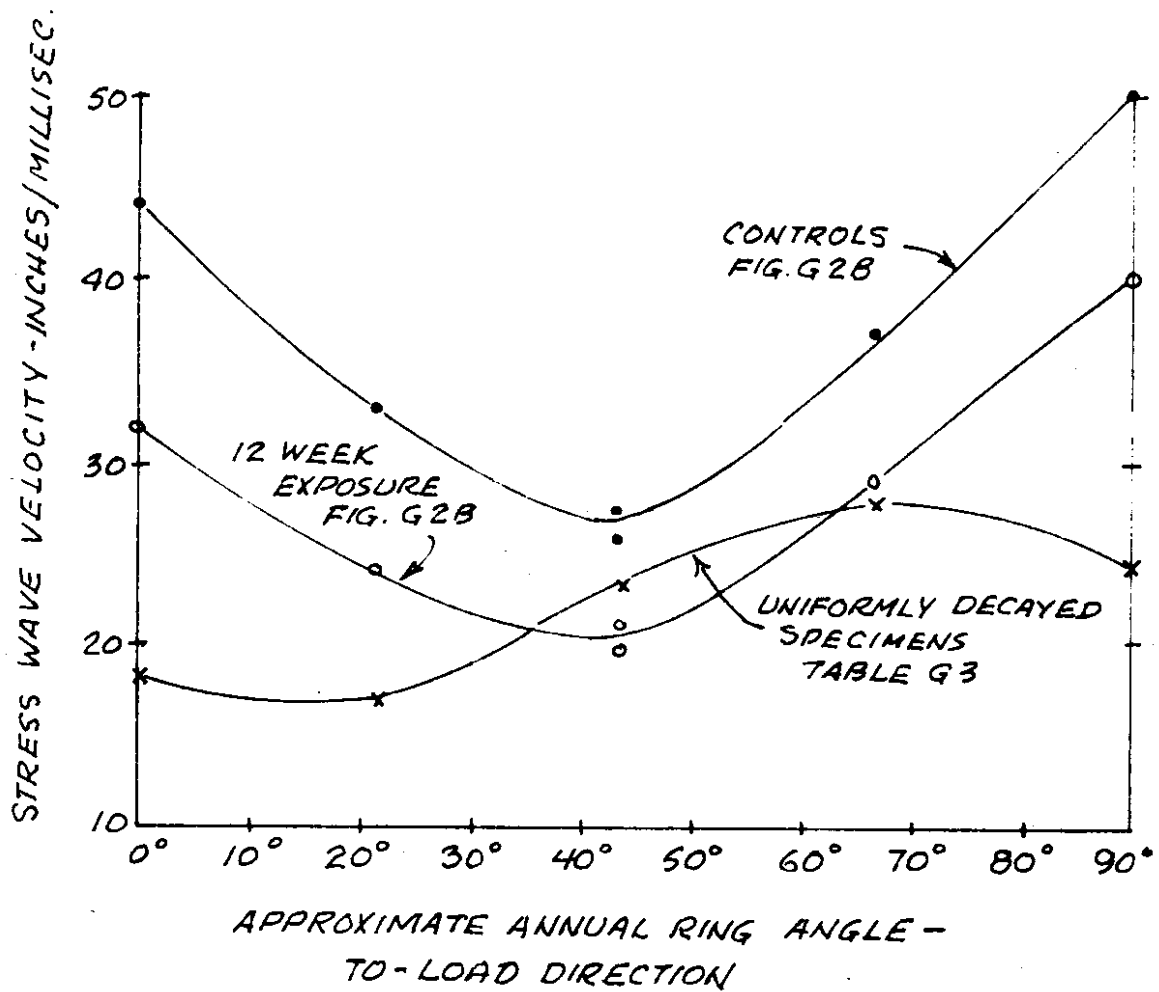
Figure G3. Stress Wave Velocity vs. Ring Angle

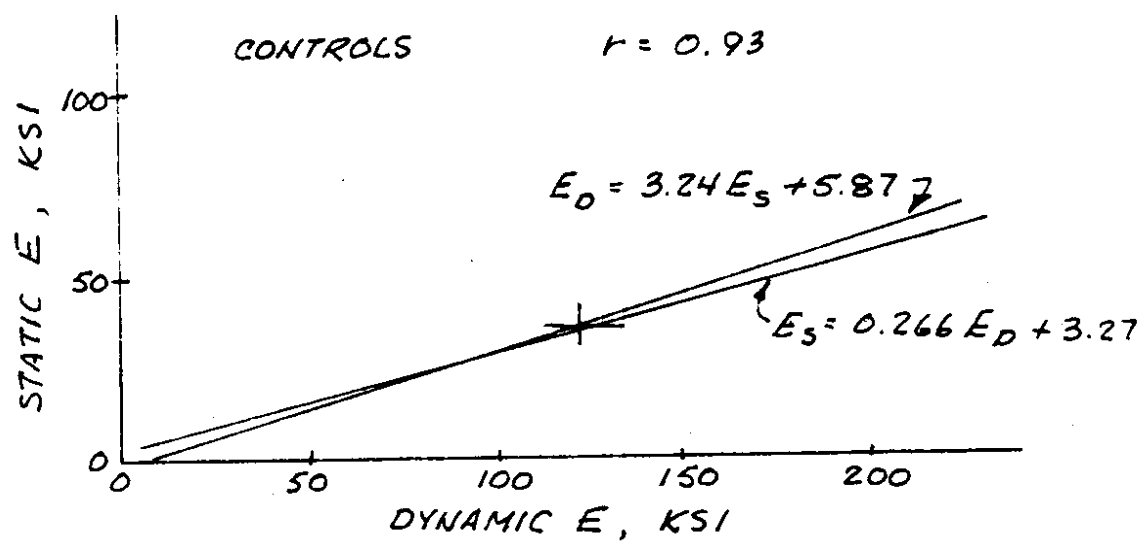
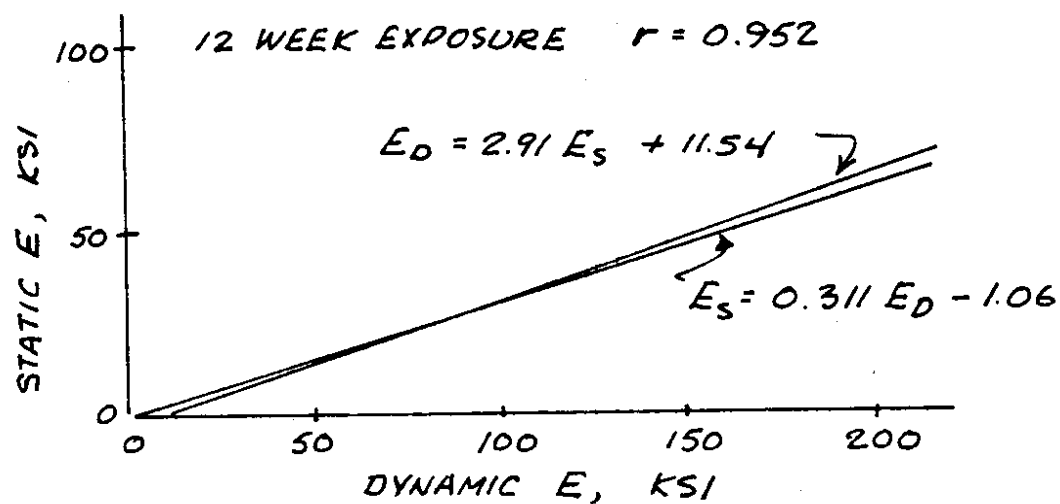
Figure G4. Static vs. Dynamic Elastic Modulus for Undecayed and Decayed Douglas Fir
