Thin Overlay South 154th Street Overcrossing 5/523E

WA-RD 243.1

Post Construction Report
October 1991

Washington State Department of Transportation

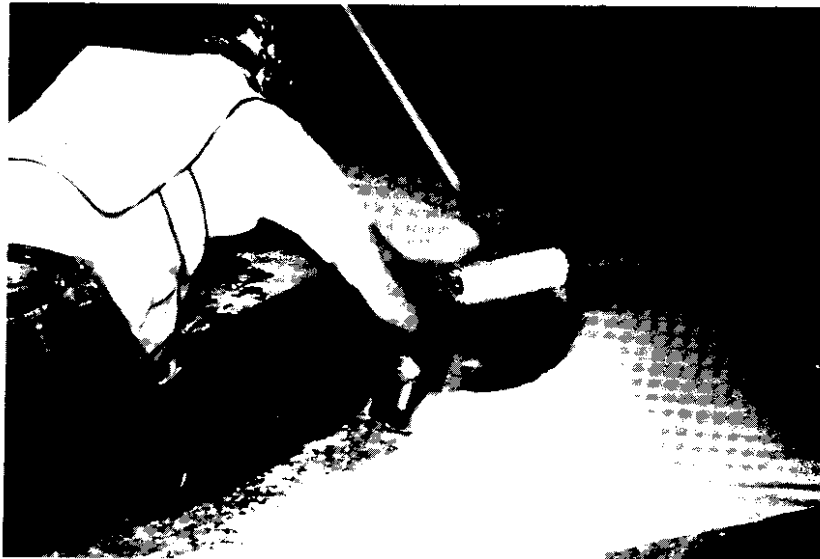
Spreading MMA by hand trowel and tined roller.

Proper proportions of Conkryl Paviour Liquid, Conkryl Hardener, and Conkryl Paviour Powder were mixed in a galvanized wash tub with a heavy duty drill and a mixing paddle. The mixture was trowelled and rolled on the deck with a porcupine roller, to a thickness of five millimeters, or about 1/4 inch. This mixture is self-leveling. The Steilacoom

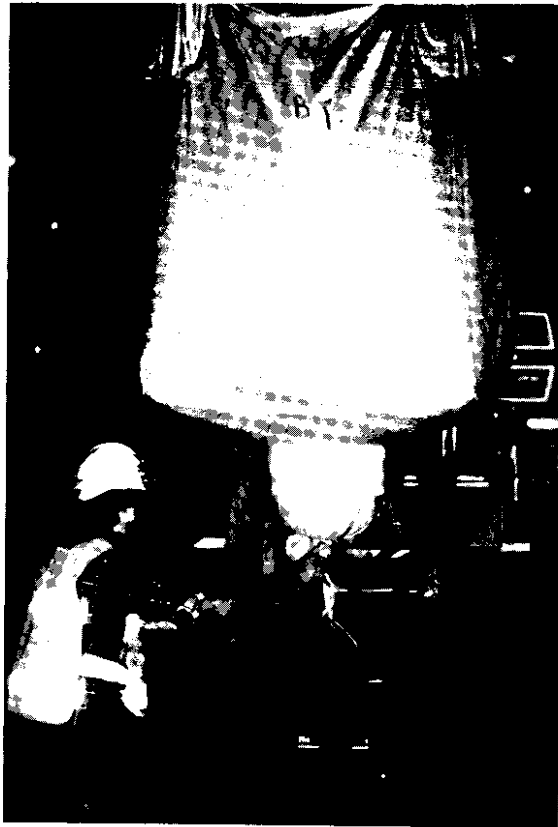
Dispensing aggregate to wheelbarrow.
