Thin Overlay Custer Way Undercrossing 5/316

WA-RD 244.1

Post Construction Report
October 1991

Washington State Department of Transportation

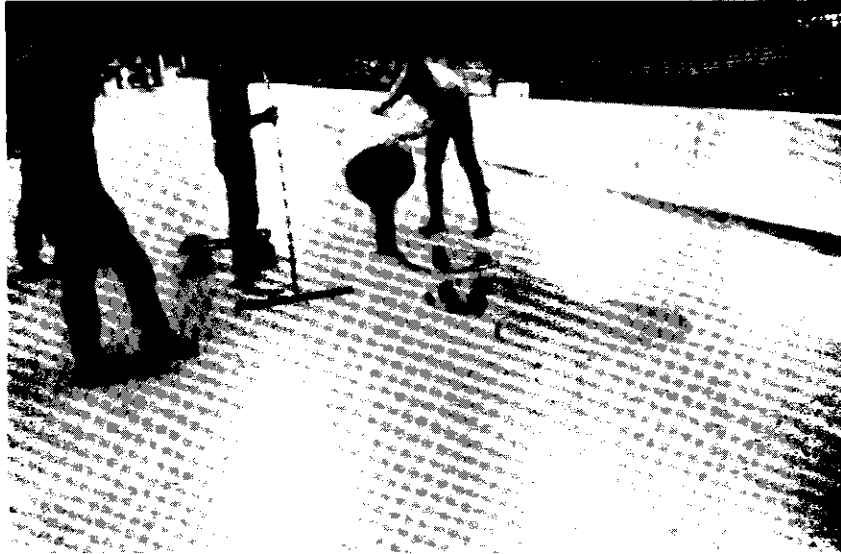
Pouring epoxy on deck from 55-gallon drums cut in half..

The epoxy was mixed, wheeled to the overlay area, and dumped on the deck. Two laborers spread the epoxy over the deck, with 3 foot wide serrated squeegees. The serrated

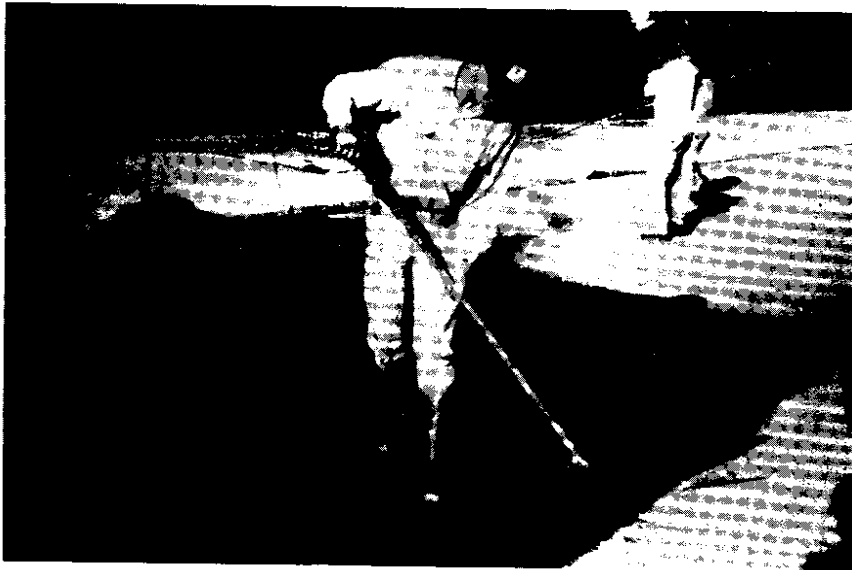
Another view of spreading.

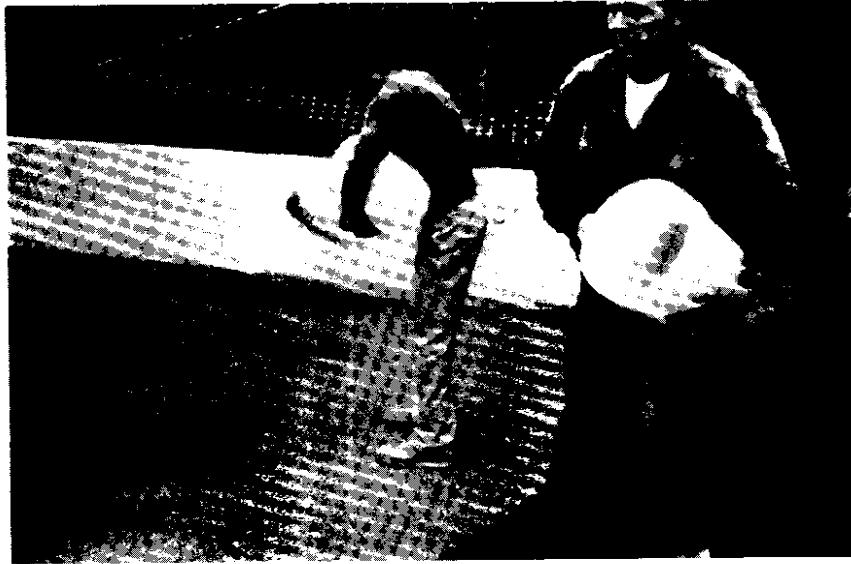
Spreading aggregate from 5-gallon pail.

squeegees were designed to allow the proper amount of epoxy to remain on the deck. Immediately after the epoxy was spread, three laborers began hand broadcasting aggregate, from 5-gallon pails, over the epoxy. The aggregate was broadcast in sufficient quantity to ensure 100 percent coverage. The aggregate was placed up to 1 inch thick in areas, to cover any additional bleeding areas which might appear. The bleed areas resulted from thick placement of the epoxy in isolated low spots. The cure period began at the conclusion of the aggregate placement, and took 3 hours. The epoxy had hardened by this time and a power broom was used to remove excess aggregate. The ambient temperature was approximately 70 degrees Fahrenheit.
