1. REPORT NO. WA-RD 392.1	2. GOVERNMENT ACCESSION NO.	3. RECIPIENT'S CATALOG NO.	
4. TITLE AND SUBTITLE Maintenance Free Crash Cushion		5. REPORT DATE June 1995

Final Report
for
Research Project WSDOT-GC 9938
“Maintenance Free Crash Cushion”

MAINTENANCE FREE CRASH CUSHION

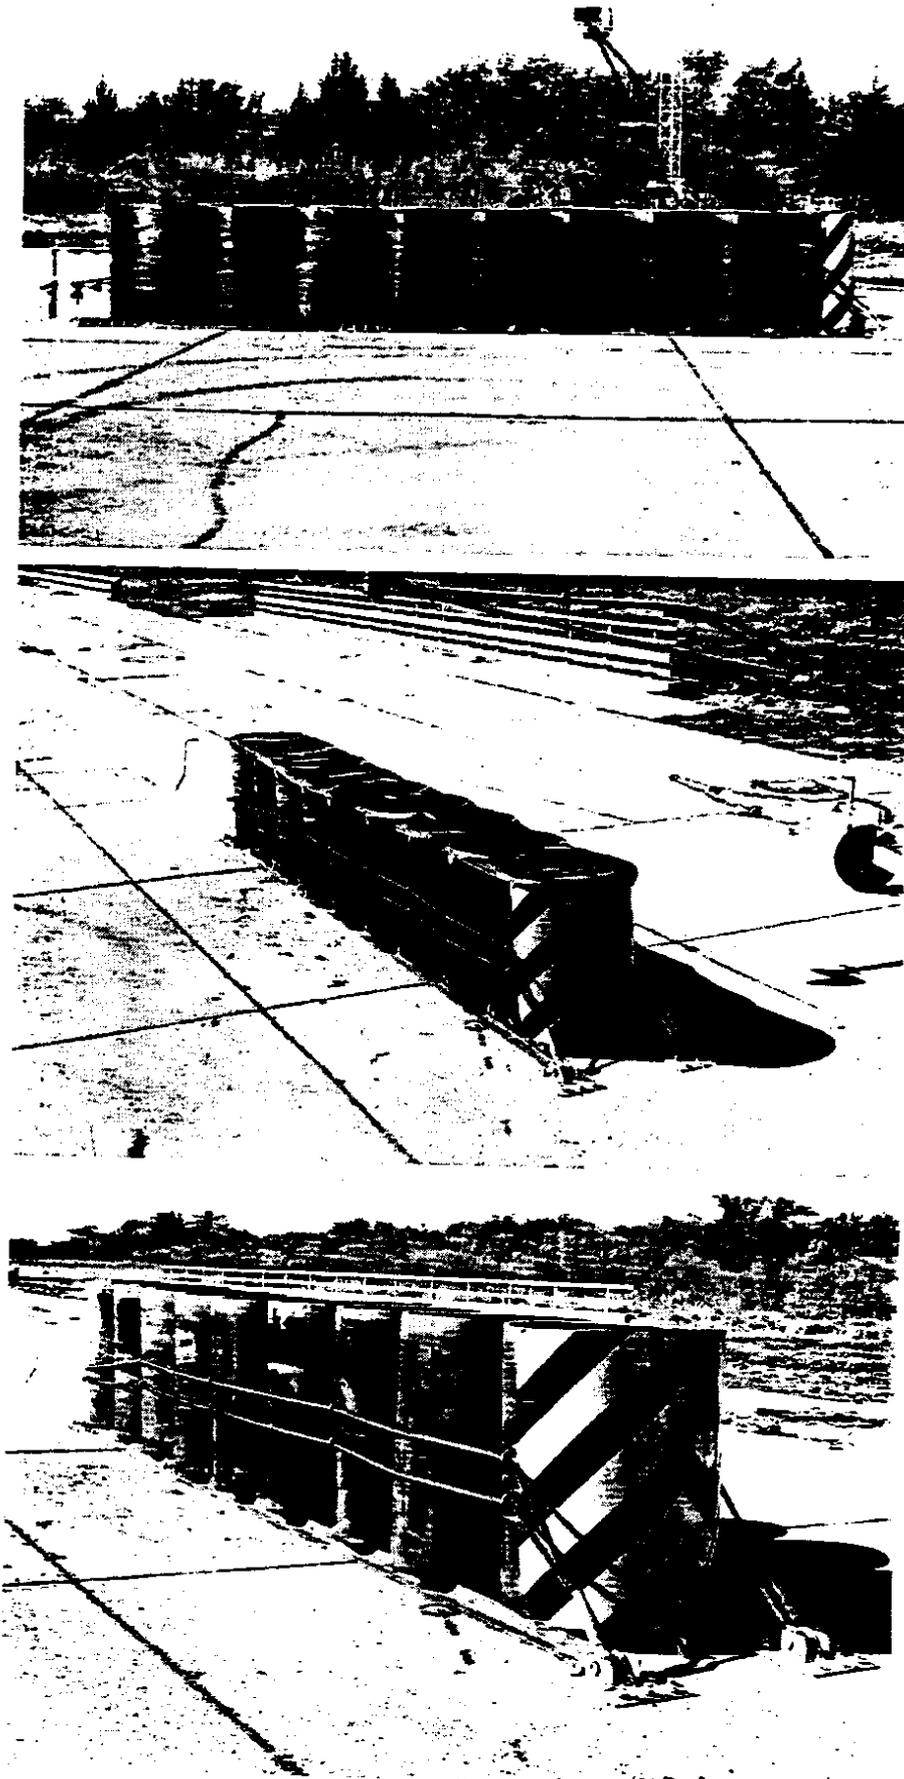
Figure 1. The REACT 350 Crash Cushion

In this project, the HMW/HDPE 100 km/h narrow hazard crash cushion(React 350.9) was designed using the experimental information summarized above. The device is shown in Figure 1. It is composed of nine HMW/HDPE cylinders with wall thicknesses varying from 20.23 mm in the nose cylinder to 35.18 mm in the rear cylinder. All cylinder diameters are 0.92 m, and all cylinder heights are 1.22 m. Two 25.40 mm diameter cables are located on each side of the device to assist in redirecting vehicles impacting the crash cushion on the side. Steel chain links, attached to the bottom connection at the interfaces of cylinders 6-7, 7-8, and 8-9 and sliding on a 38.10 mm diameter rod (part of the support structure) also contributes to the development of the lateral resisting force required to redirect errant vehicles impacting on the side. The other key parts of the React 350.9 are the stand-alone backup structure and front cable support assemblies.

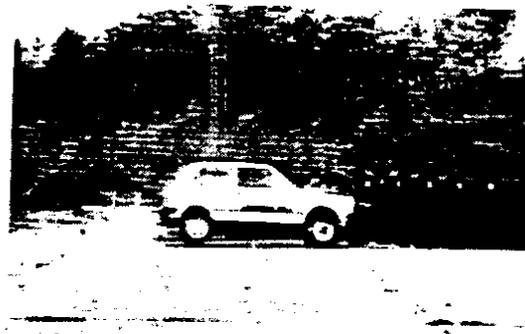
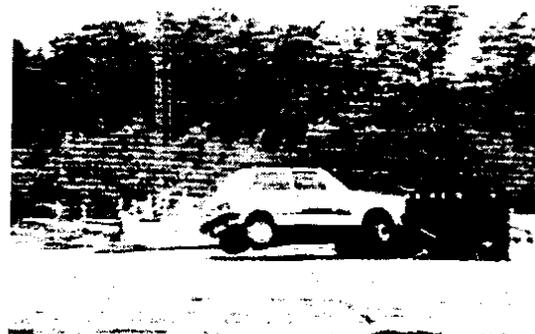
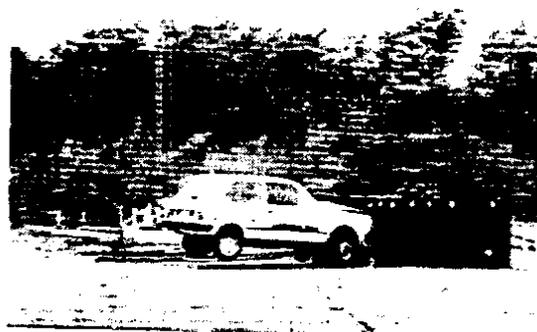
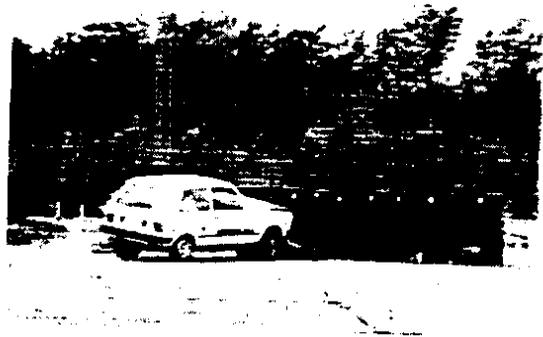
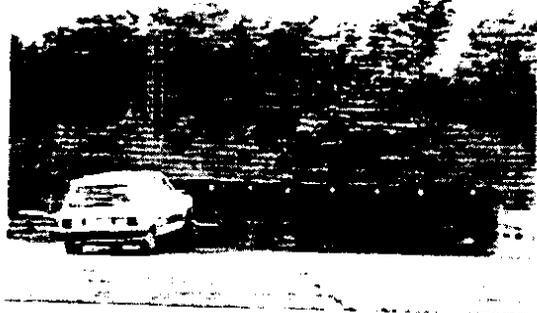
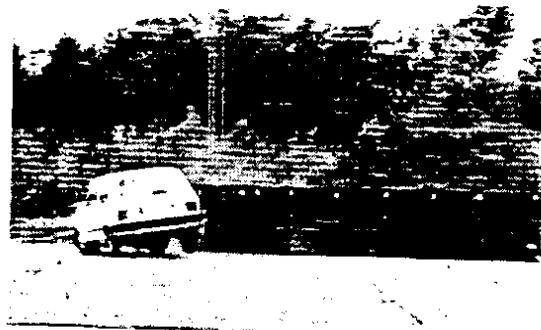
Figure 3. Sequential photographs for NCHRP Report 350
Test 3-30. (overhead and perpendicular views)

Figure 3. Sequential photographs for NCHRP Report 350 Test 3-30 continued. (overhead and perpendicular views)

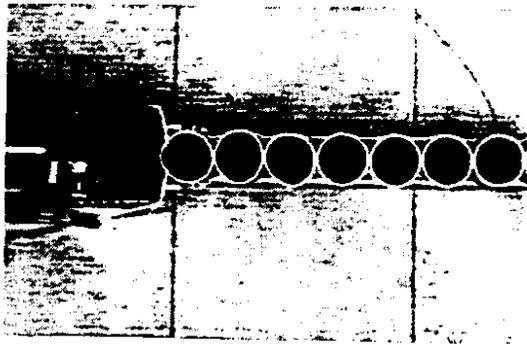
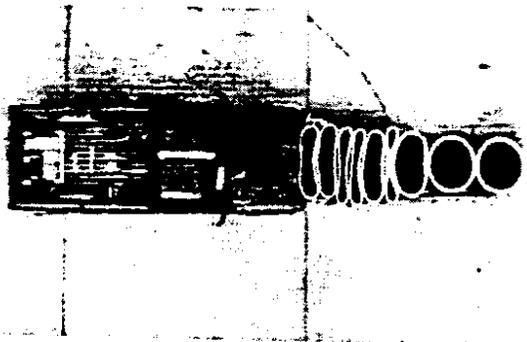
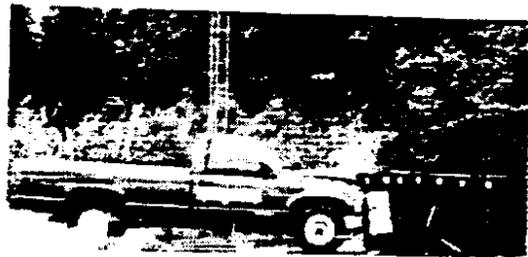
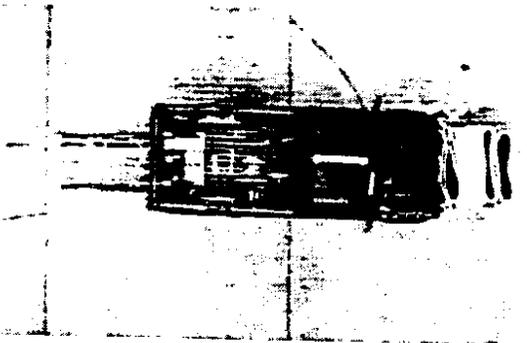
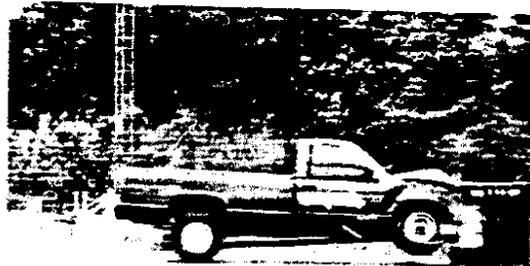
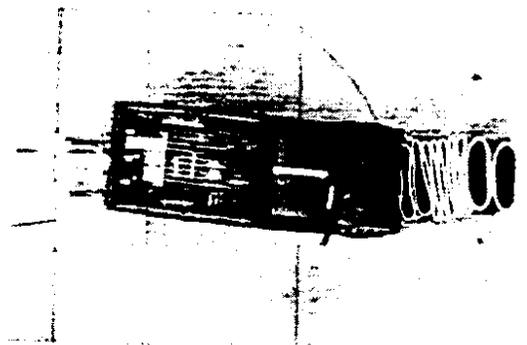
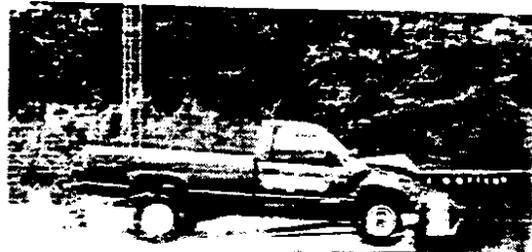
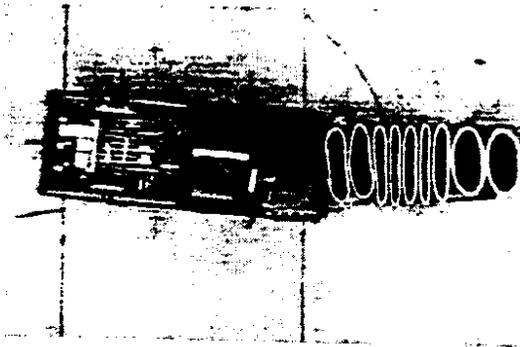
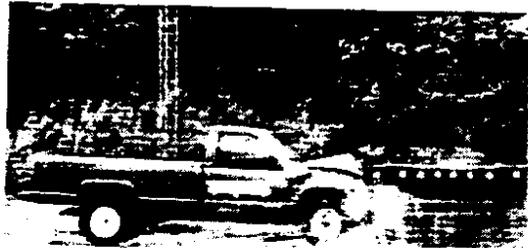
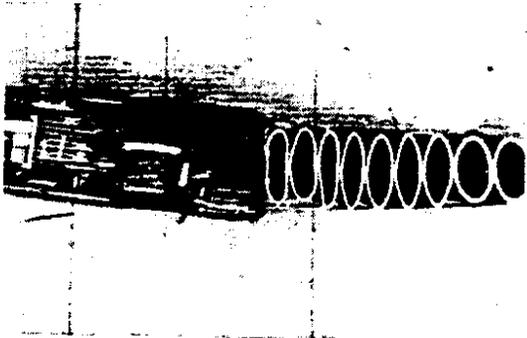
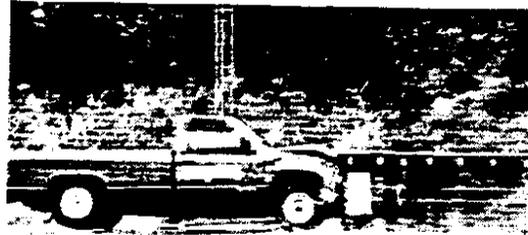
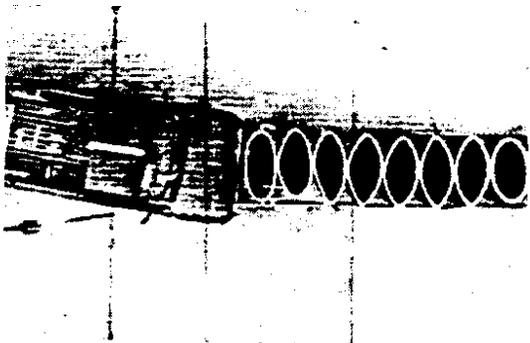
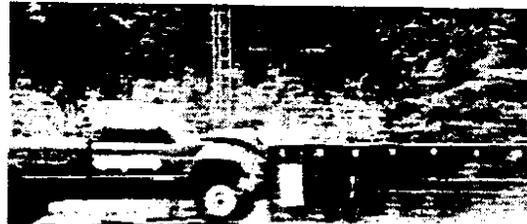
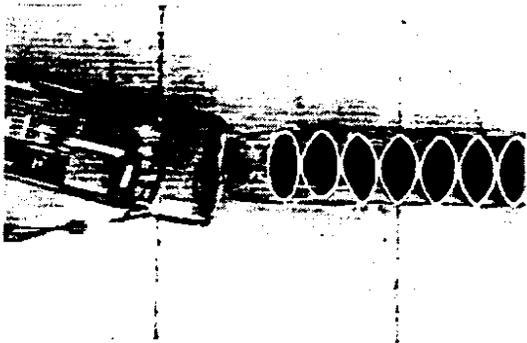
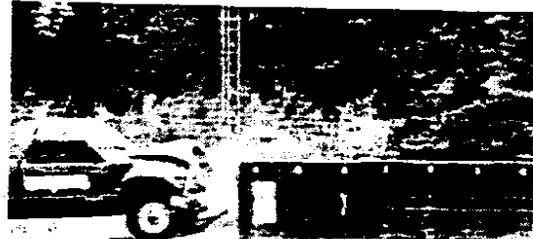
Figure 5. Sequential photographs for NCHRP Report 350
Test 3-31. (overhead and perpendicular views)

Figure 5. Sequential photographs for NCHRP Report 350 Test 3-31 continued. (overhead and perpendicular views)

The second test was 3-31 and involved a head-on impact with a 2000 kg pickup truck. All of the test criteria were again met, and Figures 5-6 present the collapse process for this test. The occupant impact velocity was 6.23 m/s, and the subsequent ridedown deceleration was 19.43 g's. The brake system again did not activate, and again it was not needed. Minor changes were made to this brake device for the next test. The I-beams in the first two cylinders were permanently deformed in this test. Since the goal was to develop a reusable crash cushion which will not require replacement parts after an impact, these I-beams were replaced with stiffer box beams for the next test.

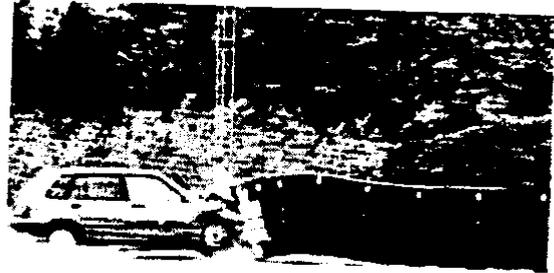
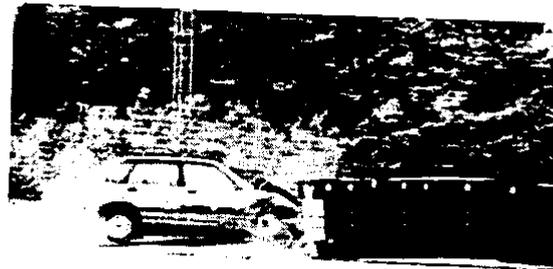
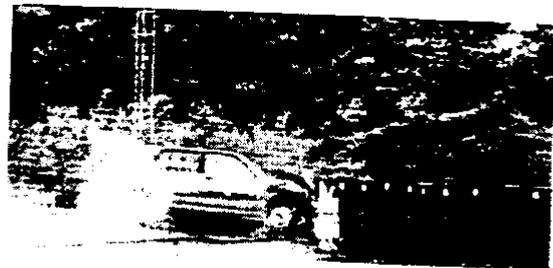
Figure 7. Sequential photographs for NCHRP Report 350
Test 3-32. (overhead and perpendicular views)

Figure 7. Sequential photographs for NCHRP Report 350 Test 3-32 continued. (overhead and perpendicular views)

The third test was 3-32, a nose impact with a 820 kg automobile at an impact angle of 15 degrees. This impact event is shown in Figures 7-8, which show that the test vehicle was brought to a controlled stop. As in the previous two tests, all test criteria were met (occupant impact velocity was 10.06 m/s and ridedown deceleration was 7.80 g's), and the brake system did not activate. It was now clear that a brake system was not needed, and it was removed from the device. There are three benefits associated with discarding the brake system:

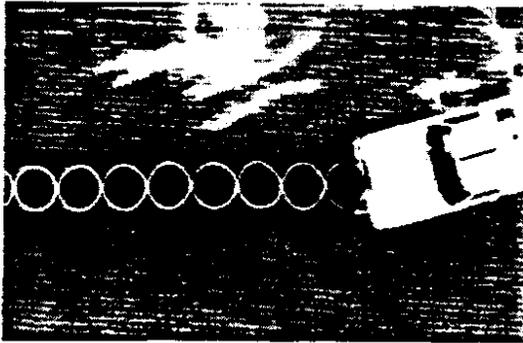
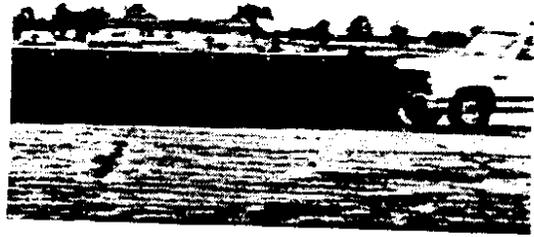
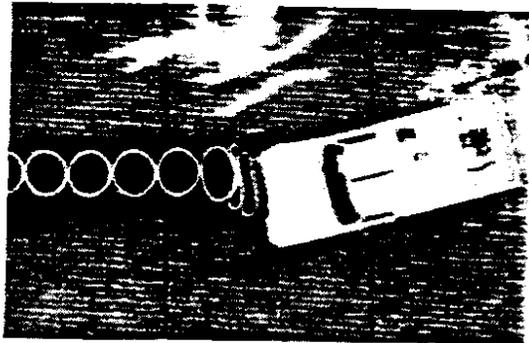
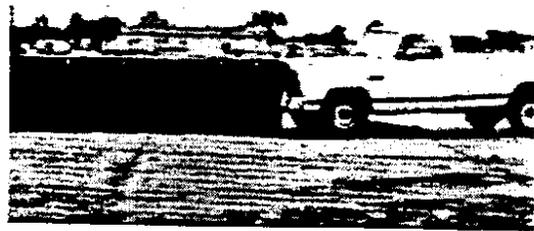
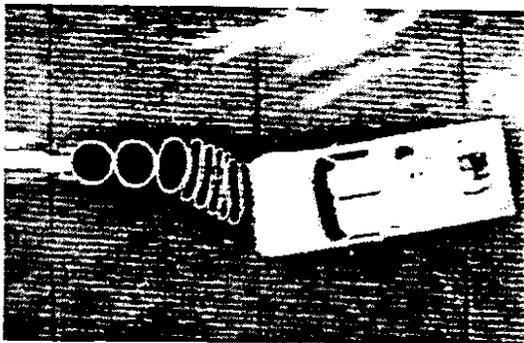
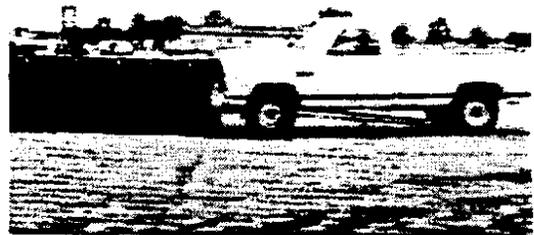
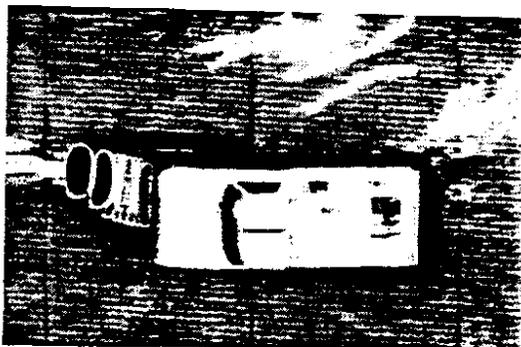
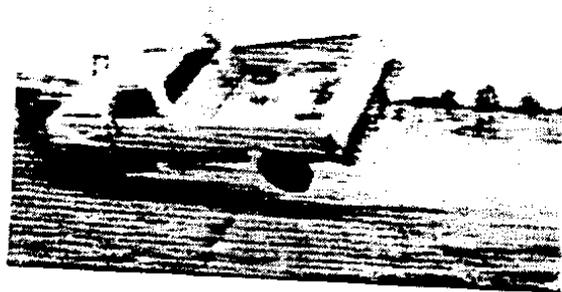
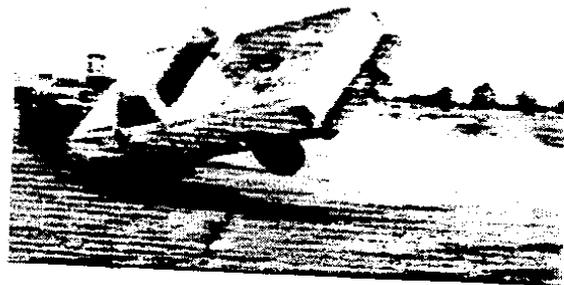
Figure 9. Sequential photographs for NCHRP Report 350
Test 3-33. (overhead and perpendicular views)

Figure 9. Sequential photographs for NCHRP Report 350 Test 3-33 continued. (overhead and perpendicular views)

Test number four, 3-33, was a demanding test involving a 2000 kg pickup truck impacting the nose of the device at an impact angle of 15 degrees. All test criteria were again met. In fact, the occupant impact velocity(6.26 m/s) and ridedown acceleration(11.75 g's) were both well below the preferred values. Figures 9-10 show the capture of the pickup truck during this severe impact event. The successful performance in tests 3-30, 3-31, 3-32, and 3-33 meant that all nose impact tests required by *NCHRP Report 350* had been passed.
