**EVALUATION OF THE INFLUENCE OF TACK COAT CONSTRUCTION  
FACTORS ON THE BOND STRENGTH BETWEEN PAVEMENT LAYERS**

**Report Prepared for  
Washington State Department of Transportation**

**Report# WCAT 06-002**

**August 2006**

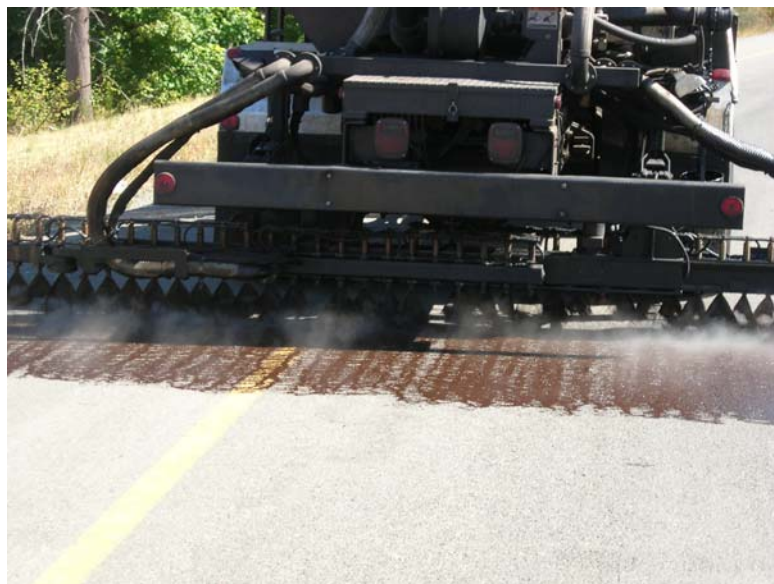
**Figure 1.1: A truck spraying tack coat on an HMA surface.**

A tack coat is a light application of an asphaltic emulsion between pavement lifts, most commonly used between an existing surface and a newly constructed overlay. Figure 1.1 shows a tack coat sprayed on an hot mix asphalt (HMA) surface. The role of a tack coat is to provide adequate adhesive bond between pavement lifts so that they behave as a monolithic structure. The inadequacy or failure of this bond causes slippage between the pavement layers, which results in a significant reduction in the shear strength of the pavement structure, thus making it more susceptible to a variety of distresses, such as cracking, rutting, and potholes (1).

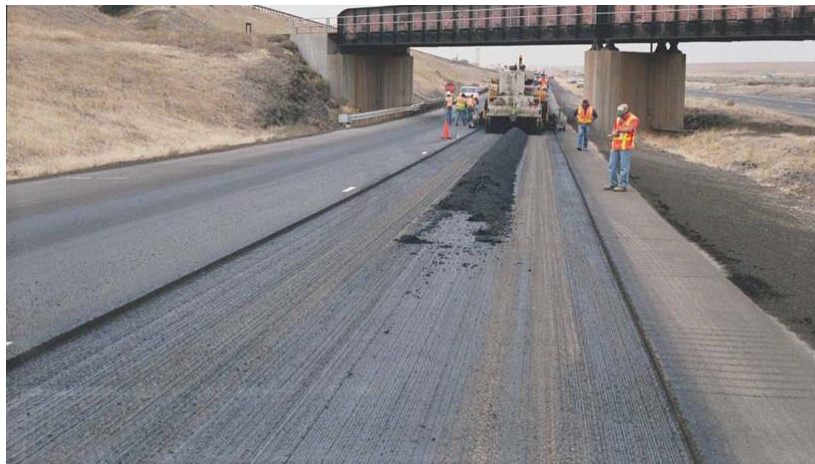
**Figure 2.1: Tracking due to the presence of debris.**

pick up the tack coat. Tracking typically occurs in both wheel paths, which is the most critical location for the new surface to bond to the existing surface. This problem happens more often with a milled surface because of the large amount of debris created during the milling process. Brooming the surface typically does not remove the debris adequately. A broom and vacuum system may be necessary to completely clean the roadway prior to the application of the tack coat (1).

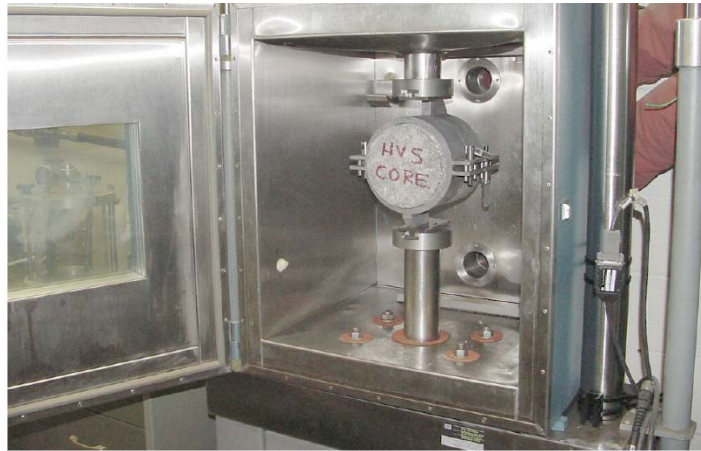
**Figure 2.2: FDOT Shear Tester device inside an MTS (Courtesy of FDOT).**

The Florida DOT identified the need for the development of a tack coat test set-up after premature failures in pavements overlaid on wetted tack coats. In 2003, the test set-up and procedure was developed after an extensive literature review and laboratory testing, as well as field investigation (15). This simple direct shear device can be used in a universal testing machine (e.g., MTS) as shown in Figure 2.2, or a Marshall Stability apparatus. The developed shear test attachment is shown in Figure 2.3.

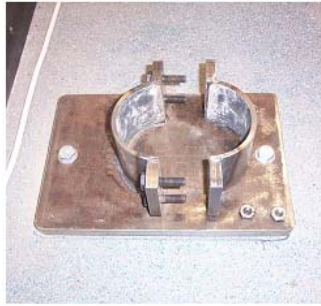
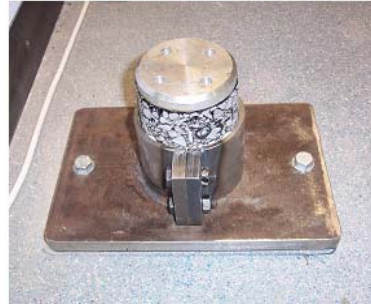
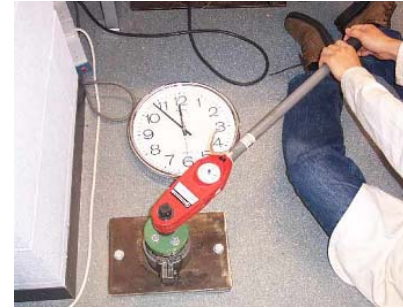
**a. Torque Grip**

**b. Specimen Set-up**

**c. Laboratory test**

**Figure 2.4: Laboratory Torque Bond test (24).**

Recently, a laboratory-based torque test was developed allowing the test to be conducted in a more controlled environment (23). The first step in conducting the Torque Bond test in the laboratory is to take a core through the pavement. The field core is then clamped below the interface using a gripping unit as shown in Figure 2.4a. A steel plate is glued to the top surface of the specimen prior to the test, which acts as an adapter between the specimen and the torque wrench (Figure 2.4b). A torque wrench is then attached to the plate and a torque is applied until the specimen fails. The force required for failure is recorded as well as the location of the failure (Figure 2.4c). The bond strength for the specimen is then calculated using the following equation:

Where  $\tau$  is the inter-layer bond strength (kPa);  $M$  is the peak torque at failure (N.m); and  $D$  is the diameter of the core (mm). The laboratory Torque Bond test is conducted at  $20 \pm 2^\circ\text{C}$  ( $68 \pm 4^\circ\text{F}$ ) unless otherwise specified. Torque is applied to the plate until failure of the bond occurs or a torque of 300-N.m is exceeded. For a well-bonded material, the failure occurs in the underlying material, and not at the bonded interface. Figure 2.5 show the laboratory test set-up that was used in this study.

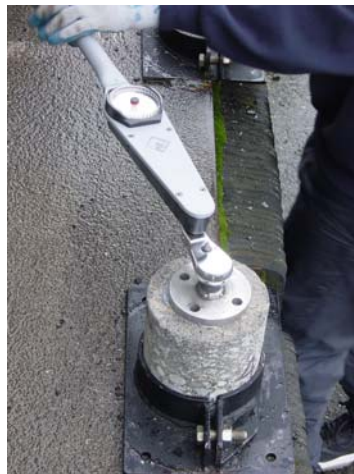
**Figure 2.5: WSDOT personnel performing the Torque Bond test.**

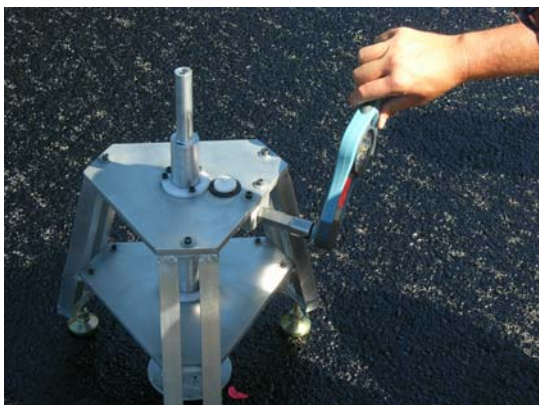
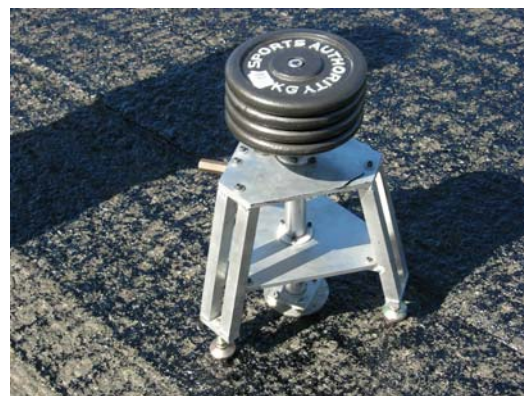
**a. Torque Wrench**

**b. 40-pound load**

**Figure 2.7: UTEP Pull-Off device used in this study.**

The UTEP Pull-Off test procedure is simple. After the tack coat is applied on the pavement, it is allowed to set (typically less than 30 minutes). Thereafter, the device is placed on the tack-coated surface. The torque wrench is rotated clockwise until the contact plate is firmly set on the tack-coated pavement. A 40-pound load is placed on the weight key (at the top of the device) for ten minutes prior to testing in order to set the contact plate. The load is then removed and the torque wrench is rotated in the counter clockwise direction to detach the contact plate from the tack-coated pavement. The torque required to detach the contact plate from the tacked pavement is recorded in inch-lb, and then is converted to the strength using a calibration factor. The calibration factor is obtained by placing loads in uniform increments on the contact plate and recording the torque required to pull the plate for each load increment. The relationship between the torque and load is established by fitting a straight line through the data points. Figure 2.7 shows one of the two UTEP Pull-Off devices used in this study.

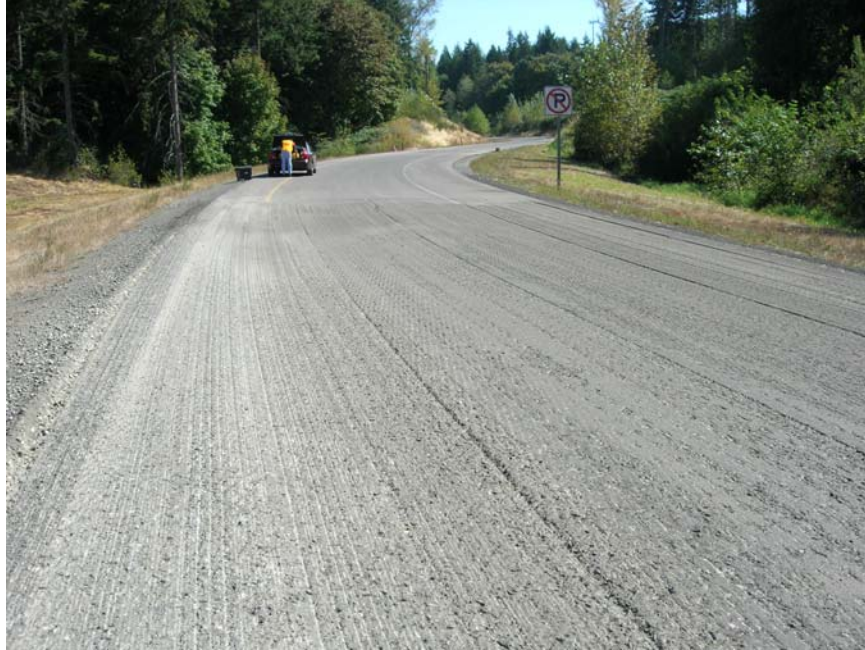
**Figure 3.2: Milled and non-milled sections after cleaning.**

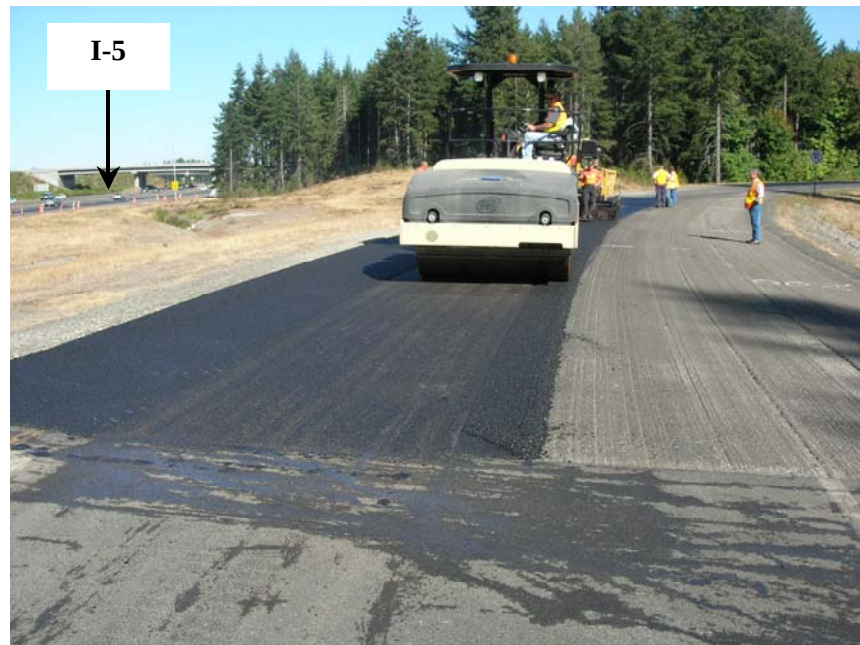
**Figure 3.3: Compaction and paving of sections number 1 and 3, respectively.**

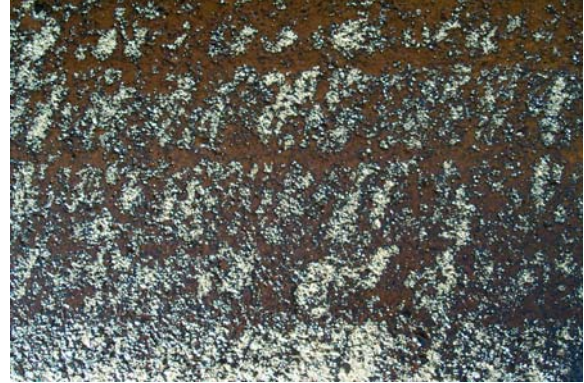
Figure 3.4: Pictures showing a broken and an unbroken section, on a non-milled surface with 0.02 gal/yd<sup>2</sup> residual rate.

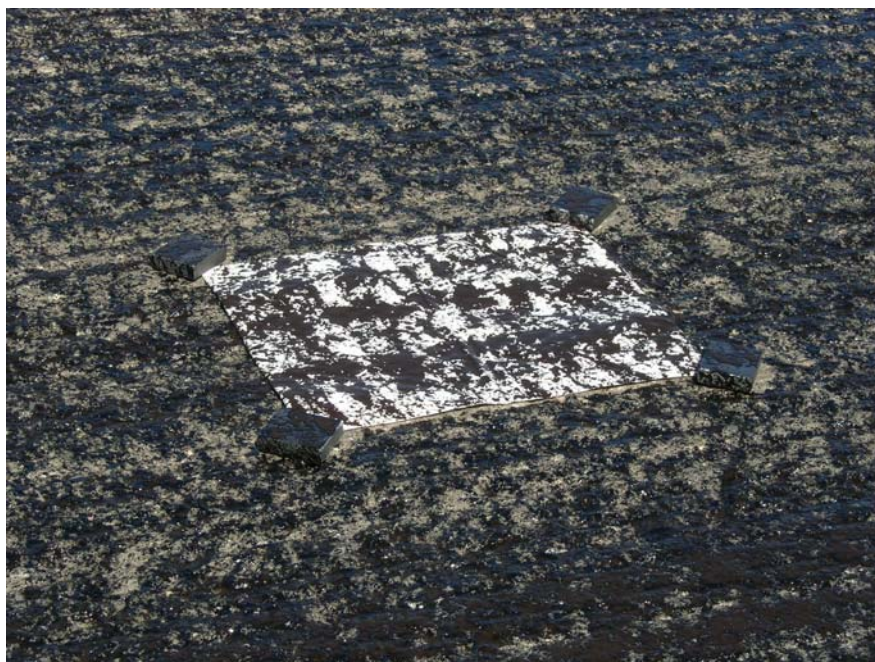
**Figure 3.6: Measuring the residual rate of tack coat on a test section.**

The residual tack coat rates were measured by WSDOT according to ASTM D2995 as shown in Figure 3.6. One measurement was taken for each section (except the No Tack sections number 7 and 8). It should be noted that WSDOT has modified the ASTM D2995 test to measure the residual rate instead of the application rate. Table 3.1 shows the target and measured residual rates. The correlation between them was 0.62 indicating that, in general, high values of target residual rates corresponded to high values of measured residual rates and low values of target residual rates corresponded to low values of measured residual rates. Nonetheless, the test over-predicted the target residual rates at lower rates and under-predicted them at higher rates as shown in Figure 3.7 (measured rates varied by only 0.019 gal/yd<sup>2</sup>). This could be attributed to an inaccuracy in measuring the target residual rates, lack of samples, an inaccuracy in applying the target rates by the truck, or any combination of these factors. However, it was noticed during the placement of the tack coat that the variations in the residual rates among the test sections were larger than the predicted values by the ASTM test as visually shown in Figure 3.5. Based on this visual observation, it was decided to use the target residual rates in the subsequent statistical analyses.

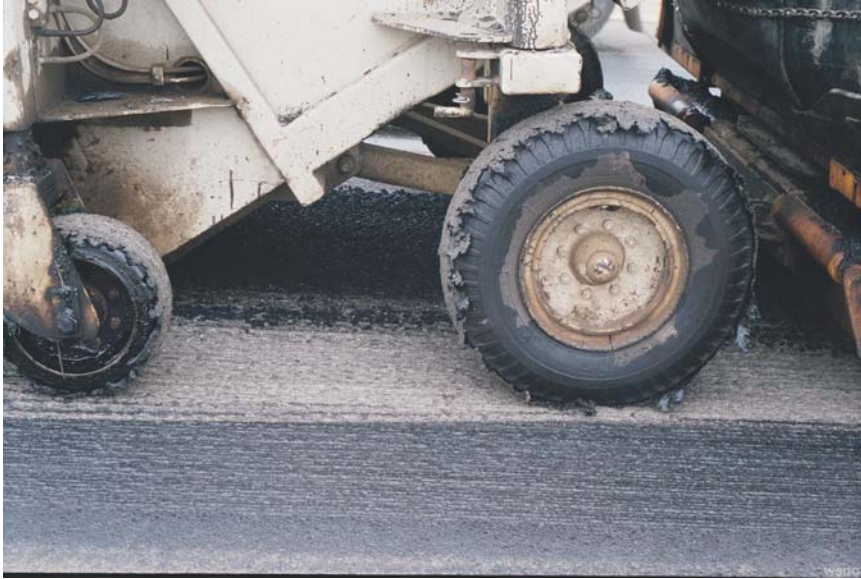
**Figure 10: Tracking as seen on separate WSDOT HMA paving projects.**

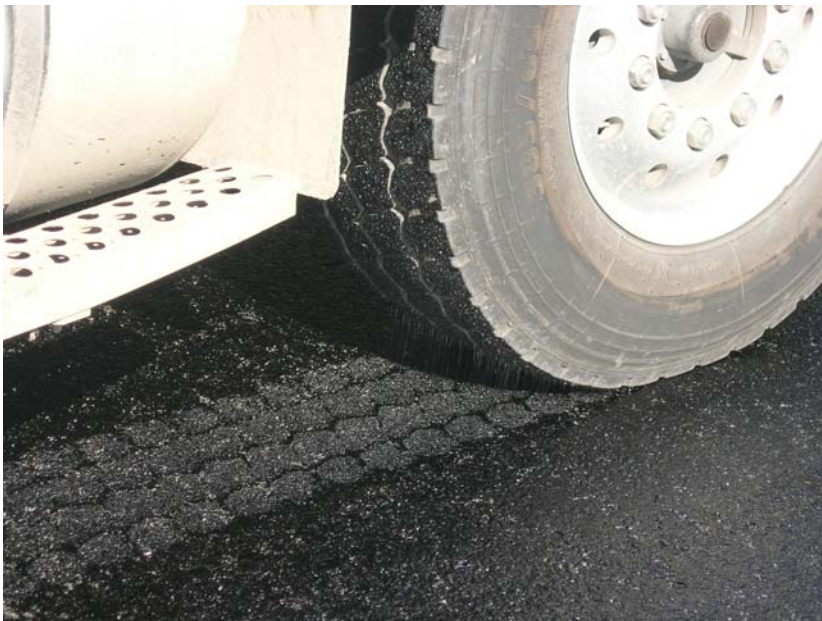
**Figure 3.11: Equipment tracking during this experiment.**

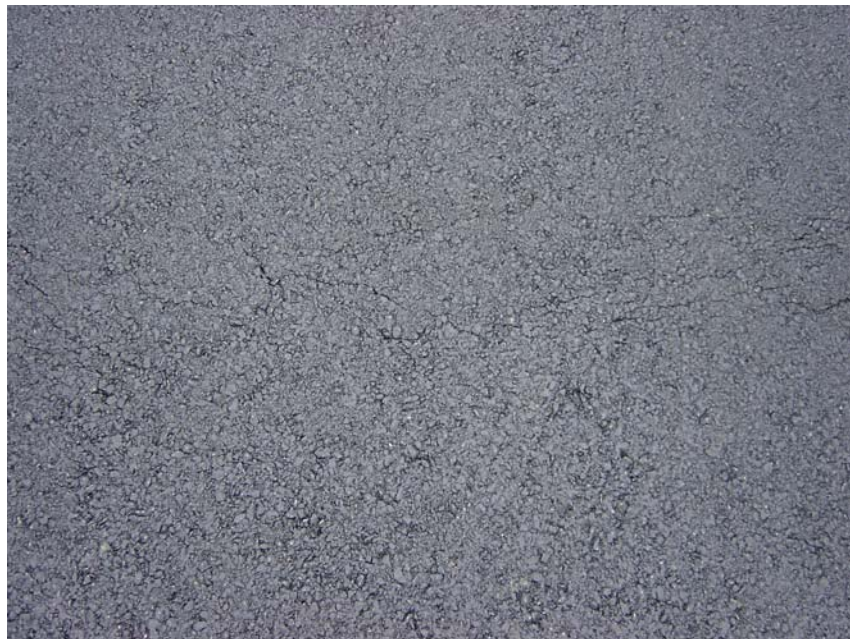
**Figure 4.7: Cracking problems in test section number 8.**

A total of 168 cores were planned to be obtained and tested. However, all the cores taken from test section number 8 de-bonded at the interface during sampling. In addition, two cores from test section number 9, two from test section number 14, and one from test section number 1, broke during sampling, shipping, or testing. Thus, a total of 151 cores were tested. Of these, 74 cores were tested using the FDOT Shear Tester, and 77 were tested using the Torque Bond test at the WSDOT Materials Lab in Tumwater, Washington. The cores that were excluded and the ones that were not tested but included in the analyses are listed in Appendix E and Appendix F.

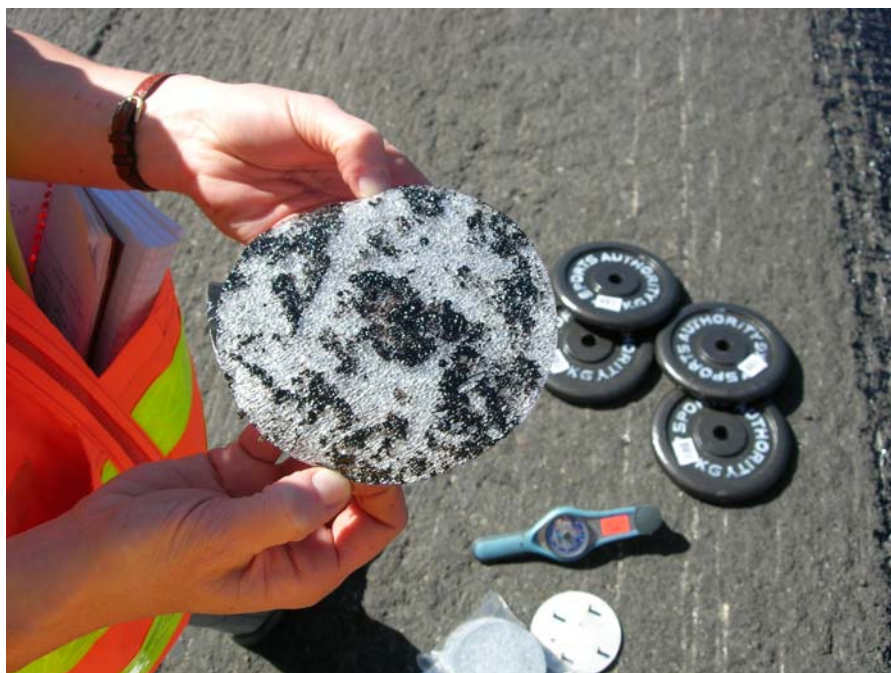
**Figure 4.9: UTEP Pull-Off contact plate after the test completion.**
