# Warm Mix Asphalt Final Report

WA-RD 723.2

# Experimental Feature Report

I-90

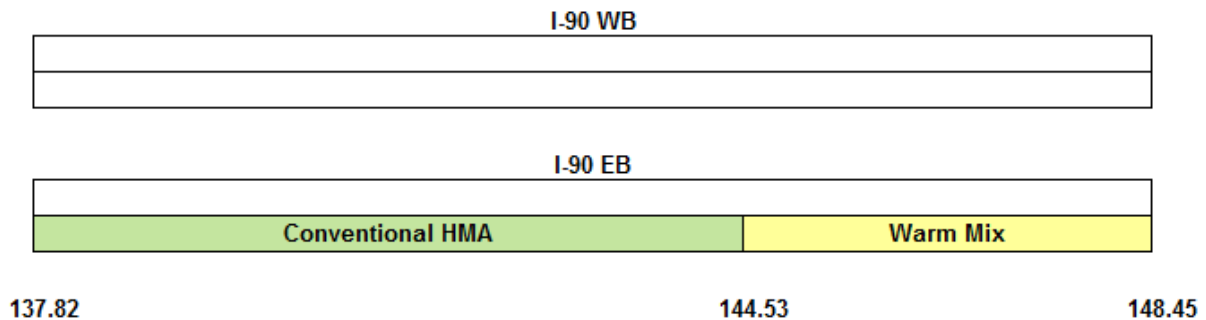
Figure 2. Plan map showing location of warm mix.

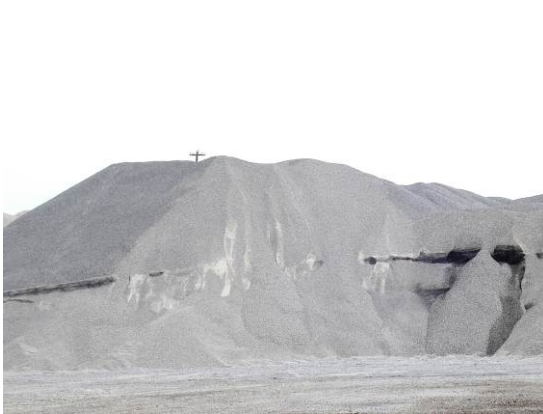
Figure 3. Three quarter inch to No. 4 stockpile.

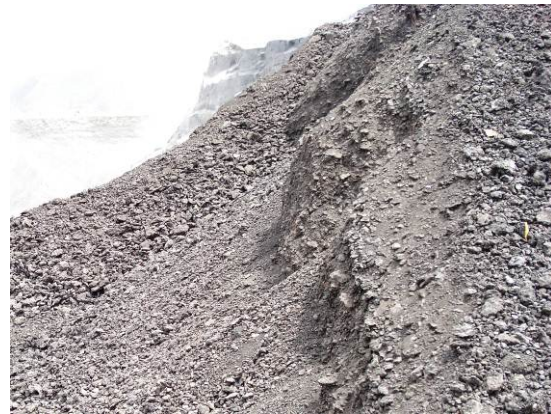
Figure 4. RAP Stockpile.

The mix included recycled asphalt pavement (RAP) at a rate of 20 percent. The RAP for the project came from the material recovered from the grinding of the existing pavement.

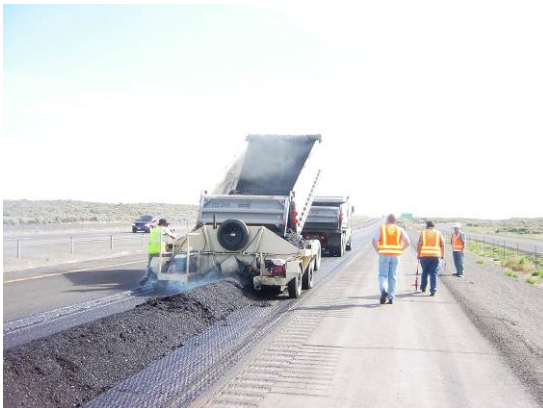
Figure 5. Truck dumping into the windrow device and forming windrow.

Placement of the HMA and WMA used the same equipment and methods (Figures 5 through 8). End dumps with trailers delivered the mix to the project. Haul times varied from 30 to 45 minutes during placement of the HMA and from 25 to 35 minutes during placement of the WMA. Loads were not covered. Once delivered to the site, the trucks dumped the mix into a windrow device to form a windrow. A windrow elevator delivered the mix from the windrow into the hopper of an Ingersoll-Rand PF-5510 paving machine equipped with an Omni 3E screed. The paving machine was forced to stop on occasion to wait for the delivery of mix. Otherwise the placement operation proceeded smoothly. Placement dates, location and tonnage are shown in Table 5.

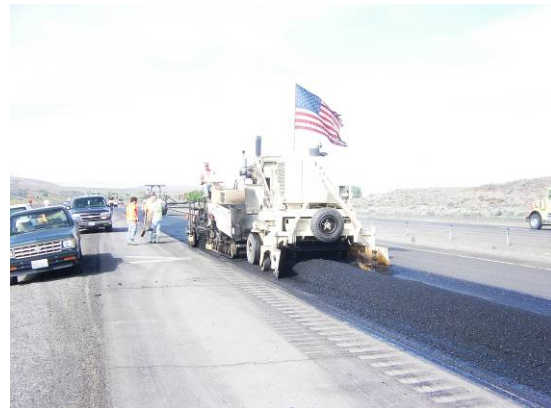
Figure 6. Windrow elevator picking up mix in windrow.

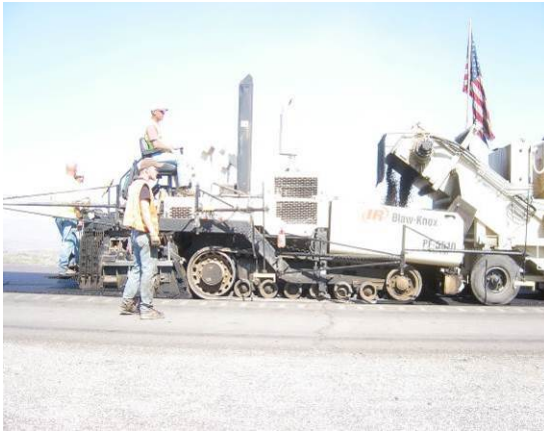
Figure 7. Windrow elevator delivering mix to machine.

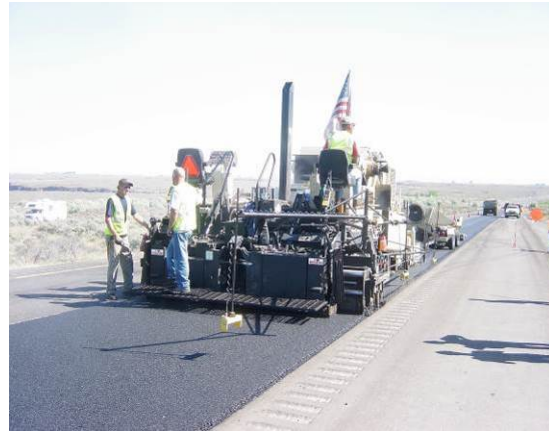
Figure 8. Paving machine spreading the mix.

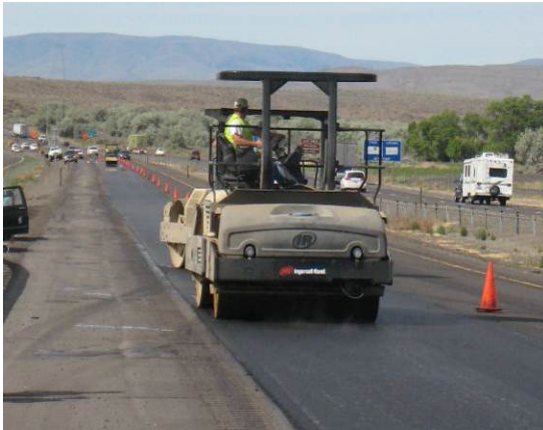
Figure 9. Breakdown roller.

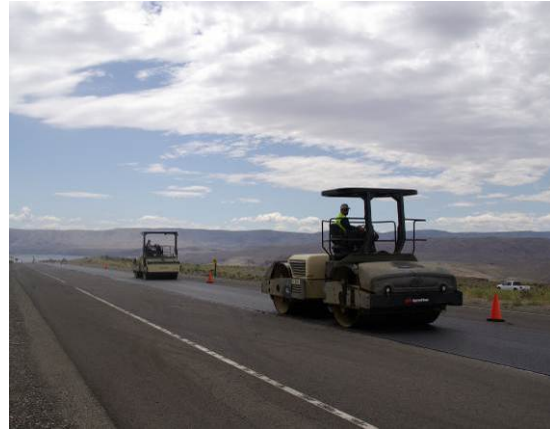
Figure 10. Breakdown and intermediate rollers.

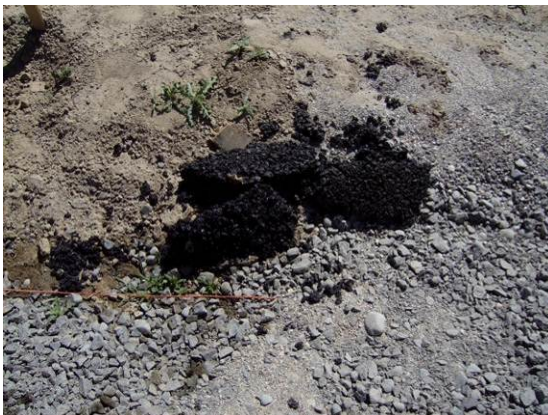
Figure 11. Clumps removed from WMA during test section near Quincy.

The only potential problem encountered was clumps of mix sticking together in the WMA. The clumps first appeared on June 19 during a test section of the WMA in a new subdivision in Quincy, WA (Figure 11). It was reported that the clumps in the test section occurred every few feet and were the result of excessive cooling of the mix during the approximately 40 minute haul (Hoffman, 2009). The lumps continued to appear during production paving on Interstate 90 but were much less frequent (Figure 12).

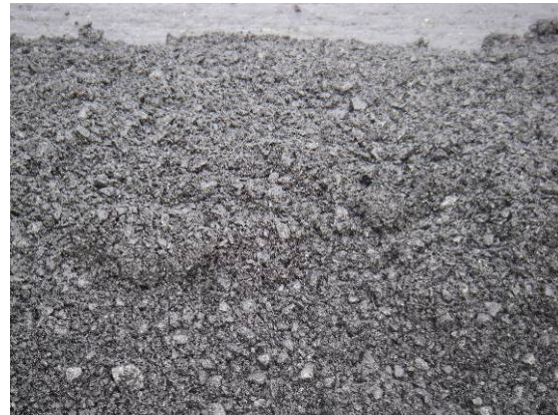
Figure 12. Clumps in windrow during placement of WMA on I-90.

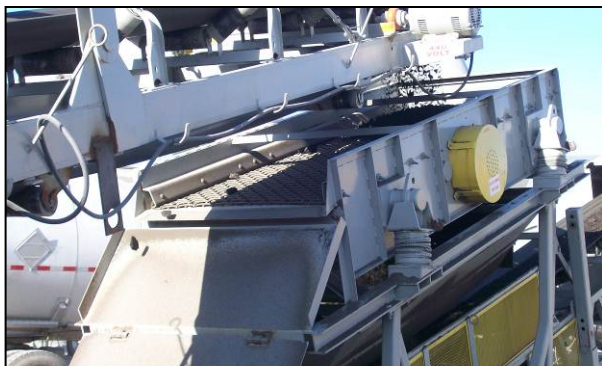
Figure 13. Screening RAP.

The source of the lumps was not verified but one theory is that mixing temperatures may not have been high enough to break up large chunks of RAP. Figure 13 shows the RAP passing through a screen before it entered the drum and Figure 14 shows the RAP which was unable to pass through the screen. This process made it unlikely that large chunks of RAP made it into the mix. Furthermore the RAP came from a  $\frac{3}{4}$  inch NMA mix with 3.2 percent of the aggregate retained on the  $\frac{3}{4}$  inch sieve. Gradation test results for the HMA and WMA showed no aggregate retained on the  $\frac{3}{4}$  inch sieve indicating the CWA did a good job of keeping the larger aggregate out of the mix. If large chunks of RAP were entering the drum some of the  $\frac{3}{4}$  inch or larger aggregate would have made it into the mix and showed up as retained on the  $\frac{3}{4}$  inch sieve.

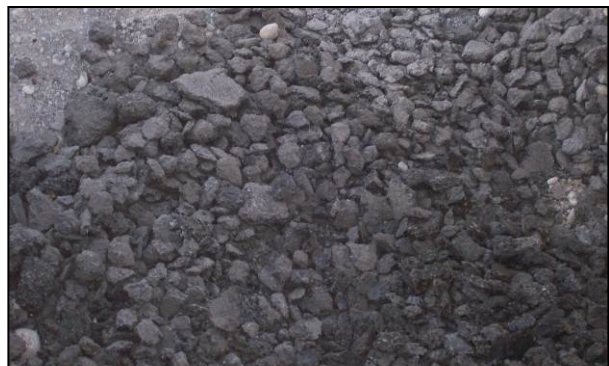
Figure 14. Material that did not pass through the RAP screen.

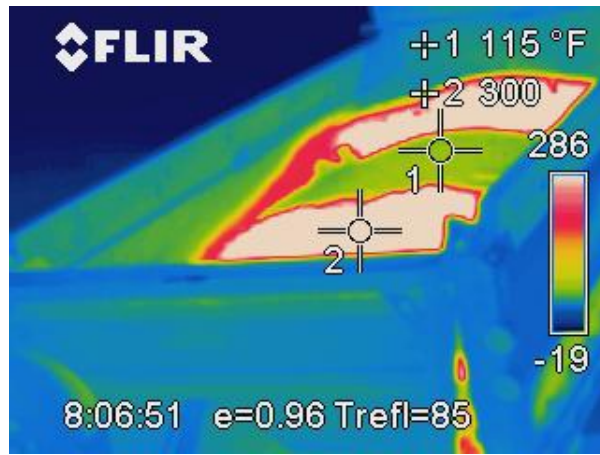
Figure 15. WMA crust temperature of 115°F leaving truck.

Thermal images of WMA in the truck and in the windrow are shown in Figures 15 and 16. The crust on the mix in the truck was at 115°F and the cool mix in the windrow at 176°F. The location of the temperature readings are denoted by a numbered symbol consisting of a circle with four bars at 0, 90, 180, and 270 degrees. The temperature at that point is noted in the upper right hand corner of the image. Mix at temperatures shown in the two photos would have hardened since Sasobit® loses its viscosity reduction ability below its melting point of about 216°F. The hardened mix could show up as clumps in the windrow. Remixing before placement in order to reheat the clumps would be the solution to this problem. The fact that no clumps were seen in the completed mat may be because the windrow elevator remixed the HMA sufficiently to eliminate the clumps.

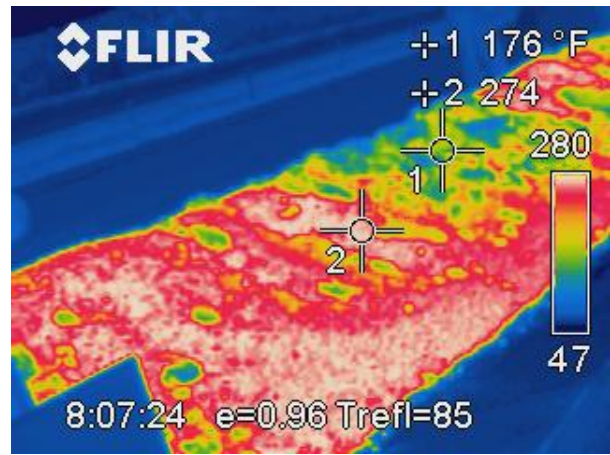
Figure 16. Cool WMA in windrow.

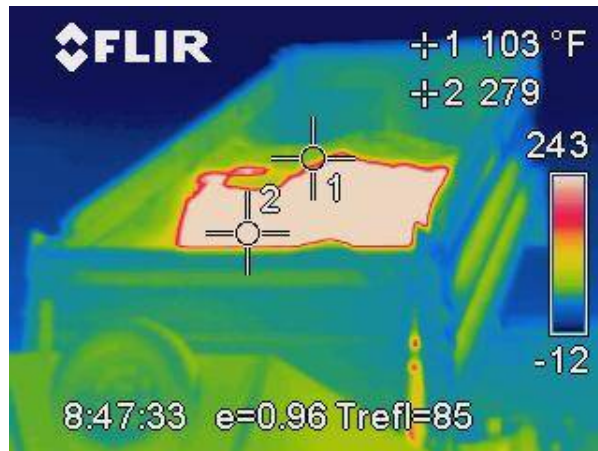
Figure 17. Thermal image of first load of WMA as it is being dumped into windrow device.

The temperature of the mix was measured using a FLIR ThermoCAM<sup>TM</sup> E4 infrared camera. The infrared camera can only measure the external temperature of the mix which is not representative of the internal temperature once a cooler crust has formed. For that reason this report only uses temperatures taken immediately after the breaking of the crust or immediately after remixing of the HMA. This occurred at three locations, when trucks dumped the mix into the windrow machine (Figure 17), when windrow elevator transferred the mix to the paving machine hopper (Figures 18), and when the augers distributed the mix to the screed (Figure 19).

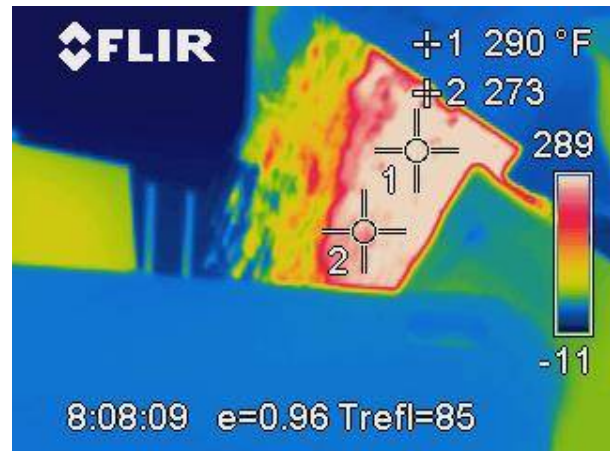
Figure 18. Thermal image of windrow elevator delivering WMA to the hopper.

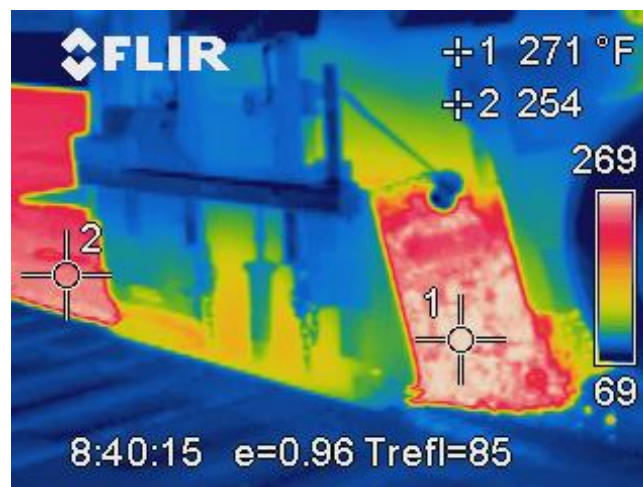
Figure 19. Thermal image of WMA in front of augers.

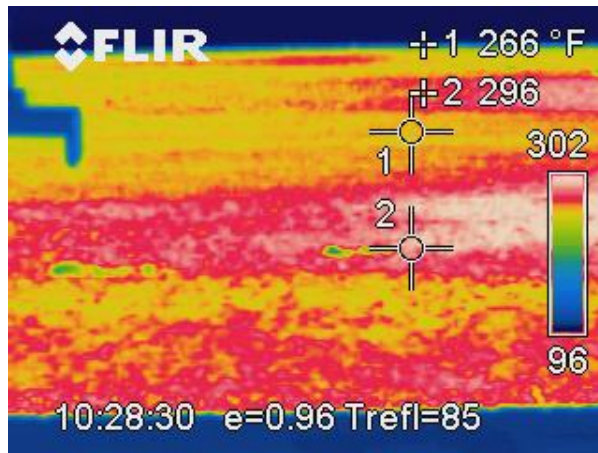
Figure 20. Thirty degree temperature differential in HMA.

Temperature differentials up to 30°F were observed in both the HMA and WMA (Figures 20 and 21). Temperature differentials were attributed to a jump in temperature in the windrow where the mix placed by one truck ended and the mix placed by the next truck began. The mix from the first truck would have sat in the windrow longer and cooled more than the mix from the next truck resulting in a change in mix temperature. The windrow elevator provided minimal remixing so the jump in mix temperatures showed up as temperature differentials behind the paving machine.

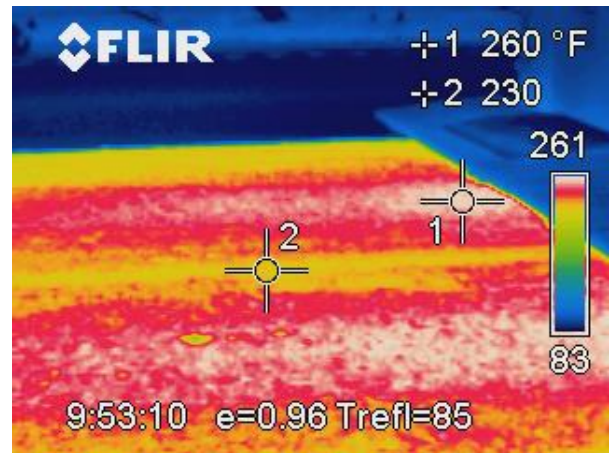
Figure 21. Thirty degree temperature differential in WMA.

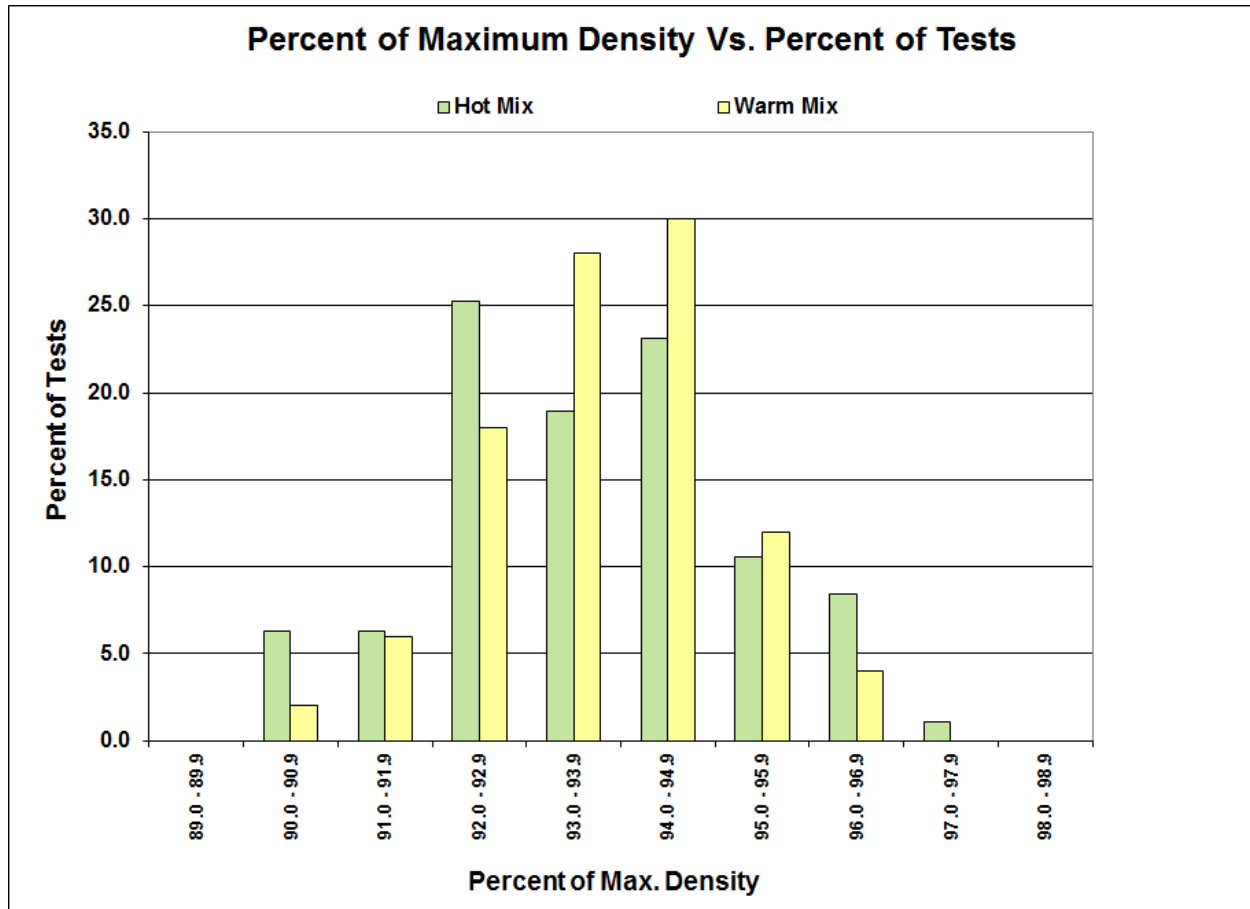
Figure 22. Distribution of compaction test results.

Density results of the HMA and WMA were similar (Figure 22). The distribution of the actual results illustrated by the bars is somewhat erratic due to the small number of tests. The average test result for HMA was 93.5 percent with a standard deviation of 1.58 versus 93.7 percent and a standard deviation of 1.36 for WMA. The size of the standard deviations as compared to the difference in average density indicates that the variation is statistically insignificant. The one notable difference was that the number of failing density tests was significantly lower with WMA. Out of 95 density tests on the HMA, six (6.3 percent) failed to reach the 91.0 percent minimum specified density. Only one out of 55 (1.8 percent) density tests on the WMA was below 91.0 percent. The compactability of the WMA was probably improved by 0.3 percent higher asphalt content. Overall the results indicate that the same level of density is achievable at lower compaction temperatures with WMA. Density test results are in Appendix E.

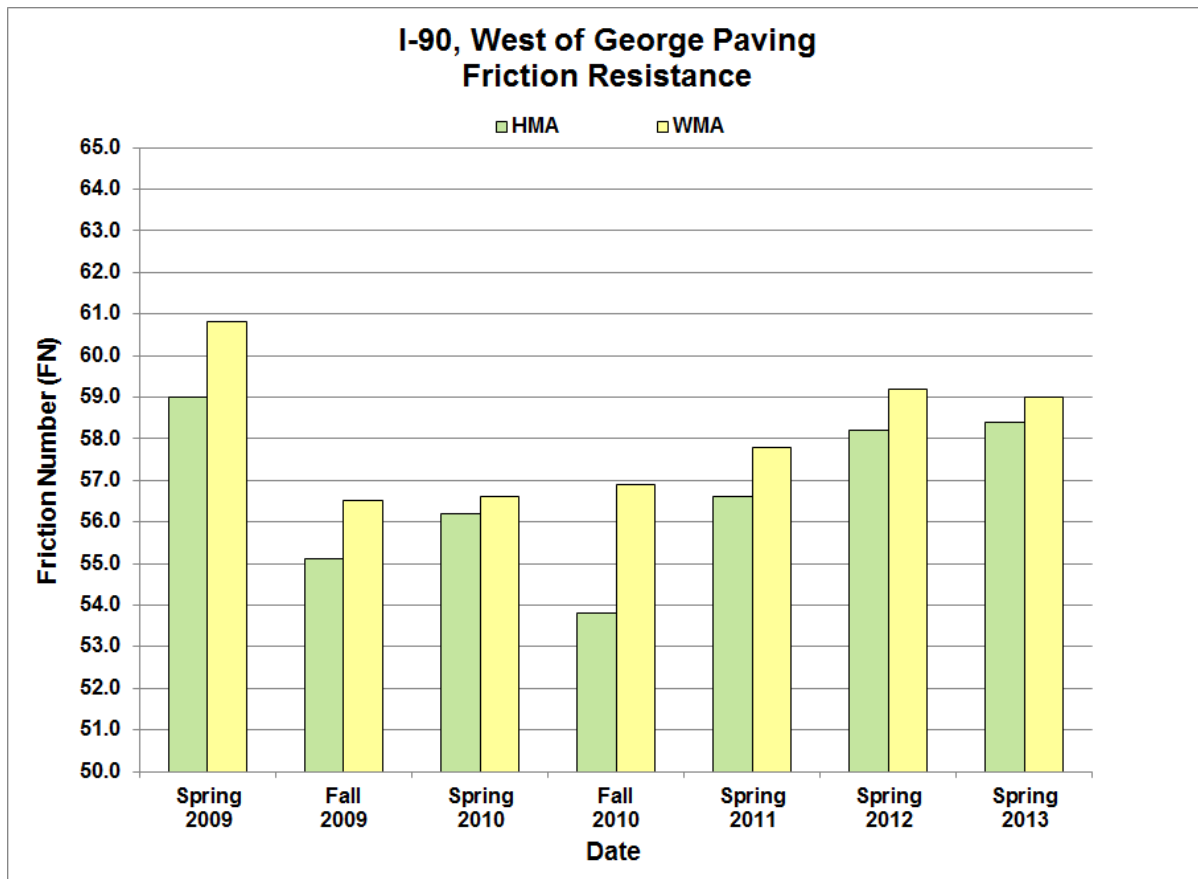
Figure 23. Friction resistance measurements over time for HMA and WMA sections.

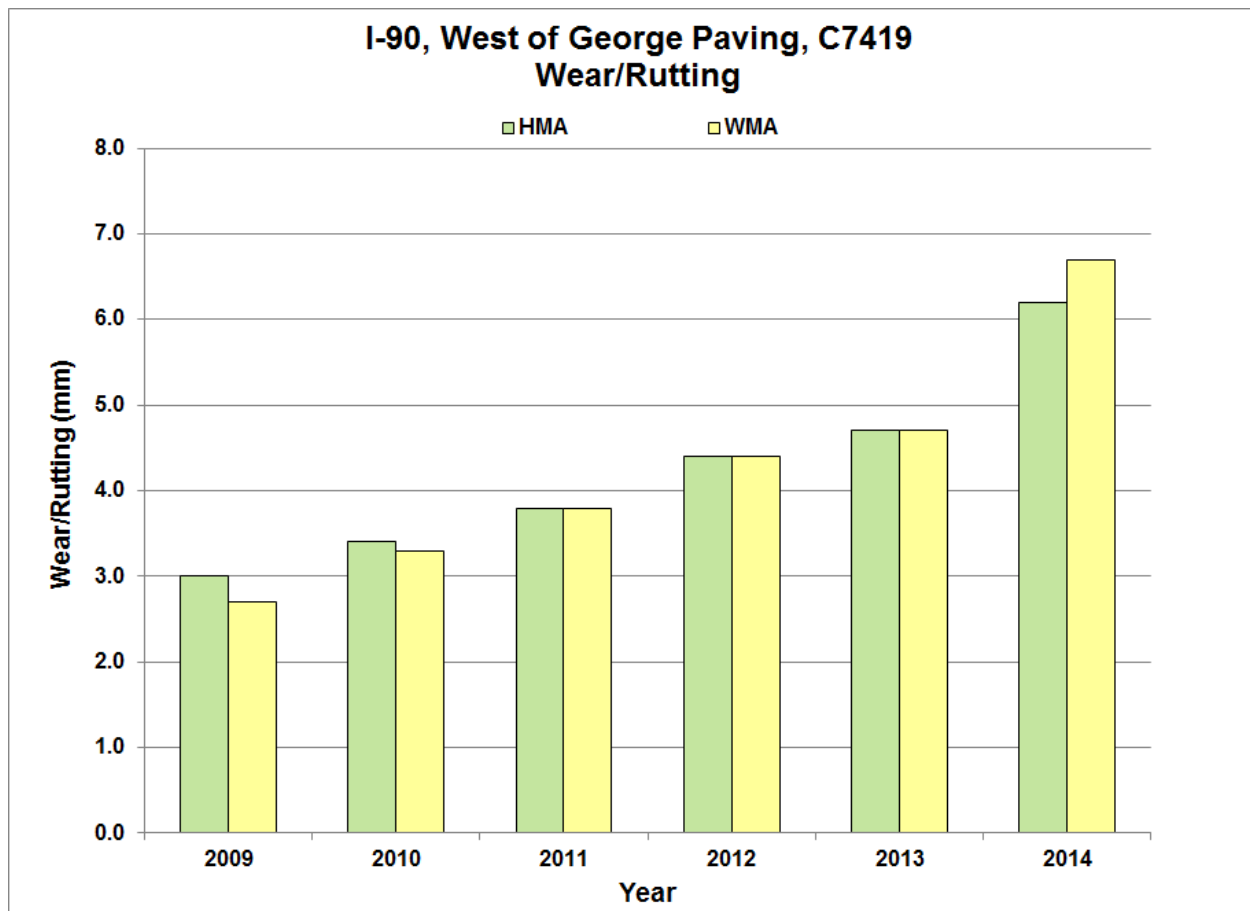
Figure 24. Wear/rutting measurements.

Wear/rutting measurements from the Pathway Road Rater are listed in Table 10 and shown graphically in Figure 24. Normal increases in wear/rutting were noted between the 2009 and 2014 data. The differences in wear/rutting between the two sections ranged from -0.3 to +0.5 mm. The small differences indicate no significant difference in wear/rutting between the two sections.

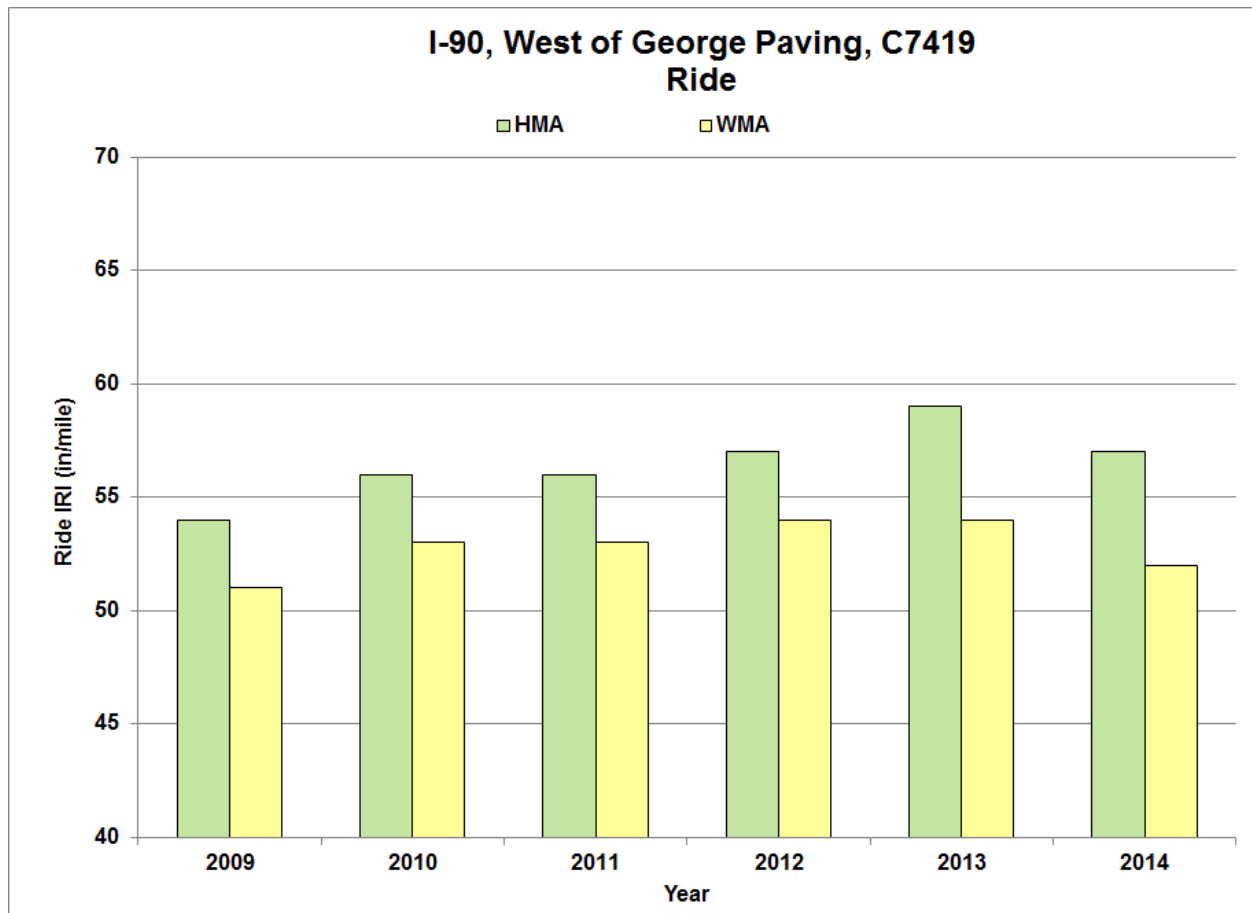
Figure 25. Ride measurements.

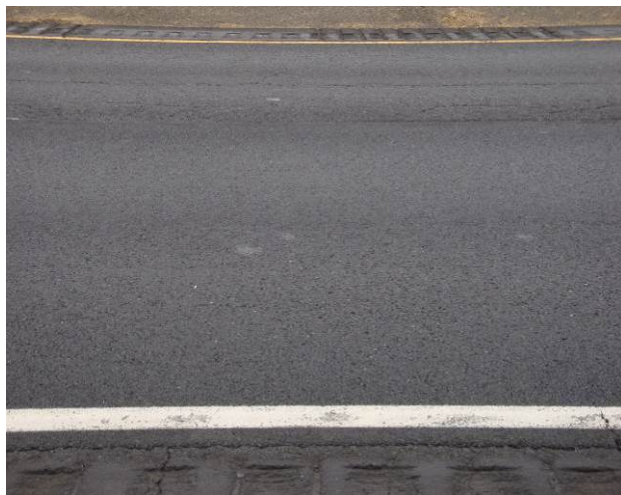
Figure 26. Sasobit® section. (Jan. 2011)

The WSU study also examined the early age field performance of the WMA and HMA pavements. Rutting/wear and ride measurements were equal for the Sasobit® and conventional HMA sections, which agrees with the longer term data reported previously. The WSU report indicated less reflective transverse cracking in the Sasobit® section, however, the authors indicated that this may not hold true into the future. Figure 26-29 show the condition of the Sasobit® and HMA section 31 months after paving.

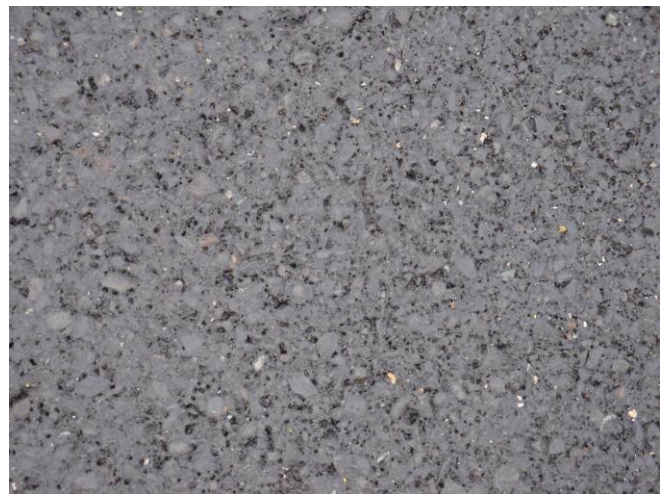
Figure 27. Sasobit® section close-up. (Jan. 2011)

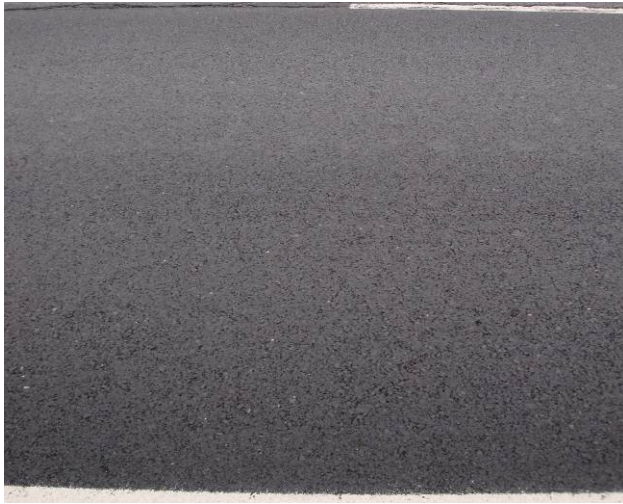
Figure 28. HMA section. (Jan. 2011)

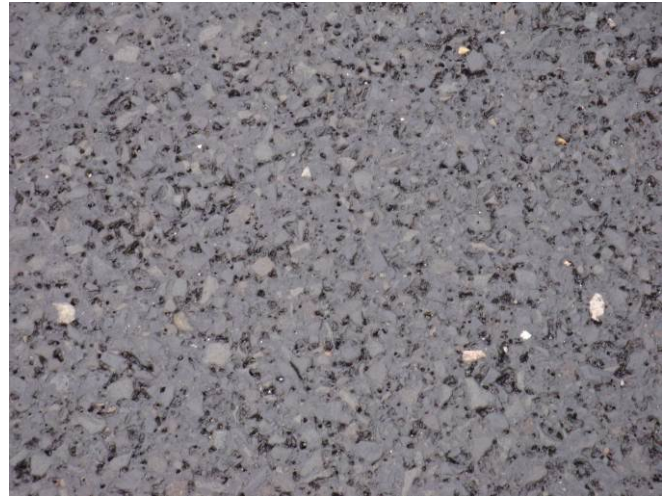
Figure 29. HMA section close-up. (Jan. 2011)

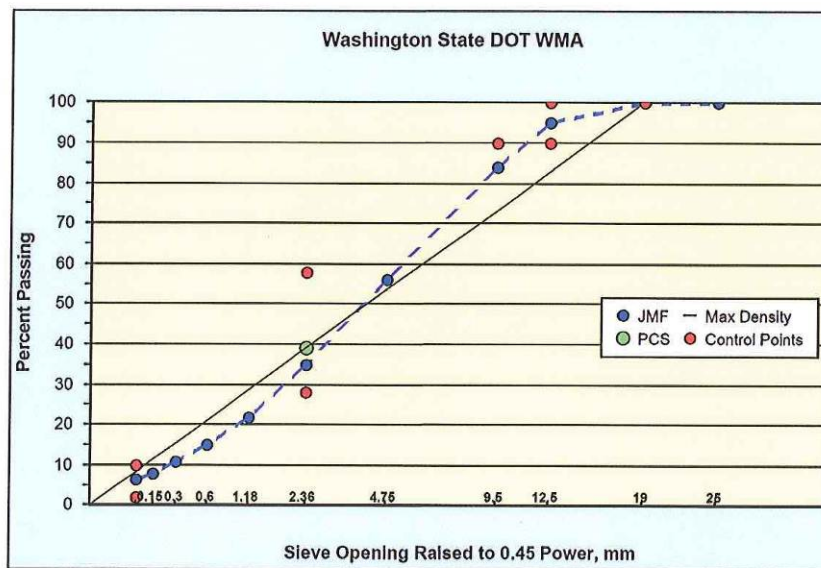
Figure 1: .45 power chart Warm Mix/Control JMF

Figure 1 plots the target mix design gradation for both the warm mix and control mix.

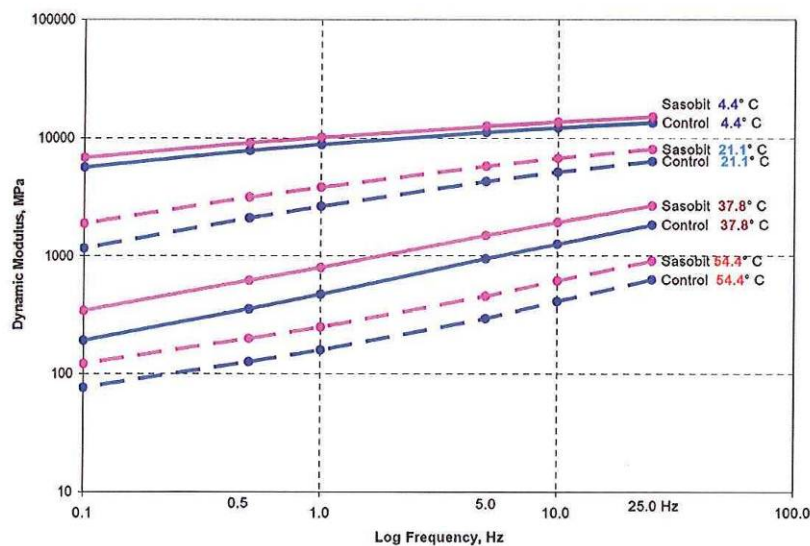
Figure 3: Dynamic Modulus,  $|E^*|$

The dynamic modulus testing results are summarized in Appendix C. Figure 3 compares the average dynamic modulus values for each mix at the selected test temperatures and frequencies applied to the test specimens.

As expected, the Sasobit WMA additive had a stiffening effect on the asphalt mixture compared to the HMA control mix. This stiffening effect by the Sasobit additive has been observed in other WMA project testing by MATL staff as well as other research.

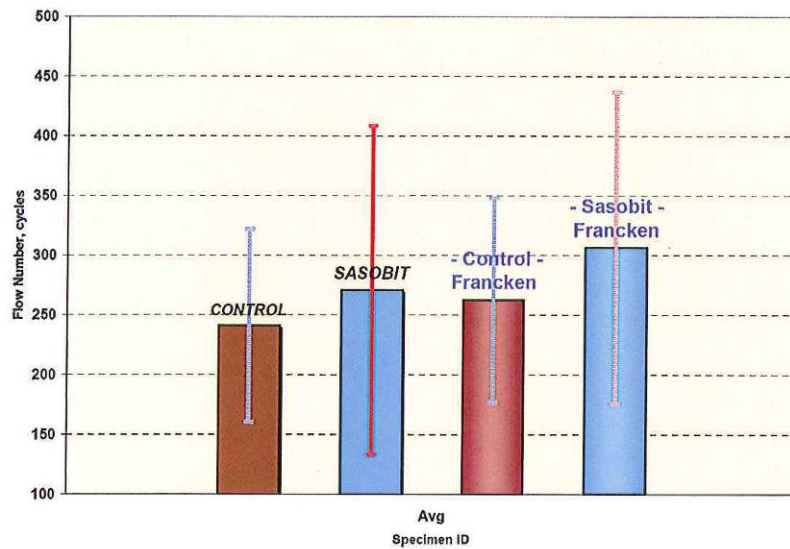
Figure 4: Flow Number,  $F_n$

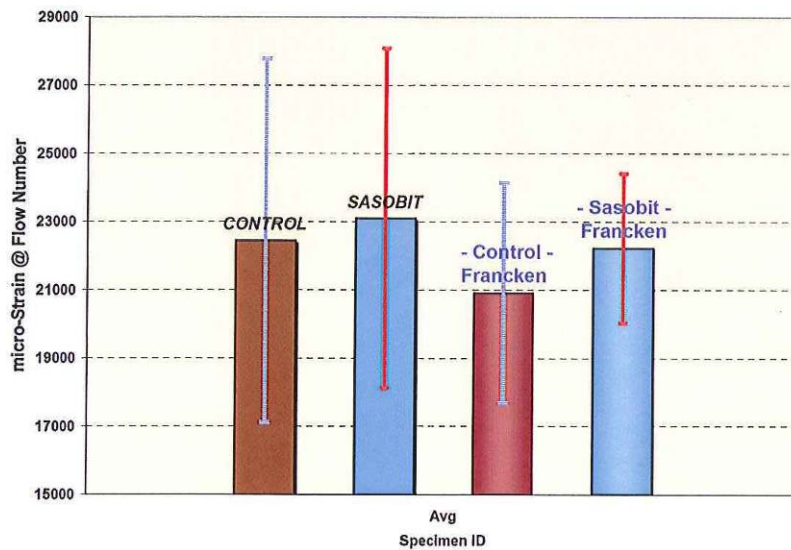
Figure 5: Accumulated Strain at Flow Number

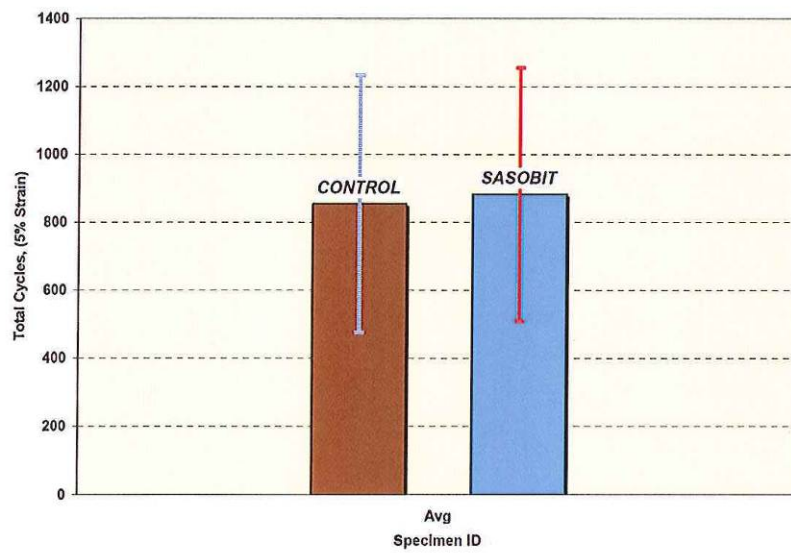
Figure 6: Total cycles at 5% Strain

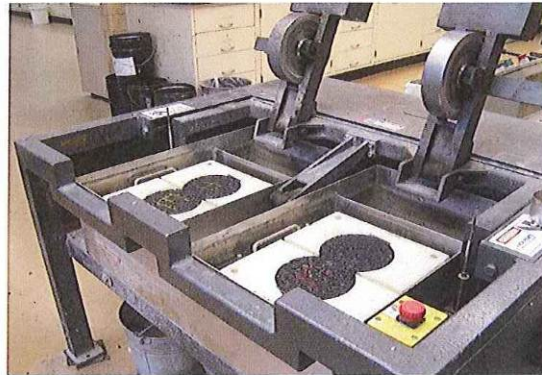
**Figure 7: Hamburg Wheel Tracking Device**

The HWTd has a water bath capable of controlling the temperature within  $\pm 1.0^\circ\text{C}$  (1.8°F) over a range of 25 to 70°C (77 to 158°F) and circulates the water to stabilize the temperature within the specimen tank. A gage capable of measuring the depth of the impression of the wheel within 0.01 mm (0.0004 in.), over a minimum range of 0 to 20 mm (0.8in.) is mounted on the HWTd to measure the depth at the midpoint of the wheel's path on the test specimen.

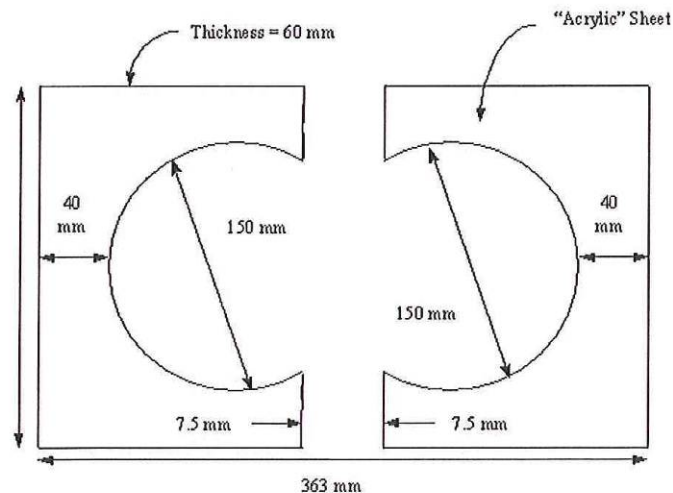
**Figure 8: Test Specimen Configuration for the Hamburg Wheel-Tracking Device**

The test requires two SGC test specimens for each test. Six gyratory specimens were compacted in accordance with AASHTO T312 with the dimensions of  $60 \pm 2$  mm height by 150 mm diameter for each of the control and WMA-Sasobit mixes with a  $7 \pm 0.5\%$  target air void content. Volumetric properties of these specimens were measured. The test specimens were cut to the dimensions shown in Figure 8 in order to fit in the molds required for performing the wheel tracking test.

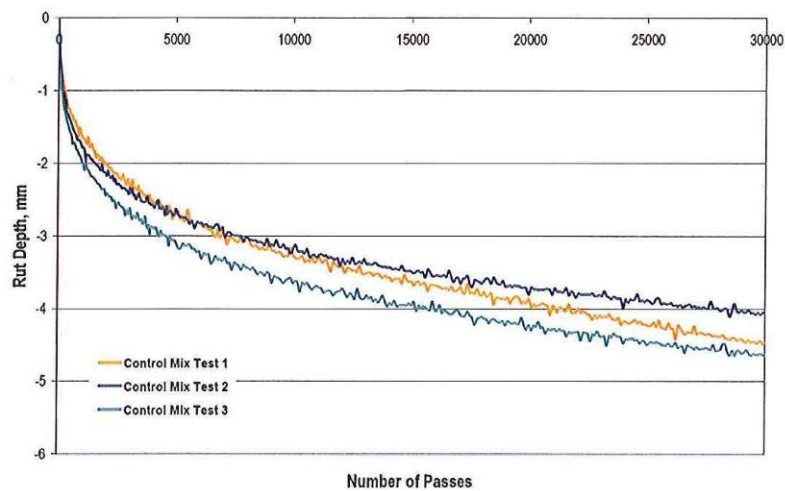
Figure 9: Hamburg Wheel Track Test Results of HMA Control Mix

Figure 9 shows the Hamburg wheel tracking test results of Washington Control mix of three tests.

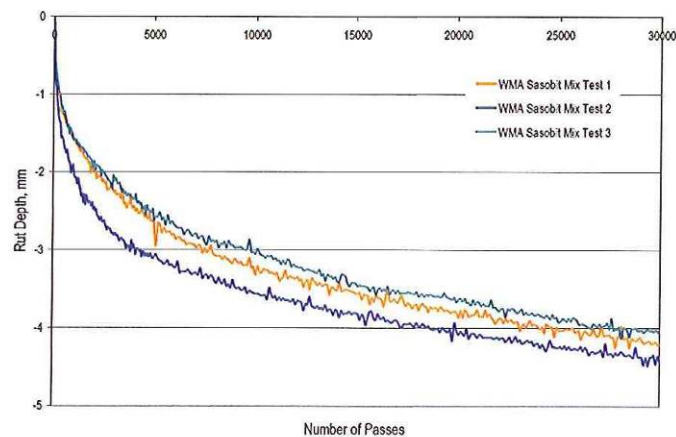
**Figure 10: Hamburg Wheel Track Test Results of Washington WMA Sasobit Mix**

Figure 10 shows the Hamburg wheel tracking test results of Washington WMA Sasobit mix of three tests. Table 2 shows the summary of Hamburg wheel track rut depths of

Washington control and WMA Sasobit mixes. Rutting slopes were determined from the start of the steady-state portion of the curve and up to 20,000 passes. Hamburg Wheel Track test results of individual tests for both Control and Sasobit mixes are presented in Appendix E.

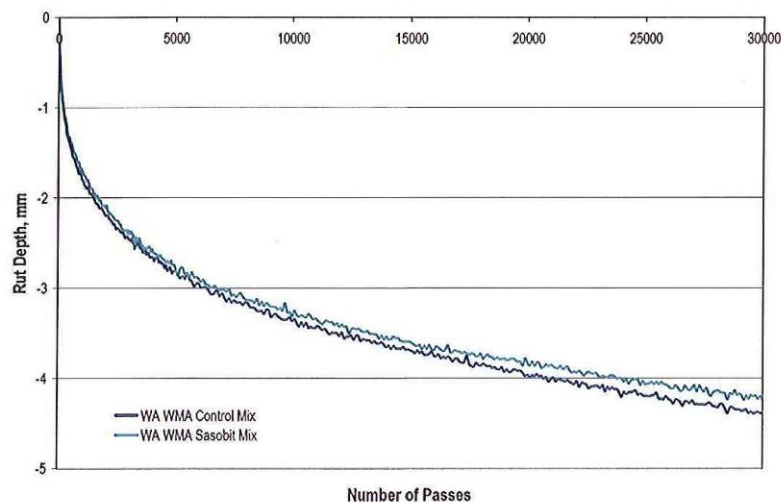
**Figure 11: Comparison of Hamburg results of Control and WMA Sasobit Mixes**

Figure 11 shows the comparison of Hamburg wheel tracking average test results of Washington control and WMA Sasobit mixes.

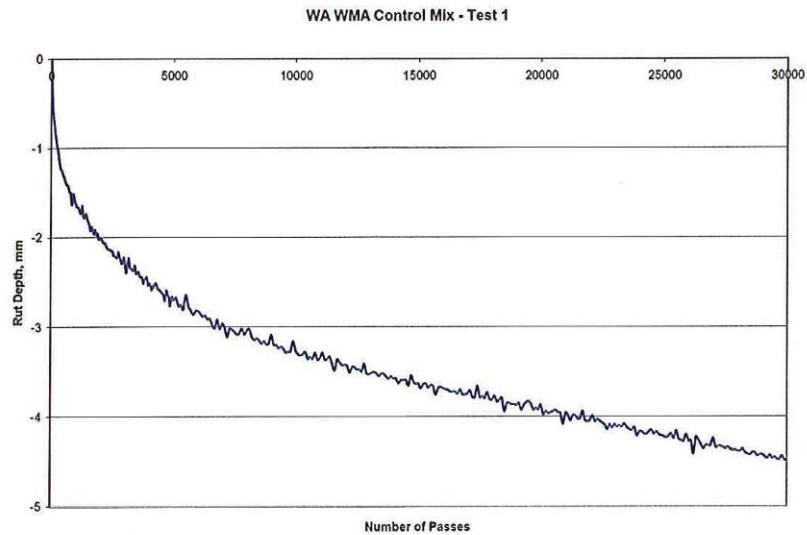
**Figure A1: Hamburg Wheel Track Test Results of Washington WMA Control Mix Test 1**

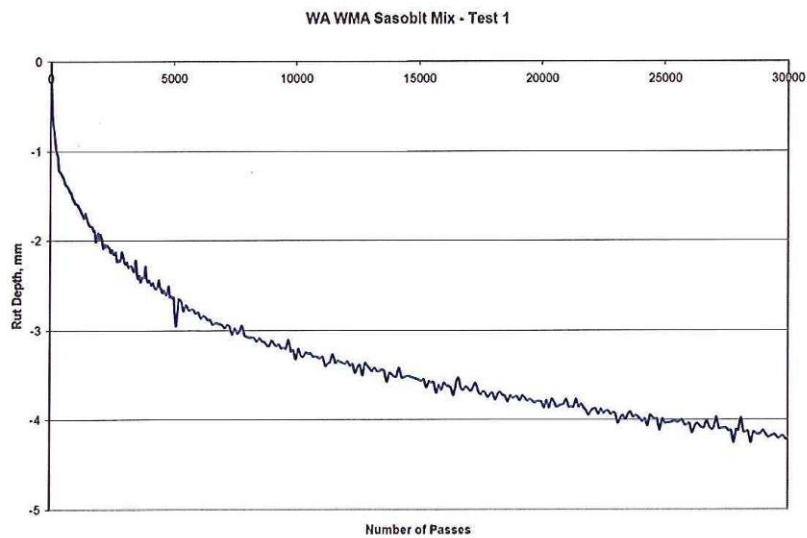
**Figure A2: Hamburg Wheel Track Test Results of Washington WMA Sasobit Mix Test 1**

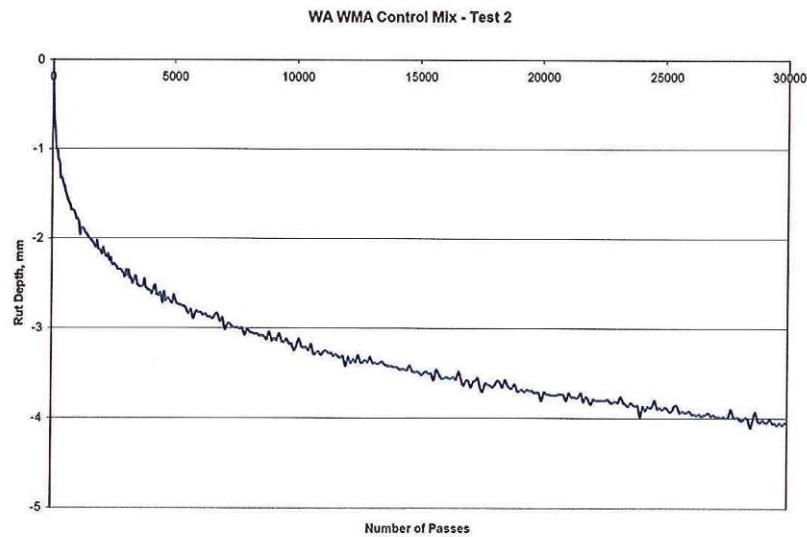
Figure A3: Hamburg Wheel Track Test Results of Washington WMA Control Mix Test 2

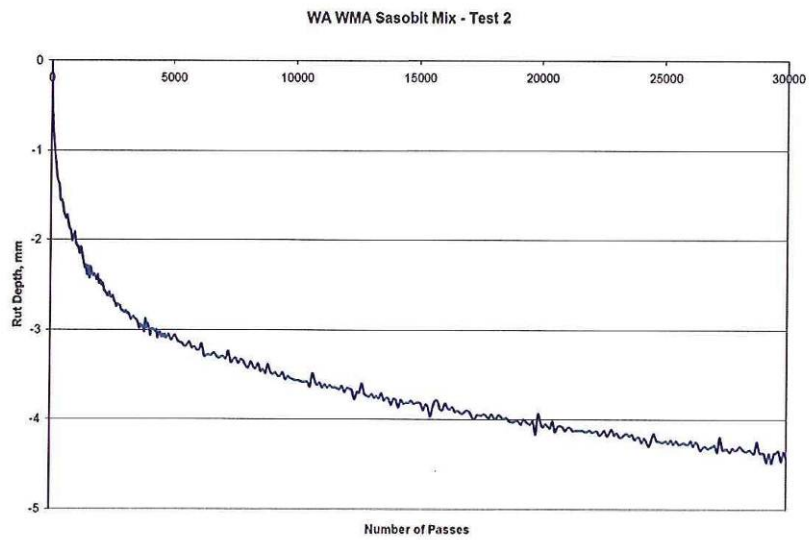
Figure A4: Hamburg Wheel Track Test Results of Washington WMA Sasobit Mix Test 2

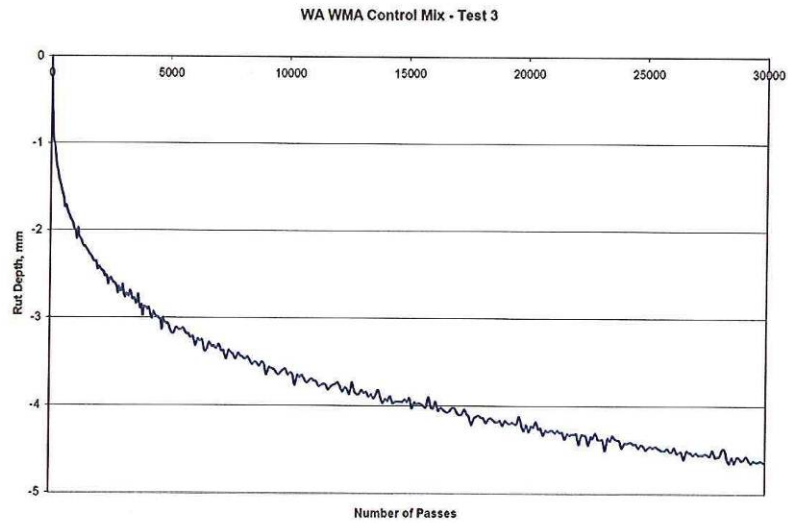
**Figure A5: Hamburg Wheel Track Test Results of Washington WMA Control Mix Test 3**

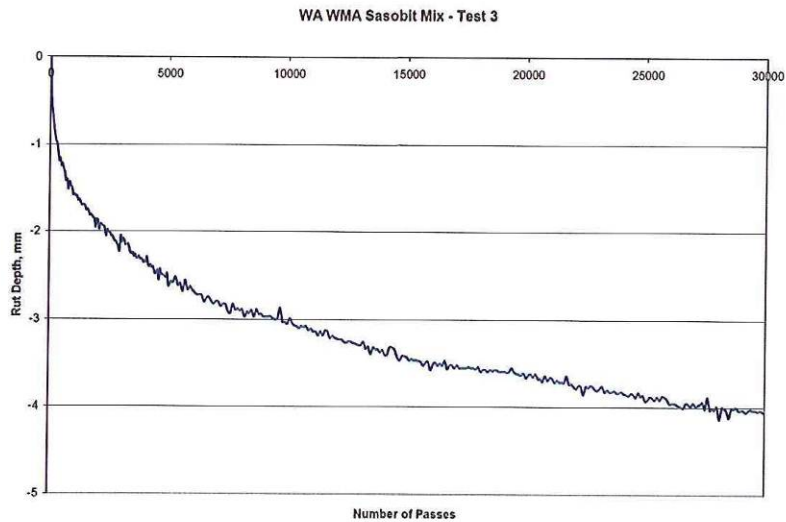
**Figure A6: Hamburg Wheel Track Test Results of Washington WMA Sasobit Mix Test 3**
