Design and Construction of a Field Test Site to Evaluate the Effectiveness of a Compost Amended Bioswale for Removing Metals from Highway Stormwater Runoff

WA-RD 724.1

A thesis
submitted in partial fulfillment of the
requirements for the degree of

University of Washington

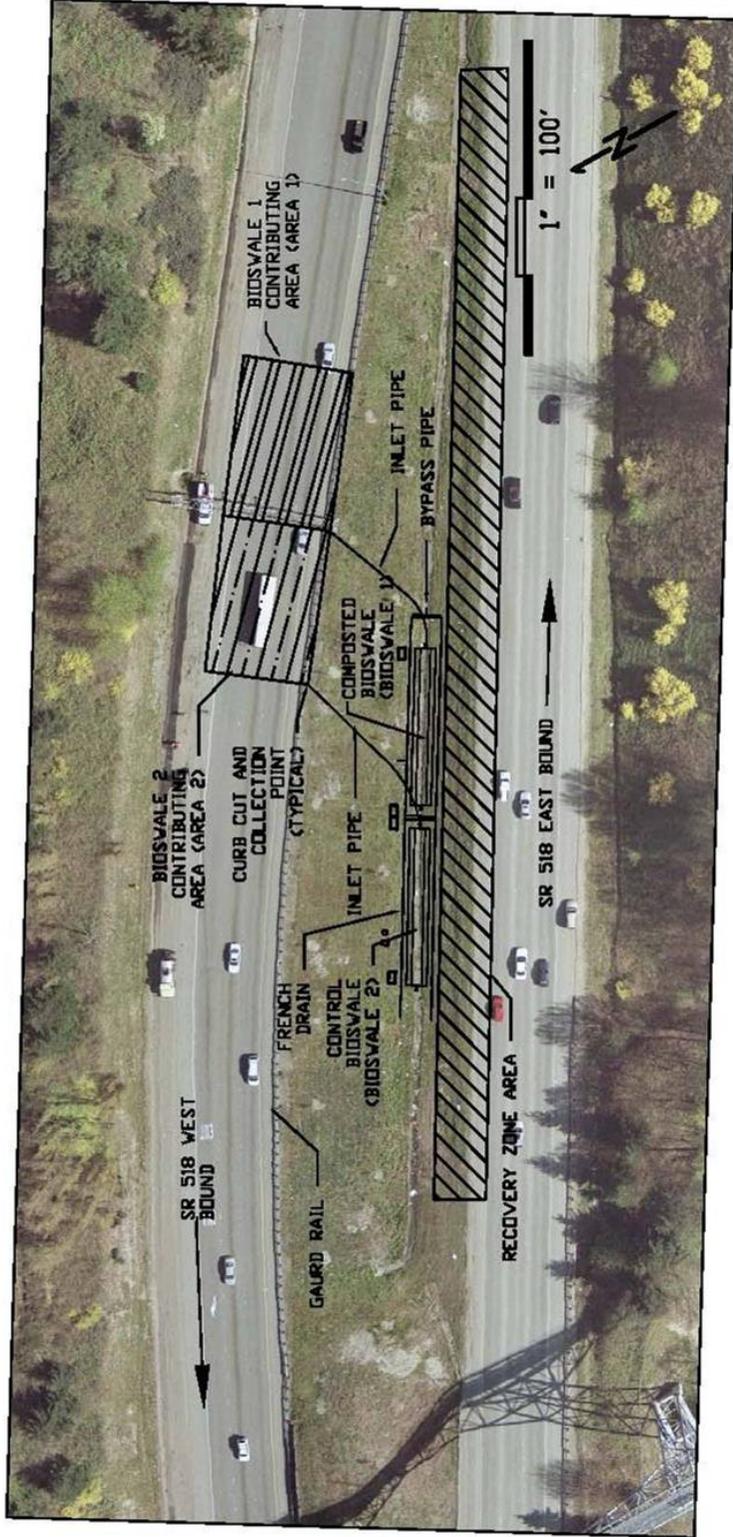
Figure 2. Layout of project site elements. (See Figure 3, Figure 14, and Figure 15 for more detail.) Map source WSDOT Photogrammetry, photo taken 3/24/2005

The layout of the anticipated site elements including the drainage areas, bioswales, instrumentation, and recovery zone is shown in Figure 2. The bioswales would be placed in the median which was about 80 feet wide and there was a guard rail on the uphill side (west-bound lanes). The highway on the uphill side drained toward the median and there was curbing under the guard rail. The curbing channeled the runoff into inlets that drained via metal pipes into the existing asphalt lined ditch in the median. By plugging the inlets and pipes and cutting the curbs, highway runoff could be controlled and easily routed from the road to the planned bioswales.

The site is located at mile post 1.29 on State Route 518 in the city of SeaTac in King County Washington (Figure 1, and Figure 2). According to the WSDOT Data Office, the average daily traffic for this section is 27,600 vehicles per day in the west bound lanes. Figure 3 shows to scale a plan view of the actual facilities.

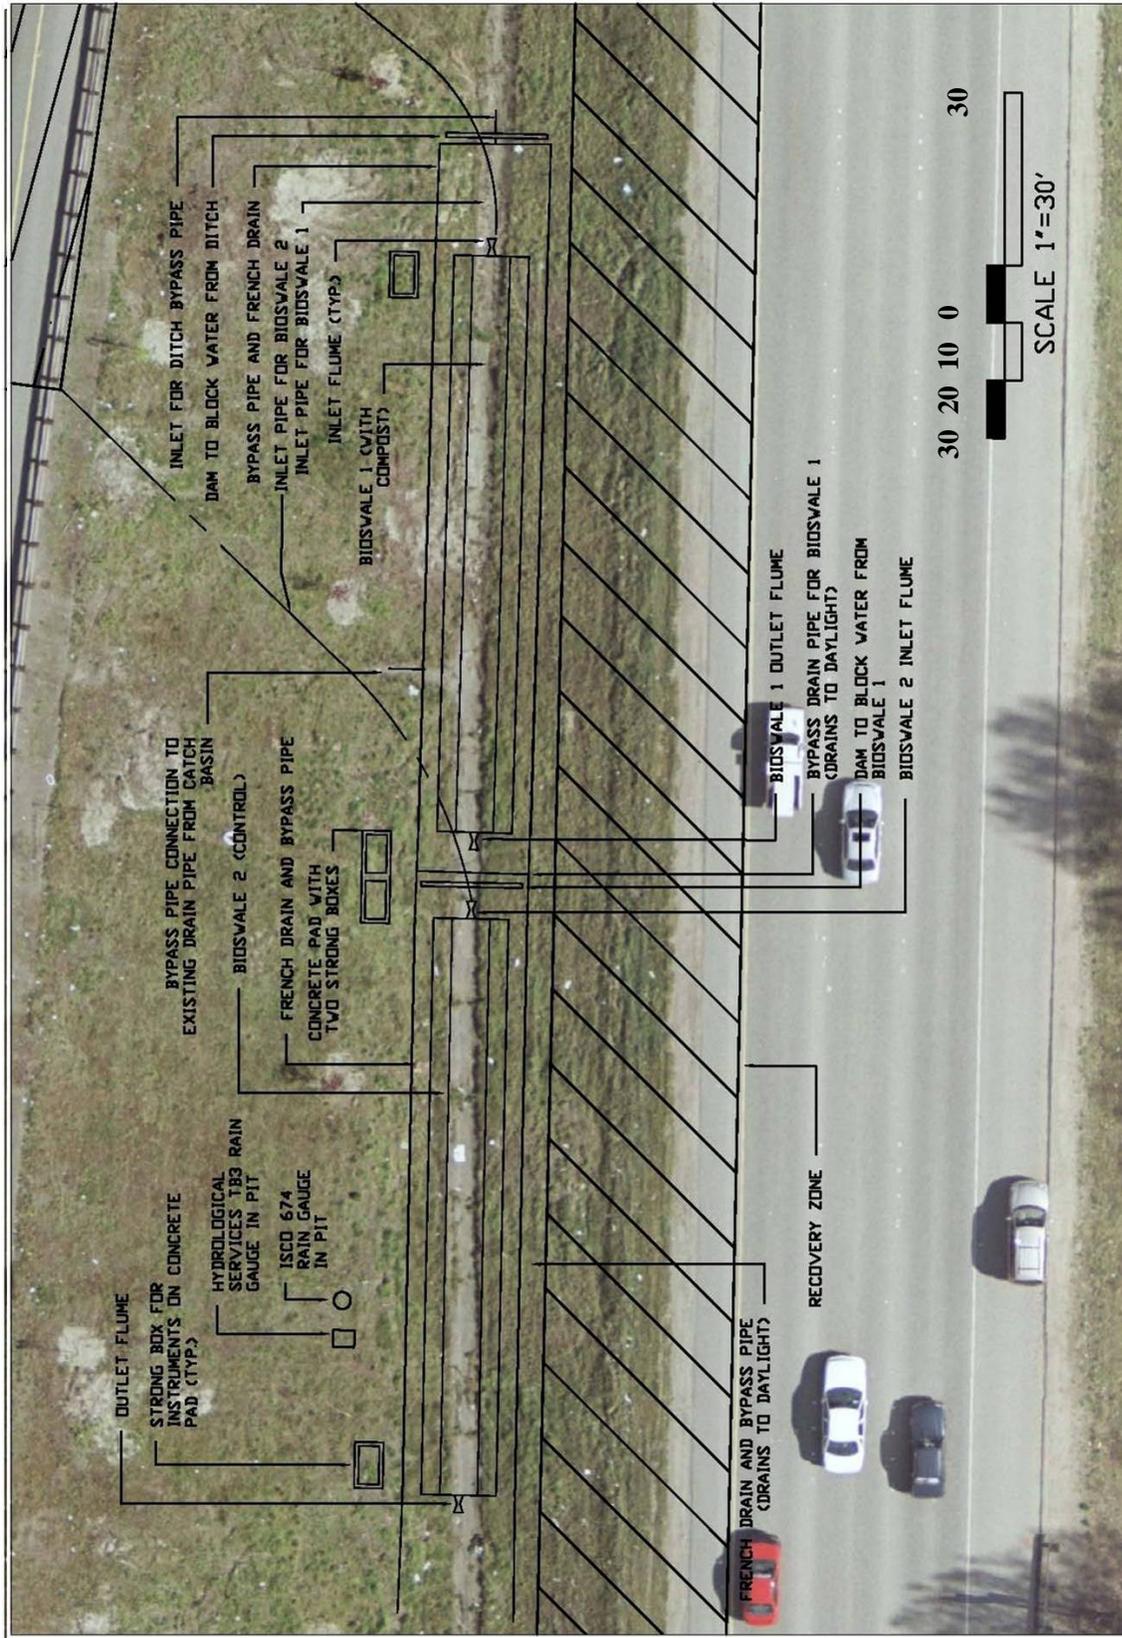
Figure 3. Site features. Photo source WSDOT Photogrammetry, date taken 3/24/2005

The test facility contains two bioswales, each 100 feet long by 6.5 feet wide, on WSDOT right of way. The bioinfiltration swales were designed according to Section 5-2.2.3 of the WSDOT Highway Runoff Manual (HRM). Both bioinfiltration swales were constructed using native soils. Bioswale 1 included a three inch deep compost blanket. The compost conformed to WSDOT Standard Specification 9-14.4(8) for coarse compost and was obtained from Cedar Grove Composting, Maple Valley, WA. Bioswale 2 serves as a control.

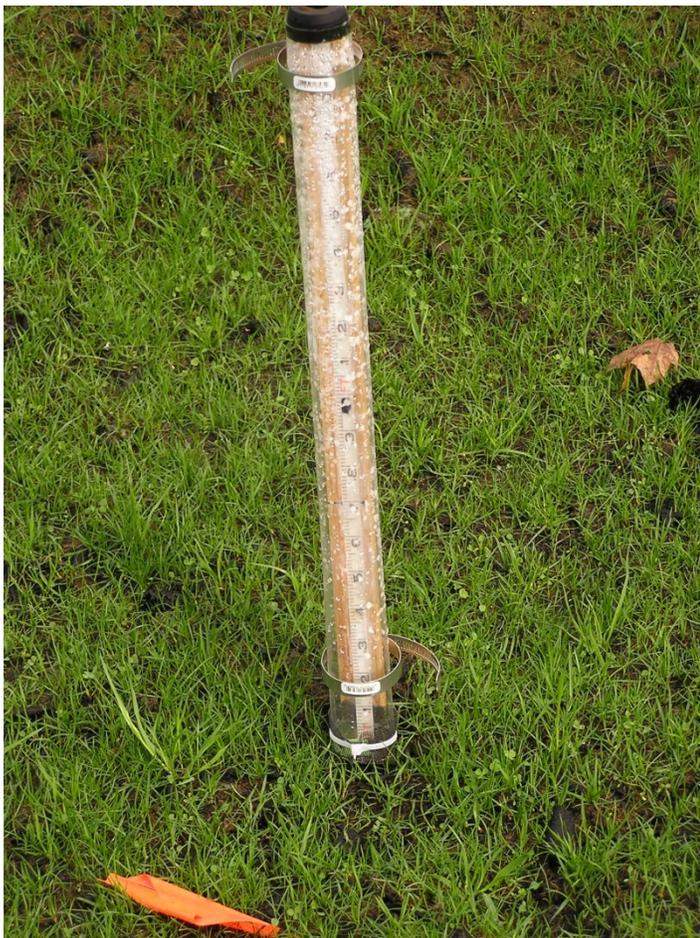
Figure 4. Crest gauge

Three water level “crest gauges” per swale are used to determine the maximum depth of flow in the swale per storm and to determine if the maximum depth is consistent along the length of the swale. The crest gauges are tubes with cork dust and an inlet in the bottom. As the water rises in the gauge the cork dust floats on top and leaves a ring on the inside at the maximum depth. After each storm the gauges will be read and the peak water level noted. A small amount of water is used to wash the dust down to reset the gauge (See Figure 4).

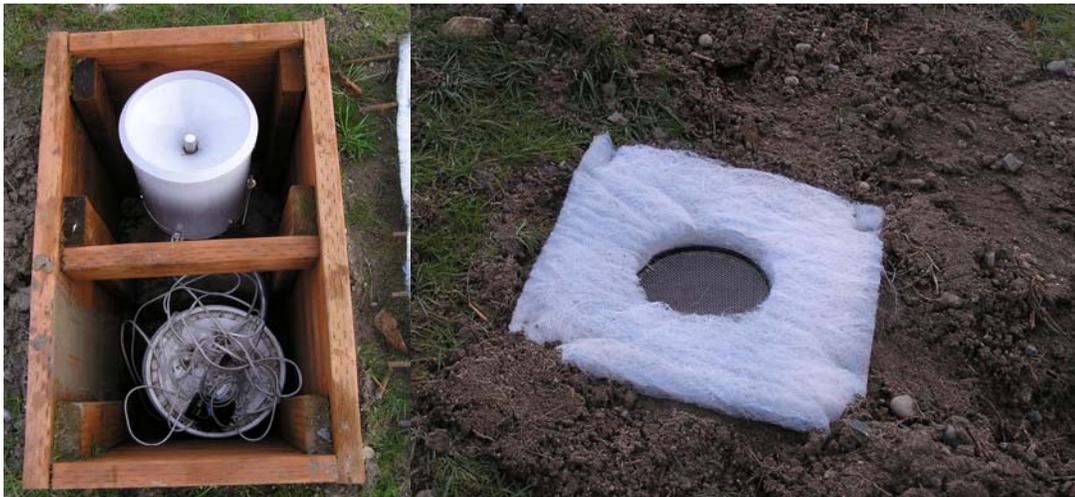
Figure 5. TB3 (left) and ISCO (right) rain gauges installed in housing in pits

Three rain gauges are used to determine the rainfall amount on the site. Two gauges are placed in pits flush to the surface of the ground and the third is mounted on a pole 6 feet above ground. Two of the gauges, one in a pit and one on the pole, are ISCO Model 674 and the second pit gauge is a Hydrological Services TB3. Campbell Scientific CR 1000 dataloggers are used to gather data from the transducers and the rain gauges.

The TB3 rain gauge is housed in a treated lumber box that allows room for the rain gauge and an accumulating bucket that is used to check the volume of water that passes through the tipping bucket gauge (Figure 5). The ISCO rain gauge is housed in a well-drained plastic 5 gallon bucket. Both rain gauges have leveling bubbles incorporated into the instrument bodies. The TB3 is mounted on 3 stainless steel rods set in concrete and the ISCO rain gauge is bolted to the bottom of the bucket. The bucket sits on a concrete pad at the bottom of the pit. Native soil is used to backfill around both housing units. A frame covered with home heating furnace air filter fabric is used to prevent water from splashing into the rain gauges. Both pits have a drain pipe leading from the bottom of the pit to a down gradient French drain to facilitate drainage.

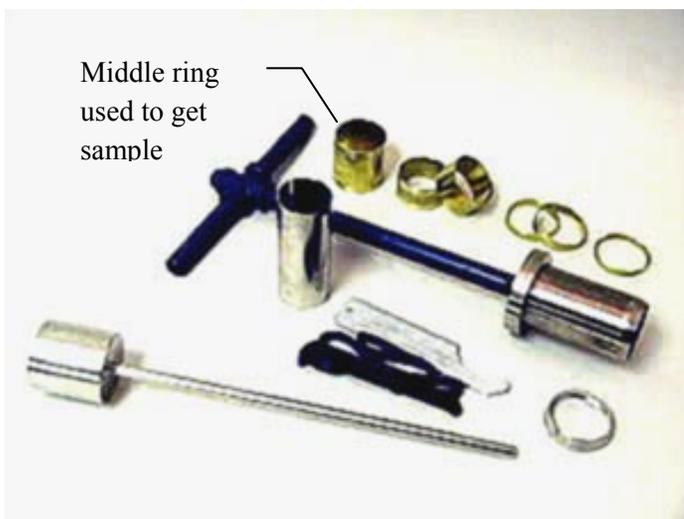
Figure 6. Soil corer used for taking soil bulk density samples
- source ICT International

An in-situ soil bulk density test was performed on the Bw2 and C soil horizons (Table 9). A soil impact corer was used to remove a sample from the Bw2 horizon. The impact corer is held perpendicular to a soil horizon and a weighted hammer is used to drive the corer into the soil. The corer is made up of an outer solid ring with a sharp edge. Inside the outer ring are 5 brass rings that slip out of the outer ring. The inner rings hold the soil. The three rings on the end of the core are removed and the soil is struck off across the faces of the two inner rings. (Figure 6) The soil from the two middle rings was placed in a sample bag and marked for further processing.

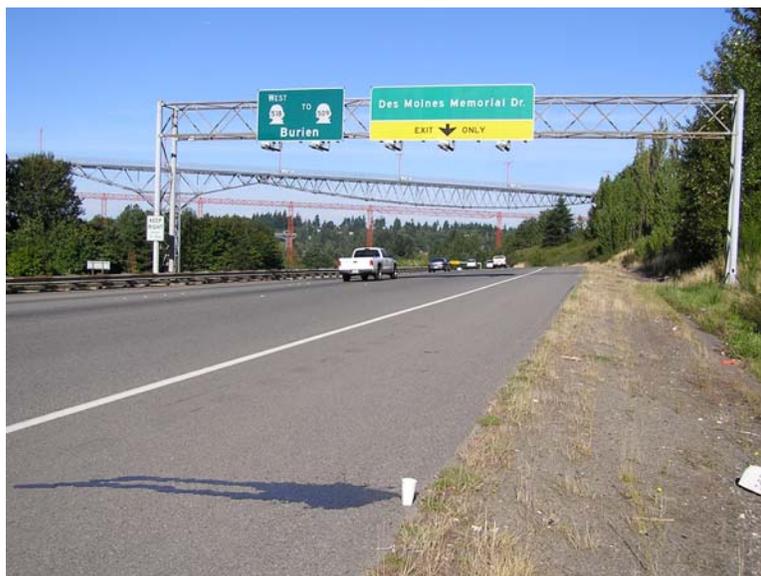
Figure 7. Water poured on the shoulder of SR 518 to determine the contributing area

A simple test was undertaken to determine which way the water flowed on the road. Water was poured on the shoulder to see which way it would flow. (Figure 7) It immediately flowed south

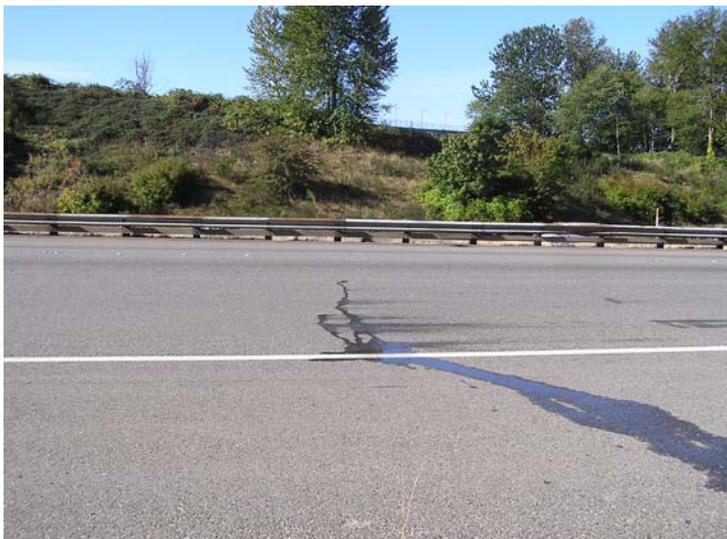
Figure 8. Water flow across the travel lanes from north to south towards curb

across the shoulder and toward the travel lanes. Water was slowly added to the stream and it continued to flow across the travel lanes toward the curb on the south side of the highway. (Figure 8) This test was repeated at the beginning and the end of each contributing area with the same results in each case.

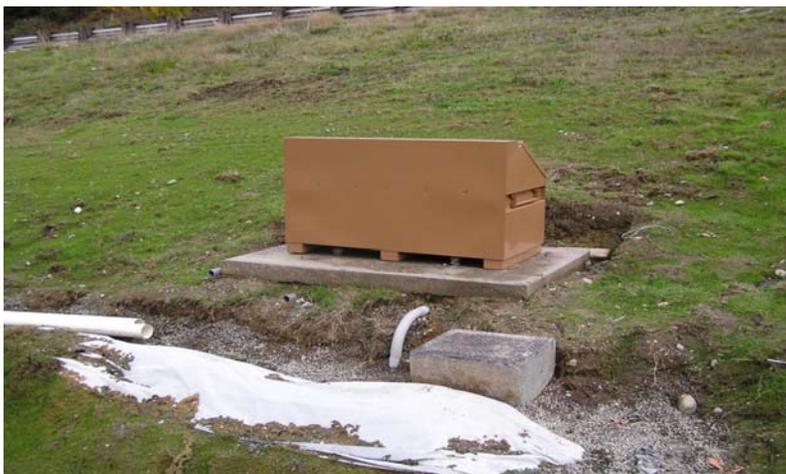
Figure 9. Instrument box on pad

Each monitoring station is equipped with an ISCO automated sampler that is housed in a vandal-resistant and waterproof metal enclosure (Figure 9). Flow rates are measured by routing the water through flumes at the inflow and outflow of each bioswale. Water depth is measured with pressure transducers located in stilling wells at each flume.

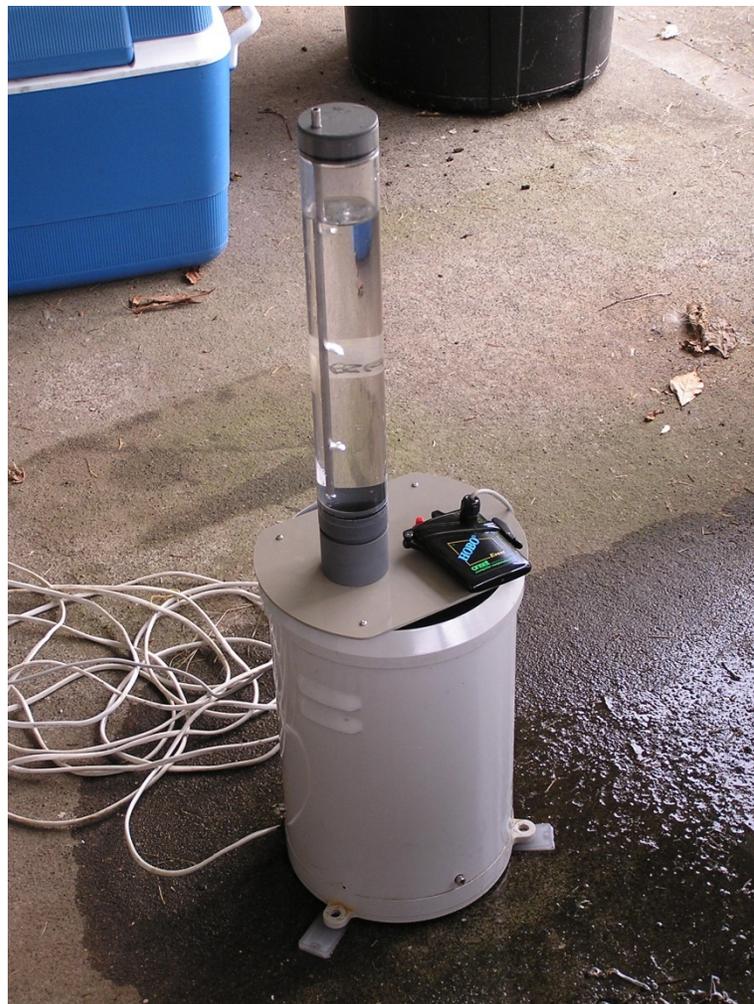
Figure 10. TB3 “tipping bucket” rain gauge calibration with a Hydrological Services TB320 Field Calibration device and a Hobo event recorder

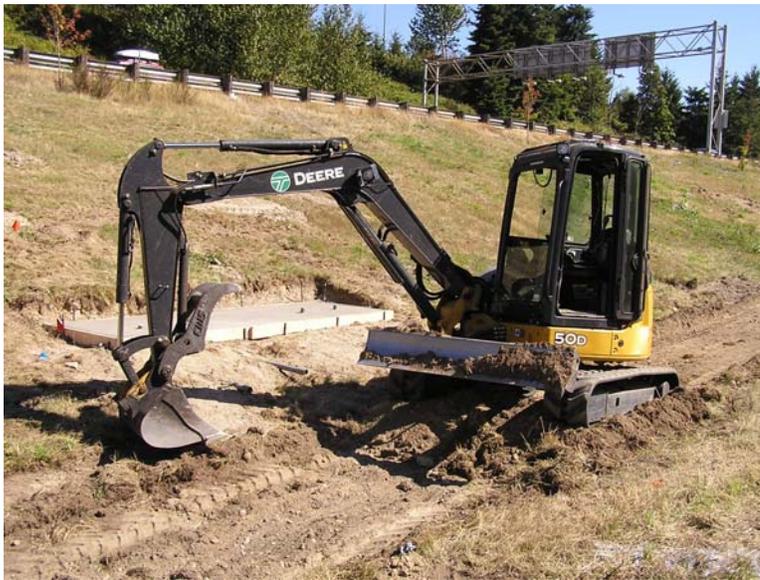
Figure 11. Excavator used to do site preparation

would fit on the site. After the layout was complete, equipment was brought in to prepare the site. A John Deere D50 excavator with a 6.5' wide blade was used to prepare the pads for the equipment, dig the trenches, and construct the bioswales (Figure 11). A laser level was used to control the slope of the bioswales.

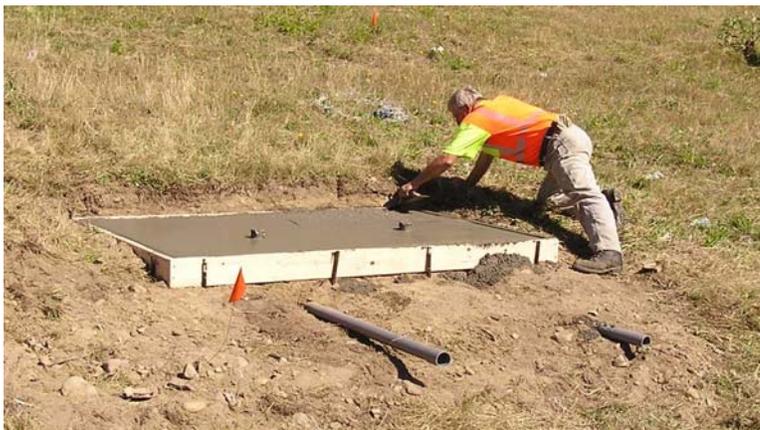
Figure 12. WSDOT employee finishing concrete pad for instrument box

Portland cement concrete pads were installed for the equipment boxes. Two inch conduit was installed in the pads to allow electrical wiring, cables, and tubing to enter through the bottom of the equipment boxes. (Figure 12) Two conduits were installed per box.

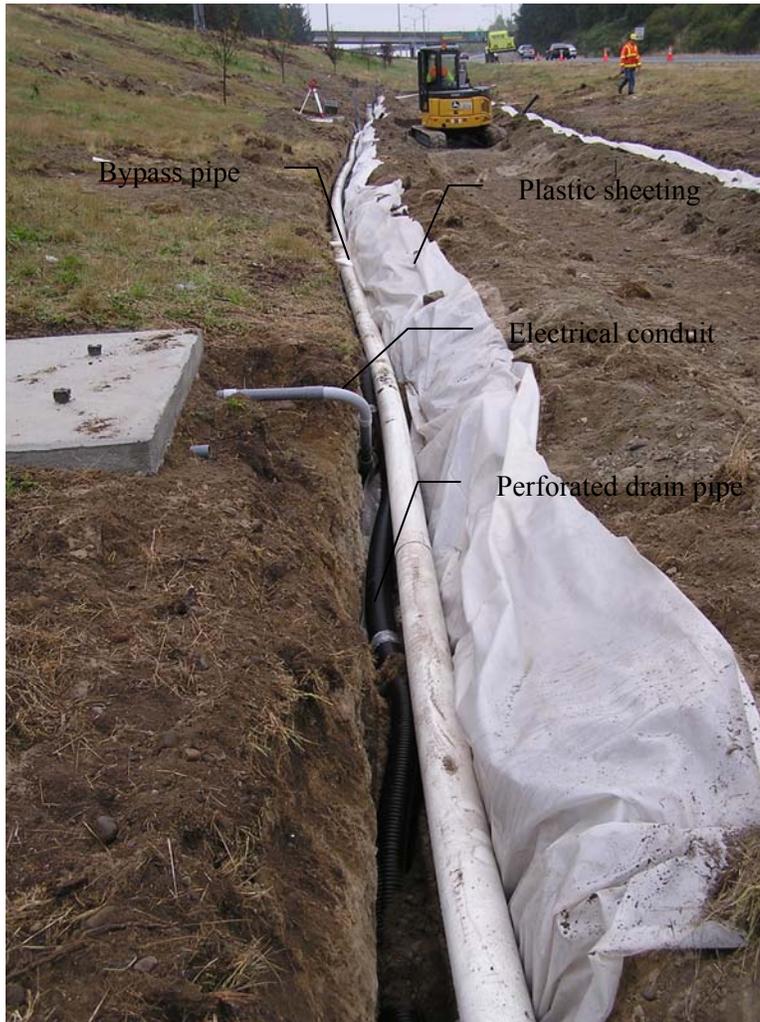
Figure 13. French drain trench with plastic sheet lining, perforated (black) and soild pipe (light), and electrical conduit installed

The trenches for the French drain and pipes from the curb cuts to the bioswales were made with the excavator using a narrow bucket. The trenches for the French drain were dug, at a minimum, to the top of the basal till layer, or two feet, whichever was deeper. The trenches for the pipes and electrical conduit were a minimum of 2 feet deep to meet local building codes for minimum cover for electrical conduit. (Figure 13)

The trenches for the French drains were lined with plastic on the bottom and bioswale (inside) sides. The top of the plastic was draped over the mounded soil from the trench excavation on the bioswale side of the trench and covered with additional soil to hold it in place (Figure 13). Conduit for electrical pipe, a 4 inch diameter perforated pipe, and a 6 inch diameter solid drain pipe was placed in the trenches on the instrument side of the bioswale and a 4 inch diameter perforated pipe and a 6 inch diameter solid drain pipe were placed on the opposite side of the bioswales (Figure 13).

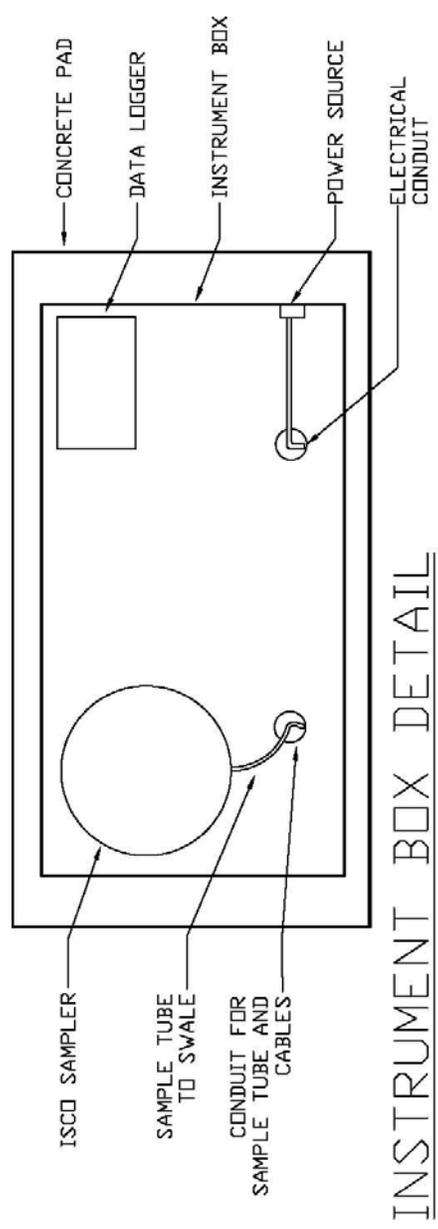
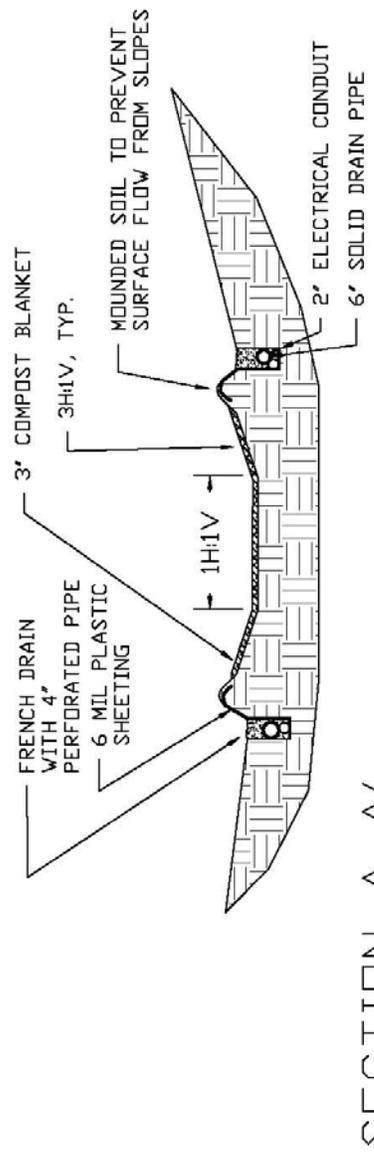
Figure 14. Instrument box detail and bioswale section

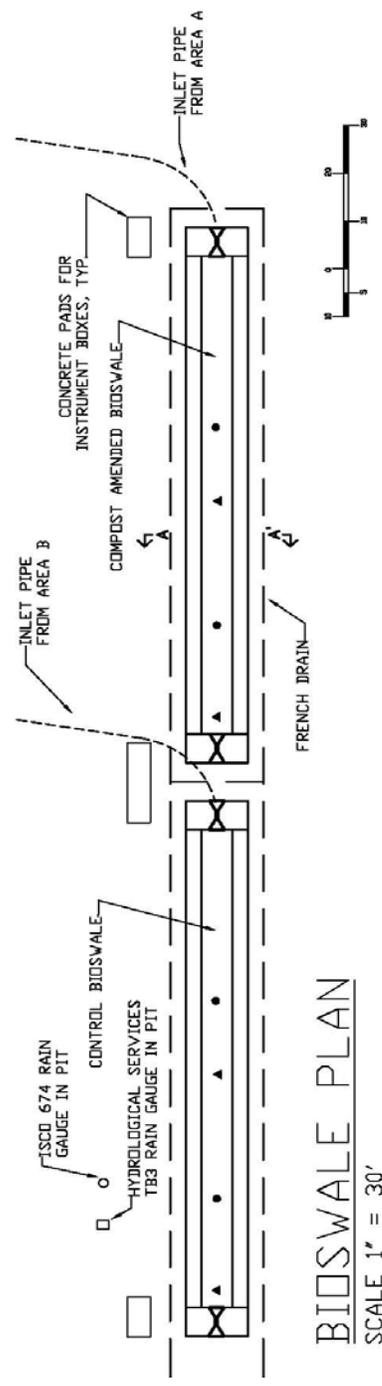
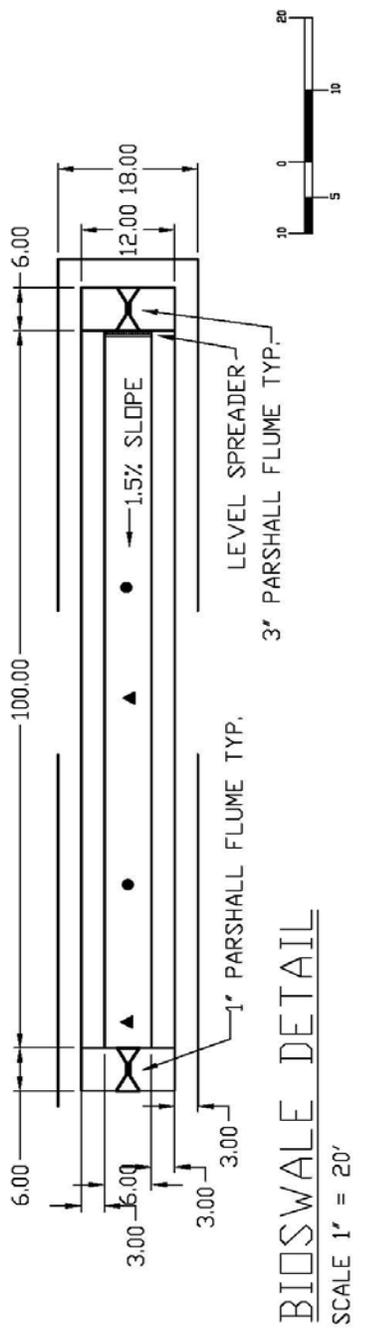
Figure 15. Bioswale plan and detail

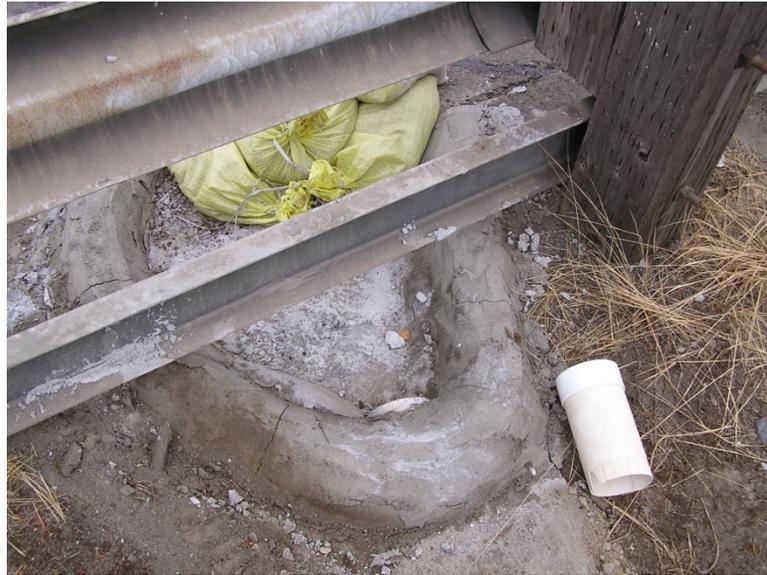
Figure 16. Curb cut and inlet pipe with temporary cap removed and flow blocking sandbags in place

The curb on the south side of SR 518 was cut in two places to create an inlet for the water to flow into each of the two pipes that feed the bioswales. A concrete pad was made behind the curb cut and a 4 inch diameter solid “schedule40” PVC pipe was embedded flush with the bottom of the pad. A concrete curb was built on the pad to funnel water to the pipe. Each pipe

was fitted with a removable cap and sandbags placed in front of the inlet to prevent water from flowing into the pipe until the site was ready to receive the stormwater flows. The existing catch basins were covered and the sandbags and cap removed on March 15, 2009 when the bioswales were ready to receive water (Figure 16).

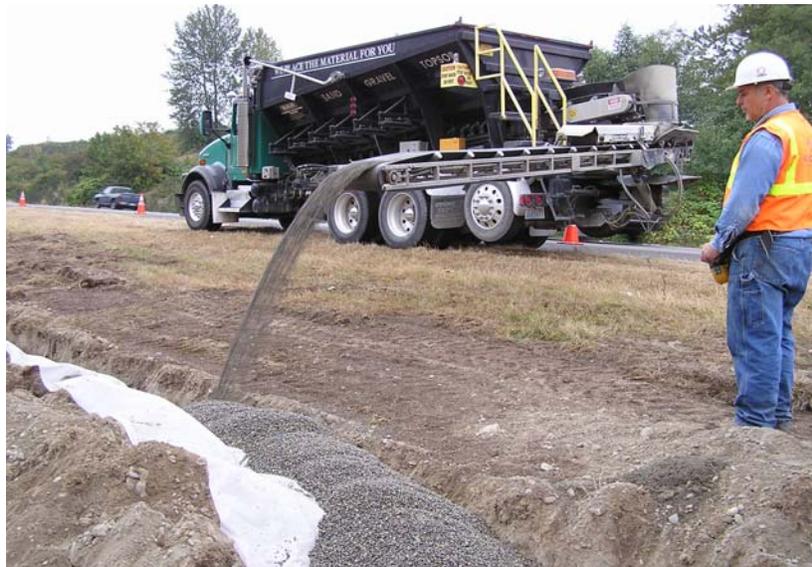
Figure 17. Pea gravel being placed in French drain by an aggregate delivery truck

Permeable “pea gravel” fill was supplied to the trenches using an aggregate delivery truck with a conveyor belt to place the gravel (Figure 17). An alternative option was to bring the gravel in with dump trucks and place the gravel with a front end loader. This truck placed the pea gravel

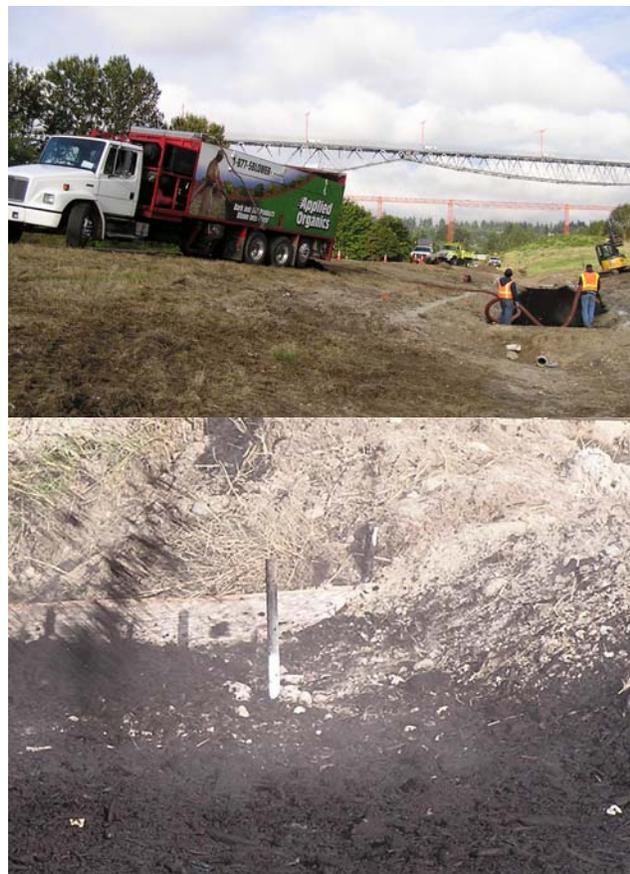
Figure 18. Compost blower truck (top) and steel pin showing final compost depth

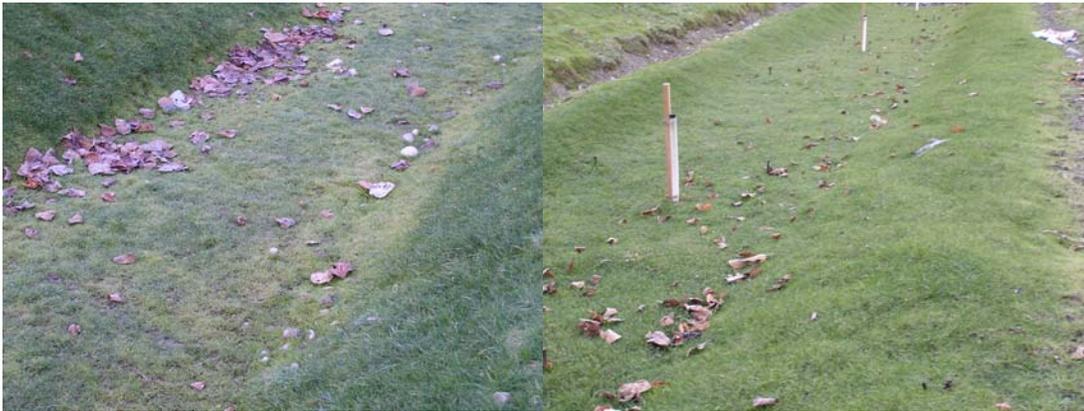
Figure 19. Bioswale 2 (left) and bioswale 1 (right)

The vegetation establishment on the two bioswales is noticeably different. Figure 19 shows the control bioswale and the composted bioswale side by side. The vegetation on the composted bioswale is denser and taller than the control (Figure 20). It is clear from these photos that the vegetation establishment has been enhanced by the addition of compost.

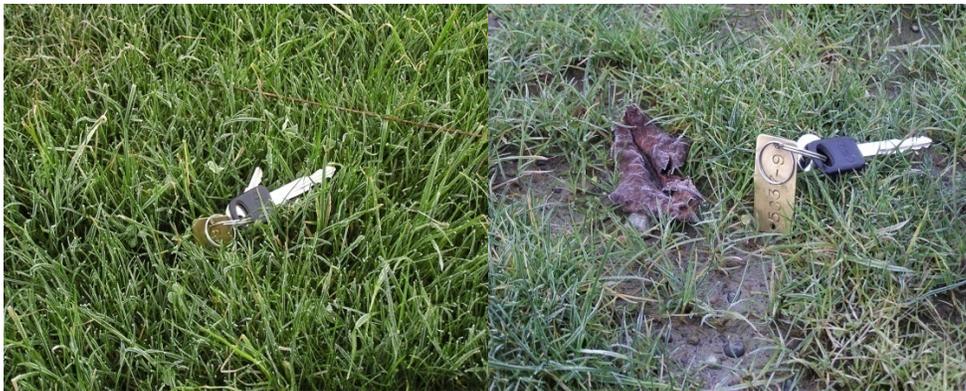
Figure 20. Vegetation on bioswale 1 (left) and bioswale 2 (right) (January 4, 2009)

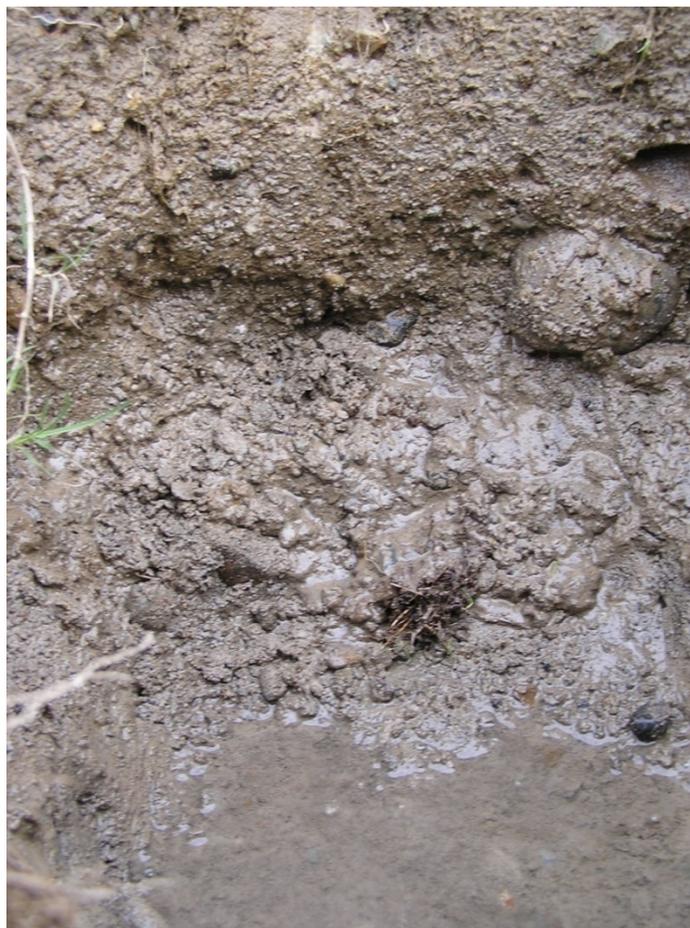
Figure 21. Water seeping from sides of ISCO pit

While digging the hole for one of the pit rain gauges water was observed seeping from the sidewalls of the hole and collecting on the bottom of the pit. The seepage is evident Figure 21.

This seepage is instructive in two ways. First it shows the need to place a drain in the pit to avoid water build up that could back into the rain gauge, but more importantly, it shows why the French drain is important around the bioswale to keep the water

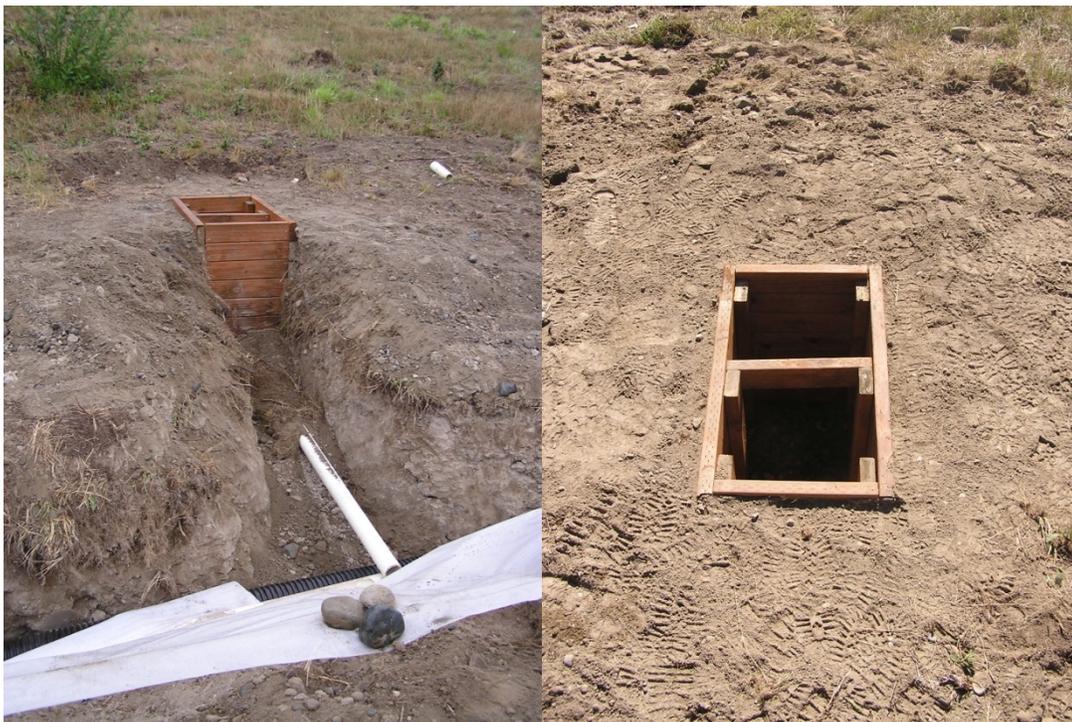
Figure 25. Wood box for TB3 pit rain gauge showing drain to French drain (left) and fully installed

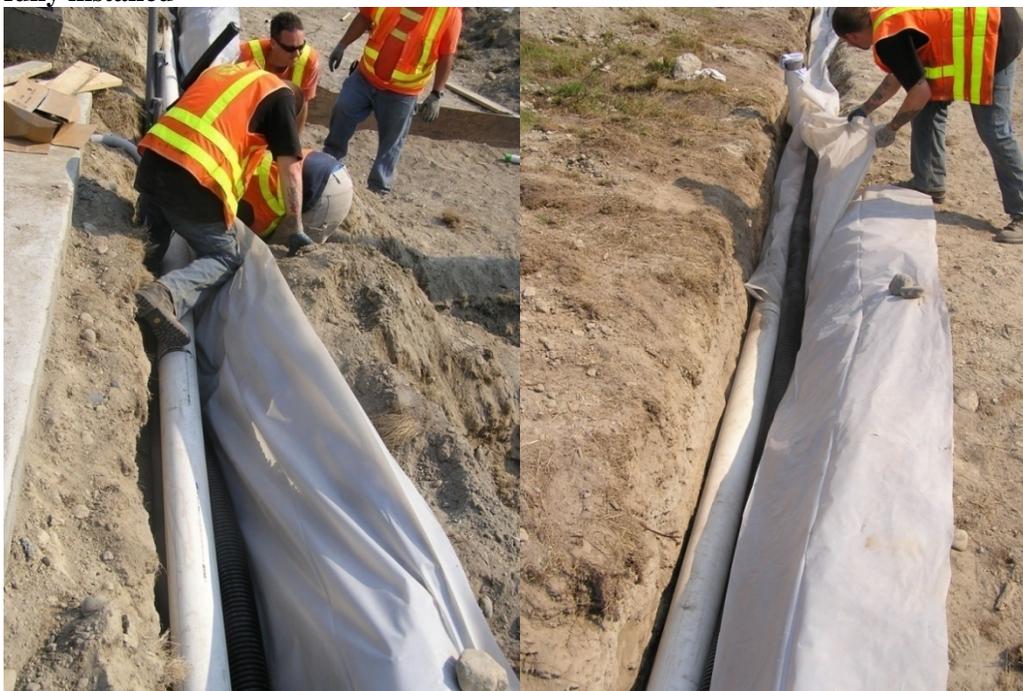
Figure 26. WSDOT workers installing pipe and plastic sheeting in French drain

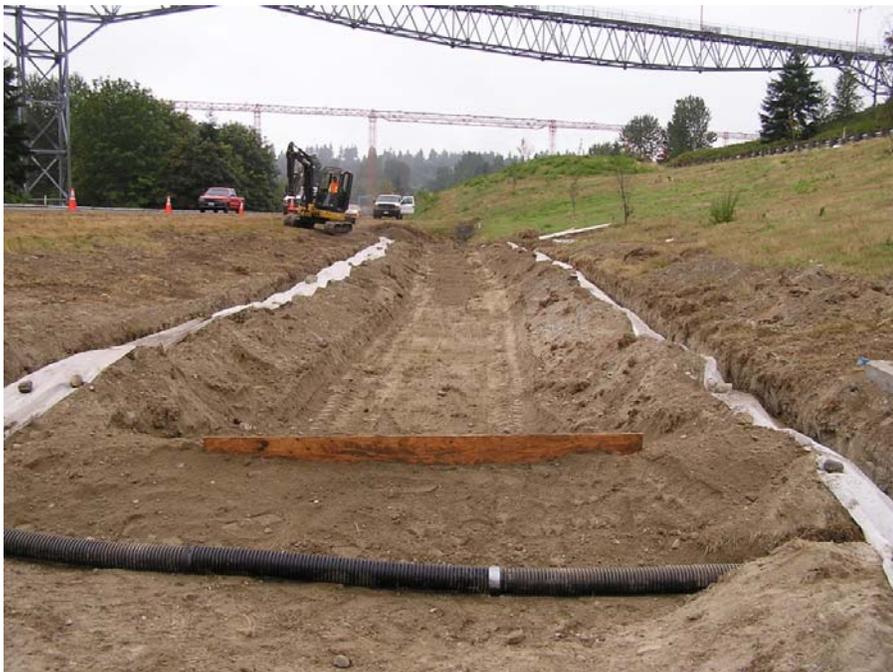
Figure 27. Bioswale 1 with dam at bottom end and French drains

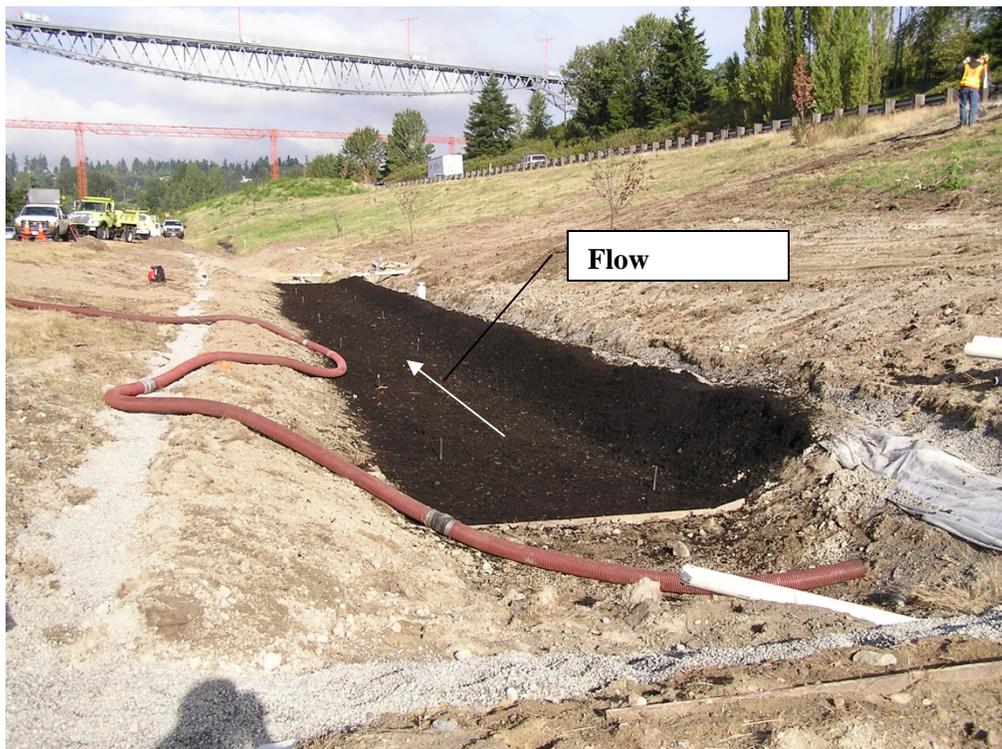
Figure 29. Bioswale with compost blanket installed

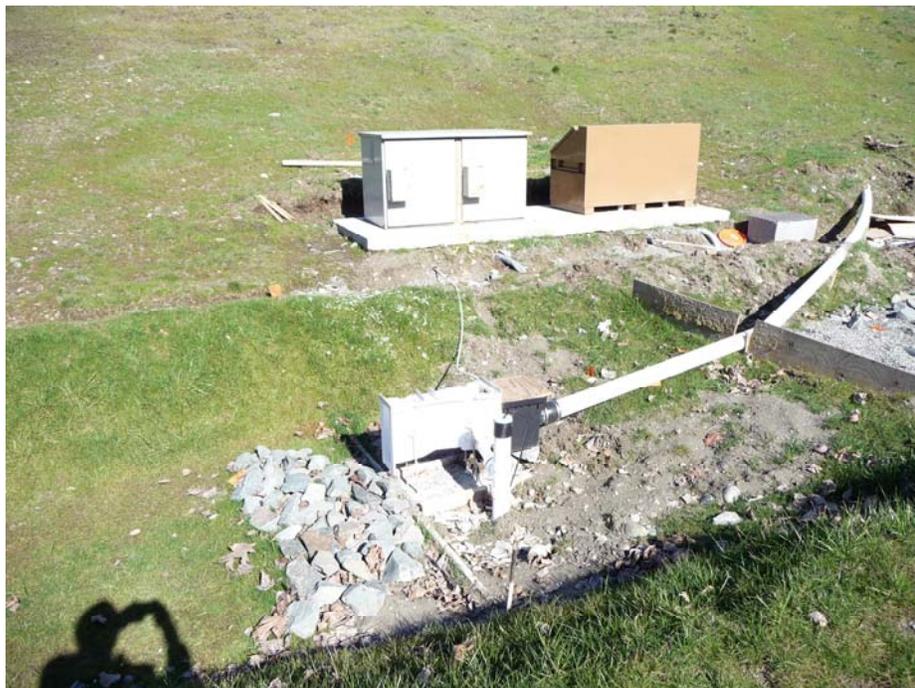
Figure 34. Parshall flume at inlet to bioswale 2

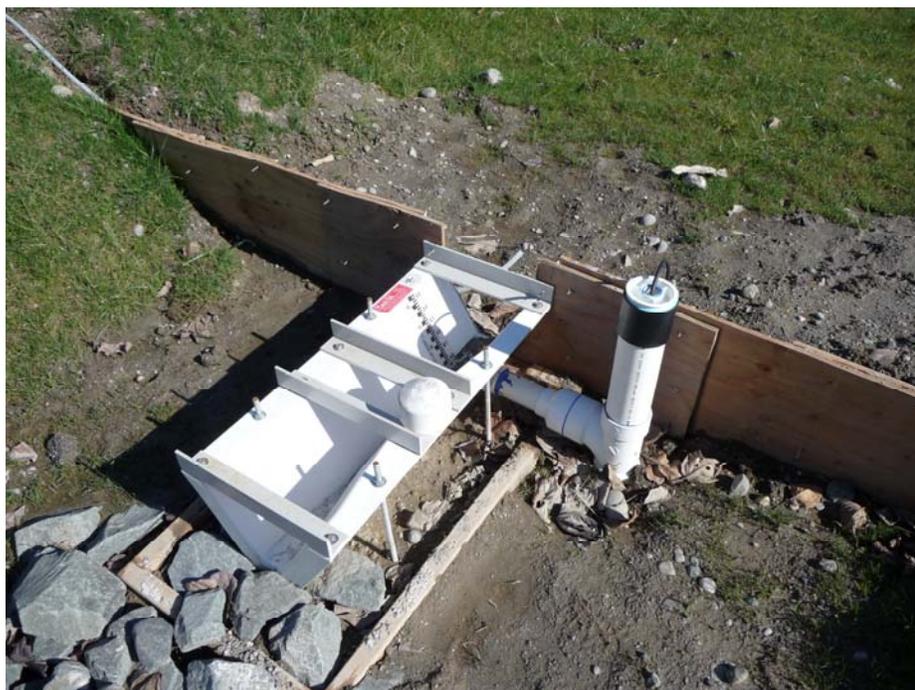
Figure 35. Parshall flume at outlet of bioswale 1

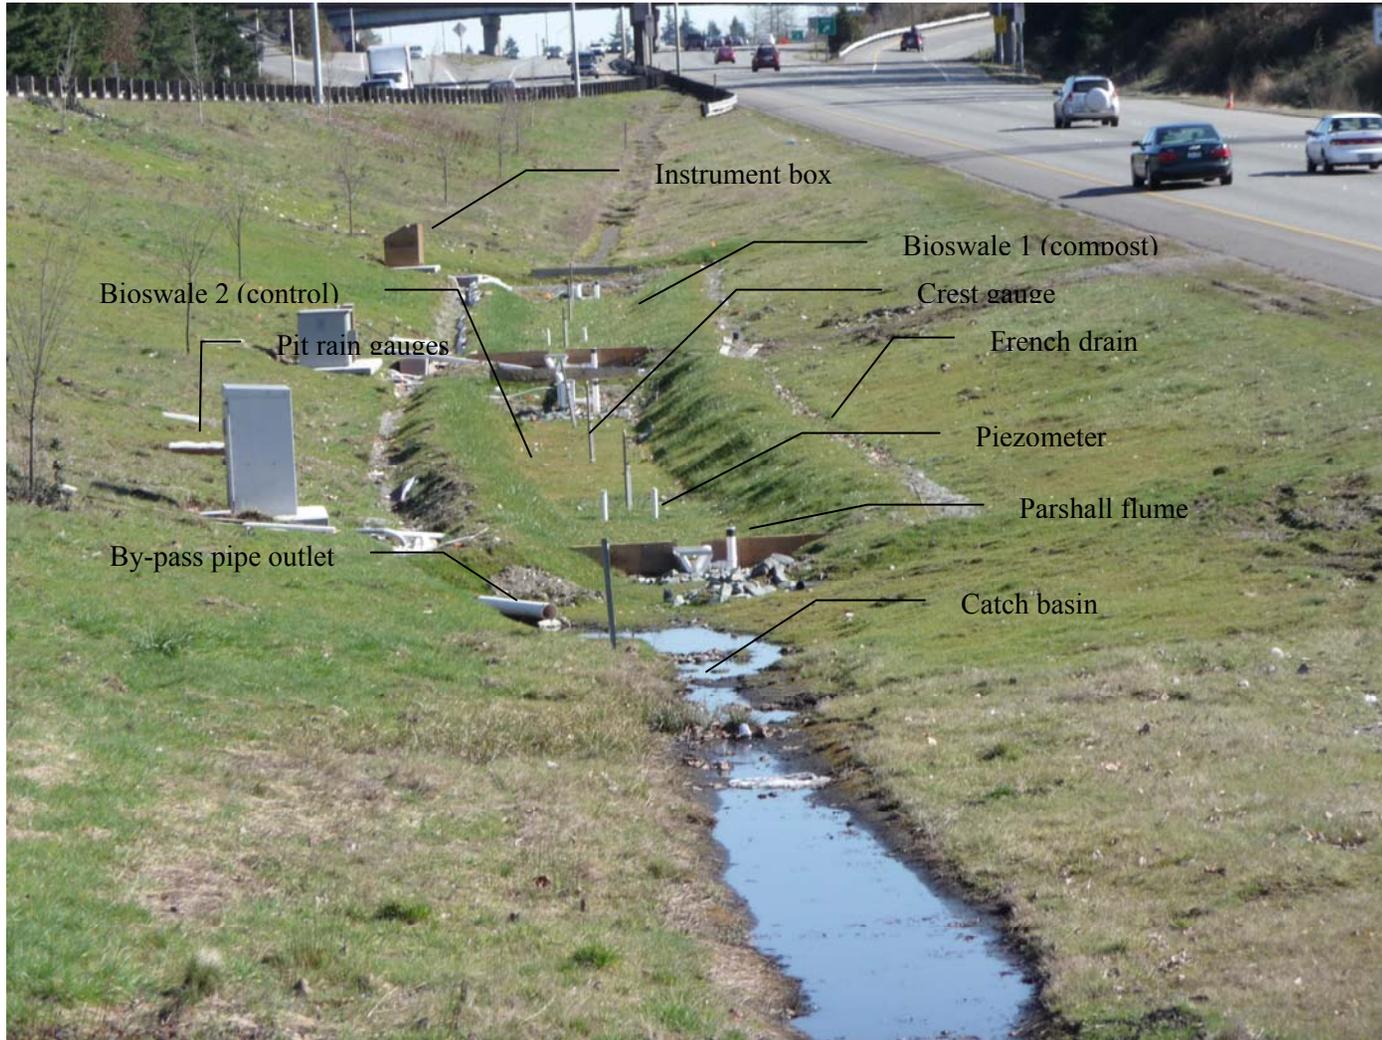
Figure 36. Swales with all equipment in place (March 6, 2009)
