# Evaluation of Long-Term Pavement Performance and Noise Characteristics of the Next Generation Concrete Surface: Final Report

Final Report: Experimental Feature WA 10-03

Granger to W. Grandview EB – Dowel Bar Retrofit and Concrete Rehab

MP 57.85 to MP 72.58

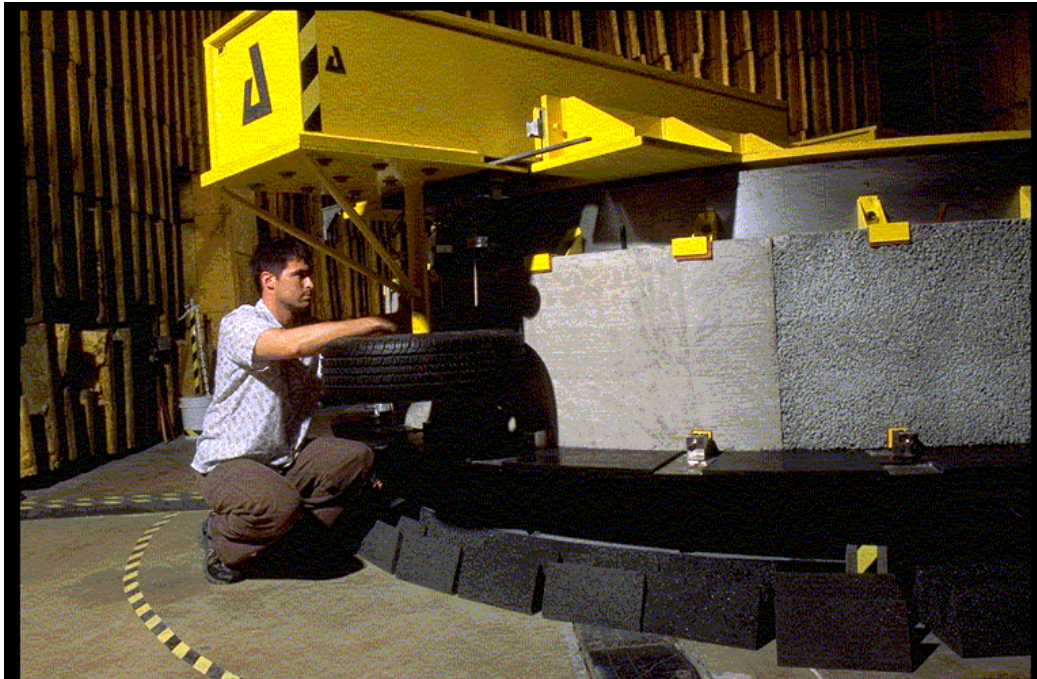
Figure 1. Tire Pavement Test Apparatus (TPTA) located at Purdue University's Herrick Laboratory. (Photo from Purdue University website)

The laboratory phase of the research was conducted at Purdue University's Herrick Laboratories beginning in 2005. The work investigated the variables that affected tire-pavement noise generation characteristics of diamond-ground surfaces (1). The Tire Pavement Test Apparatus (TPTA) was used to perform the laboratory testing. As seen in Figure 1, the TPTA consists of a revolving drum onto which slabs of concrete are attached. Tires run on the surface of the slabs as the drum rotates at speeds up to 30 mph. On-Board Sound Intensity (OBSI) measuring equipment is attached near the tire-pavement interface to measure the noise in the same manner as it is used to measure tire/pavement noise on highways. Twelve different surface textures can be tested at one time using the TPTA.

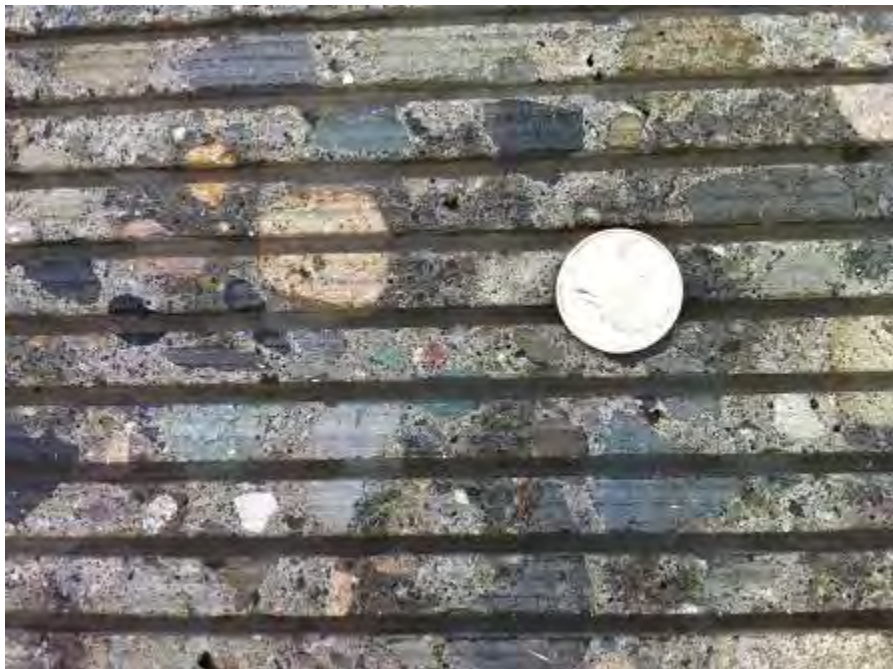
Figure 3. NGCS on I-82 with flat land surfaces and negative texture grooves.

Initial research efforts focused on measurement of the noise produced from slabs prepared using existing methods of diamond grinding. It was thought that different configurations of the blades and spacers were the key to producing a quieter surface. Findings, however, indicated that the configurations of the blades and spacers were not the controlling factor in the noise that was generated (1). The controlling factor was found to be the fin profile of the diamond-ground surface. A fin is a positive texture (sticks above the surface) as contrasted with a groove which is a negative texture. Uniform and consistent profiles with a minimum of positive texture were found to be the key to a low-noise generating surface. A new surface was then designed that consisted of a uniform profile with only negative texture. This produced the lowest laboratory noise test results. The new surface was named the Next Generation Concrete Surface. Figure 2 shows a positive fin texture and Figure 3 the NGCS texture with its uniform flat land surfaces and negative texture grooves.

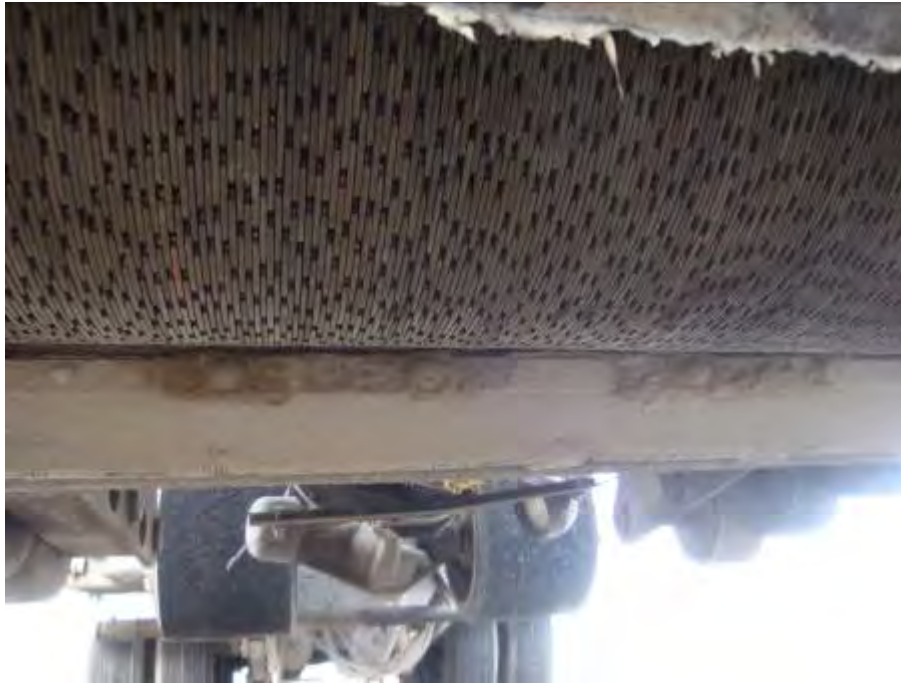
Figure 7. Grinding head for the first pass flush grind operation.

Construction began on October 4, 2010 and was completed the following day. The entire roadway had been ground previously using conventional diamond grinding methods as part of the dowel bar retrofitting operation. This was done for two reasons, the first being to restore the surface of the pavement to remove faulting, and the second, to lessen the blade wear on the flush grinding head used for the first pass of the NGCS installation.

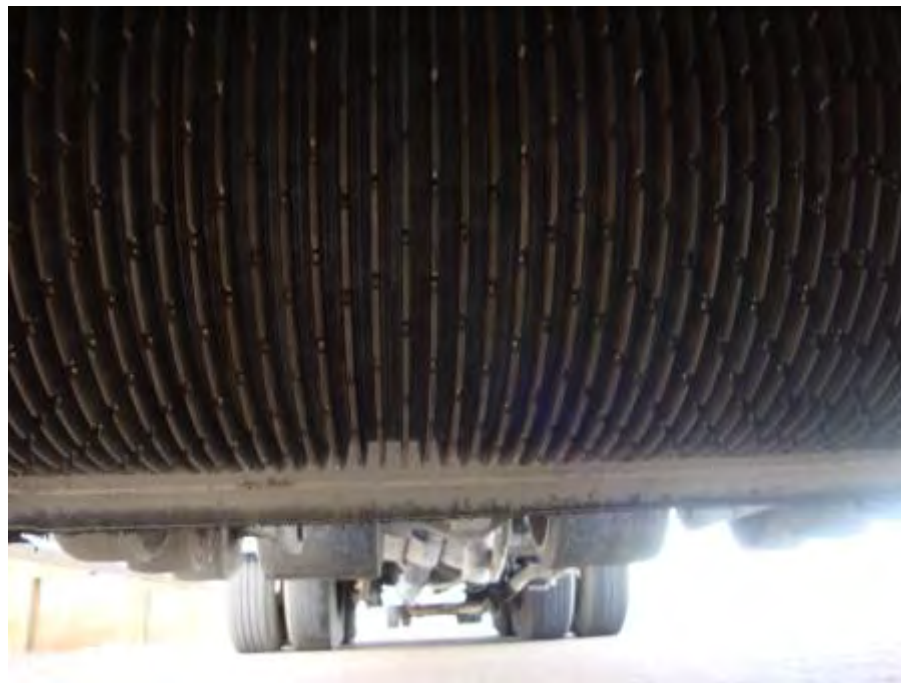
Figure 8. Grinding head for cutting the grooves on the second pass.

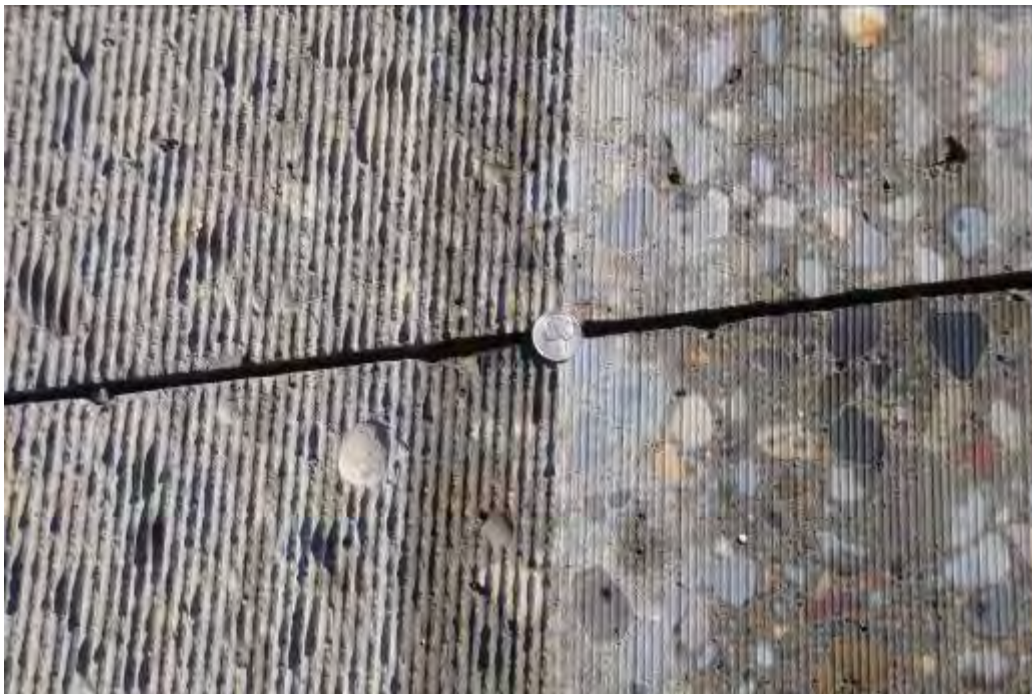
Figure 9. Conventional diamond ground surface on the left, fine flush grind surface of the NGCS first pass operation on the right.

Figures 9 and 10 compare the pavement surfaces after conventional diamond grinding and the first pass of the NGCS with the fine grinding head.

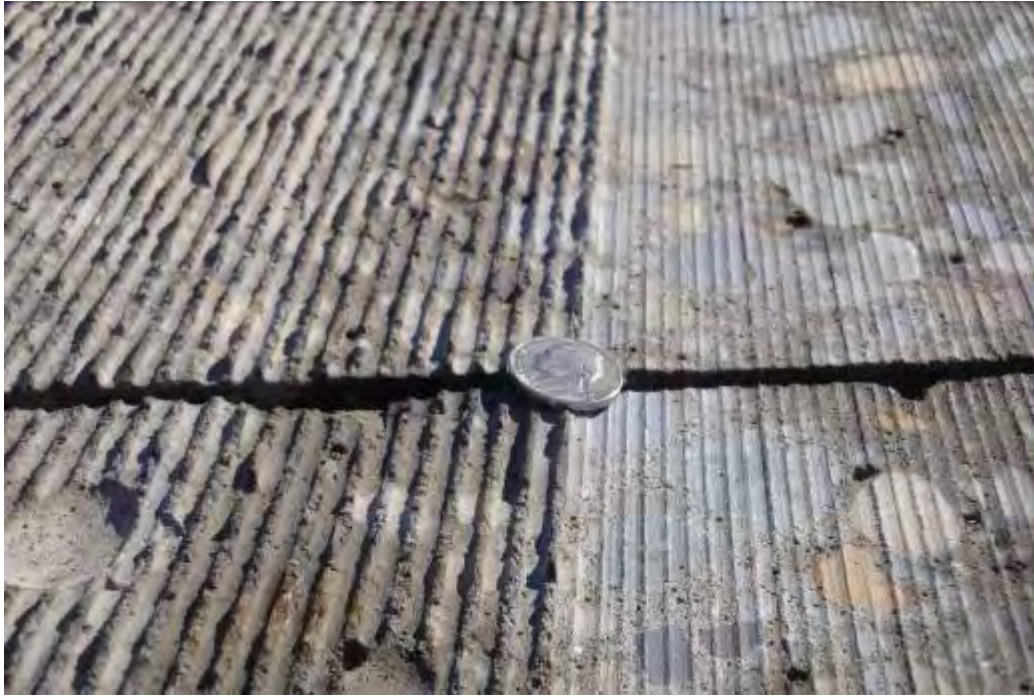
Figure 10. Close-up of the CDG surface on the left and the, first pass of the NGCS on the right.

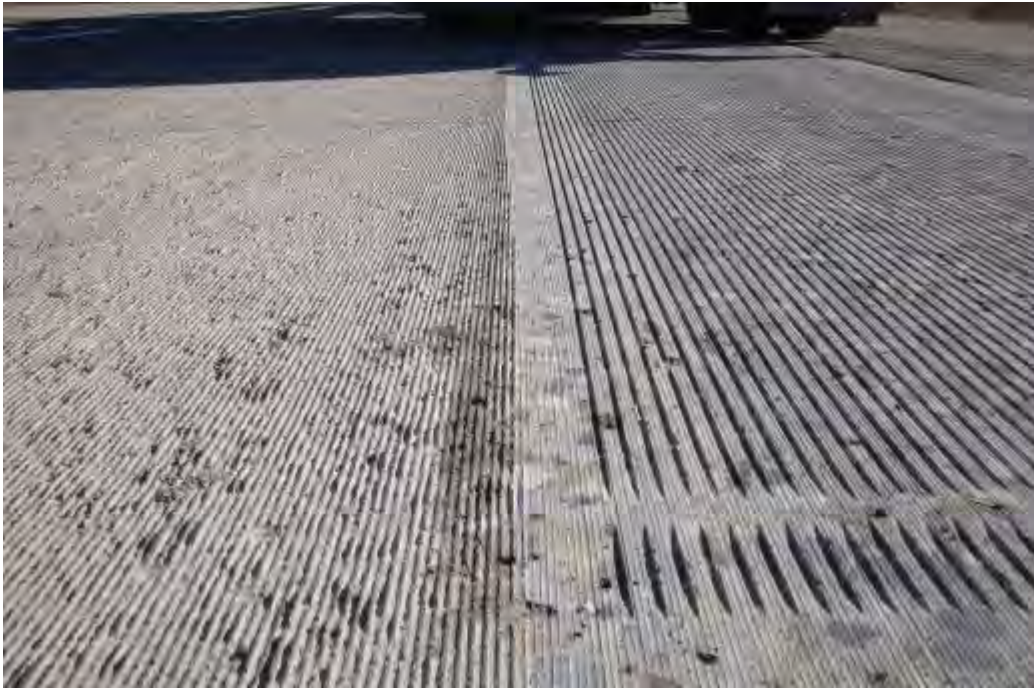
Figure 11. Conventional diamond ground surface on the left, first pass of NGCS in the middle and final pass of the NGCS on the right.

The final surface of the NGCS had flat, smooth land areas separated every  $\frac{1}{2}$  inch by grooves that were  $\frac{1}{8}$  to  $\frac{3}{8}$  inches deep as shown in Figures 11-13.

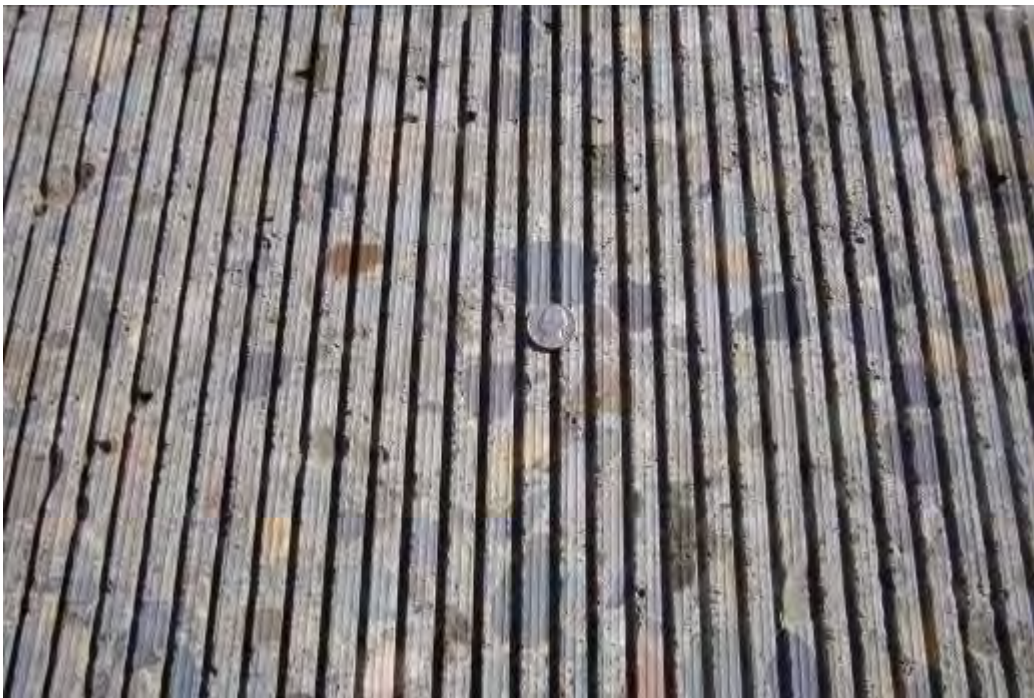
Figure 12. Finished surface of the NGCS with wide, flat land areas and deep grooves.

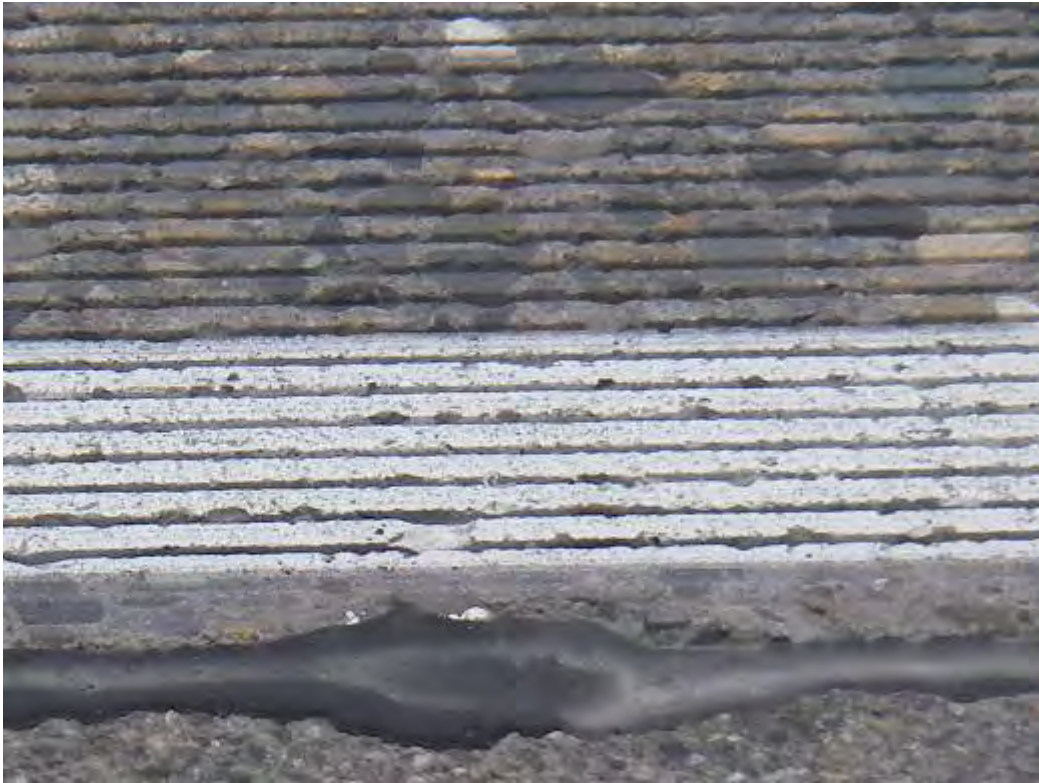
Figure 13. Close-up of NGCS with shoulder stripe in the foreground.

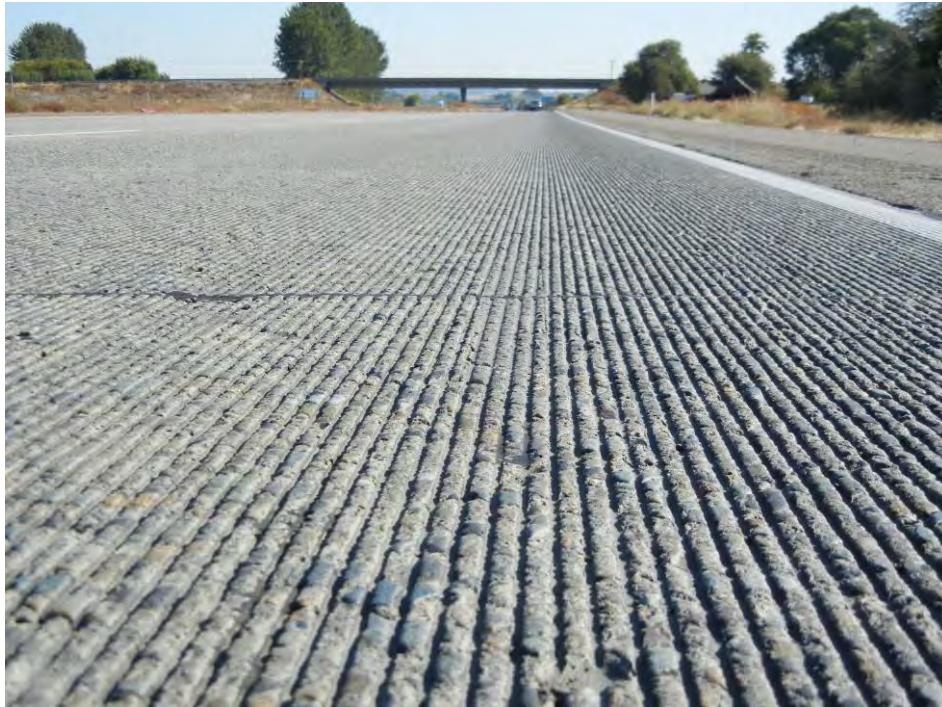
Figure 16. Attrition on the NGCS, October 2013.

Figure 15 shows photos of the NGCS taken post-construction and one year after construction. Figures 16 and 17 were taken in October of 2013 and show the attrition on the surface of the NGCS. The wear from studded tires on the land areas of the NGCS is very evident. Field inspections also indicated that a large number of aggregate pieces are missing from the pavement surface. The added roughness of the pavement due to the studded tire wear is the probable cause of the noise increases on the NGCS. The conclusion is supported by the larger increases in noise levels for the travel lane with its higher traffic volumes as contrasted with the passing lane.

The noise reduction on the NGCS lasted only a brief period of time after construction. At the end of the 2-1/2 year study period the noise levels of the NGCS were equivalent to the levels of the CDG sections. The change in noise levels was attributed to wear from studded tires. Photos and field examination of the pavement support the conclusion that the attrition is due to studded tire wear.

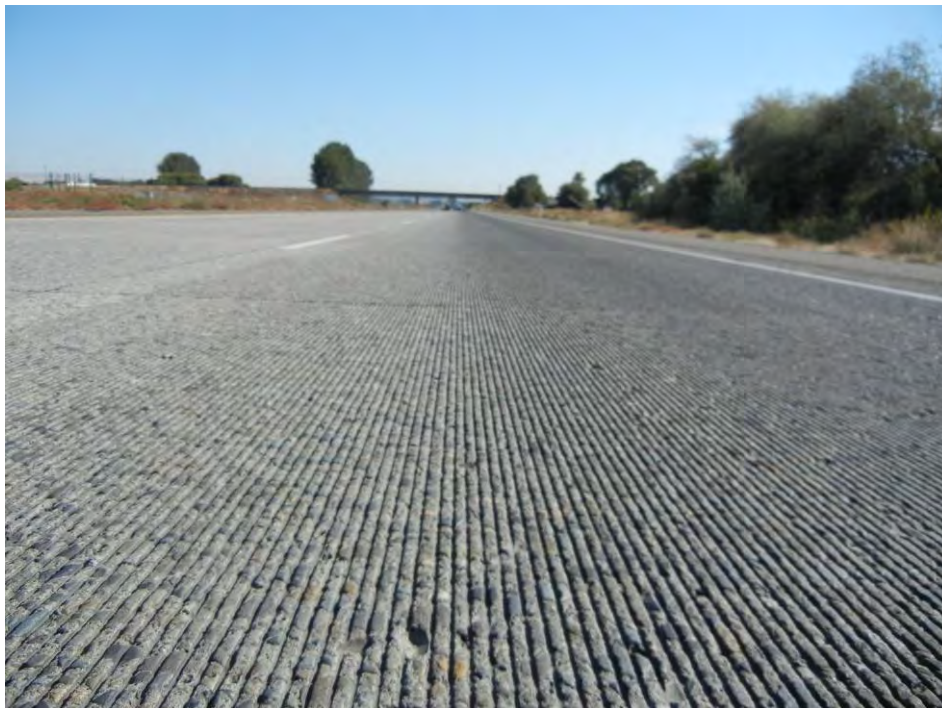
Figure 17. Another view of the attrition on the NGCS, note missing aggregate, October 2013.

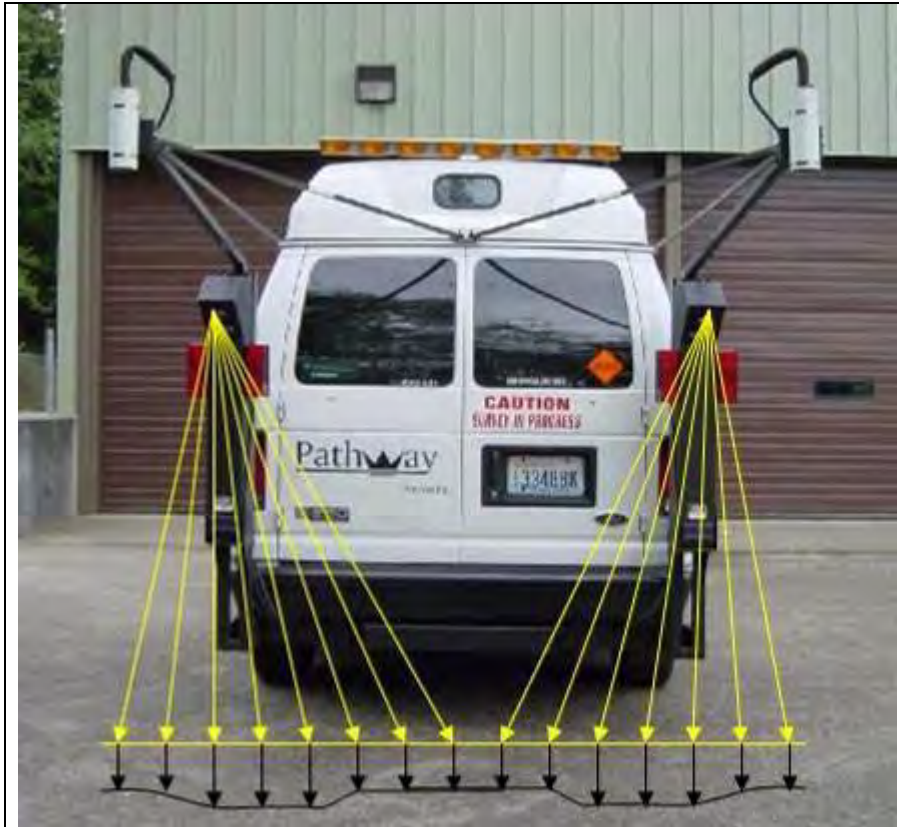
Figure 19. Rut depth measurement using the Pathway Van.

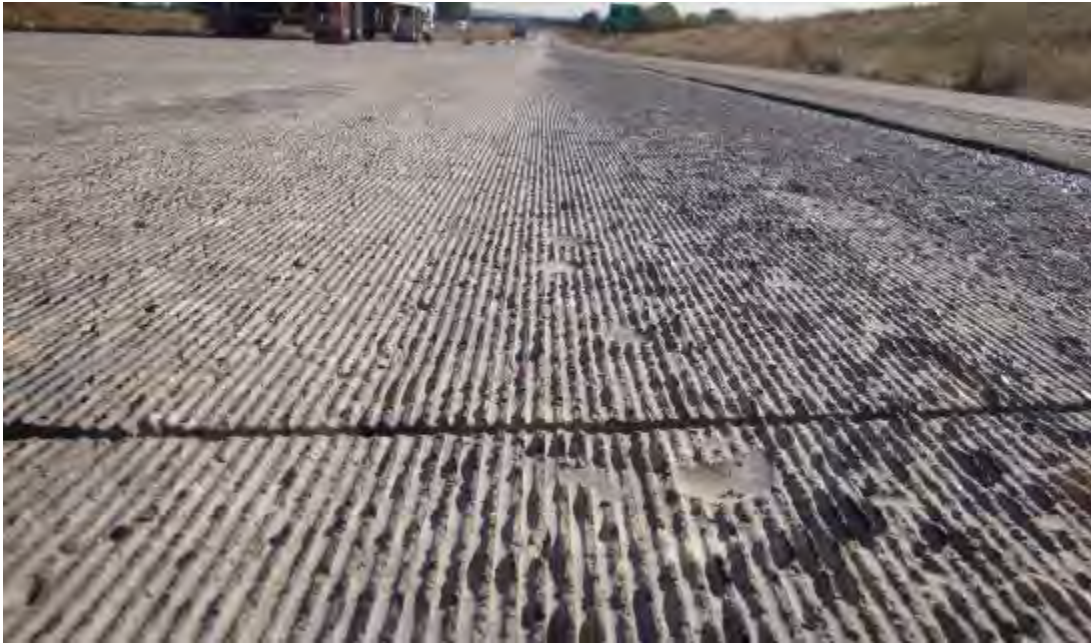
Figure 22. Roadway surface after conventional grinding.

Construction of the NGCS began on October 4, 2010 and was completed the following day. Prior to placing the NGCS, the roadway surface was diamond ground using conventional surface grinding equipment. This was done for two reasons. The first reason is that the roadway surface needed to have the surface restored because faulting was present. The second reason is that the fine grinding head of the NGCS would encounter excessive blade wear if used to restore the pavement surface. This is also the reason for not utilizing the single pass NGCS system. Figure 22 shows the roadway surface after conventional grinding was completed.

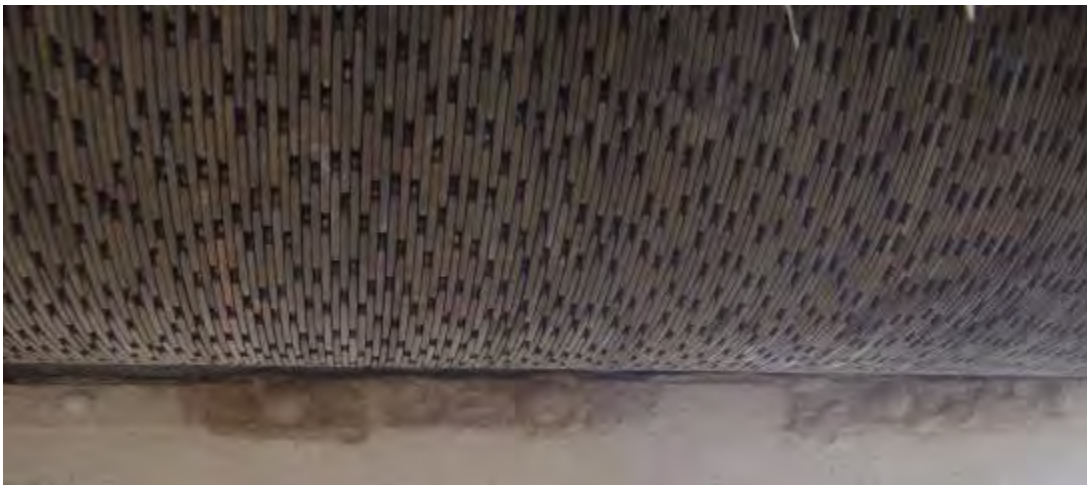
Figure 23. Configuration of fine grinding head and diamond blades.

Once conventional grinding was complete the two pass NGCS began. The grinder outfitted with the fine grinding head was positioned in the outside portion of the outside lane (Lane 1) and progressed eastbound on I-82. When the fine grinding advanced down the roadway, the appearance of the surface was substantially smoother with grooves present. Figure 23 shows the fine grinding head and the configuration of the diamond blades and Figure 24 shows the pavement surface after fine grinding.

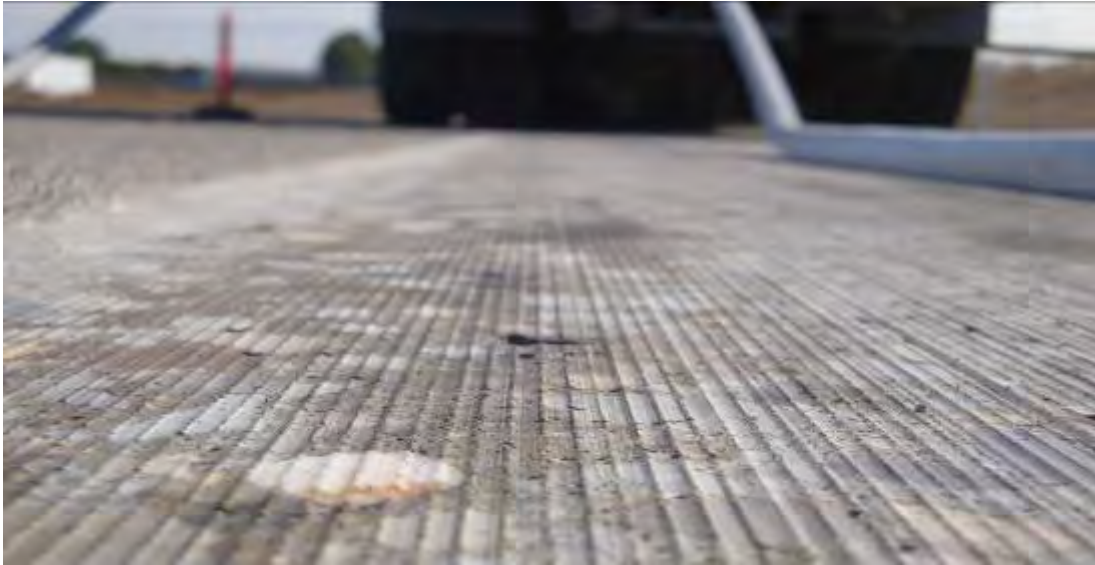
Figure 24. Pavement surface after fine grinding.

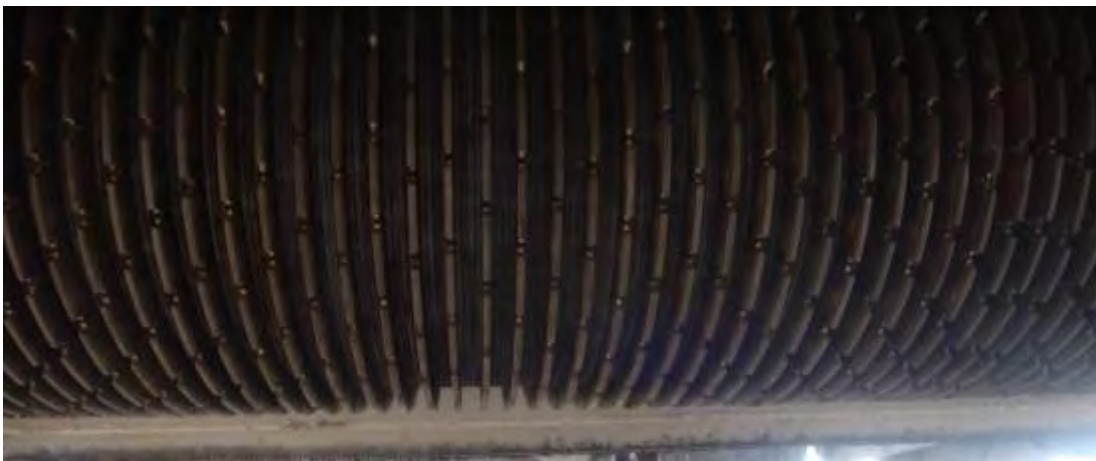
Figure 25. Configuration of taller diamond blades.

When the fine grinding was complete, the grinder equipped with the taller blades commenced operation. The taller blade grind was also placed in the outside portion of the outside lane following the fine grinding machine. This is done to ensure that the taller blades achieve the required depth. Figure 25 shows the configuration of the taller diamond blades across the grinding head and Figure 26 shows the pavement surface after grinding with the taller blades.

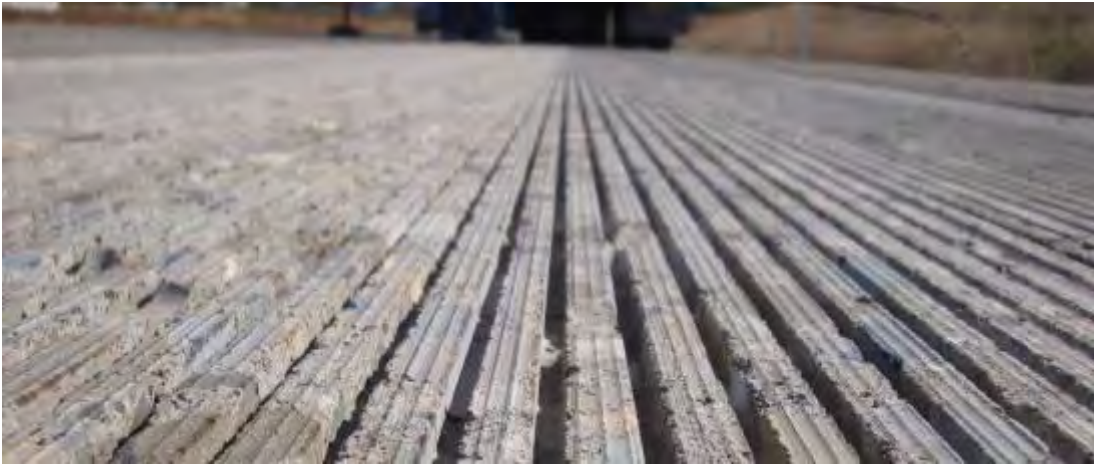
Figure 26. Pavement surface after tall blade grinding.

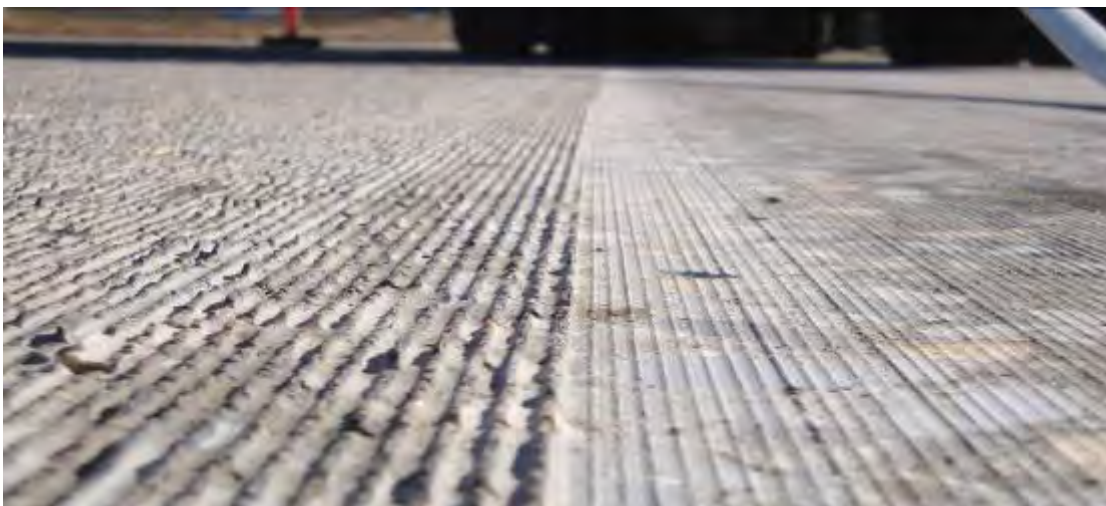
Figure 27. Conventional diamond grind on left with fine grind of NGCS on right before grooves were cut.

The overall operation was no different than conventional grinding seen on dowel bar retrofit projects. The same equipment is used with the only variance being that different grinding heads were used to create a substantially diverse surface texture than typically seen. Figure 27 shows the conventional diamond grind texture next to the flush grind of the NGCS done prior to the cutting of the grooves. Figure 28 shows all three textures, the CDG, the flush grind, and the completed NGCS.

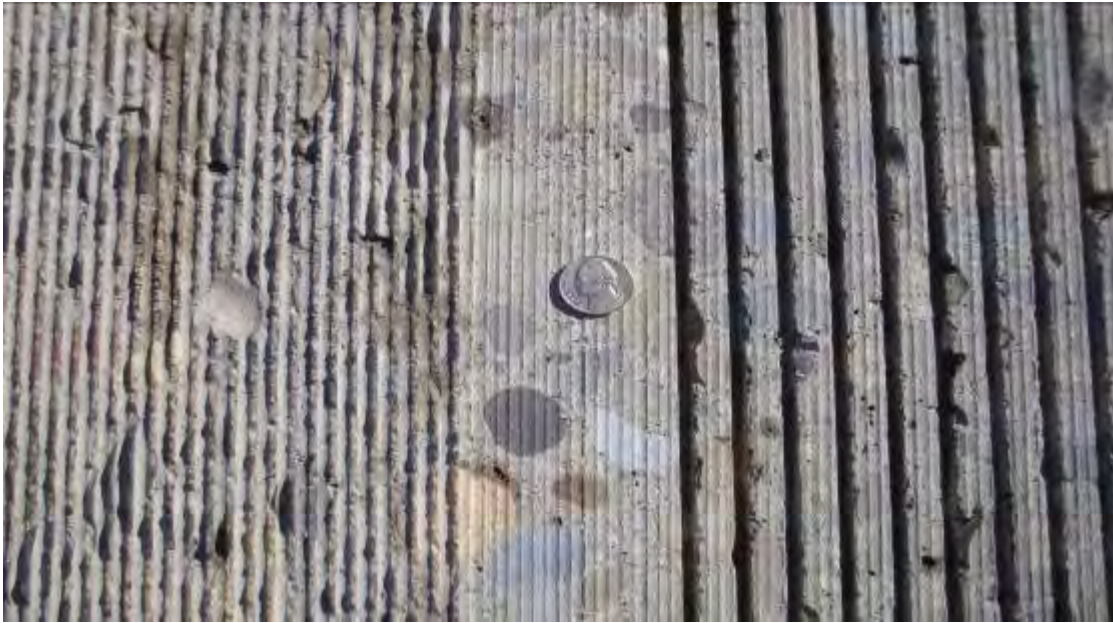
Figure 28. Conventional grind on left, fine grind in middle, and tall grind (complete NGCS) on right.
