# **Eastern Washington Steep Slope Research for Management of Highway Stormwater**

**WA-RD 771.1**

Aimee Shay Navickis-Brasch, P.E. May 2011

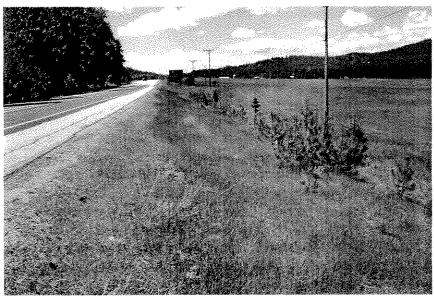
Figure 1.1 Typical Vegetated Filter Strip and Dispersion Area Source: (WSDOT, 2008a)

Vegetated Filter Strip (VFS), also known as Filter Strip, Riparian Buffer, and Vegetated Buffer, are effective at providing runoff treatment of total suspended solids (TSS) when highway runoff sheet flows through vegetation where velocities are slowed, in turn trapping sediment and other pollutants. While some flow control is provided through evaporation, vegetation uptake and transpiration, and infiltration, since these BMPs are generally located at sites with limited area or low saturated hydraulic conductivity (K<sub>sat</sub>), it is assumed that most of the volume of stormwater will be conveyed to the downstream end of the BMP and if required another BMP is used for flow control (WSDOT, 2008a).

Dispersion, is an abbreviated term that will be used in this paper to represent both Natural or Engineering Dispersion. The difference between the two is engineered dispersion represents an area that has been modified to meet the design criteria and natural dispersion represents sites that meet the design criteria without modification. Dispersion is located at sites with a large areas compared to VFS or where  $K_{\text{sat}}$  is high, either of these site conditions allow all the stormwater to

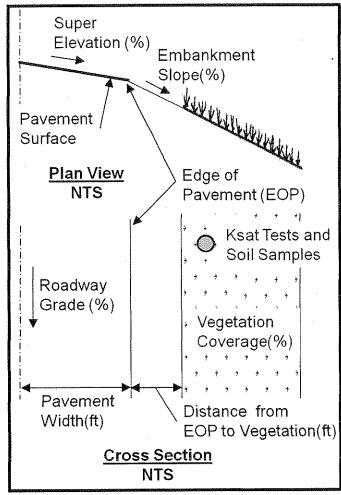
Figure 3.2 Locations of Measured Site Characteristics

A list of the 14 measured site characteristics inventoried is summarized in Table 3.1, along with the representative nomenclature, definitions, and the range of values found over the forty-five sites evaluated. Figure 3.2 illustrates the typical location of these measured site characteristics and a complete inventory if the site characteristics for each site is located in Appendix A. Thirteen of the measured site characteristics represent most of the independent variables necessary to design VFS and dispersion BMPs and design a stable embankment as described below:

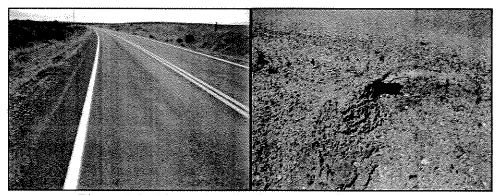
• EOP and Embankment Interface – Evidence of flow channelizing in streamlets between the EOP and embankment interface is shown in Figure 3.3 at Sites 23-52.1RT (left) and 292-0.8-RT (right). These conditions were observed at 10 of the 25 sites with erosion and only 1 site without erosion.

Figure 3.3 EOP and Embankment Interface Channels

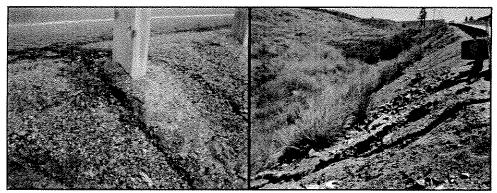
Guard Rail – Site conditions that required guard rail to redirect an errant vehicle away from the embankment can also encourage highway runoff to erode the embankment (WSDOT, 2010b). This condition can occur when runoff flows behind the guardrail or along a curb installed in conjunction with the guardrail creating concentrated flows that can cause erosion as depicted in Figure 3.5 shown at site 20-389.1 RT (left) and 155-70.8 RT (right). Of the 45 sites tested, 9 had guard rail. Of those sites, only 4 showed evidence of erosion.

Figure 3.5 Erosion from Channelized Flow at Guard Rails

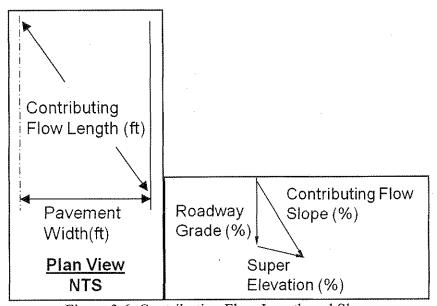
shown in Figure 3.6. Finally, as runoff sheet flows across the pavement the roughened surface of the pavement could cause runoff to be redirected and spread. For the shear stress analysis the longest hypothetical contributing flow path is an dependant variable based on independent highway geometry variables and is calculated using equation 3.2.

Figure 3.6 Contributing Flow Length and Slope

The slope of the contributing flow line is a measure of the pavement incline from the horizontal assumed to be straight as shown in Figure 3.15. This is also considered hypothetical for the same reason as described for the contributing flow path. The slope is calculated based on the super elevation and the roadway grade using equation 3.3 and also used to determine the flow rate.

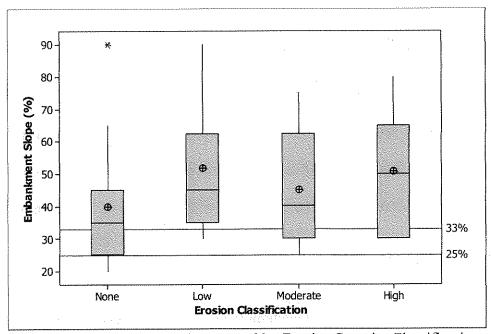
Figure 4.1 Embankment Slope sorted by Erosion Severity Classification

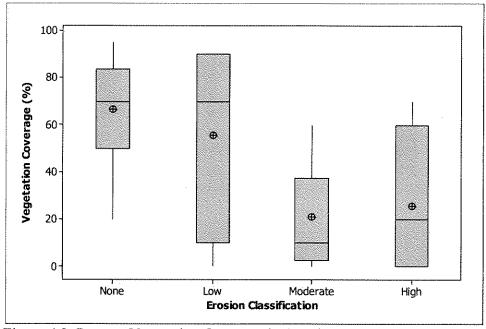
Vegetation coverage had the strongest correlation coefficient of r =-0.559 which indicates a moderately strong negative relationship to erosion severity meaning as vegetation coverage decreases erosion severity has a tendency to increase (see Figure 4.2). The p-value was 0 indicating the percentage of vegetation was highly significant (p-value < 0.01) compared to other site characteristics. Standard practices to stabilized soils and prevent erosion typically includes vegetation, which further supports to the statistical relationship noted between vegetation coverage and erosion severity (TXDOT, 2009; WSDOT, 2003). Table 4.3 shows that all the sites with no erosion had a minimum of 20% vegetative cover, and an average of 66.75%, which is

Figure 4.2 Percent Vegetation Coverage by Erosion Severity Classification

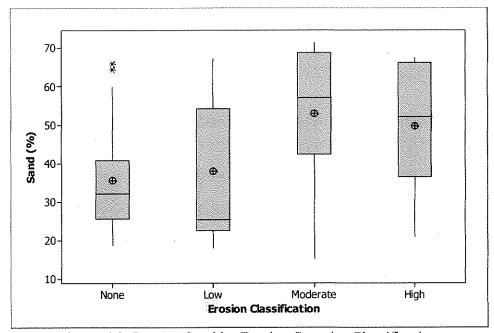
The percentage of sand composition in the embankment soils had the second strongest correlation coefficient at 0.363 indicating a moderately low positive relationship to erosion severity. In other word, as the percentage of sand increases, erosion severity also has a tendency to increase (see Figure 4.3). This relationship can also be observed in Table 4.3 where the mean percentage of sand is lower at the sites with no or low erosion compared to sites with moderate to high erosion. The p-value for percentage sand was 0.015 indicating there was a strong significance (p-value < 0.05) compared to other site factors.

Figure 4.3 Percent Sand by Erosion Severity Classification

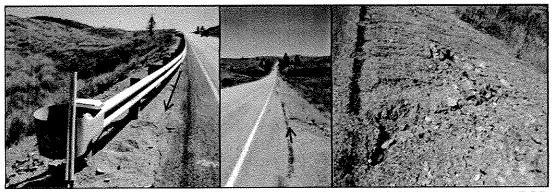
The most significant empirical observation noted was channelized flow in streamlets between the EOP and embankment interface which was documented at 10 of the 25 sites with erosion and only one site without erosion. This may indicate that the conditions at the interface location between the EOP and the embankment could be contributing to erosion by encouraging highway runoff to concentrate. Although observed less frequently, other site characteristics which may also encourage runoff to concentrate included guardrail and cracks or imperfections at the EOP. The worst case observed, site 155.70.8 RT, appeared to be caused by a combination of these site characteristics where the highest erosion severity was documented. As shown in Figure 4.16, at Site 155-70.8 RT, it appears flows concentrated along the guard rail curbing, travel in the channel along the EOP interface, to imperfection in the EOP where the embankment eroded.

Figure 4.4 Evidence of Concentrated Flows: along Guard Rail, in Streamlets at EOP Interface, and from Imperfections at EOP

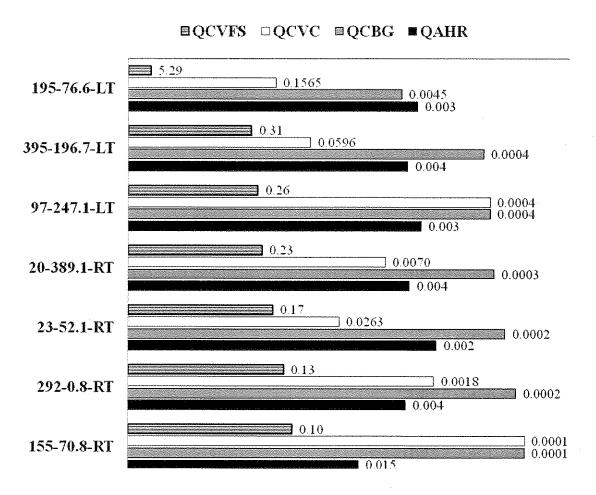
fail was at site 195-76.6 LT which has clayey soils and a higher critical flow rate based on the cohesive soil properties. At this site there was no obvious site factor affecting the stability of the embankment. Next, the VFS condition was assessed to determine if a densely vegetated embankment prevent erosion. As shown, the critical flow rate for VFS condition is higher than the applied flow rate for all sites indicating if these sites. This indicates that if these sites were constructed as VFS, all would have had a critical flow rate high enough to prevent erosion along the embankment.

Figure 4.5 High Erosion Sites Comparison of Critical Flow Rates (cfs) (Shown on a Reverse Logarithmic Scale)

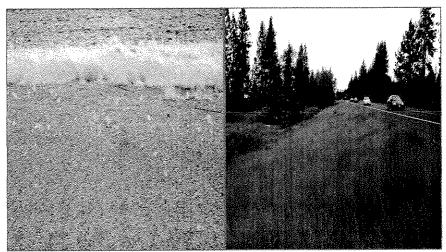
The vegetation along the embankments varied from 0-95% coverage and the majority of vegetation was native grasses or weeds. The density of coverage also varied from uniform to non-uniform, including bunch grasses. To estimate the percentage of area covered with vegetation, an approximate 10 ft by 10 ft area was located that appeared to represent the average amount of vegetation coverage and density along the embankment. Within this "square" the amount of area covered in vegetation was estimated and (usually) rounded to the nearest tenth percent. Figure B1 shows two sites where the vegetation was estimated at 0% on the left and 95% on the right.

Figure B1 Estimating the Vegetation Coverage

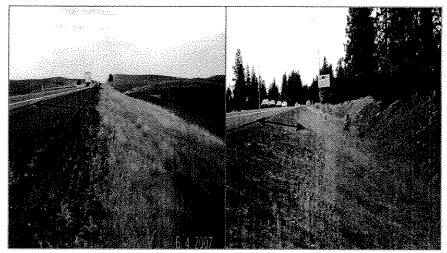
In addition to estimating the coverage of vegetation, the distance from the edge of pavement (EOP) to the start of consistent vegetation coverage was also documented. For sites with uniform density, it was fairly apparent (see left in Figure B2). However, for sites with non-uniform density, the distance represents an approximate average along the embankment (see right Figure B2).

Figure B2 Estimating the Distance From EOP to Vegetation

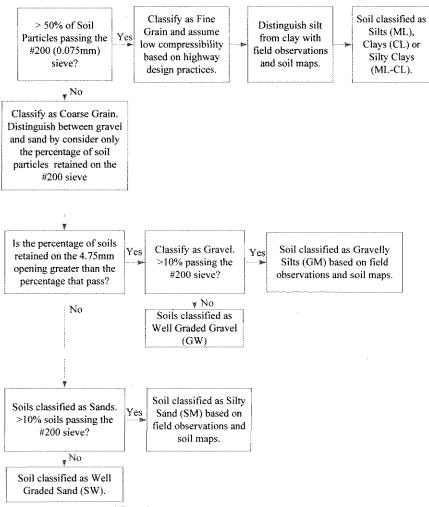
Figure B5 Soil Classification Process

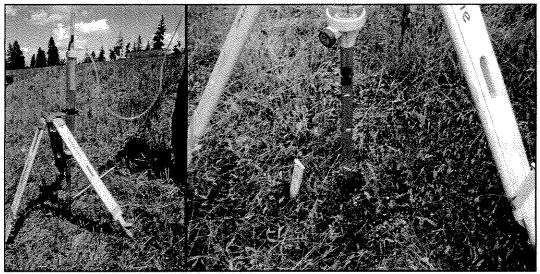
The K<sub>sat</sub> was measured using the Guelph Permeameter which is a quasi steady state, constant head test used to measure the saturated hydraulic conductivity of unsaturated soil. This method was selected because it is the approved method to measure K<sub>sat</sub> for sizing dispersion BMPs as part of the stormwater design guidance in the HRM (WSDOT, 2008a). For most sites, two tests were performed with the averaged reported in the inventory in Appendix A. Actual testing was performed within the vegetated area of the embankment and a minimum of 8 feet from the EOP. Test wells were prepared by auguring a hole approximately 8-12 inches deep and the soil removed was collected for sieve analysis. Figures 3.9 shows a typical Ksat test using the Guelph Permeameter along the highway embankment.

Figure B6 Typical Ksat Testing on a Highway Embankment Area

The K<sub>sat</sub> was calculated based on Darcys Law and used the soil classification, the diameter of the well, the height of water (head) applied to the test well, and the rate of fall of the head (Soilmoisture, 2005). With the Guelph Permeameter, a single or double head test can be performed and the results of the double head can also be used to calculate Ksat for two single head test. The double head test is recommended for moderate to high permeability soils such as coarse grain and the single head test is recommended for low permeability soils such as fine grain. In most cases, the double head test was attempted first since it is assumed to be more accurate. The single head test was only used for sites where the soil visually appeared to be primarily fine grained. Since the test well diameter and head were the same depending on which test was performed, the actual equation used to calculate K<sub>sat</sub> is based primarily on the rate of steady state fall as shown in Equation 3.8 and 3.9, representing the double head and single head analysis respectively.

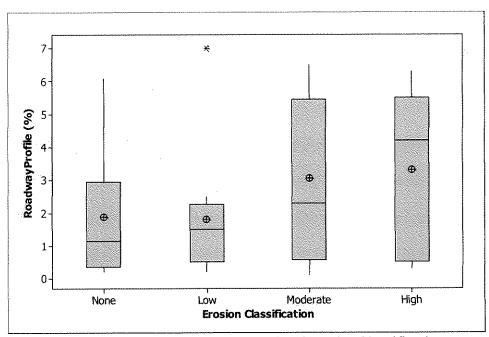
Figure F1 Roadway Profile vs Erosion Severity Classification

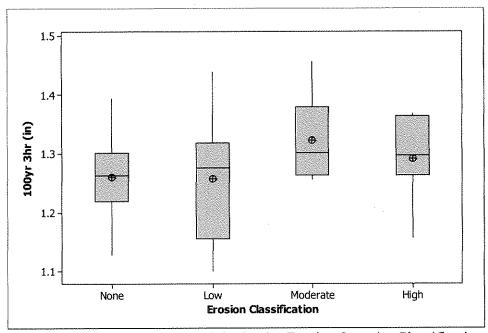
Figure F2 100 year 3 hour Precipitation by Erosion Severity Classification

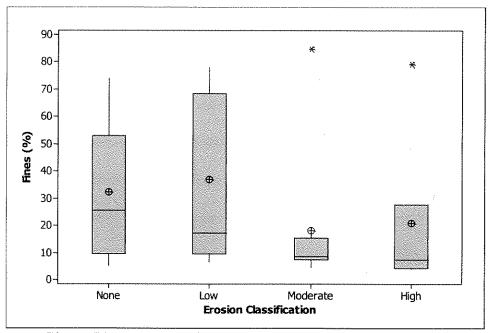
Figure F3 Percentage Fines by Erosion Severity Classification

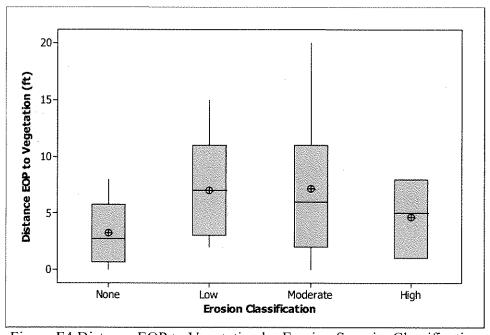
Figure F4 Distance EOP to Vegetation by Erosion Severity Classification

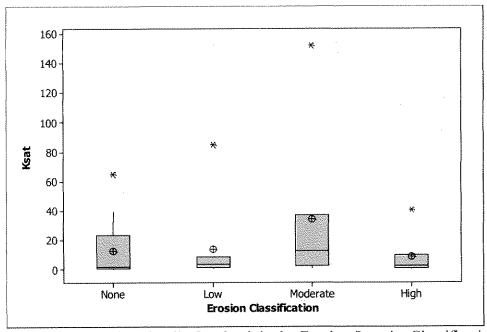
Figure F5 Saturated Hydraulic Conductivity by Erosion Severity Classification

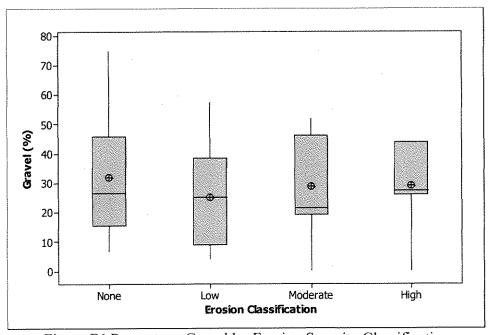
Figure F6 Percentage Gravel by Erosion Severity Classification

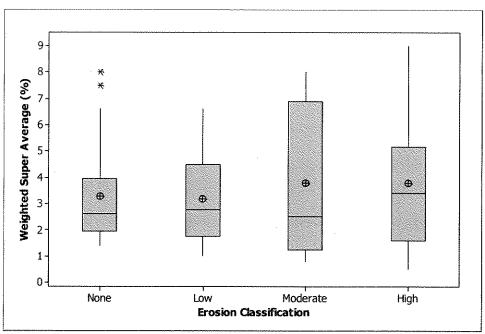
Figure F7 Super Elevation vs Erosion Severity Classification

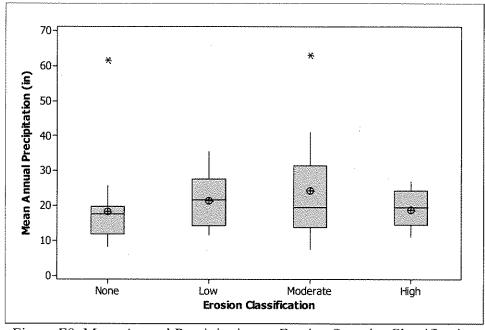
Figure F8 Mean Annual Precipitation vs Erosion Severity Classification

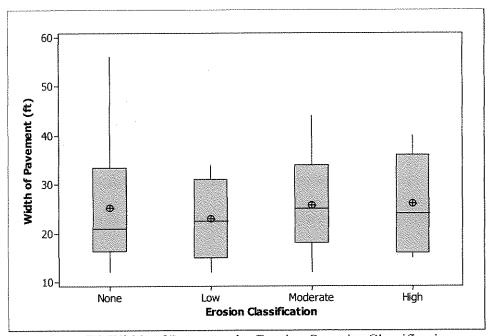
The width of pavement had the thirteenth and least strong correlation coefficient of 0.012, indicating a weak positive relationship. As the width of pavement increased, there was a slight increased trend to erosion severity. The p-value was 0.92, indicating the relationship between the width of pavement and erosion severity is not statistically significant (p-value > 0.05) compared to other site characteristics. This is can be observed in Figure F9, which shows the mean is nearly consistent at both the no erosion and high erosion sites.

Figure F9 Width of Pavement by Erosion Severity Classification
