# Pavement Edge Treatment — Final Report

WA-RD 798.2

Experimental Feature WA 11-01

# Pavement Edge Treatment

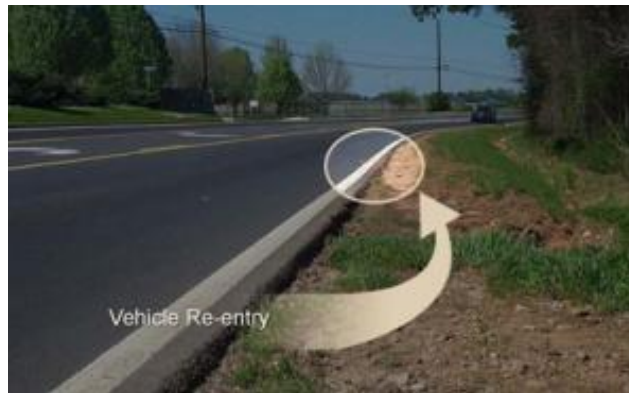
Figure 5. Vertical drop off at pavement edge. (FHWA Safety Edge<sub>SM</sub> PowerPoint)

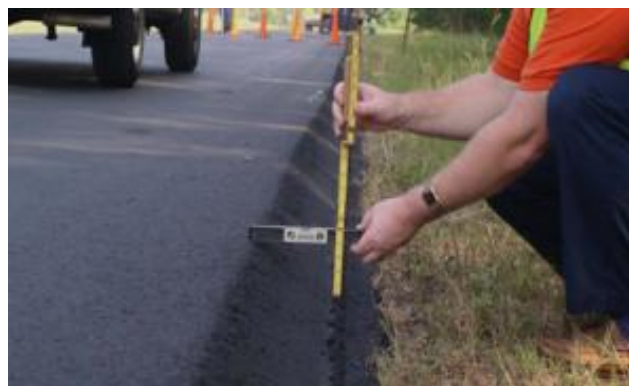
Figure 6. Sloping edge produced by pavement edge hardware. (FHWA Safety Edge<sub>SM</sub> PowerPoint)

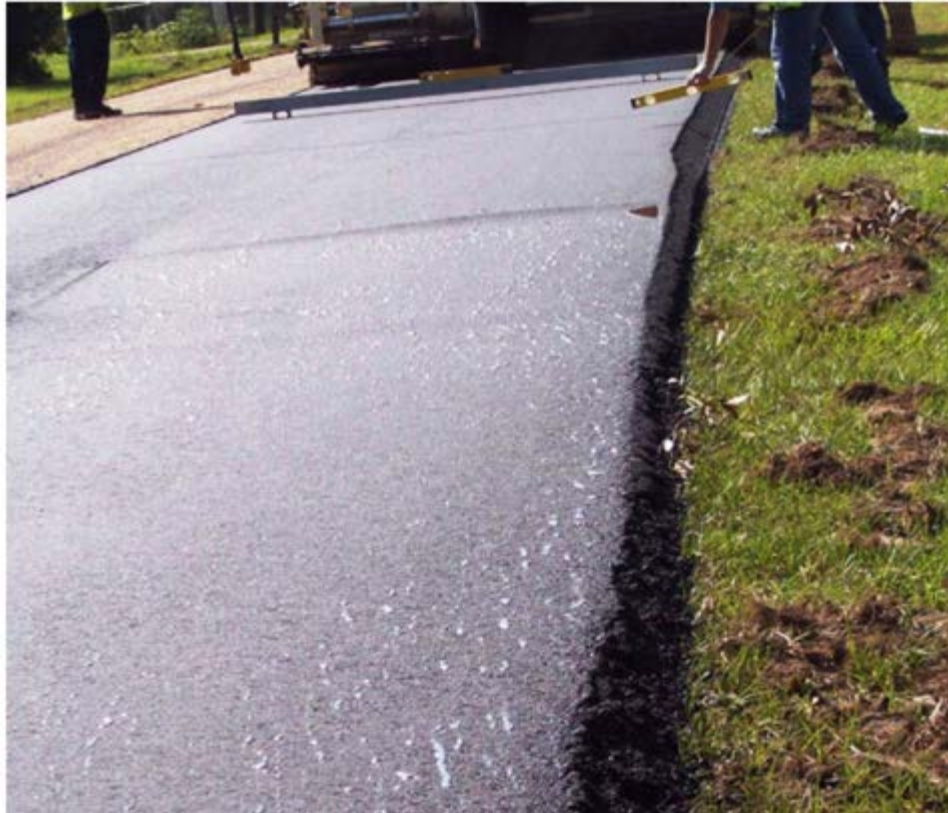
Figure 7. Pavement edge without the Safety Edge<sub>SM</sub> in foreground and with the Safety Edge<sub>SM</sub> in the background. (FHWA Safety Edge PowerPoint)

The Safety Edge<sub>SM</sub> pavement edge treatment provides a non-vertical wedge at the edge of the pavement which reduces the steering forces needed for re-entering the roadway. With this treatment, the pavement edge is sloped at a 30° angle (see Figure 2). The presence of a slope instead of a vertical face makes it easier for a vehicle to re-enter the roadway. Figures 3 and 4 are diagrams of a pavement edge with and without the pavement edge treatment. Figures 5 and 6 are photos of a pavement with a vertical edge and one with the pavement edge treatment. Figure 7 shows a pavement under construction.

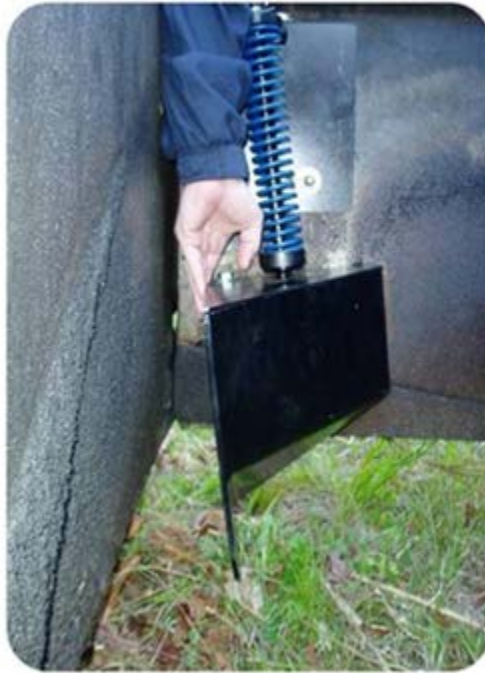
trowel to smooth the surface of the wedge fillet. Both left and right-hand devices are available for paving with or against traffic.

Figure 9. Troxler SafeTSlope™ Edge Smoother.

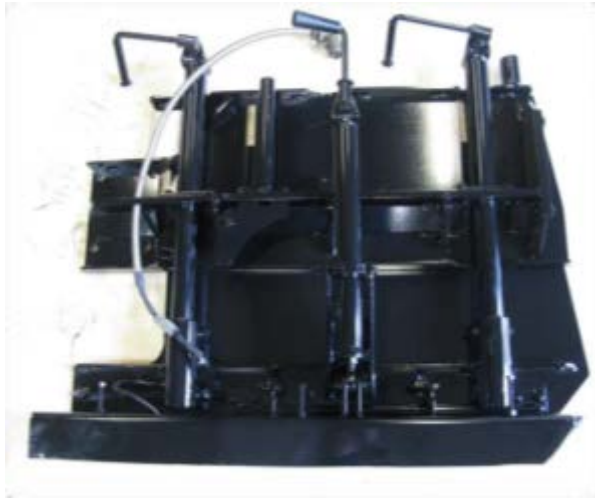
Figure 10. Carlson Safety Edge End Gate hardware. (FHWA, Madison Co., WI)

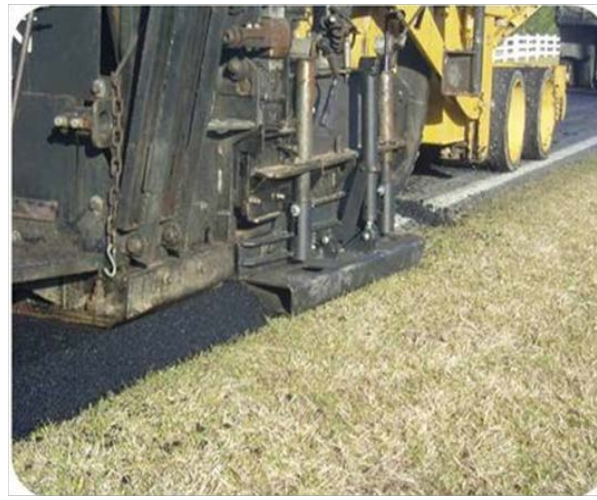
Figure 11. Carlson Safety Edge End Gate in use. (FHWA, Menominee, WI)

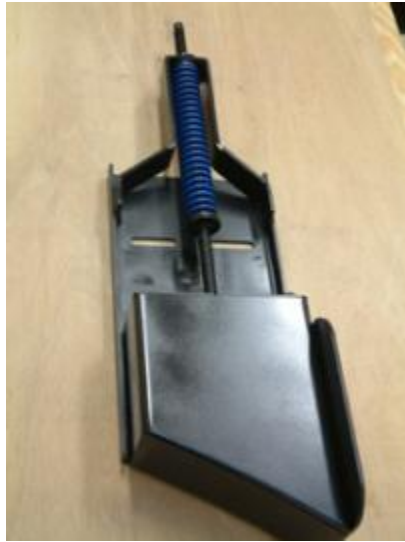
Figure 12. The Advant-Edger™ creates a tapered 30° safety edge along the shoulder of the road.

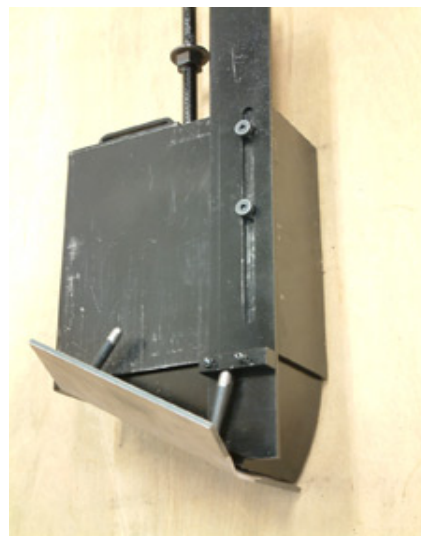
Figure 13. The Advant-Edger Ramp Champ™ forms a tapered safety edge or a longitudinal center lane joint.

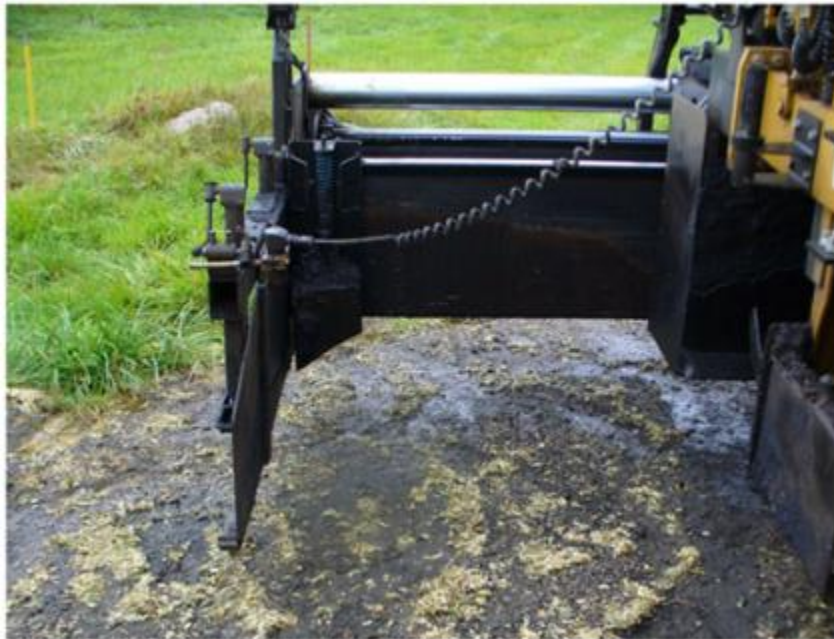
Figure 14. Advant-Edger™ mounted on a paver. Unit is designed to automatically adjust to shoulder elevation changes (driveways and intersections).

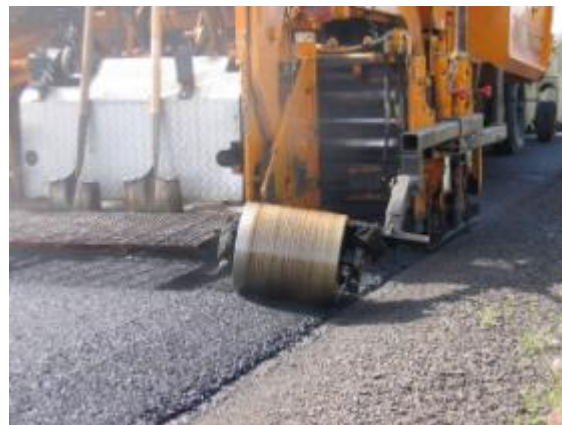
Figure 17. Paver forming and compacting pavement edge treatment.

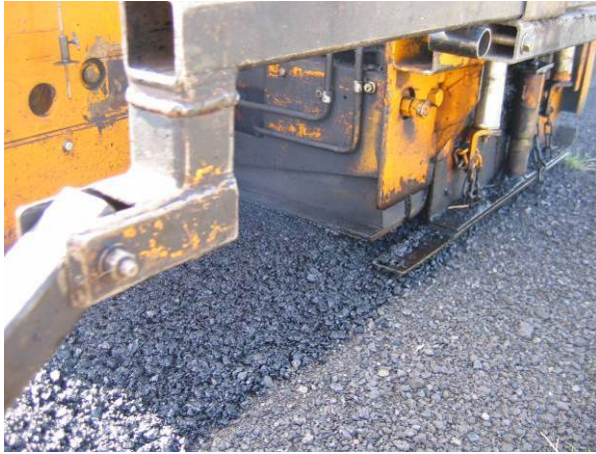
Figure 18. Close-up of paver screed.

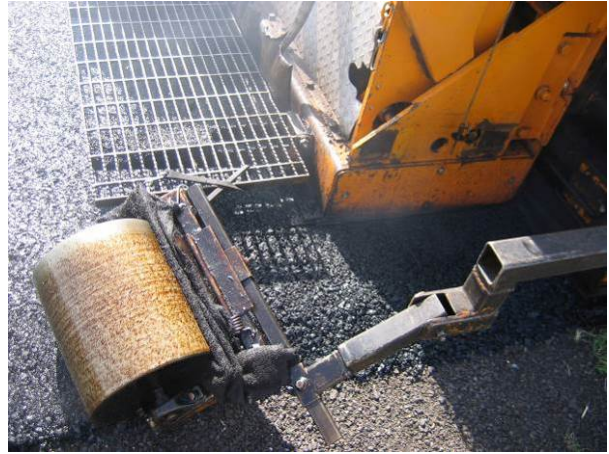
Figure 19. Close-up of roller hardware.

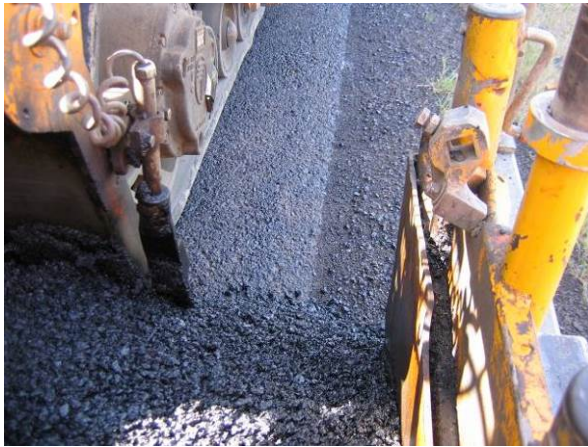
Figure 20. Close-up of sloped pavement edge showing top of slope at existing pavement edge.

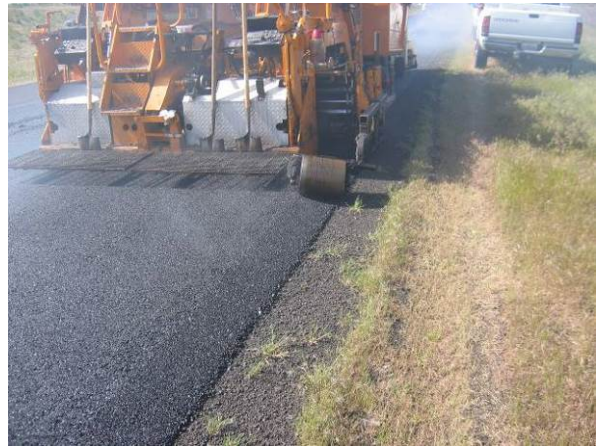
Figure 21. View of rolled pavement edge treatment.

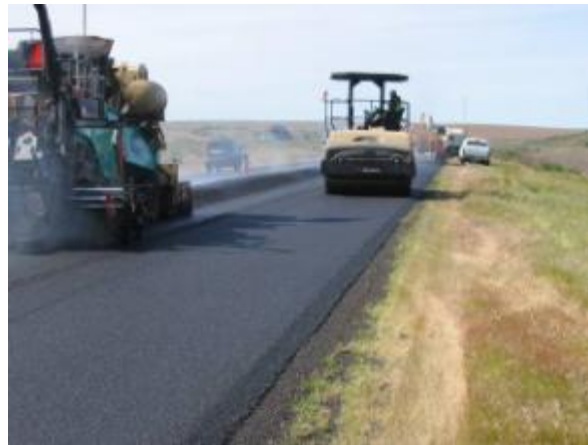
Figure 22. Distant view of paver with edge rolling hardware.

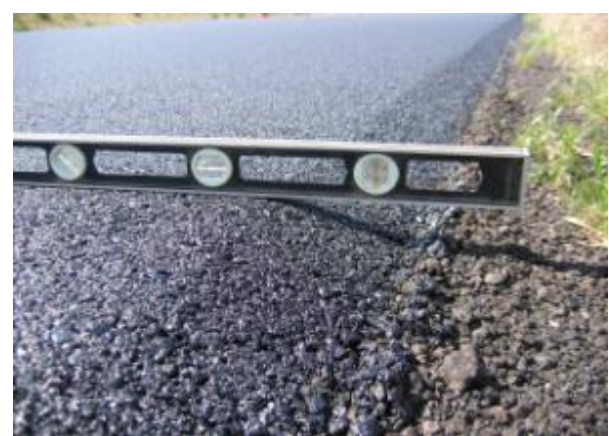
Figure 23. Angle of sloped pavement edge. Note the uniform compaction.

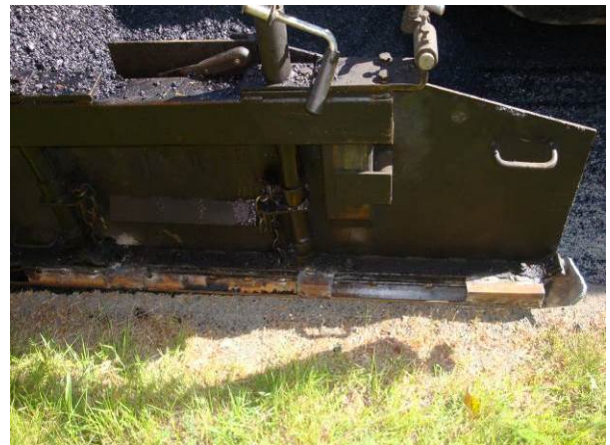
Figure 28. Side view of TransTech hardware.

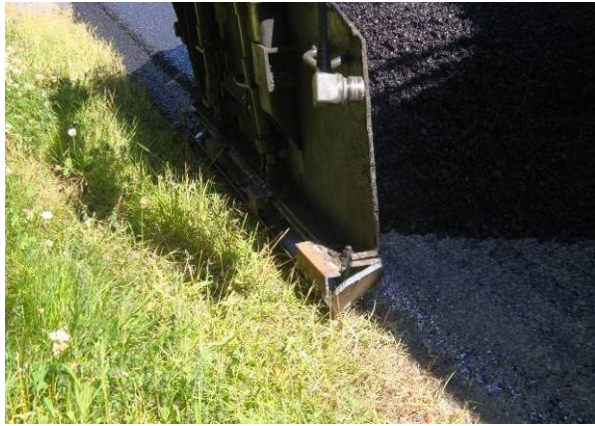
Figure 29. End view of TransTech pavement edge hardware without the roller.

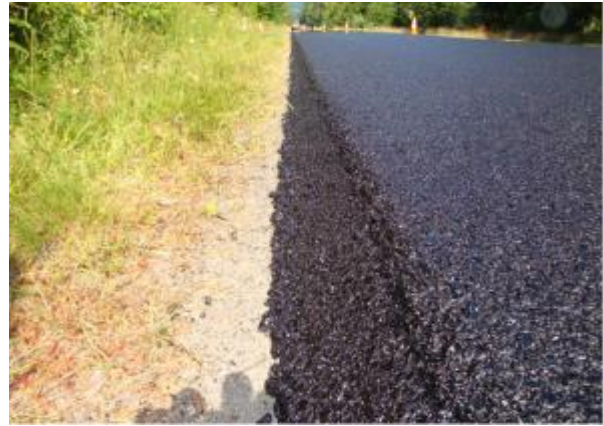
Figure 30. Pavement edge formed by the TransTech hardware prior to adding the roller. Note open texture of the HMA.

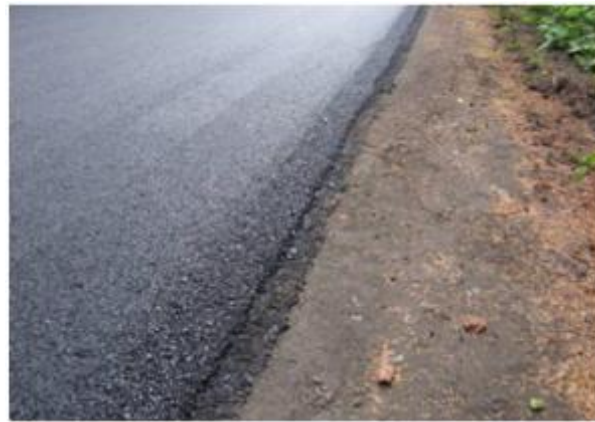
Figure 31. Pavement edge treatment after addition of a roller behind the paver.

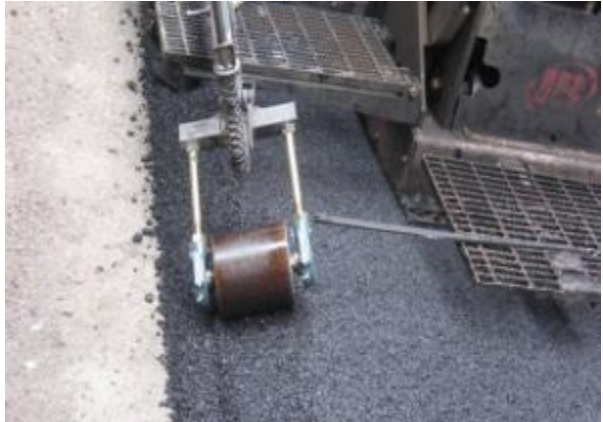
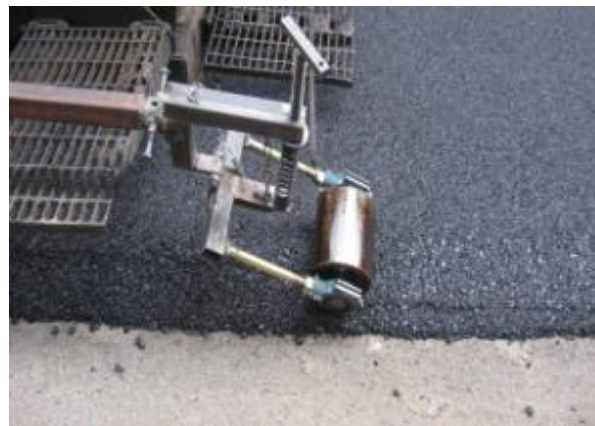
Figure 32. Roller added to compact the vertical edge at the top of the slope.

Figure 33. Roller added to compact the vertical edge at the top of the slope.

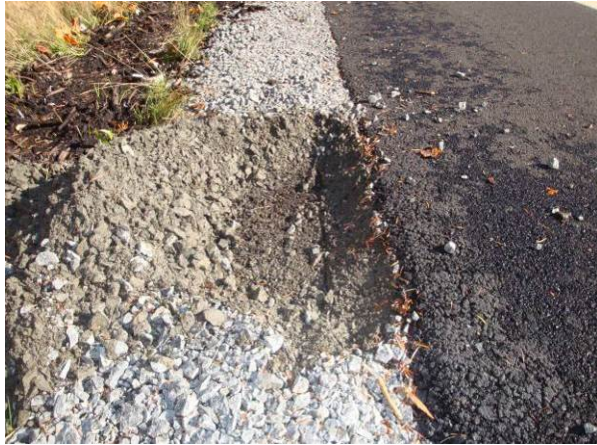
Figure 35. Dig out showing slope of pavement edge.

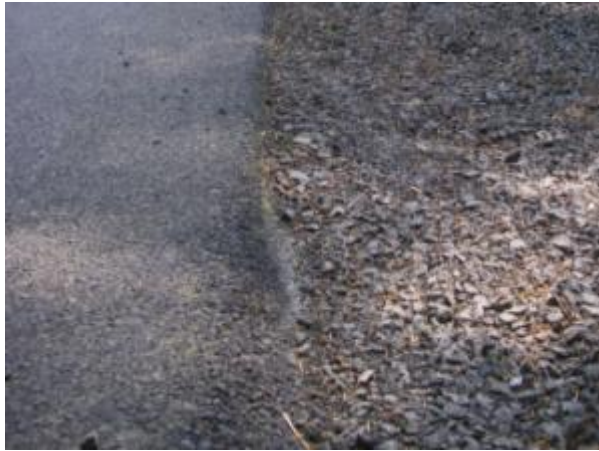
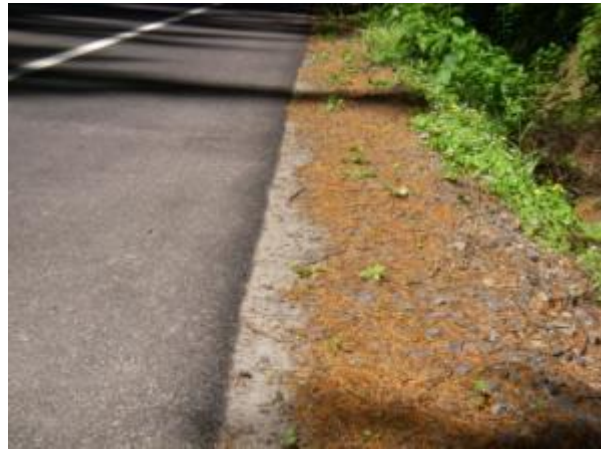
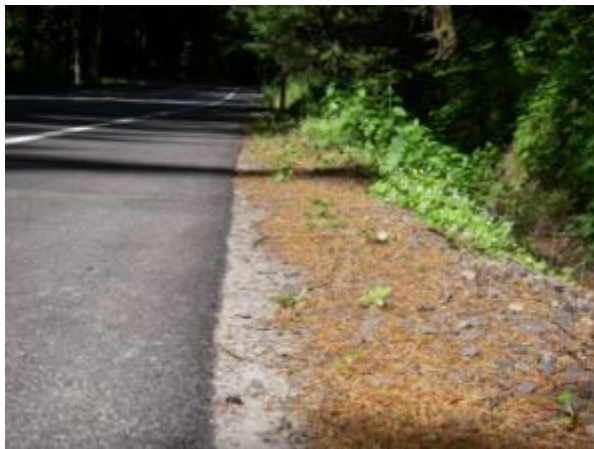
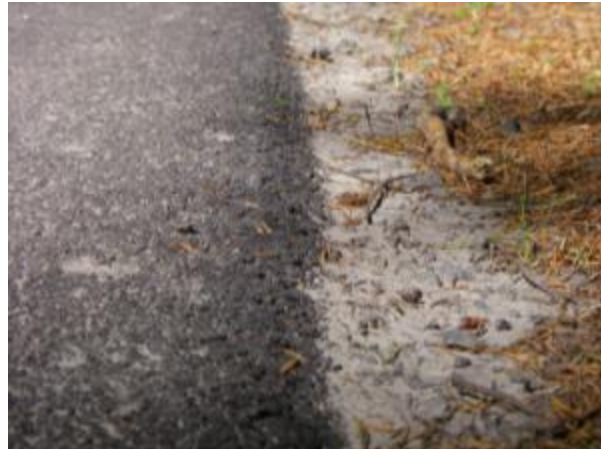
Figures 37 through 40 show the SR 410 pavement edge treatment one year after construction. Some erosion can be seen of the shoulder material exposing the pavement edge treatment.

Figure 37. Pavement edge treatment close-up one year after construction.

Figure 38. Pavement edge treatment on SR 410 one year after construction.

Figure 39. Another photo of the SR-410 pavement edge treatment one year after construction.

Figure 40. Close-up of pavement edge treatment on SR 410 one year after construction. Shows some exposure of pavement edge treatment.

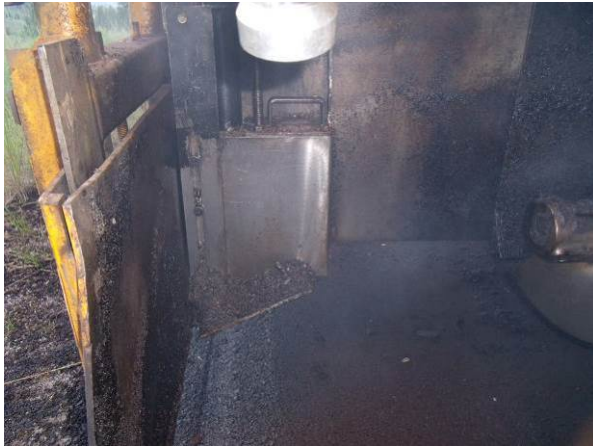
Figure 42. Advant-Edger<sup>TM</sup> used to produce the pavement edge treatment.

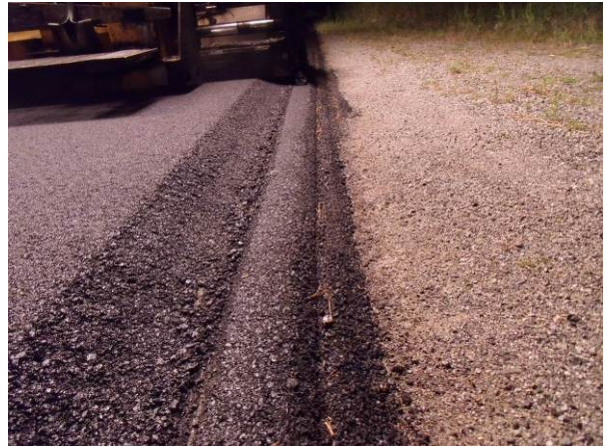
Figure 43. Pavement edge treatment produced by the Advant-Edger<sup>TM</sup>.

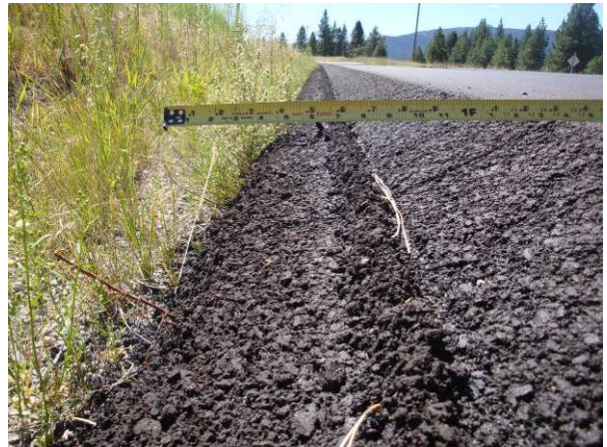
Figure 45. Close-up of edge treatment slope.

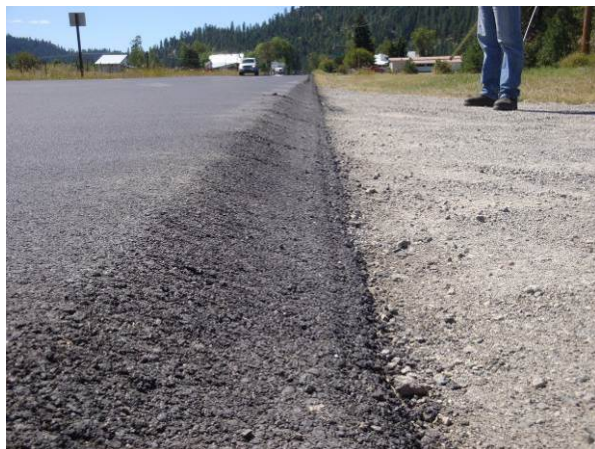
Figure 50. Slope of edge treatment across a road approach.

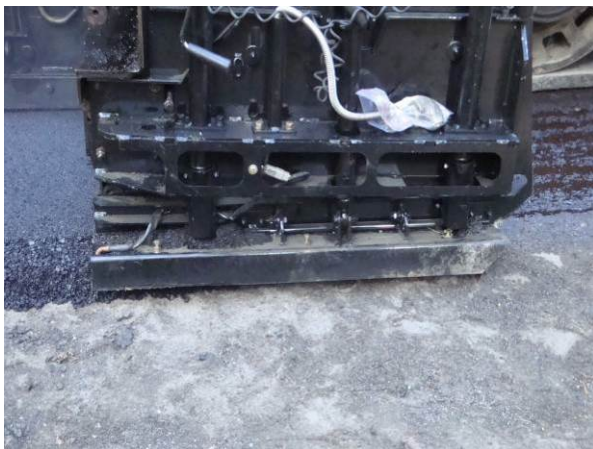
Figure 53. Side view of Carlson end gate.

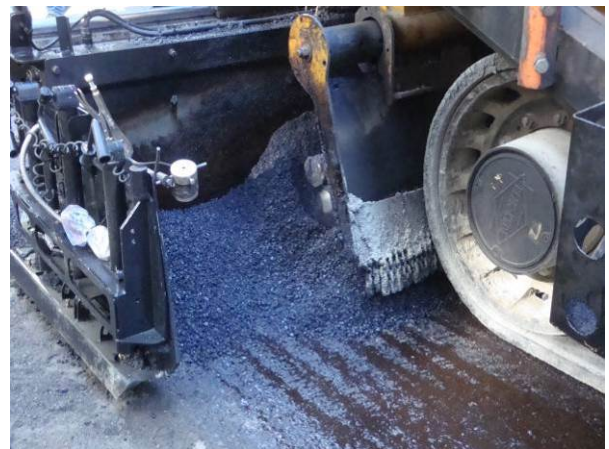
Figure 54. Mix passing through the end gate.

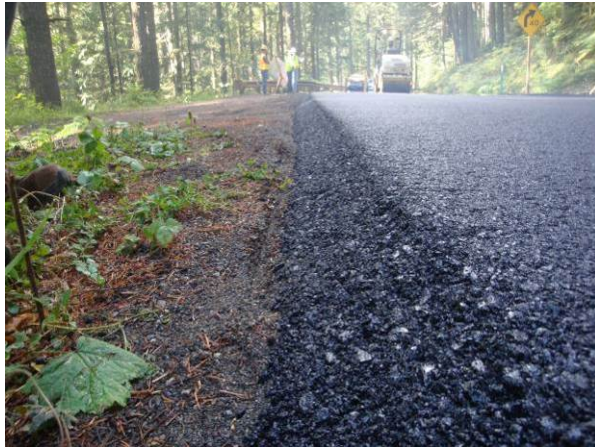
Figure 55. Pavement edge treatment produced by the Carlson end gate.

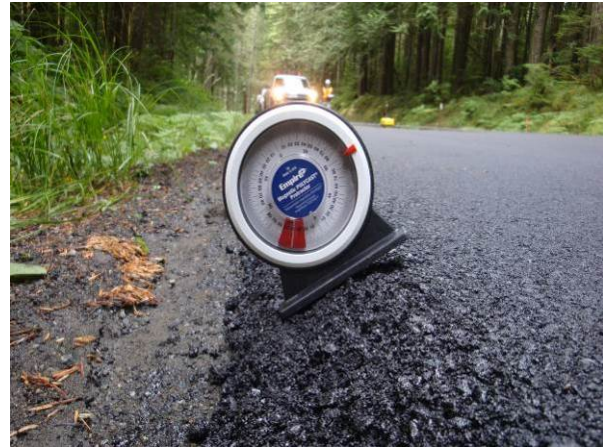
Figure 56. Slope indicator device on the edge treatment. Slope does not appear to be compacted.

Table 6 lists the slope measurement made of the finished pavement using a slope indicator gauge (Figures 56 and 57). The average of 28° meets the pavement edge goal of 30° and none of the slopes fall out of FHWA's 26 to 40° recommended range.

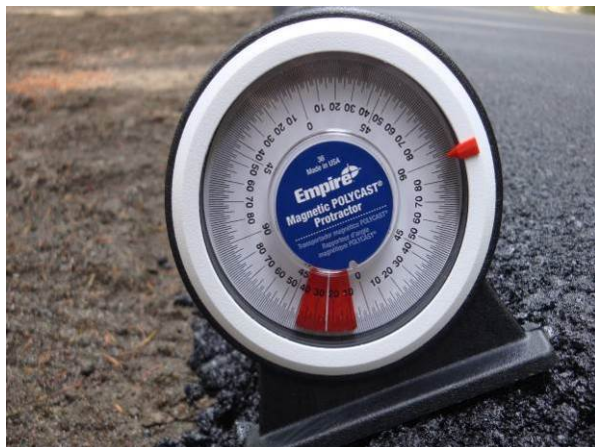
Figure 57. Close-up of slope indicator.

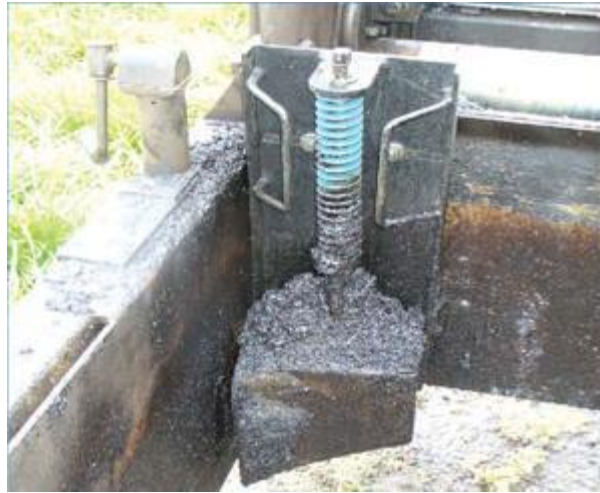
Figure 1. Pavement edge “shoe” bolted to paving machine screed (FHWA).

The pavement edge treatment is a wedge of pavement placed by a device bolted to the screed of the paving machine (Figure 1). FHWA recommends an angle of 30° to 35° between the roadway slope and the slope of the wedge (Figure 2). After completion of paving the gravel is graded back flush with the new pavement just as when a conventional vertical pavement edge is constructed.
