Pavement Edge Treatment

WA-RD 798.1

Post-Construction Report Experimental Feature WA 11-01

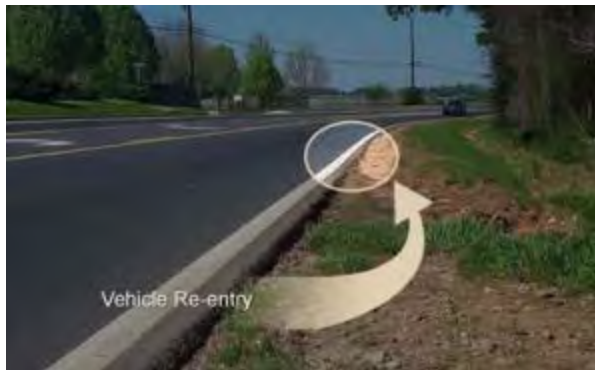
Figure 5. Vertical drop off at pavement edge. (FHWA Safety Edge_{SM} PowerPoint)

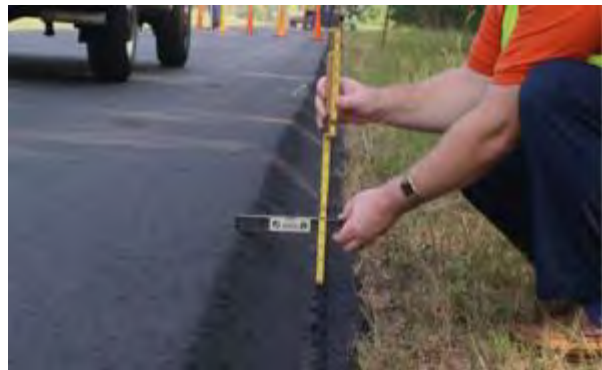
Figure 6. Sloping edge produced by pavement edge hardware. (FHWA Safety Edge_{SM} PowerPoint)

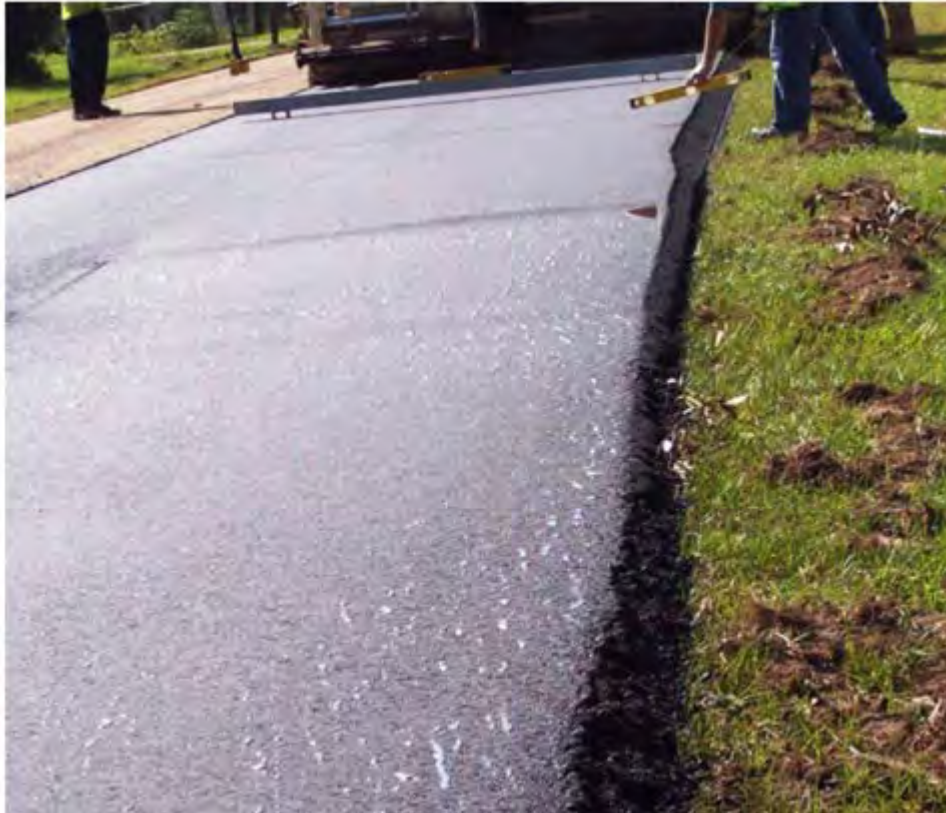
Figure 7. Pavement edge without the Safety Edge_{SM} in foreground and with the Safety Edge_{SM} in the background. (FHWA Safety Edge PowerPoint)

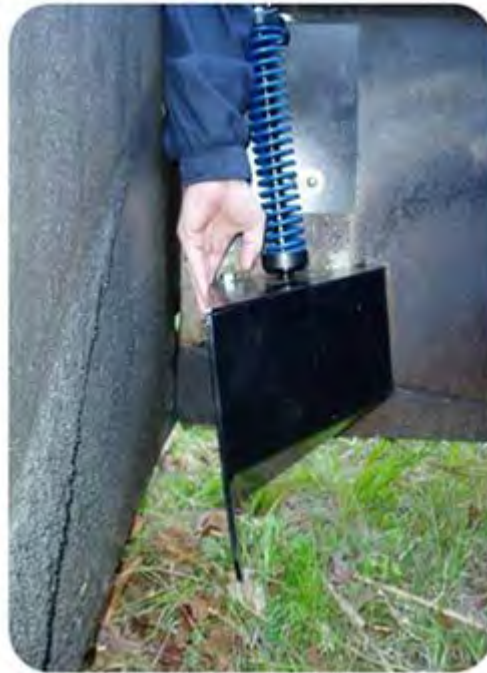
Figure 9. Troxler SafeTSlope™ Edge Smoother.

trowel to smooth the surface of the wedge fillet. Both left and right-hand devices are available for paving with or against traffic.

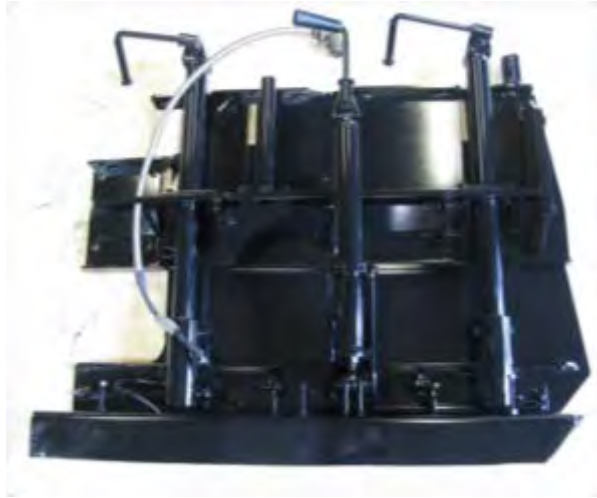
Figure 10. Carlson Safety Edge End Gate hardware. (FHWA, Madison Co., WI)

The Carlson Safety Edge End Gate features a spring loaded and heated end gate for the paving screed (see Figures 10 and 11). It utilizes the length of the end gate to apply compaction to the slope face of the pavement edge treatment. The screed operator's normal end adjustments automatically control the edge. The end gate ski is flat in the front and transitions to 30° at the back of the ski. The relatively long length of the end gate ski results in a smooth/sealed slope face.

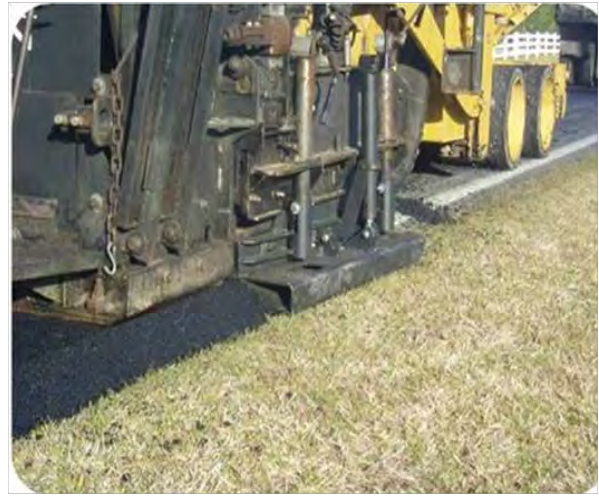
Figure 11. Carlson Safety Edge End Gate in use. (FHWA, Menominee, WI)

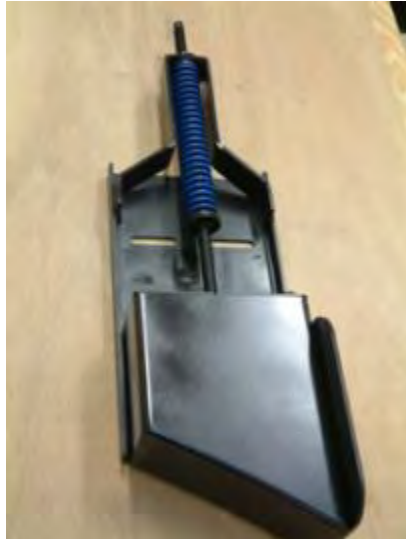
Figure 12. The Advant-Edge™ creates a tapered 30° safety edge along the shoulder of the road.

The Advant-Edge™ attaches to the screed extension and shapes the edge to a 30° tapered angle (Figures 12 and 14). It automatically adjusts to changes in shoulder elevations (i.e. driveways) via its internal spring. The Advant-Edge™ is reversible so that it may be attached to either side of the paving machine. A new model called the Ramp Champ™ is designed to create either a safety edge or a tapered longitudinal center lane joint (Figure 13). It is also spring loaded to automatically adjust for changes in shoulder elevation. The slope of the safety edge is adjustable from 5° to 30° and its forming surfaces (shoes) are detachable permitting the same unit to create a variety of edge profiles.

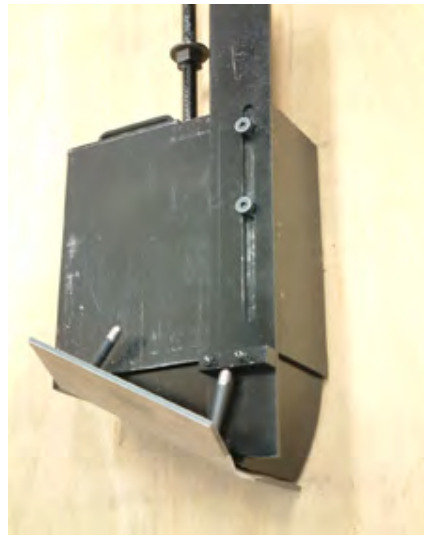
Figure 13. The Advant-Edge Ramp Champ™ forms a tapered safety edge or a longitudinal center lane joint.

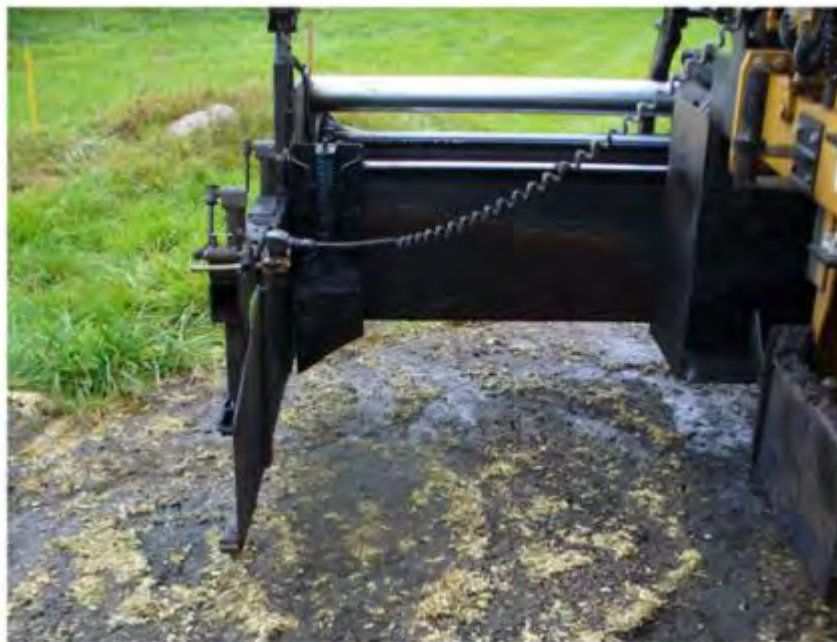
Figure 14. Advant-Edge™ mounted on a paver. Unit is designed to automatically adjust to shoulder elevation changes (driveways and intersections).

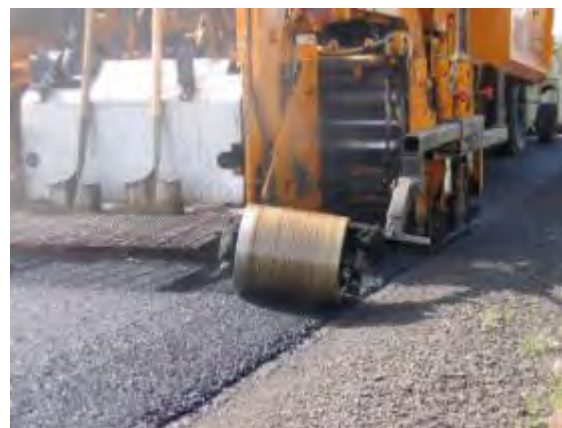
Figure 17. Paver forming and compacting pavement edge treatment.

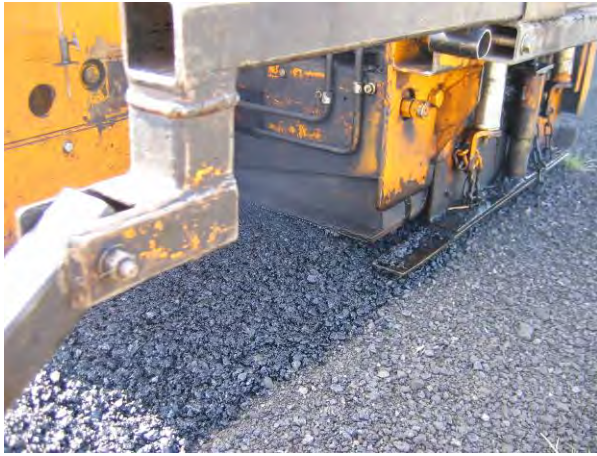
Figure 18. Close-up of paver screed.

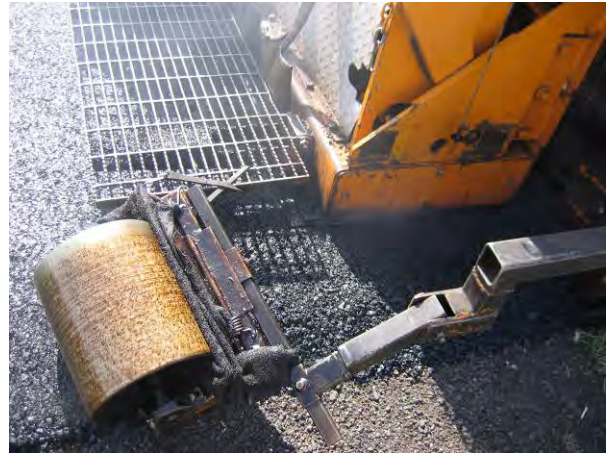
Figure 19. Close-up of roller hardware.

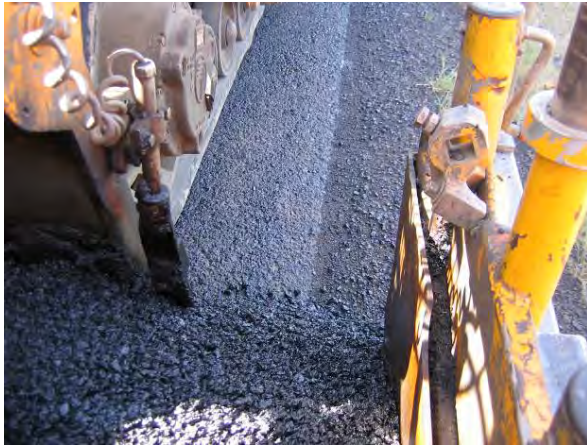
Figure 20. Close-up of sloped pavement edge showing top of slope at existing pavement edge.

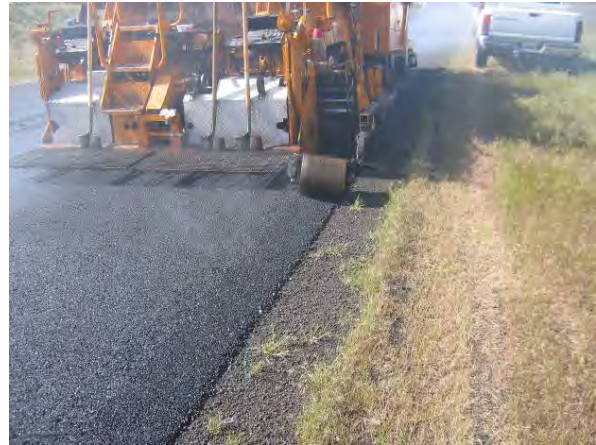
Figure 21. View of rolled pavement edge treatment.

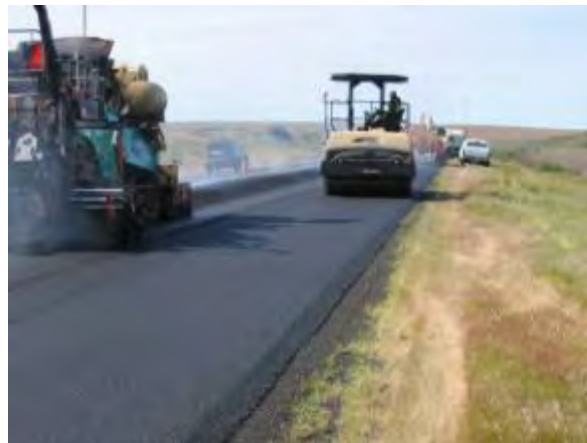
Figure 22. Distant view of paver with edge rolling hardware.

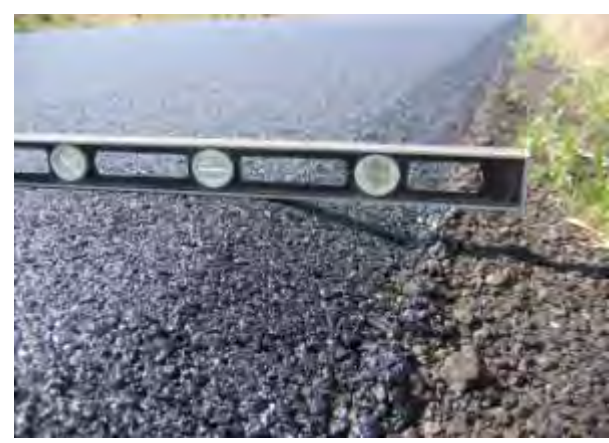
Figure 23. Angle of sloped pavement edge. Note the uniform compaction.

Measurements were taken of the pavement edge angle at various locations before and after compaction of the edge. The results are summarized in Table 2. The average final slope angle of the compacted slopes at 23° misses the 30° goal on the good side since it is a much flatter slope and would be easier to mount by a vehicle running off the road. The FHWA Design and Construction Guide states that the recommended range for the slopes is 26 to 40 degrees ([FHWA Safety Edge Web Site](#)).

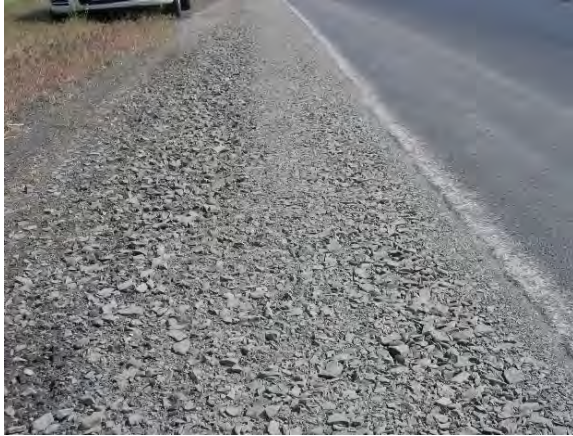
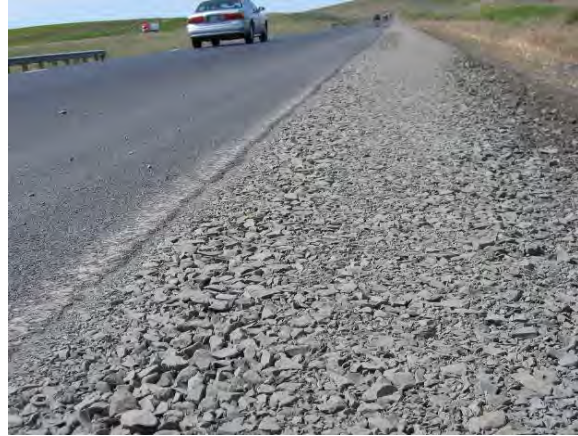
Figure 24. Finished pavement with shoulder material in place.

Figure 25. Finished pavement with shoulder material in place.

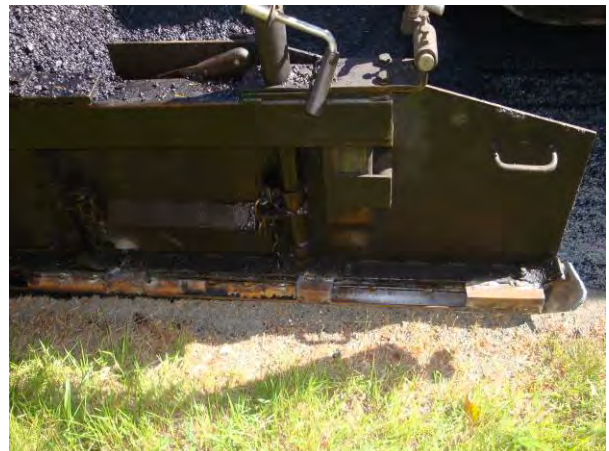
Figure 28. Side view of TransTech hardware.

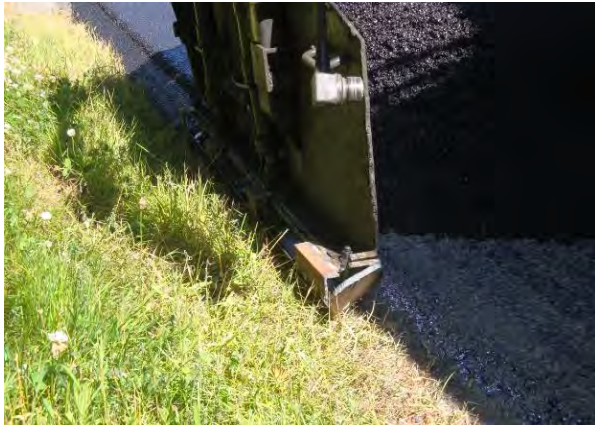
Figure 29. End view of TransTech pavement edge hardware without the roller.

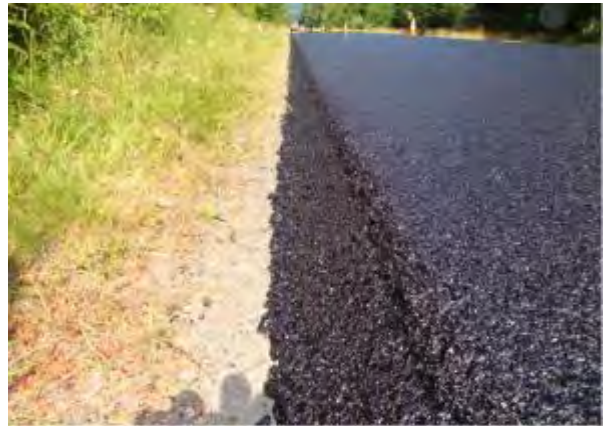
Figure 30. Pavement edge formed by the TransTech hardware prior to adding the roller. Note open texture of the HMA.

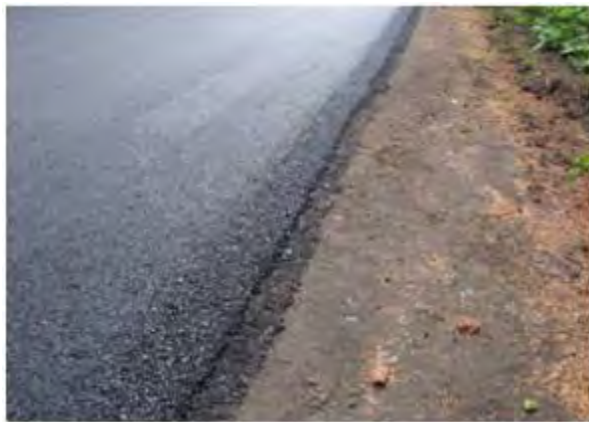
Figure 31. Pavement edge treatment after addition of a roller behind the paver.

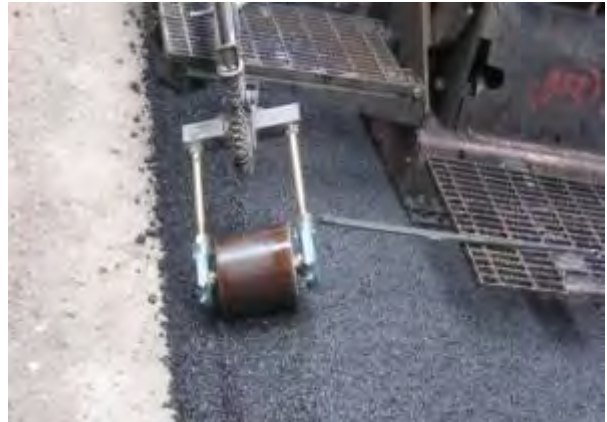
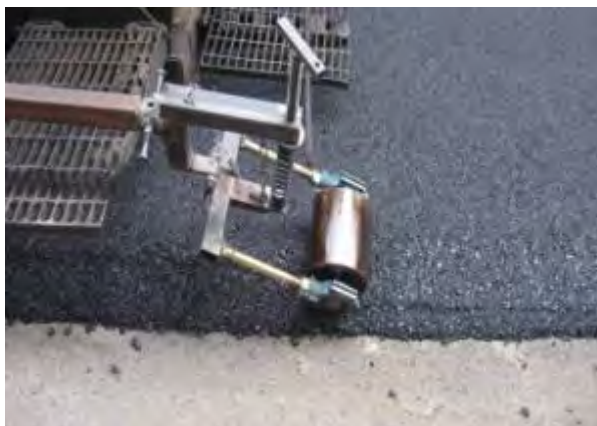
Figure 32. Roller added to compact the vertical edge at the top of the slope.

Figure 33. Roller added to compact the vertical edge at the top of the slope.

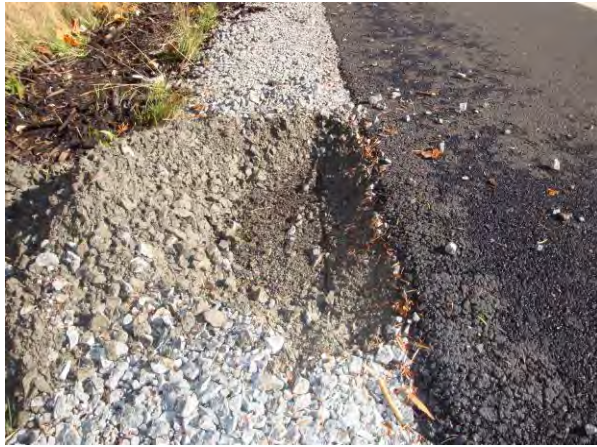
Figure 35. Dig out showing slope of pavement edge.

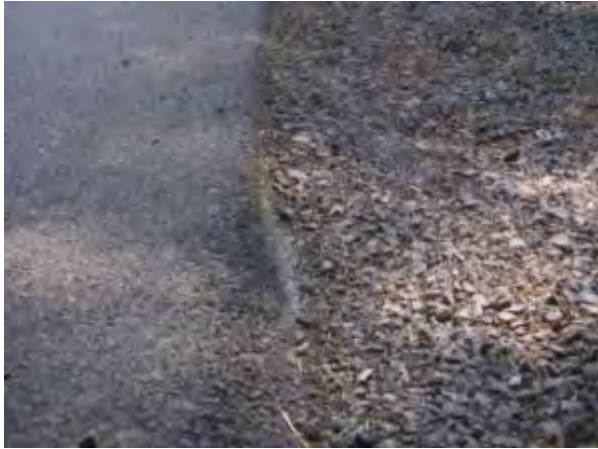
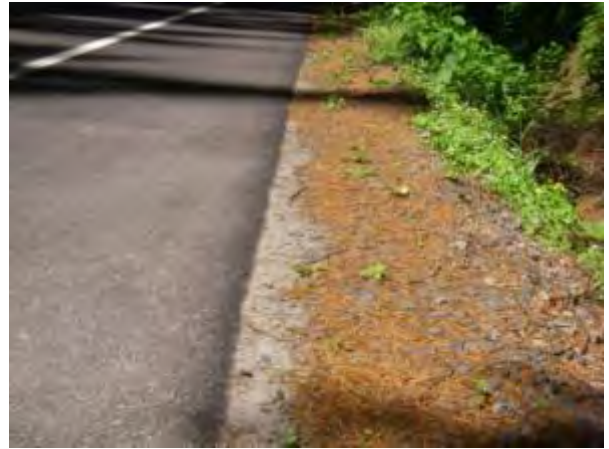
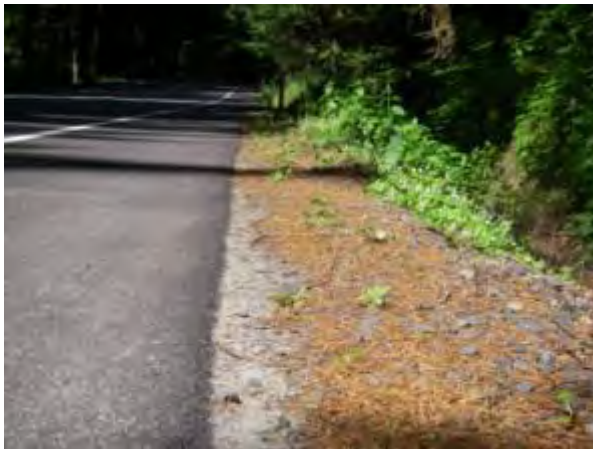
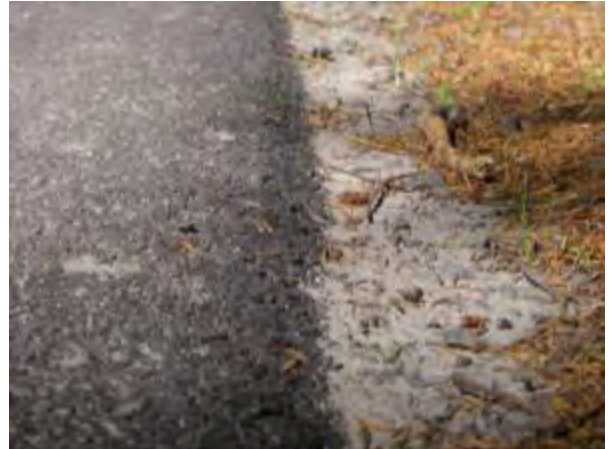
Figures 37 through 40 show the SR 410 pavement edge treatment one year after construction. Some erosion can be seen of the shoulder material exposing the pavement edge treatment.

Figure 37. Pavement edge treatment close-up one year after construction.

Figure 38. Pavement edge treatment on SR 410 one year after construction.

Figure 39. Another photo of the SR-410 pavement edge treatment one year after construction.

Figure 40. Close-up of pavement edge treatment on SR 410 one year after construction. Shows some exposure of pavement edge treatment.

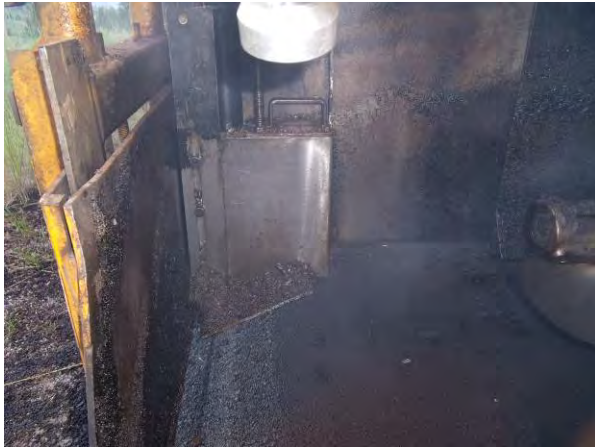
Figure 42. Advant-Edge™ used to produce the pavement edge treatment.

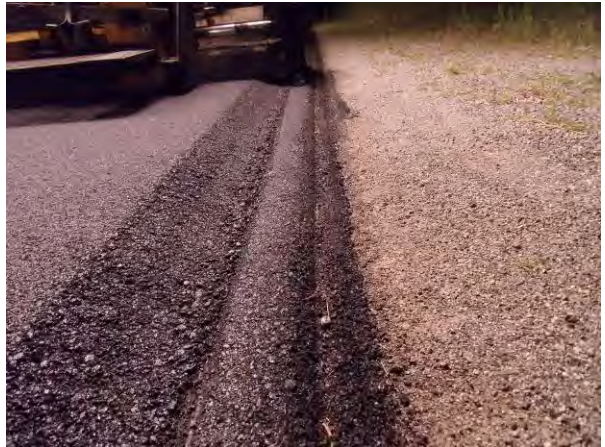
Figure 43. Pavement edge treatment produced by the Advant-Edge™.

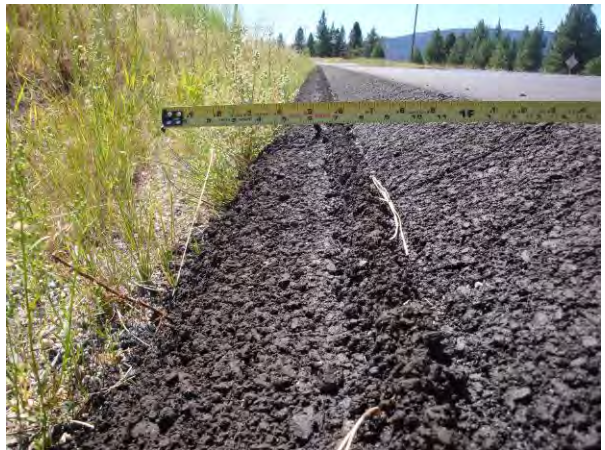
Figure 45. Close-up of edge treatment slope.

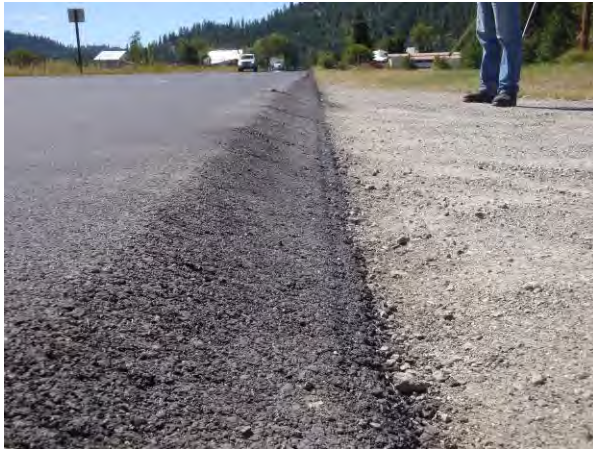
Figure 50. Slope of edge treatment across a road approach.

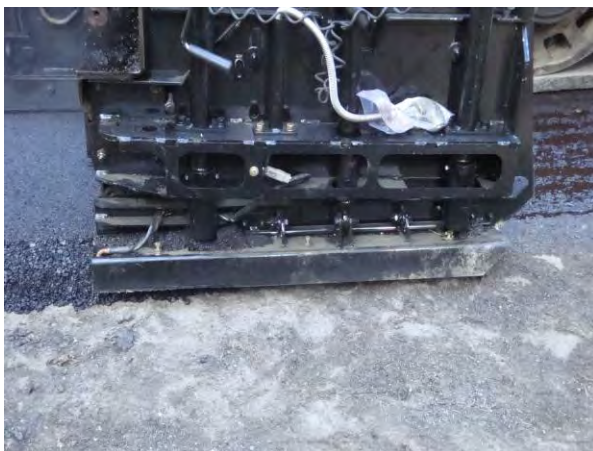
Figure 53. Side view of Carlson end gate.

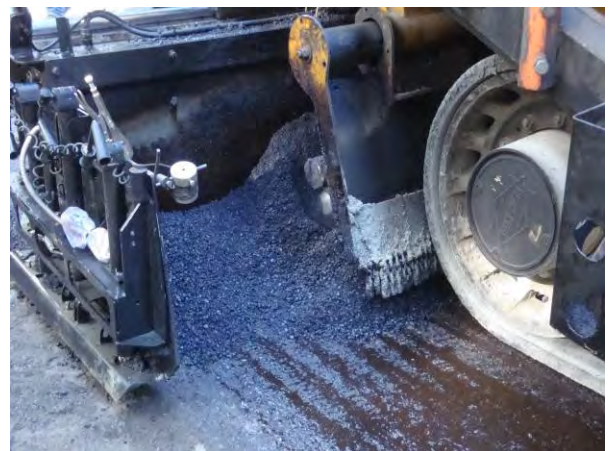
Figure 54. Mix passing through the end gate.

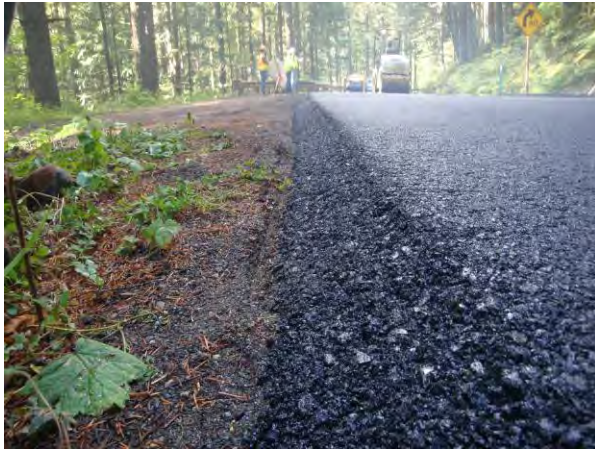
Figure 55. Pavement edge treatment produced by the Carlson end gate.

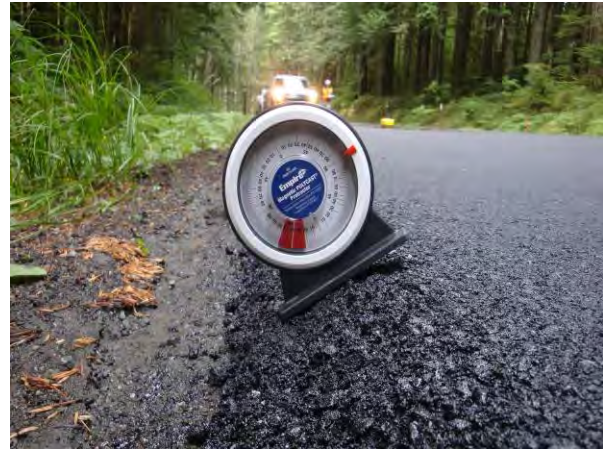
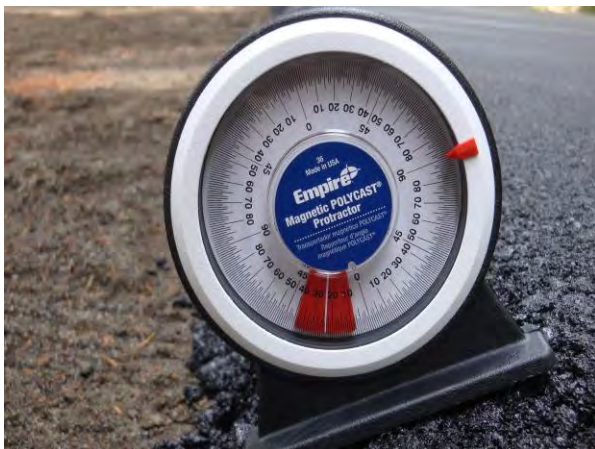
Figure 56. Slope indicator device on the edge treatment. Slope does not appear to be compacted.

Figure 57. Close-up of slope indicator.

Table 6 lists the slope measurement made of the finished pavement using a slope indicator gauge (Figures 56 and 57). The average of 28° meets the pavement edge goal of 30° and none of the slopes fall out of FHWA's 26 to 40° recommended range.

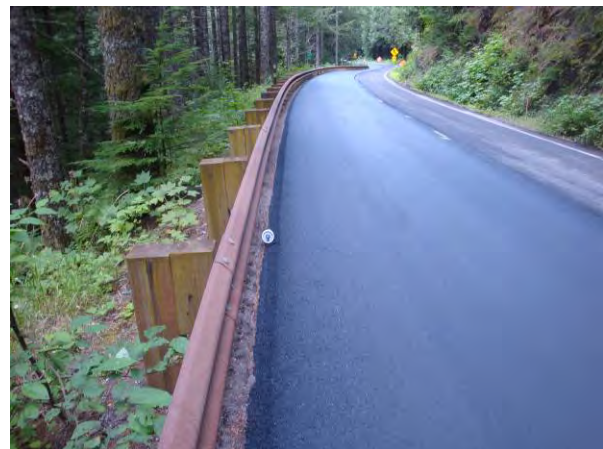
Figure 58. View showing uniform appearance of edge treatment.

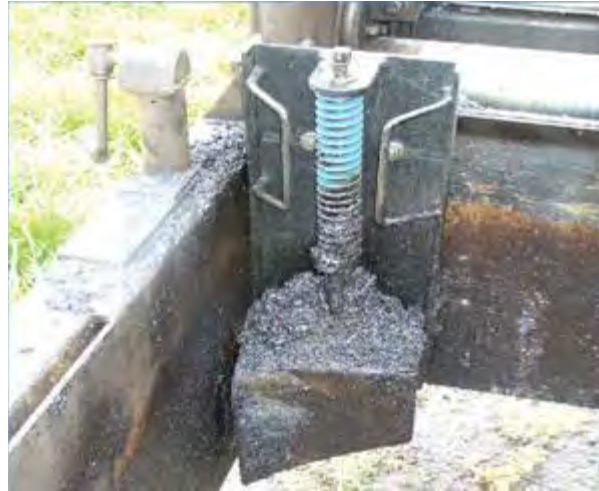
Figure 1. Pavement edge “shoe” bolted to paving machine screed (FHWA).

The pavement edge treatment is a wedge of pavement placed by a device bolted to the screed of the paving machine (Figure 1). FHWA recommends an angle of 30° to 35° between the roadway slope and the slope of the wedge (Figure 2). After completion of paving the gravel is graded back flush with the new pavement just as when a conventional vertical pavement edge is constructed.
