Preventive Maintenance Study - Final Report

WA-RD 871.2

Preventive Maintenance Study

Washington State – Statewide Locations

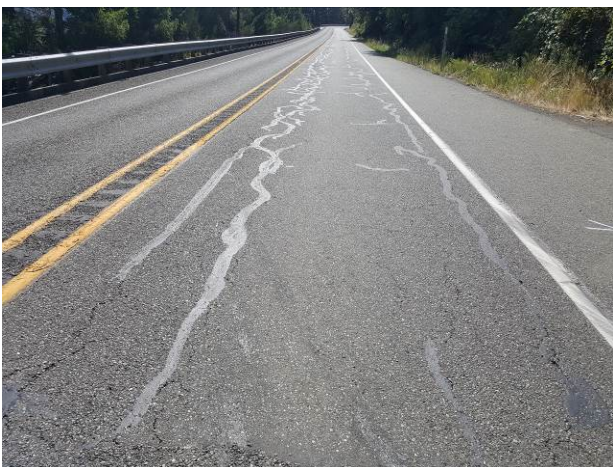
Figure 2. OR1, SR101, Poor, age 62 months.

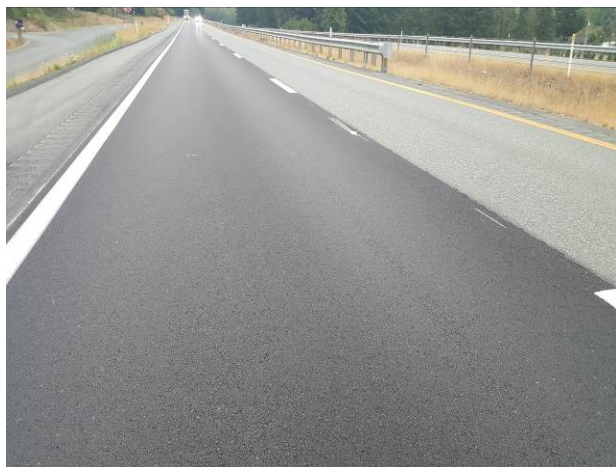
Figure 3. OR6, SR8, Good, age 50 months. HMA grind/inlay in 2017, C9001.

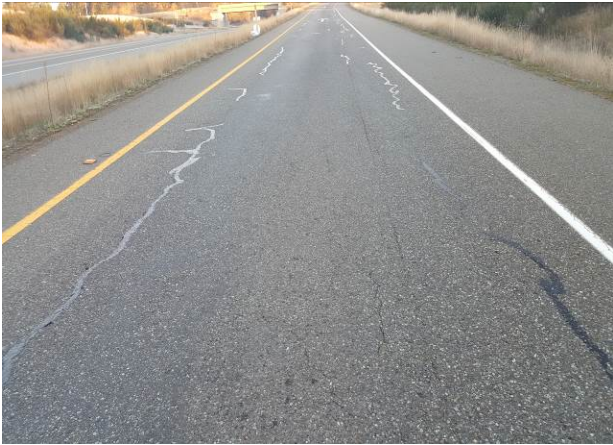
Figure 4. OR8, SR8, Ramp, Poor, age 51 months.

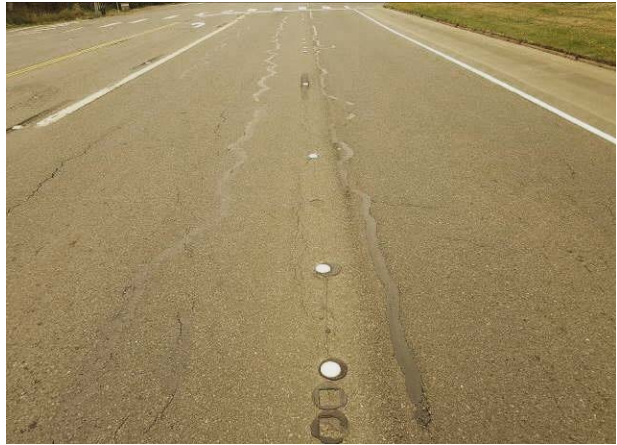
Figure 5. OR9, SR105, Good, 50 months.

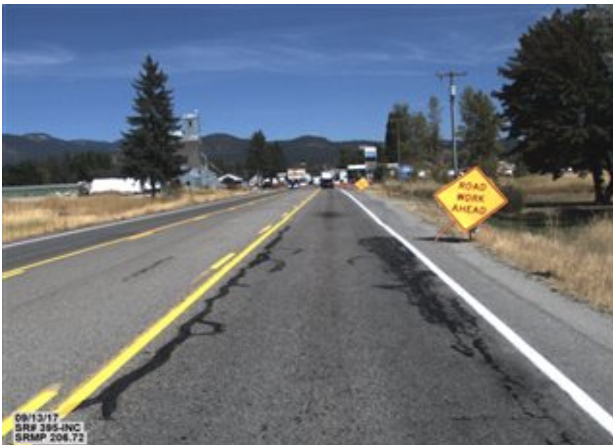
Figure 8. ER41, SR395, Good, age 15 months.

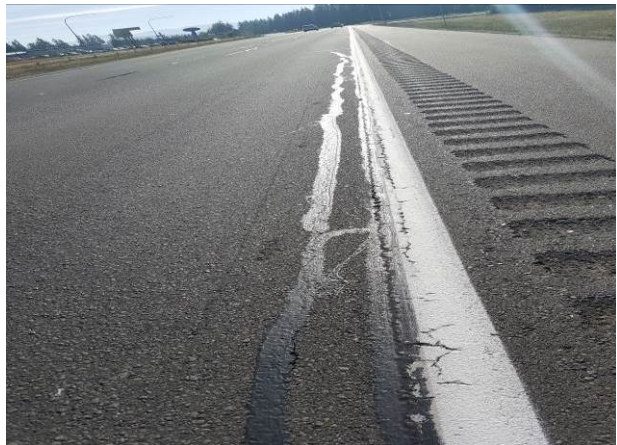
Figure 9. OR20, SR12, Good, age 15 months.

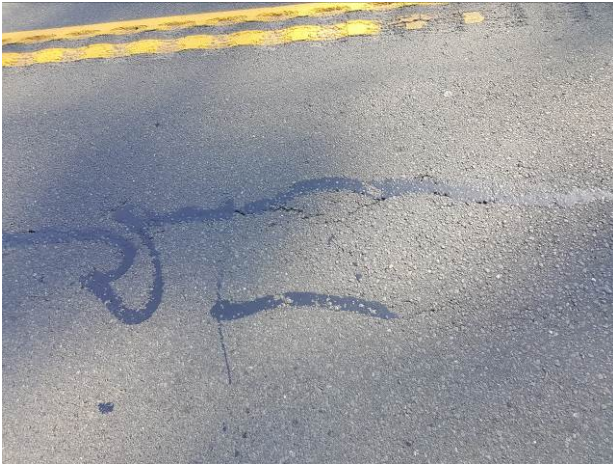
Figure 10. OR21, SR12, Good, age 15 months.

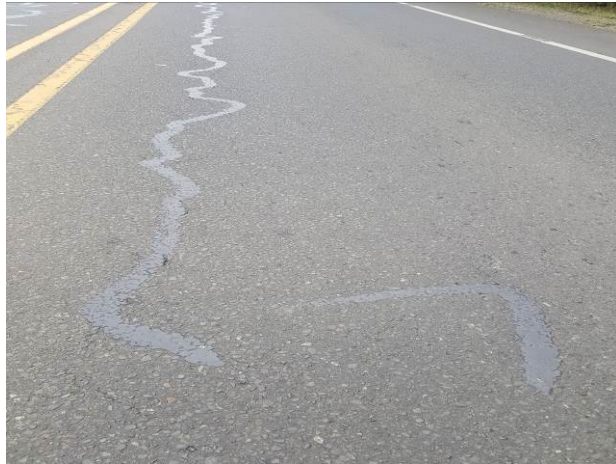
Figure 11. OR31, SR115, Good, age 14 months.

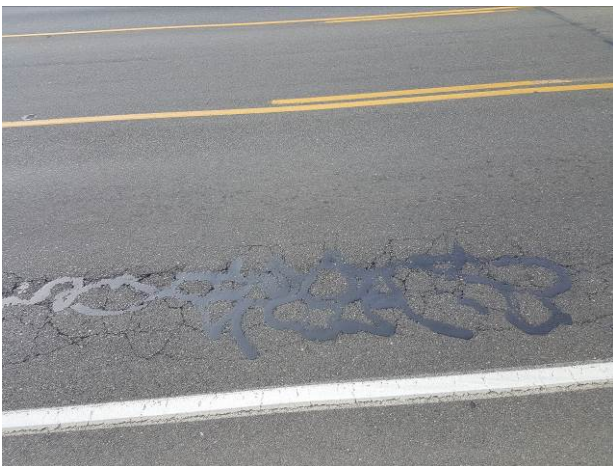
Figure 12. OR32, SR160, Good, age 15 months.

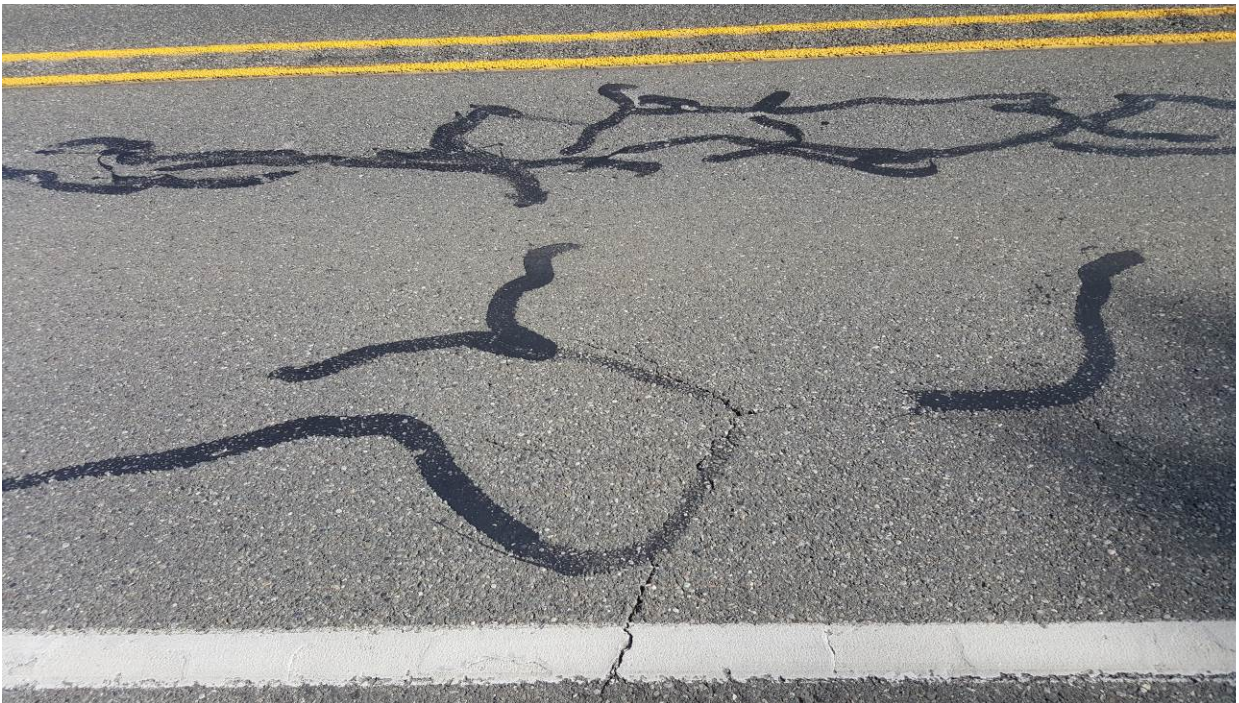
Figure 17. OR1, SR101, three years after installation. There is not much change from year one.

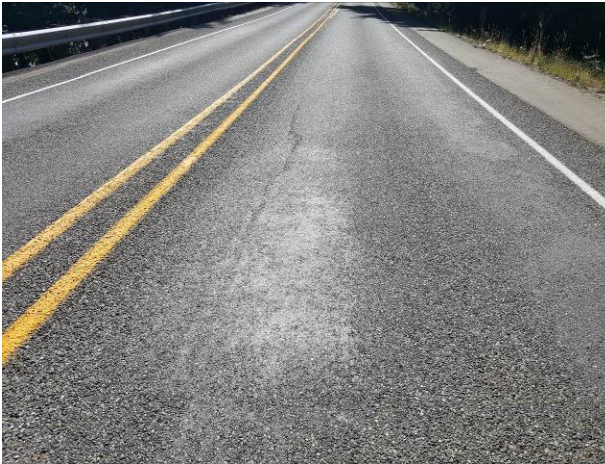
Figure 20. OR1b, SR101, Poor, age 62 months. Longitudinal cracking noted at 21 months. Slight flushing in the wheel paths.

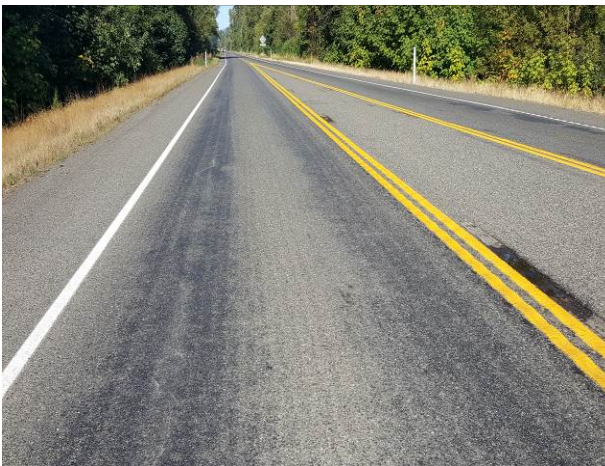
Figure 22. OR16, SR16, Good, age 49 months. Longitudinal cracking and pumping of fines noted at 14 months. Alligator cracking noted at 49 months.

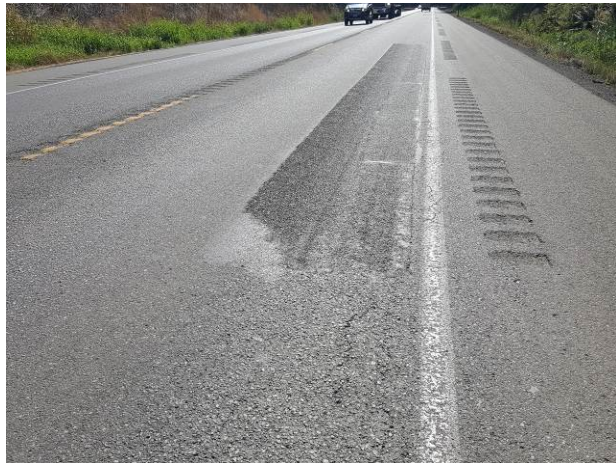
Figure 31. OR23, SR104, Good, age 25 months.

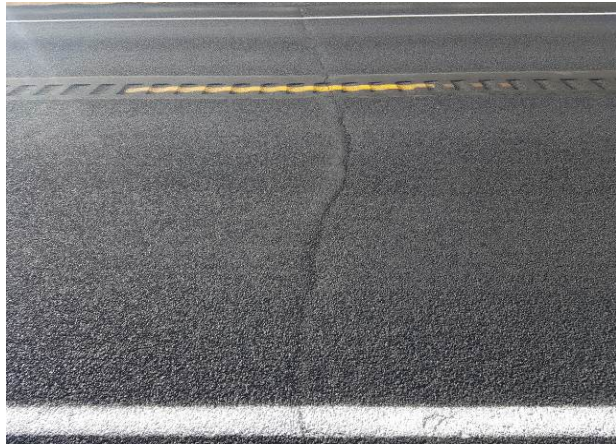
Figure 49. NC1, SR155, Good, age 38 months. Transverse crack locations are depressed and very thin cracks are present.

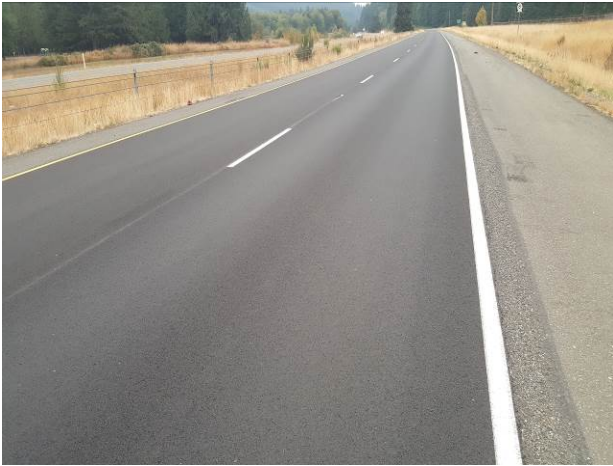
Figure 56. OR2, SR8, Fair, age 62 months. HMA grind/inlay in 2017, C9001.

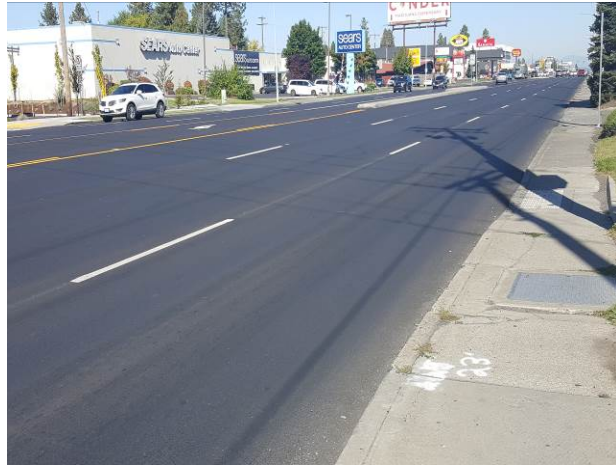
Figure 57. ER2, US2, Fair, age 62 months. HMA grind/inlay in 2017, C9063.

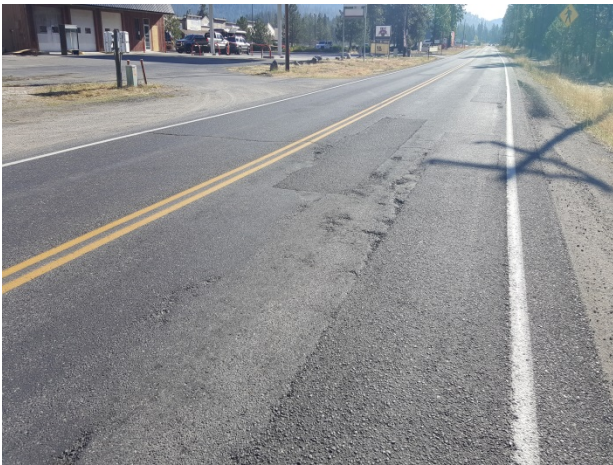
Figure 58. ER3, SR291, Fair, age 62 months. Additional dig outs added in 2015. Transverse reflection crack noted at 10 months after treatment. More dig outs are scheduled for installation in 2017 and a HMA grind/inlay in 2018, C9223.

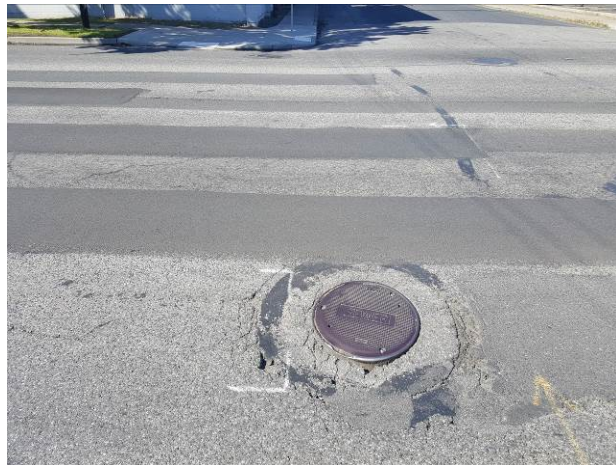
Figure 59. ER4, US2, Fair, age 62 months. Additional dig outs installed in 2013 and 2015. Note different colors of dig out patches done in different years. HMA grind/inlay scheduled in 2018, C9187

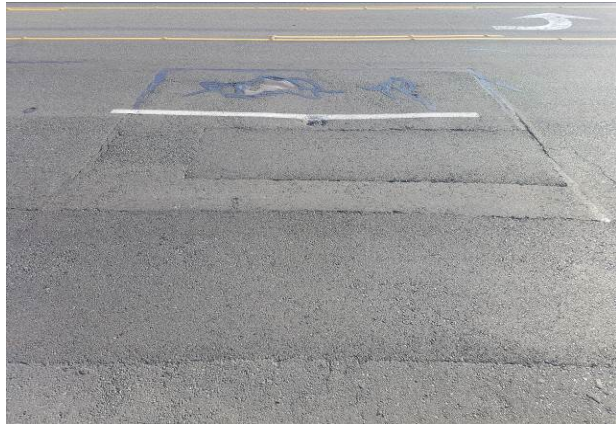
Figure 61. OR5, SR7, Good, age 51 months.

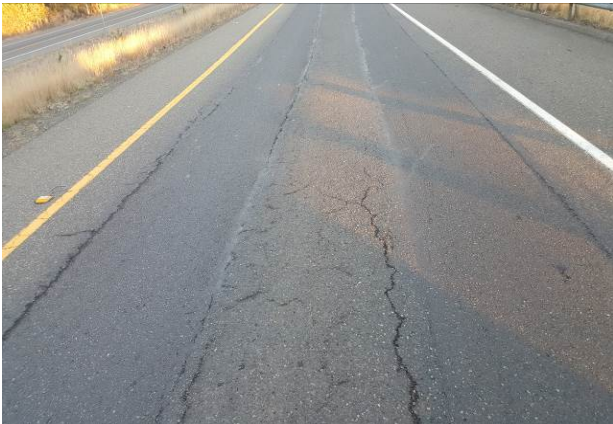
Figure 62. OR8a, SR101, Poor, age 51 months.

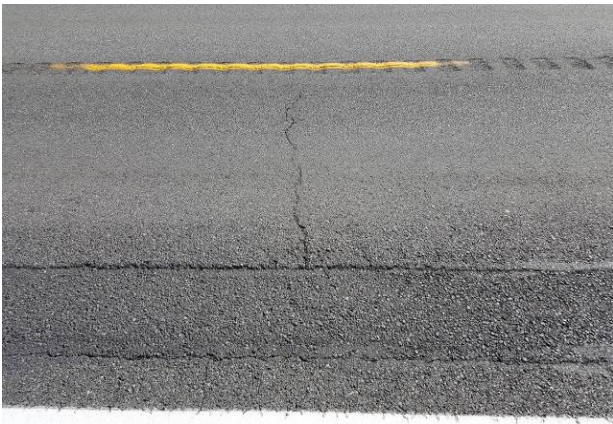
Figure 64. OR11, SR20, Good, age 49 months. Raveling of patch edges noted at 25 months.

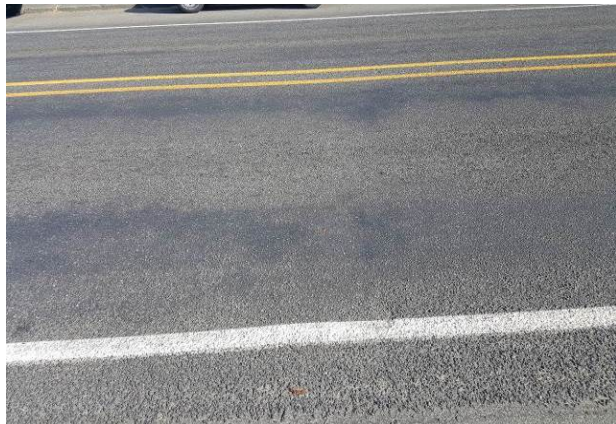
Figure 65. OR15, SR12, Fair, age 49 months. BST in 2016, C8870.

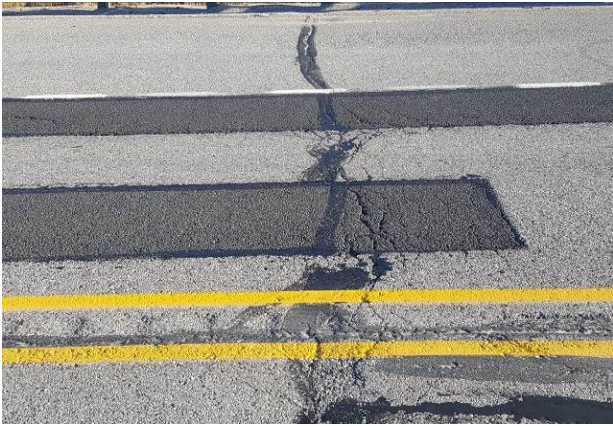
Figure 66. ER9, SR395, Good, age 37 months. Additional dig outs installed in 2015. Transverse reflection cracking noted in 2017.

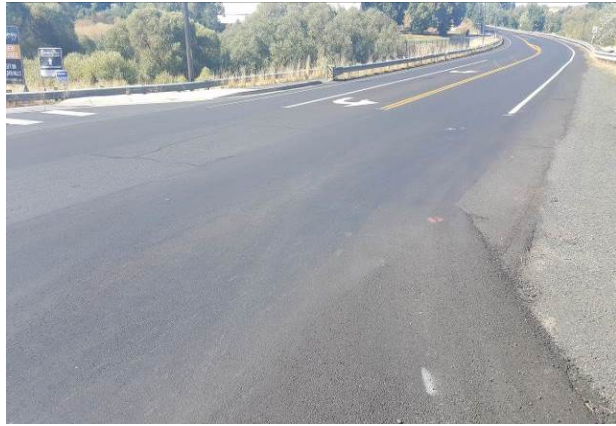
Figure 67. ER11, SR270, Fair, age 37 months. HMA grind/inlay in 2017, C9062.

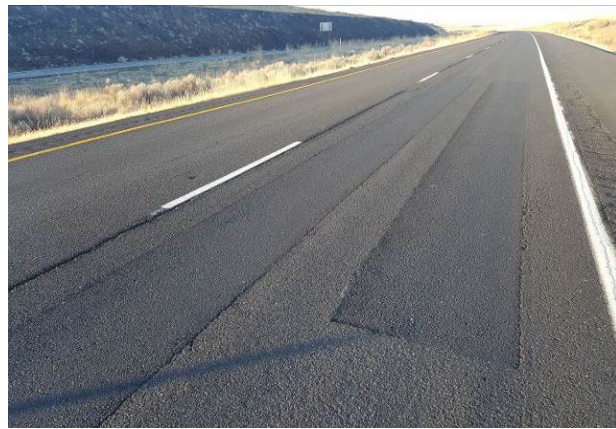
Figure 69. ER17, SR395, Good, age 26 months. Transverse reflection cracking in 2017.

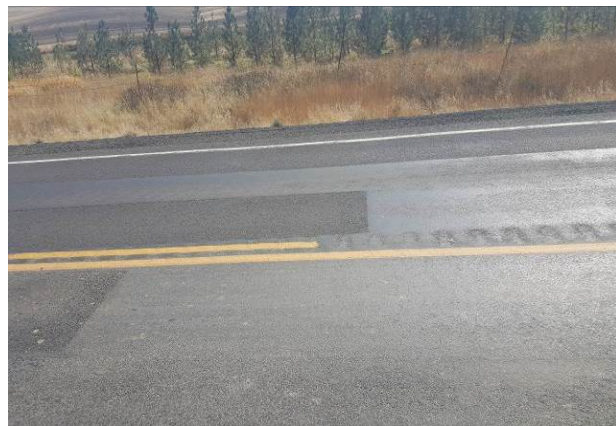
Figure 71. ER29, SR27, Good, age 26 months. Excellent performance.

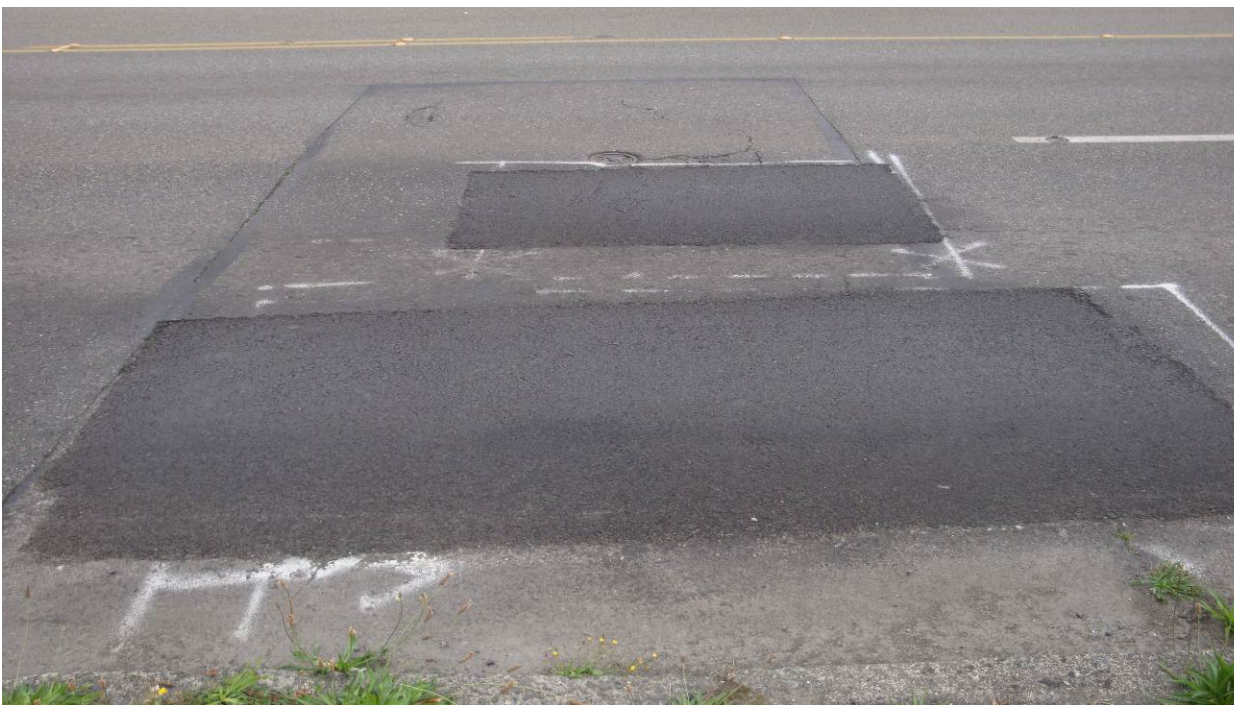
Figure 85. OR5, SR7, immediately after installation in 2013. Dig out patches look good. They appear to be related to utility cuts in original pavement.

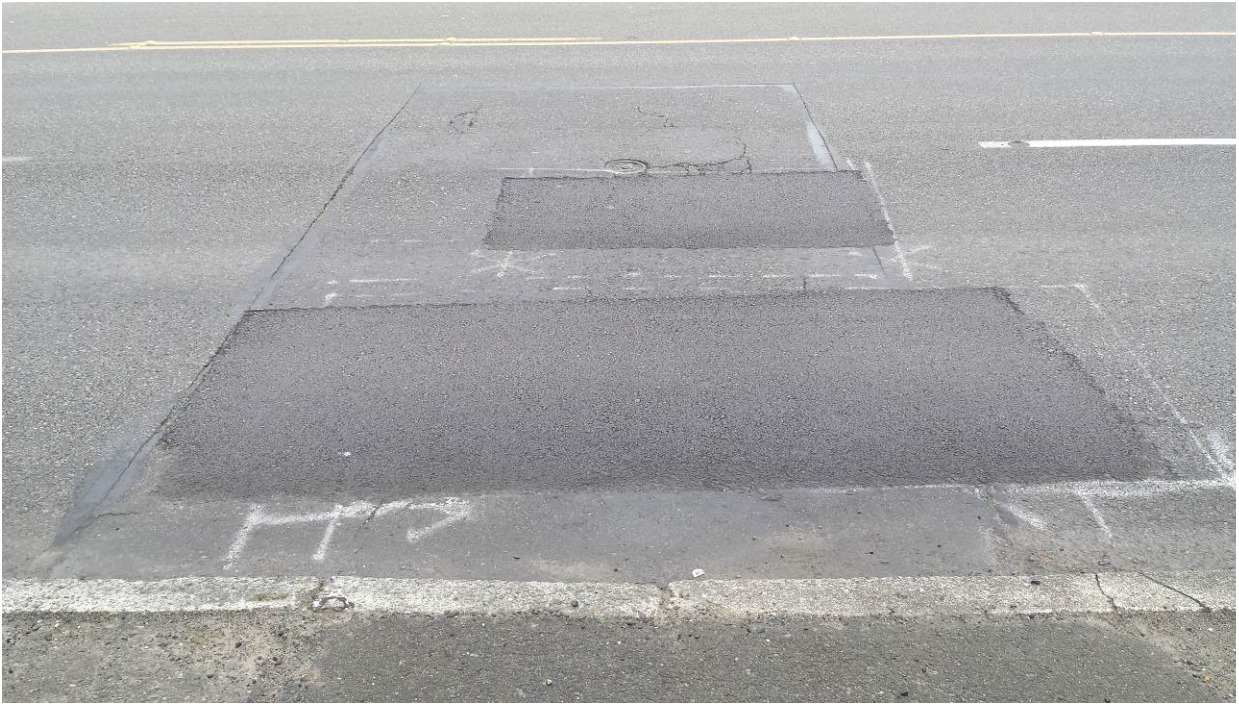
Figure 86. OR5, SR7, one year after installation. No change in the dig out patches.

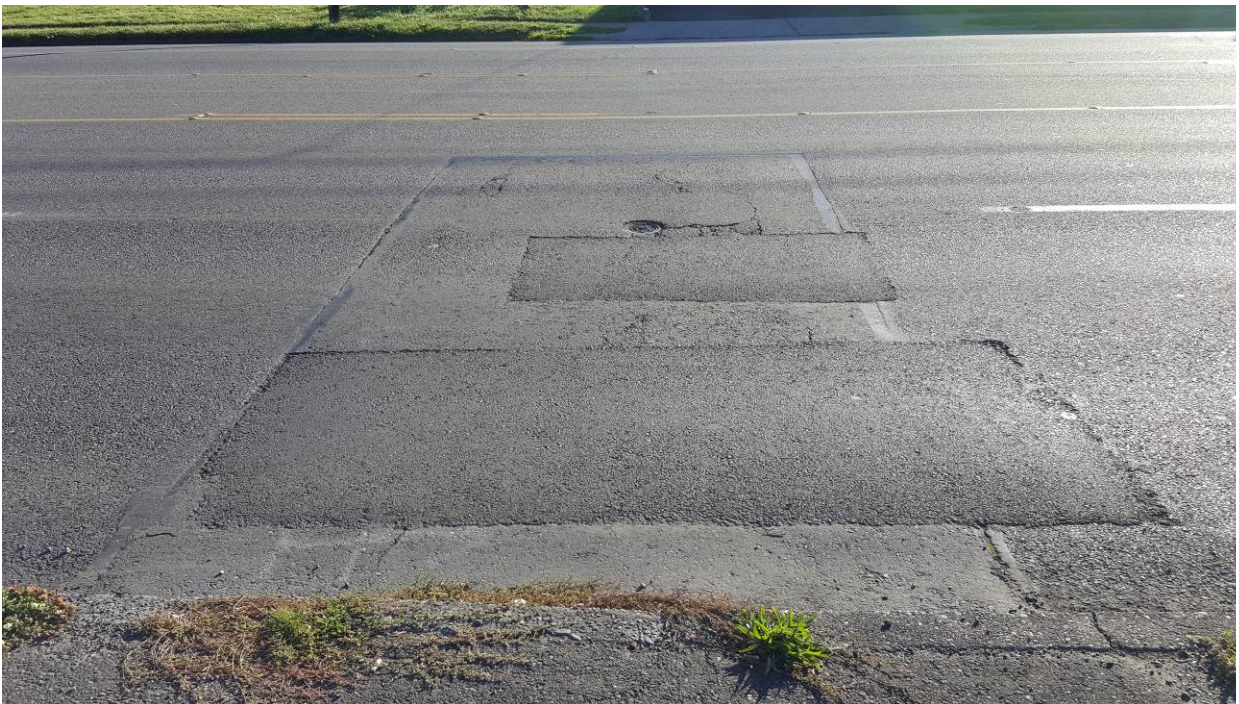
Figure 87. OR5, SR7, two years after installation. No change in the dig out patches.

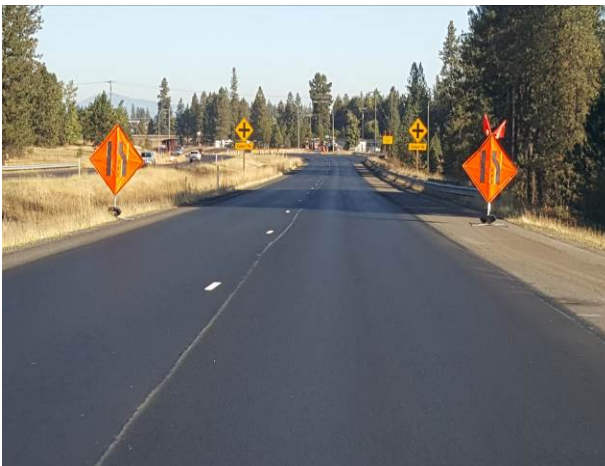
Figure 90. ER1, US2, Poor, 62 months. Additional dig outs and crack sealing done in 2015. HMA grind/inlay in 2017, C9124.

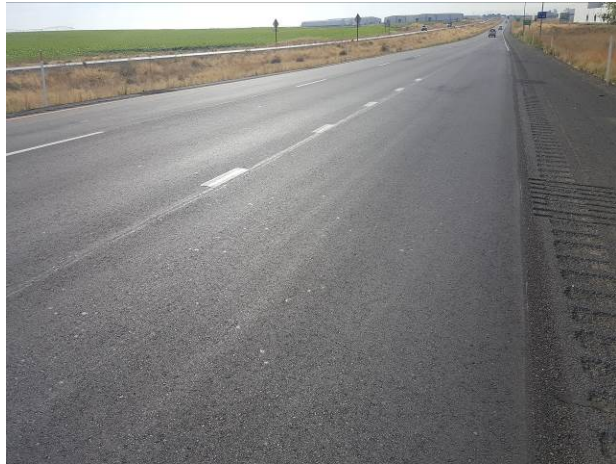
Figure 93. SC4, SR395, Good to Poor, age 26 months. HMA grind/inlay in 2017, C9052.

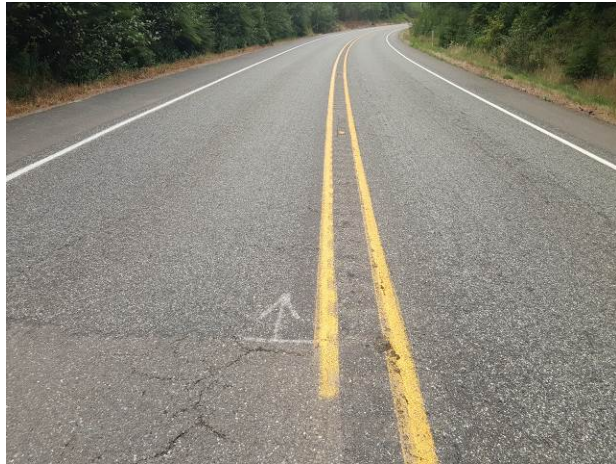
Figure 101. OR3, SR101, Poor, age 62 months. Excellent performance.

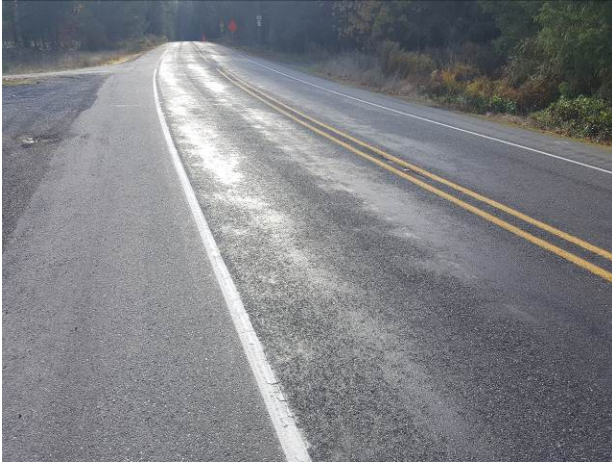
Figure 104. OR14, SR7, Good, age 51 months. Dig out patches flushing through the chip seal at 27 months.

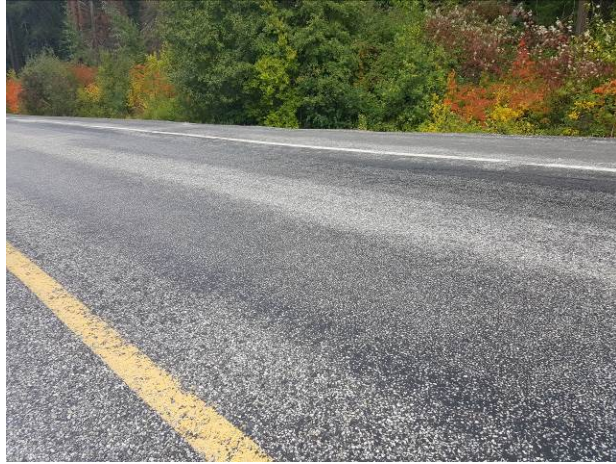
Figure 105. NC3, SR207, Good, age 38 months. Dig out patches flushing through the chip seal after 12 months. This is actually a HBST with 100% embedment in the wheel paths.

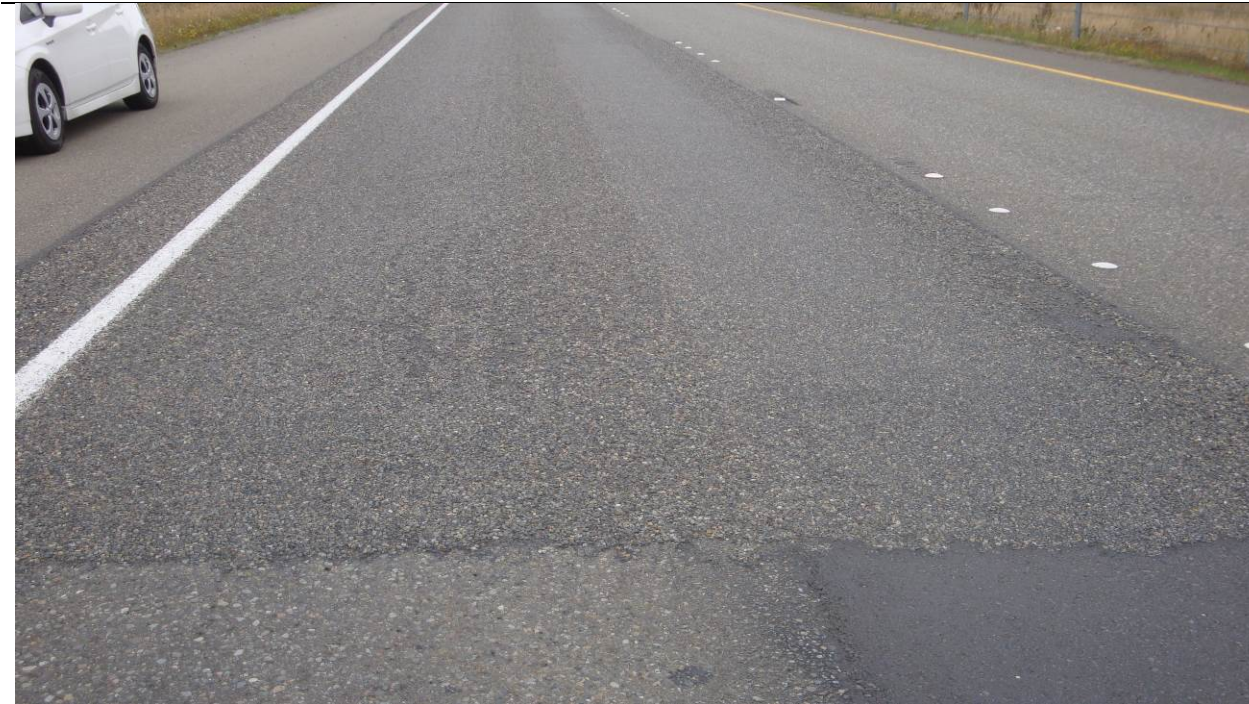
Figure 107. OR2a, SR8, one year after installation. Slight flushing in the wheel paths over the dig out patches.

The type of flushing observed on this site was typical of five of the six sites. The flushing was caused by an excess of asphalt binder that results from a combination of the binder from the patch and the new binder used for the chip seal process. The common practice used to prevent this type of flushing is to wait for a period of time before applying the chip seal. One year is advisable, but shorter periods of time may also work. If there is not sufficient time between the patch and the chip seal, it is recommended to apply a fog seal over the patch prior to the chip seal.

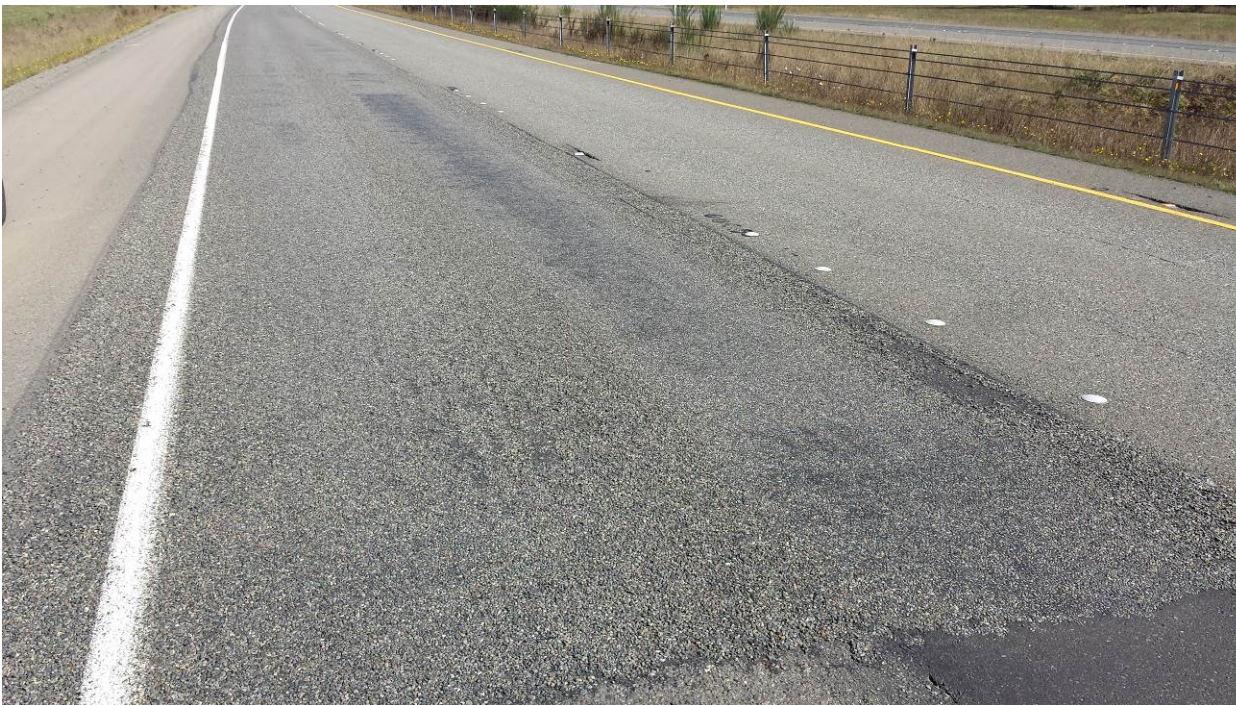
Figure 108. OR2a, SR8, two years after installation. Increased flushing in the wheel paths over the dig out patches.

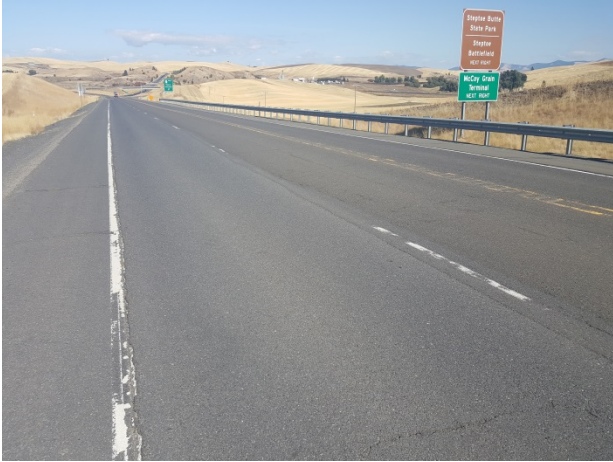
Figure 112. ER8, SR195, Good, are 39 months. Blade patch used to fill wheel path ruts. Additional patches placed in 2017.

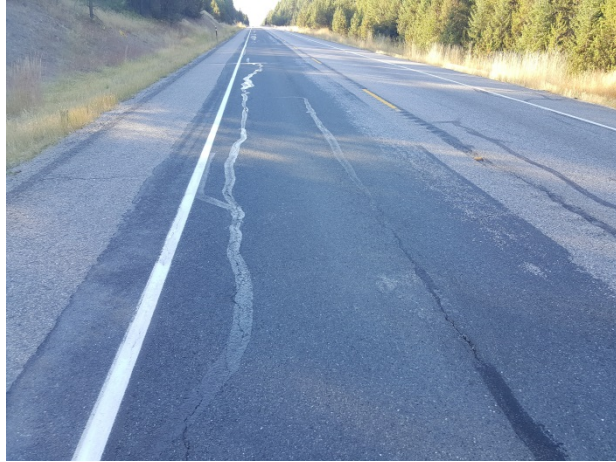
Figure 113. ER9a, SR395, Good, age 37 months. Transverse and longitudinal cracking reflecting through the patch at 13 months.

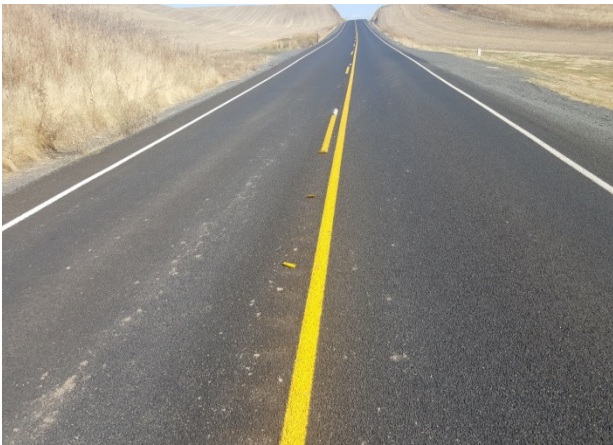
Figure 114. ER20, SR272, Good, age 24 months. Transverse crack reflecting through the patch. HMA grind/inlay in 2017, 9031.

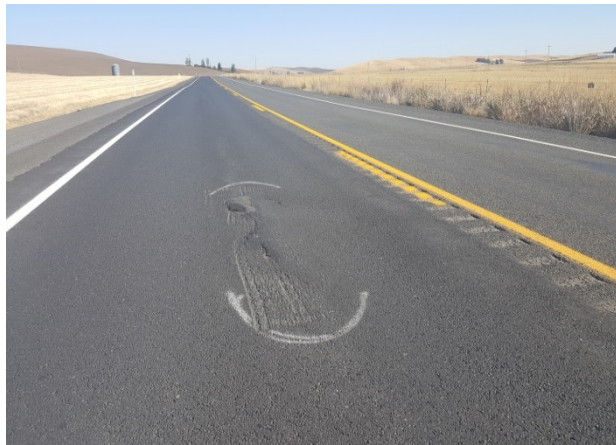
Figure 115. ER26, SR127, Good, age 26 months. Pot hole formed in 2016. Flushing in wheel paths noted in 2017.

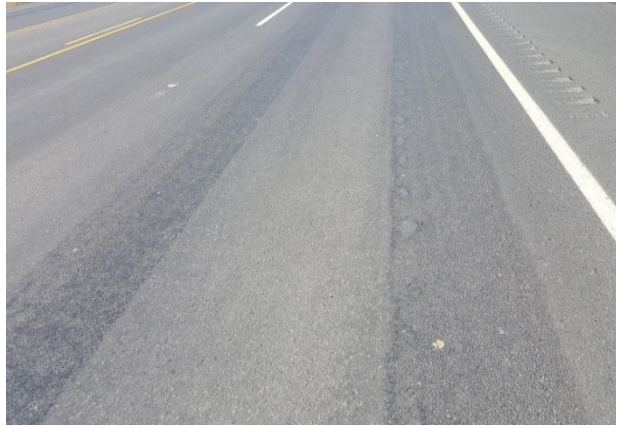
Figure 117. ER33, SR270, Good, age 24 months.

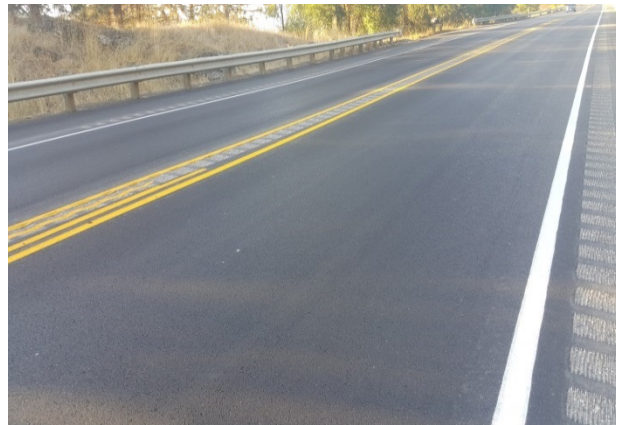
Figure 119. ER37, SR395, Fair, age 25 months. Excellent performance. HMA grind/inlay in 2017, C9105.

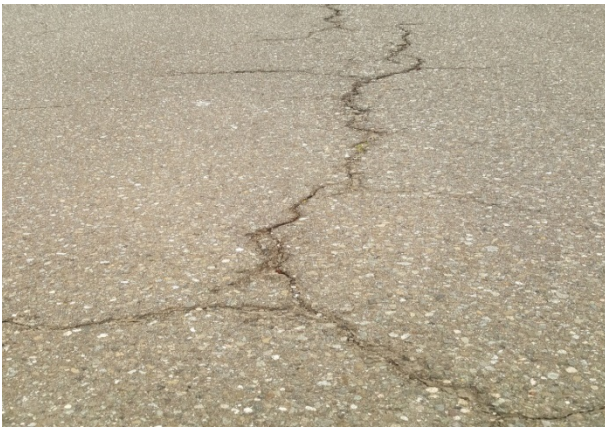
Figure 125. OR3a, SR101, Poor category, age 62 months. No maintenance as of the 2017 inspection.

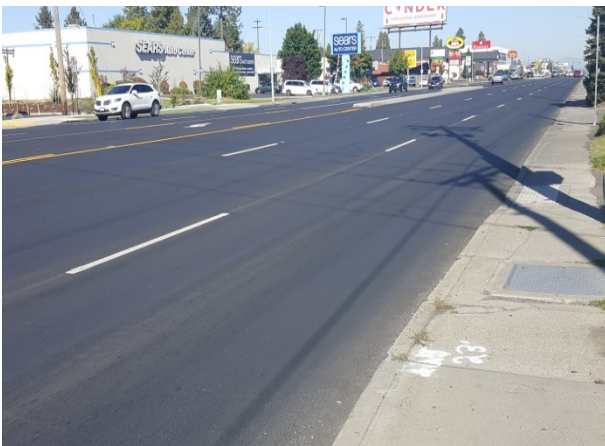
Figure 127. ER2a, US2, Poor category, age 62 months. Dig outs, crack sealing and patching were necessary to preserve the roadway. HMA grind/inlay in 2017, C9063.

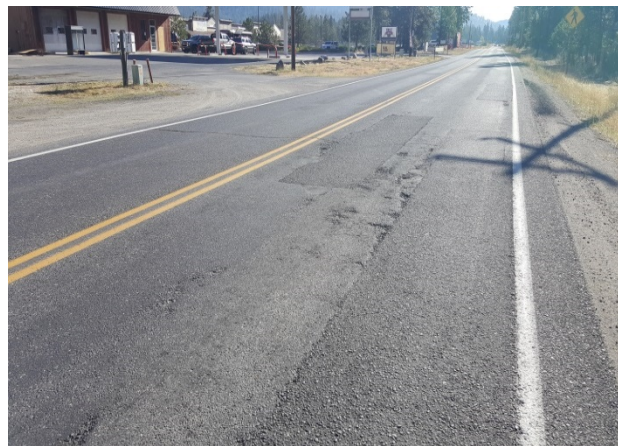
Figure 128. ER3a, SR291, Fair category, 62 months. Dig outs, crack sealing and patching were necessary to preserve the roadway. HMA grind/inlay scheduled in 2018, C9223

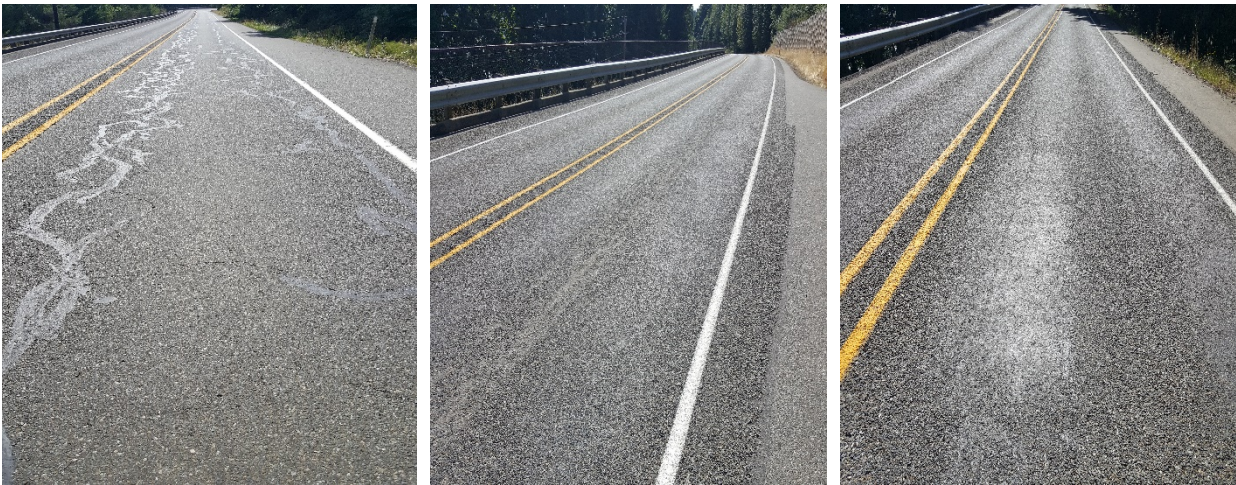
received a chip seal, and OR1b received just a chip seal with no crack sealing (see Figure 136). The site with only crack sealing performed very well with no deterioration of the crack sealant except where traffic had worn down the over-banding. Additional cracking and growth of the existing cracks was noted in the section, but no additional work was required on the site during the five plus years of observation. The site with the crack seal followed by a chip seal was in very good condition with no flushing and no cracks reflecting through from the underlying pavement. As with the crack sealing only site, no additional work was required on the section for five plus years. The section with only the chip seal did not perform as well as the other two sections with rutting and flushing in the wheel paths and a longitudinal crack reflected through the chip seal. No additional work occurred on the chip seal only section for five plus years; however, the flushing, rutting, and reflection crack may have warranted some additional attention. It could be argued that crack sealing was the best treatment solution for this particular location knowing that the cost of crack sealing would be much less than the other two treatment choices. The correct choice depends on how long the pavement needed to be preserved before rehabilitation could be scheduled.

Figure 135. OR1, OR1a and OR1b on SR 101. OR1 has crack sealing, OR1a has crack sealing and chip sealing, and OR1b has a chip seal with no crack sealing. Photos from 2017.

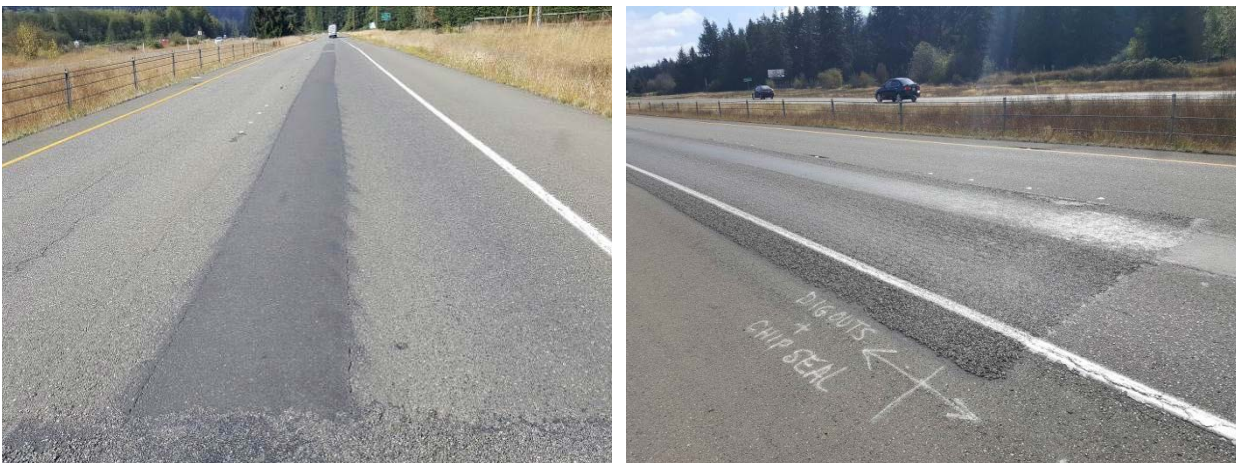
The next location with multiple treatments was OR2 and OR2a, located on the westbound lanes of SR 8 approaching McCleary. It is a four lane divided roadway (two lanes in each direction) classified as a rural-principal arterial. OR2 received dig outs and OR2a received dig outs and a chip seal (Figure 137). The section with dig outs performed very well with no deterioration of the dig out patches and minor transverse reflection cracks. The dig out patching was only required in the inside wheel path. The outside wheel path had severe longitudinal and transverse cracking with some spalling where they intersected. The section that received the chip seal over the dig outs had flushing present in the wheel paths throughout the section with severe flushing over the dig out patches. Longitudinal cracks also reflected through the chip seal in the outside wheel path, the same longitudinal cracks not addressed in the section with only the dig outs. Dig outs without the chip seal performed much better than the section with the chip seal due to the flushing of the chip seal; however, both sites lasted five plus years without additional treatment. The application of the chip seal was apparently due to a misunderstanding between the Olympic Region Materials Engineer and Maintenance. The Materials Engineer indicated that the dig outs and chip sealing were alternatives for the treatment and were not meant to be applied in combination, but was a good comparison.

Figure 136. OR2 and OR2a on SR8. OR2 received dig outs and OR2a received dig outs and a chip seal. Photos are from 2016, both sections were milled and filled with HMA in 2017

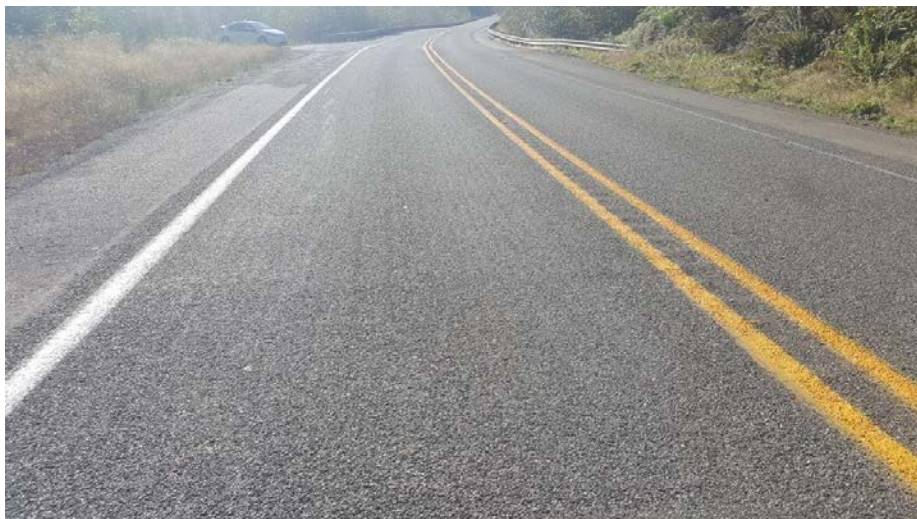
Full lane chip sealing is one of the most effective treatments because it can cover a multitude of pavement distress (Figure 141). This would include alligator cracking, longitudinal cracking and transverse cracking (provided the cracks are less than $\frac{1}{4}$ inch in width), and patching. The experience in this study with three of the four test sites exhibited flushing would seem to indicate that this is a choice to be avoided, especially if the wheel paths are rutted; however, the very good experience when full lane chip seals placed under Region wide chip seal contracts would indicate just the opposite. As indicated previously, it may be that the materials used or the application techniques that may need to be given scrutiny in order to achieve the best results. Chip sealing is often described as an art due to the many factors that can contribute to either success or

Figure 141. OR3b full lane chip seal on SR 101. (September 2016)

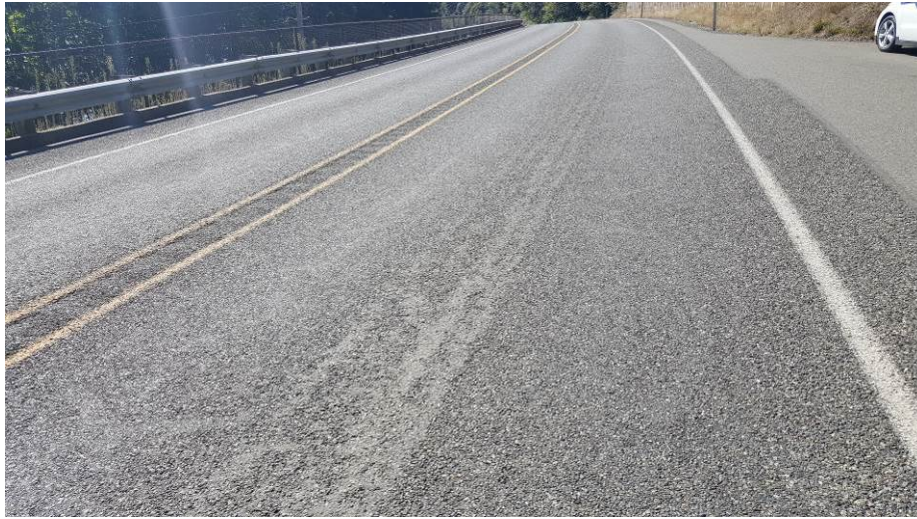
The crack sealing plus chip sealing is the next lowest cost option (Figure 142). It is best used where some of the cracks exceed 1/4 inch in width and some are very fine. Sealing these larger cracks prior to the application of the chip seal will likely prevent the cracks from reflecting through the chip seal. Its use was limited to two test sites, probably due to the higher costs involved. On the Olympic Region test site (OR1a), either crack sealing or chip sealing alone would probably have provided a solution that would have lasted five plus years. The adjacent sections, OR1 and OR1b, which received only crack sealing or chip sealing, respectively, have performed very well. On the North Central site NC1, a special crack sealant was used to seal very wide

Figure 142. OR1a crack sealing plus chip sealing on SR 101.
(September 2016)

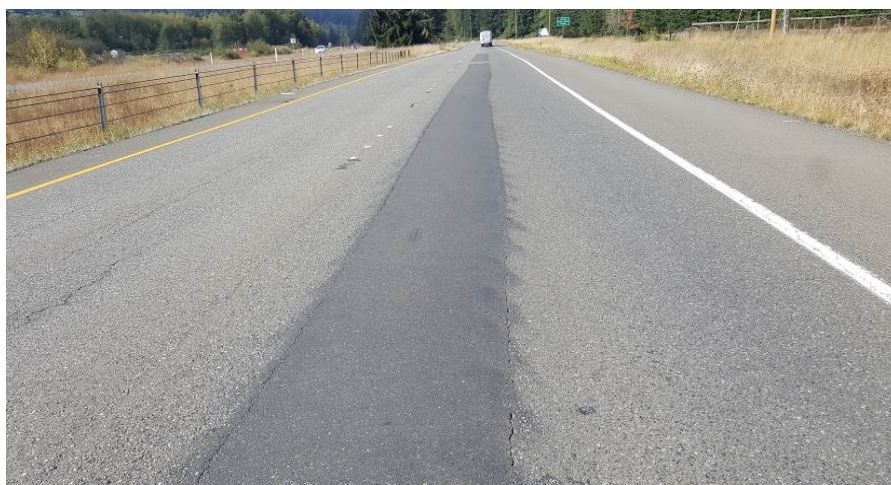
Dig outs are one of the more expensive treatments due to the high cost of equipment, labor and materials required to prepare the holes, fill the holes, and compact the HMA (Figure 144). It is used when the cracks in the wheel path have become wide or alligator cracking has developed and potholes are forming. It is very effective because it removes the entire area of the distressed pavement and replaces it with new HMA. The performance of the dig out patches has been excellent on all of the test sites.

Figure 144. OR2 dig outs on SR 8. (September 2016)

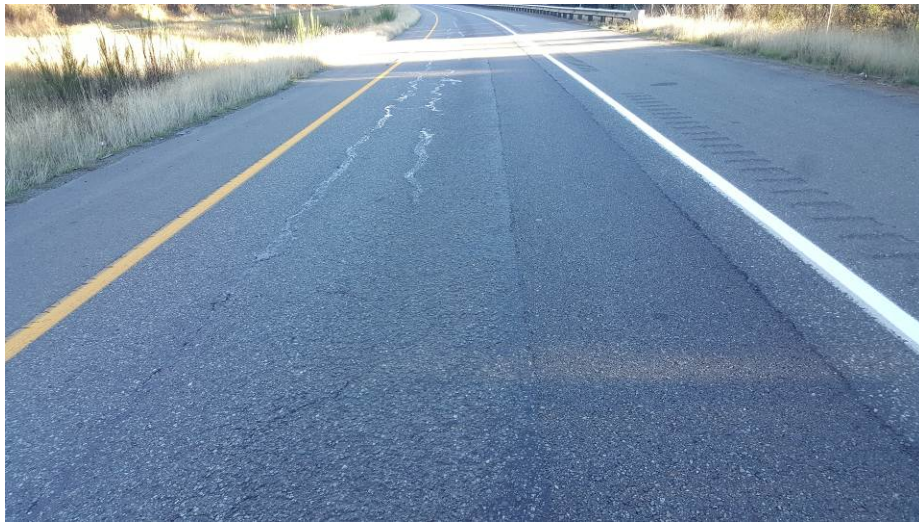
Using a combination of dig outs and crack sealing is a very expensive fix, but may be necessary to fix a pavement with alligator cracking in the wheel paths and longitudinal and transverse cracking throughout (Figure 145). The dig outs plus crack sealing test sites were ones in which the pavement was in such poor condition that the dig outs could not encompass all of the distressed pavement, and as a result, crack sealing was necessary to fill the large cracks between the dig outs.

Figure 145. OR4 dig outs plus crack sealing on SR 3. (September 2016)
