Review of Hot Bituminous Surface Treatments in Washington State

WA-RD 887.1

January 2019

WSDOT Special Project
Post-Construction Report

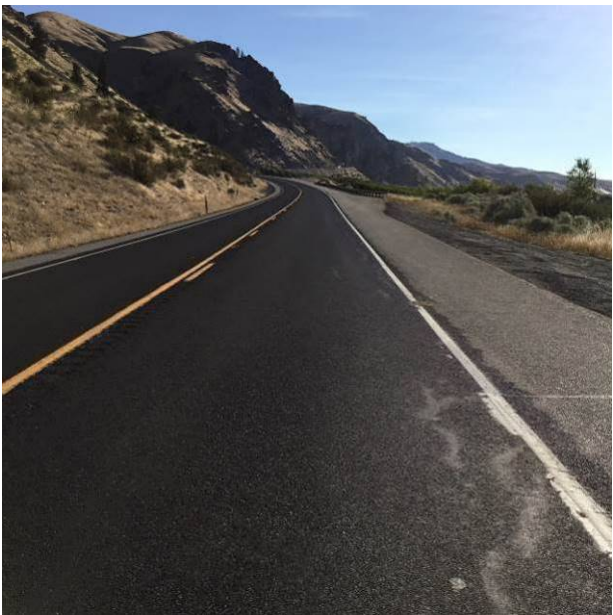
This project is one of the best looking HBST of all the ones visited on the review (Figures 1-10). Embedment was observed to be 80-90% and there was very little loose aggregate on the shoulders (evidence of little raveling). The underlying pavement was in very good condition prior to the application which may have added to the good performance of the HBST. Snowplow damage was noted at the centerline, Figures 7 and 8, which may have been in the portion of the project where the steel wheel roller was omitted. Some of the longitudinal cracks that were not sealed prior to the HBST are reflecting through the HBST. The HBST gives the appearance of flushing in the wheel paths due to the 100% embedment; however, the statewide friction inventory did not find any problems with low friction on this section.

Figure 1. Looking north from the start of the HBST at MP 223.76. (August 2017)

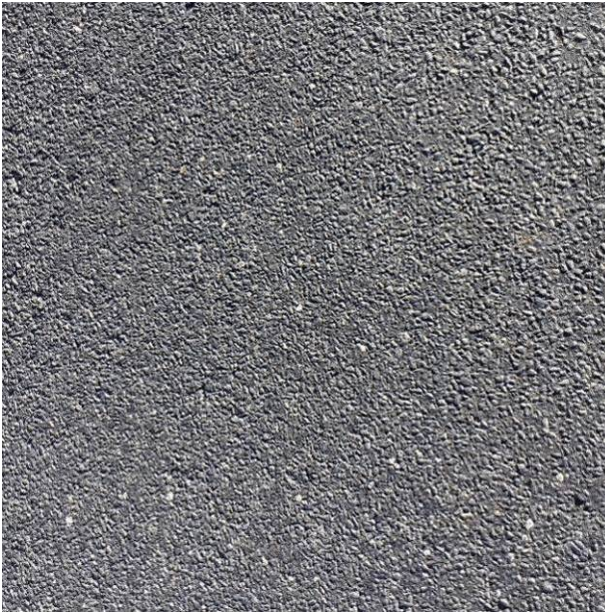
Figure 3. Closer view at MP 223.76. (August 2017)

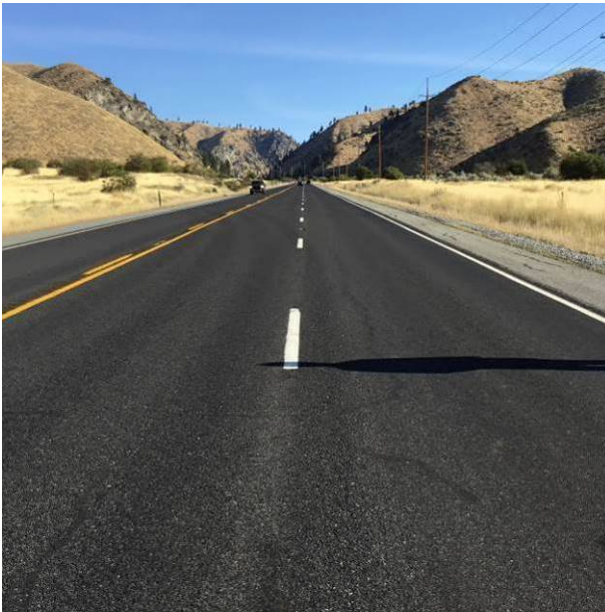
Figure 5. Looking north from MP 226.30. (August 2017)

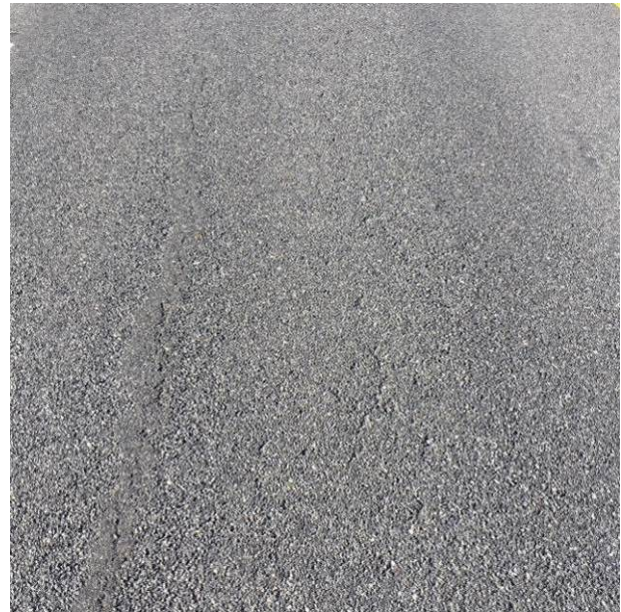
Figure 6. Closer view at MP 226.30. (August 2017)

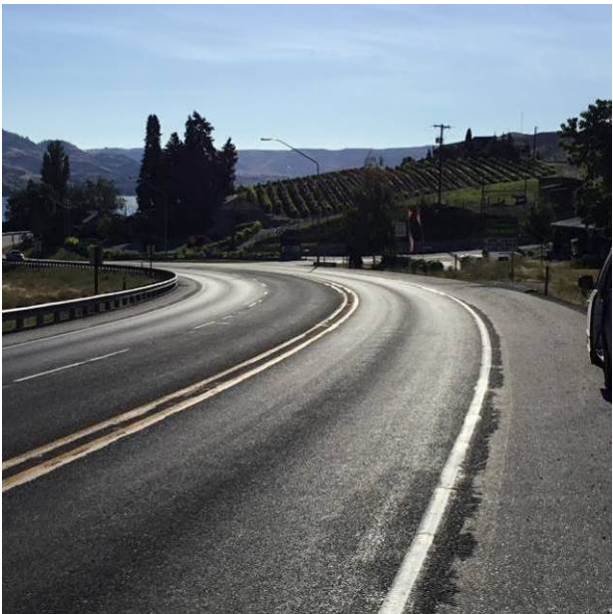
Figure 9. HBST with 100% embedment in the wheel paths at MP 230.20. (August 2017)

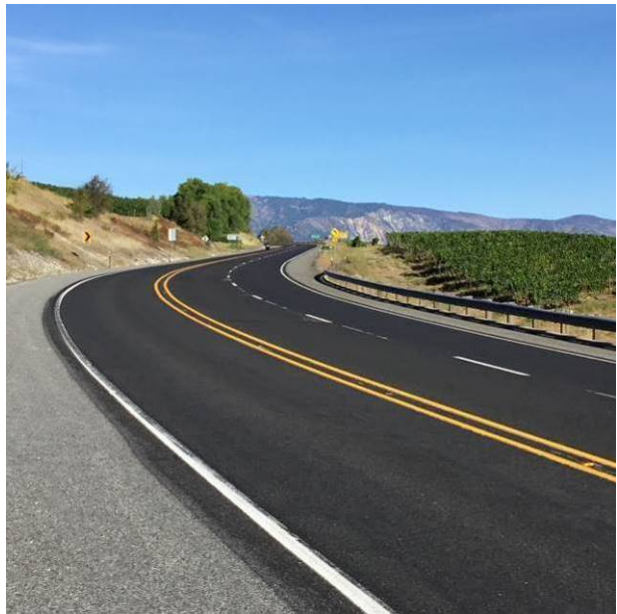
Figure 10. HBST with 100% embedment in the wheel paths at MP 230.20. (August 2017)

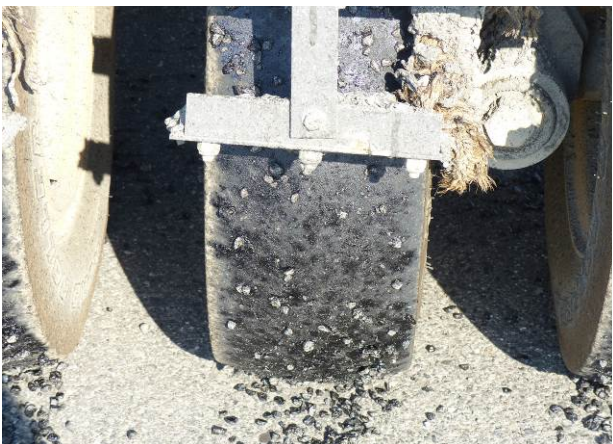
Figure 17. Aggregate and binder sticking to pneumatic roller tire. (July 2015)

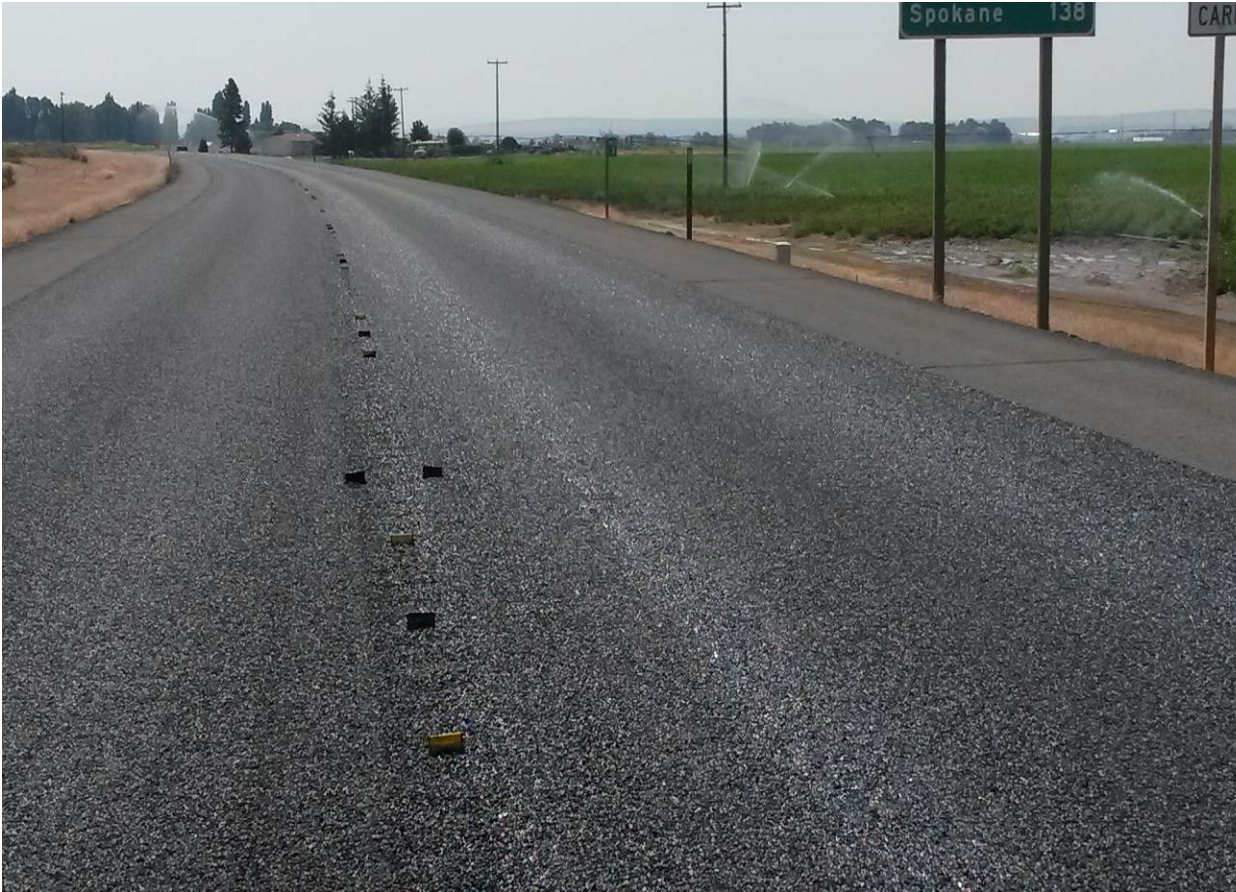
Figure 23. Both lanes of the completed HBST on SR 281 Spur showing 100% embedment in the wheel paths. (July 2015)

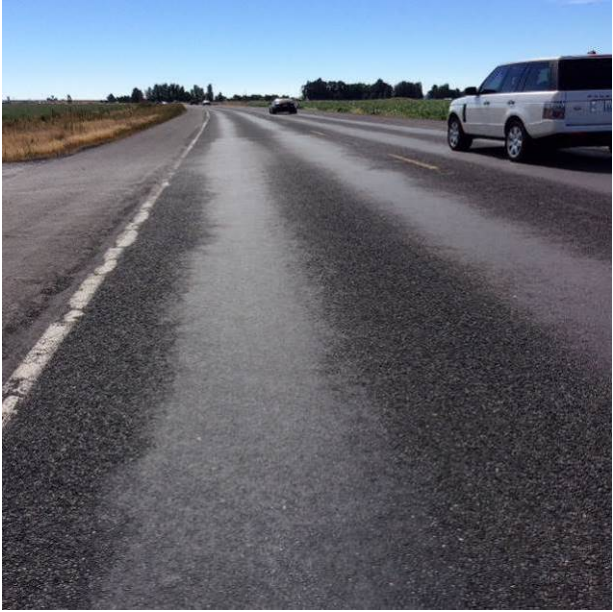
The 2017 review tour took place on August 18 (Figures 24-27). The embedment ranged from 70-80% except in the wheel paths where it was 100% and thus the rich appearance. The 2016 friction survey found one value below a FN of 30, but a retest did not confirm that there was a problem with friction. The North Central Region indicated that this section should last a long time since there is no snow plowing on this roadway.

Figure 24. Looking north from MP 3.35 showing 100% embedment in the wheel paths. (August 2017)

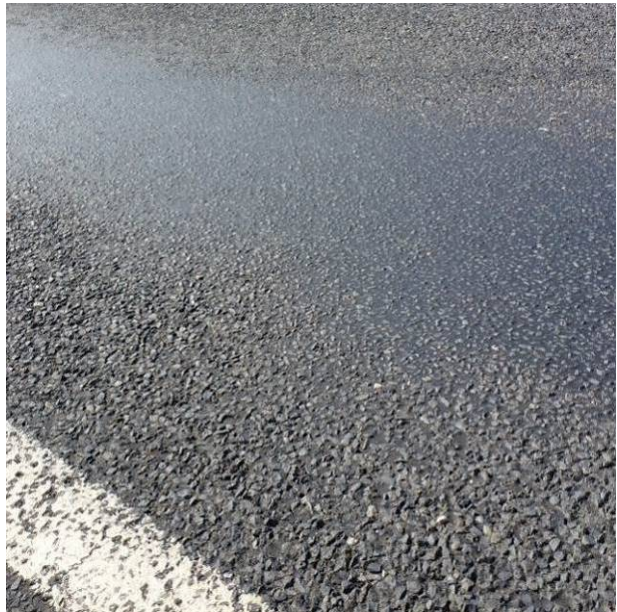
Figure 27. Close-up of the wheel path with 100% embedment at MP 3.35. (August 2017)

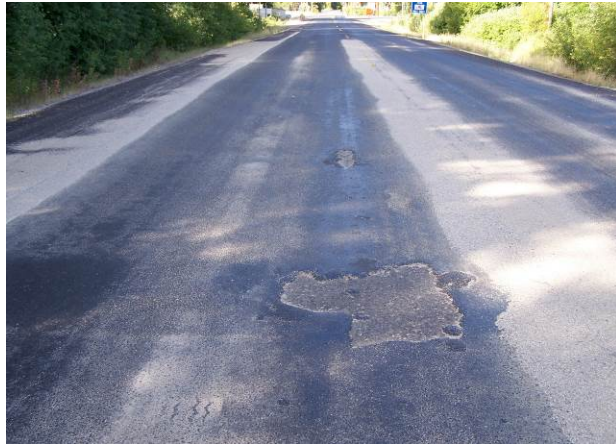
Figure 29. Delamination of HBST. (July 2015)

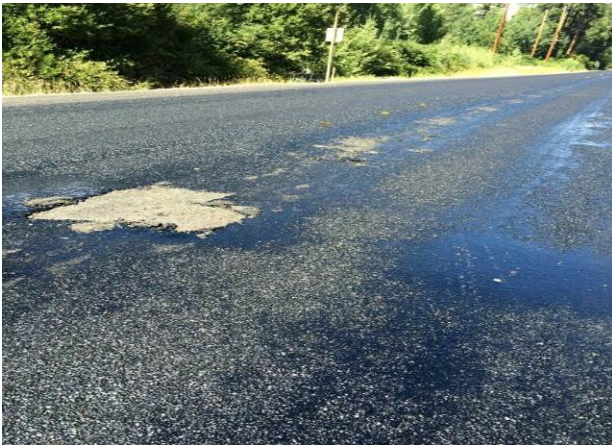
Figure 30. Delamination and flushing of the HBST. (July 2015)

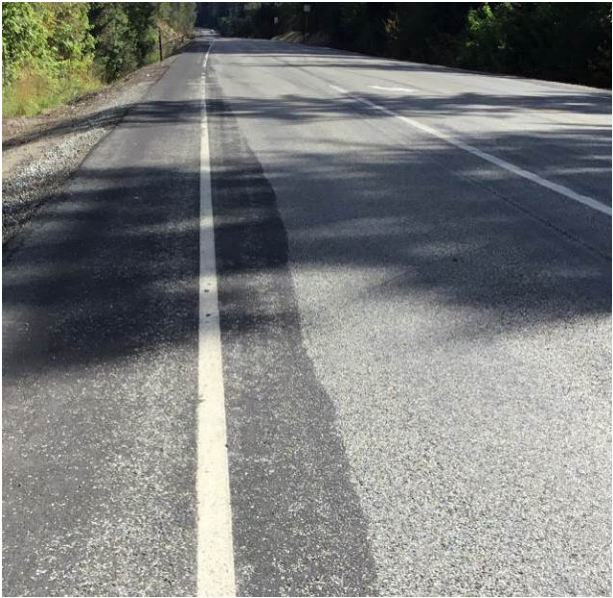
This section was reviewed on August 16, 2017 (Figures 32-37). The HBST has a somewhat streaky appearance due to the 100% embedment in the wheel paths. The North Central Region indicated that the oil shot was too heavy on this section. A slurry seal applied to the shoulder overlaps the HBST unevenly added to the negative ascetics of the project.

Figure 32. Looking north from MP 4.00. (August 2017)

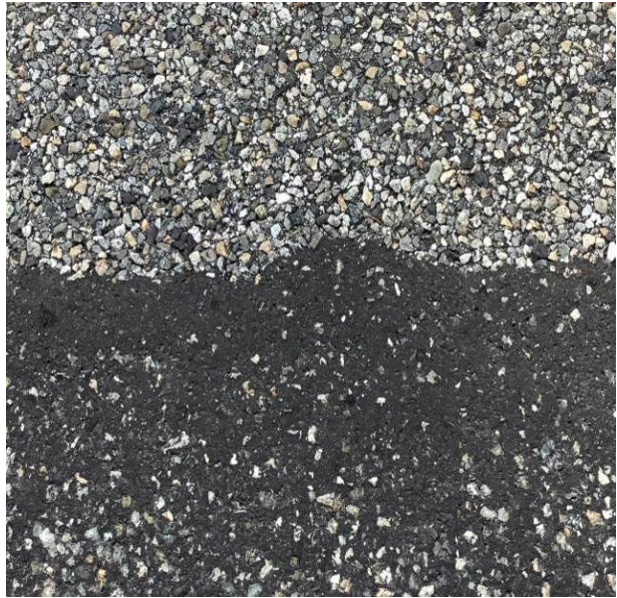
Figure 33. HBST and slurry seal contact at MP 4.00. (August 2017)

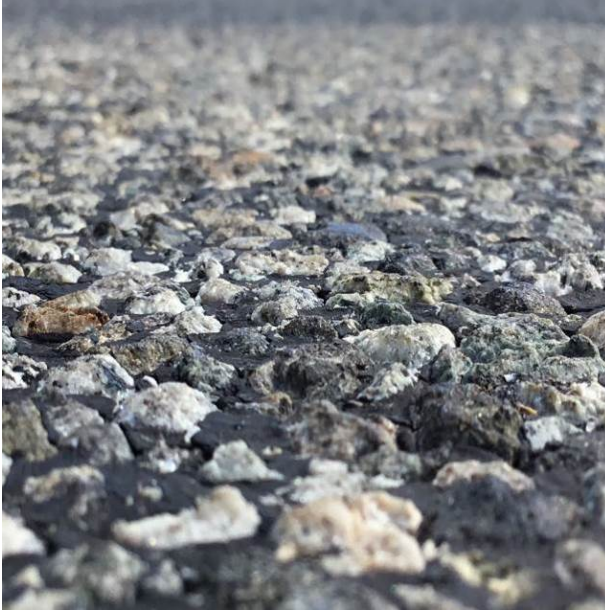
Figure 36. Low level view at MP 4.00 showing 60% embedment. (August 2017)

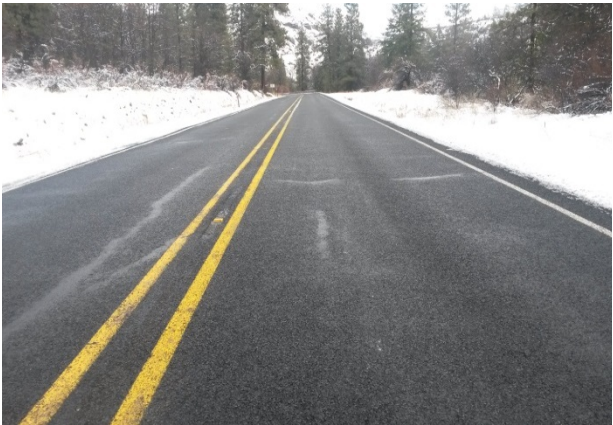
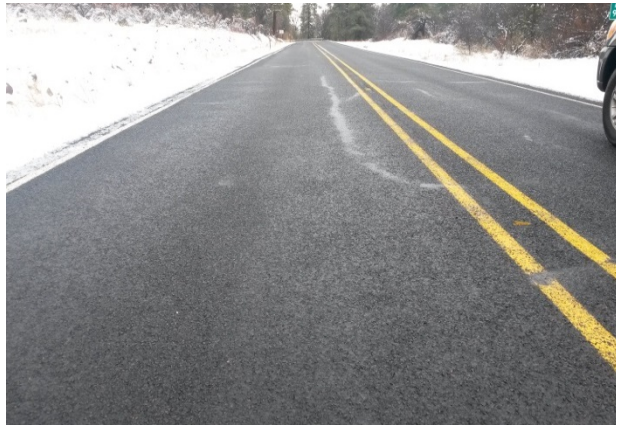
The project was inspected on December 11, 2016, six months after installation (Figures 48-59). The HBST was in generally good condition with some streaking and rich appearing wheel paths and transverse cracking.

Figure 48. HBST at the age of six months. (Dec. 2015)

Figure 49. HBST at the age of six months. (Dec. 2015)

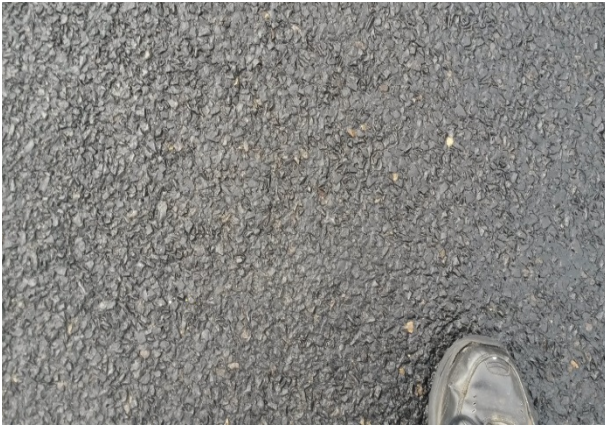
Figure 50. Close-up view at the age of six months. (Dec. 2015)

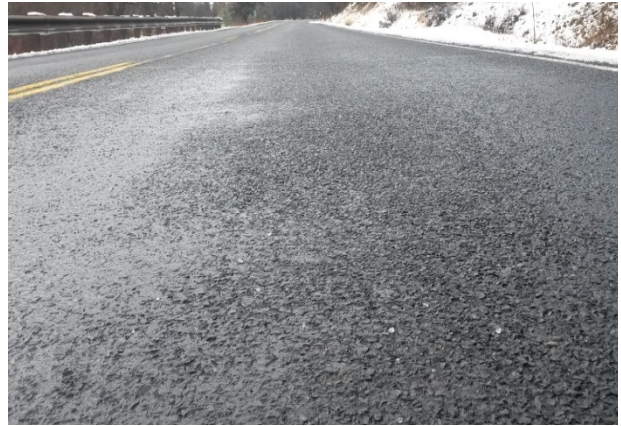
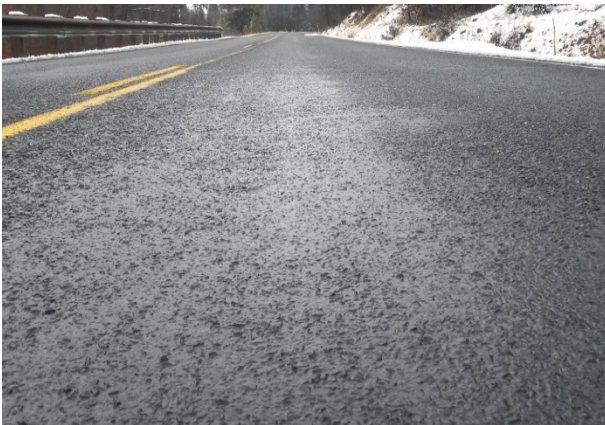
Figure 51. HBST with 100% embedment at the age of six months. (Dec. 2015)

Figure 52. HBST with 100% embedment at the age of six months. (Dec. 2015)

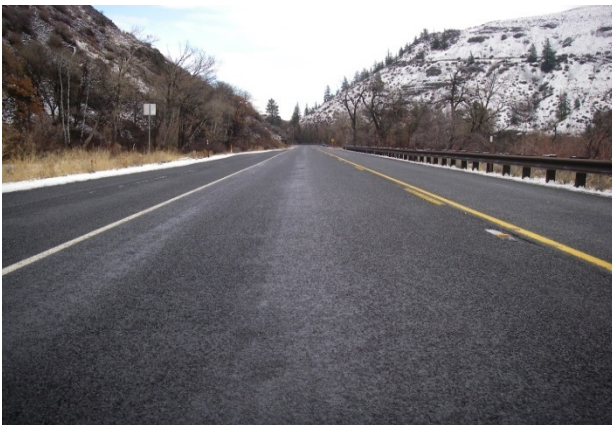
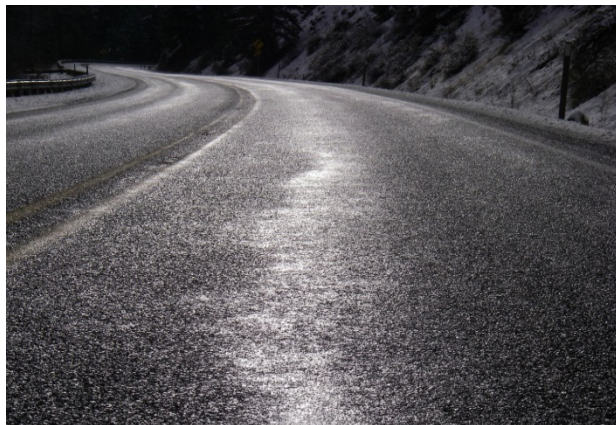
Figure 58. Rich appearing wheel paths at the age of six months. (Dec. 2015)

Figure 59. Rich appearing wheel paths at the age of six months. (Dec. 2015)

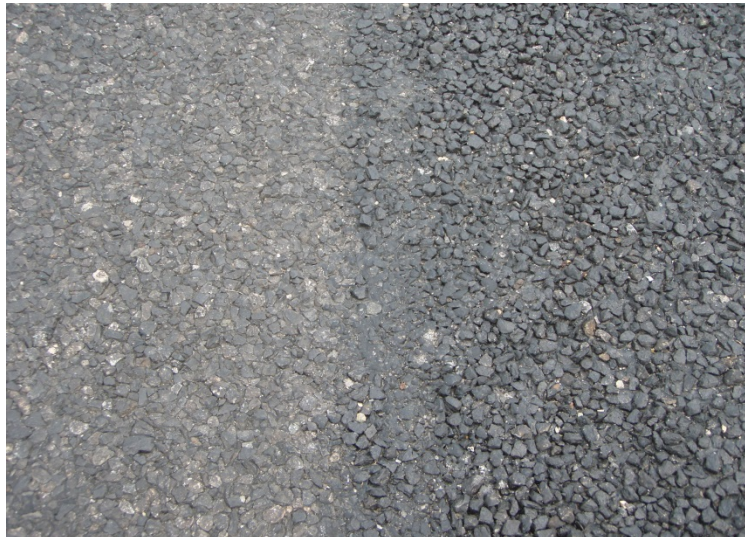
Figure 60. Choked (left) and un-choked (right) HBST.
(Sept. 2015)

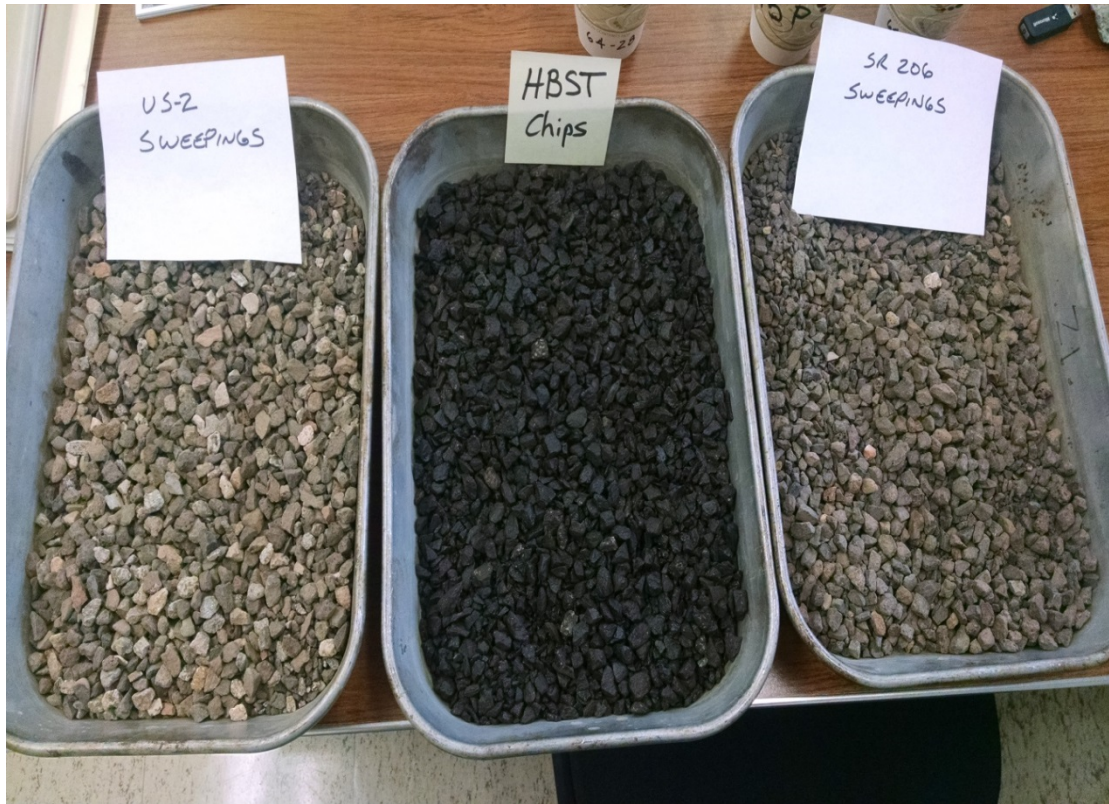
Figure 61. Aggregate sweepings from US-2 (left tray), HBST pre-coated chips (center tray) aggregate sweepings from SR-206 (right tray). (Sept. 2015)

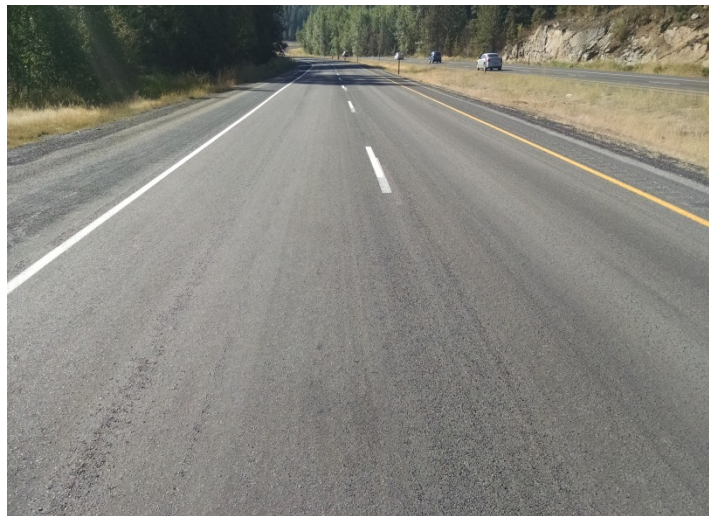
Figure 62. Finished HBST on US-2. (Sept. 2015)

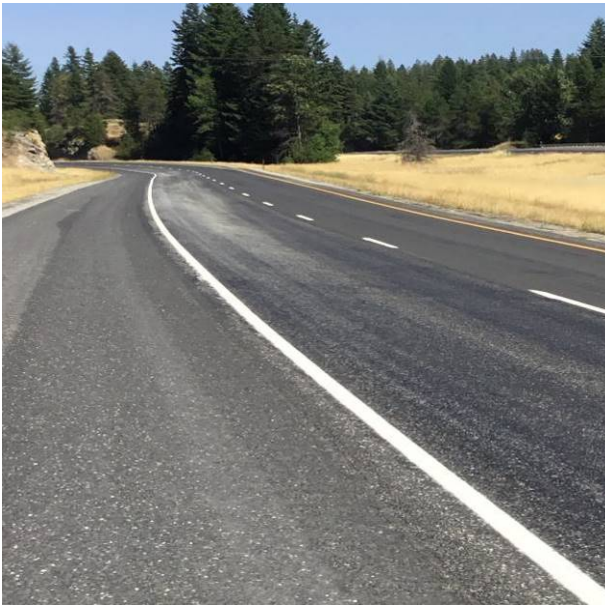
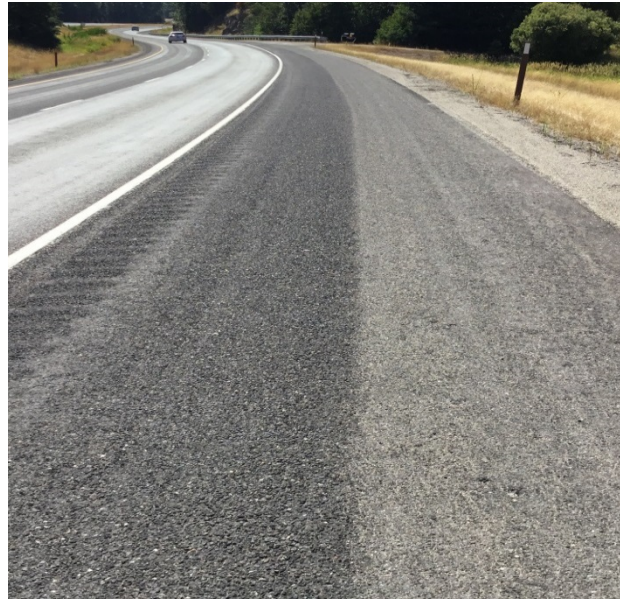
The 2017 review occurred on August 17 (Figures 63-66). Embedment ranges from 60-100% which accounts for the rich appearance of the HBST in the wheel paths.

Figure 63. Looking east from MP 319.70. (August 2017)

Figure 64. Looking west from MP 319.70. (August 2017)

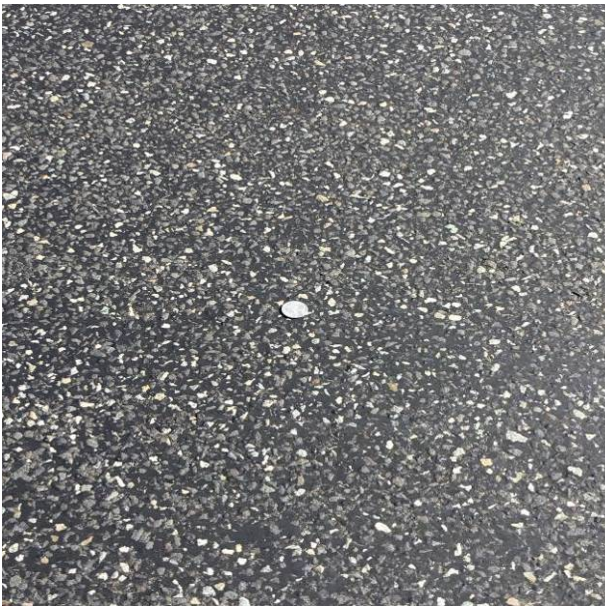
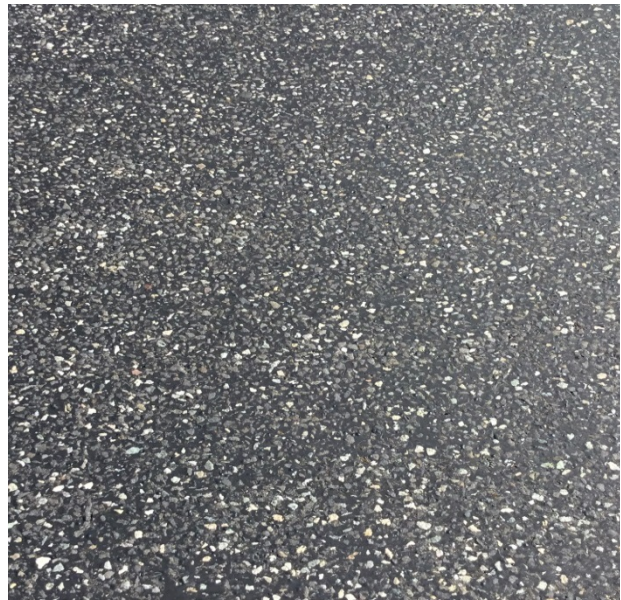
Figure 65. HBST at MP 319.70 with 100% embedment. (August 2017)

Figure 66. HBST at MP 319.70 with 100% embedment. (August 2017)

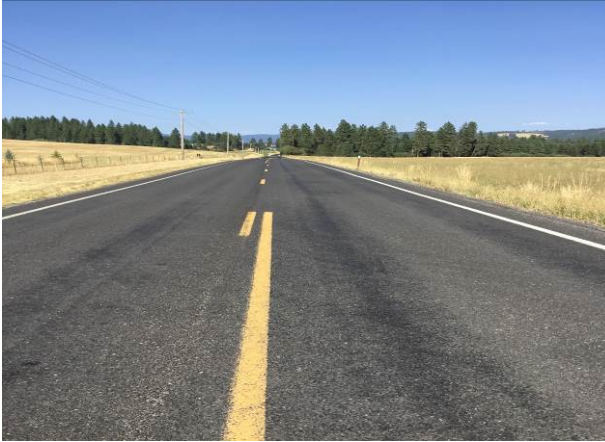
The 2017 review occurred on August 17 (Figures 67-72). Embedment ranged from 60-100% which accounts for the rich appearance of the HBST in the wheel paths. Raveling and snowplow damage was noted. The first two miles of the project look better than the roadway where the photos were obtained.

Figure 67. HBST at MP 5.39 on with 100% embedment in the wheel paths. (August 2017).

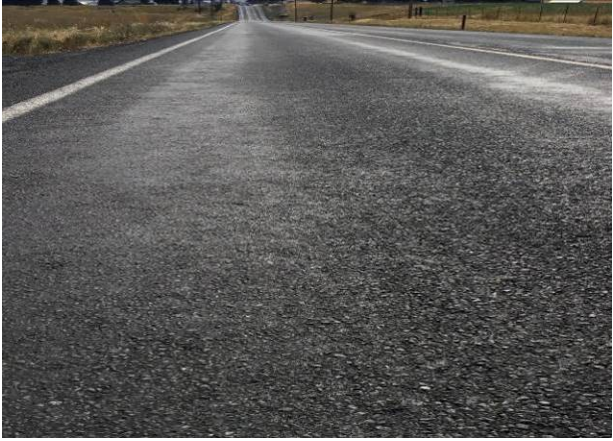
Figure 71. Rich appearance of HBST at MP 5.39 with 100% embedment in the wheel paths. (August 2017)

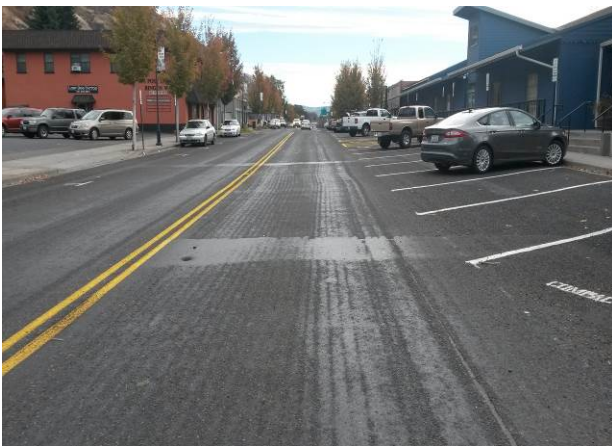
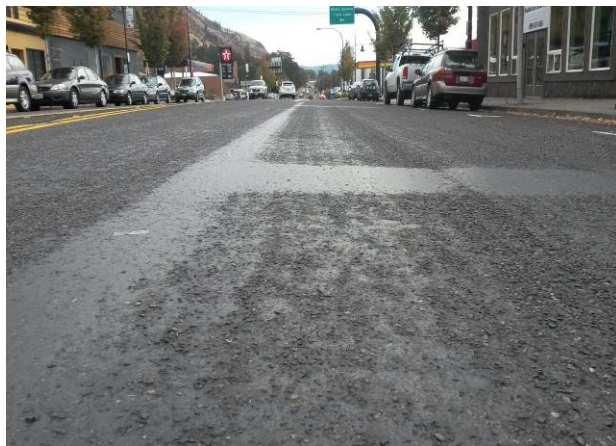
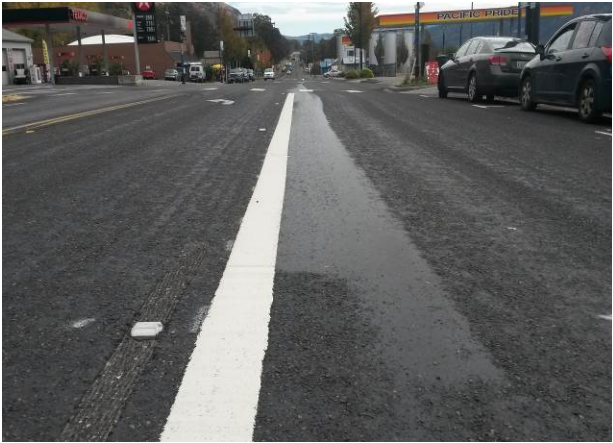
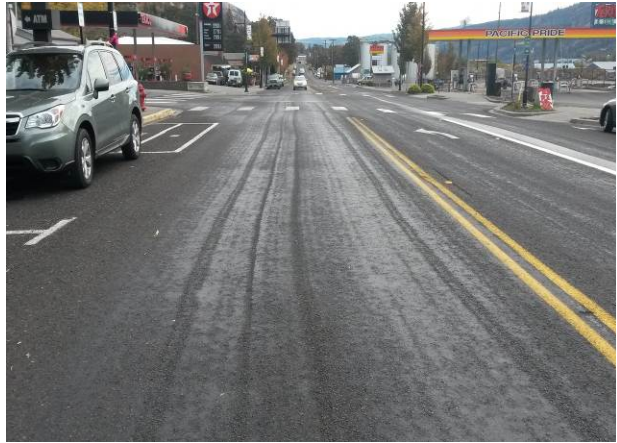
The project was paved during daylight hours except through the towns of Bingen and Stevenson where paving occurred at night due to high traffic volumes. The result was rapid cooling of the binder which did not allow the oil to flow causing streaking. Streaks along the longitudinal joints was attributed to an overlap of the oil shot due to the distributor operator not being able to see the area that had been already paved. The rock loss problems were so extensive that portions of the project through Stevenson and Bingen were repaved in 2016 with HMA. The IDR's indicate that the paving started on August 24 and was completed on September 11, 2015. The IDR's contained no information on rock and oil yield.

Figure 73. HBST through Bingen. (October 2015).

Figure 74. HBST through Bingen. (October 2015).

Figure 75. HBST through Bingen. (October 2015).

Figure 76. HBST through Bingen. (October 2015).

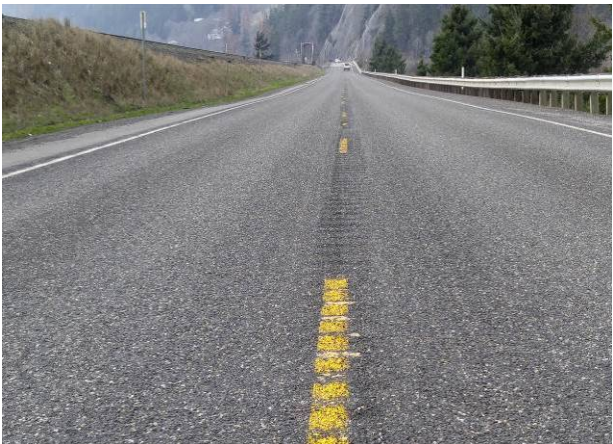
Figure 77. HBST showing one of the better areas. (Jan. 2016)

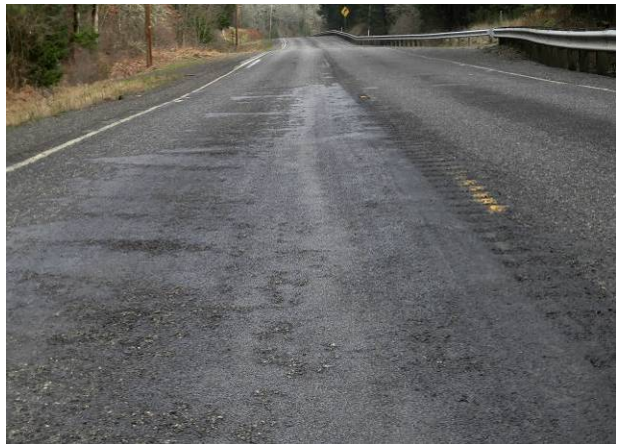
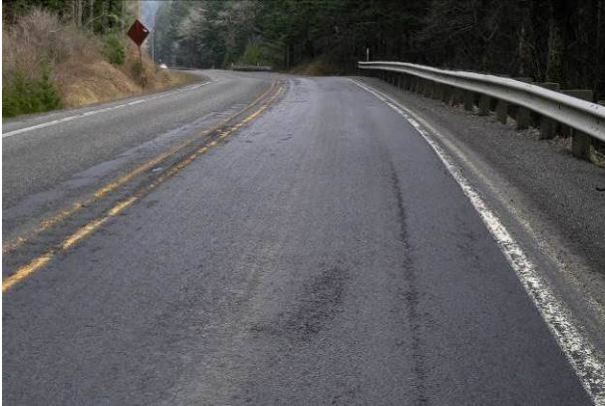
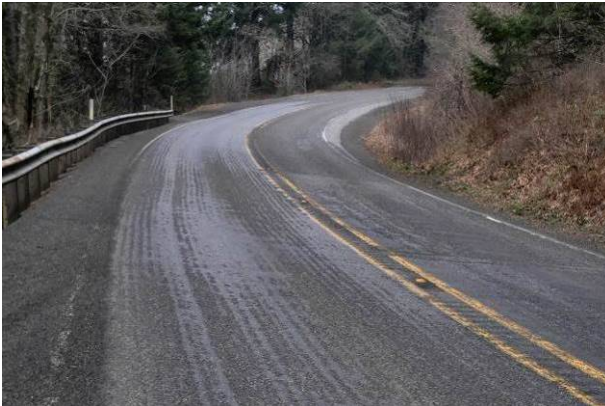
Photos from January of 2016 show the streaking and areas where the chips were lost (Figures 77-82).

Figure 78. HBST showing aggregate loss. (Jan. 2016)

Figure 79. HBST showing aggregate loss. (Jan. 2016)

Figure 81. HBST showing aggregate loss. (Jan. 2016)

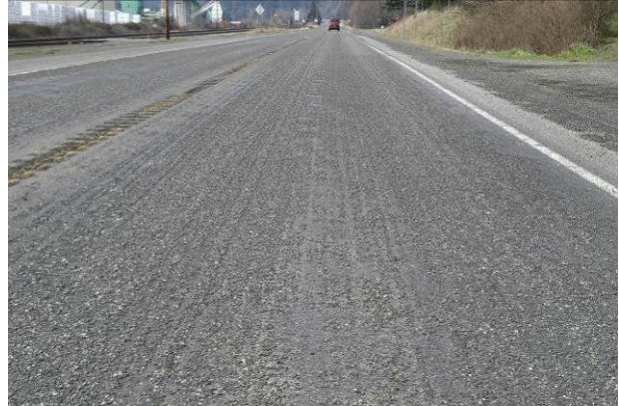
Figure 80. HBST showing cornrows. (Jan. 2016)

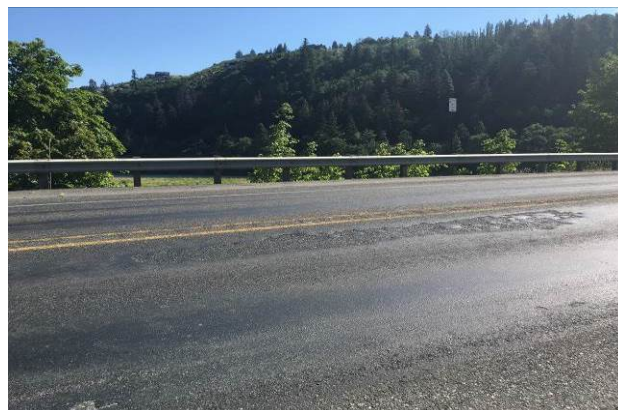
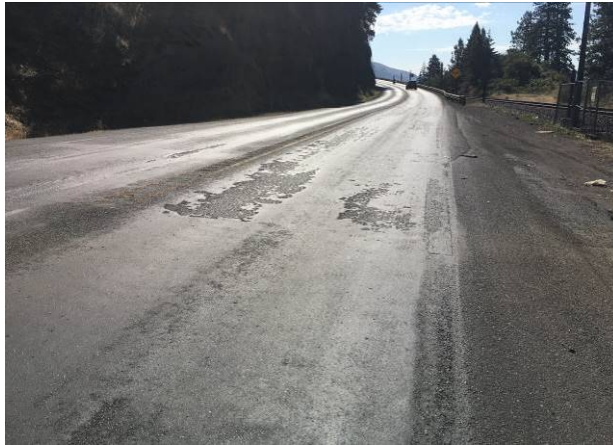
Figure 84. Delamination of HBST. (June 2016)

Figure 85. Delamination of HBST. (June 2016)

A change order was issued in 2016 to repair portions of the project with a grind and inlay due to potholes developing in the HBST. The limits of the repairs were from MP 44.07 to 44.60 in Stevenson and MP 62.57 to 67.10 in Bingen. The change order stated that the chip seal through Stevenson and Bingen was conducted at night and that the seal did not achieve the expected results. The chip seal in these towns were characterized as showing oil/asphalt bleeding and streaking. On the section beyond Bingen the initial performance was excellent, but over time the pavement began to lose aggregate especially along the tree-shaded segments. The shedding of aggregate was exacerbated by snowplows during the winter. During very hot summer temperatures oil came to the surface of the seal and was so soft that a boot would leave an imprint. Citizens complained that flying aggregate was causing windshield damage and oil was collecting on the undercarriages of their vehicles. Also, on June 3, 2016 a train derailment in Mosier, OR shut down I-84 in Oregon and traffic was detoured onto SR-14. As a result of hot weather, long delays and extra traffic, sections of the HBST delaminated.

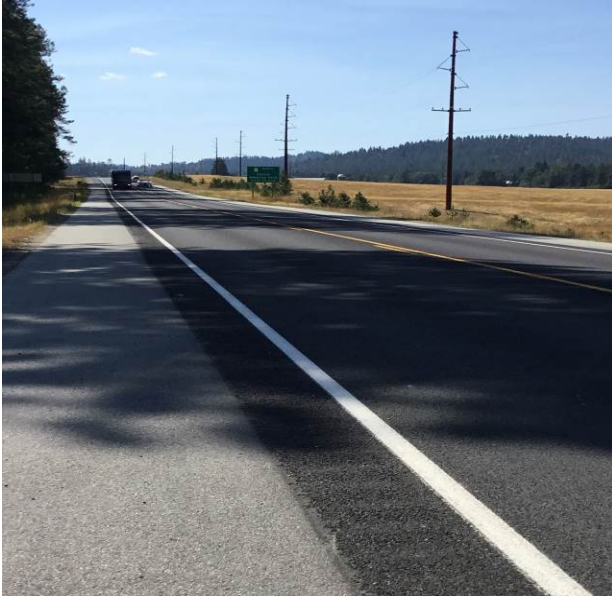
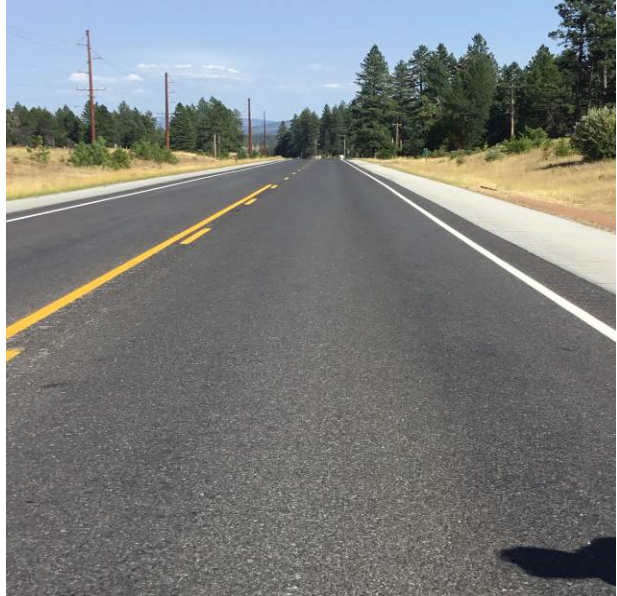
The 2017 review took place on August 17 (Figures 94-97). The aggregate embedment was about 60% over most of the lane and 100% in the wheel paths.

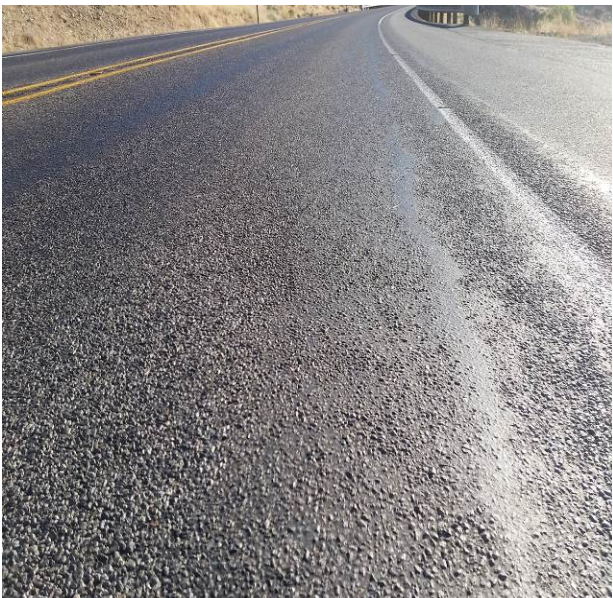
Figure 96. Closer view of HBST at MP 321.85 showing 100% embedment in the wheel paths and 60% between wheel paths. (August 2017)

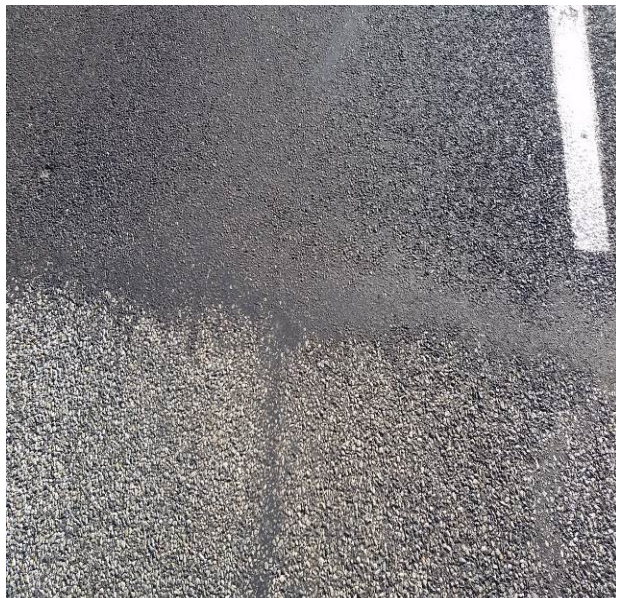
Figure 97. HBST at the top and conventional BST at the bottom at MP 321.85. (August 2017)

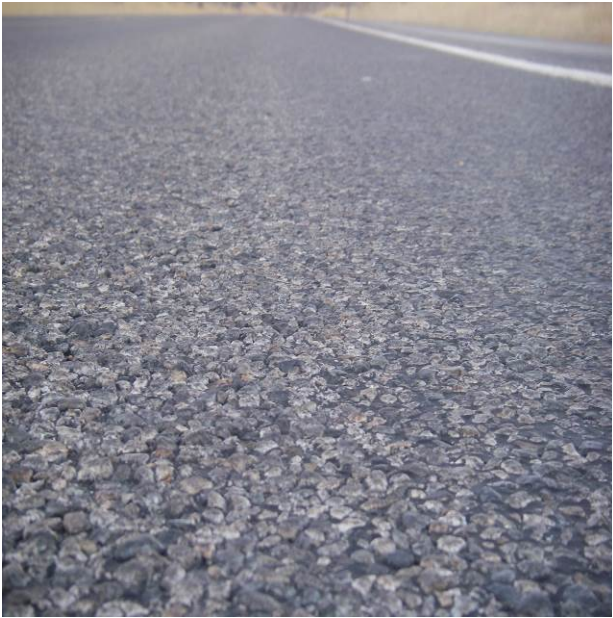
The SR-97 portion of the project was inspected on August 17 at MP 234.00 (Figures 98-101). The rich appearance of the HBST in the wheel paths was due to 100% embedment of the chips. Snowplow damage at the centerline was noted.

Figure 100. Closer view of the HBST at MP 234. (Aug. 2017)

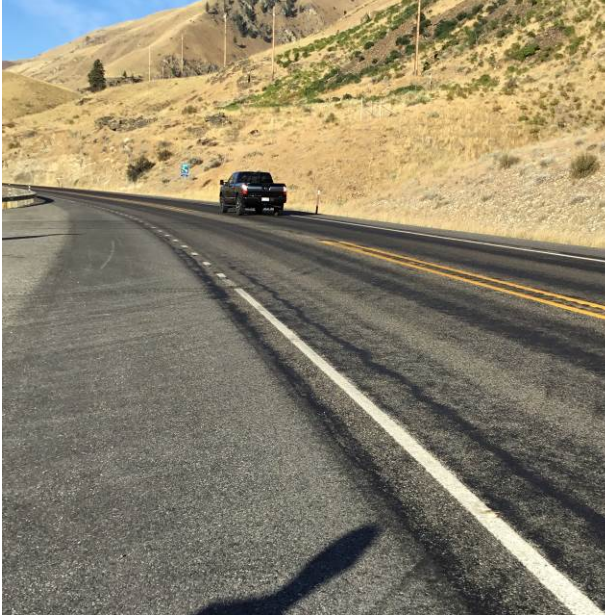
The SR-97A portion of the project was inspected on August 17 at MP 205.09 (Figures 102-105). There is an appearance of flushing in the wheel paths due to the 100% embedment. The North Central indicated that there were problems with the oil setting too quickly and that is the cause of the chips not sticking to the centerline portion. Longitudinal cracks that were sealed prior to the paving are visible through the HBST.

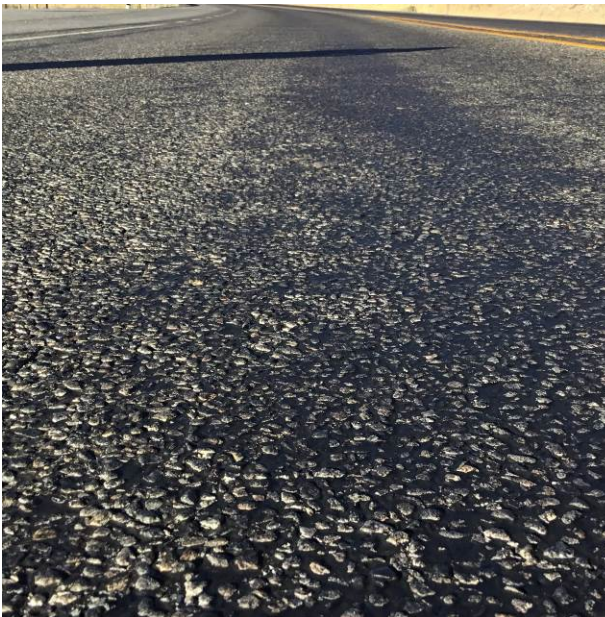
Figure 104. HBST at MP 205.09 showing 100% embedment in the wheel paths. (August 2017)

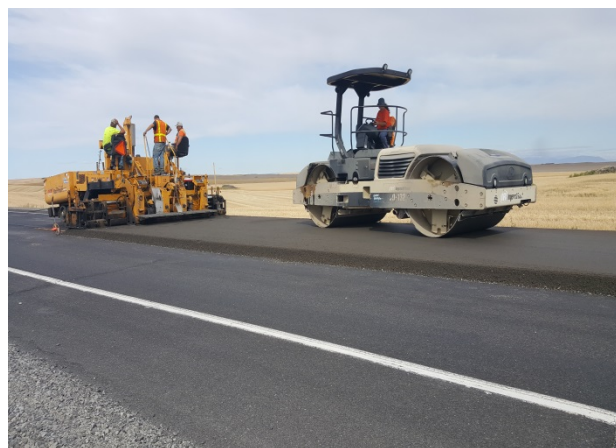
Figures 106-109 show the transverse cracking and the paving and compaction of the cushion course. Pre-level paving shown in Figures 110-111 and mill and fill in 112-113.

Figure 107. Spreading and compacting
cushion course on US-2. (August 2016)

Before and after ride measurements documented the improvements provided by the cushion course and other treatments (see Table 4). The cushion course sections improved 65% as compared to the pre-leveled section which improved 44% and the rut filled section 38%. As expected the mill and fill section showed the most improvement at 69%. This section will be monitored to determine the success of the various treatments in reducing reflection cracking from the underlying pavement. Detailed ride data is provided in Appendix B, Table 14.

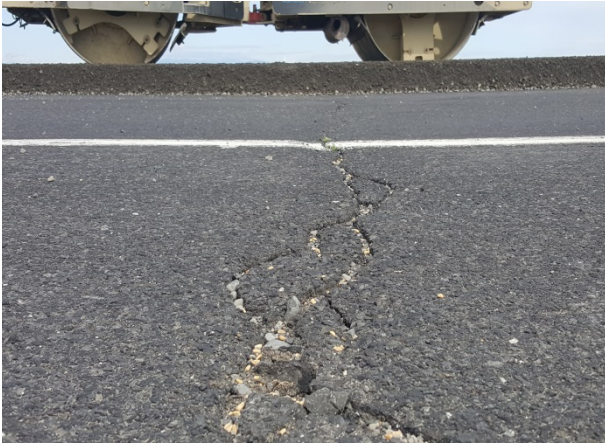
Figure 108. Rolling of cushion course on US-2 over transverse crack. (August 2016)

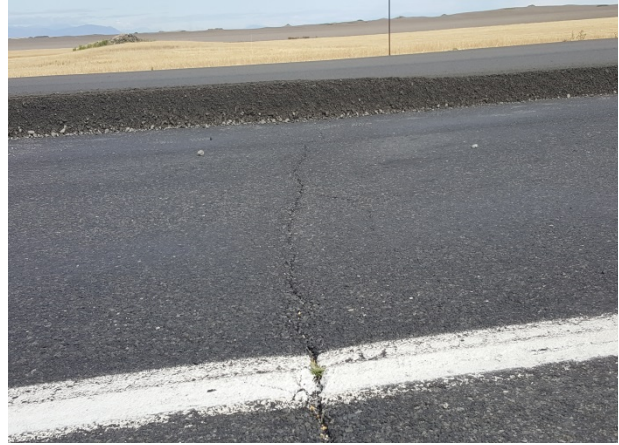
Figure 109. Rolling of cushion course on US-2 over transverse crack. (August 2016)

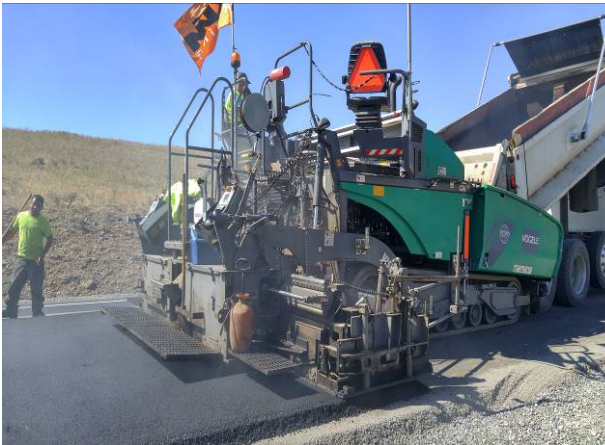
Figure 110. Pre-level paving over the cushion course. (August 2016)

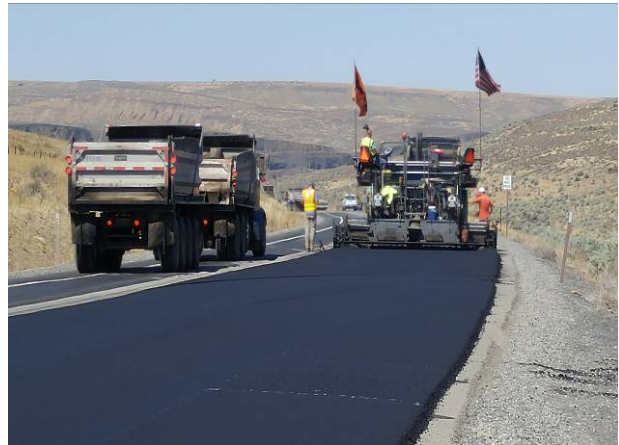
Figure 111. Pre-level paving over the cushion course. (August 2016)

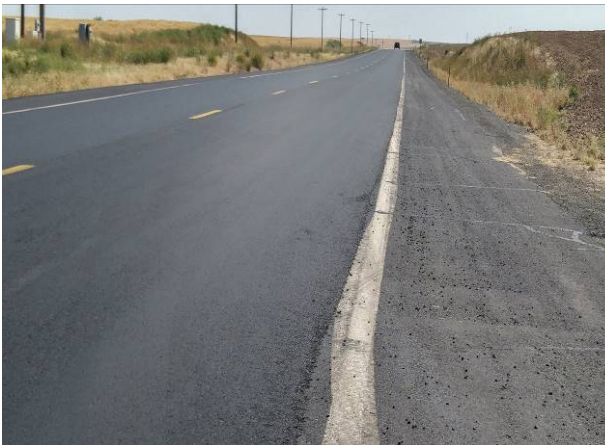
Figure 112. Pre-level on US-2. (August 2016)

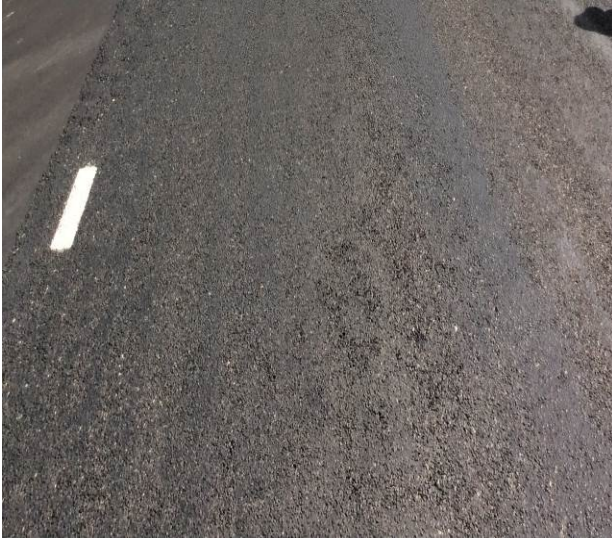
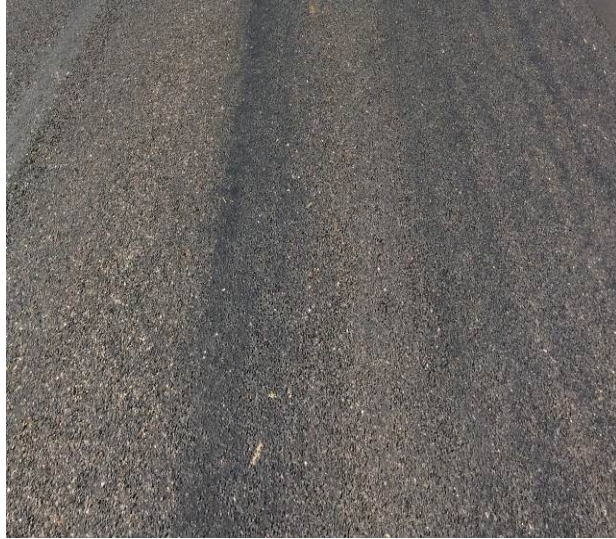
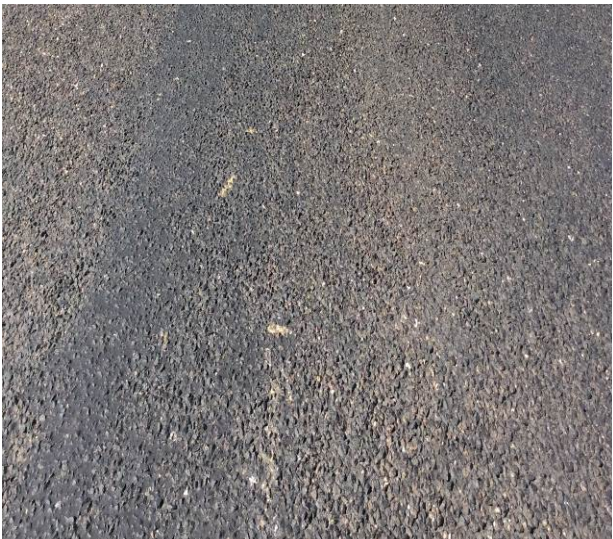
The 2017 review took place on August 18 (Figures 149-152). The HBST looked very good with 70-80% embedment outside of the wheel paths which were at 100% embedment. The North Central Region indicated that a steel wheel roller was used to embed the chips. Snow plows are rarely used on this section of SR-283 which should increase the chip seal life.

Figure 149. View at MP 4.41 with 70-80% embedment (100% in the wheel paths). (August 2017)

Figure 150. Another view at MP 4.41 with 70-80% embedment (100% in the wheel paths). (August 2017)

Figure 151. HBST at MP 4.41 with 70-80% embedment (100% in the wheel paths). (August 2017)

Figure 152. HBST at MP 4.41 with 70-80% embedment (100% in the wheel paths). (August 2017)
