Review of Hot Bituminous Surface Treatments in Washington State

WA-RD 887.1

January 2019

WSDOT Special Project
Post-Construction Report

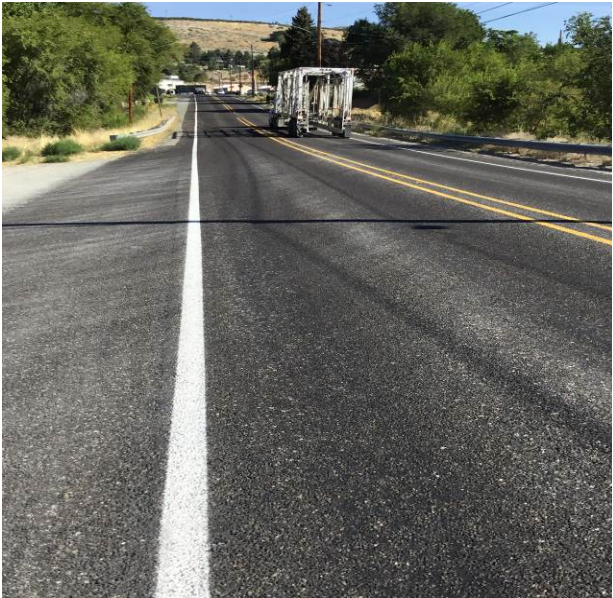
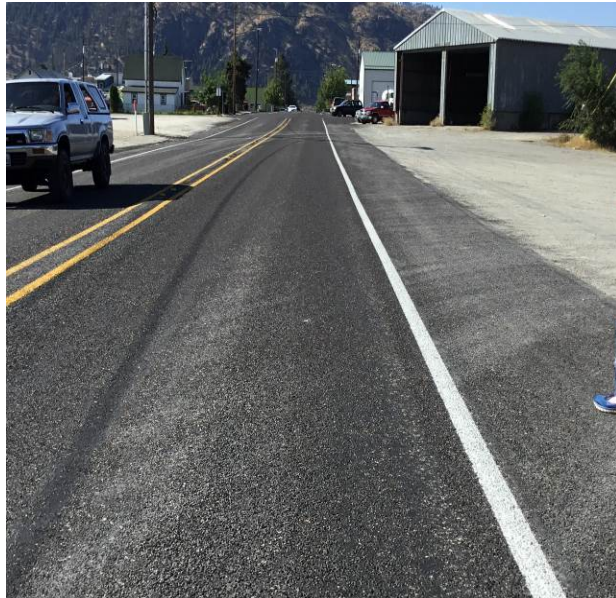
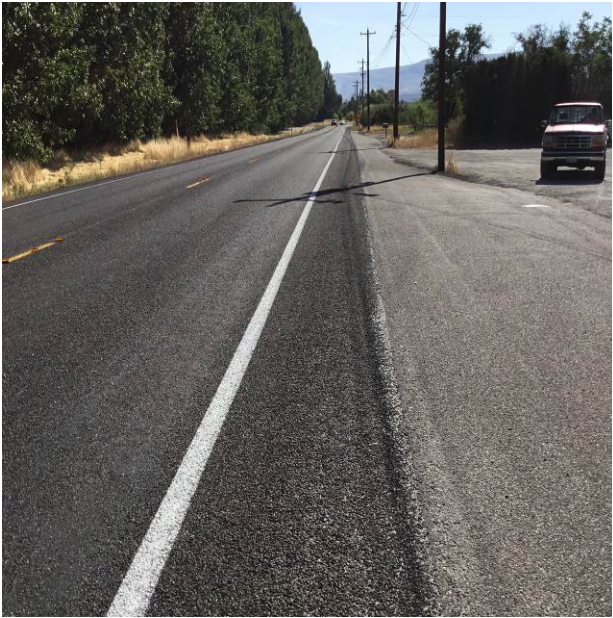
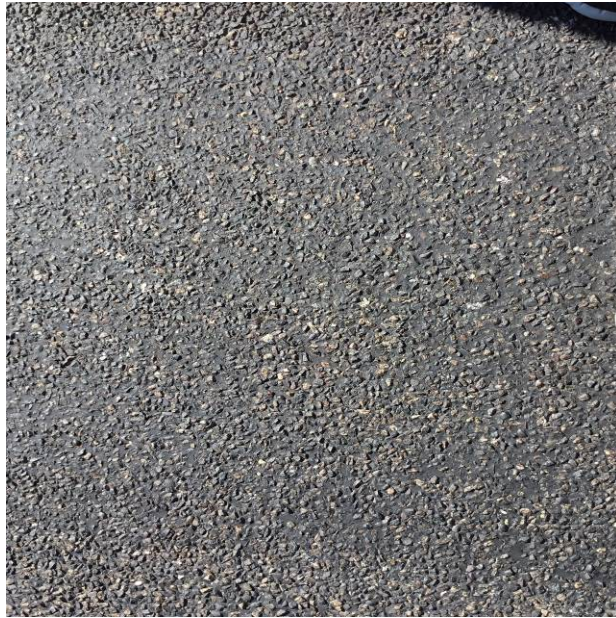
The 2017 review took place on August 17 (Figures 153-158). This section of Contract 9006 looks very good with 60-90% embedment. Each distributor shot had a different appearance. The North Central Region indicated that there has been very little traffic on this section since it was paved. A double shot of HBST was applied from the SR-97 junction to the bridge, MP 10.95 to 11.98.

Figure 155. Close-up view at MP 11.74 with 40-50% embedment. (August 2017)

Figure 158. Close-up view at MP 8.00 with 60-90% embedment. (Aug. 2017)

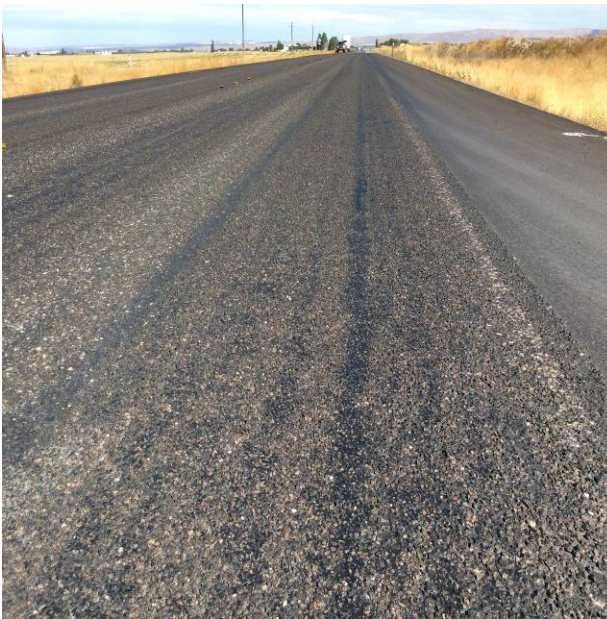
The 2017 review took place on August 18 (Figures 159-162). Streaking was noted due to an uneven application of the binder. The embedment ranged from 70-80%.

Figure 161. Looking south from MP 3.55
showing streaky appearance (cornrows).
Embedment is 70-80%. (August 2017)

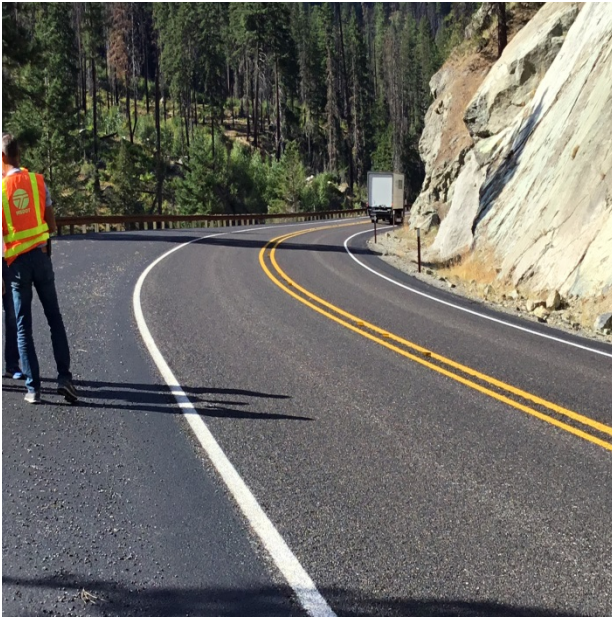
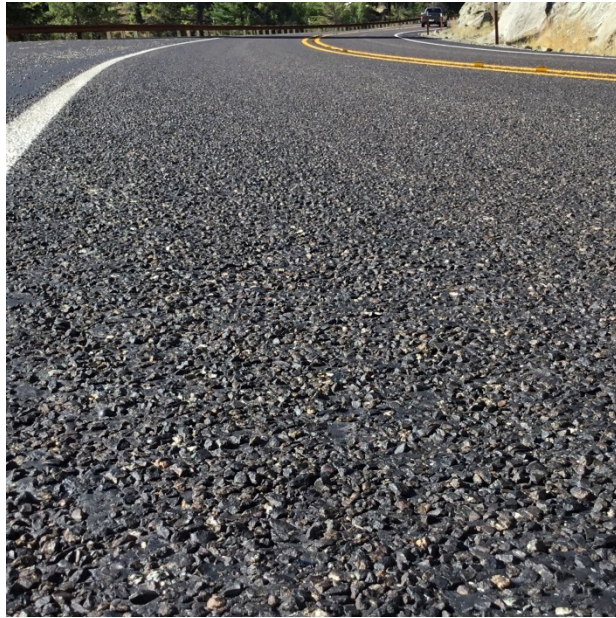
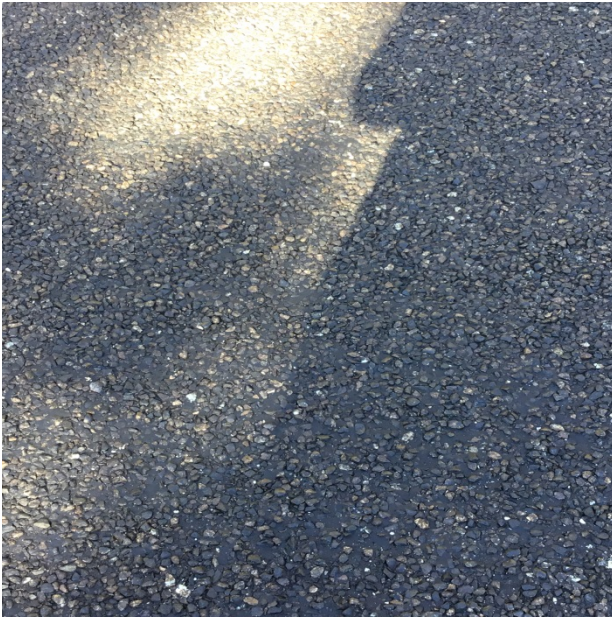
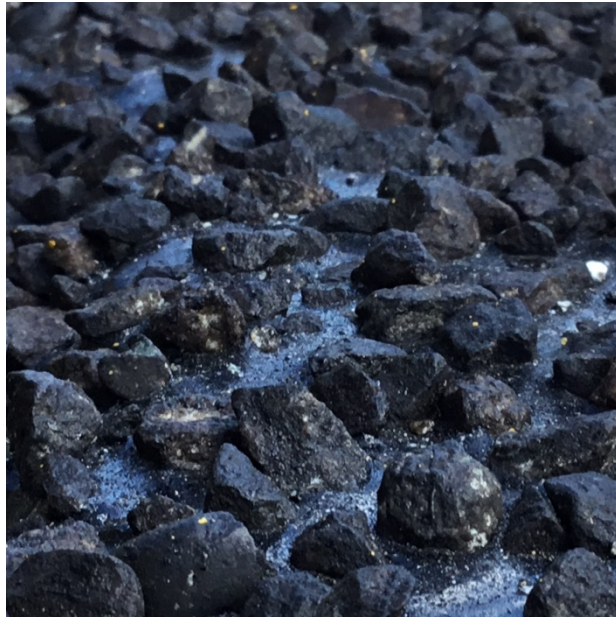
Figures 163-166 are from the 2017 review which took place on August 16. The chips were 50% embedded and there were lots of chips on the shoulder.

Figure 166. Close-up view of the 50% chip embedment at MP 91.38. (August 2017)

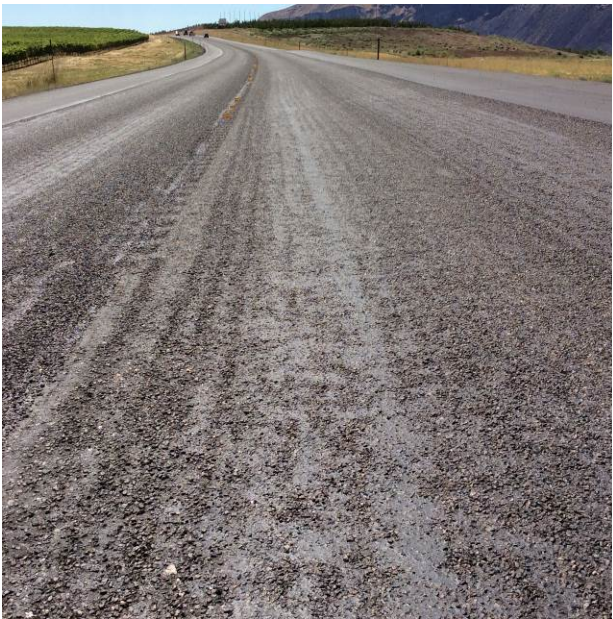
The 2017 review took place on August 18 (Figures 167-170). The HBST had 50-60% embedment of the chips in the oil. The North Central Region indicated that it appeared that the oil was too cool when the chips were applied causing the corn rows.

Figure 169. Streaky appearance at MP 18.30.
(August 2017)

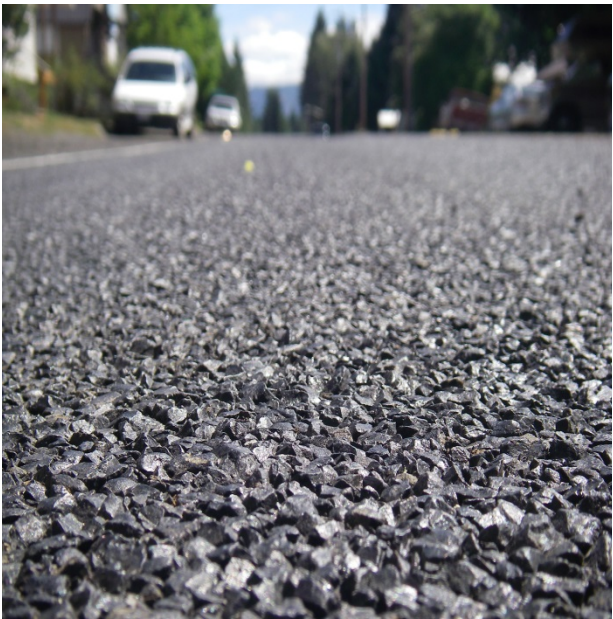
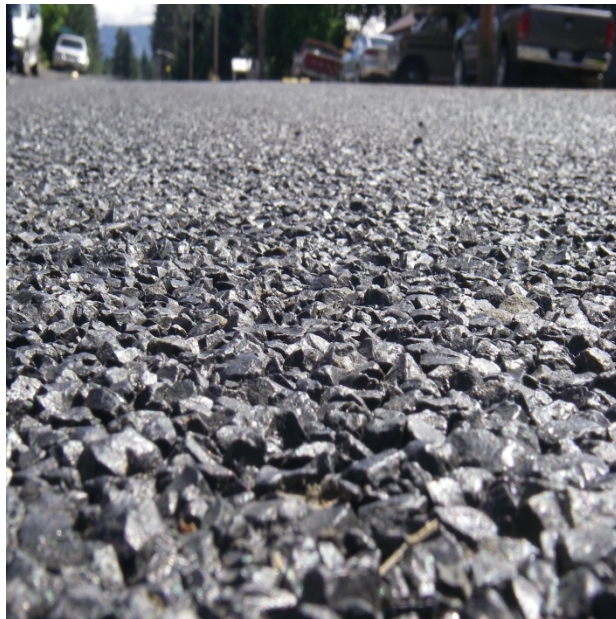
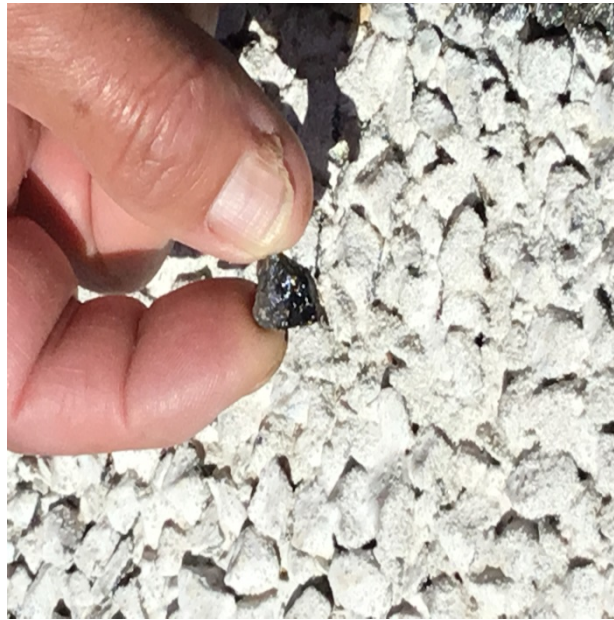
The 2017 review occurred on August 16 (Figures 171-175). Only 50% embedment of the chips was noted on this section. The HBST had a uniform appearance that was devoid of rich areas in the wheel paths.

Figure 173. Close-up view at MP 7.30
showing 50% embedment. (Aug. 2017)

Figure 175. Chip taken from the HBST at MP 7.30 showing 50% embedment. (Aug. 2017)

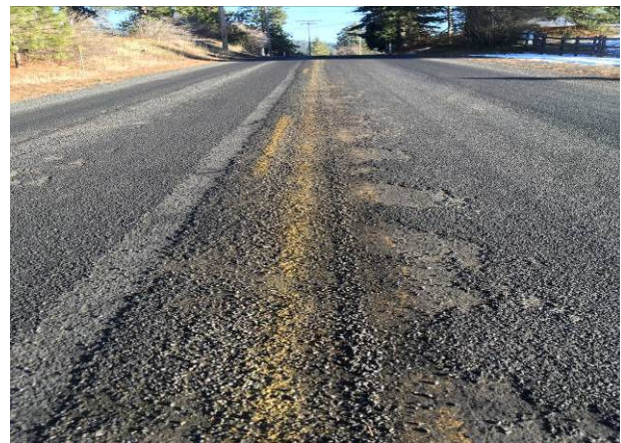
The Cle Elum to Roslyn section, MP 2.10 to MP 4.75 showed minor raveling where snowplows have scraped the high spots, but overall the surface was in good condition. From Roslyn to Ronald, MP 6.10 to MP 7.10, the wheelpaths have raveled (see Figures 176 and 177). In Ronald (MP 7.10 to MP 7.50) the HBST looks good with only minor raveling. From Ronald to the Forest Service Boundary (MP 7.5 to MMP 10.06) the HBST is in poor condition with complete raveling in the wheel paths or across the entire lane (Figures 178 and 179). Figure 180 shows covered chips on the snow berm on the side of the road.

Figure 177. Raveling at MP 6.10 on the section between Roslyn and Ronald.

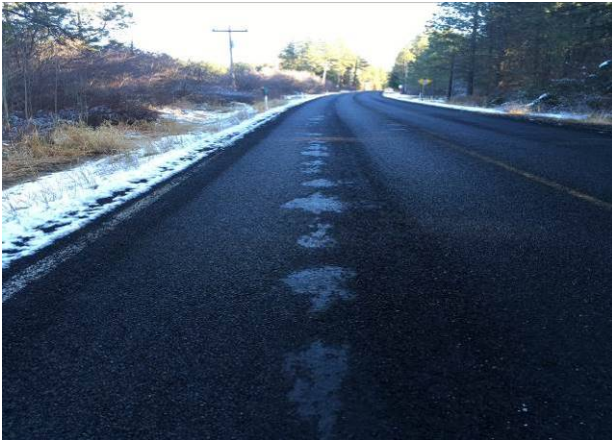
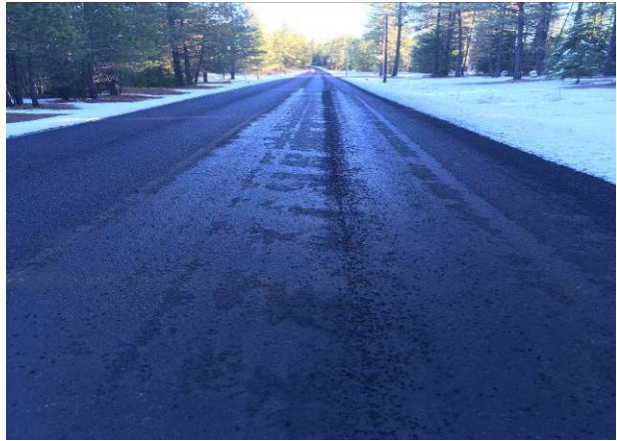
Figure 178. Raveling at MP 8.00 on the section between Ronald and National Forest Boundary.

Figure 179. Raveling at MP 9.00 on the section between Ronald and National Forest Boundary.

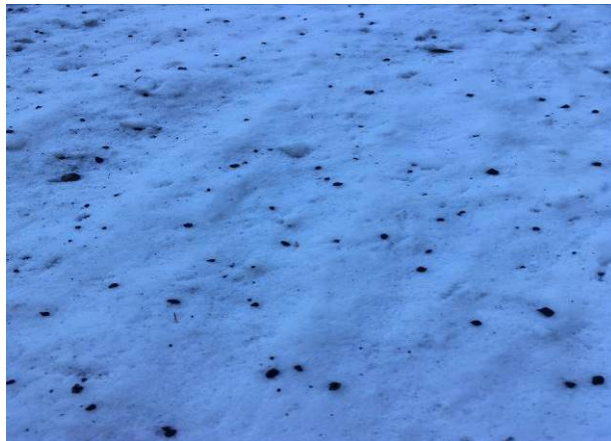
Figure 180. Aggregate chips on the snow berm, milepost unknown.

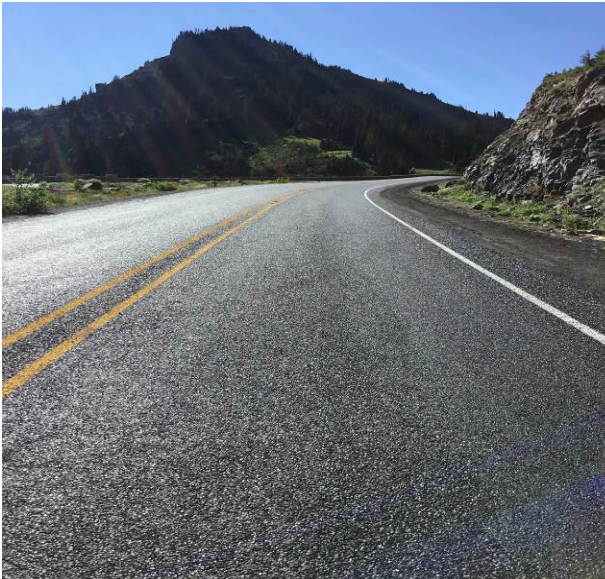
Figure 181. Looking west from MP 69.44. (August 2017)

The 2017 review took place on August 16 (Figures 181-186). The HBST looked very good from a distance, but upon closer examination the chips were only embedded about 30% in the oil. The evaluation team felt chip loss due to low aggregate embedment may be an issue due to snowplow action. Pre-coated chips that had shed to the shoulder were well coated.

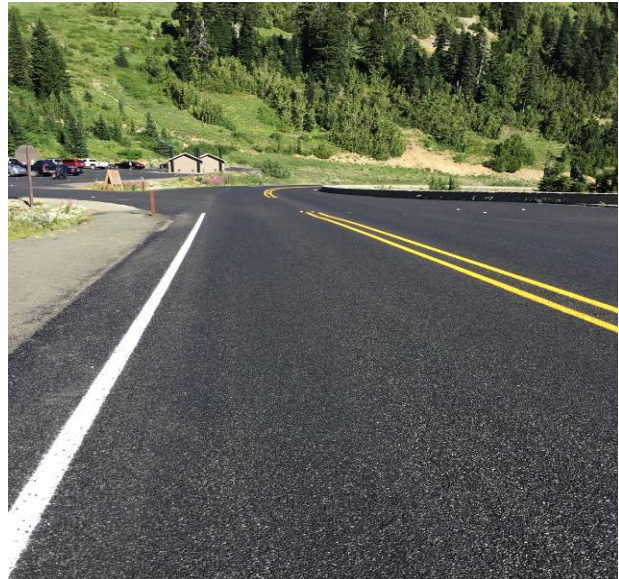
Figure 182. Looking east from MP 69.44. (August 2017)

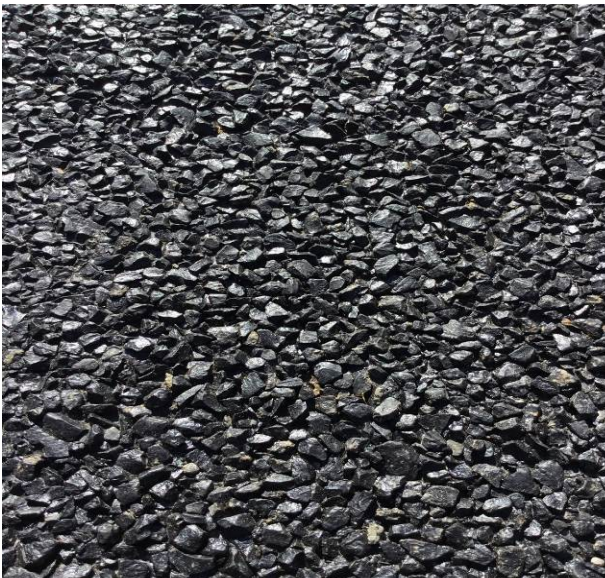
Figure 183. Close-up at MP 69.44 showing 30% embedment. (Aug. 2017)

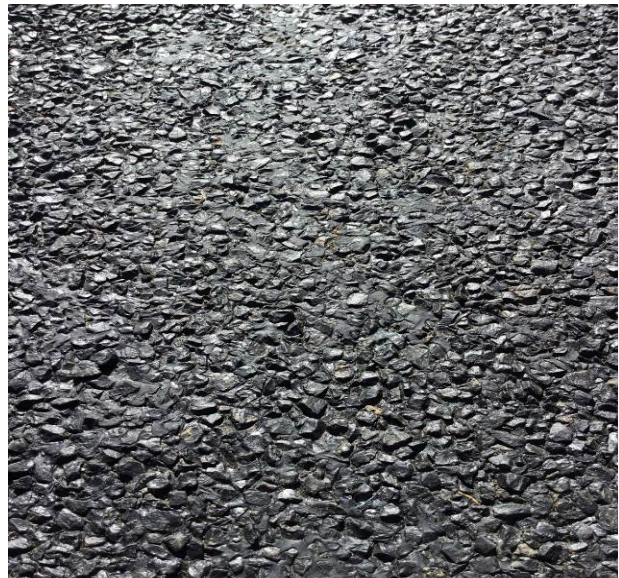
Figure 184. Close-up at MP 69.44 showing spots where the embedment is 60-70%. (August 2017)

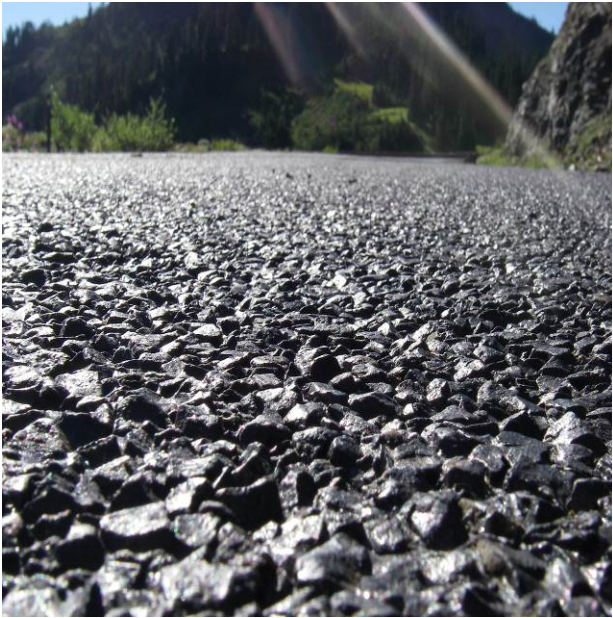
Figure 185. Road level view at MP 69.44 showing lack of embedment. (August 2017)

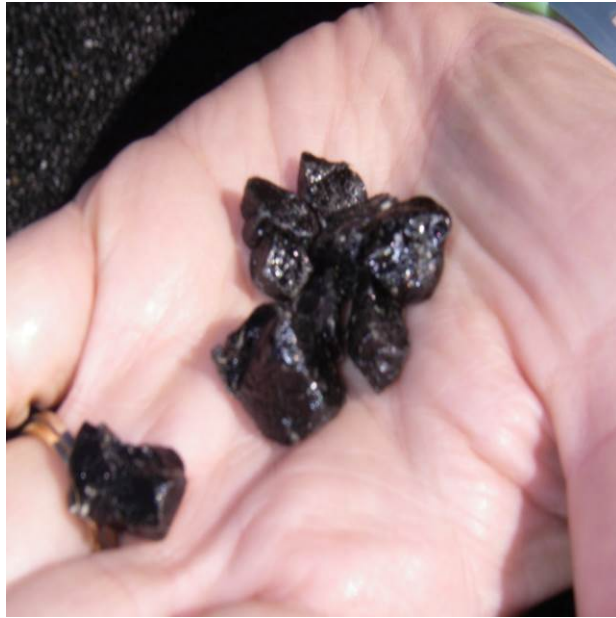
Figure 186. Chips from the shoulder at MP 69.44 with 100% coating. (August 2017)

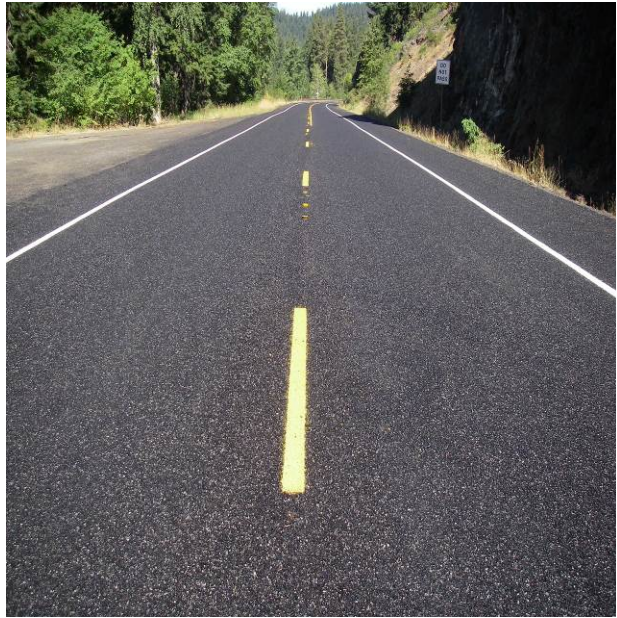
The 2017 review also took place on August 16 (Figures 187-191). This section showed better embedment possible due to higher temperatures at this lower elevation and more traffic. Embedment was 90% in the wheel paths and 30% outside of the wheel paths. There were bubbles of air under the chip seal at the centerline (may lead to delamination in the future).

Figure 188. Looking west from MP 94.30.
(August 2017)

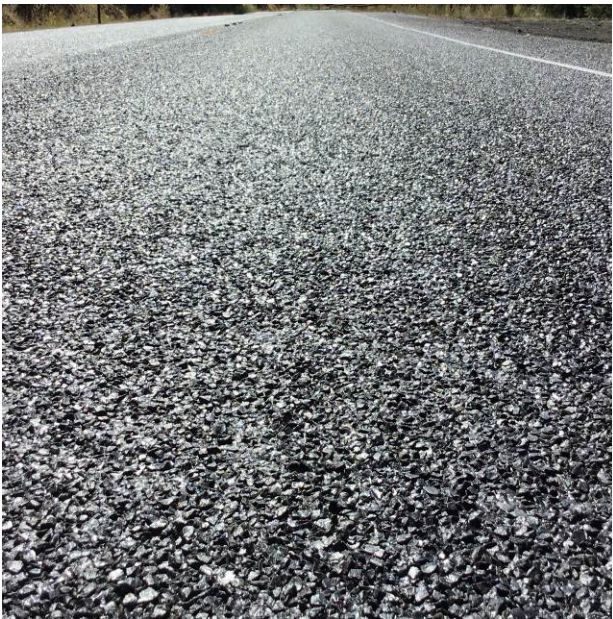
Figure 189. Close-up at MP 94.30 showing
uniform texture across the lane.

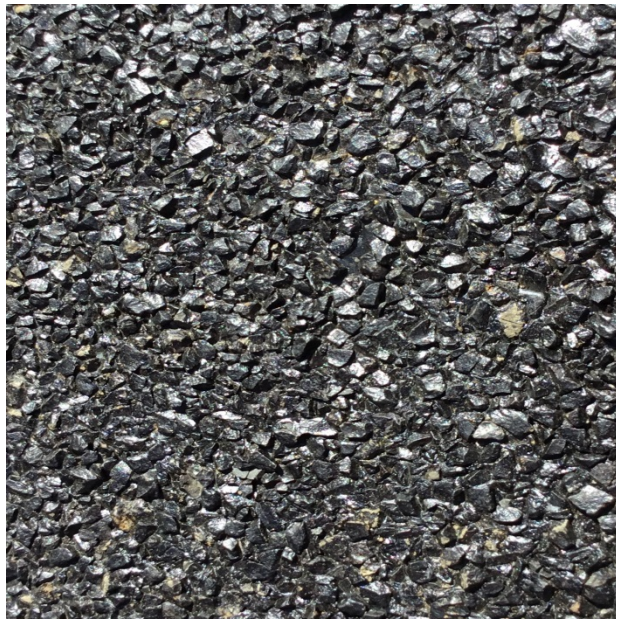
Figure 190. Closer-up at MP 94.30. (August
2017).

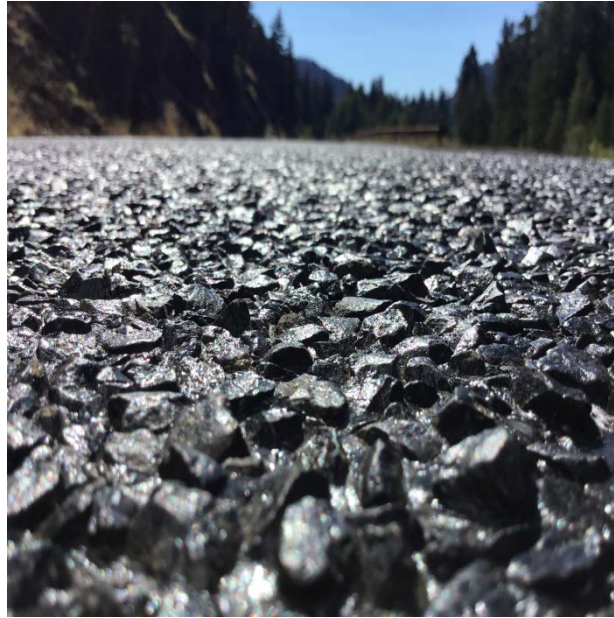
Figure 191. Road level view at MP 94.30 showing 30% embedment. (Aug. 2017)

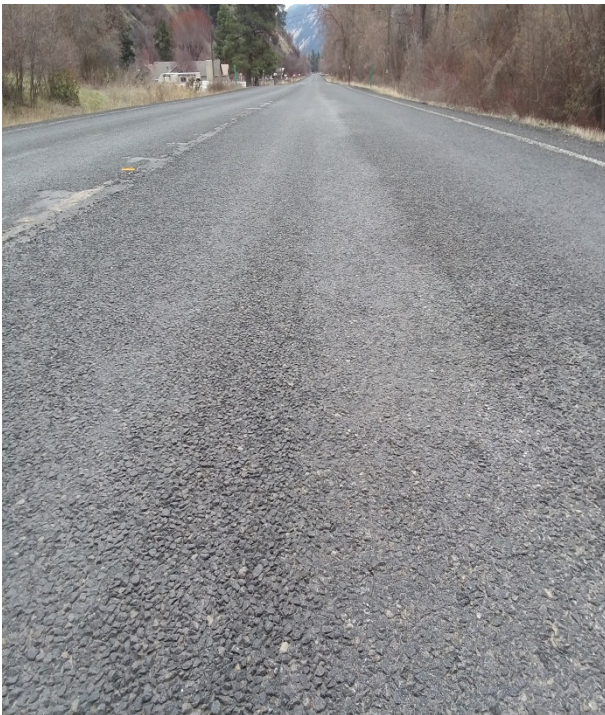
Figure 202. Typical good embedment on SR-410. (April 2018)
